MOLD AND MOISTURE ASSESSMENT REPORT

FRANCES W. MCCLENNEY ELEMENTARY

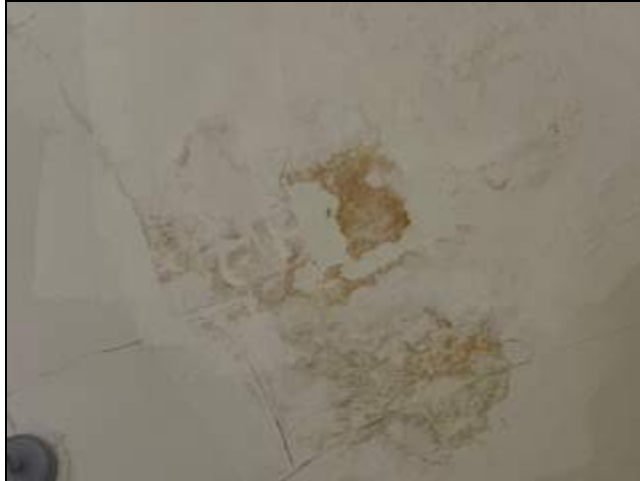
3 - Room 218 with water stained ceiling plaster; suspect mold observed.

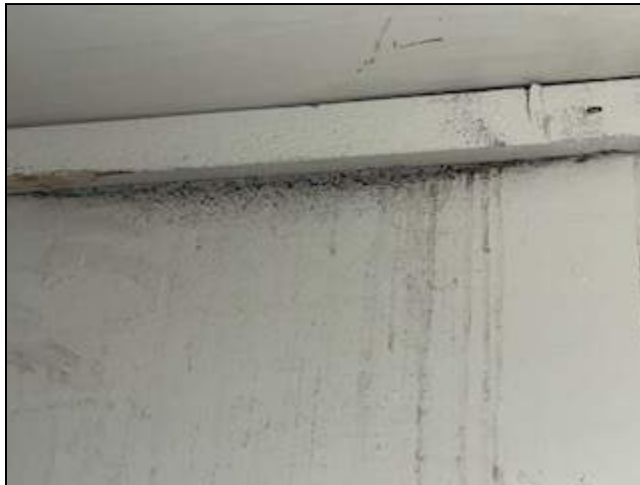
4 - View of plaster wall in the closet of room 218 with visible mold.

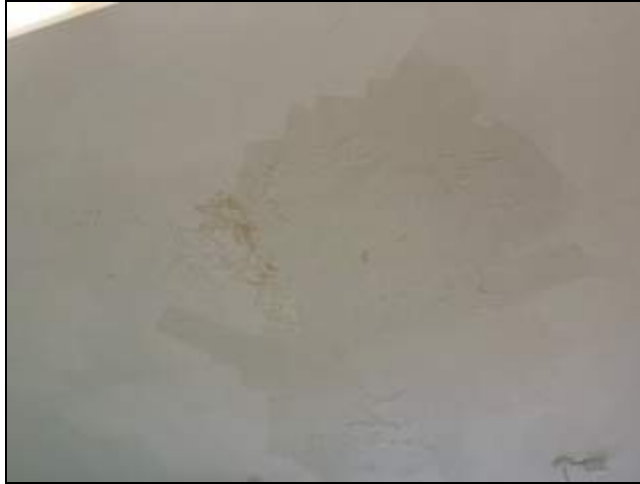
5 - View of room 217 ceiling with damaged plaster and water staining.

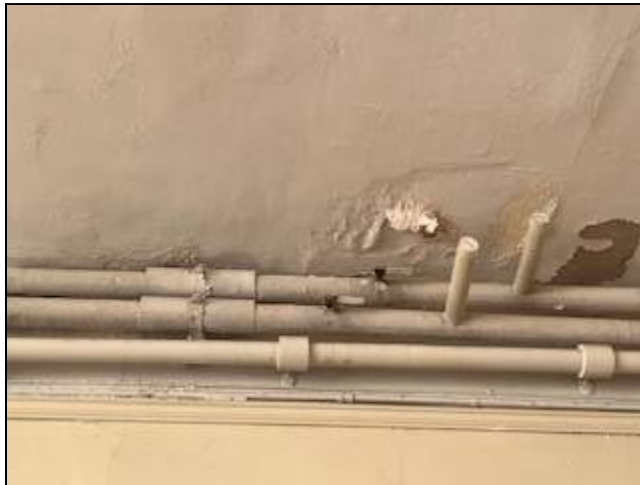
6 - View of room 211 ceiling showing water damage. ECS also observed a portion of the plaster on the floor below ceiling plaster.

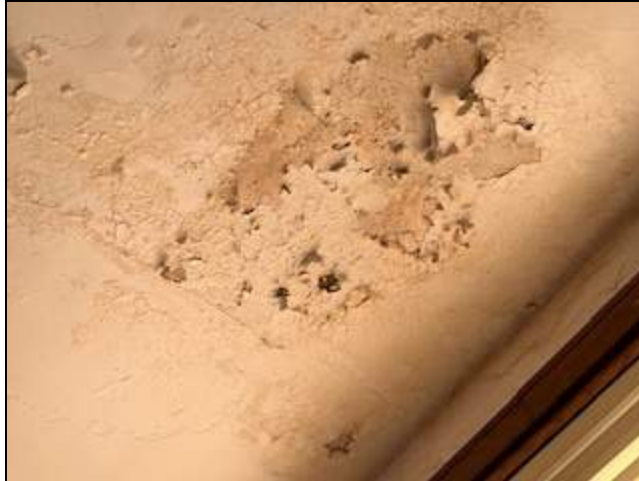
7 - View of room 211 ceiling showing water damage. ECS also observed a portion of the plaster on the floor below the damaged plaster.

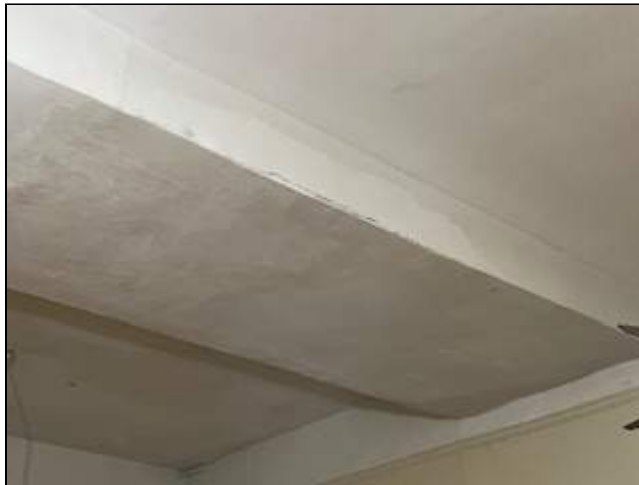
8 - View of the bulk head in the teachers lounge where it appears damage to the plaster has occurred from a possible pipe leak.

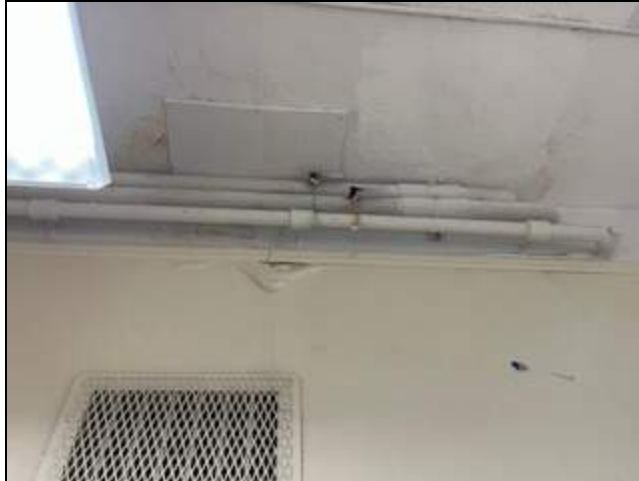
9 - View of room 222 with water damaged and stained ceiling plaster.

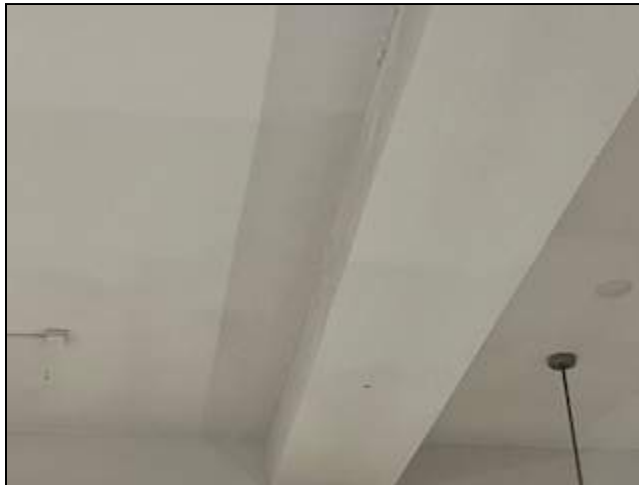
10 - View of damaged plaster bulk head in room 220 - possibly from pipe leaks.

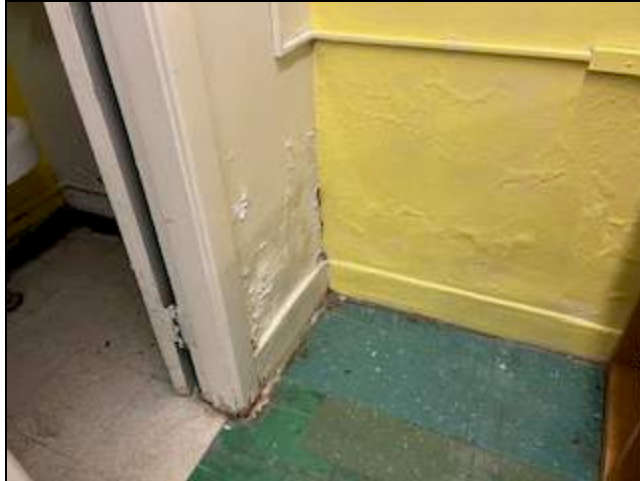
11 - View of damaged plaster in room B8 possibly from water intrusion from the exterior.

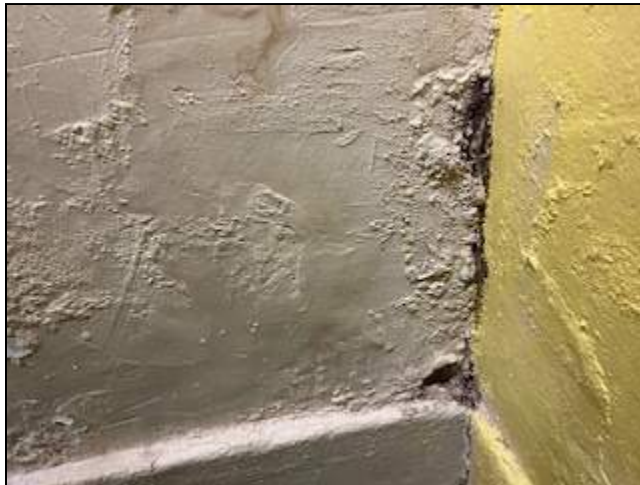
12 - View of damaged plaster in room B8 with visible mold observed.

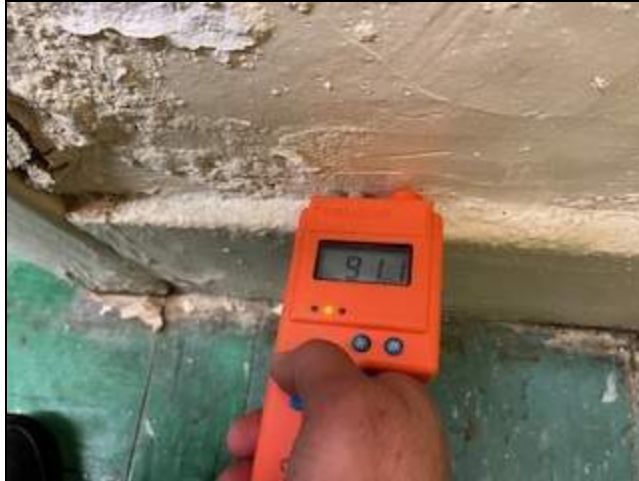
13 - View of moisture reading of the plaster wall in B8 showing elevated moisture levels.

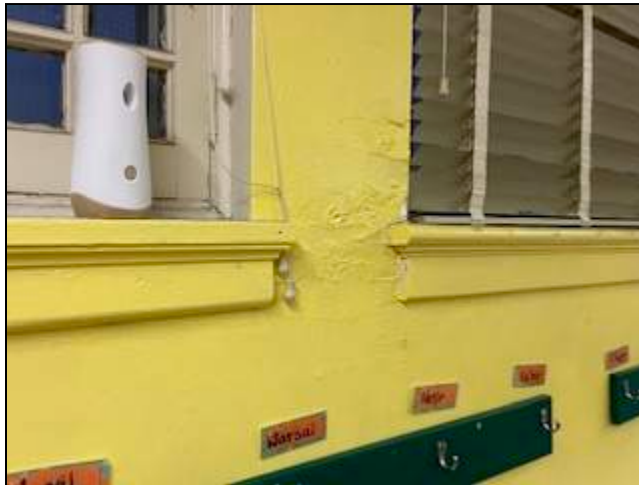
14 - View of water damaged plaster wall between the windows of room B7.

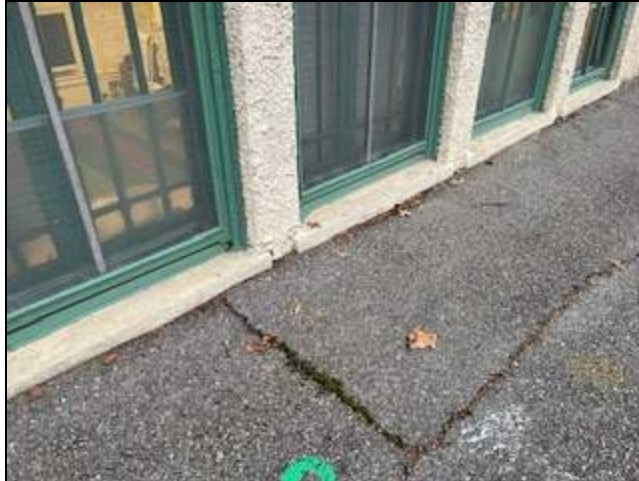
15 - View of exterior asphalt outside the basement room. ECS is unsure if this is outside room B8 where we observed active water intrusion and damaged plaster.

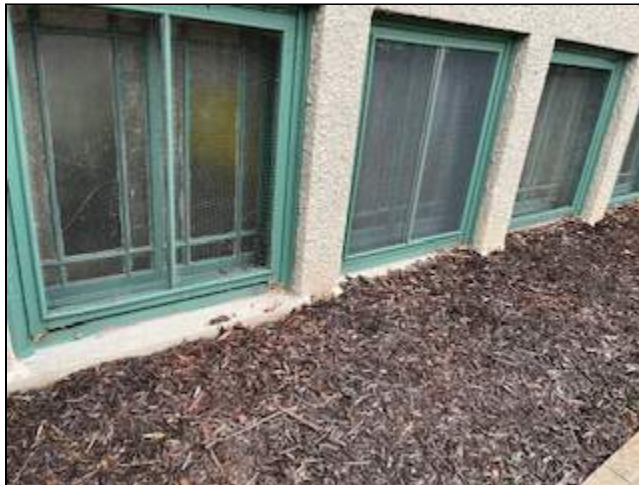
16 - View of mulch outside the basement room. ECS believes this may contribute to water intrusion if exterior water proofing is failing.
