MOLD AND MOISTURE ASSESSMENT REPORT

WOODVILLE ELEMENTARY SCHOOL

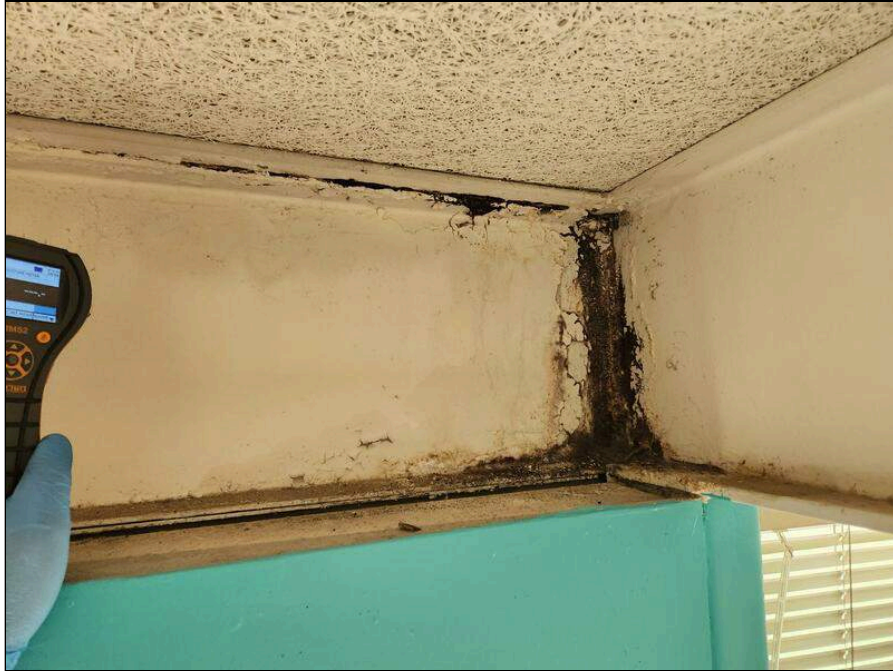
1 - Evidence of water intrusion and suspect mold on structural steel in B-105

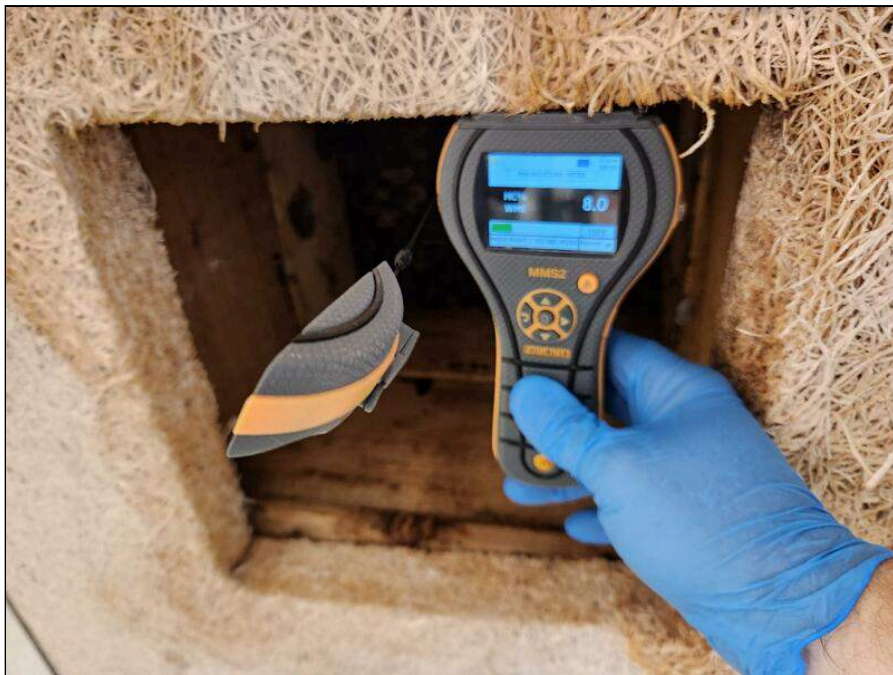
2 - Moisture stained tectum ceiling in B-106 Storage Room

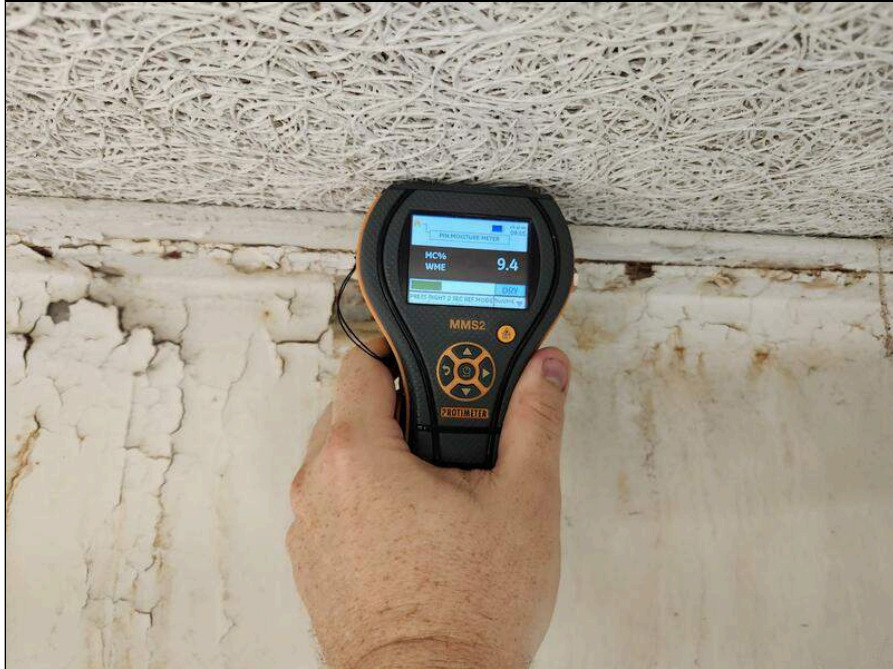
3 - Evidence of water intrusion on structural steel in B-106

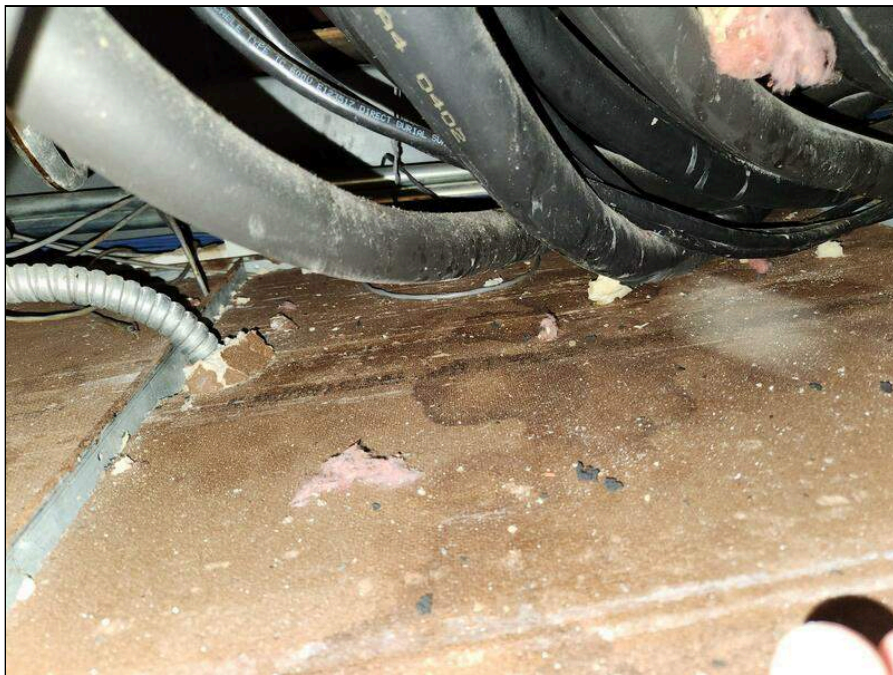
4 - Moisture staining and suspect mold on the back of a ceiling tile in the exterior exit hallway

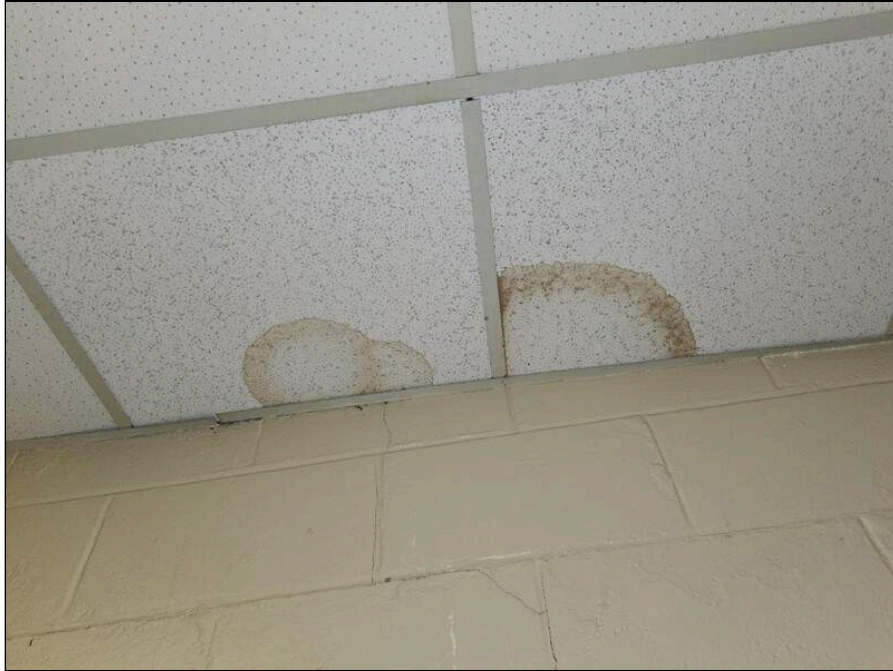
5 - Moisture stained ceiling tiles in the connector hall

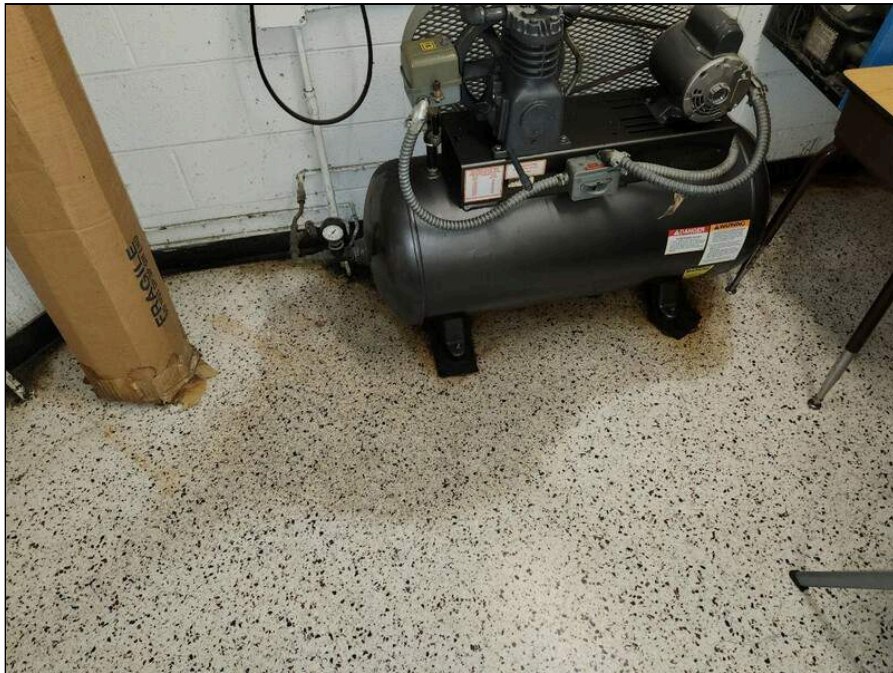
6 - Staining on floor associated with the compressor in the HVAC room

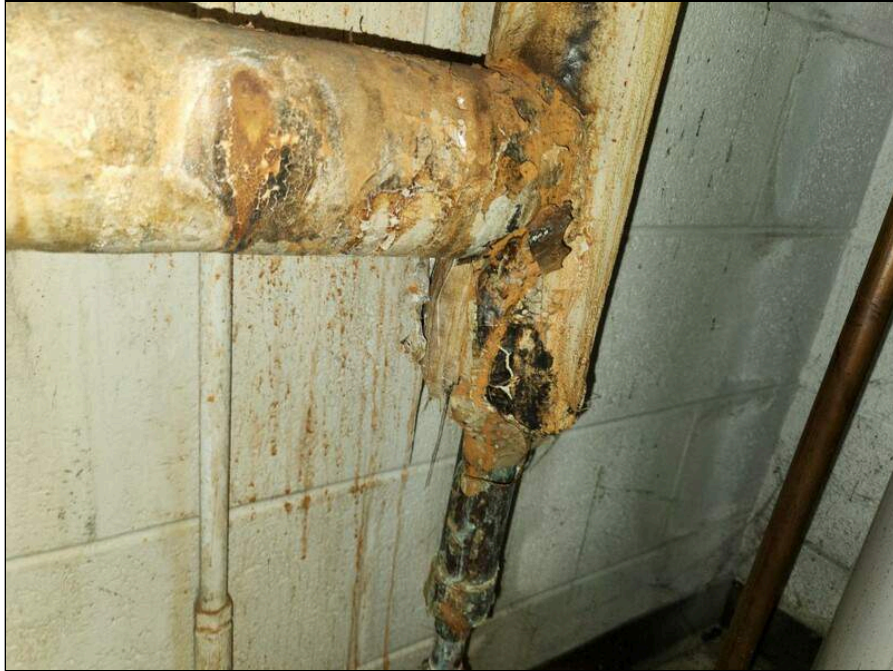
7 - Mold impacted pipe insulation in the HVAC Room

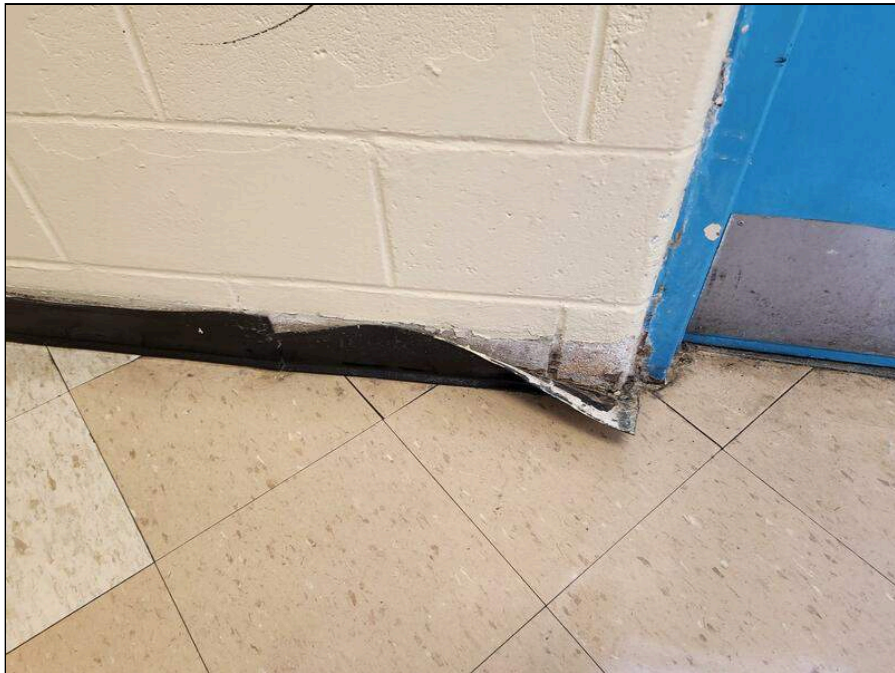
10 - Delaminating vinyl cove baseboard in the connector hallway

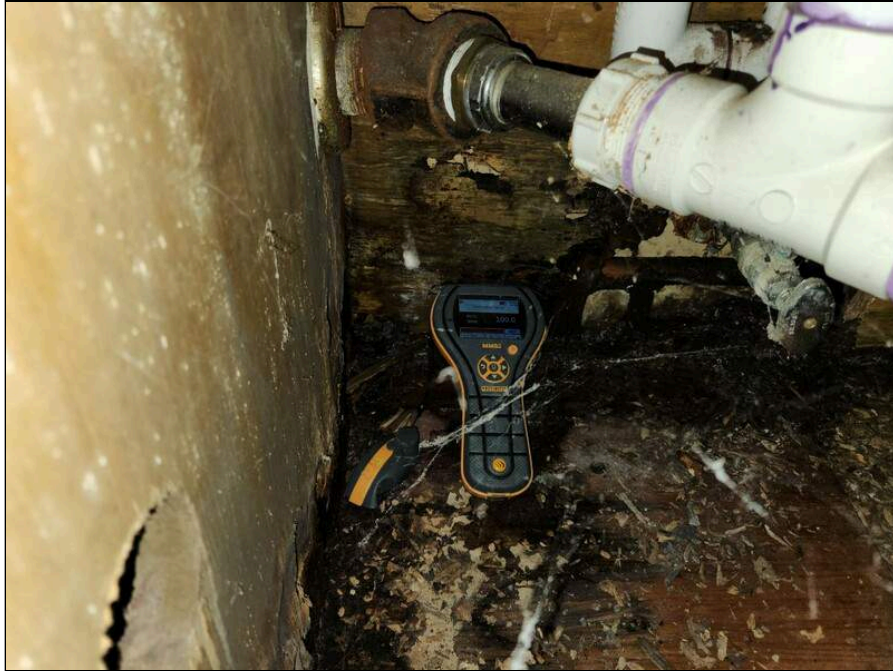
1 - Mold and evidence of an active water leak in the sink cabinet in Room 107

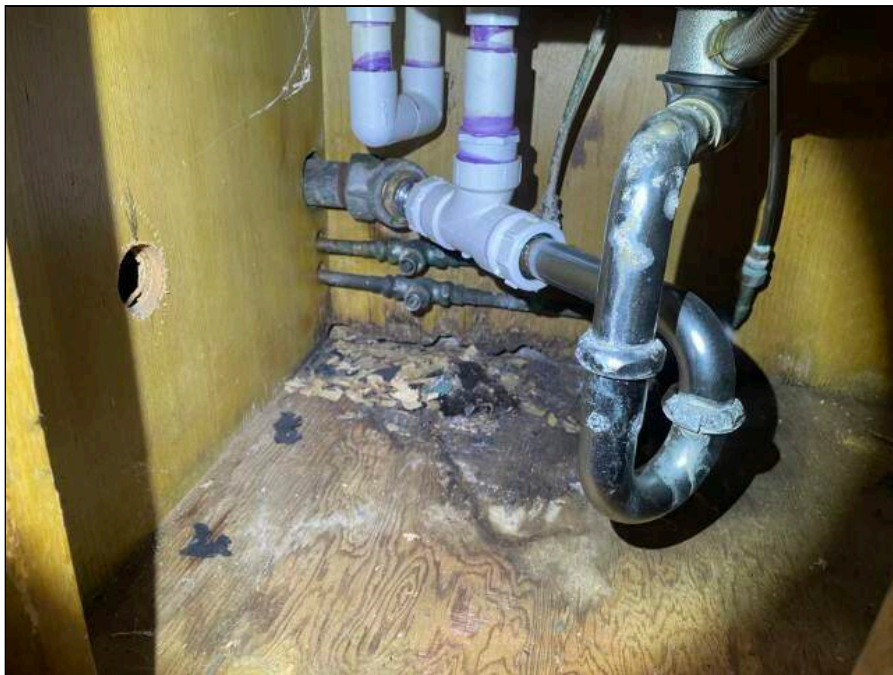
2 - Mold and moisture damaged sink cabinet in Room 109

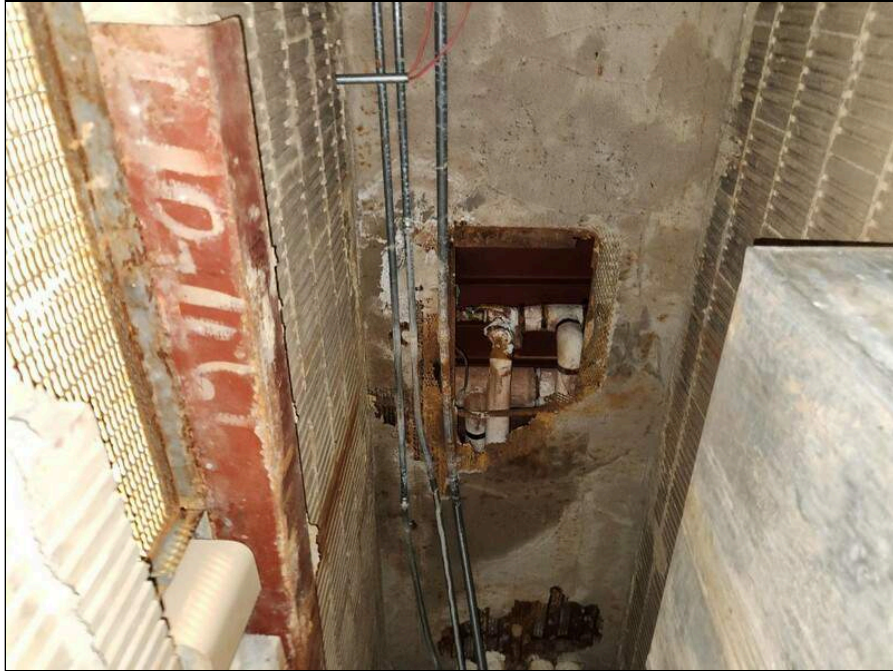
3 - Moisture damaged plaster ceiling within the hall bathroom - wet wall chase

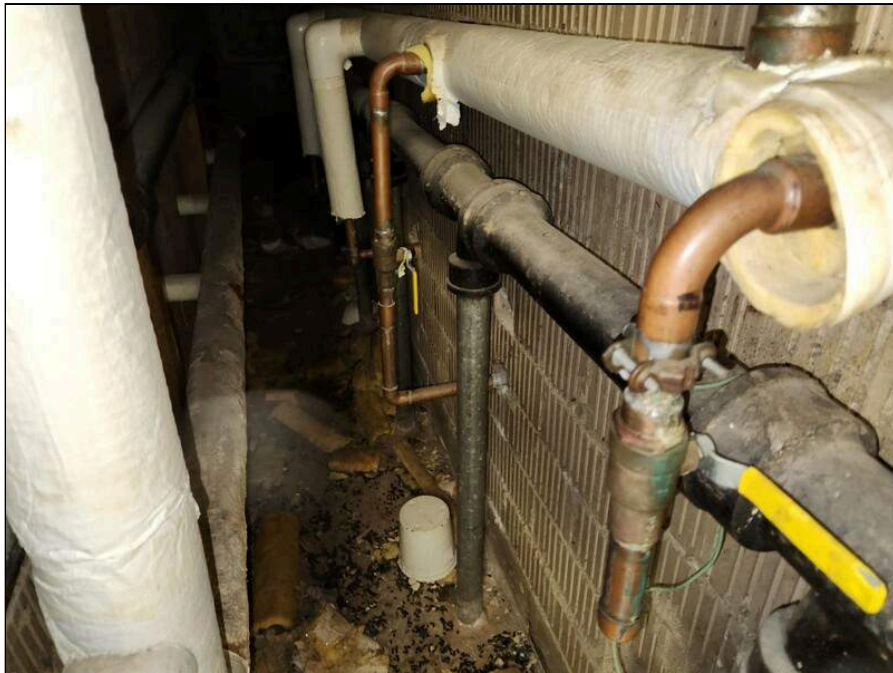
4 - Failing pipe insulation in the hall bathroom wet wall chase

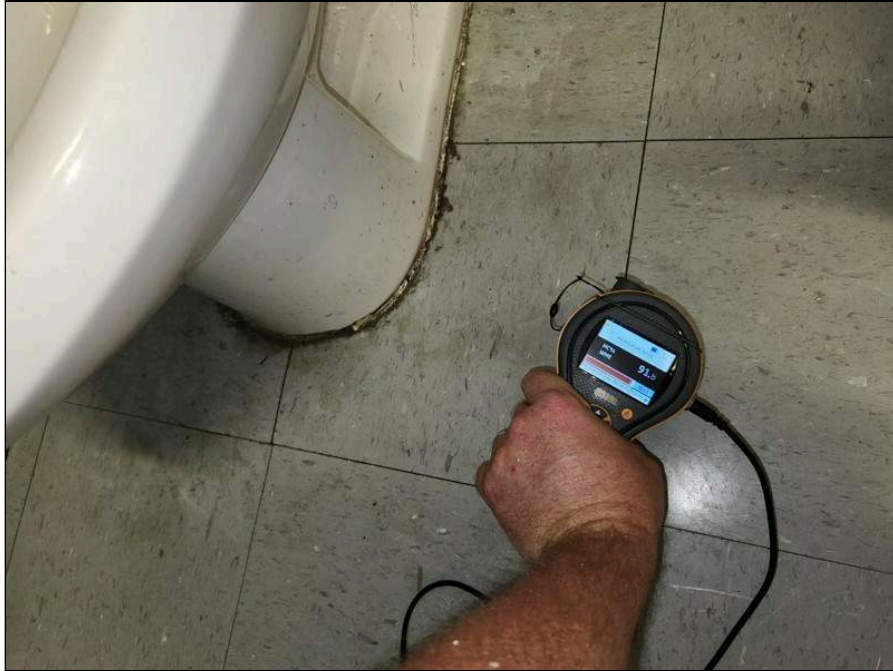
5 - Elevated moisture associated with the flooring around the toilet in the Clinic

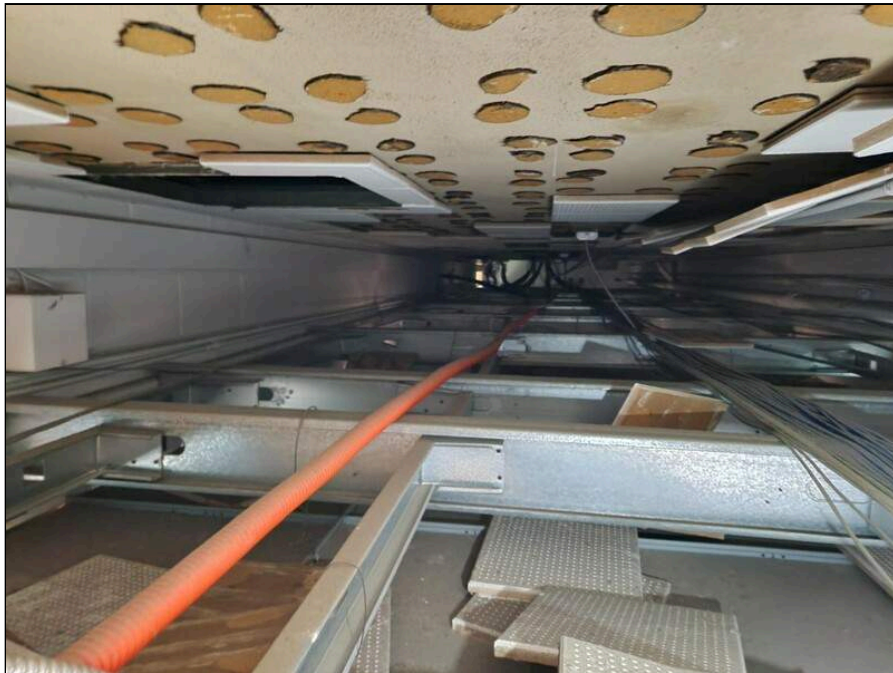
6 - Delaminating 1'x1' ceiling tiles above the main hallway

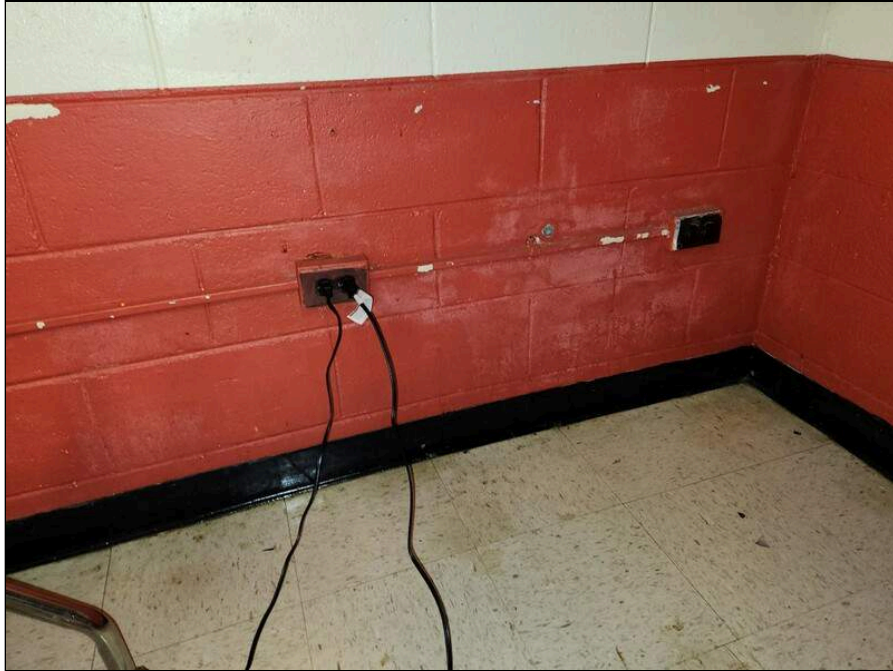
7 - Mold staining on the walls of the Social Worker's office, tape lift sample location T1

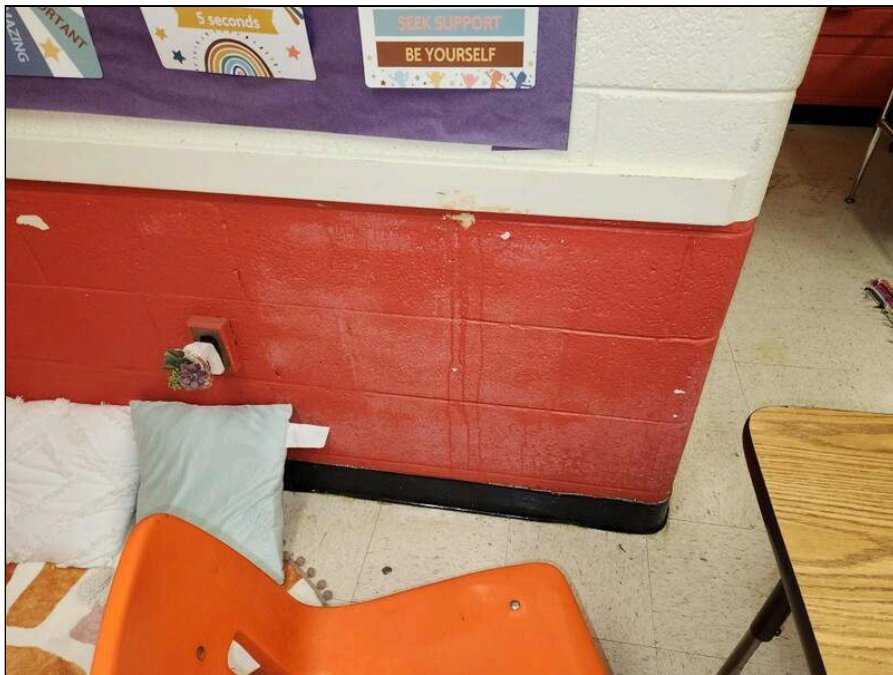
8 - Mold staining on the walls of the Social Worker's office

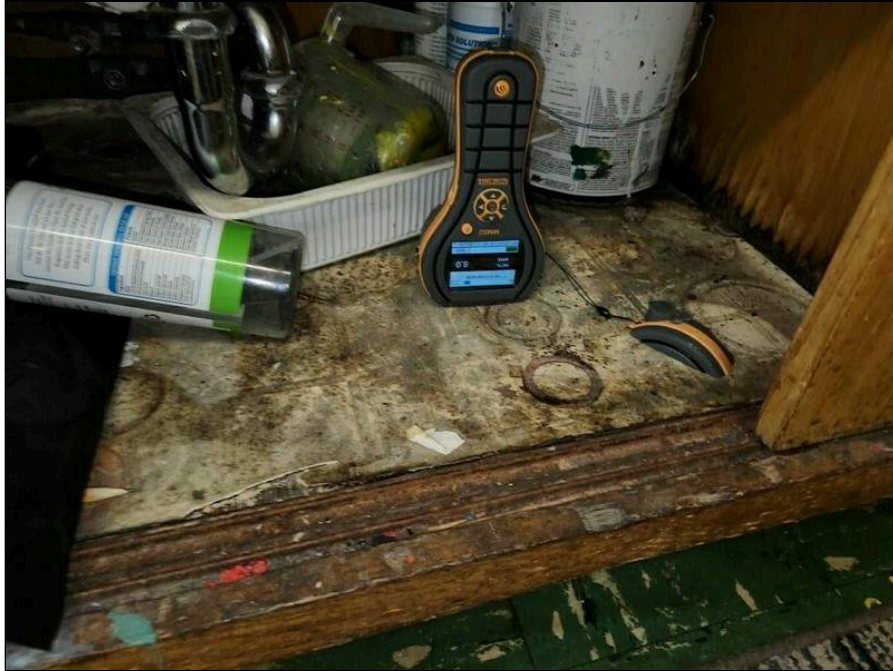
9 - Mold impacted sink cabinet in Room 102

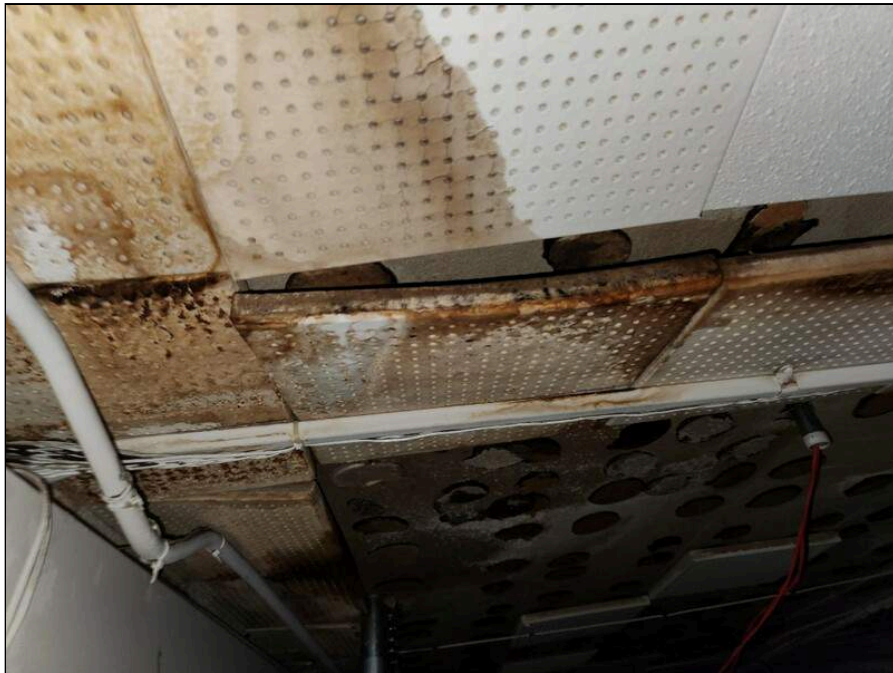
10 - Moisture damaged plaster ceiling in the main hallway

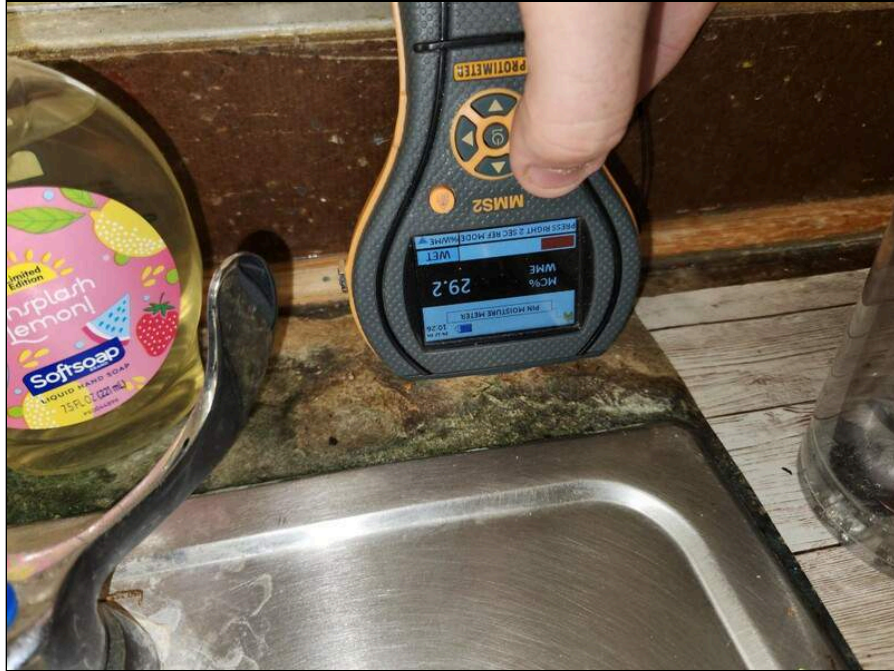
11 - Elevated moisture meter reading on the top of the sink in Room 119

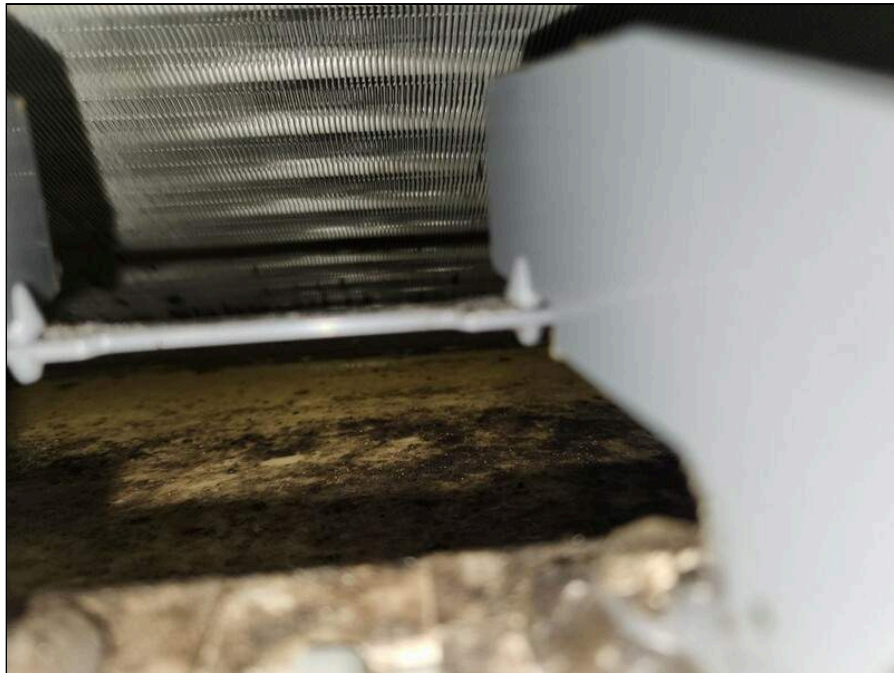
12 - Mold observed within the PTAC unit in Room 116

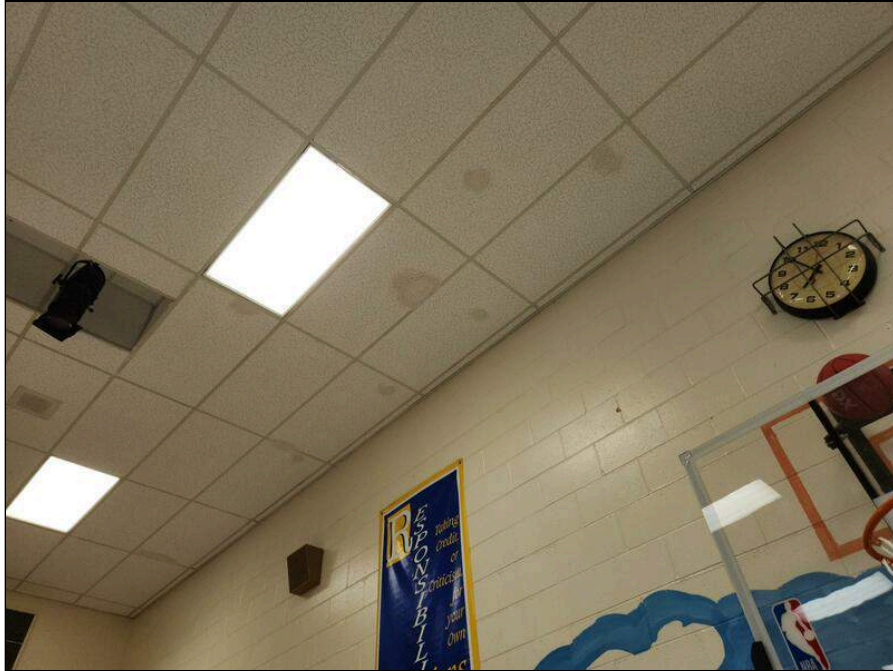
13 - Moisture stained ceiling tiles in the multi-purpose room

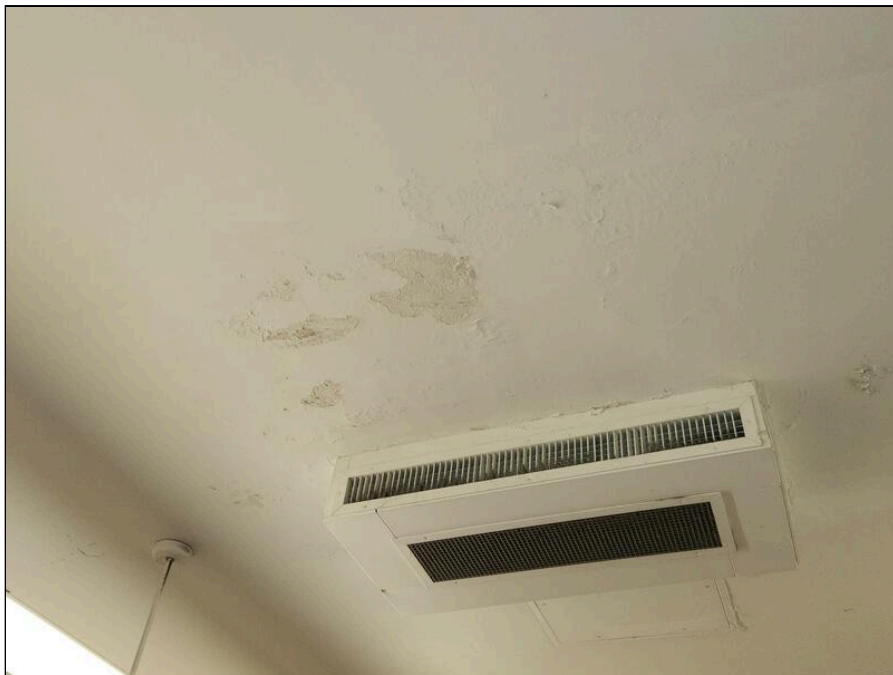
14 - Moisture and Mold impacted plaster ceiling and mold impacted ceiling PTAC unit in Room 113

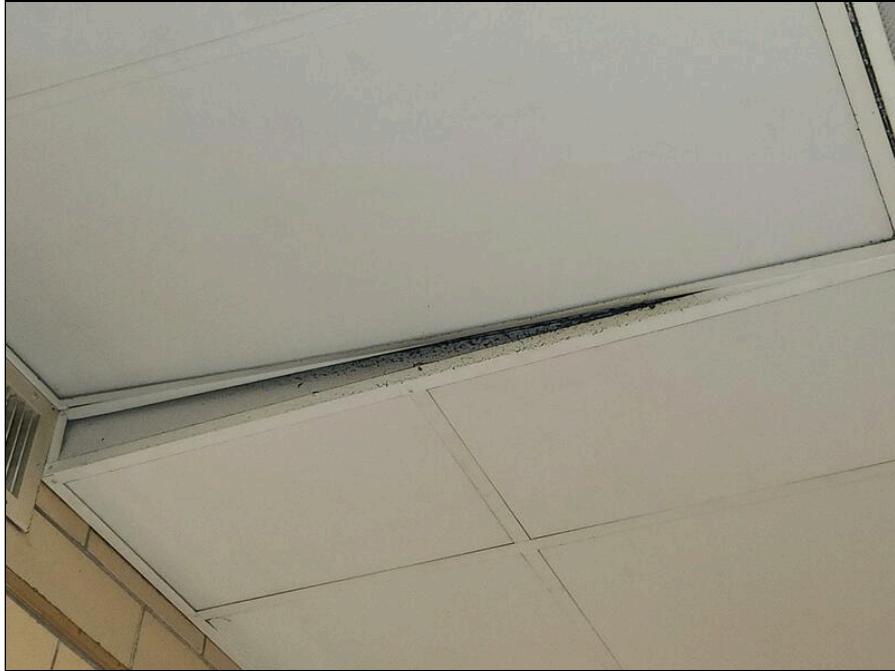
15 - Mold impacted ceiling tiles in the kitchen adjacent to an HVAC supply

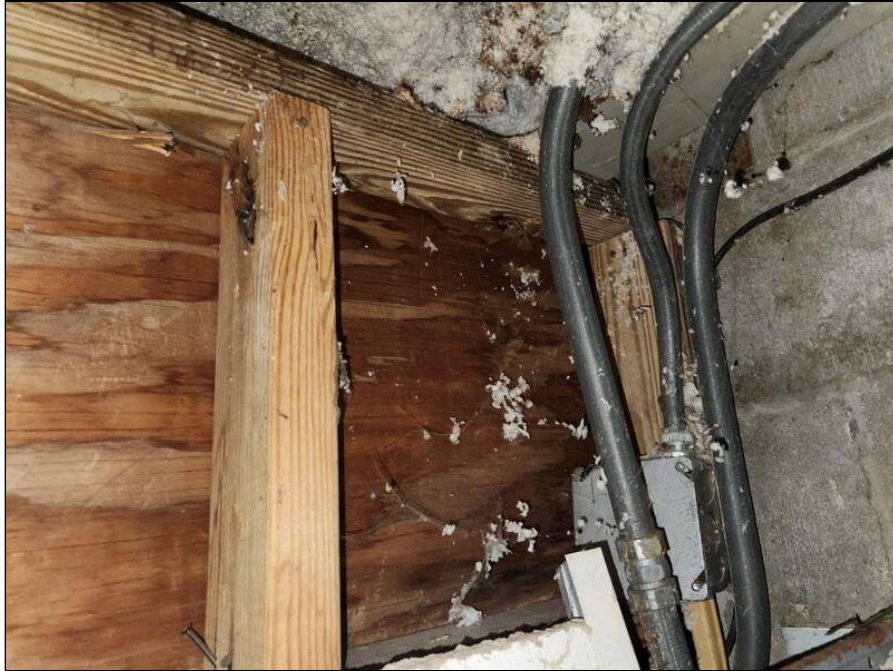
1 - Moisture impacted wood paneling above the ceiling in the A-Pod connector Hall

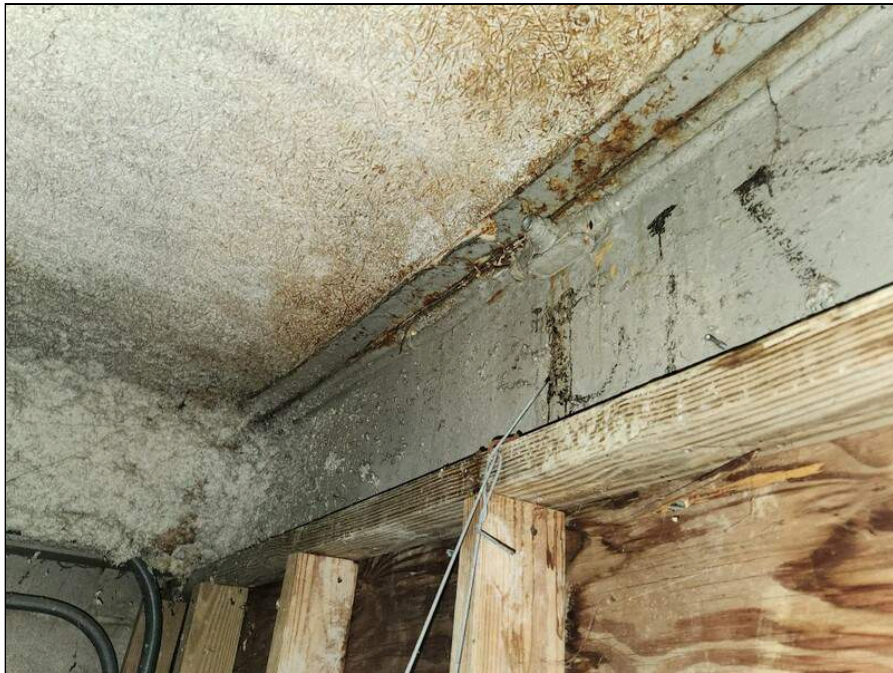
2 - Moisture impacted tectum ceiling and steel beam above the ceiling in the A-Pod connector Hall

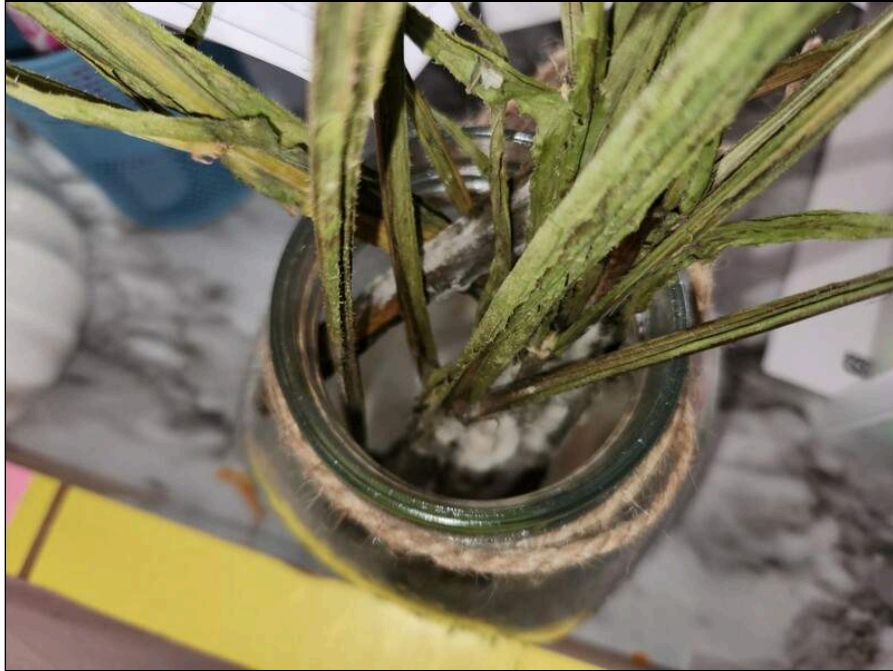
3 - Mold observed on a plant on the teacher's desk in Room A-5

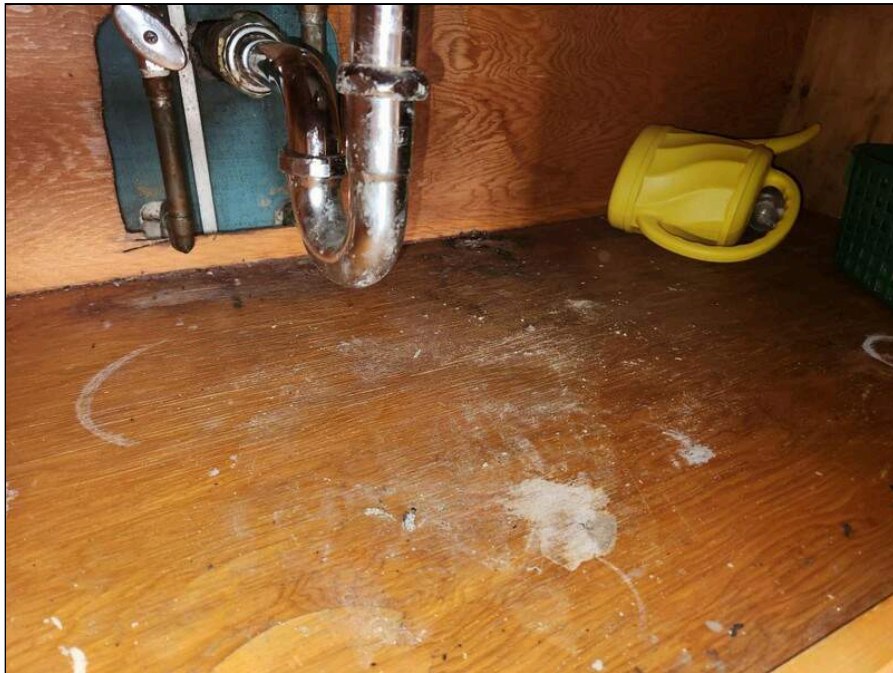
4 - Moisture and mold impacted sink cabinet in Room A-5

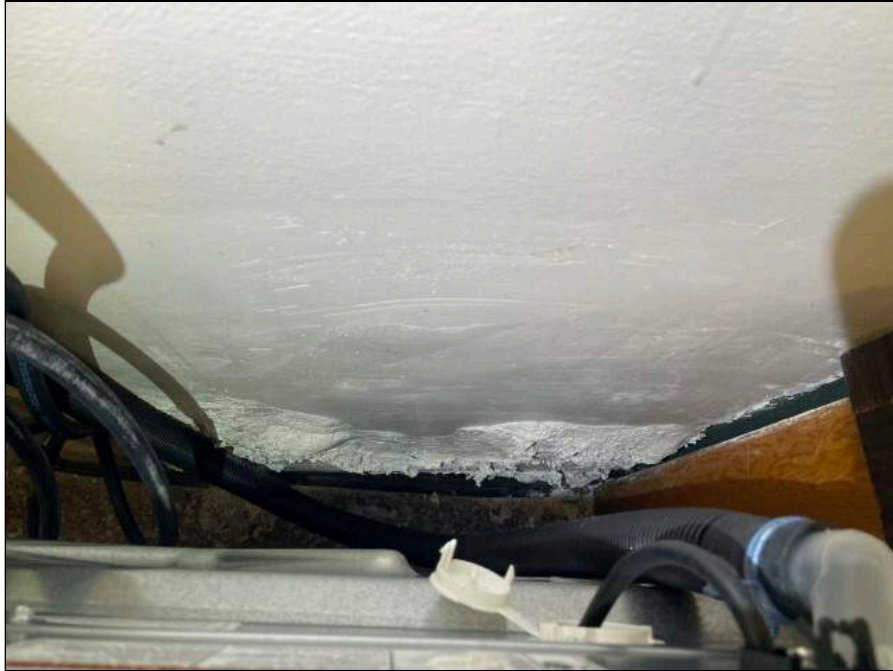
5 - Moisture damaged plaster wall behind the washing machines in Room A-8

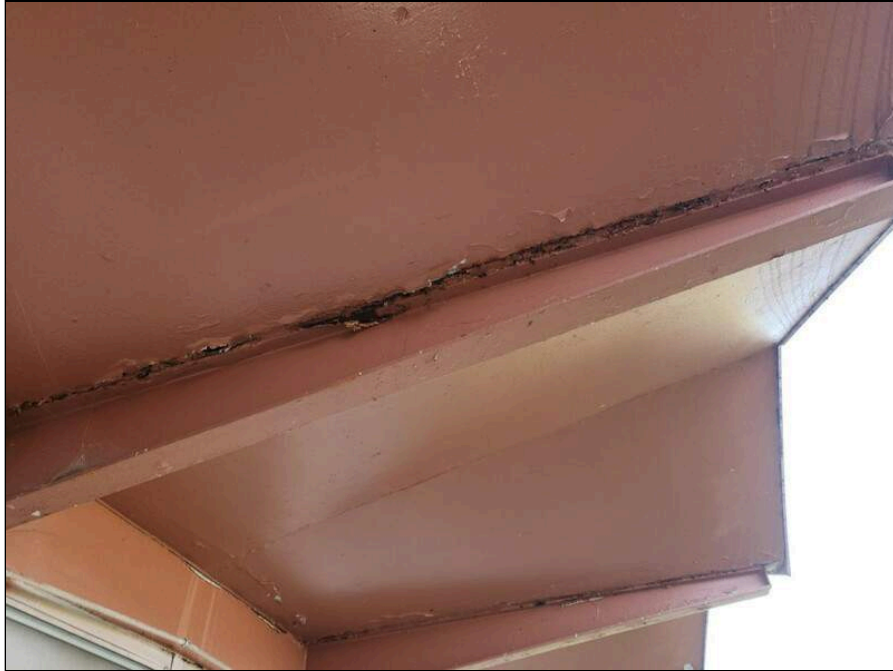
1 - Damaged roof support beam and soffit at B-Pod

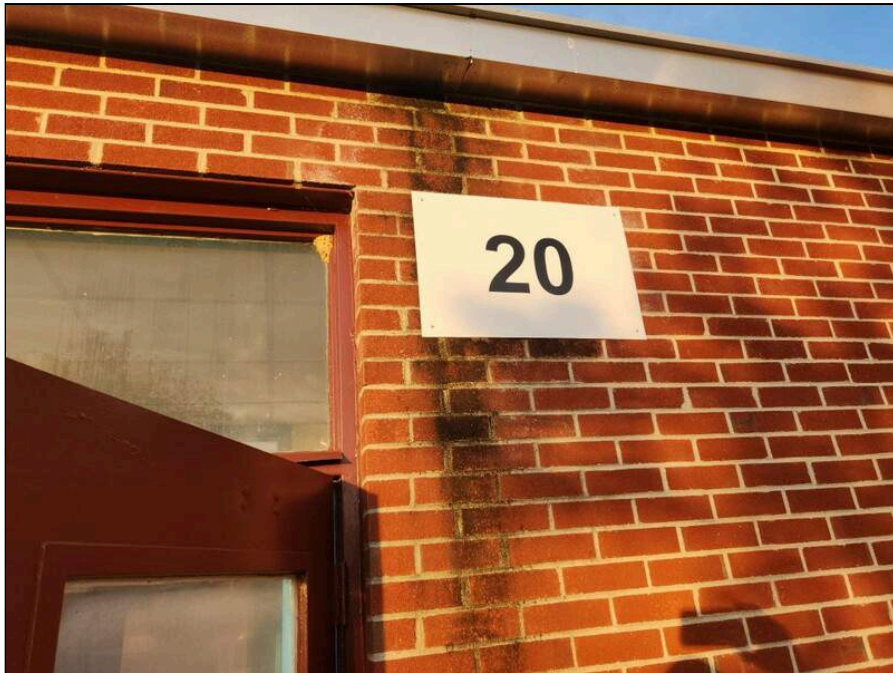
2 - Staining on the exterior brick outside the B-Pod connector hall

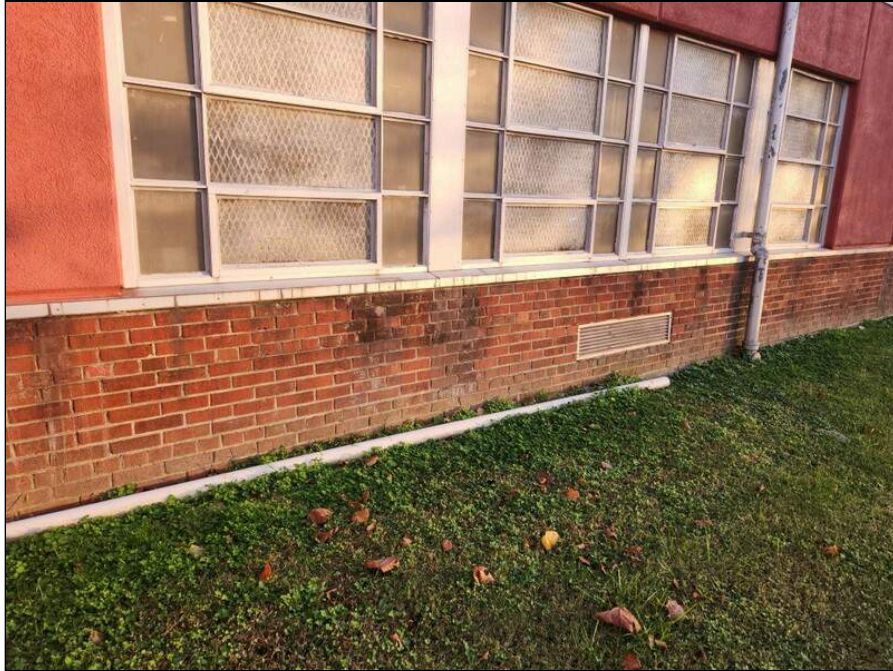
3 - Staining on the exterior brick outside Room 109

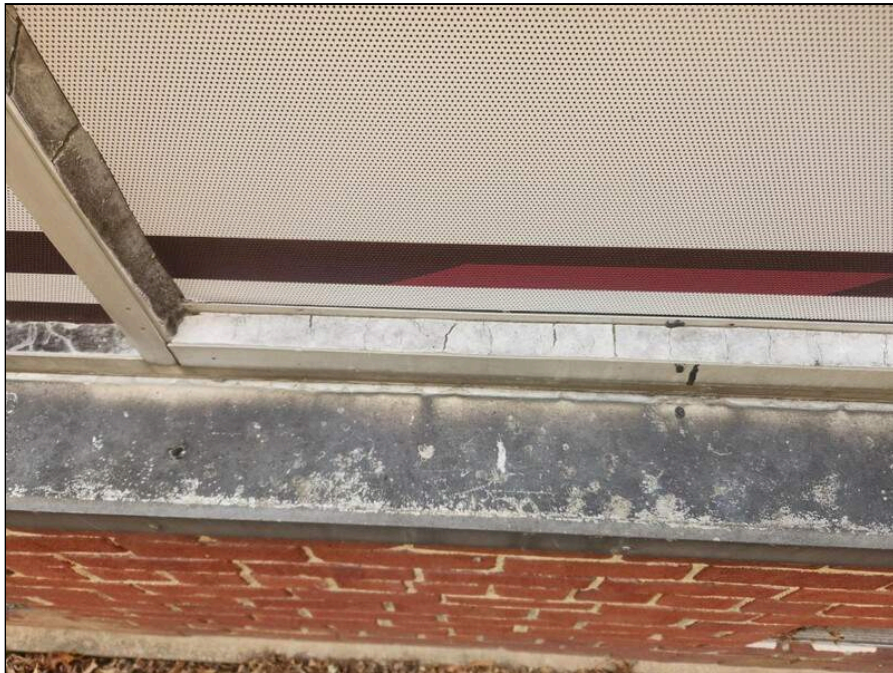
4 - Failing window sash glazing on the main building

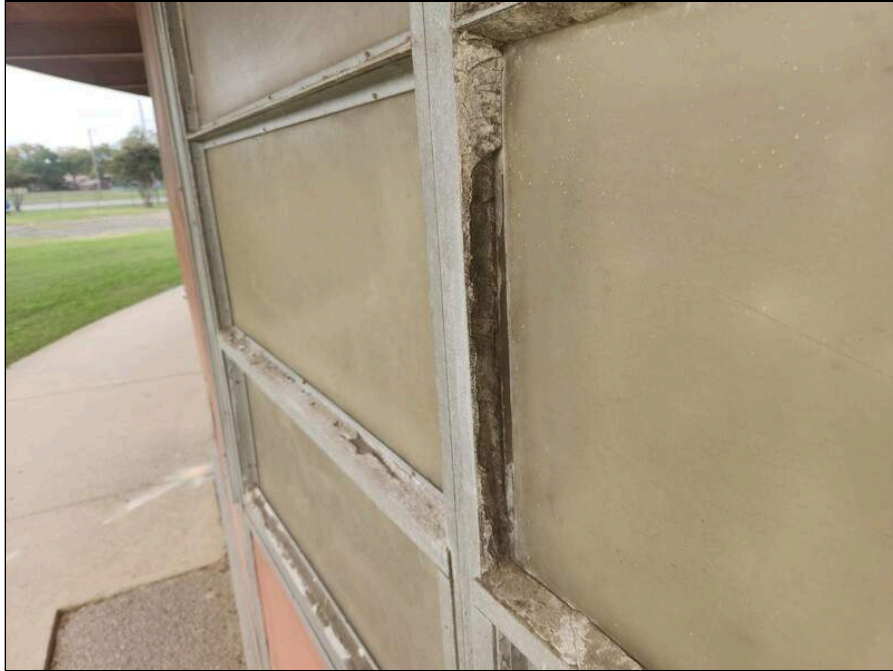
5 - Failing window sash glazing on the A-Pod

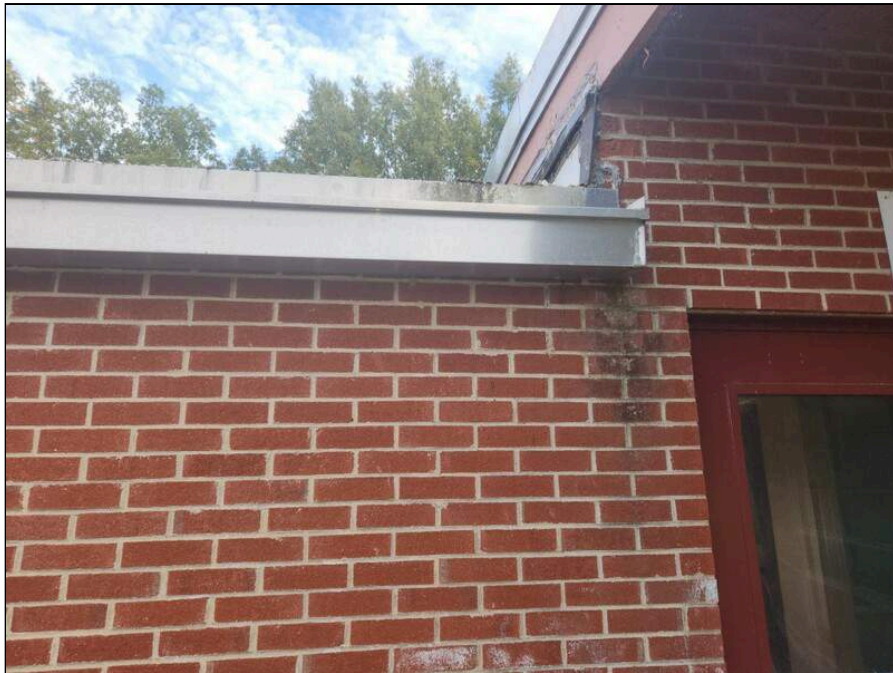
6 - Staining on the exterior brick outside the A-Pod connector

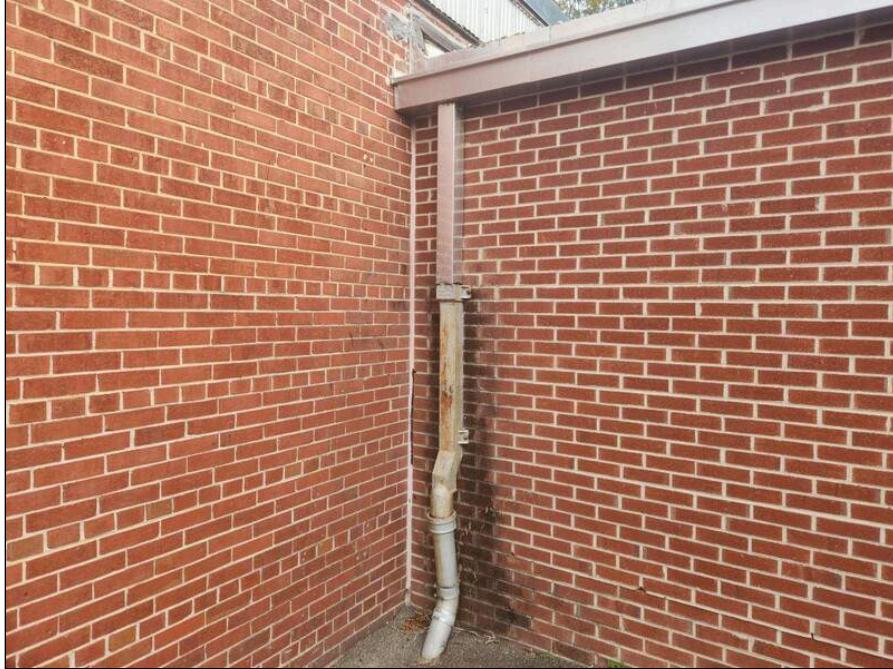
7 - Staining on the exterior brick outside the A-Pod connector

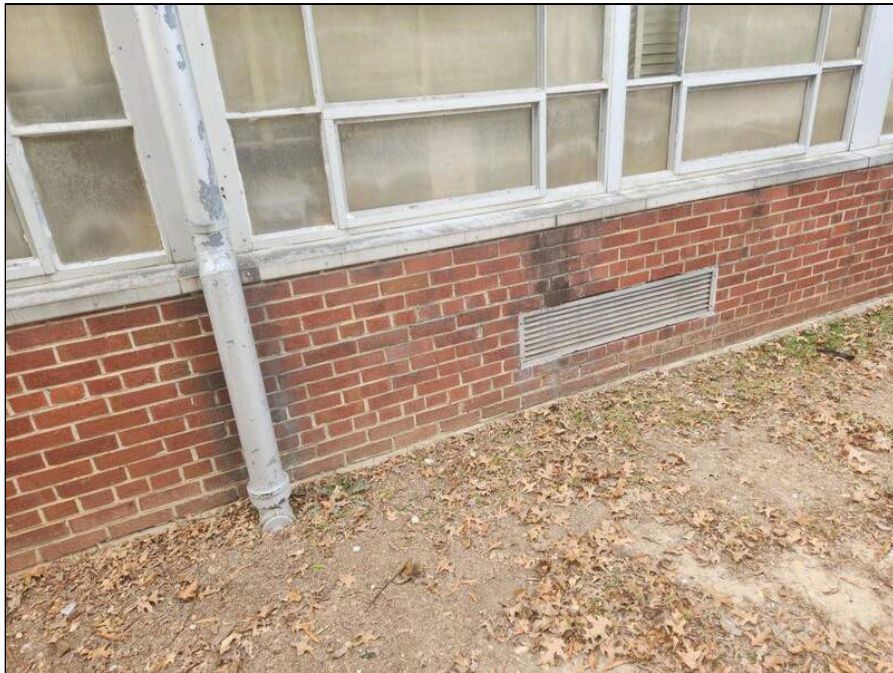
8 - Staining on the exterior brick outside room 102
