# MOLD AND MOISTURE ASSESSMENT REPORT

MAYMONT PRESCHOOL

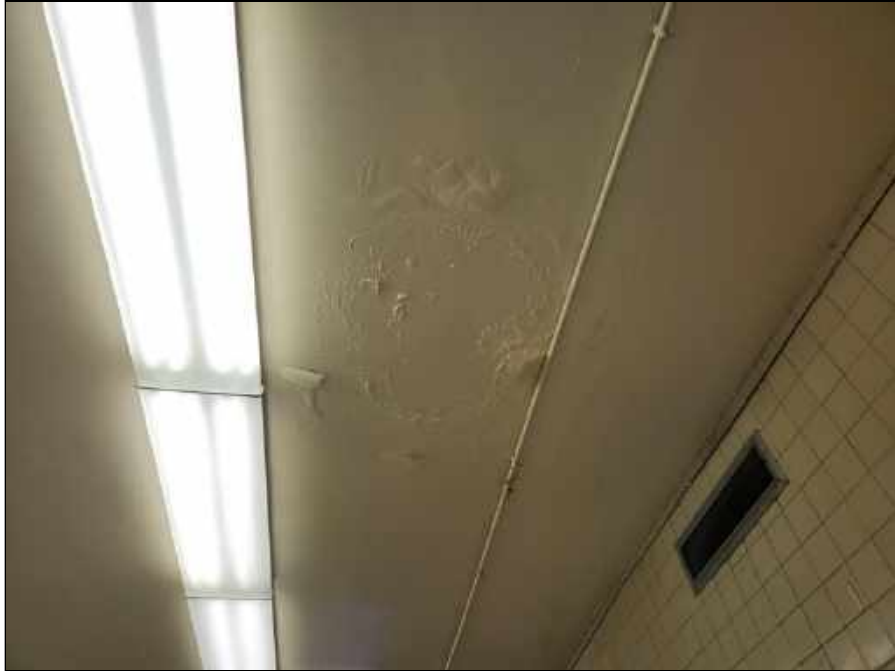
1 - Moisture Impacted Plaster Ceiling in the Kitchen

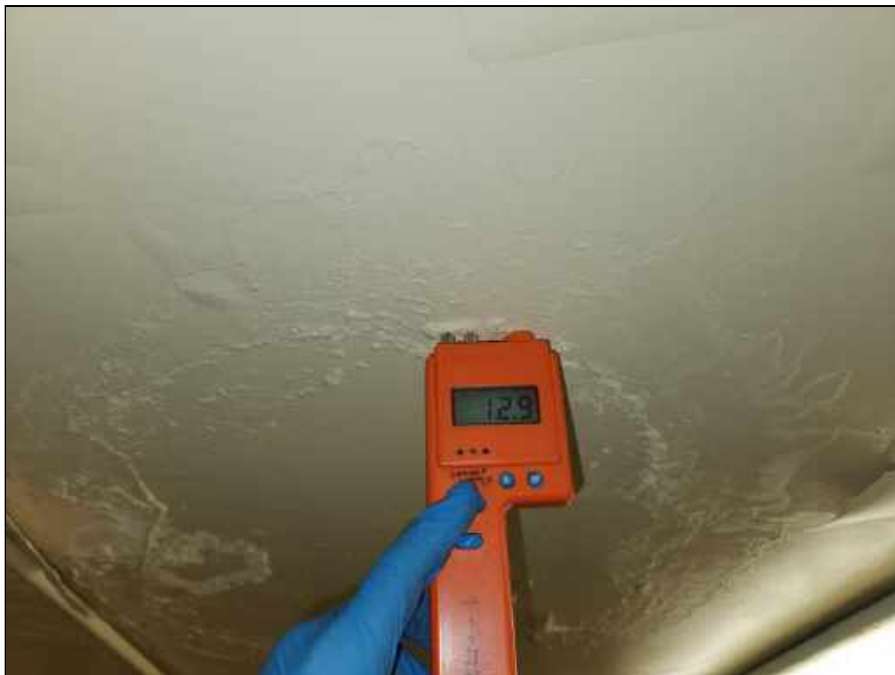
2 - Moisture Meter Indicating the Plaster Ceiling is Dry

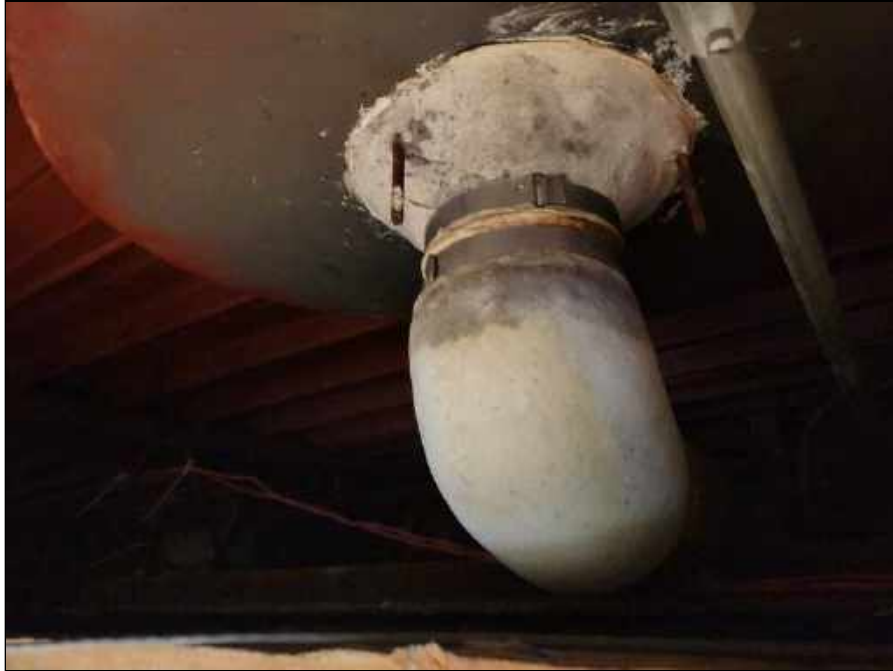
3 - Mold Impacted Roof Drain Collar and Mudded Elbow Above the Teacher's Lounge

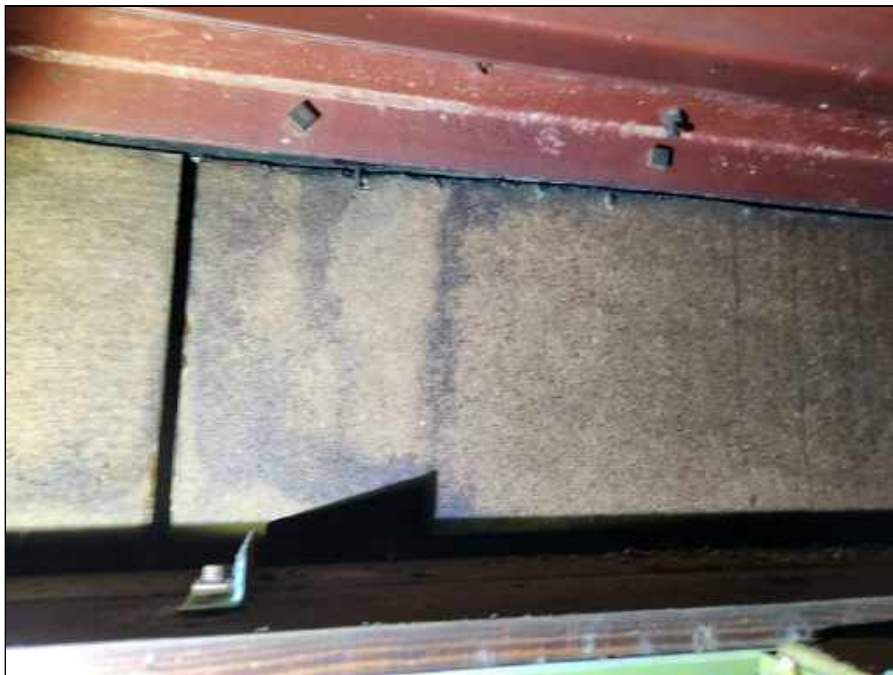
4 - Moisture Impacted Particle Board Soffit Materials in the Teacher's Lounge

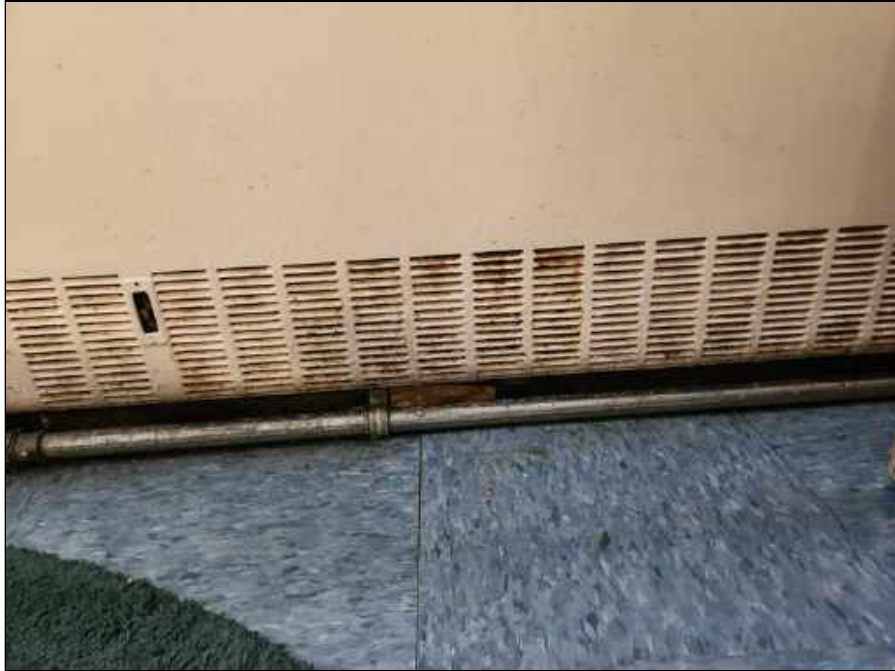
5 - Dust and Dirt Buildup on the Fan Coil Unit in Room 100

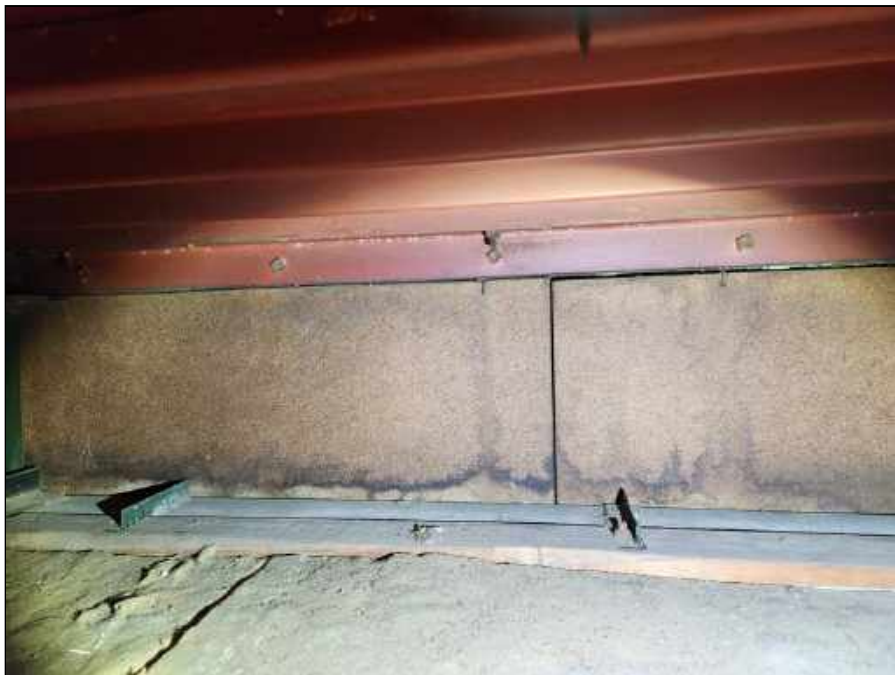
6 - Moisture Impacted Particle Board Soffit Material in Room 102

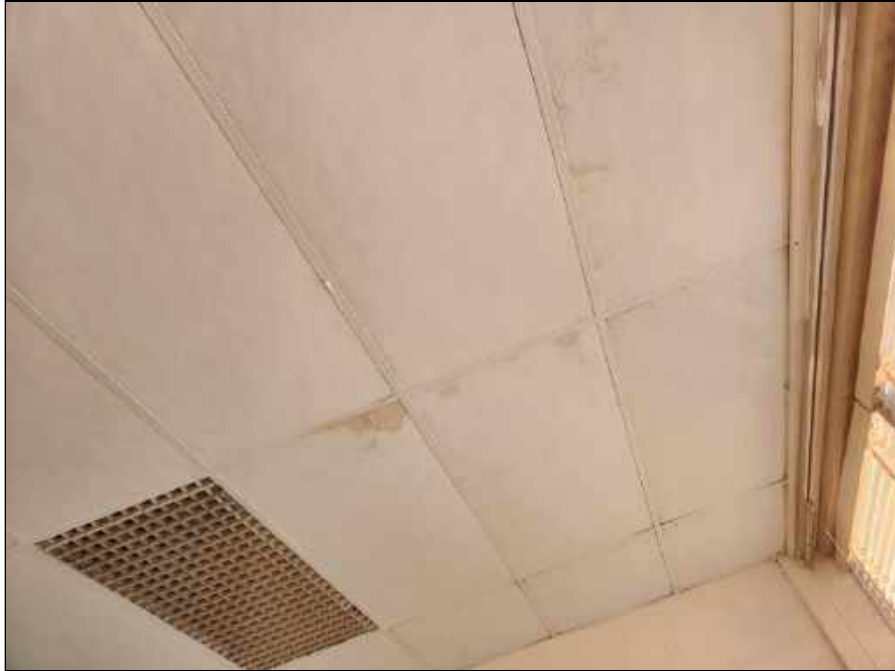
7 - Water Stained Ceiling Tiles in the Teacher's Lounge

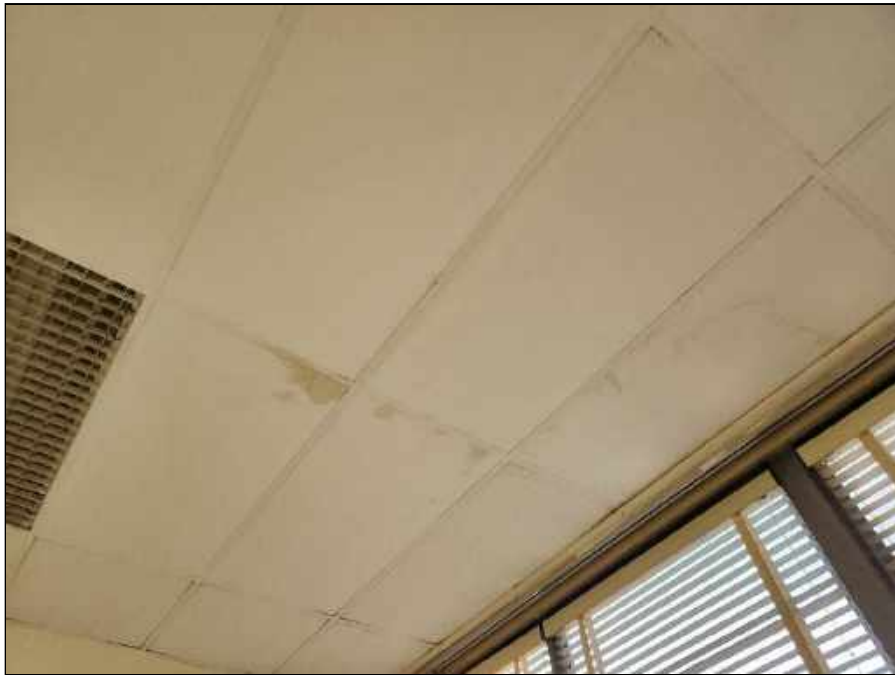
8 - Water Stained Ceiling Tiles in Room 100

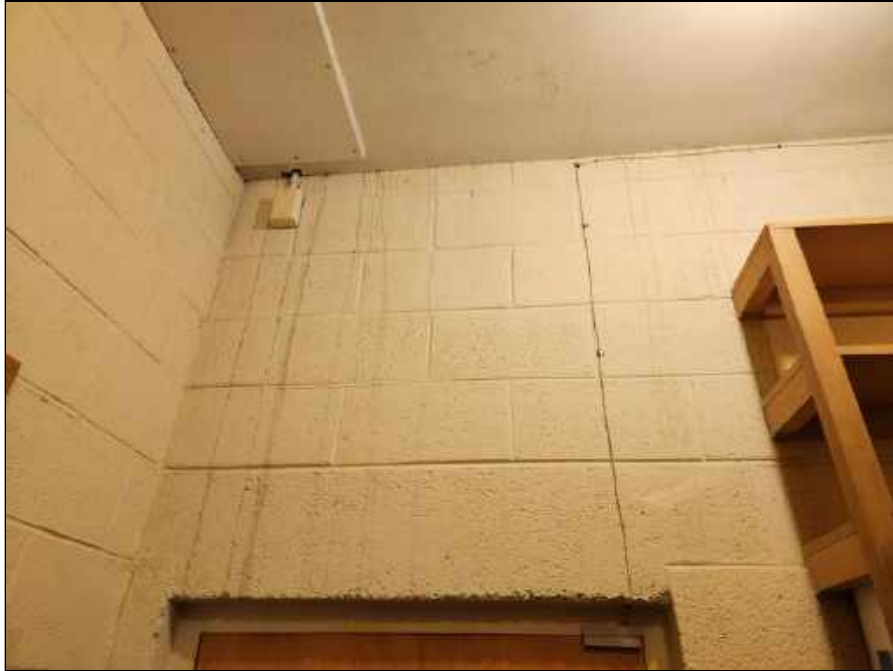
9 - Moisture Stained Plaster Ceiling in the Office

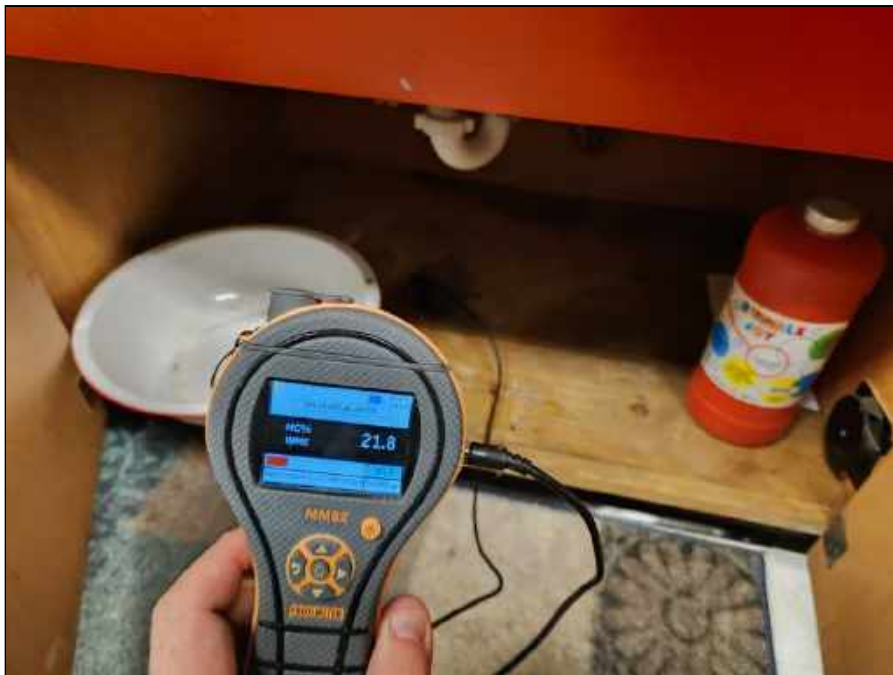
10 - Elevated Moisture Meter Reading in the Sink Vanity in the Office

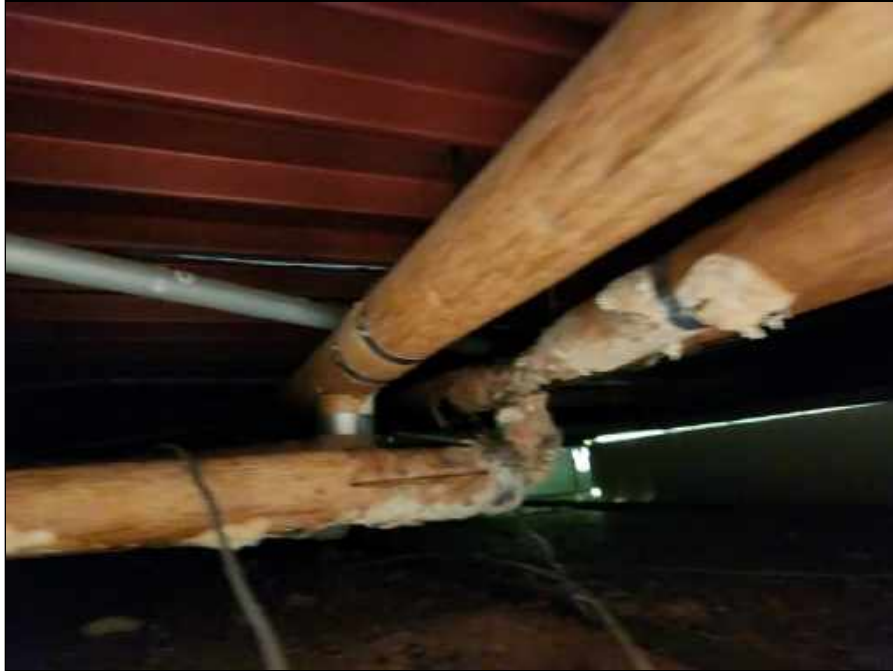
11 - Damaged Asbestos Containing Mudded Pipe Fitting Above the Nurse's Office

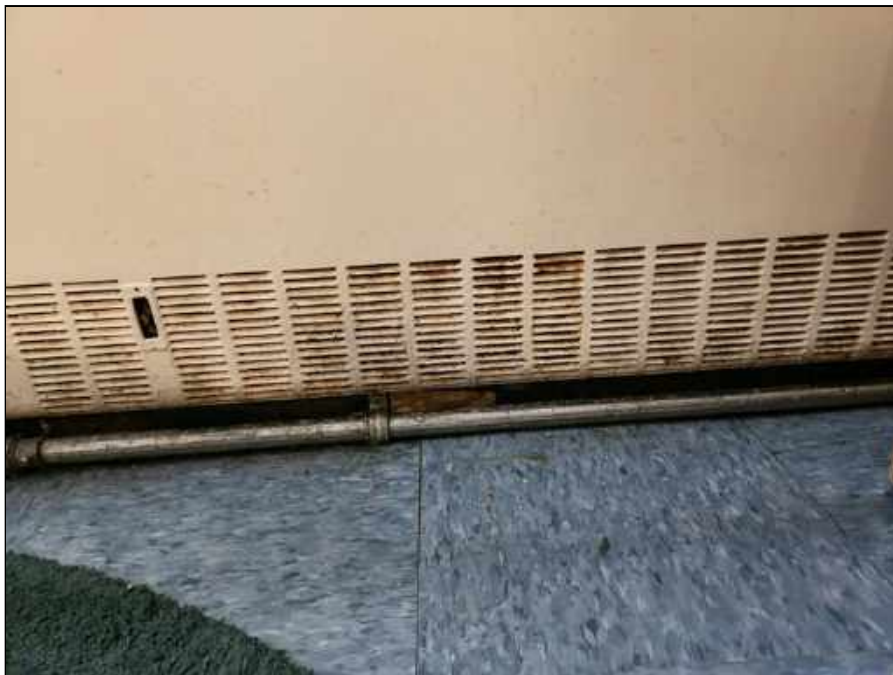
12 - Dust and Dirt Buildup on the Fan Coil Unit in the Teacher's Lounge

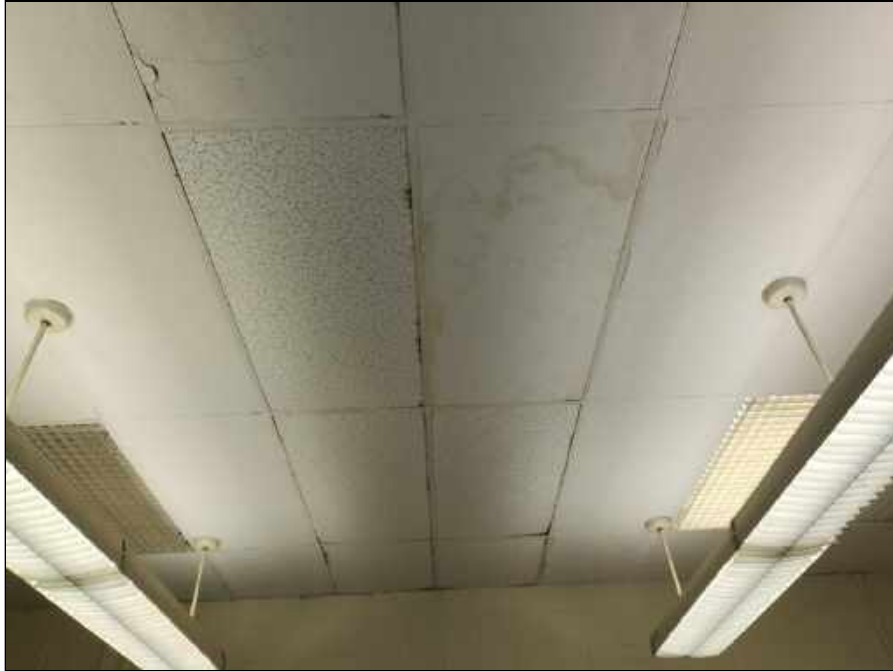
15 - Moisture Stained Ceiling Tiles in Room 108

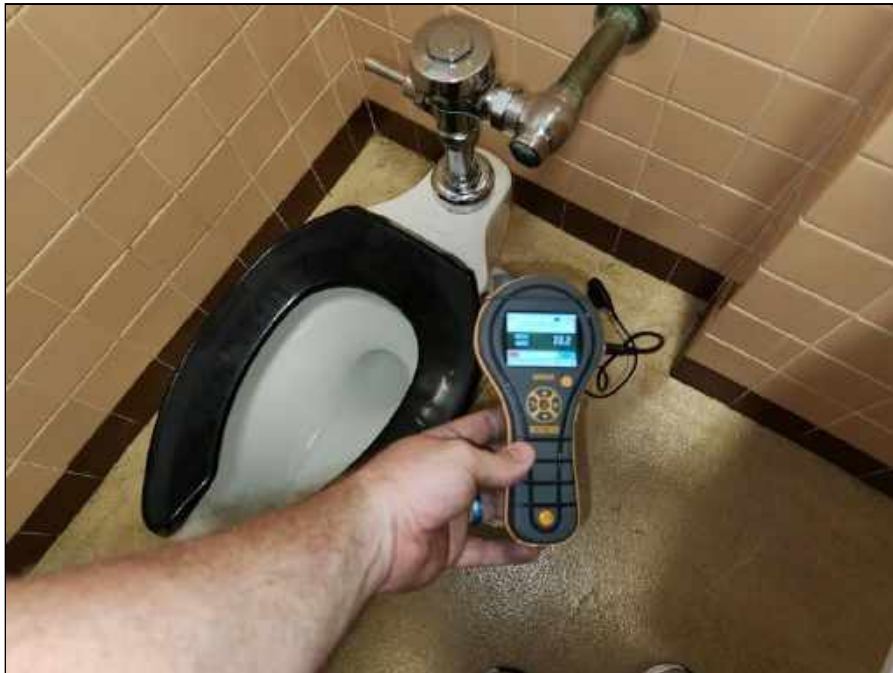
16 - Elevated Moisture Meter Reading Indicating Elevated Moisture Beneath the Sheet Flooring in the Room 110 Bathroom

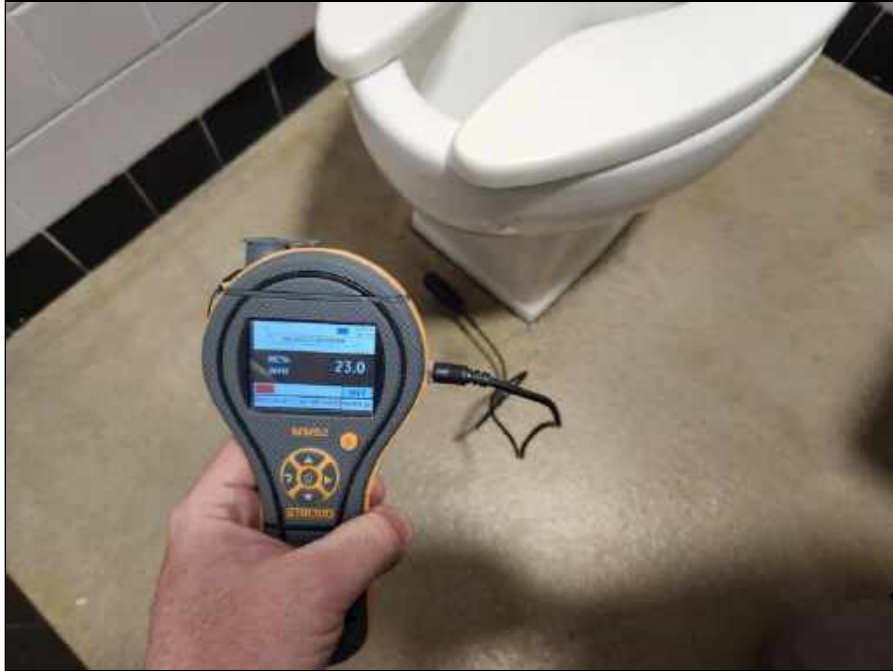
17 - Elevated Moisture Meter Reading Indicating Elevated Moisture Beneath the Sheet Flooring in the Room 105 Bathroom

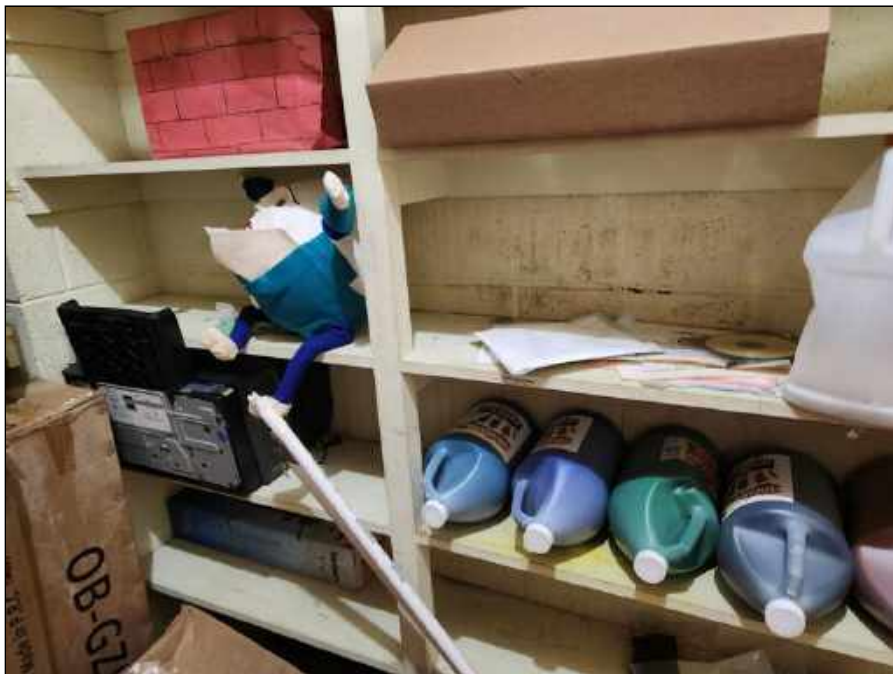
18 - Mold on the CMU Walls in the Book Room

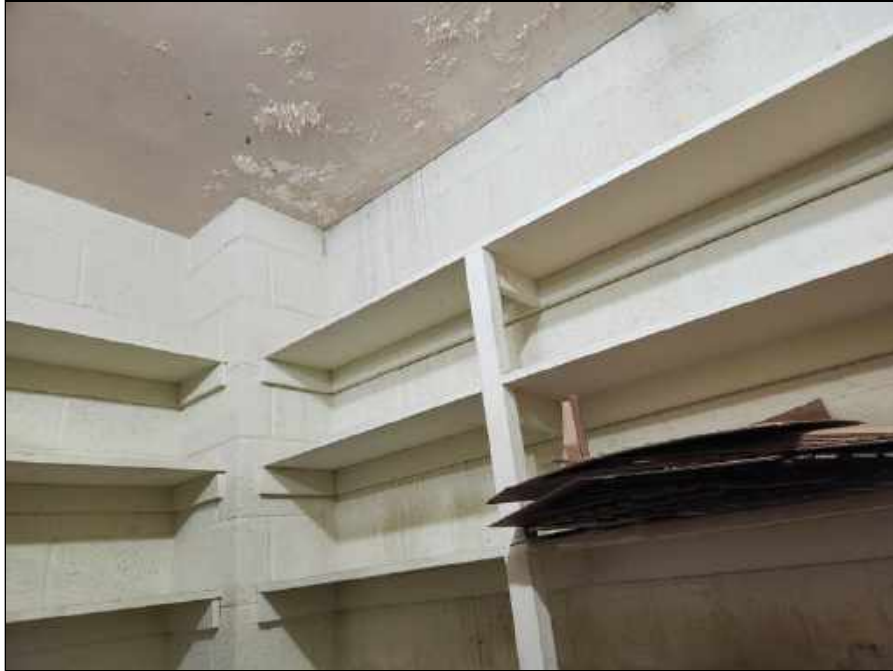
19 - Moisture Damaged Plaster Ceiling and Mold Impacted Materials in the Book Room

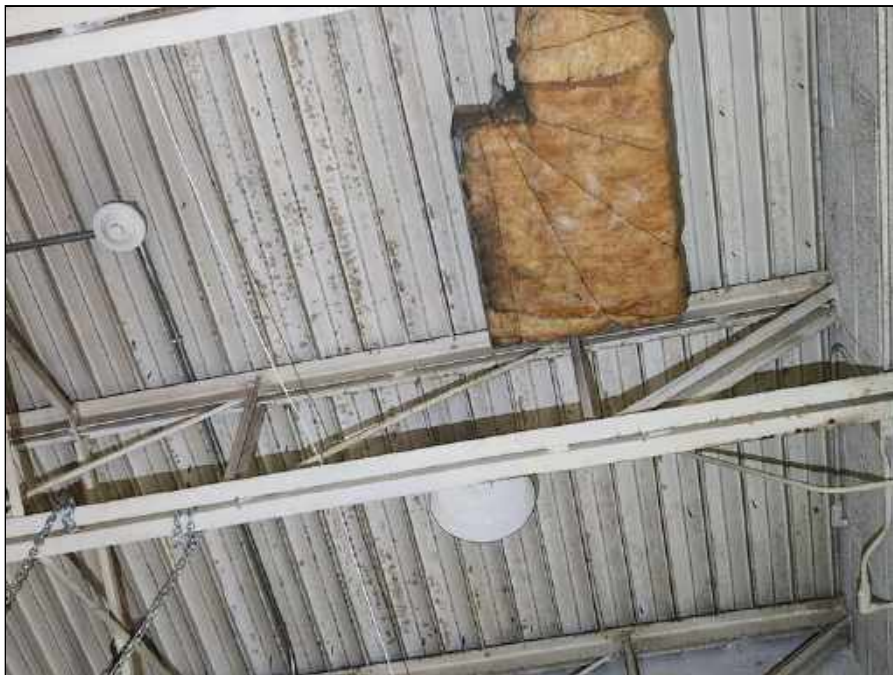
20 - Mold Observed on the Roof Deck in the Auditorium

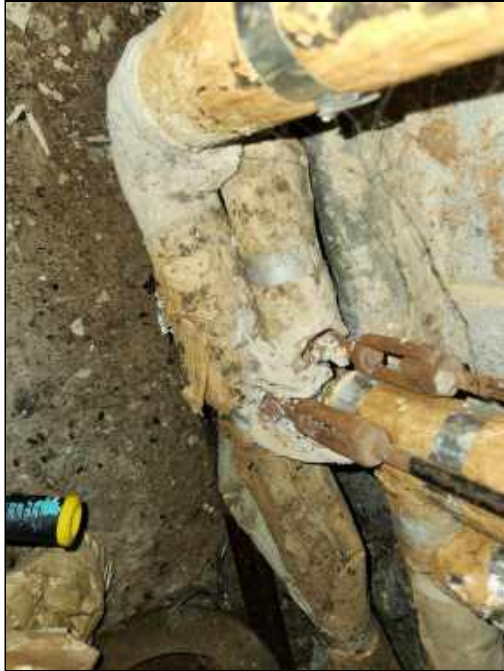
21 - Mold and moisture impacted pipe insulation and mudded elbows in the bathroom wet wall chase

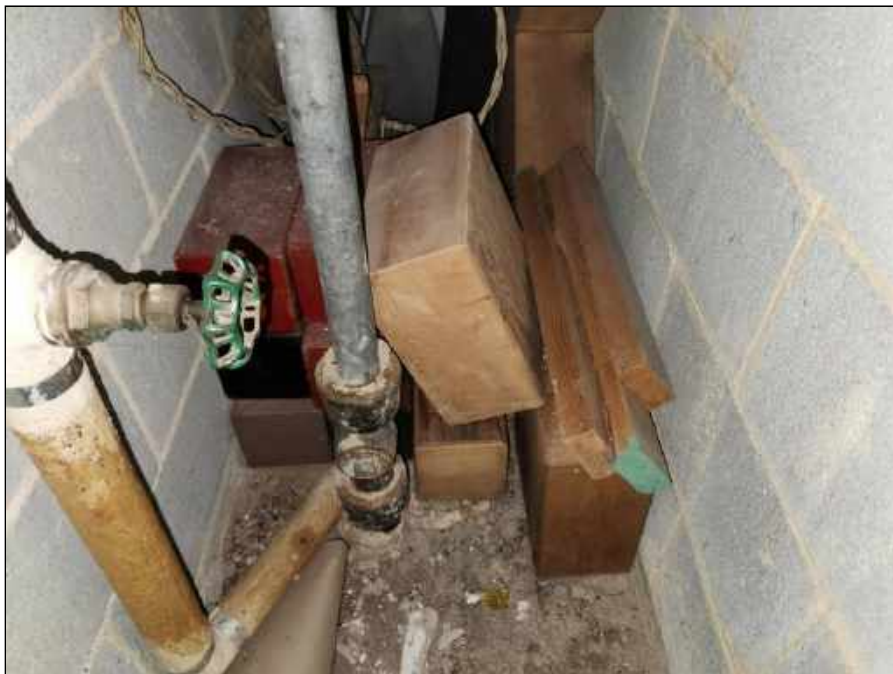
22 - Mold Impacted Stored Materials in the Wet Wall Chase Behind the Girl's Bathroom

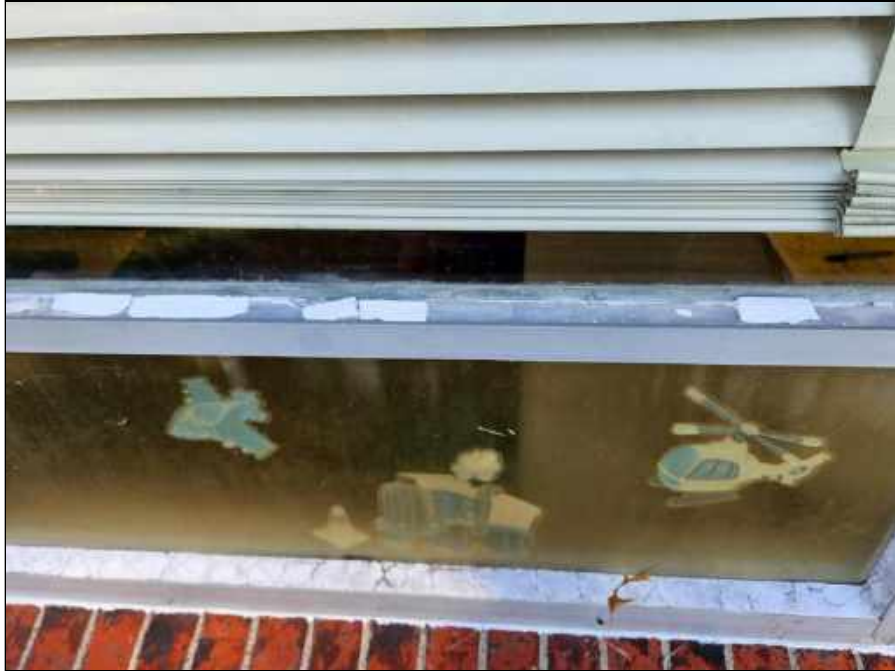
1 - Damaged Window Sash Glazing

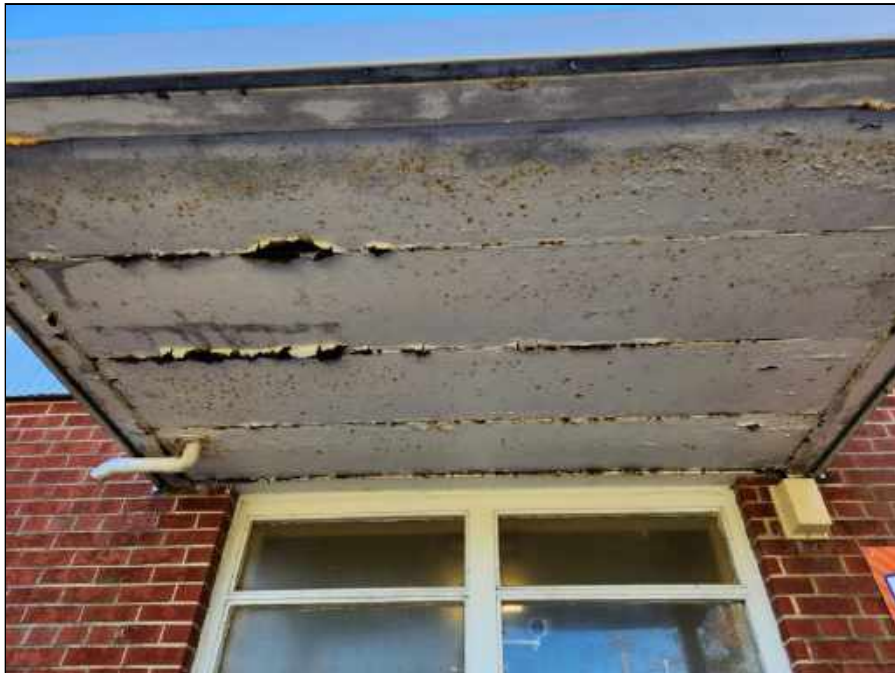
2 - Moisture Damaged Exterior Portico on the North Side of the Building

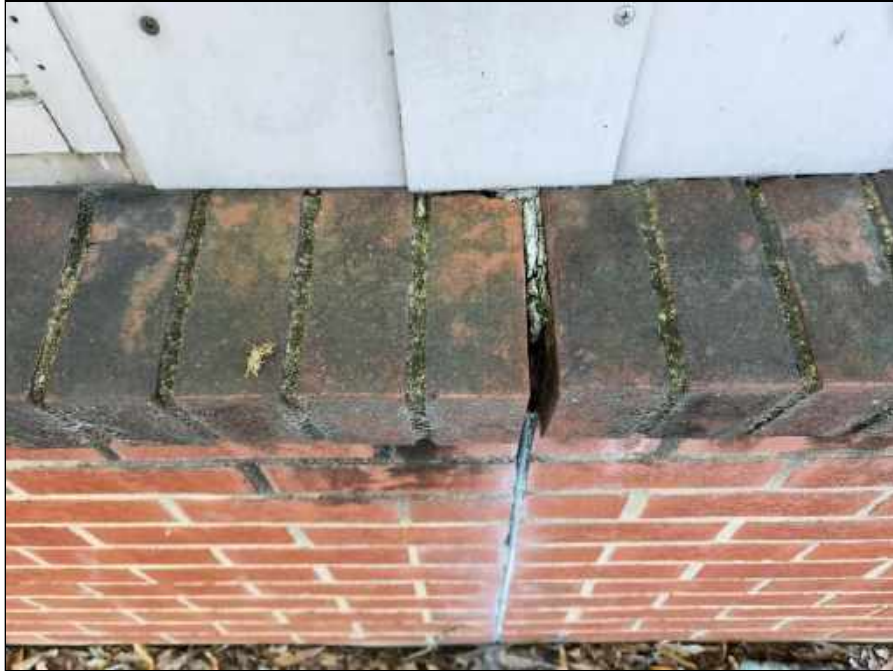
3 - Damaged Window Ledge Sealants

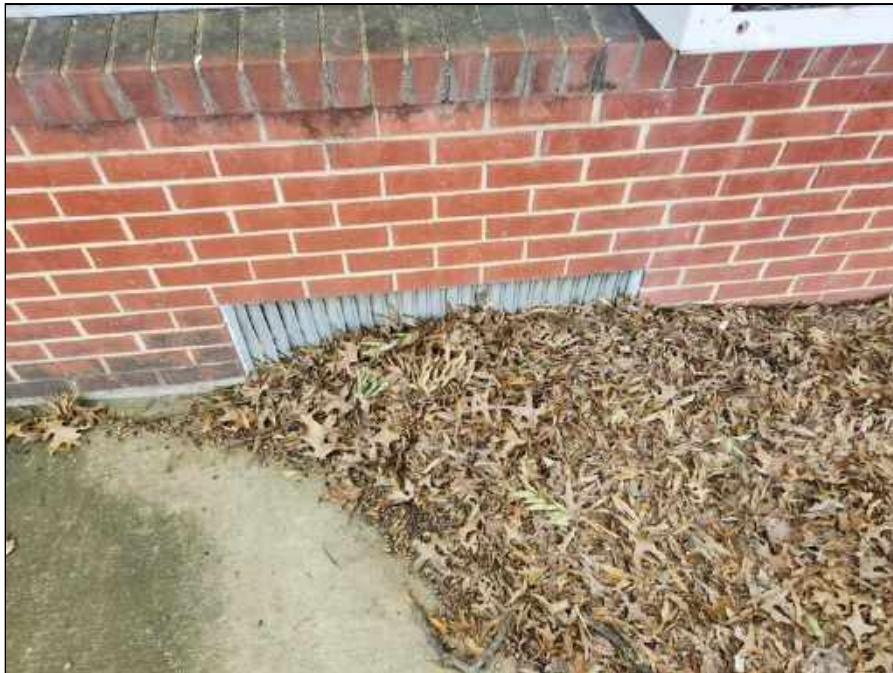
4 - Leaves Blocking a Fan Coil Intake

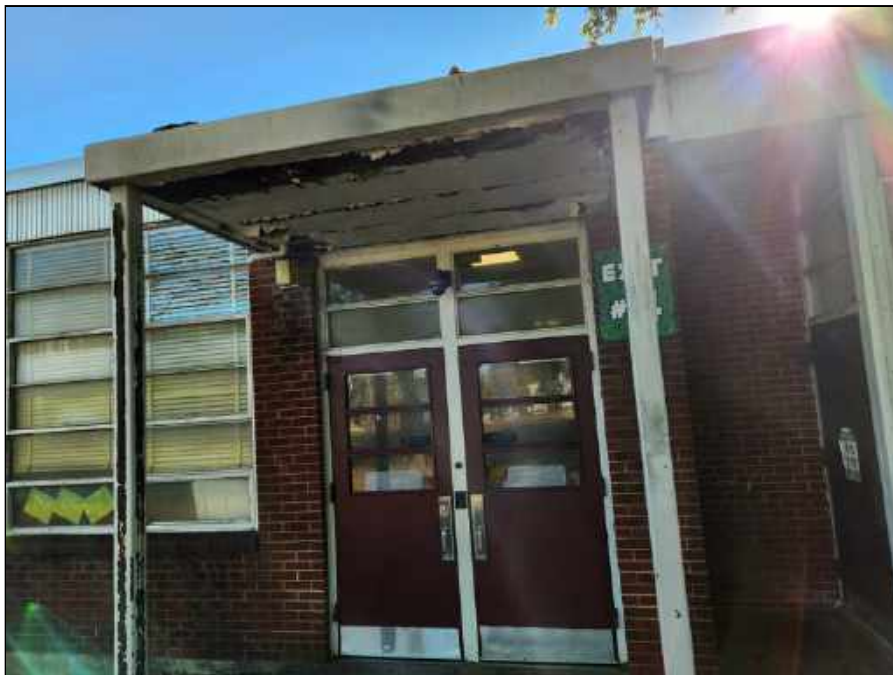
6 - Damaged Exterior Portico on the East Wing of the Building

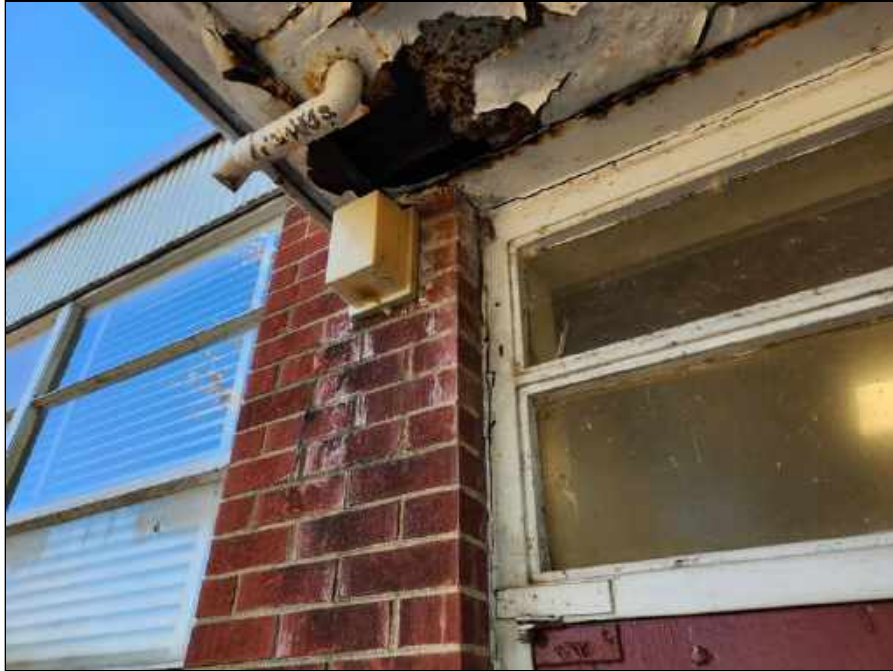
7 - Evidence of Moisture Intrusion Through the Portico Roof

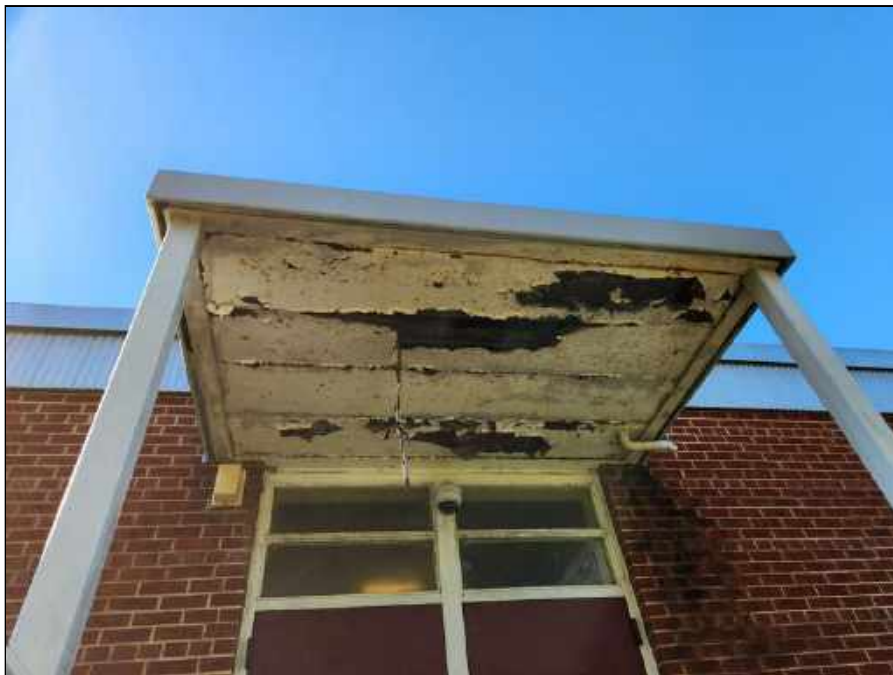
8 - Moisture Damaged Exterior Portico on the East End of the School

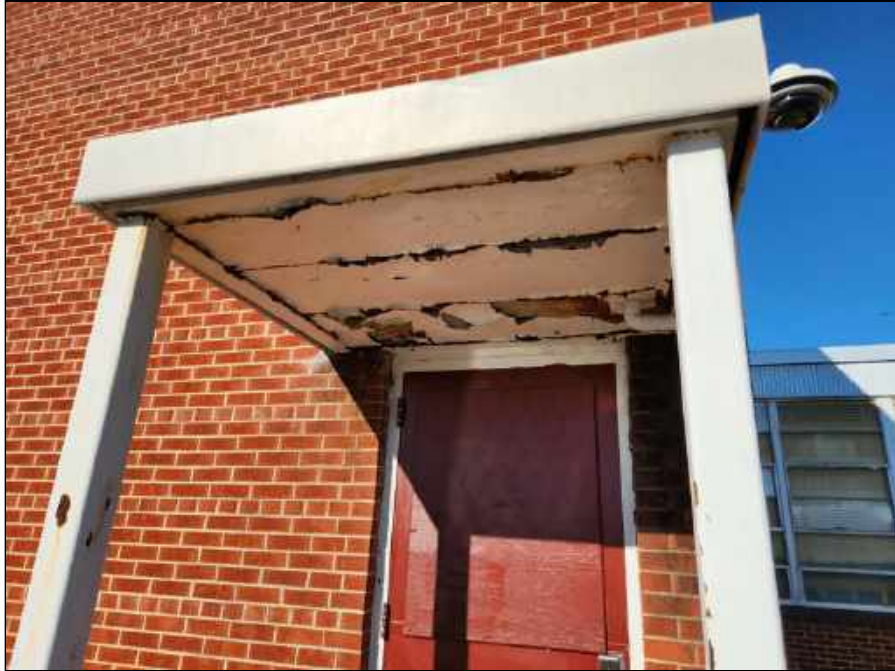
9 - Moisture Damaged Exterior Portico at the Cafeteria
