Post Mitigation Radon Sampling Report

Sampling Period: January 29-31, 2024

Mill Hill Elementary School

February 2024

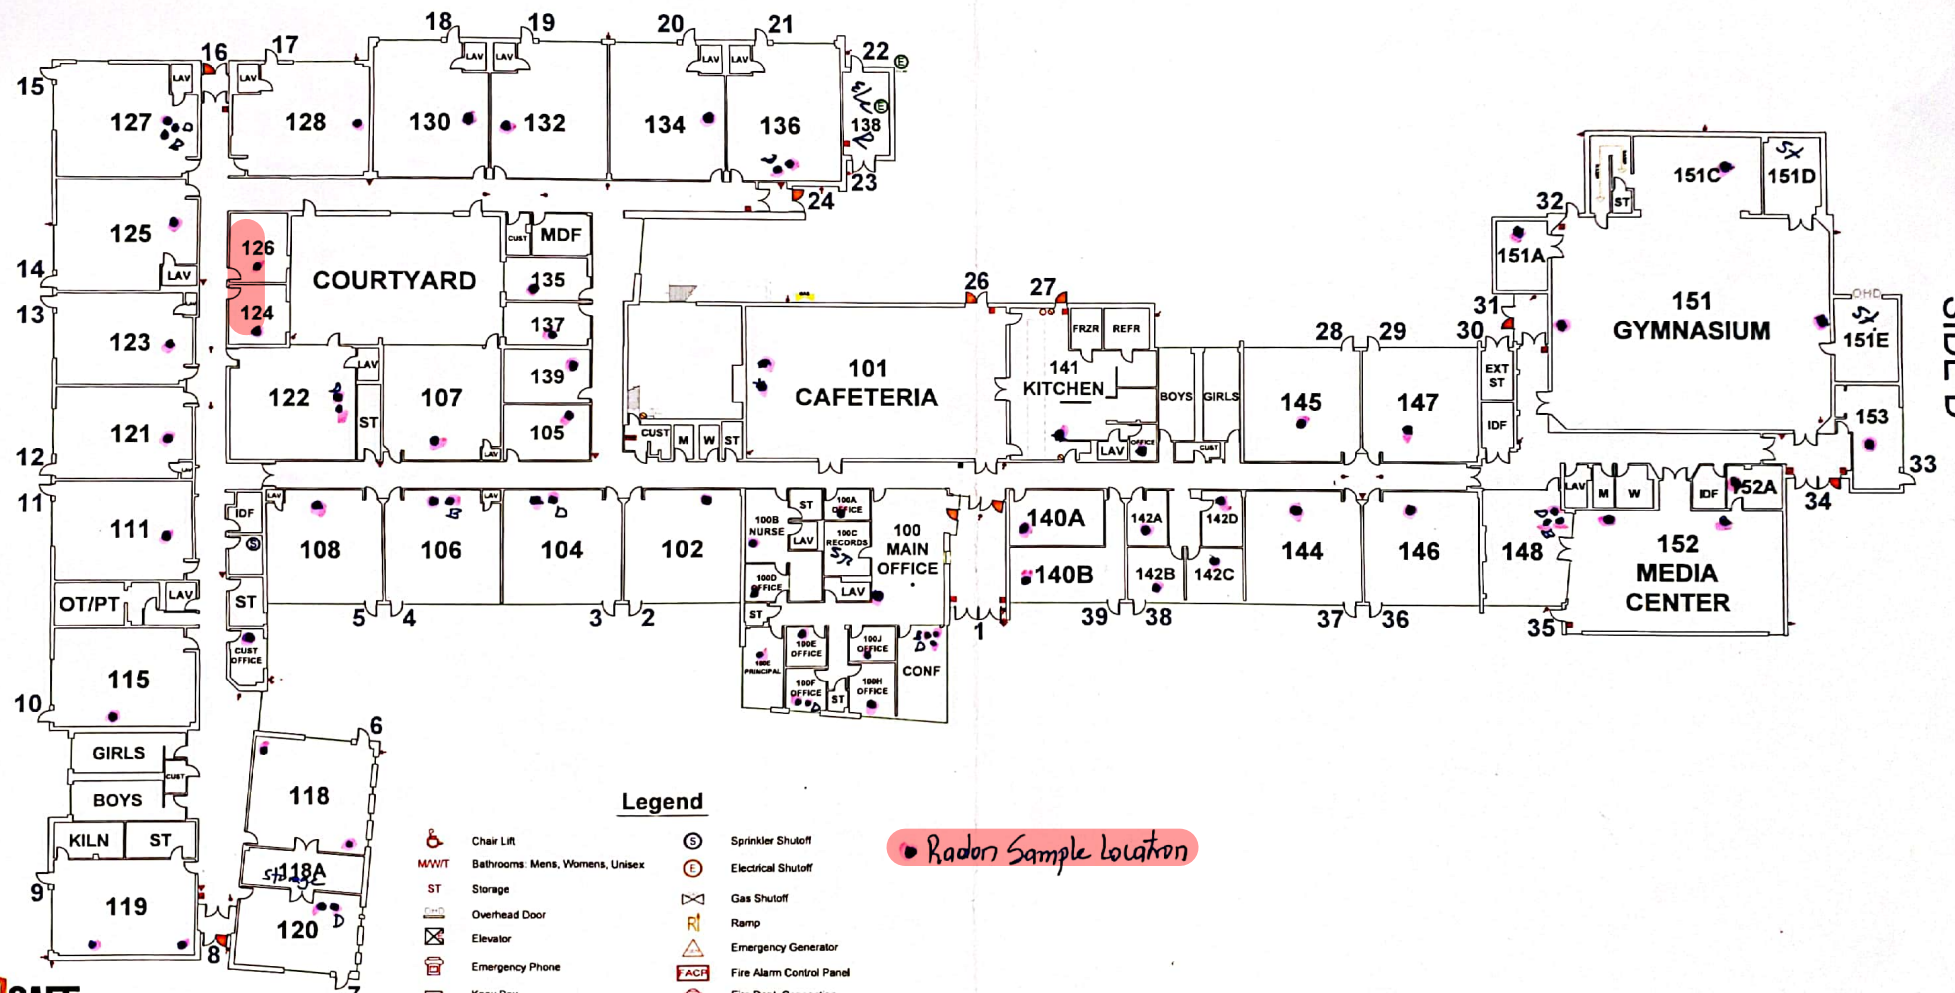
Sample Location Diagram

A total of four canisters, including one duplicate sample and one blank sample, were placed in Resource Rooms 1 & 2 at the Site. The radon concentrations in the samples ranged from 0.1 pCi/L to 0.5 pCi/L. The EPA AL for radon is 4.0 pCi/L.

Location	Canister Numbers	Radon Gas Concentration (pCi/Liter)
Resource Room 1	4865809	0.5
Resource Room 2	4878675	0.5

All results were below the EPA Action Level of 4.0 pCi/L and follow-up sampling is not required at this time.

Based on these sample results, no additional action is required at this time. Per CTDPH requirements, the facility must be continually evaluated on a two-year cycle.
