MOLD AND MOISTURE ASSESSMENT REPORT

BLACKWELL ELEMENTARY SCHOOL

300 E. 15TH STREET
RICHMOND, VIRGINIA 23224

ECS PROJECT NO. 47:14153-B

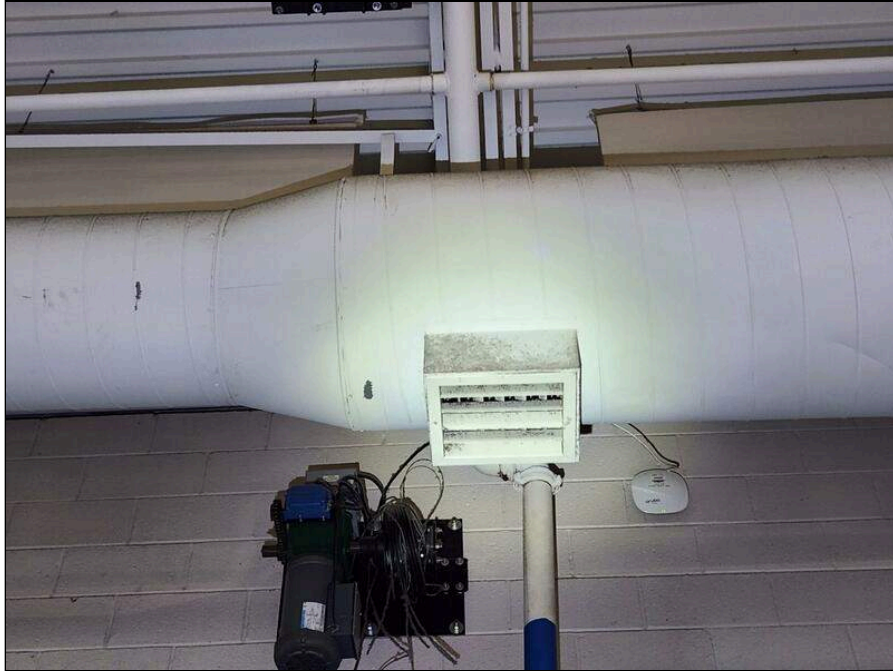
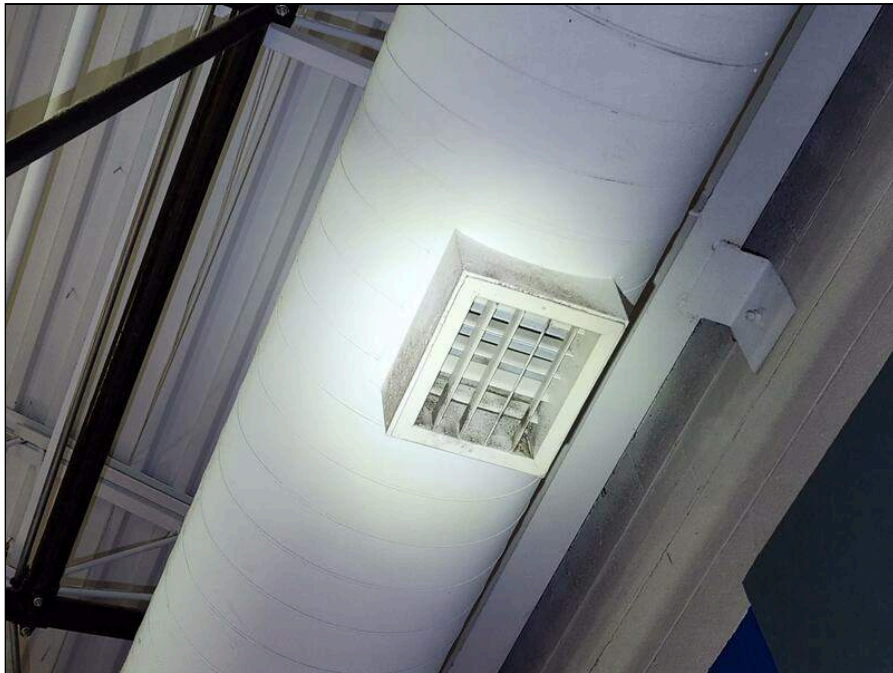
- Mold was observed on the HVAC supply ducts associated with the main trunk line that runs throughout the ceiling of the Gym and the diffusers in the equipment storage cage; these areas were not accessible for tape lift testing;

1 - Mold on the HVAC Main Trunk Line Diffusers in The Gym

2 - Mold on the HVAC Main Trunk Line Diffusers in The Gym

- Perform further investigation into the HVAC main trunk line in the gym and associated with the ducts in the gym storage cage and over the stage to inspect for additional evidence of mold or moisture impact within the ducts. If additional mold is observed within the HVAC main trunk line and ducts then the ducts in these areas should undergo a thorough duct cleaning by a certified National Air Duct Cleaning Association (NADCA) contractor;

- Have the air handler(s) servicing the gym and stage inspected by a qualified HVAC engineer or technician and perform a review of the maintenance and service schedule to determine if they are being properly maintained and operating per the manufacturer's recommend specifications;

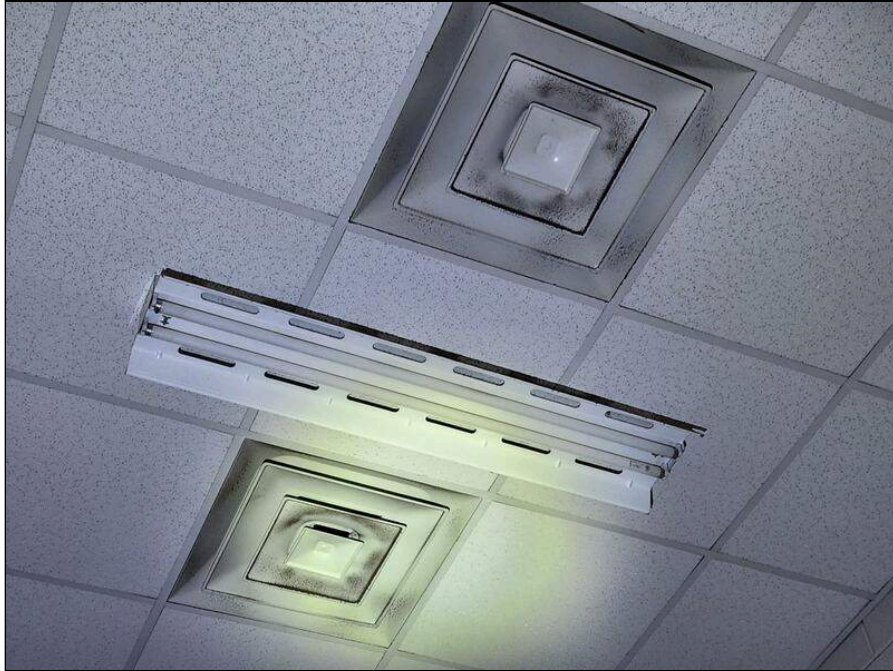
3 - Mold on the Diffusers in the Gym Equipment Storage Cage

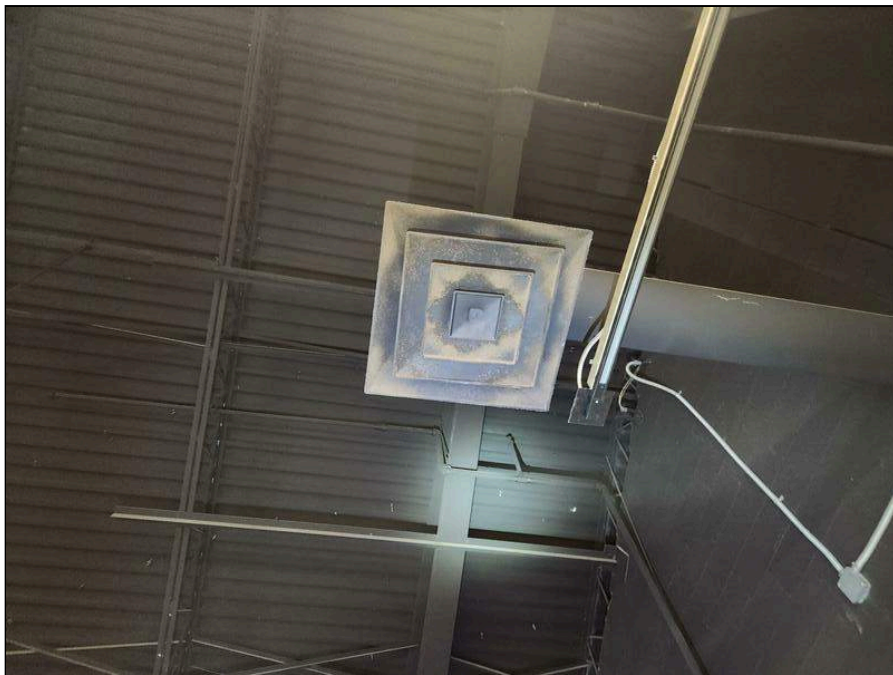
- Significant dust accumulation and suspect mold were observed on the HVAC supply ducts above the stage between the gymnasium and cafeteria;
- Damaged drywall was observed in the main office break room above the back entrance to the media center. ECS does not believe that the damage in this area was caused by water intrusion and is rather structural settling of the building in this area. Suspect mold or elevated moisture meter readings were not identified in this area;

4 - Dust Accumulation and Suspect Mold on the Stage Diffusers

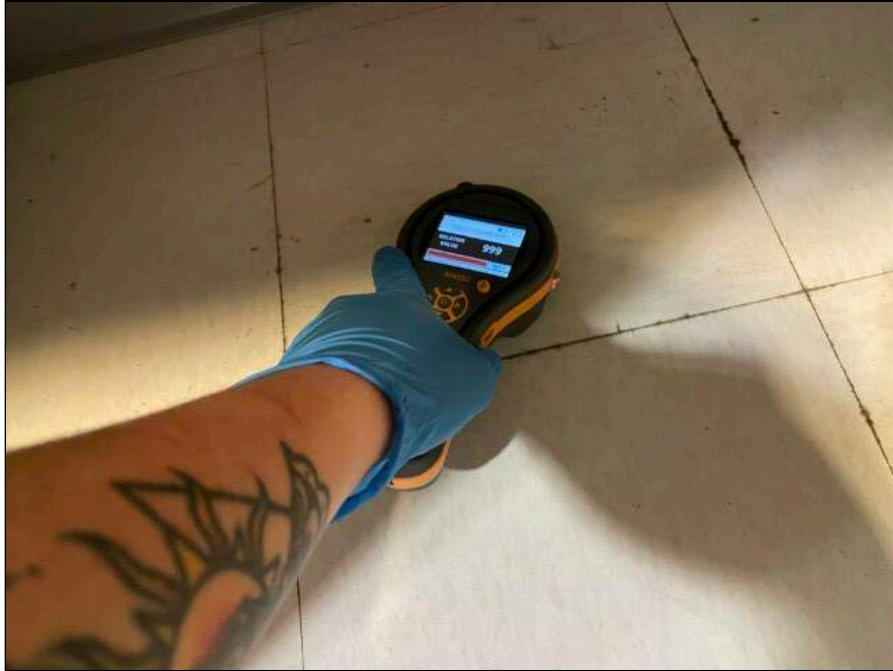
- Elevated moisture meter readings were identified beneath the sink in the main office break area associated with vinyl tiled floors in this area;
- Minor airborne mold spore elevations were identified associated with teacher's planning office (Room 235).

5 - Elevated Relative Moisture Meter reading Beneath the Sink in the Office Break Room

- Perform removal and replacement of the floor tiles beneath the sink in the main office break room. The exposed concrete slab and surrounding building materials should be verified to be dry with the use of a moisture meter prior to re-installation of new flooring materials. Have a qualified plumber inspect the sink and plumbing in this area prior to remediation activities to determine if the sink and plumbing may be the source of the elevated moisture levels in this area and correct any issues; The school may try to dry the floor tiles in-place to avoid removal.

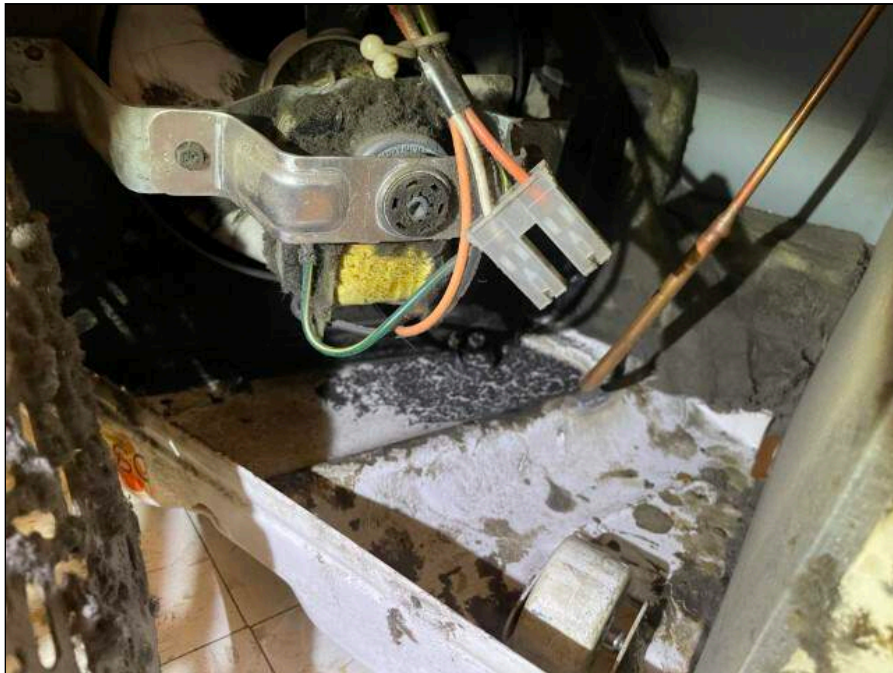
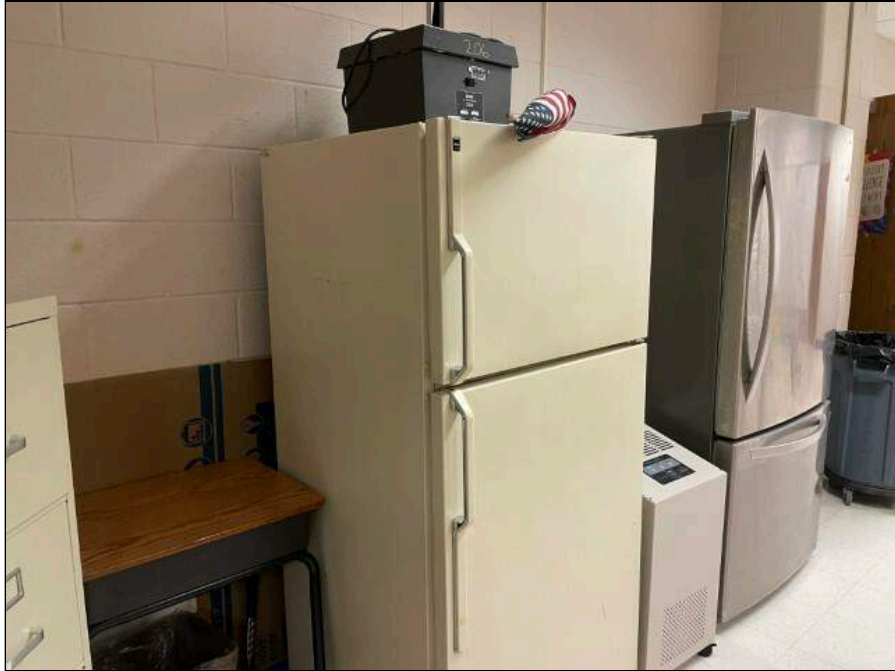
Analytical results of the mold air testing determined that total spore counts reported in the rooms tested in the school were below the level of airborne mold spores reported on the outside samples. The fungal genera detected were also generally comparable with fungal genera detected outdoors, with the exception of sample A46 collected in Room 235 which identified an elevation of *Penicillium/Aspergillus* spores above the levels of that genera identified on the outside samples. During the site assessment ECS observed mold growth within the back of one of the refrigerators at the bottom around the fan and condenser which is likely the cause of the elevation of the *Penicillium/Aspergillus* spores identified on sample A46.

6 - Mold observed within the back of a refrigerator in Room 235

7 - The refrigerator in Room 235 with mold in the back

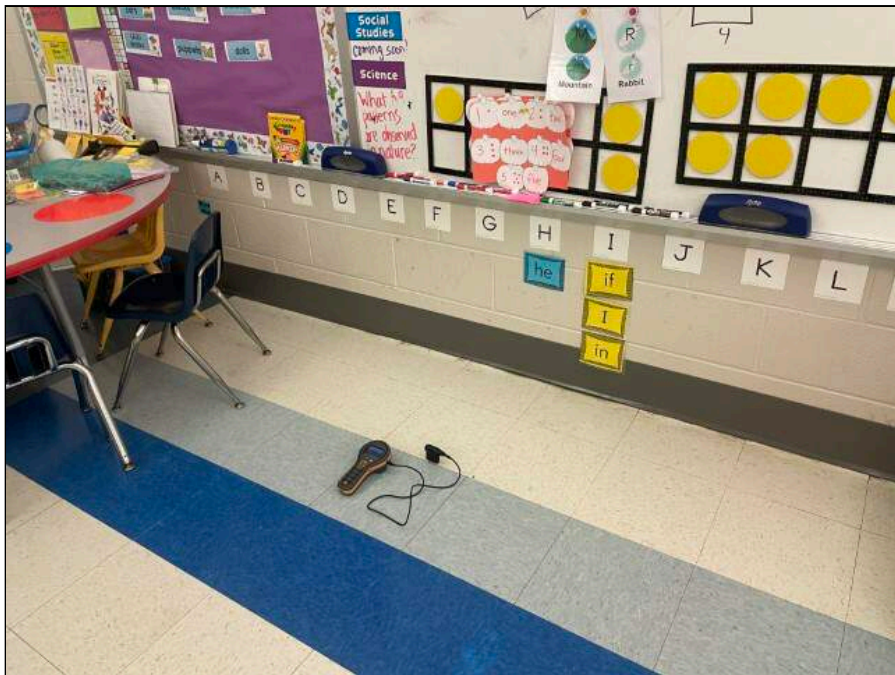
- Moisture damaged vinyl floor tiles were observed along the North perimeter wall associated with classrooms 105 and 106. Moisture meter readings collected from these areas indicated that moisture is trapped beneath the flooring in this area. The floor tiles and mastic in these areas were determined to be non-asbestos containing;

- The apparent cause of the moisture damaged flooring and elevated moisture meter readings in rooms 105 and 106 is water intrusion from the exterior on the North perimeter walls in these rooms. ECS observed that the property slopes towards the building in this area

likely causing storm water to directly impact these exterior walls. A storm water drain was observed adjacent to this area of the building but ECS is not aware if it is properly managing the storm water run-off at this section of the building;

8 - Damaged Floor Tile Along the North Perimeter Wall in Room 105

- Following the correction of the apparent water intrusion into room 105 and 106, perform drying of the wall and flooring areas in these locations. Based on the time of year this would be expected to be successful. Remove and replace the damaged floor tiles in these areas as needed. The concrete slab floor and surrounding building materials should be verified to be dry with the use of a calibrated moisture meter;

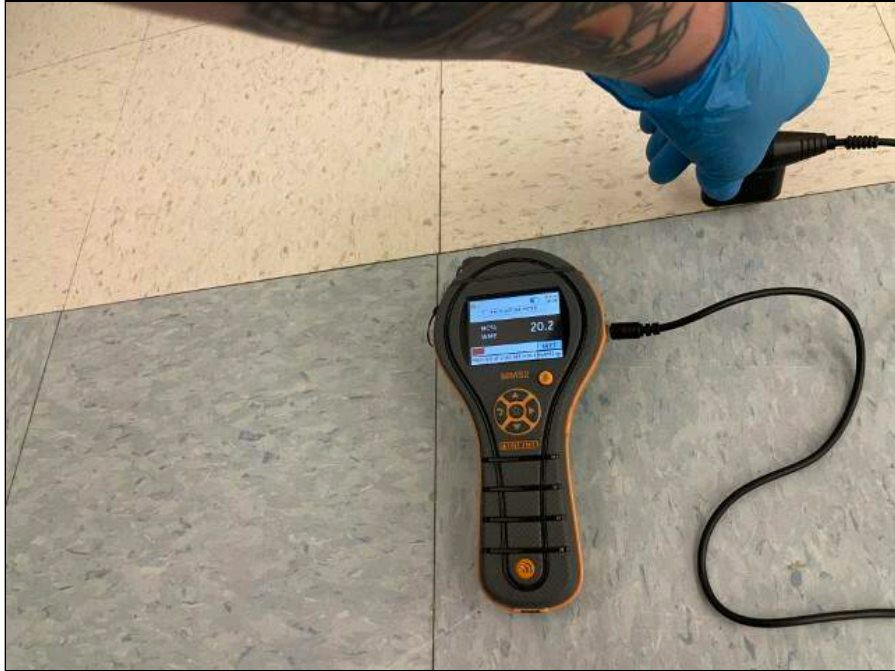
- The North perimeter wall beneath vinyl floor tile in Rooms 105 and 106. The moisture meter readings in these areas ranged from approximately 20% to 25% WME;
- Moisture meter readings collected using the Protimeter survey mode indicated moisture values of up to 999 REL on flooring at the base of the exterior back doors on the ground floor classrooms. The comparative measurements collected in the center of the rooms were in the 400 to 500 REL range indicating elevated moisture in the areas at the base of the exterior doors.

9 - Elevated Moisture Meter Reading From Floor Tile in Room 105

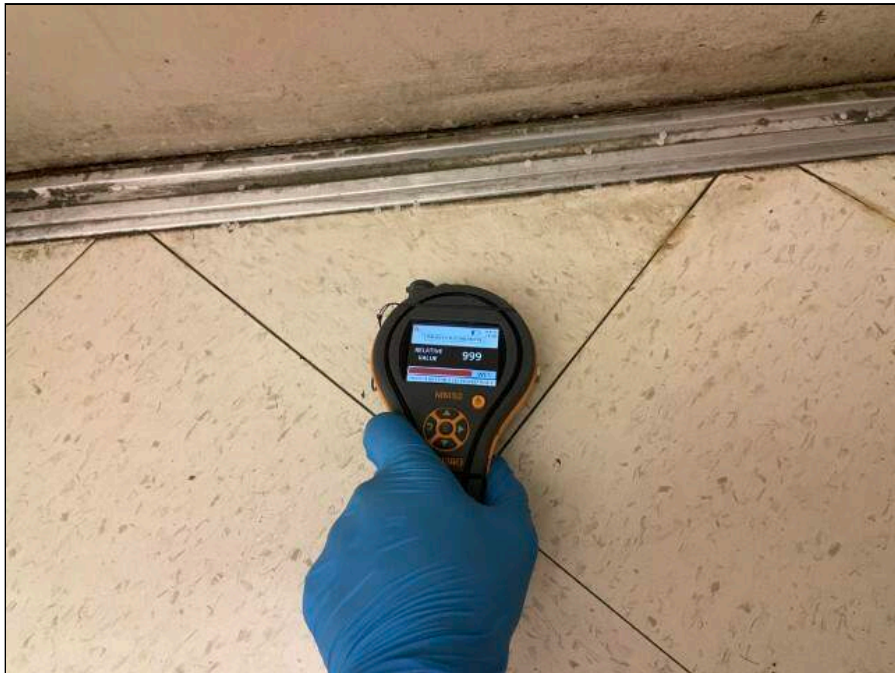
- Elevated relative moisture meter readings were observed associated with the floor tiles at the base of the exterior back doors compared to readings collected from the center of the rooms in many of the classrooms on the ground floor indicating moisture is trapped beneath the flooring in these areas. The apparent cause is water infiltration from the exterior of the building in these areas;

- The apparent cause of the elevated moisture meter readings identified associated with the flooring at the back doors of the majority of the ground floor classrooms is apparent water infiltration from the exterior of the building.

10 - Elevated Relative Moisture Meter Reading at the back door in Room 118

- Perform aggressive drying of the flooring at the base of the exterior doors (and walls if needed) in each of the ground floor classrooms. During the building envelope assessment determine the cause of the water intrusion in these areas and correct prior to or concurrent with drying efforts. Verify that the areas have been properly dried with the use of a calibrated moisture meter.

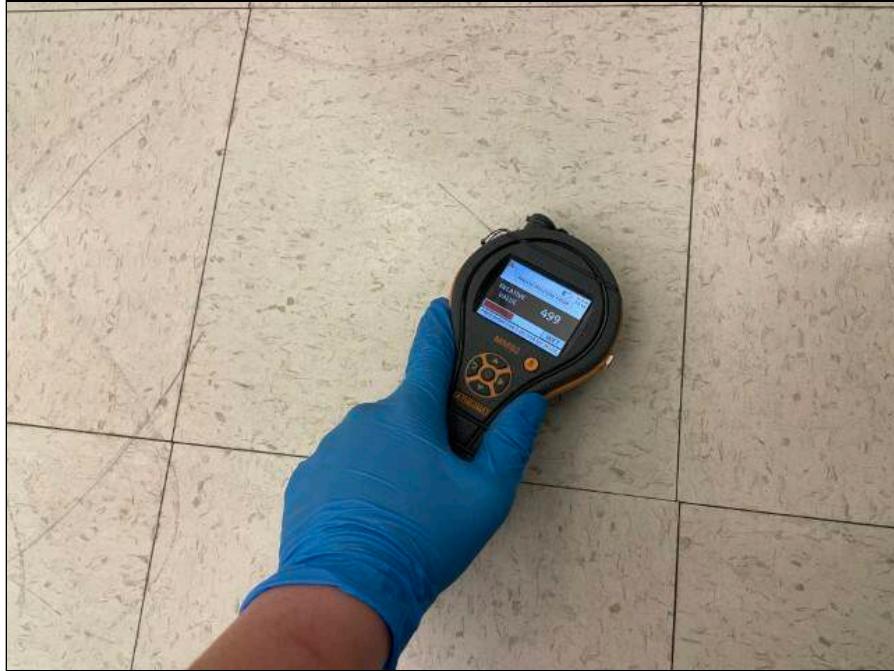
11 - Lower Moisture Meter Reading in the Middle of Room 118 Relative to elevated Reading by the Back Door

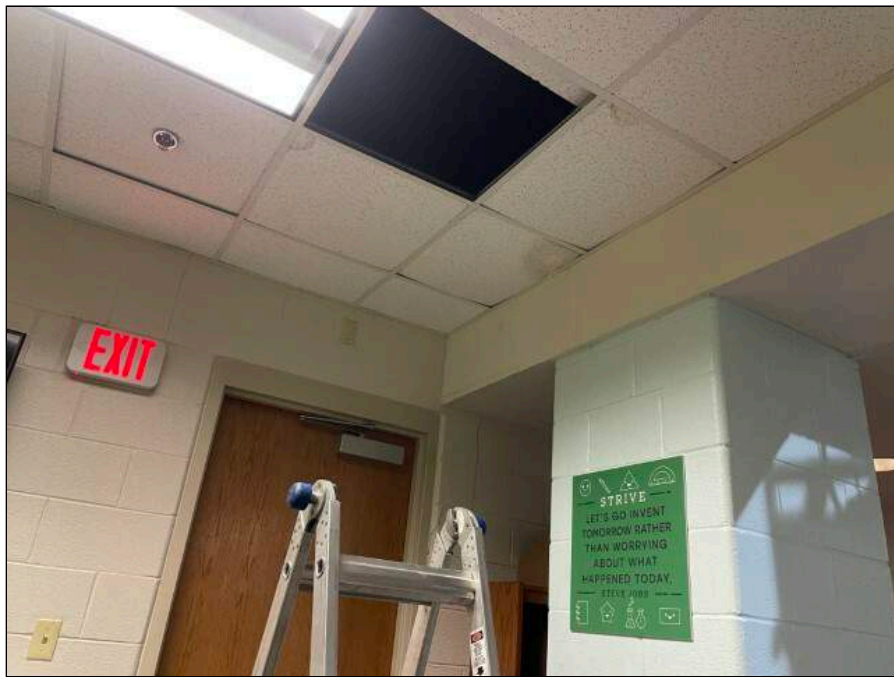
- Moisture impacted drywall and a moisture stained light fixture were observed in the Northeast corner of the Media Center near the door leading to the Main Office break room. The cause of these moisture impacted materials was not readily apparent;

12 - Moisture Stained Ceiling Tile in the NE Corner of the Media Center

- Remove and replace the moisture impacted drywall wall and drop ceiling tile and wipe down the moisture stained light fixture in the Northeast corner of the media center and determine and correct the source of water intrusion in this area;

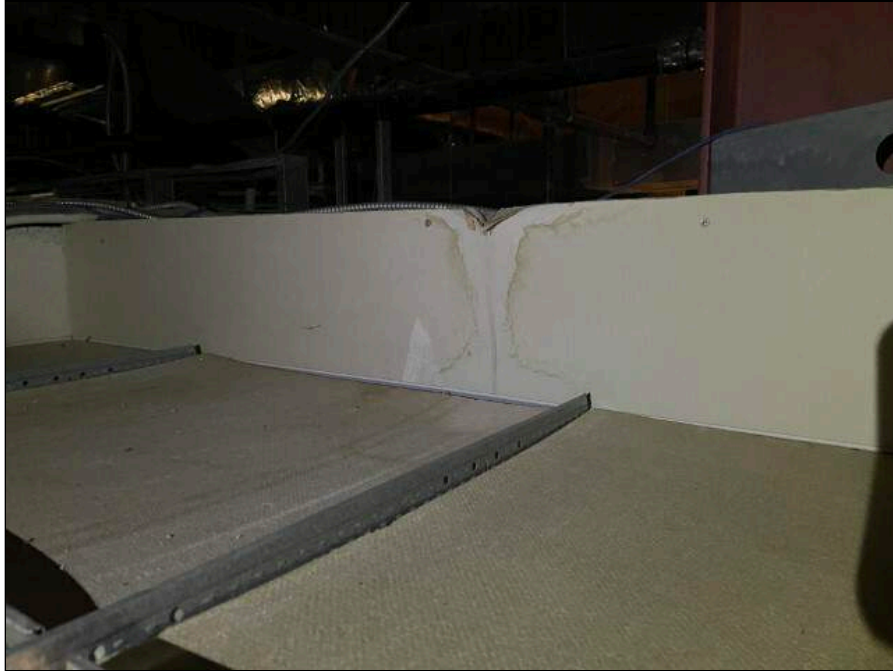
13 - Moisture Damaged Drywall Above the Ceiling in the NE Corner of the Media Center

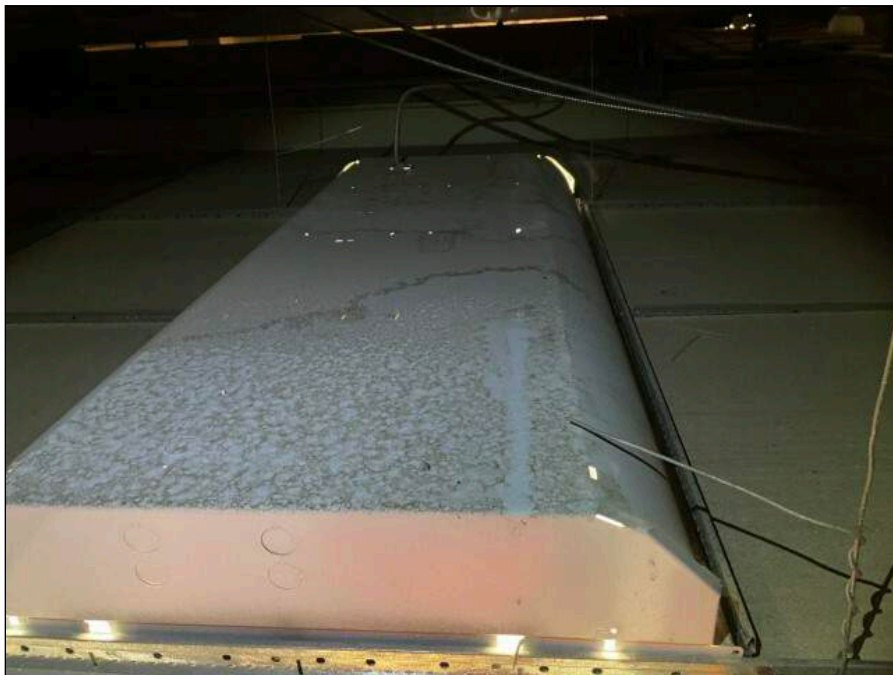
14 - Moisture Staining on a Light Fixture in the NE Corner of the Media Center

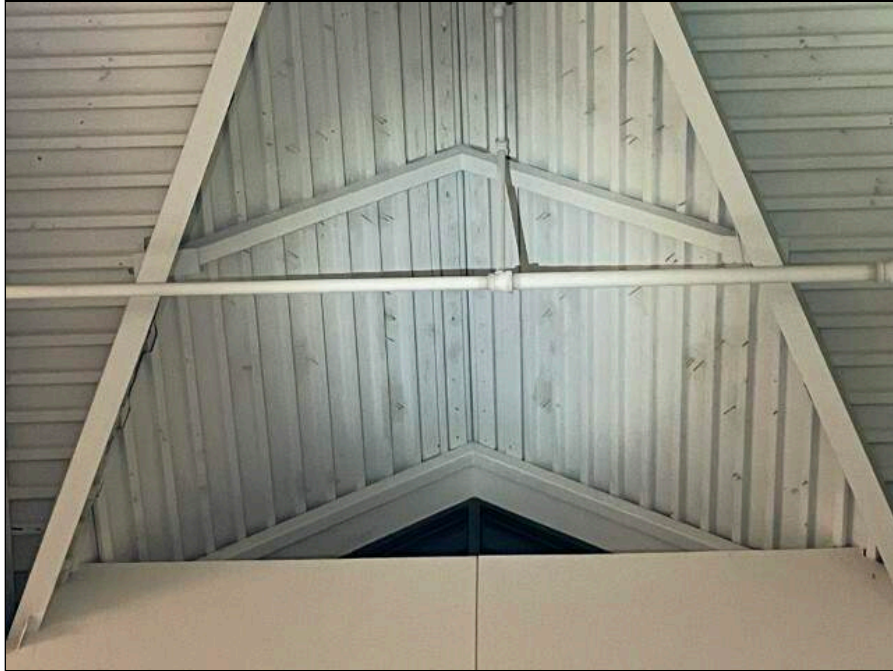
- A damp, mold/mildew odor was present in the media center at the time of the assessment. Evidence of water staining in the form of discolored spots around screws on the metal roof deck above the media center was observed. Moisture may be trapped within the roof substrate in these areas potentially causing the odor in the media center. These areas were not accessible for moisture testing or closer inspection;

15 - Staining Possibly Indicating Moisture Intrusion Above the Metal Roof Deck in the Media Center

- During the building envelope review inspect the roof for evidence of damage or water intrusion, especially the portion of roof over top of the media center where staining or discoloration was observed on the bottom of the metal ceiling deck;
