MOLD AND MOISTURE ASSESSMENT REPORT

SUMMER HILL PRESCHOOL

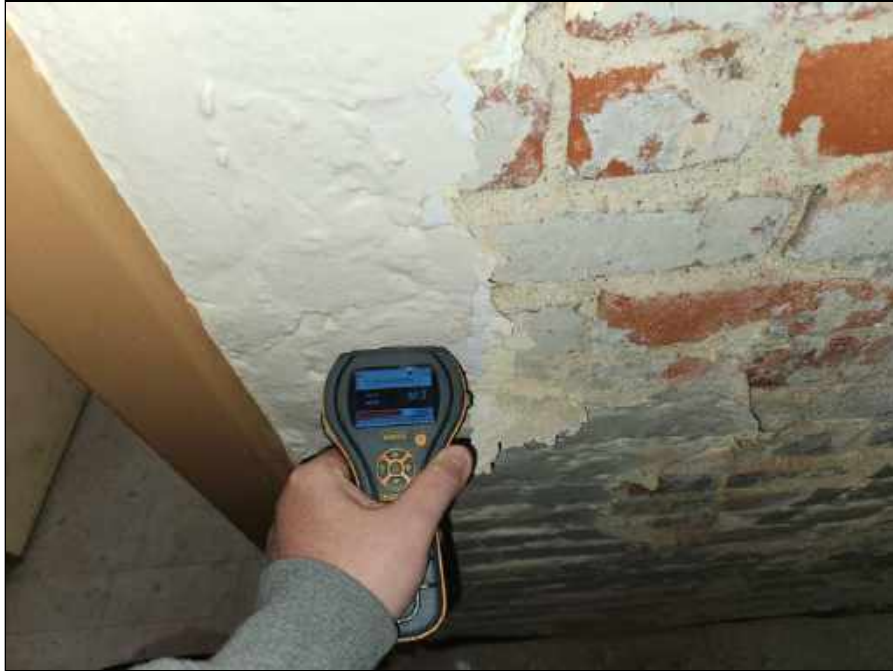
1 - Elevated moisture meter reading collected from plaster in the basement of the original building

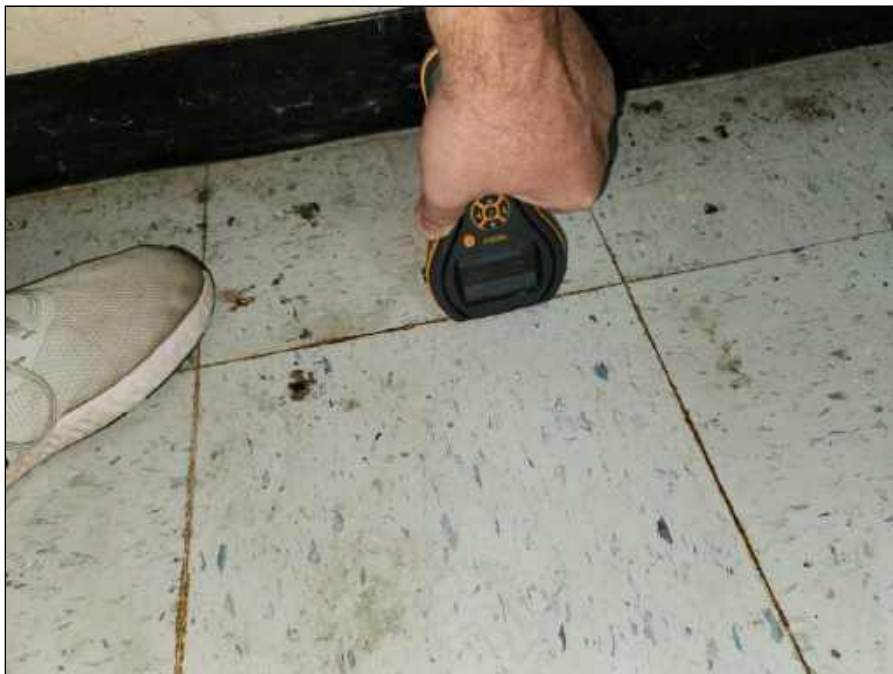
2 - Elevated moisture meter reading collected from flooring in the basement of the original building

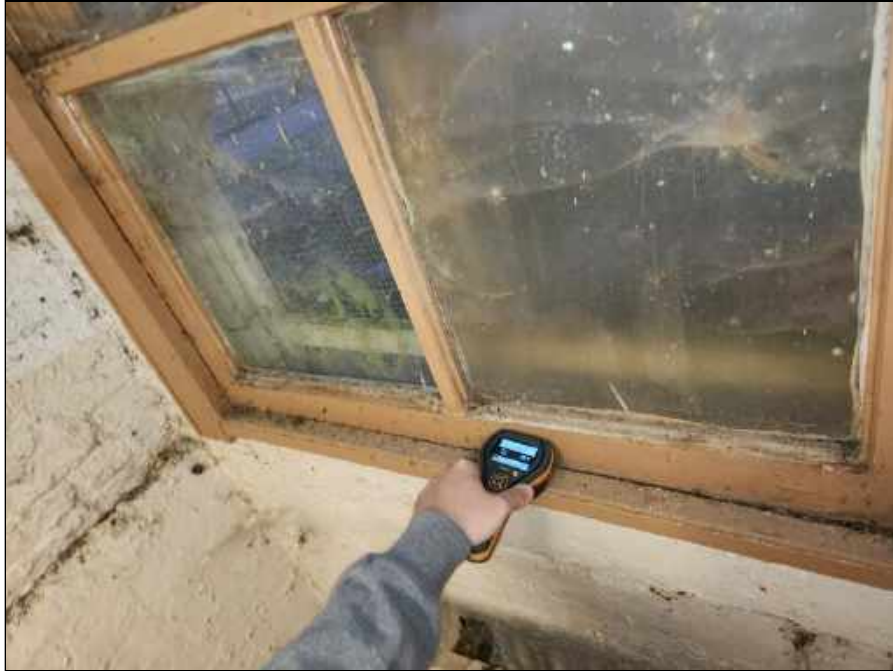
3 - Elevated moisture meter reading collected from a wood window sash in the basement of the original building

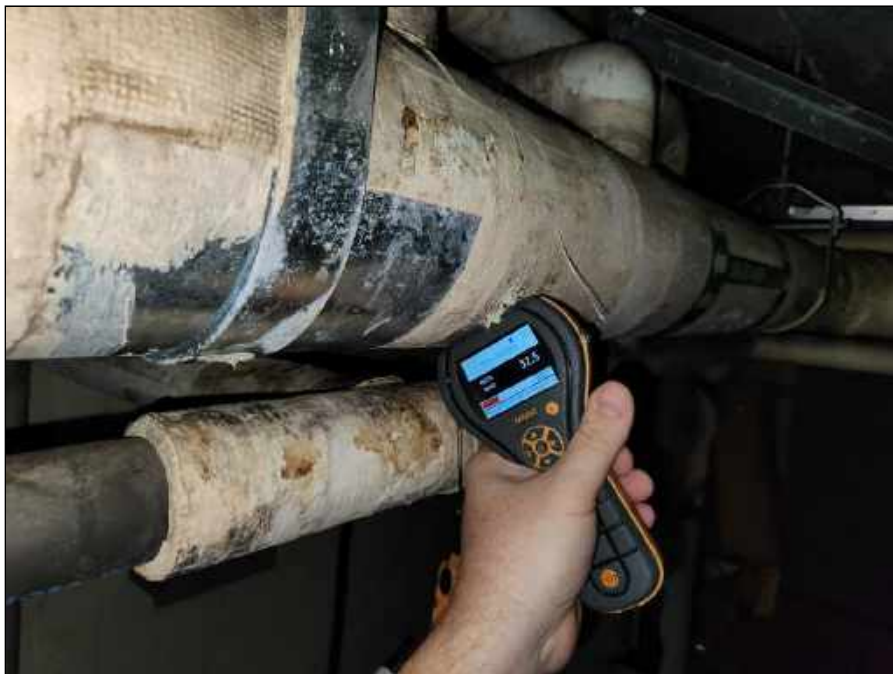
4 - Elevated moisture meter reading collected from pipe insulation in the basement of the original building

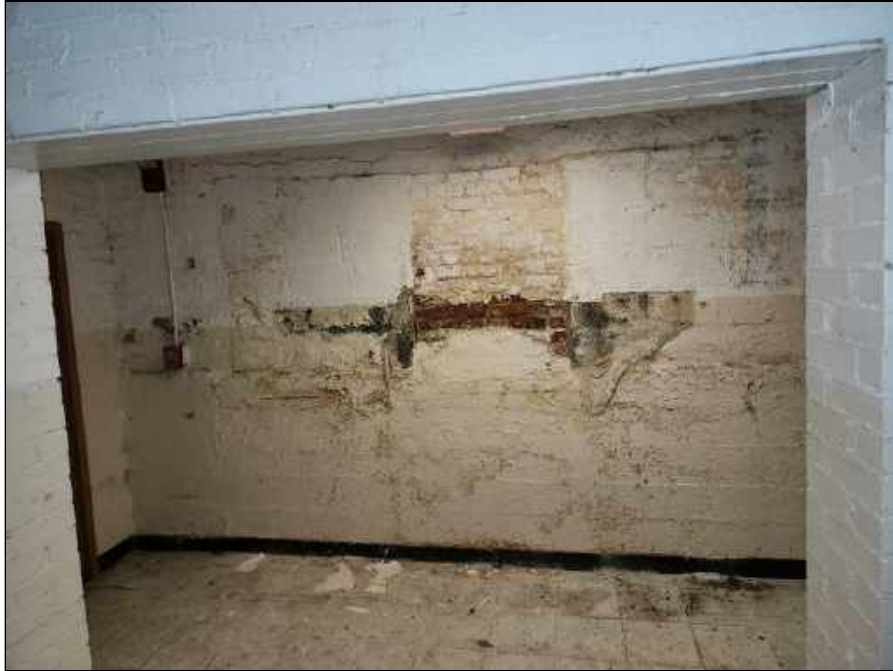
5 - Mold on the wall in the basement hallway

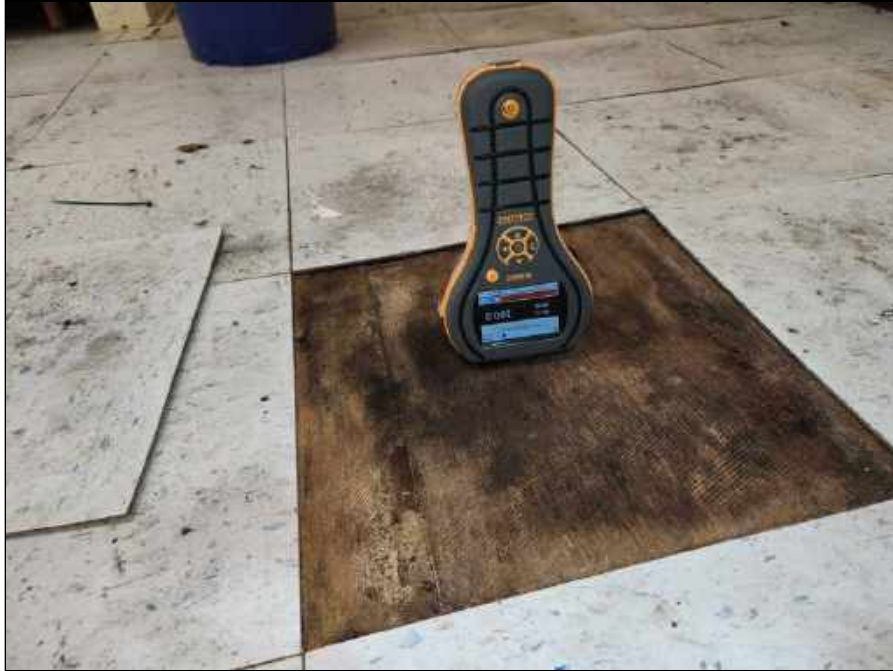
7 - Elevated moisture meter reading and mold on the sub-floor in Room 15 in the original building

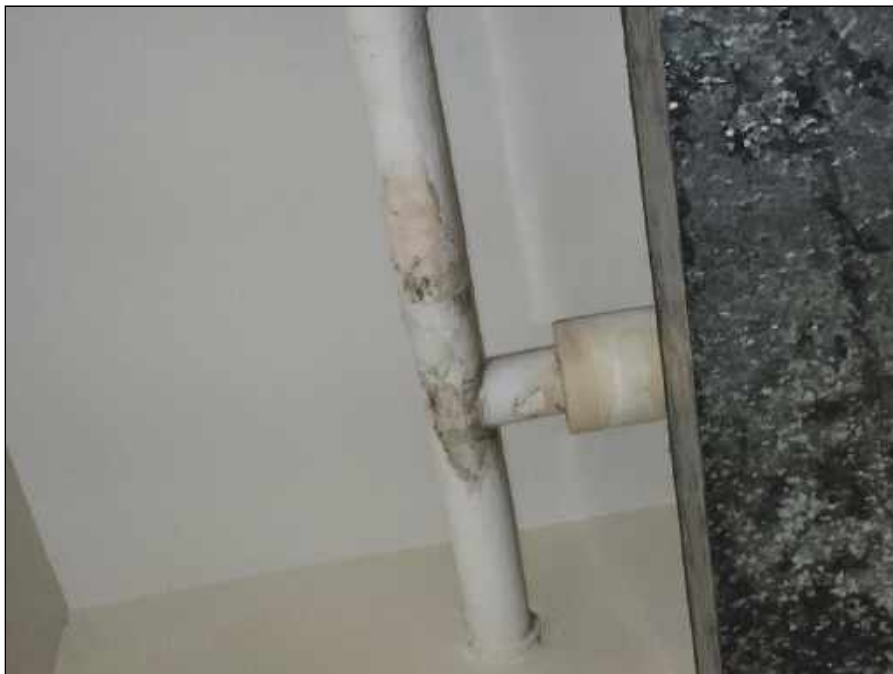
8 - Mold on pipe insulation in a room on the upper floor of the original building

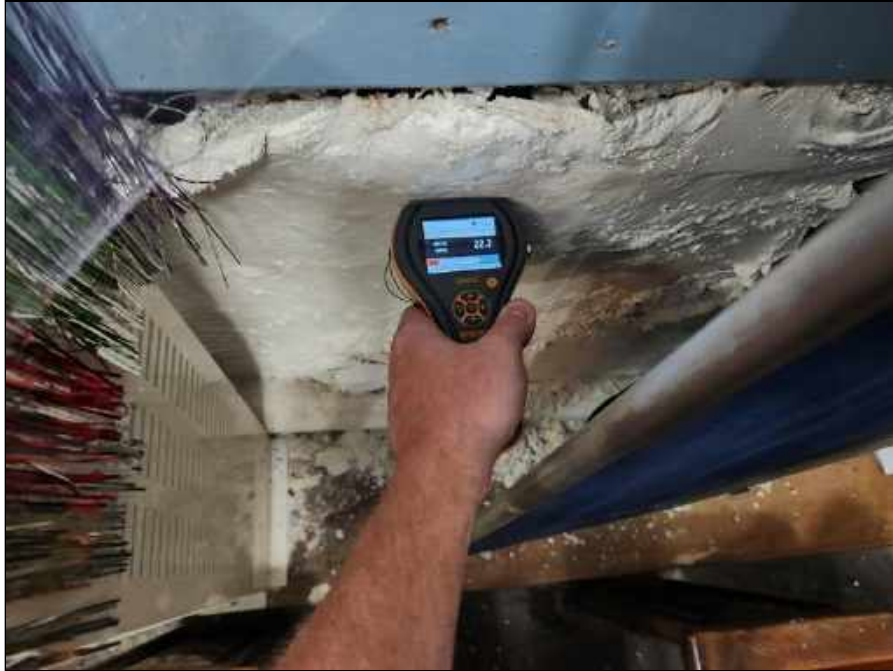
13 - Moisture damaged plaster wall in the Auditorium

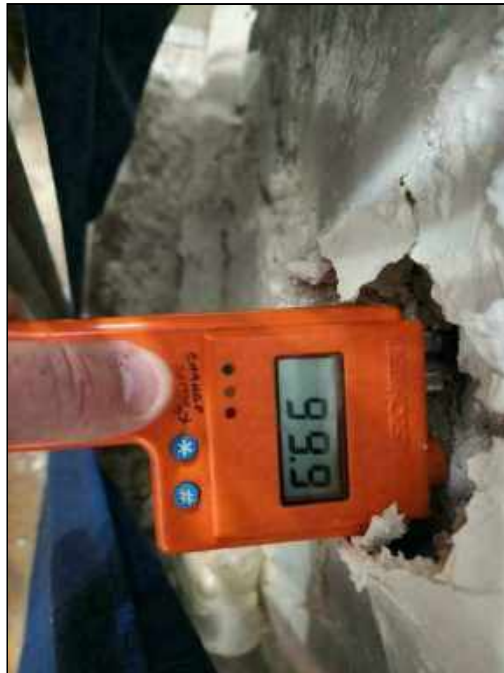
14 - Wet moisture meter reading collected from the damaged plaster wall

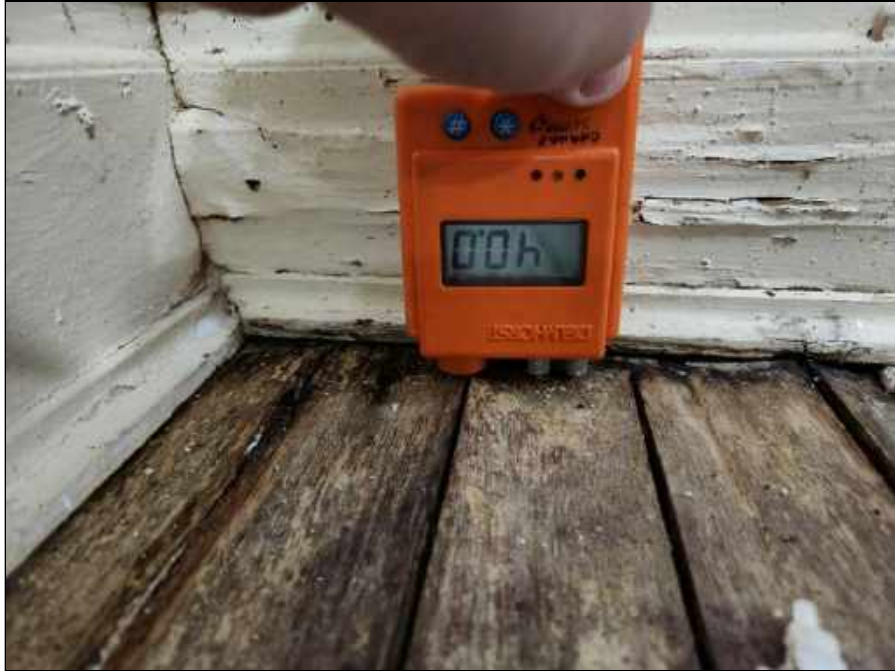
15 - Wet moisture meter reading collected from the stage floor

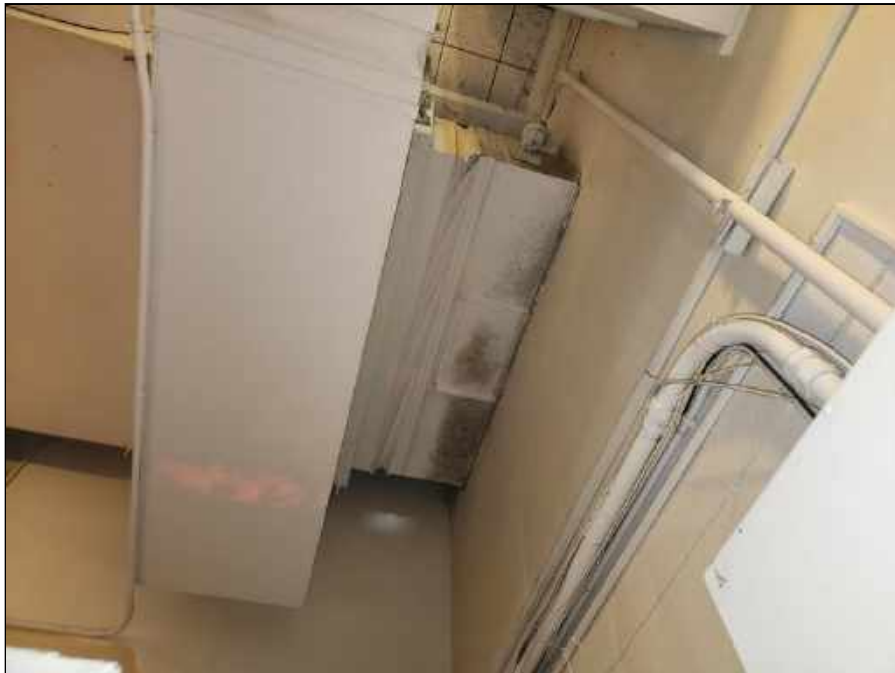
16 - Mold on an HVAC duct above the stage

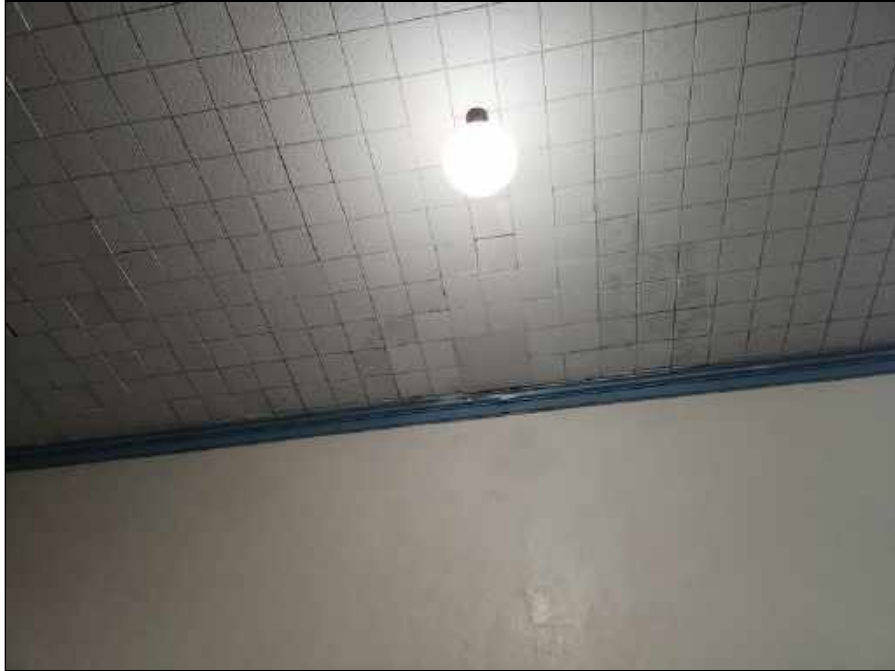
17 - Moisture impacted ceiling tiles and plaster wall in the Auditorium

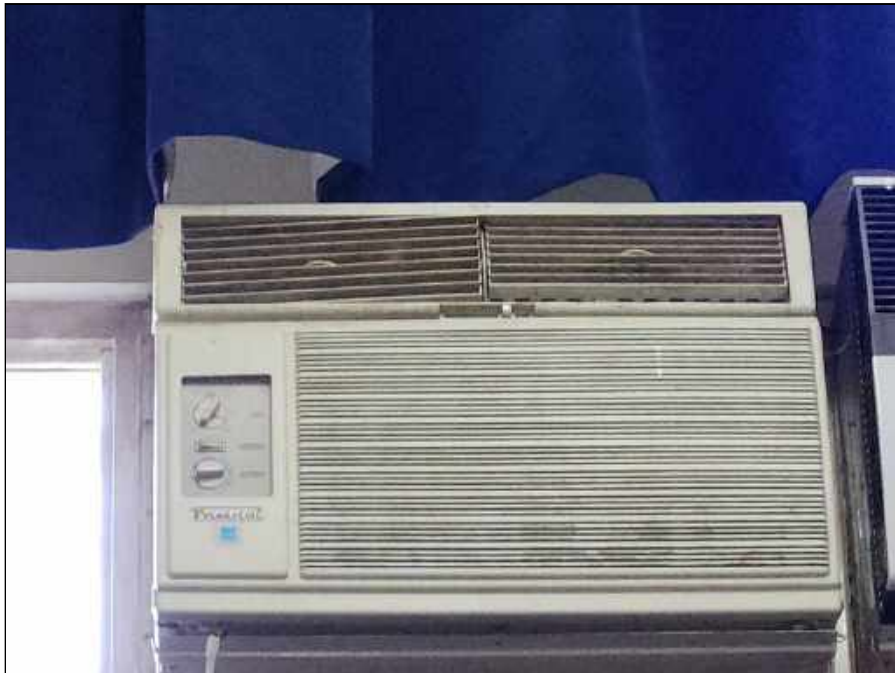
18 - Mold on a window mounted A/C unit in the Auditorium

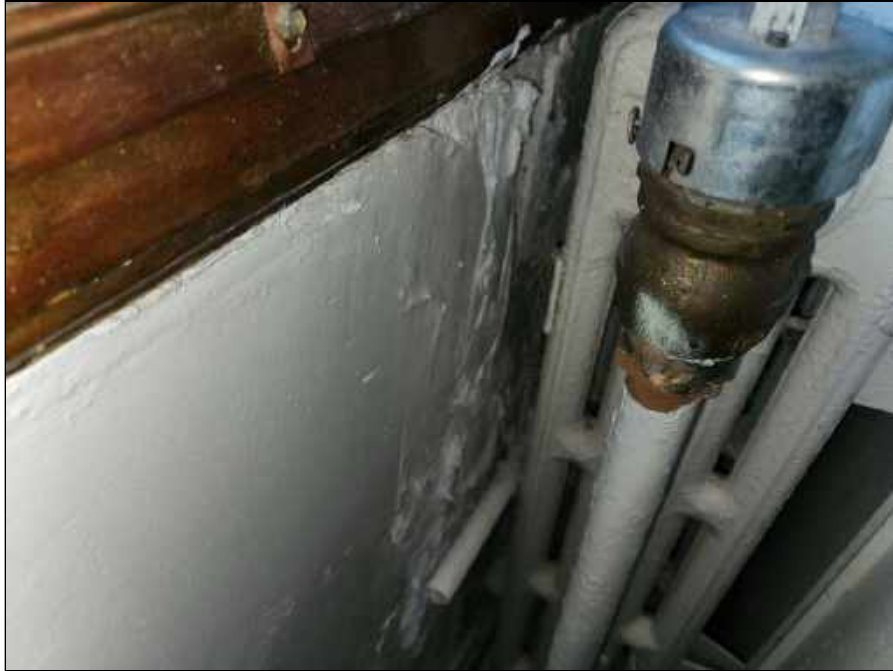
21 - Damaged plaster wall in Room 14

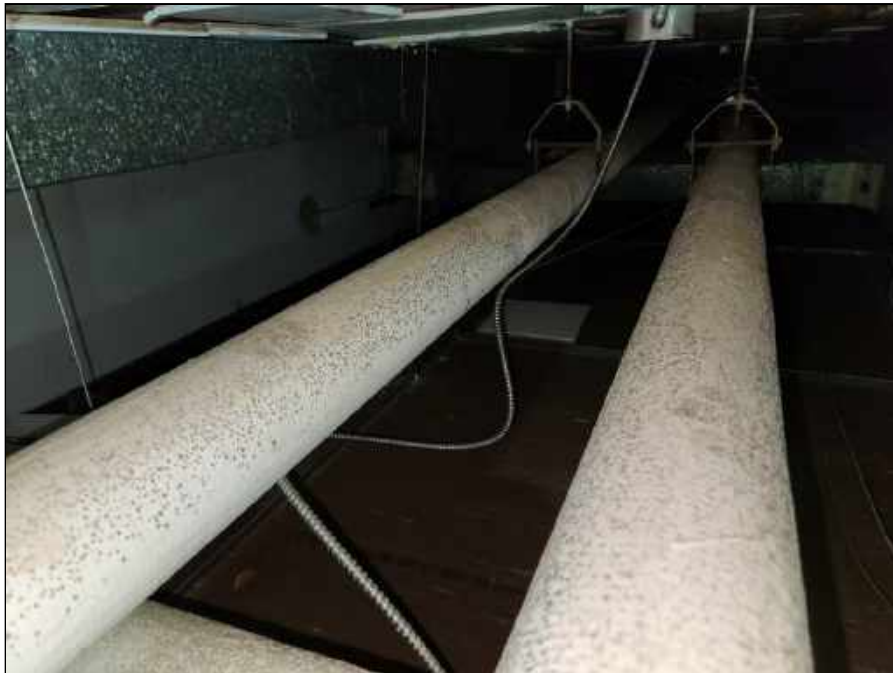
22 - Surface mold on pipe insulation above the ceiling in the South hallway

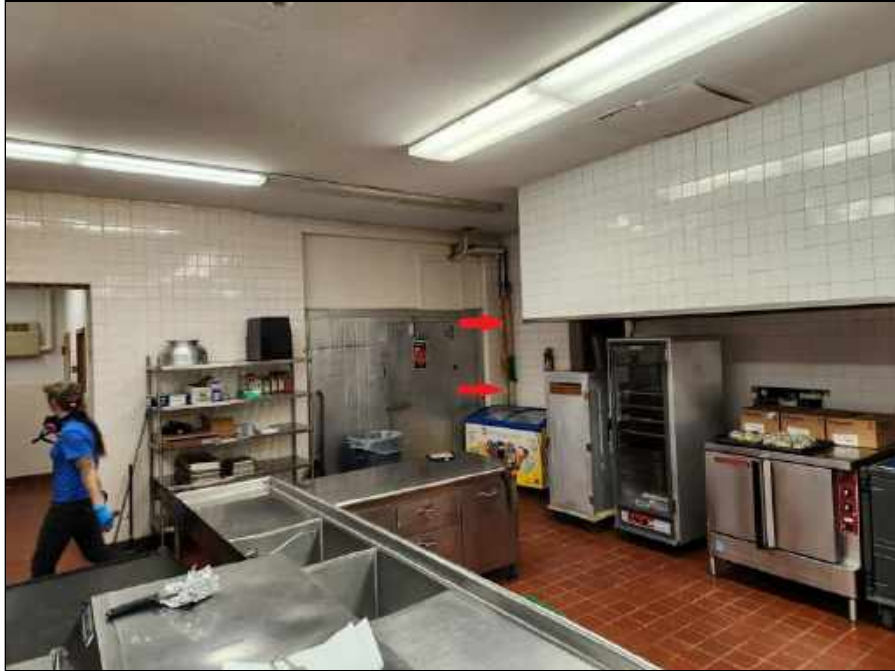
25 - Mold on pipe insulation in the kitchen

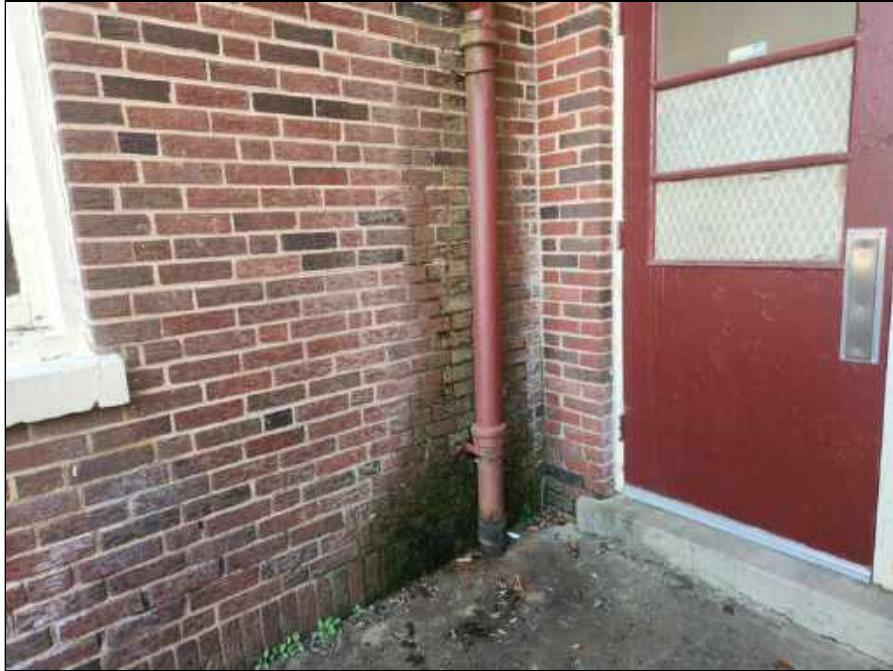
1 - Staining on the brick wall around the downspout indicating the water is running down the wall outside Room 14

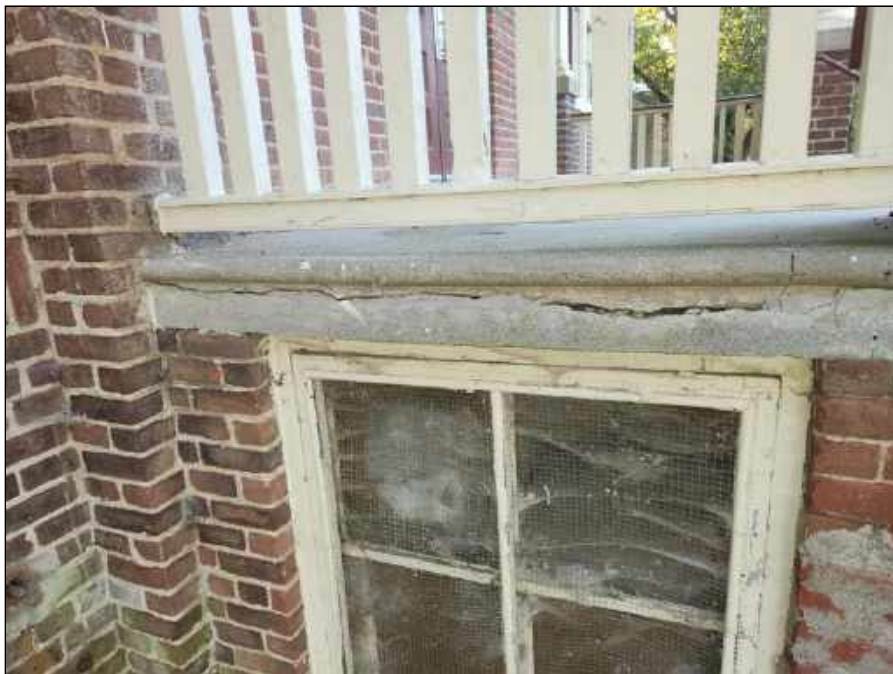
2 - Cracked concrete porch on the North side of the original building

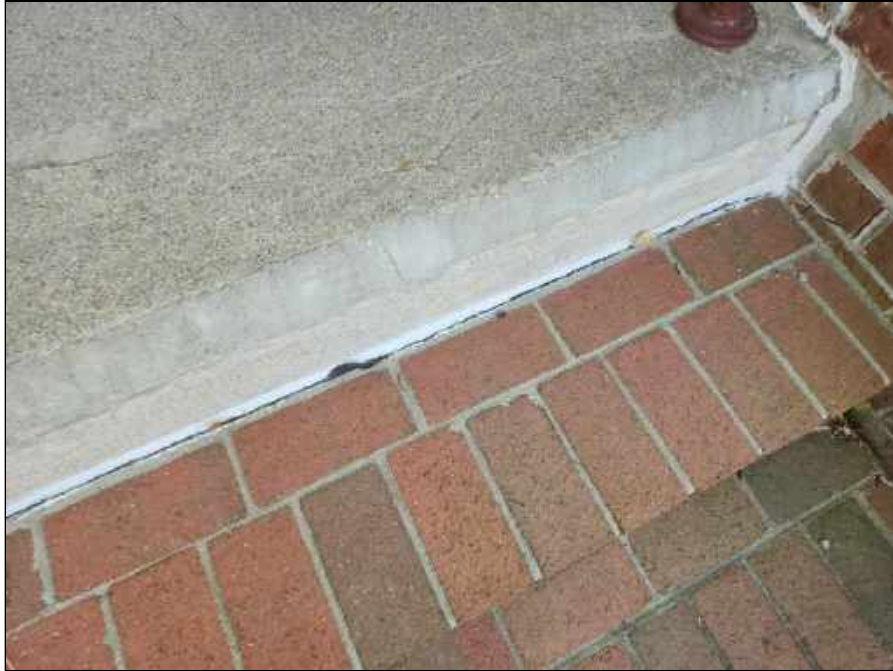
3 - Area where porch step is separating and likely a cause of water intrusion into the basement

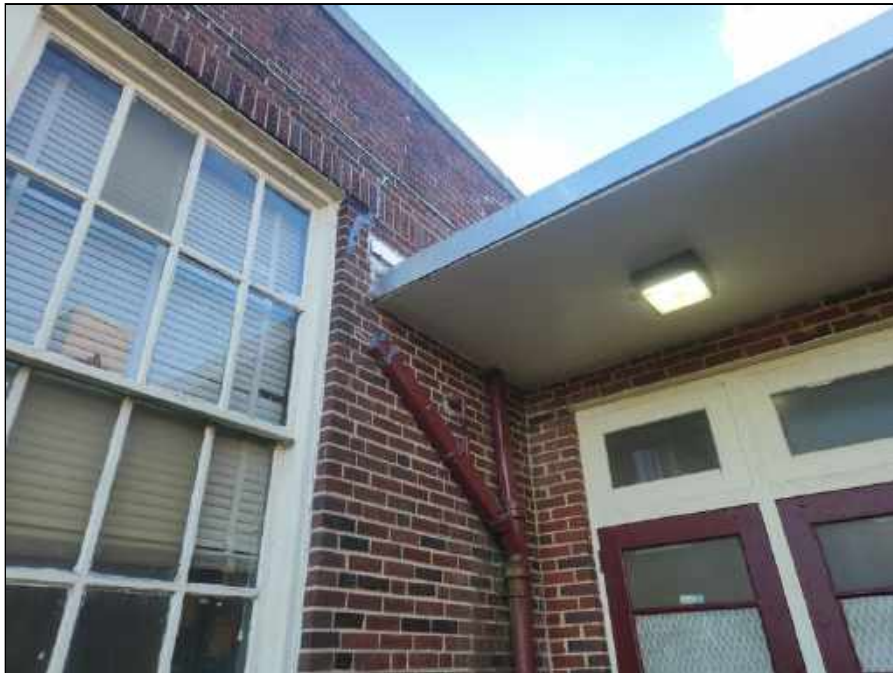
4 - Disconnected gutter outside room 14 likely causing water damaged plaster wall

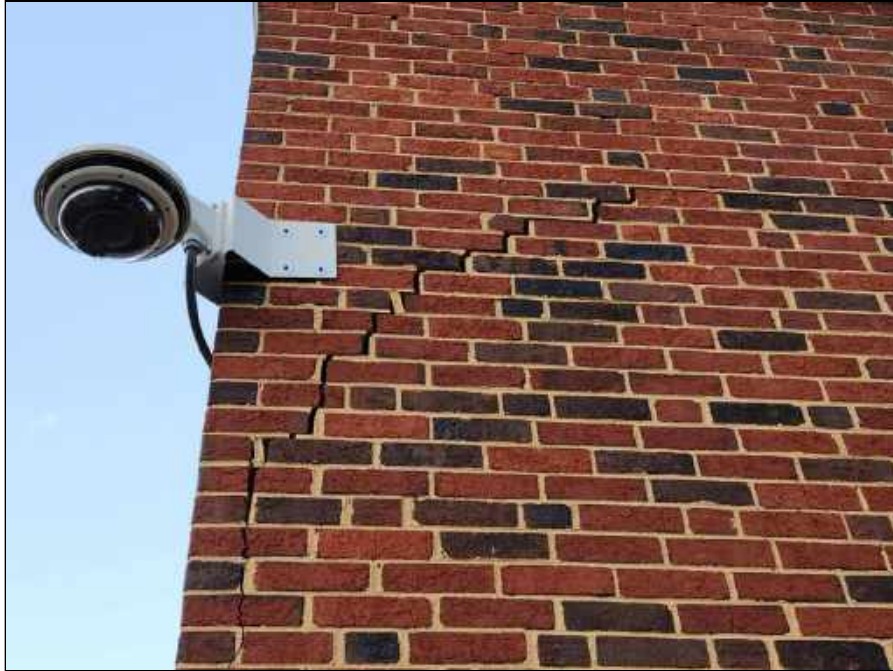
5 - Brick wall separating in the Southwest corner of the building outside room 9

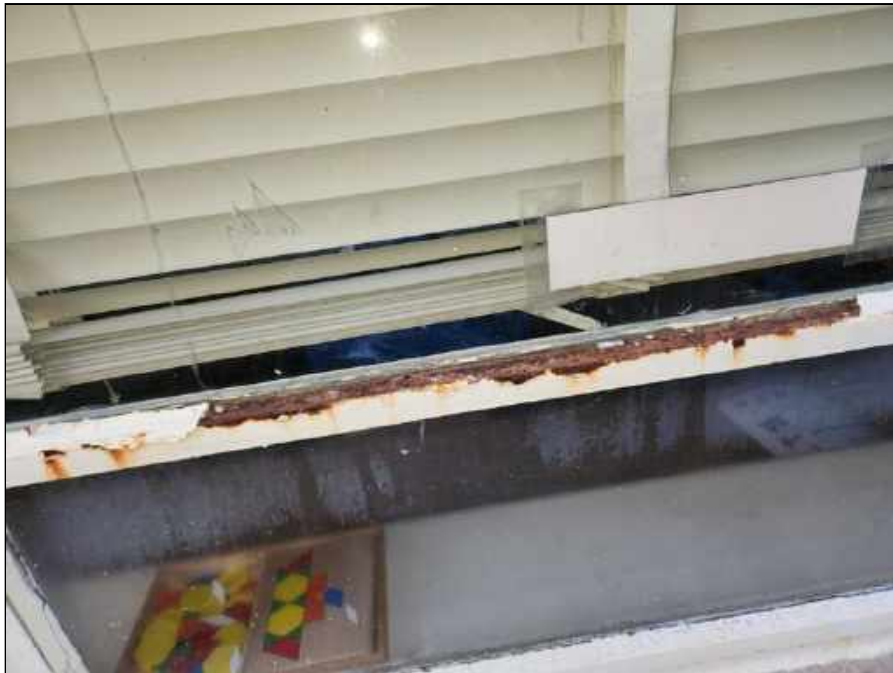
6 - Rusted window sash mullion and damaged window sash glazing on the South side of the building

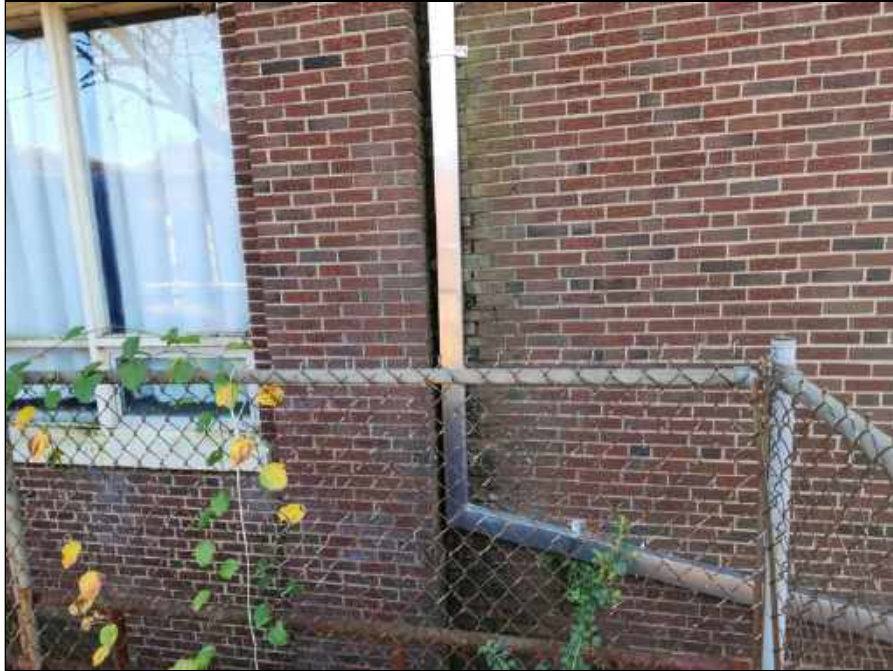
7 - Staining on the brick wall around the downspout indicating the water is running down the wall outside the Auditorium

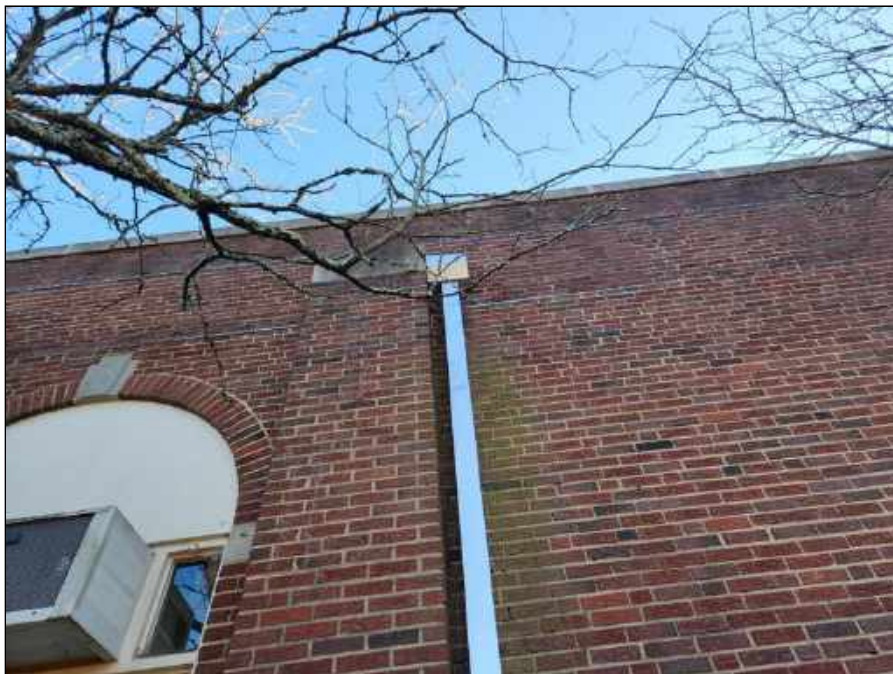
8 - Staining on the brick wall around the downspout indicating the water is running down the wall outside the Auditorium

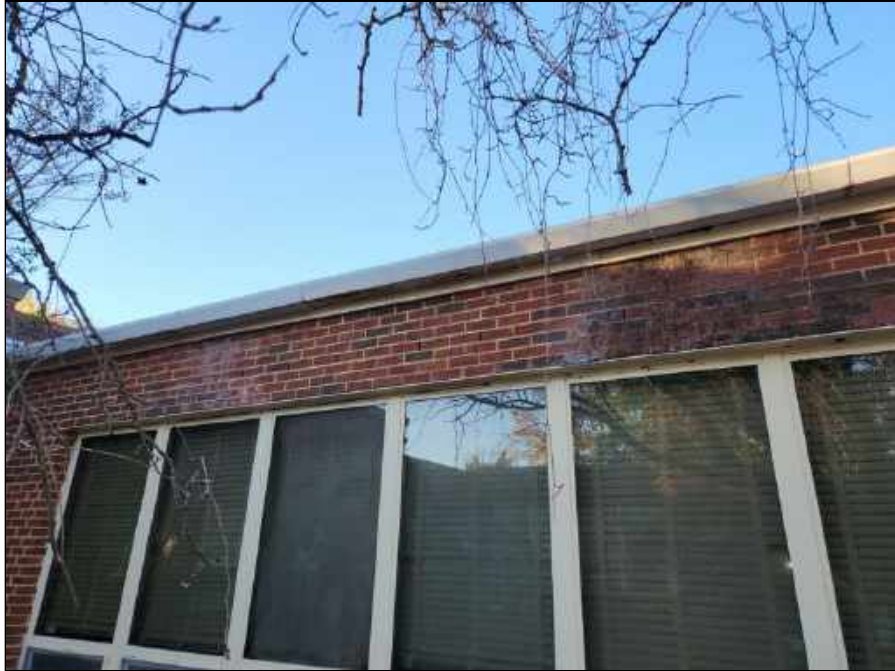
9 - Staining on the exterior wall in the courtyard outside Room 5
