# MOLD AND MOISTURE ASSESSMENT REPORT

FOX AT CLARK SPRINGS ELEMENTARY SCHOOL

ECS PROJECT NO. 47:14153-A

OCTOBER 4, 2023

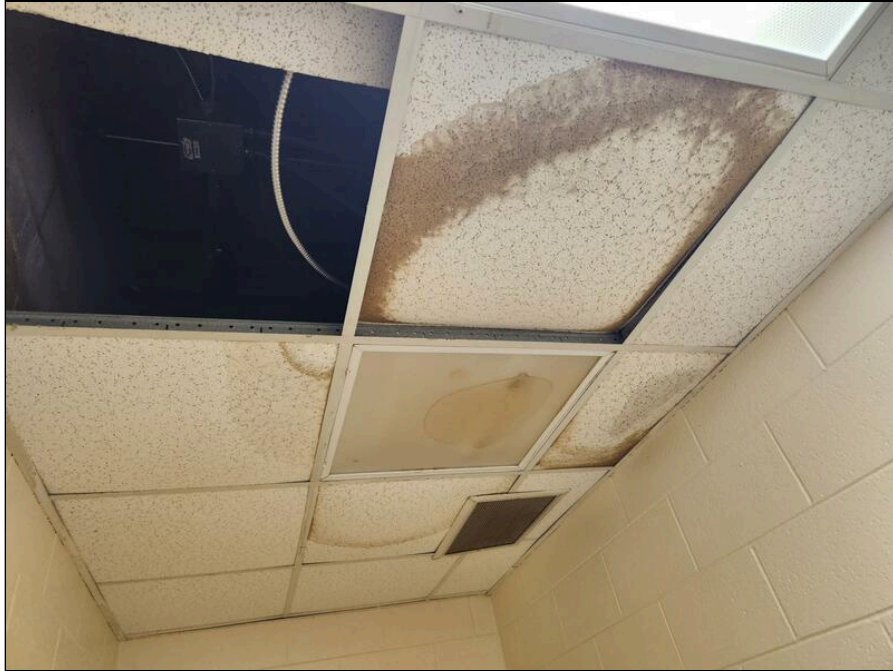
1 - Water and mold impacted ceiling tiles in the Conference Room/Locker Room

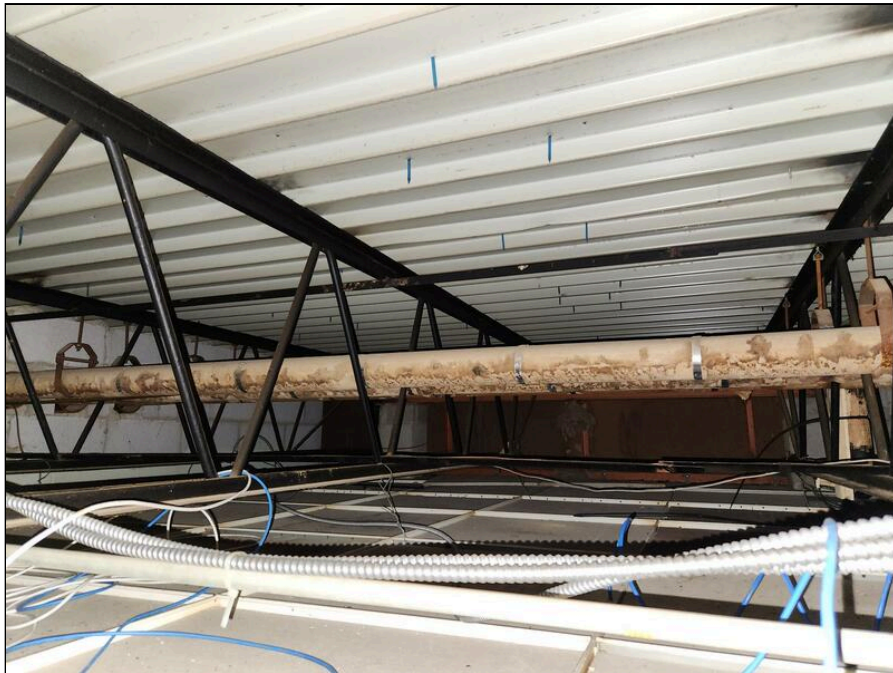
2 - Mold and water impacted insulation on the fan coil loop plumbing in the Faculty Lounge

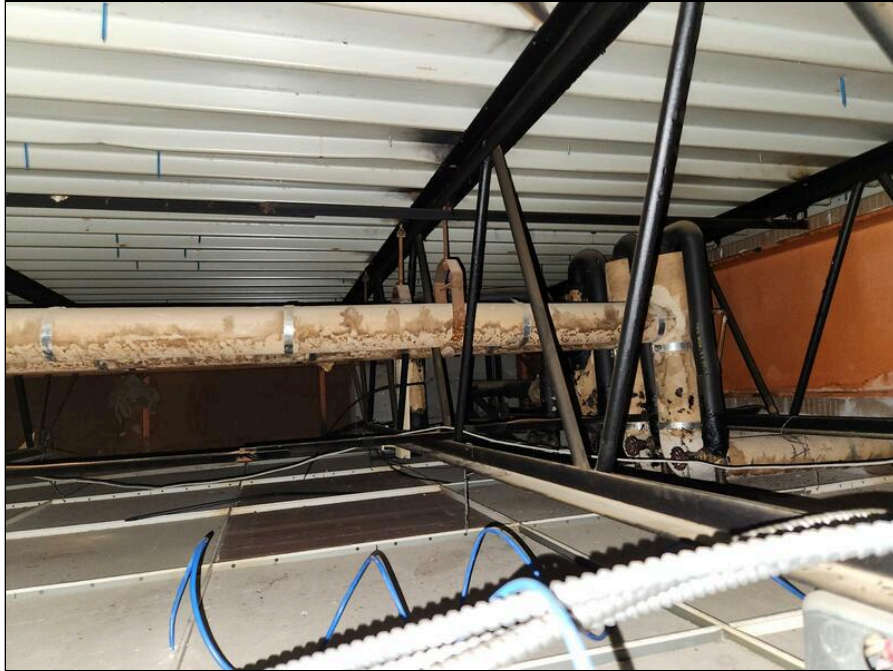
3 - View of mold impacted fan coil loop insulation above the faculty lounge

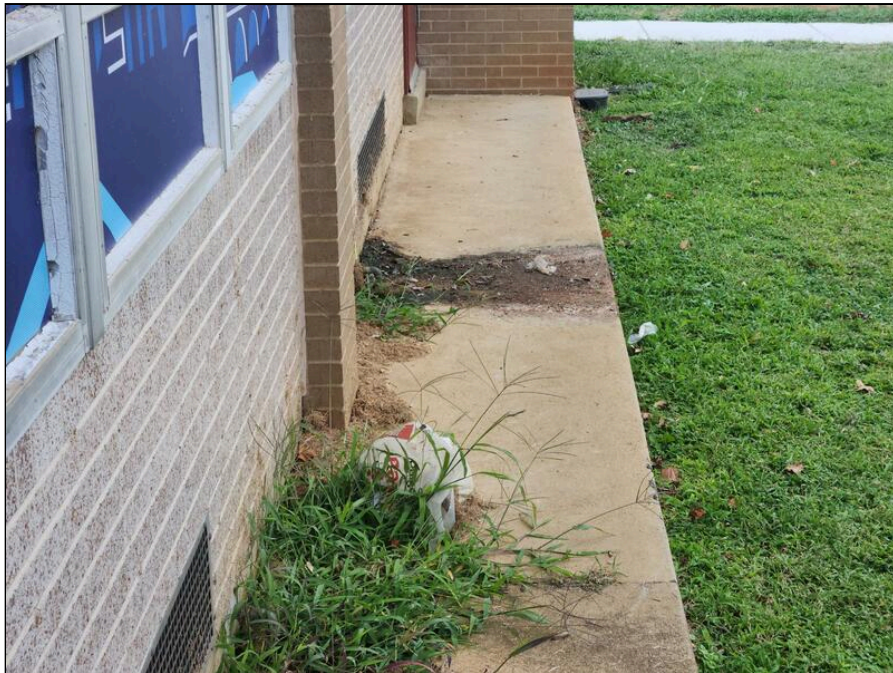
5. Evidence was observed that the condensate drains for the fan coils for many of the classrooms were clogged and condensate moisture is pooling and infiltrating back into the perimeter classroom walls. **Recommendation;** Inspect and clear the clogged drains. Open up and inspect the fan coil units and adjoining chases throughout the school for evidence of mold and moisture. Individually these areas may need to be dried out. If suspect mold is observed address as recommended further in this report. ECS also observed that the fan coil units and associated filters appeared dirty and should be cleaned and/or under routine preventive maintenance/inspection/cleaning. With regards to the condensate drain issues, once the school switches to heating season this issue should subside until cooling season begins.

4 - Fan coil condensate backing up outside the classrooms

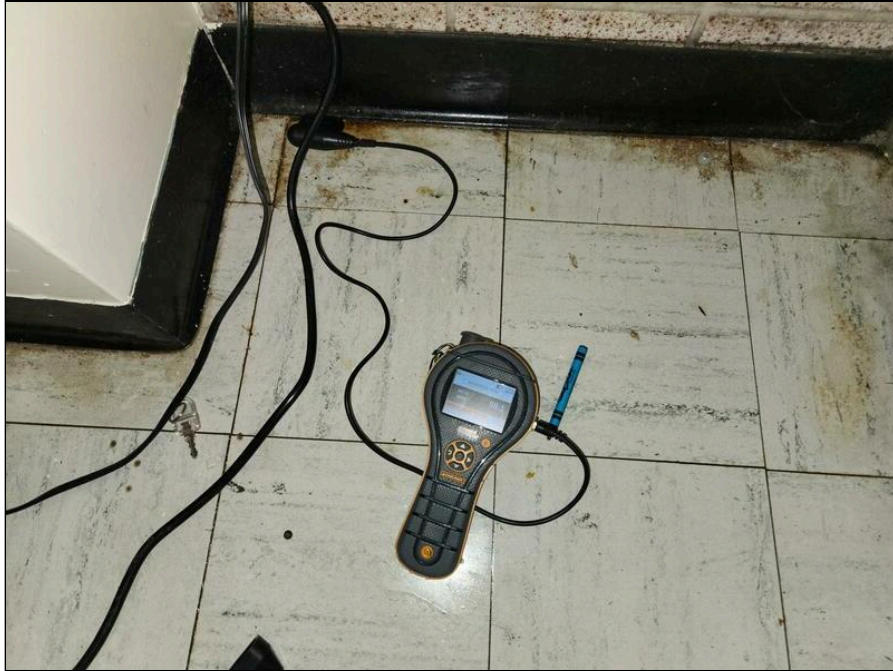
Elevated moisture readings were also measured around the floors and walls by the fan coil units in classrooms 109, 111 and 112; ECS observed these were classrooms with backed up condensate drains on the exterior. It is likely this is a common issue wherever there are clogged condensate drains draining back up against the building.

5 - Staining on floor tile and elevated moisture meter reading in room 112

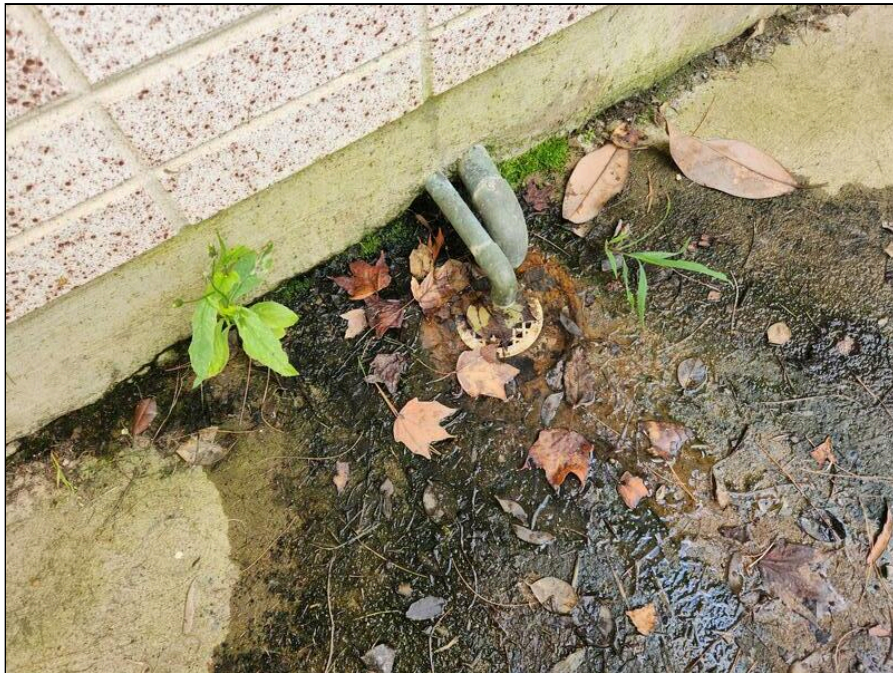
6 - View of overflowing condensate drain

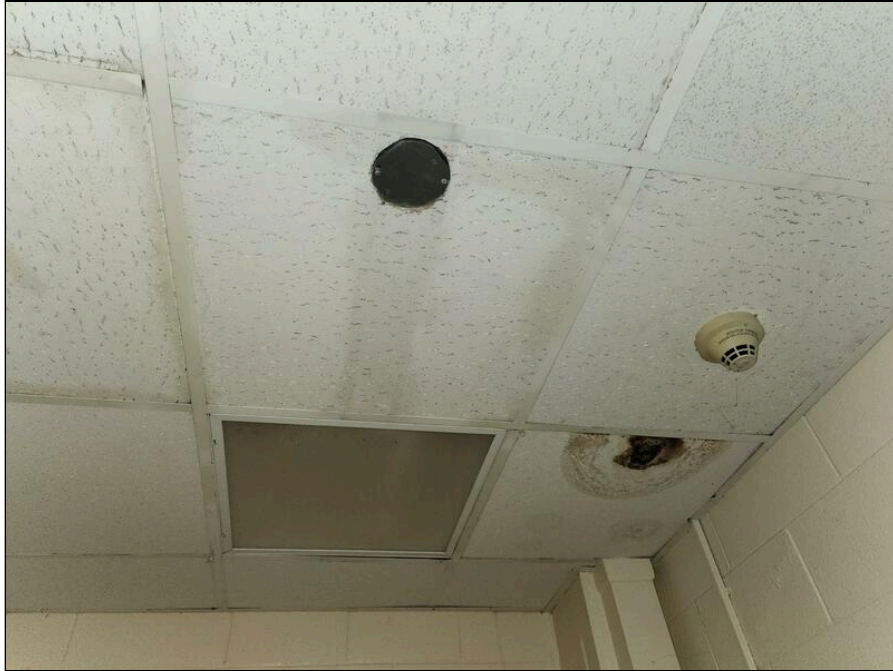
7 - Mold and water impacted ceiling tiles above exit near room 110

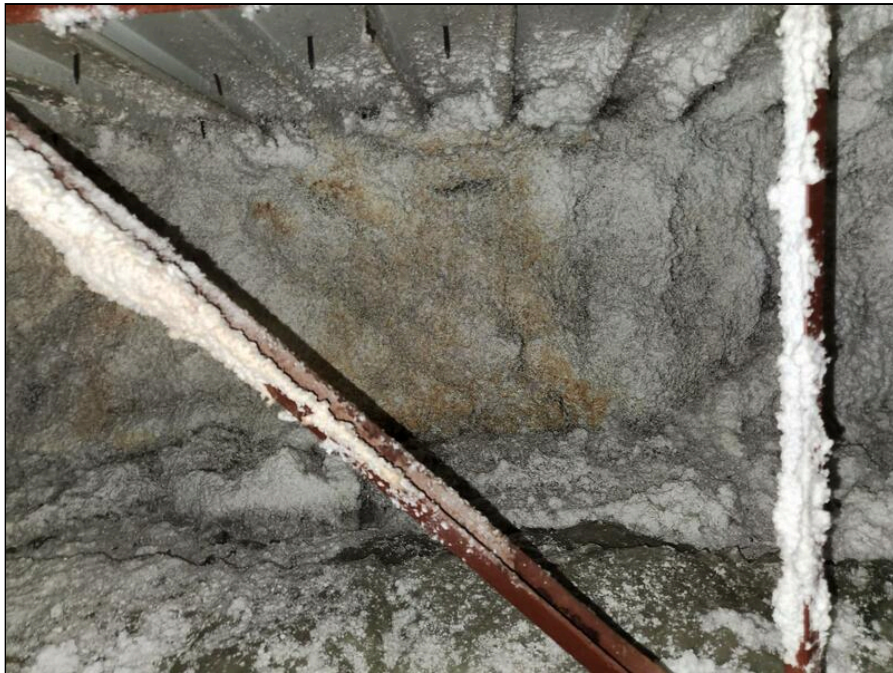
11. The blown-in insulation in the soffit around the perimeter classrooms and fiberboard panels above the windows in the library and cafeteria were visibly discolored and stained in some areas. This appears to indicate infiltration of outdoor air and potentially moisture through gaps in the exterior corrugated soffit panels. **Recommendation:** ECS recommends further review by a building envelope engineer for the appropriate corrective action.

8 - Discolored blown in Soffit insulation in room 112

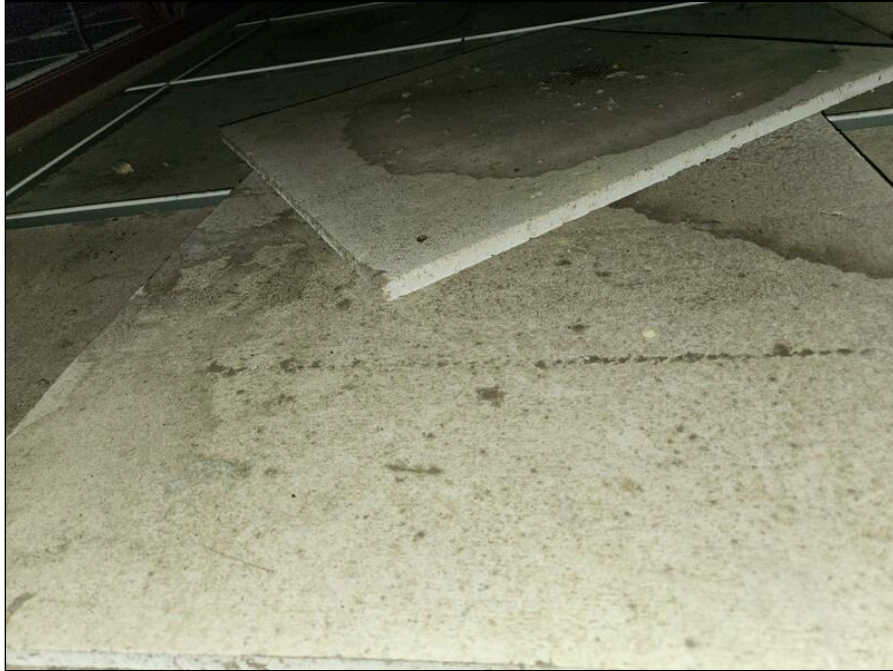
During the survey ECS observed apparent surface mold staining on the back of older fissure style ceiling tiles mainly in the classroom wings. ECS collected a direct tape lift sample from two ceiling tiles that were in Room 113 and Room 118. The results indicate that mold spores are present but that a source of growth is not likely present. It appeared that the older fissure style ceiling tiles all showed this evidence of light surface mold staining on the backs of the ceiling tiles. These ceiling tiles are present in the school anywhere they have not been previously replaced and are still present in areas all over the school. ECS believes that the condition may be caused by a temperature and relative humidity differential between the classroom and the ceiling cavity that are causing conditions in the cavity to encourage mold growth during the cooling season. ECS does not believe that the surface mold on the ceiling tiles is necessarily contributing to or is a direct source of any airborne mold spore elevations.

9 - Visible evidence of mold on the back of the older ceiling tiles in Room 113.

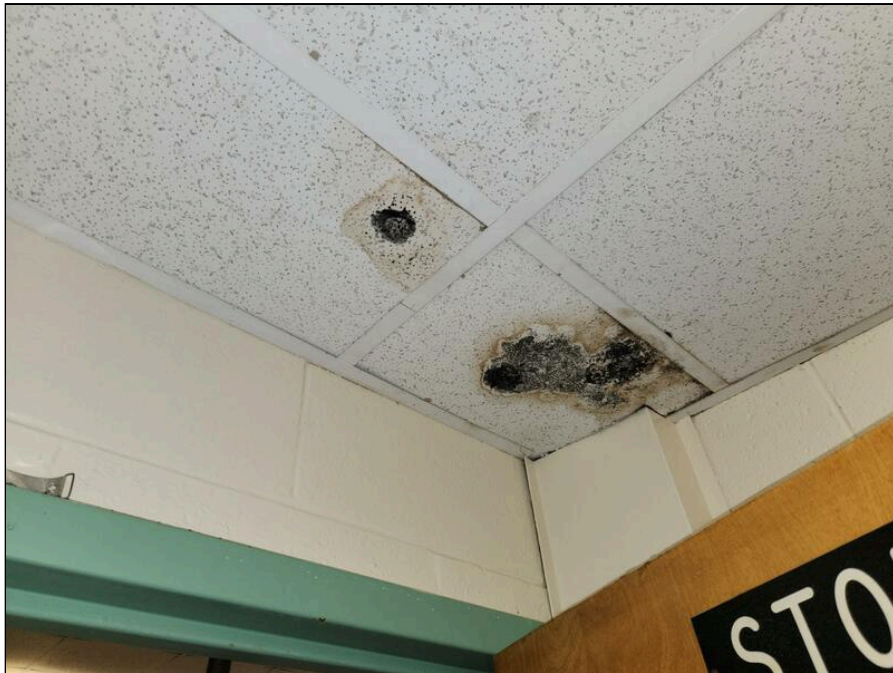
10 - Mold and moisture impacted ceiling tile in storage Room by Room 118

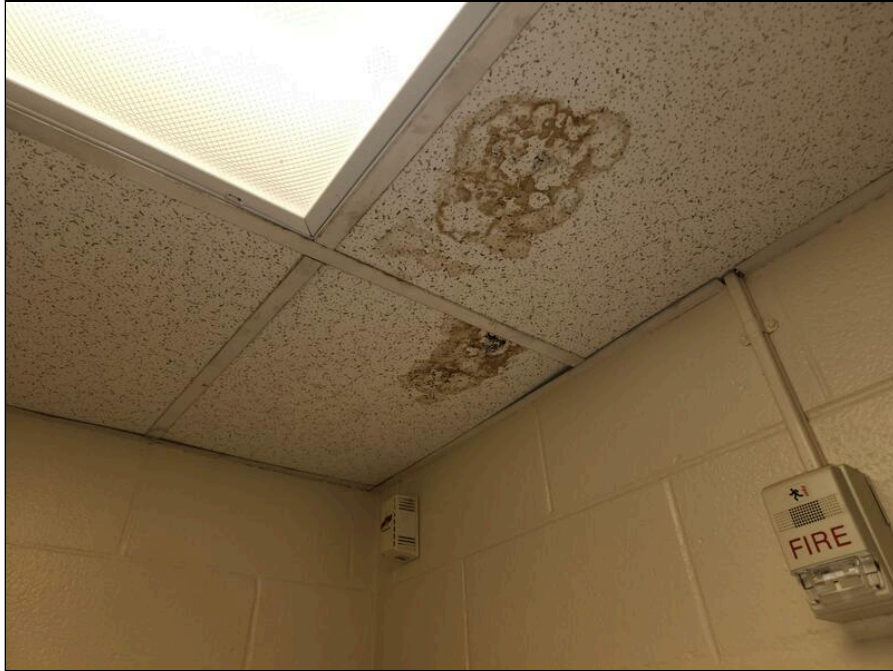
11 - Water and mold impacted ceiling tile in the Room 108 bathroom

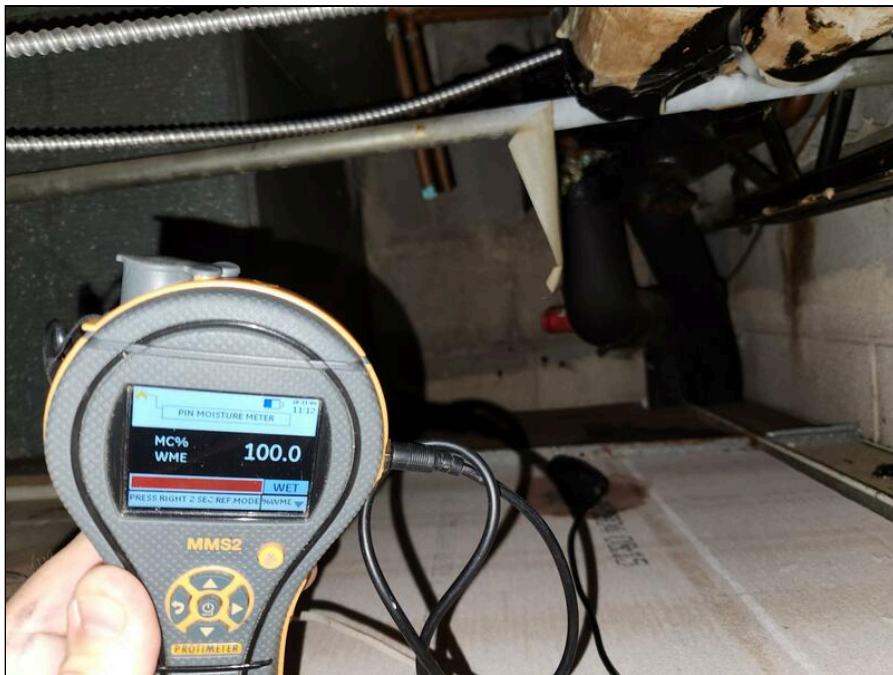
most significantly elevated air sample for mold was detected on the sample collected in the Room 104. Visible mold and an active leak were observed on ceiling tiles associated with a leaking hydronic piping valve above the ceiling at the entrance to Room 104. The other areas where elevations were noted were in locations where visible mold was present or present in adjacent rooms.

Elevated moisture meter readings were detected in ceiling tiles in room 104 , the room 106 bathroom and the exit vestibule outside room 117 from visibly active leaks from plumbing valves above these areas.

12 - Wet moisture meter reading and active hydronic plumbing leak in Room 104

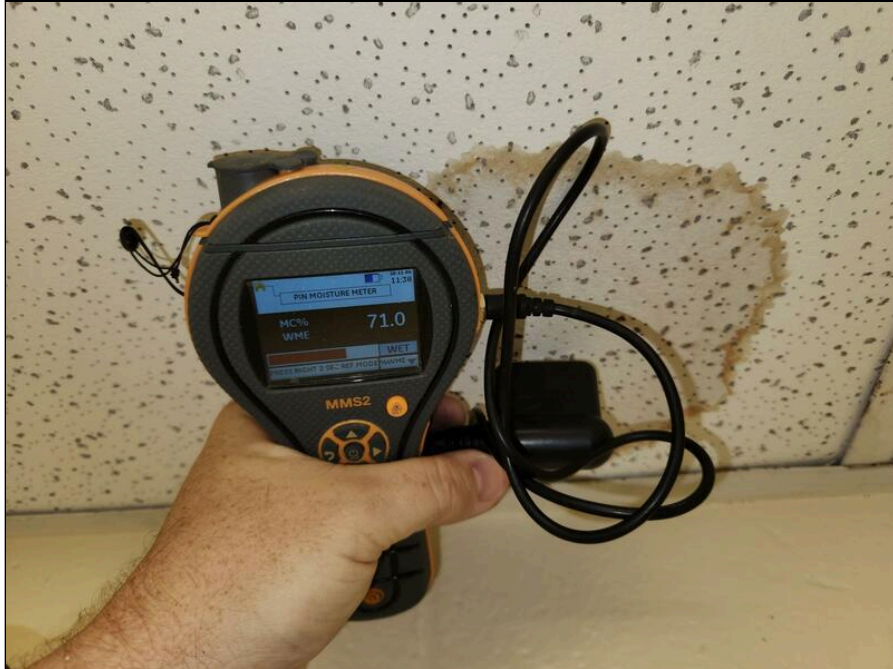
13 - Wet ceiling tile in Room 106 bathroom

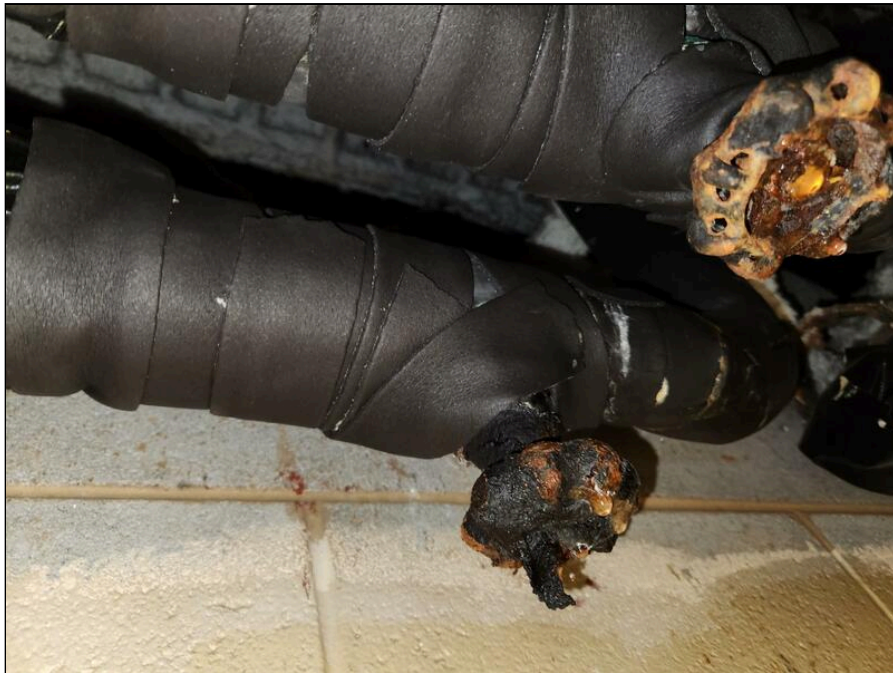
14 - Source of leak in Room 106 Bathroom

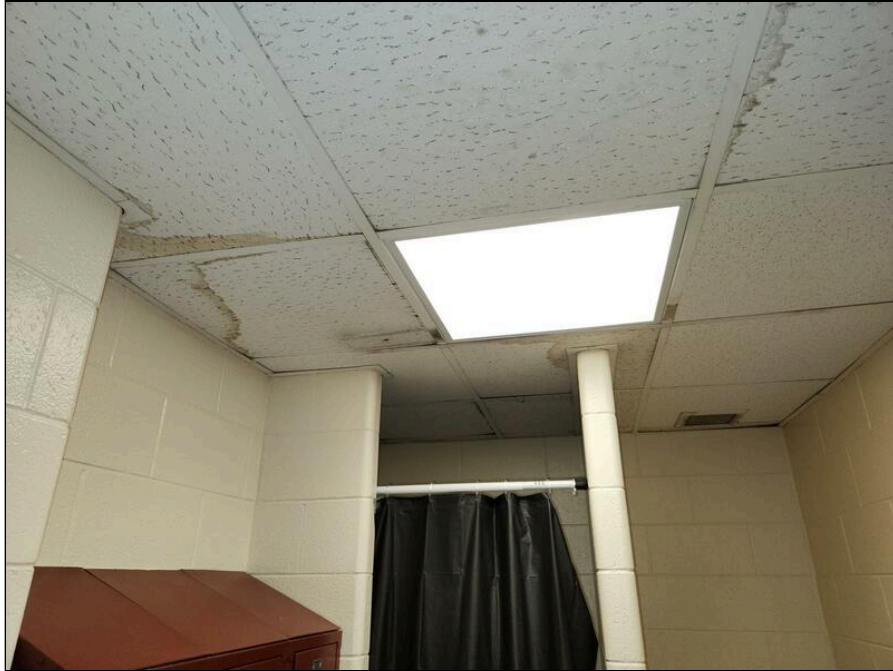
15 - Mold and moisture impacted ceiling tiles in the employee locker room

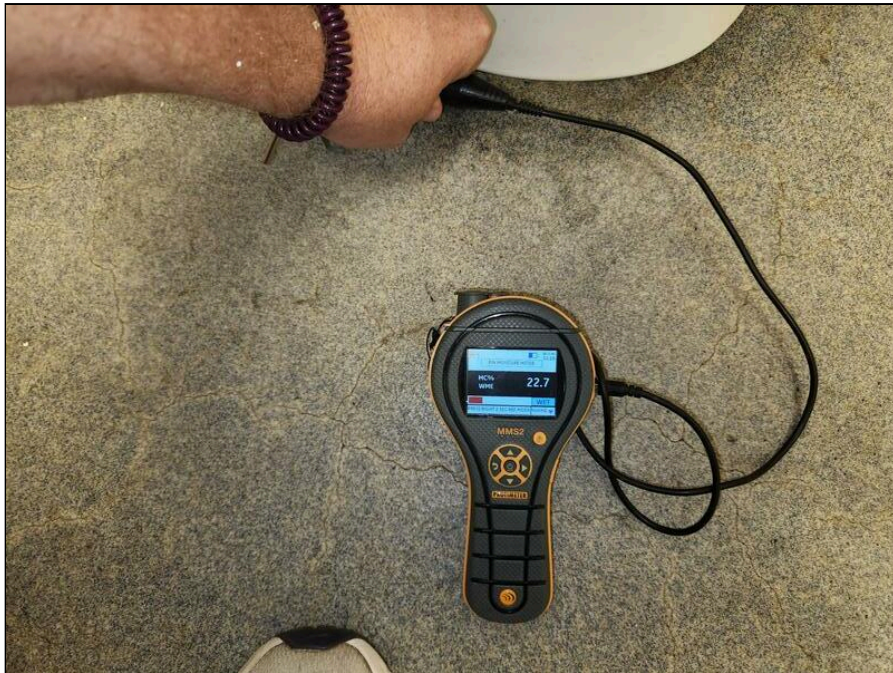
9. In the North wing ECS observed elevated moisture readings associated with the base of the toilet in the Room 104 bathroom. This may indicate that the wax ring on the toilet is failing and water is infiltrating beneath the bathroom flooring material. **Recommendation:** Inspect the wax rings of all the toilets in the North wing and remove and replace them as needed by a qualified plumbing contractor or maintenance technician.

16 - Elevated moisture meter reading collected from the base of the toilet in the Room 104
