### SUFFIELD MIDDLE SCHOOL ~ PROGRAMMING

## SUFFIELD MIDDLE SCHOOL ~ Why do a building project?

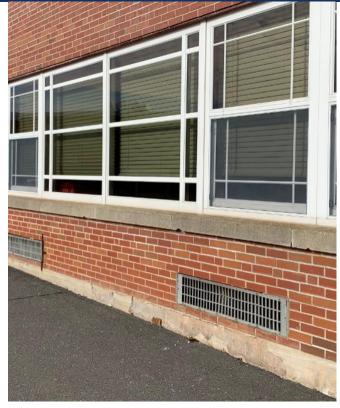
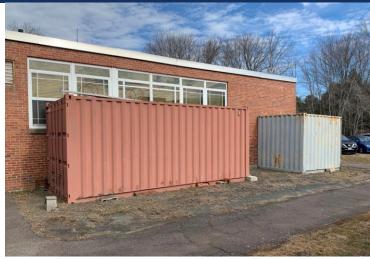
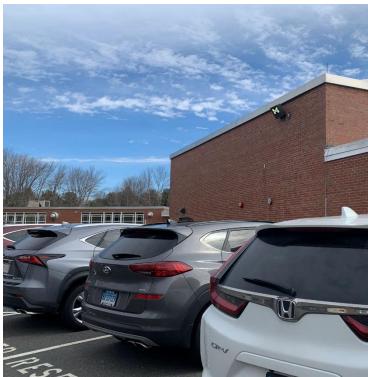
- 1. Site conditions are in fair to poor condition ~ sidewalks, curbs, paving, drainage issues,
- 2. Site traffic flow, parking, security major concerns. Unsecured perimeter access & parking a security concern.
- Fields are remote from building with limited outdoor opportunities for education. Areas of poor drainage on west/southwest side of site.

- Consistent roof leaks, roof replaced in phases by different contractors, various warranties, other envelope concerns ~ pointing of masonry, doors, etc.
- 2. Majority of building contain brick veneer in fair to good condition with areas of isolated spalling at base of wall/ exposed concrete foundation wall. Existing lintels are in fair to poor condition.

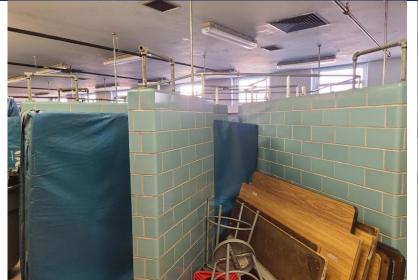
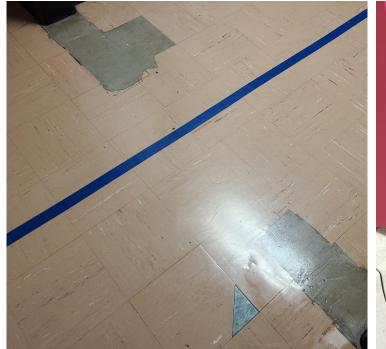
- 1. Overall, well maintained brick structure, but many areas poorly constructed.
- 2. Observed significant inefficiencies due to additions/renovations over time.
- 3. Noise/Acoustical concerns in 70's additions renovations due to "modular" wall construction.
- 4. Various additions eliminated natural daylight to educational space creating poor conditions for educating students.
- 5. Overall current condition of finishes are generally in poor condition. Yearly improvements have had to be made to isolated areas, science labs, finishes in media center, tech education planned.
- 6. Majority of toilet cores are in poor condition due to age and use. In some instances, are not used/obsolete

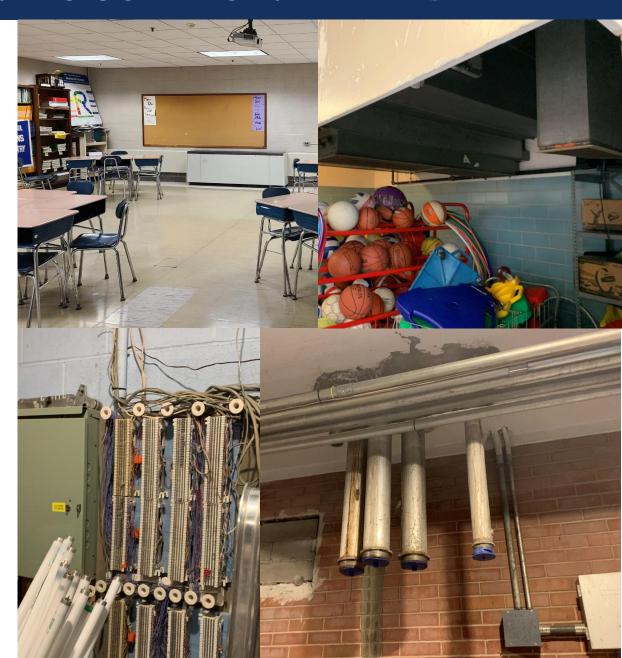
- 1. Many renovations and varying vintages of systems. Some newer, some original.
- 2. No central domestic Hot Water Plant. Lots of distributed water heaters. Leads to more maintenance and repairs.
- 3. Electrical systems have many vintages. While service is newer it back feeds original vintage systems.
- 4. Most major mechanical systems past or at the end of their useful life.
- 5. No natural ventilation/windows to many classrooms/educational spaces.
- 6. Overall MEP systems need a complete overhaul.
