Barre Unified Union School District

MEMORANDUM

FACILITY CONDITION ASSESSMENT

**Vermont Agency of Education_FCA Phase Two
1 National Life Drive, Davis 5
Montpelier, VT 05620-2501**

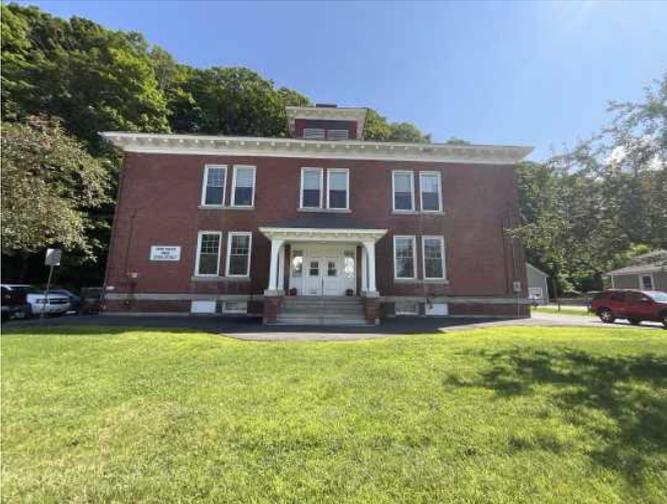
1 - OVERVIEW OF FRONT ELEVATION

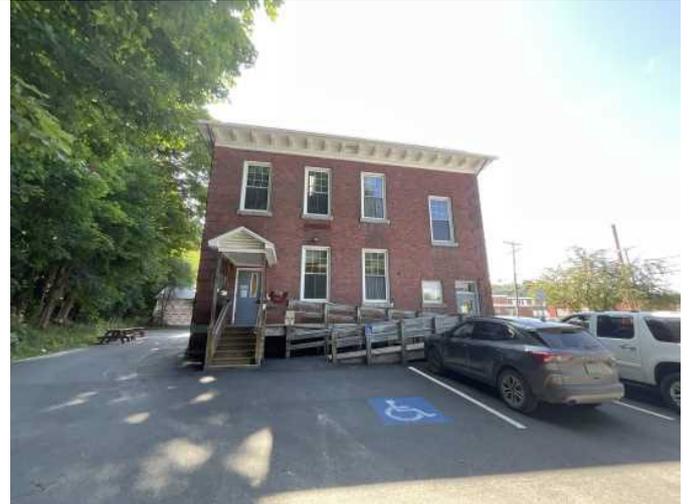
2 - OVERVIEW OF LEFT ELEVATION

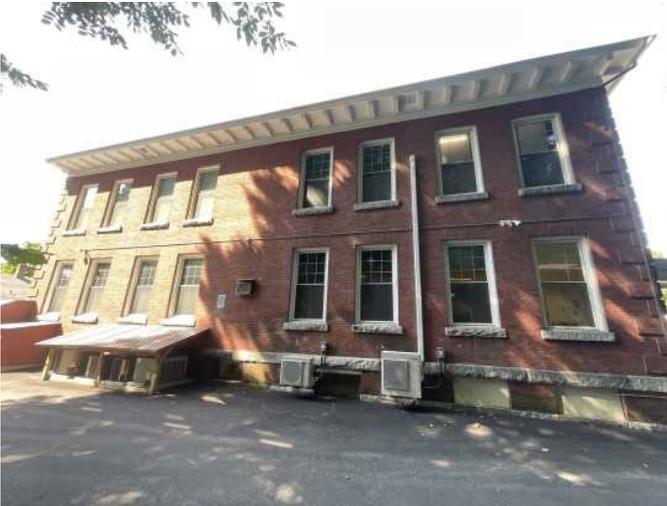
3 - OVERVIEW OF REAR ELEVATION

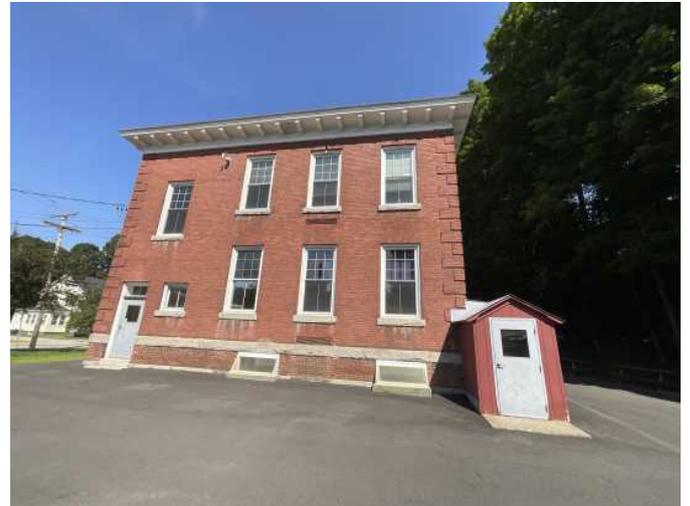
4 - OVERVIEW OF RIGHT ELEVATION

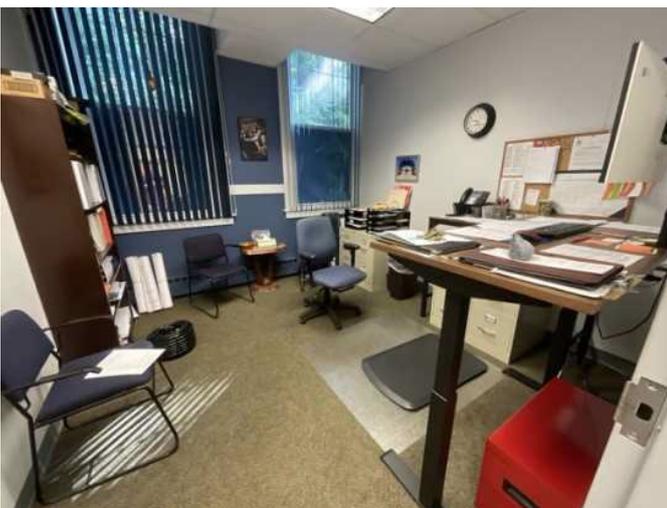
5 - OVERVIEW OF OFFICE SPACE

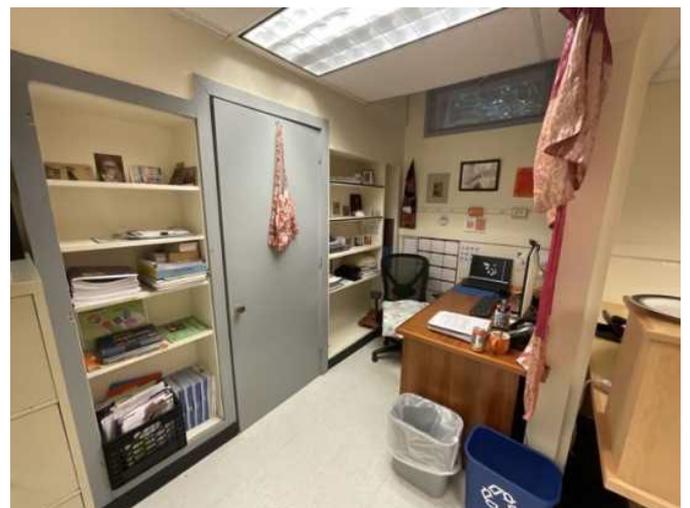
6 - OVERVIEW OF OFFICE SPACE

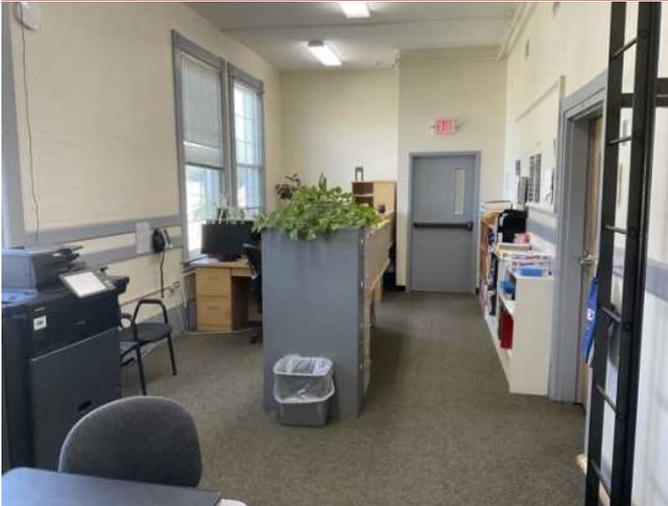
7 - PHOTO OF SHARED OFFICE SPACE

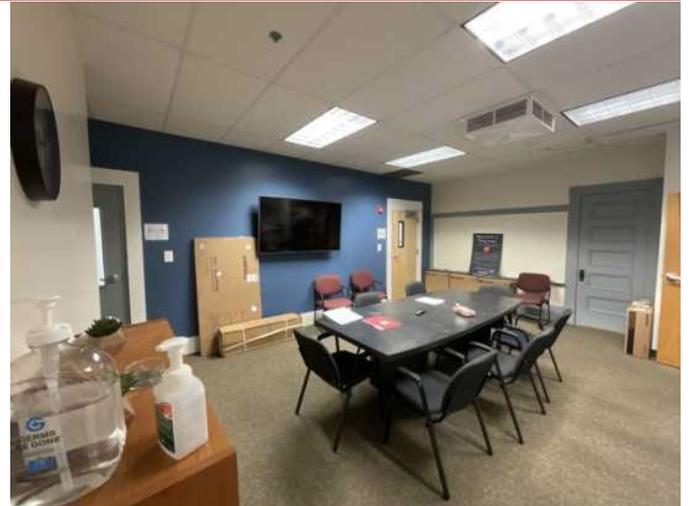
8 - OVERVIEW OF CONFERENCE ROOM

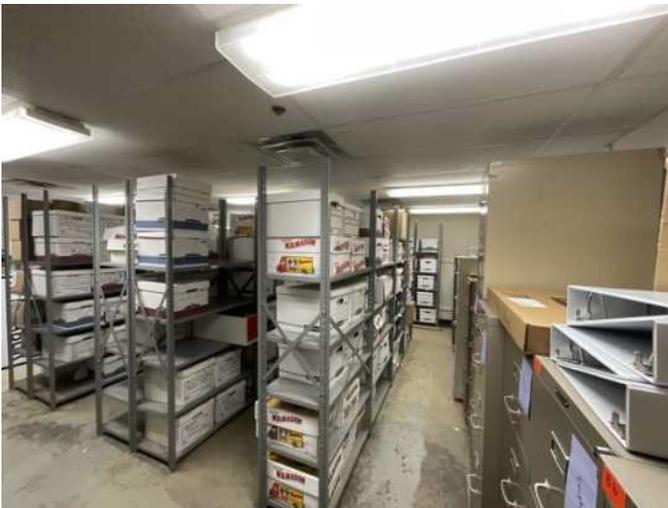
9 - OVERVIEW OF FILE STORAGE

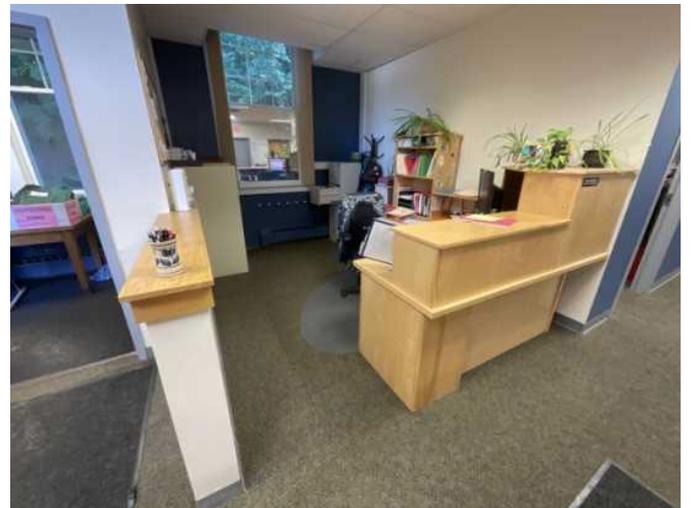
10 - OVERVIEW OF RECEPTION AREA

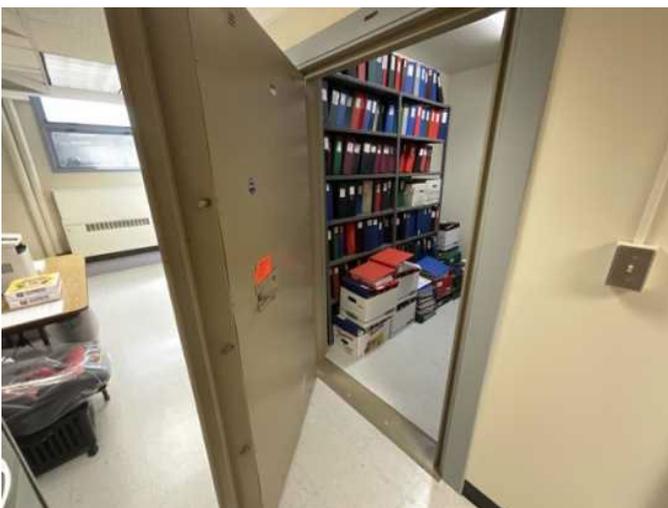
11 - PHOTO OF FILE SAFE

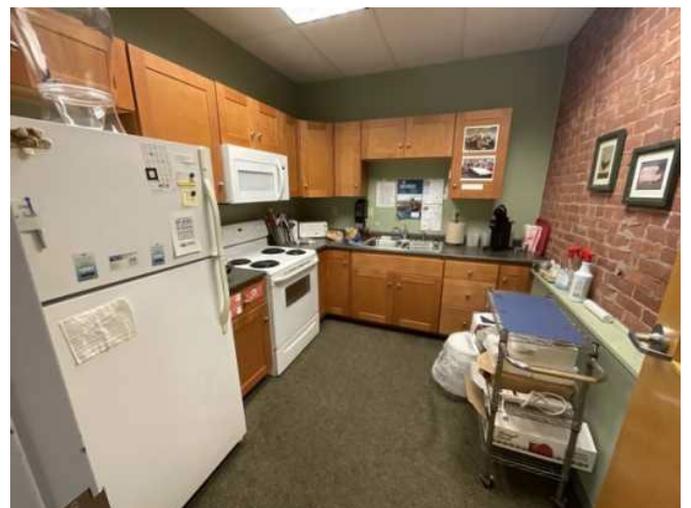
12 - OVERVIEW OF BREAKROOM SPACE

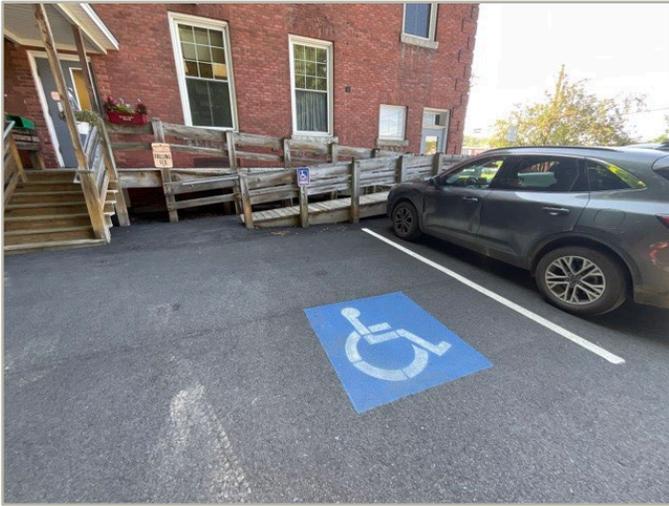
1 - OVERVIEW OF ACCESSIBLE PARKING AREA

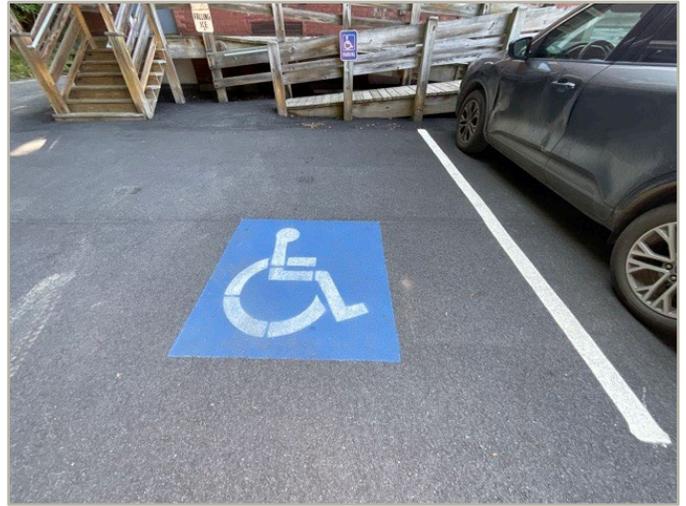
2 - CLOSE-UP OF STALL or 2ND PARK AREA

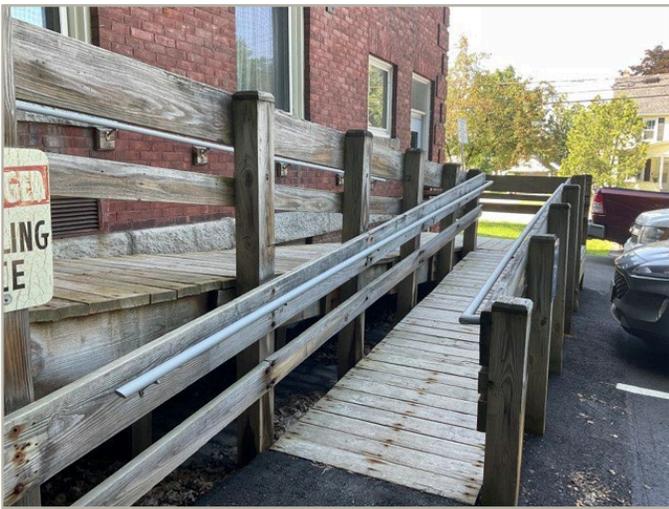
3 - EXT RAMP or PRIMARY PATH OF TRAVEL

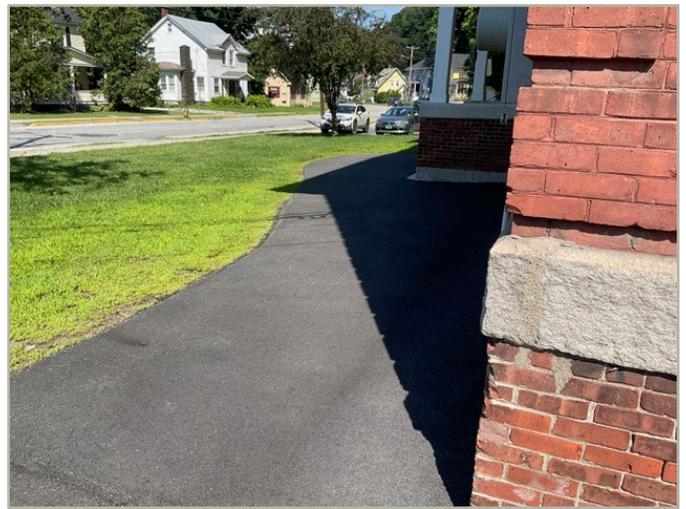
4 - CURB CUT or 2ND PATH OF TRAVEL

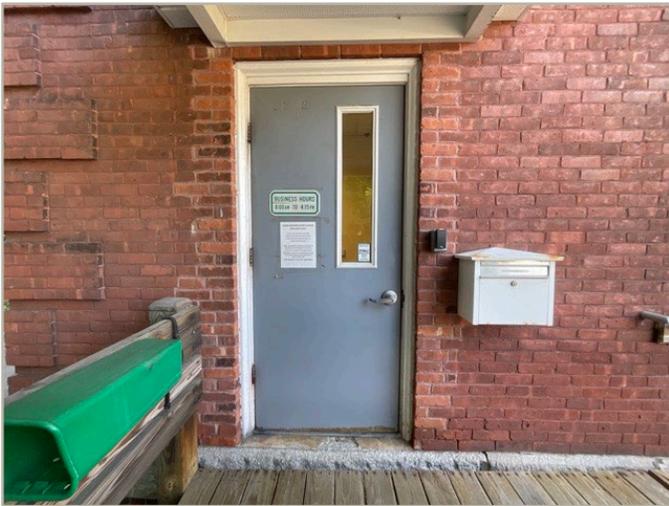
5 - MAIN ACCESSIBLE ENTRANCE

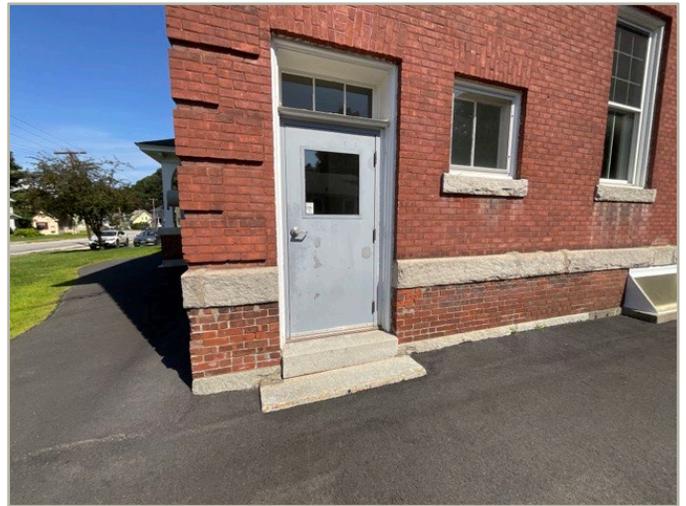
6 - 2ND ENTRANCE or SIGNAGE/HARDWARE

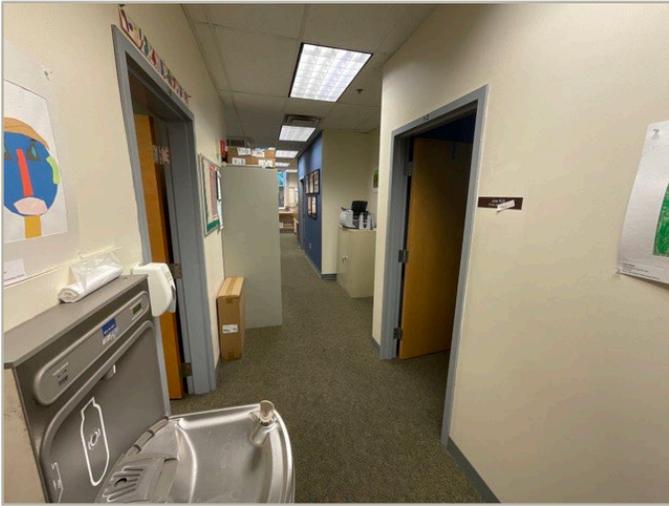
7 - ACCESSIBLE INTERIOR PATH (RAMP/LIFT)

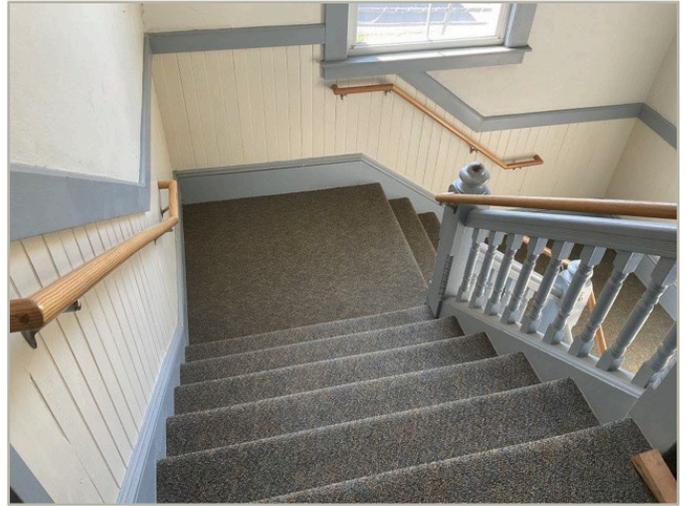
8 - HARDWARE, STAIR RAILS or SELF-SERVICE AREA

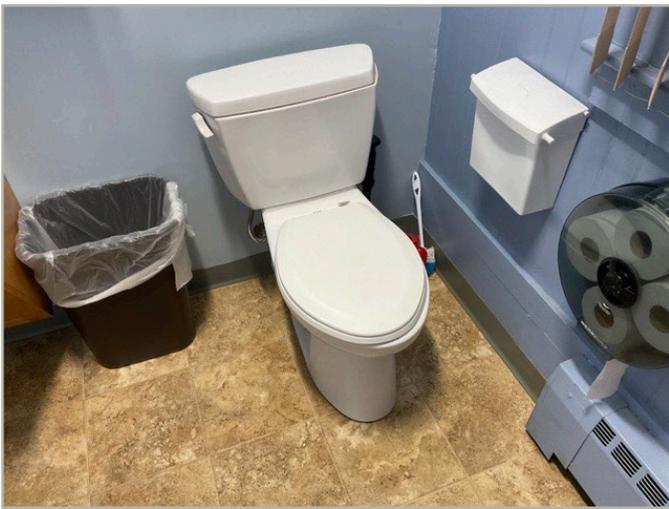
9 - TOILET STALL OVERVIEW

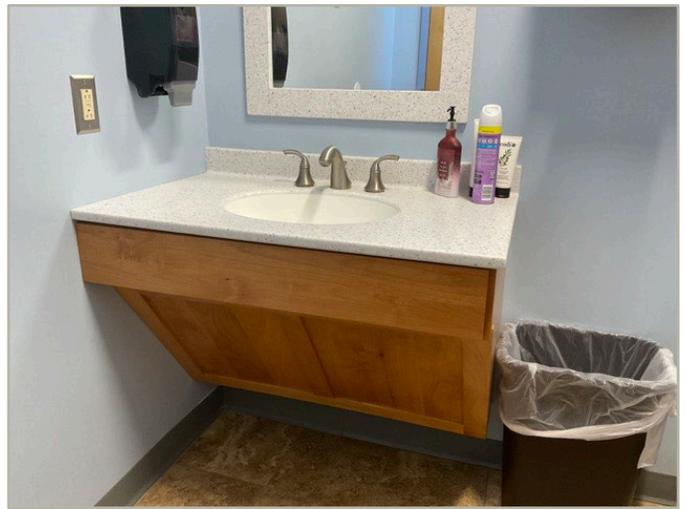
10 - SINK, FAUCET HANDLES or ACCESSORIES
