Gap Mountain Consulting Engineers, PLLC

April 7, 2024

Subject: **GREENWICH CENTRAL MIDDLE SCHOOL
POST-EARTHQUEST STRUCTURAL CONDITION INSPECTION**

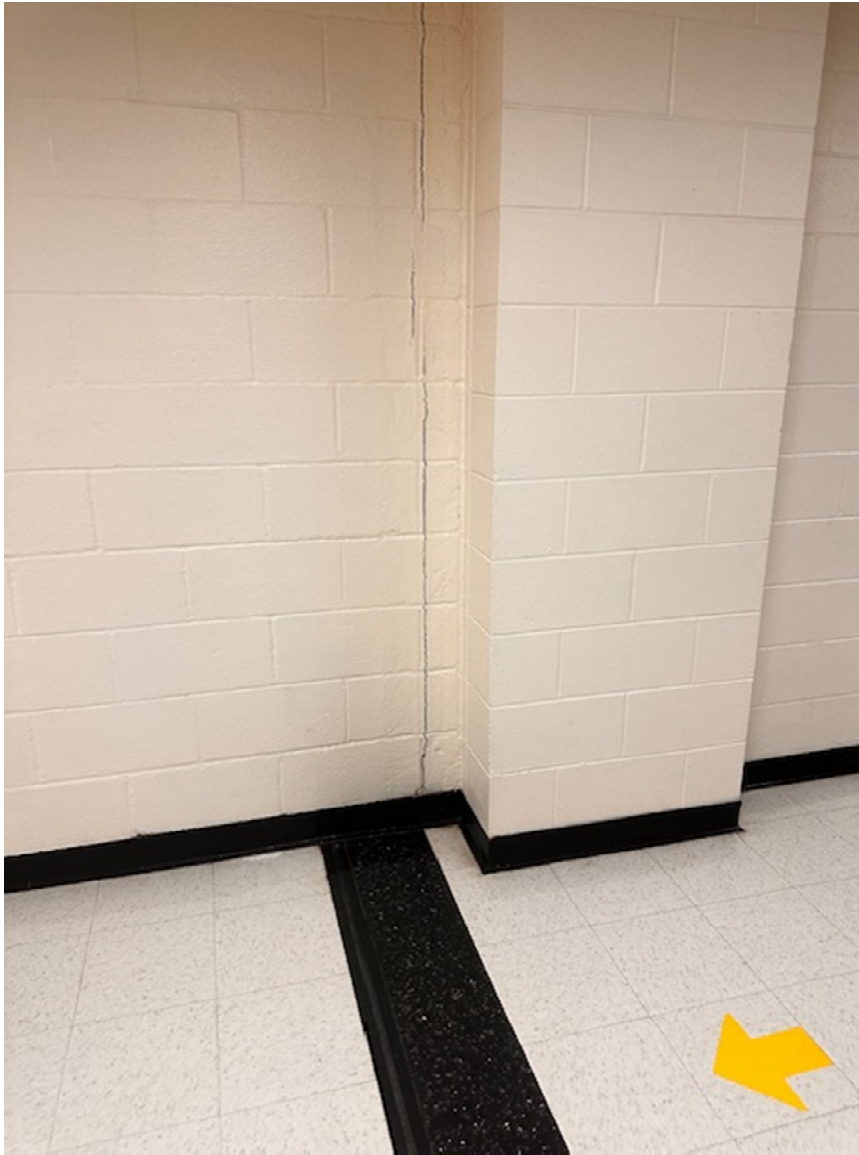
We believe that designers of the addition accounted for differential settlement using an expansion joint. However, the expansion joint was either not design or constructed correctly. The flaw is that joint in the floor does not align with the joint in CMU walls. The results are: 1) natural expansion joints are formed in walls of the sallyport; and 2) uncontrolled cracking. During our above ceiling inspection, we observed that uncontrolled cracking extends to the roof and beam pockets. Some cracks are indicative of lateral loads such as wind and seismic. Cracks are more extensive where the sallyport abuts the existing building at the roof and beam pockets, which is where forces concentrate and the sallyport structure is confined by the existing building. We observed fine cracks at and above the ceiling which is indicative of response to seismic loading. These cracks may have formed or been exacerbated by the earthquake but they are not a structural or life safety concern.

Figure 1 - expansion joint in the floor is covered with vinyl strip while the naturally formed expansion joint in the wall is off-set and formed through CMU block and joints. The abutting pilaster remains in serviceable condition.

Recommend that the Town program a minor maintenance and repair project to “stich” uncontrolled cracks in CMU walls abutting the existing building in the sallyport. Do not stitch what are now naturally formed expansion joints in the walls as these are now expansion joints. The joint can be caulked for aesthetic and weather proofing purposes. The caulk needs to be elastic while stich repairs are rigid and structural. Stich repairs to masonry construction are retrofit mechanical devices that structurally connect cracked CMU or brick, permanently restoring a masonry wall to its original structural condition. We would be pleased to provide you with SK level drawings and performance specifications for a minor project that can be performed sometime during summer months.

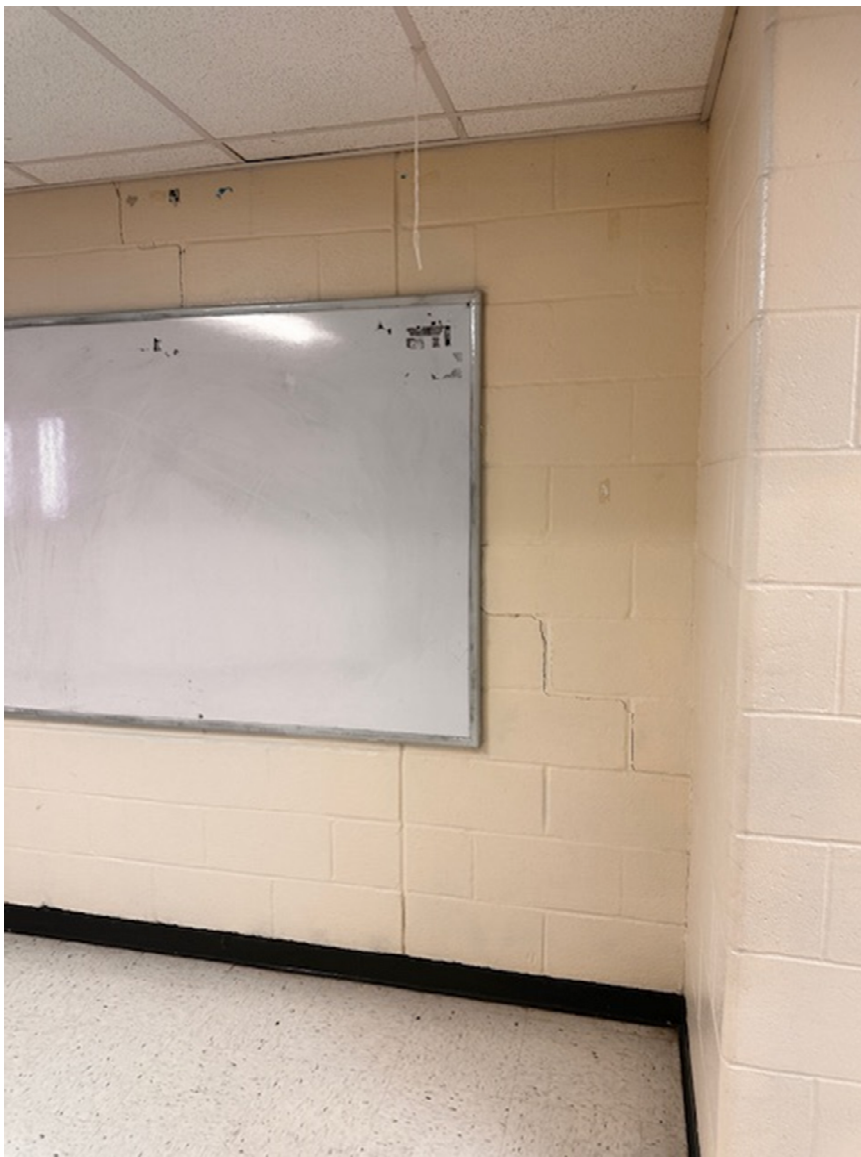
Some minor repairs and maintenance to CMU partition walls in the sallyport are recommended. Reference earlier reports and discussions with the Town regarding differential settlement⁴. During earlier inspections we observed that the building experienced some differential settlement following construction of the 1999 addition. Contributing factors are ground and surface water conditions surrounding the library and sallyport coupled with their geotechnical subgrade conditions. The observed result is cracking in CMU walls acutely in the sallyport connecting existing to new. These conditions predate the earthquake.

Figure 2 - stepped cracking typical of differential settlement. Note the expansion joint in the wall is not aligned with one in the floor and is not functioning.

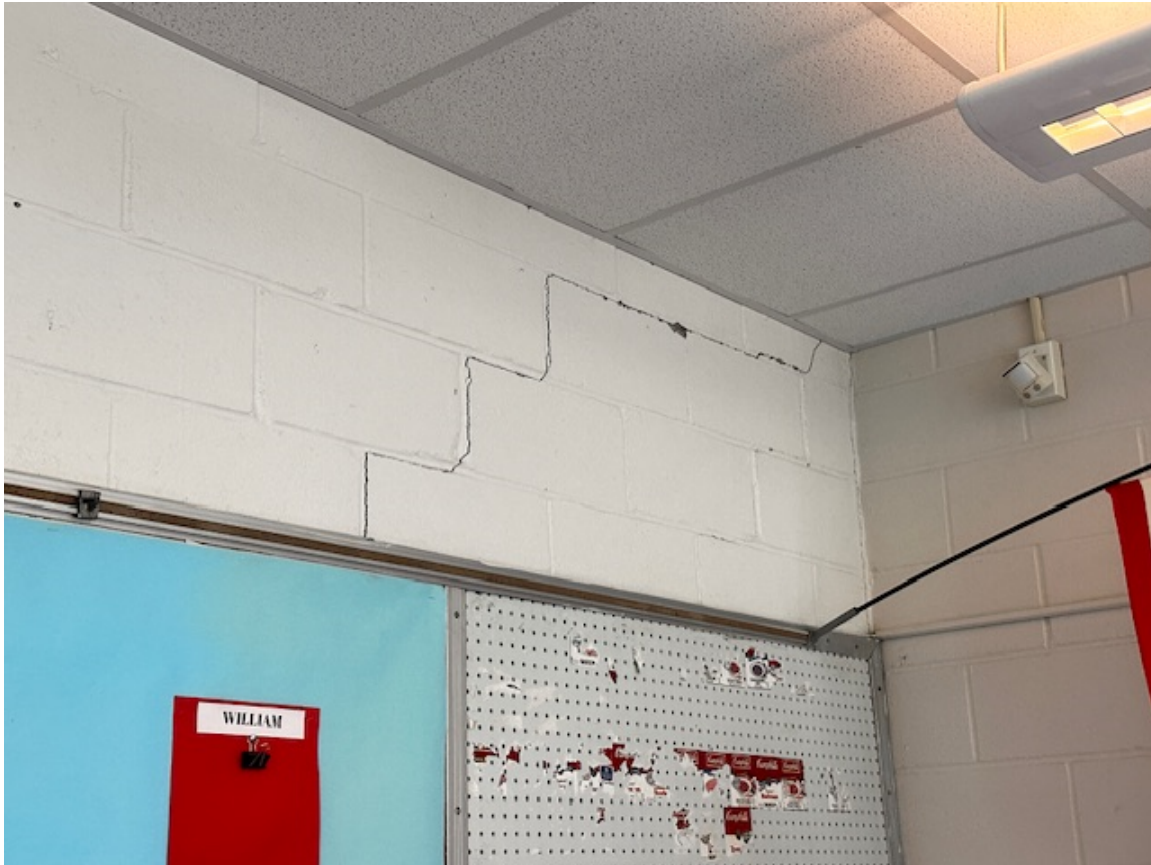
Figure 3 - opposite side of the wall in Figure 2 showing that the stepped cracking carries through the wall. This is typical of differential settlement conditions in non-structural CMU walls.

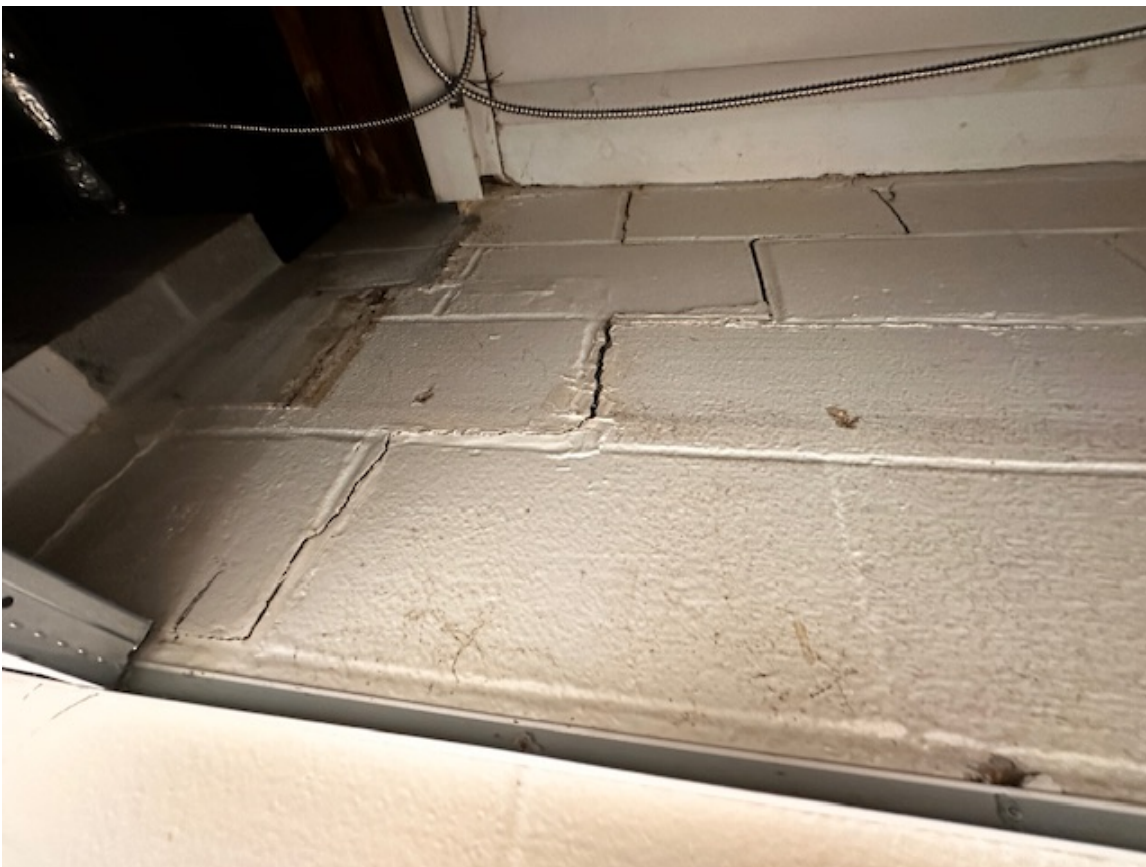
Figure 4 - Uncontrolled cracking above the ceiling in the area of the expansion joint of the sallyport.

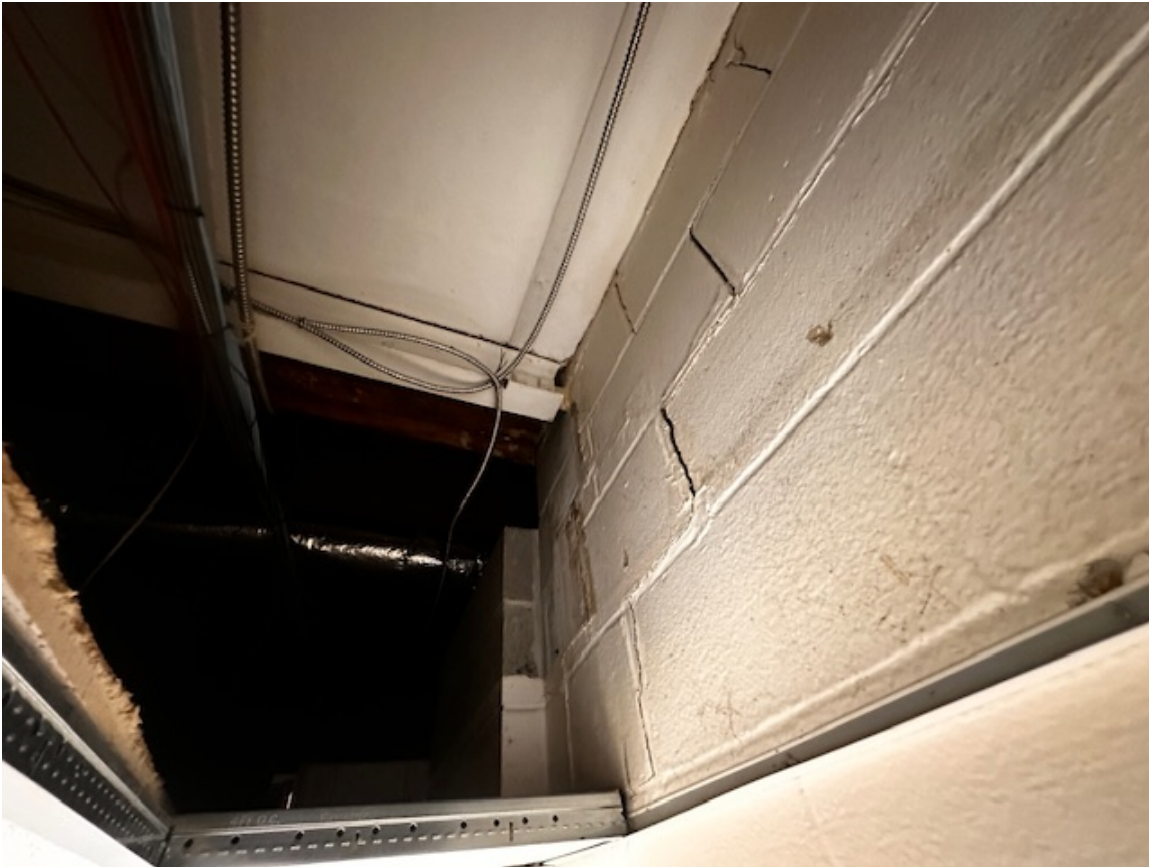
Figure 5 - different angle on Figure 4 where we observed fine hairline cracks around the beam pocket which is consistent with the response of CMU block under seismic loads.

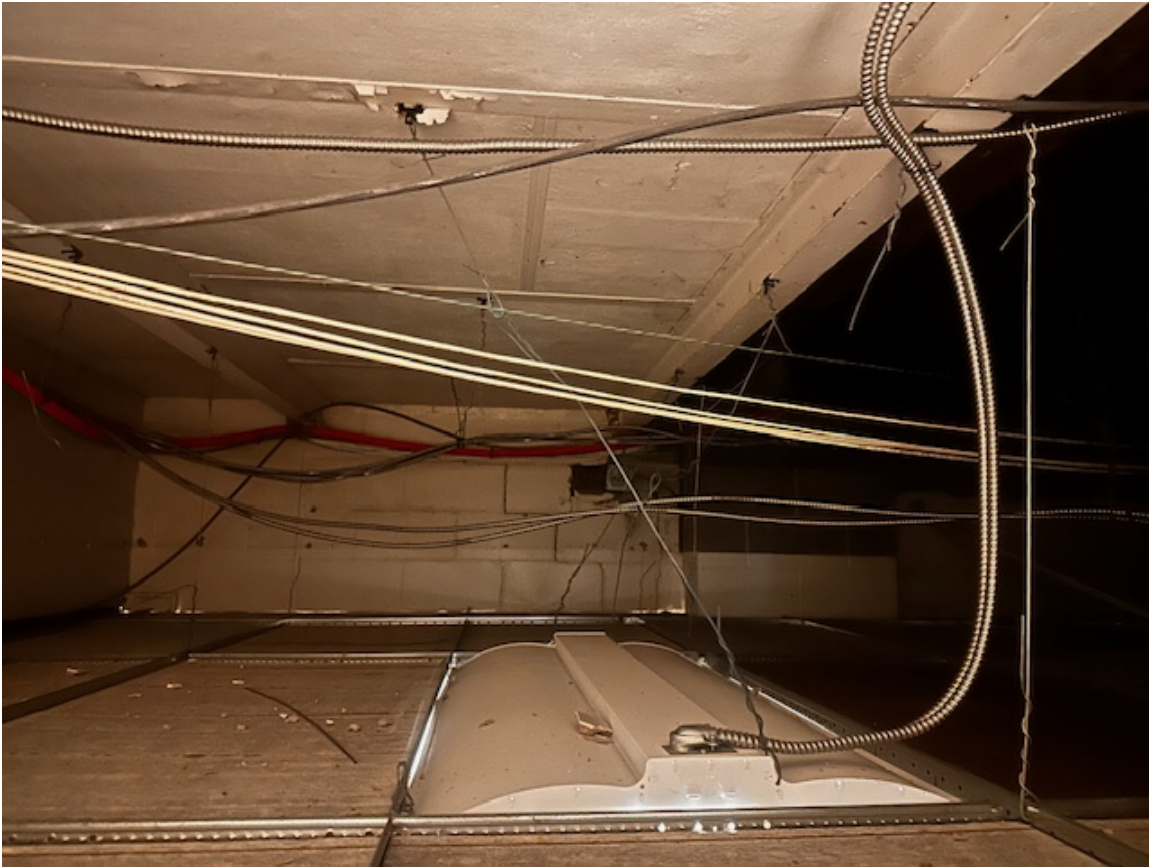
Figure 6 - Above ceiling and opposite side of the hallway from Figure 5 which is consistent with differential settlement. Fine hairline cracks around beam pockets cannot be seen in this photo but were observable.

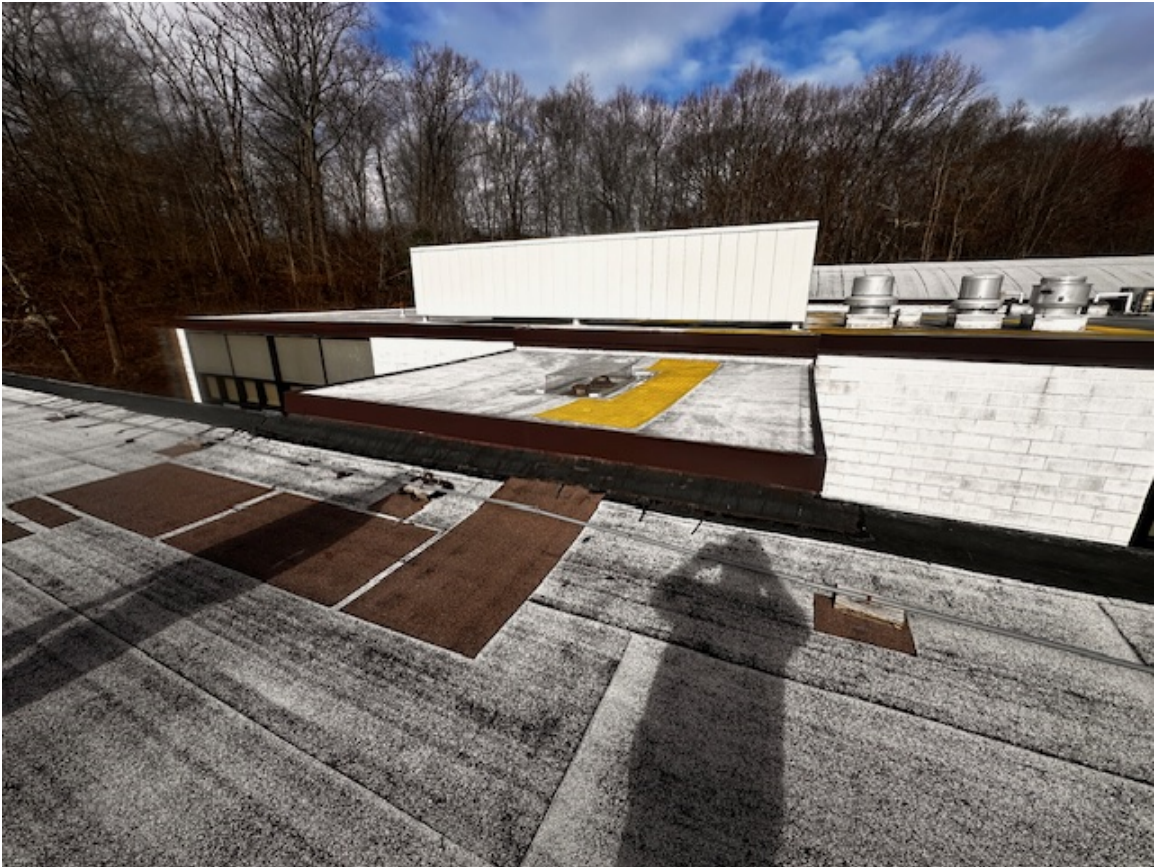
Figure 7 - Perspective of standing on the roof looking down on the cracked CMU walls of the sallyport, where it abuts the existing building. Photo is taken from the existing building with the library in the background.
