BEDFORD CITY SCHOOL DISTRICT

***Ohio Facilities Construction Commission
Classroom Facilities Assistance Program
Facilities Assessment Report***

***Submitted by
Harrison Planning Group
June 2018***

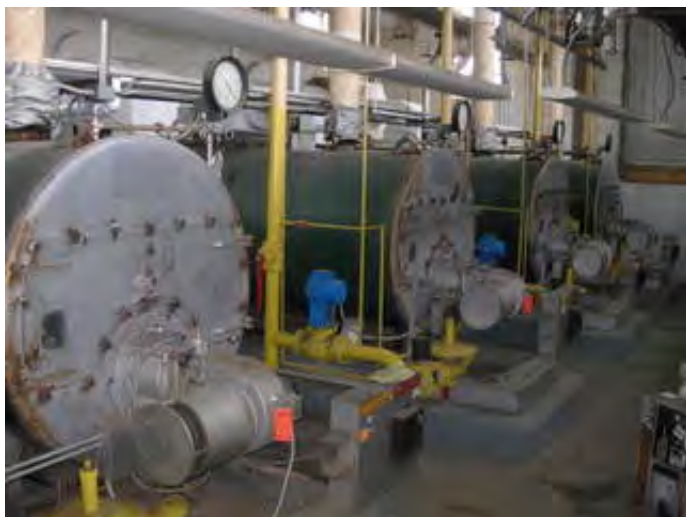
1958 mechanical building steam boilers

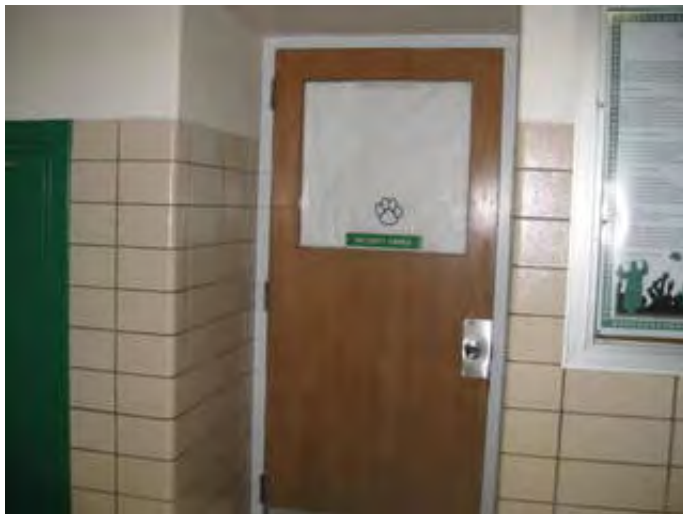
Non-compliant door hardware and clear area

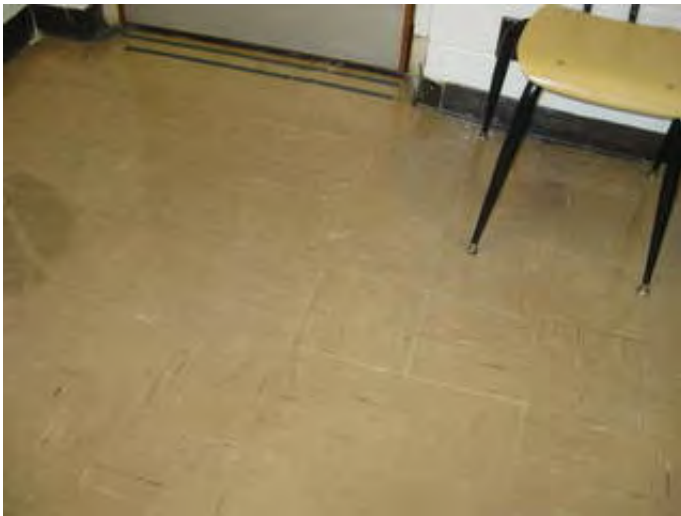
Assumed hazardous flooring material

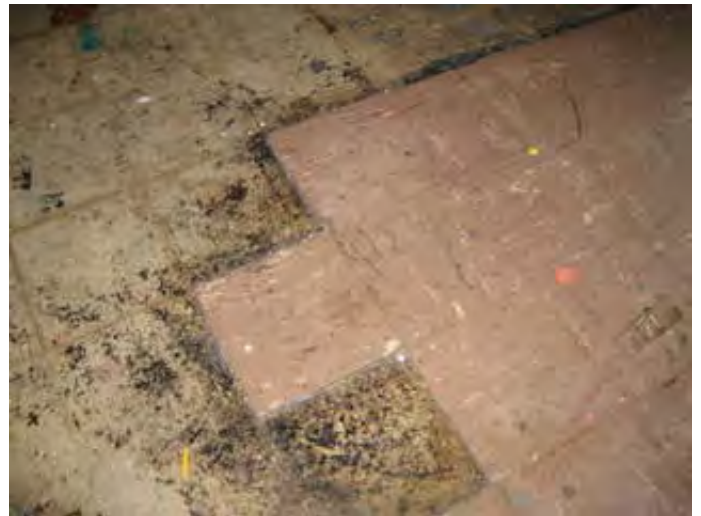
Assumed hazardous flooring material

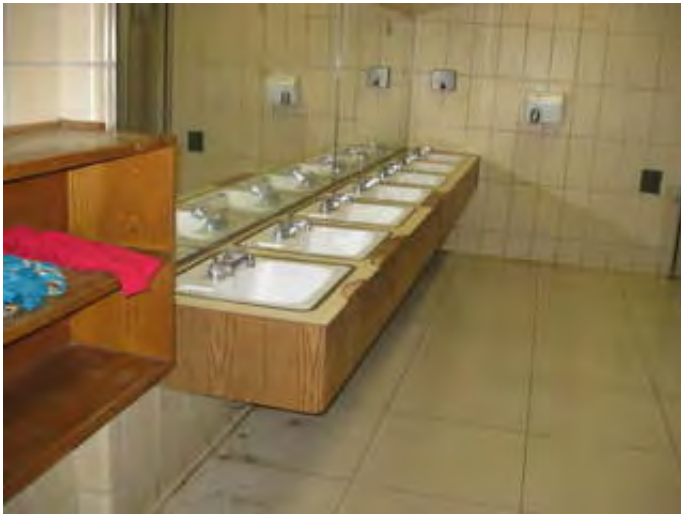
Noncompliant restroom lavatories

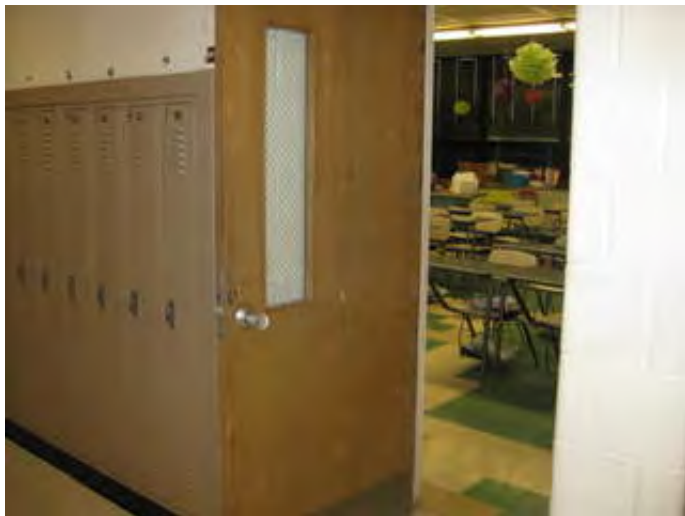
Non-compliant door hardware and clear space

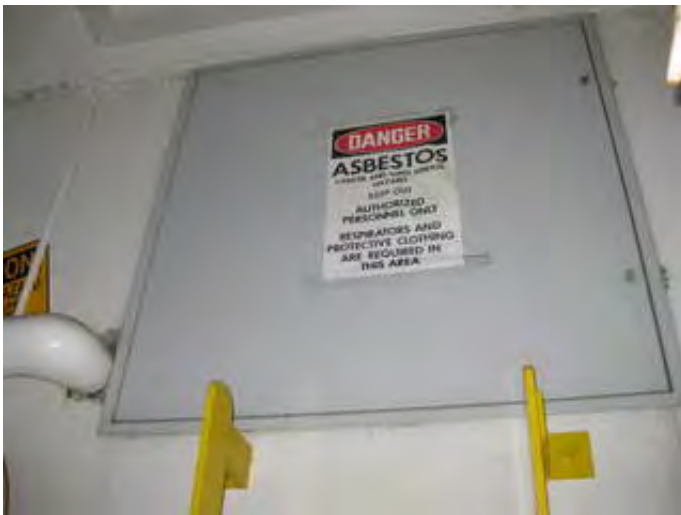
Hazardous material warning signage outside crawl spaces

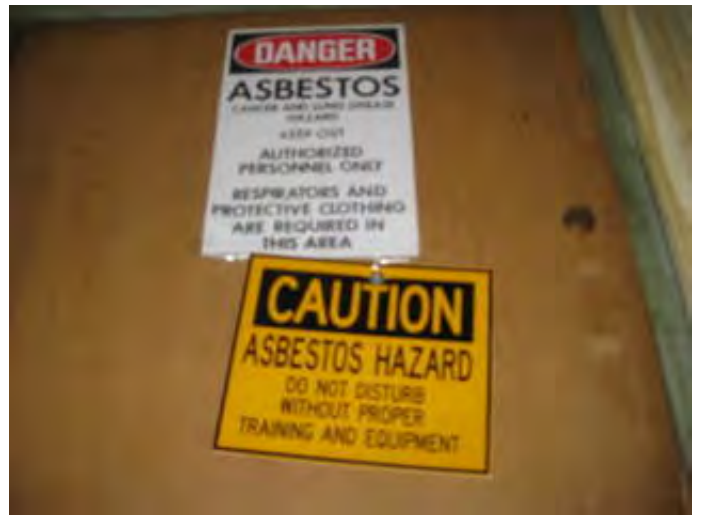
Hazardous material warning signage outside crawl spaces

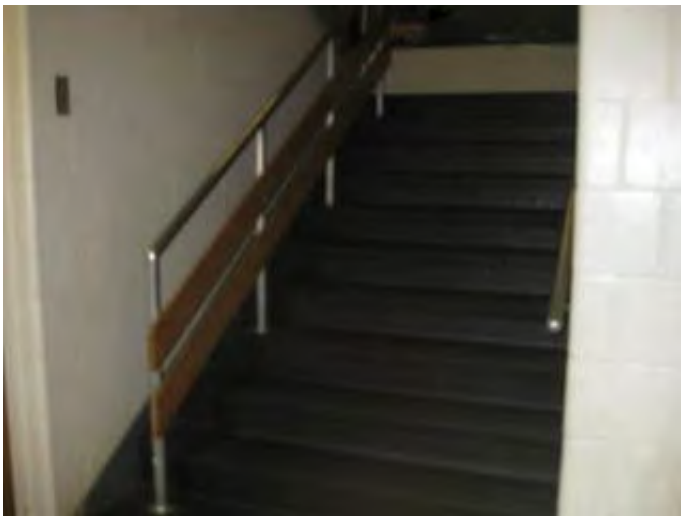
Non-compliant stair handrails

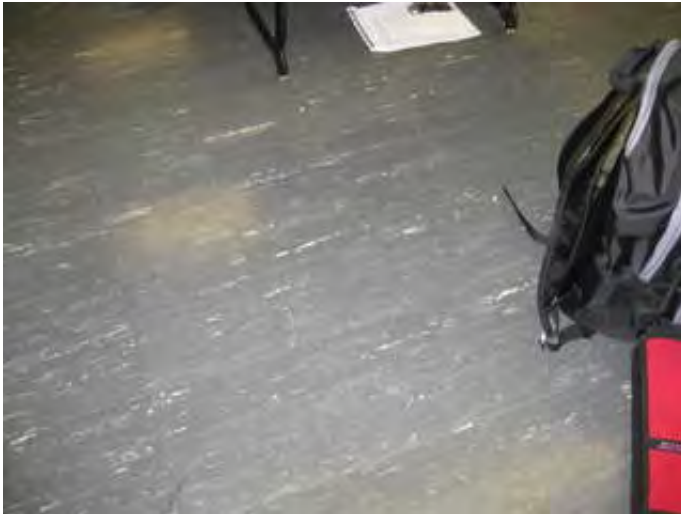
Assumed hazardous flooring material

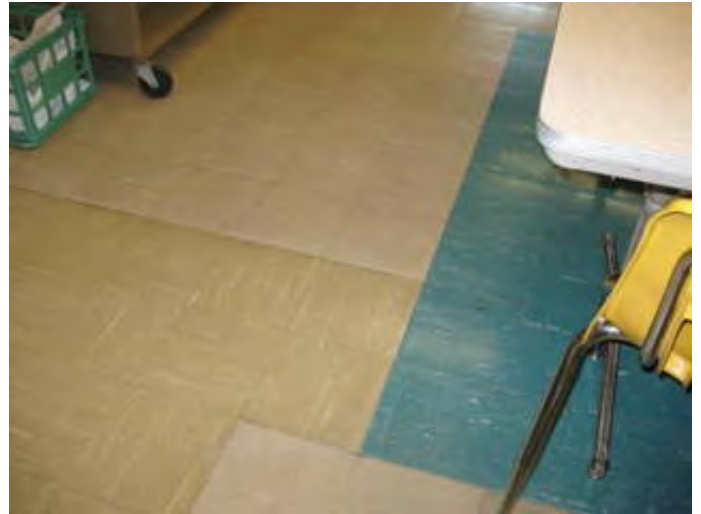
Assumed hazardous flooring material

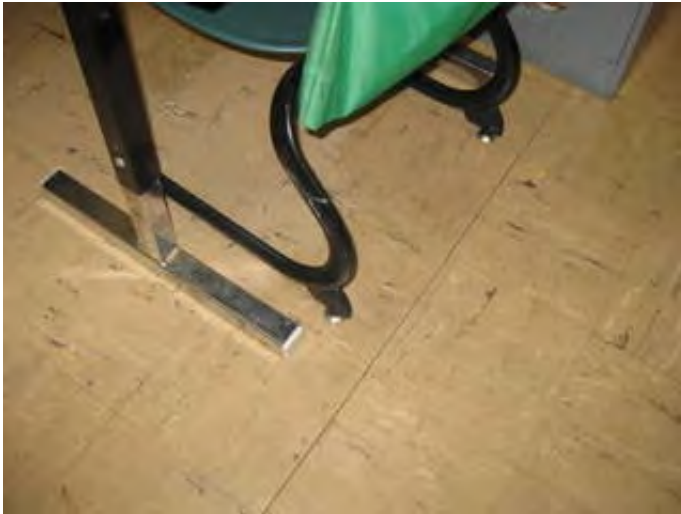
Assumed hazardous flooring material

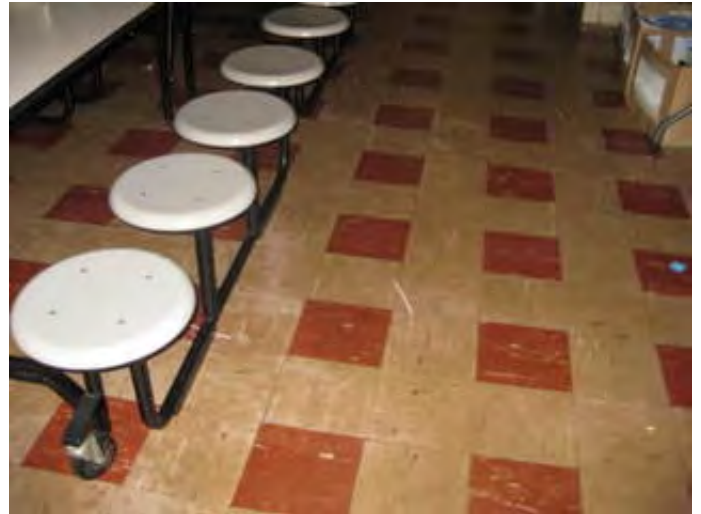
Assumed hazardous flooring material

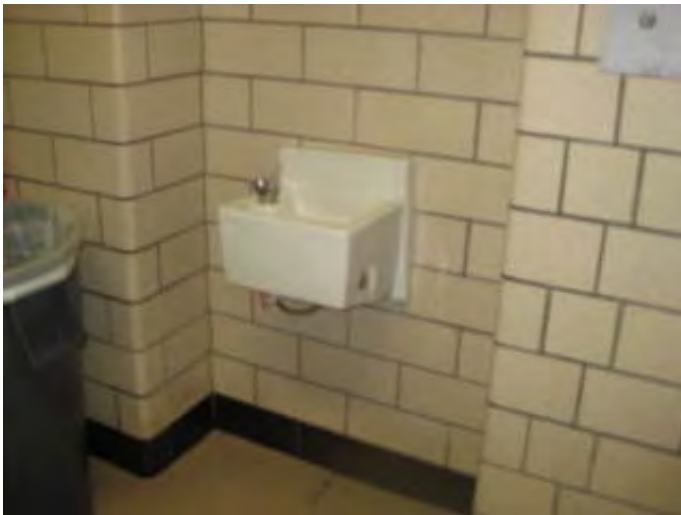
Non-compliant water fountain

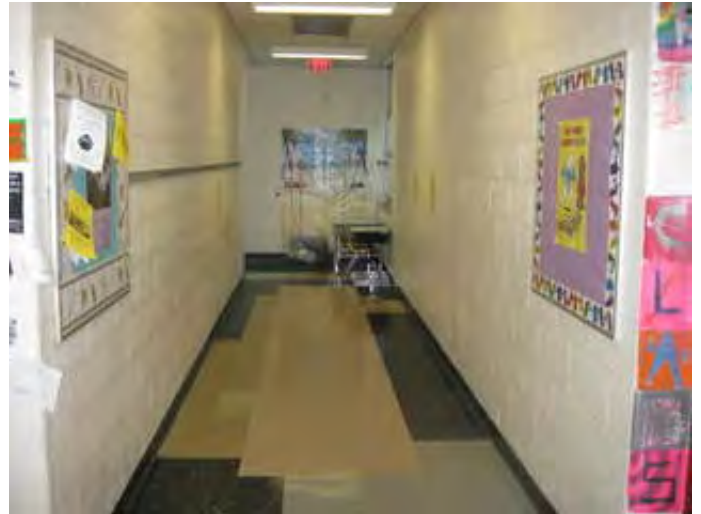
Assumed hazardous flooring material
