Field Test & Inspection Report

Project Scope:
SC-Flora Site – Inspection of turf for Gmax, infill depth, planarity and overall condition of turf
5 Additional Site Visits - Visual inspection of fields, record infill depth

Date Tested: April 17-18, 2019
Report Number: 1936-041719-01

Subject: Field Inspection and Testing Per ASTM F1936

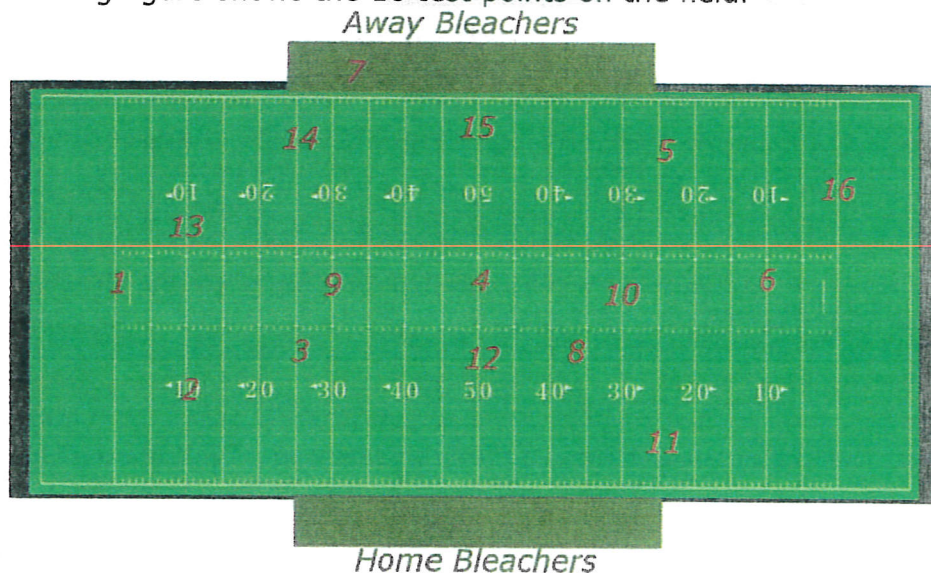
The following is a schematic of the points where Gmax and Infill Depths were measured in the facility. The first 8 points are at locations mandated by ASTM F1936. Points 9 through 16 were selected by ASET Services to provide a more complete view of the fields performance.

The field at SC Flora produced an average Gmax of 73, with a maximum value of 80 and a minimum value of 65. The average infill depth at SC Flora was 1.0 in with a maximum of 1-1/4" and a minimum of 7/8" .

ASTM F1936 establishes a maximum allowable level of 200 for the Gmax property of a turf field. This is the only mandatory requirement that ASET is aware of within North America. The Synthetic Turf Council® have published guidelines stating that synthetic turf fields not should exceed 165 during the life of the field. The guidelines from the Synthetic Turf Council are voluntary and are not mandatory within North America. While the project specification has not been reviewed, it is likely that the values for Gmax recorded during the testing are significantly lower than any that would be present in a specification.

There are no mandatory standard regarding infill depth in North America. It is possible that individual projects or products might include requirements in the specifications. At this time we have not found a specification posted on-line or been provided one by the school district to review. The Gmax values measured on this field conform to the mandatory requirements and also exceed the guideline published by the Synthetic Turf Council.

While the infill depth varied by approximately 3/8 inch, ASET is unaware of any decrease in safety or performance that would be associated with that level deviation. The system was found to have an average of 1" infill depth. Additionally, it is unknown what the difference will be once the field experiences some rain and athletic use to settle and compact the infill. FIFA which has very stringent rules regarding their systems requires infill to be within 15% of the specification. If the specification for these fields was 1" then the FIFA rules would allow a 0.3" range for infill depth, which is just slightly larger than measured during this inspection.

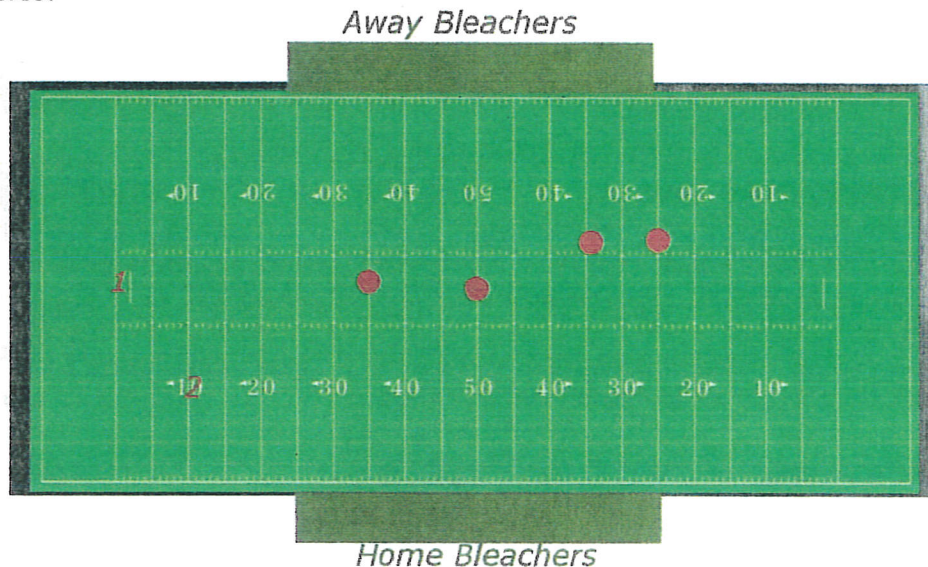
One of the areas tested was at the center of the field where a hump was clearly visible. It was determined that this area produced an 8 mm change in elevation. The other three areas were where the field was clearly lower than nearby points, and each of the 3 test points produced an elevation change that was greater than 18 mm.

Most of the depressions were only 18 inches to 30 inches wide. We were unable to determine the cause of these localized depressions. The infill was checked in these four areas and in all cases it was found to be 1 inch to 1-1/8 inches. The depth of infill did not appear to be a significant cause for these dips. ASET was unable to determine the cause of the dips, but they are likely due to the planarity, or lack thereof, in the sub-base layers. It is impossible to know if these dips were present at the time of installation or if they have developed since the field was installed.

North American fields that are for football generally have a specification stating 'that the surface shall not vary from a true plane by more than 1/4" in 10 ft'. This would allow the surface to have a positive 1/4 inch mound and a negative 1/4 inch dip and still pass, and would create a spec that is equivalent to stating that the 'surface shall not deviate from the straightened by more than 12 mm.' There is no safety standard that specifies a maximum allowable deviation from planarity within

North America. This field has multiple points that exceed the industry standard of less than $\frac{1}{4}$ inch deviation from a true plane. Certainly there are natural turf fields that exceed the measurements reported here. While ASET does think that the elevation changes lead to a significant lack of planarity, there is no clear guidance provided by standards to indicate how non-uniform the surface can be before it becomes dangerous. ASET does not feel that the lack of planarity constitutes grounds for shutting down the field or deeming it unplayable, but ASET does advise that the school district work with the installer to improve the planarity of the playing surface at SC Flora.

- During checks of planarity, it was determined that the field has multiple points where the elevation of the field varies by more than 18 mm from the straightened. ASET considers this to be a significant deviation from the industry standard but it does not violate any known safety standards, therefore it does not constitute a reason to consider the field unfit for play. However, these areas should be addressed and the planarity of the field should be restored to the industry standard of ¼ inch deviation from a plane in 10 ft.

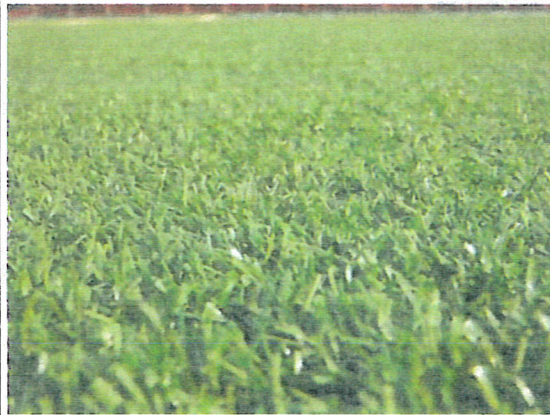
Memorial Field

fibers were standing straighter than other and sections where the fibers were laying over, or less vertical. The photo in the previous table are intended to represent some of what was present. One clear example was a comparison between the fibers at Eau Claire and the fibers at SC Flora. The fibers in the photo from SC Flora all tend to bend and point to the left of the photo, while the fibers in the photo from Eau Claire are more vertical, and random in their direction. The photos show that the fibers at three schools (SC Flora, Lower Richland, and WJ Keenam) had similar traits. The also show that the fibers at Memorial and Eau Claire tend to be more vertical.

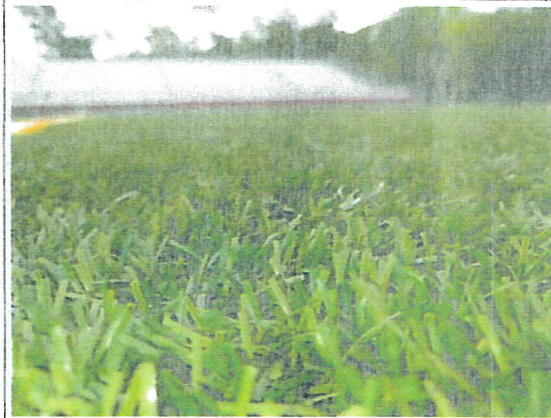
WJ Keenam

- The infill depth at AC Flora appears to be sufficient based on the inspections from the other 5 schools that were visited.
- The fibers at SC Flora, WJ Keenum and Lower Richmond appear to be laying over more than the fibers at Memorial and Eau Claire. It was not possible to document the cause as it could be related to the fibers, the manufacturing of the turf, maintenance or use practices. ASET did not find the condition of the fibers to create an increased hazard.

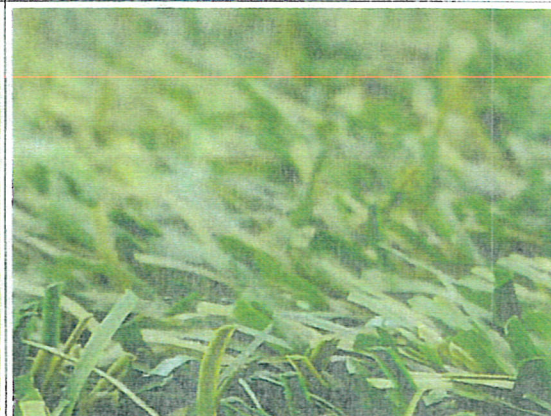
Mr Raymond Perkins of the Richland One District said that the school expressed concern that the fibers at SC Flora were laying over more than they were at other schools. During our inspections of the schools, each school had sections where the

The results are simply noted in this report. ASET does not find any of the differences in direction to be related to a safety issue. Also, the cause of the appearance differences is unknown. The field at SC Flora was brushed just minutes before ASET started the inspection there. The athletic use and maintenance that each field receives is unknown as well and that could have significant effects regarding the effect of the turf.

Many of today's new turf systems are not doing a good job of retaining fibers during use and maintenance activities. ASET urges the Richland One School District to monitor the fibers removed during reconditioning and maintenance activities. If significant numbers of fibers being removed, then the grooming equipment, practices and frequency should be reconsidered in an attempt to retain fibers for as long as possible.
