# Roanoke County Schools

## Three Year AHERA Reinspection

### Burlington Elementary School Facility 013

#### Reinspection Dates:

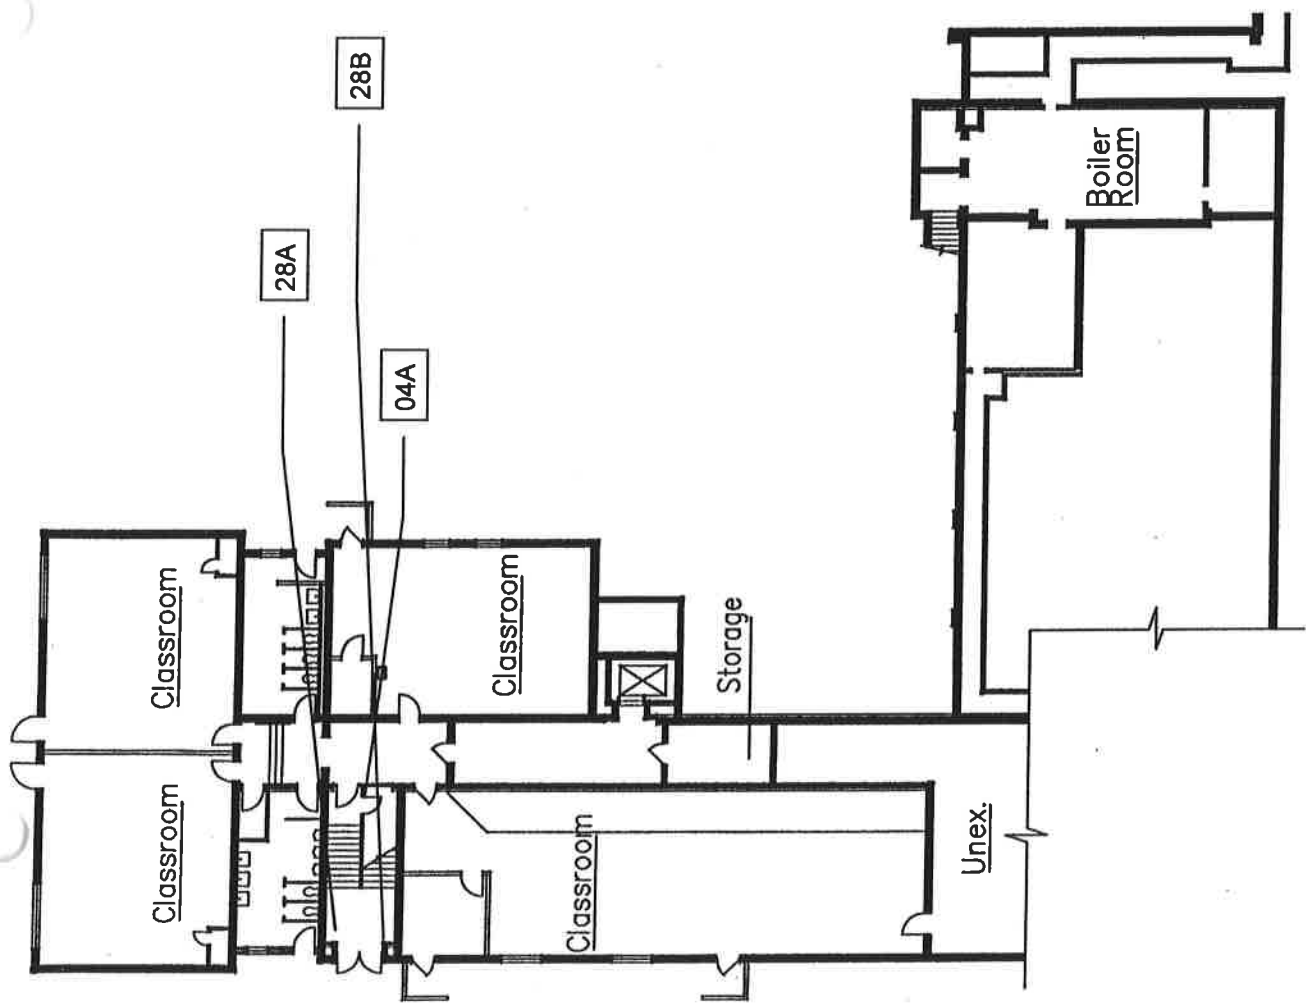
# Basement Floor Plan

HA-04 Fitting TSI on domestic CW lines  
 Sample 04A

HA-28 Sheet vinyl, grey  
 Samples 28A; 28B

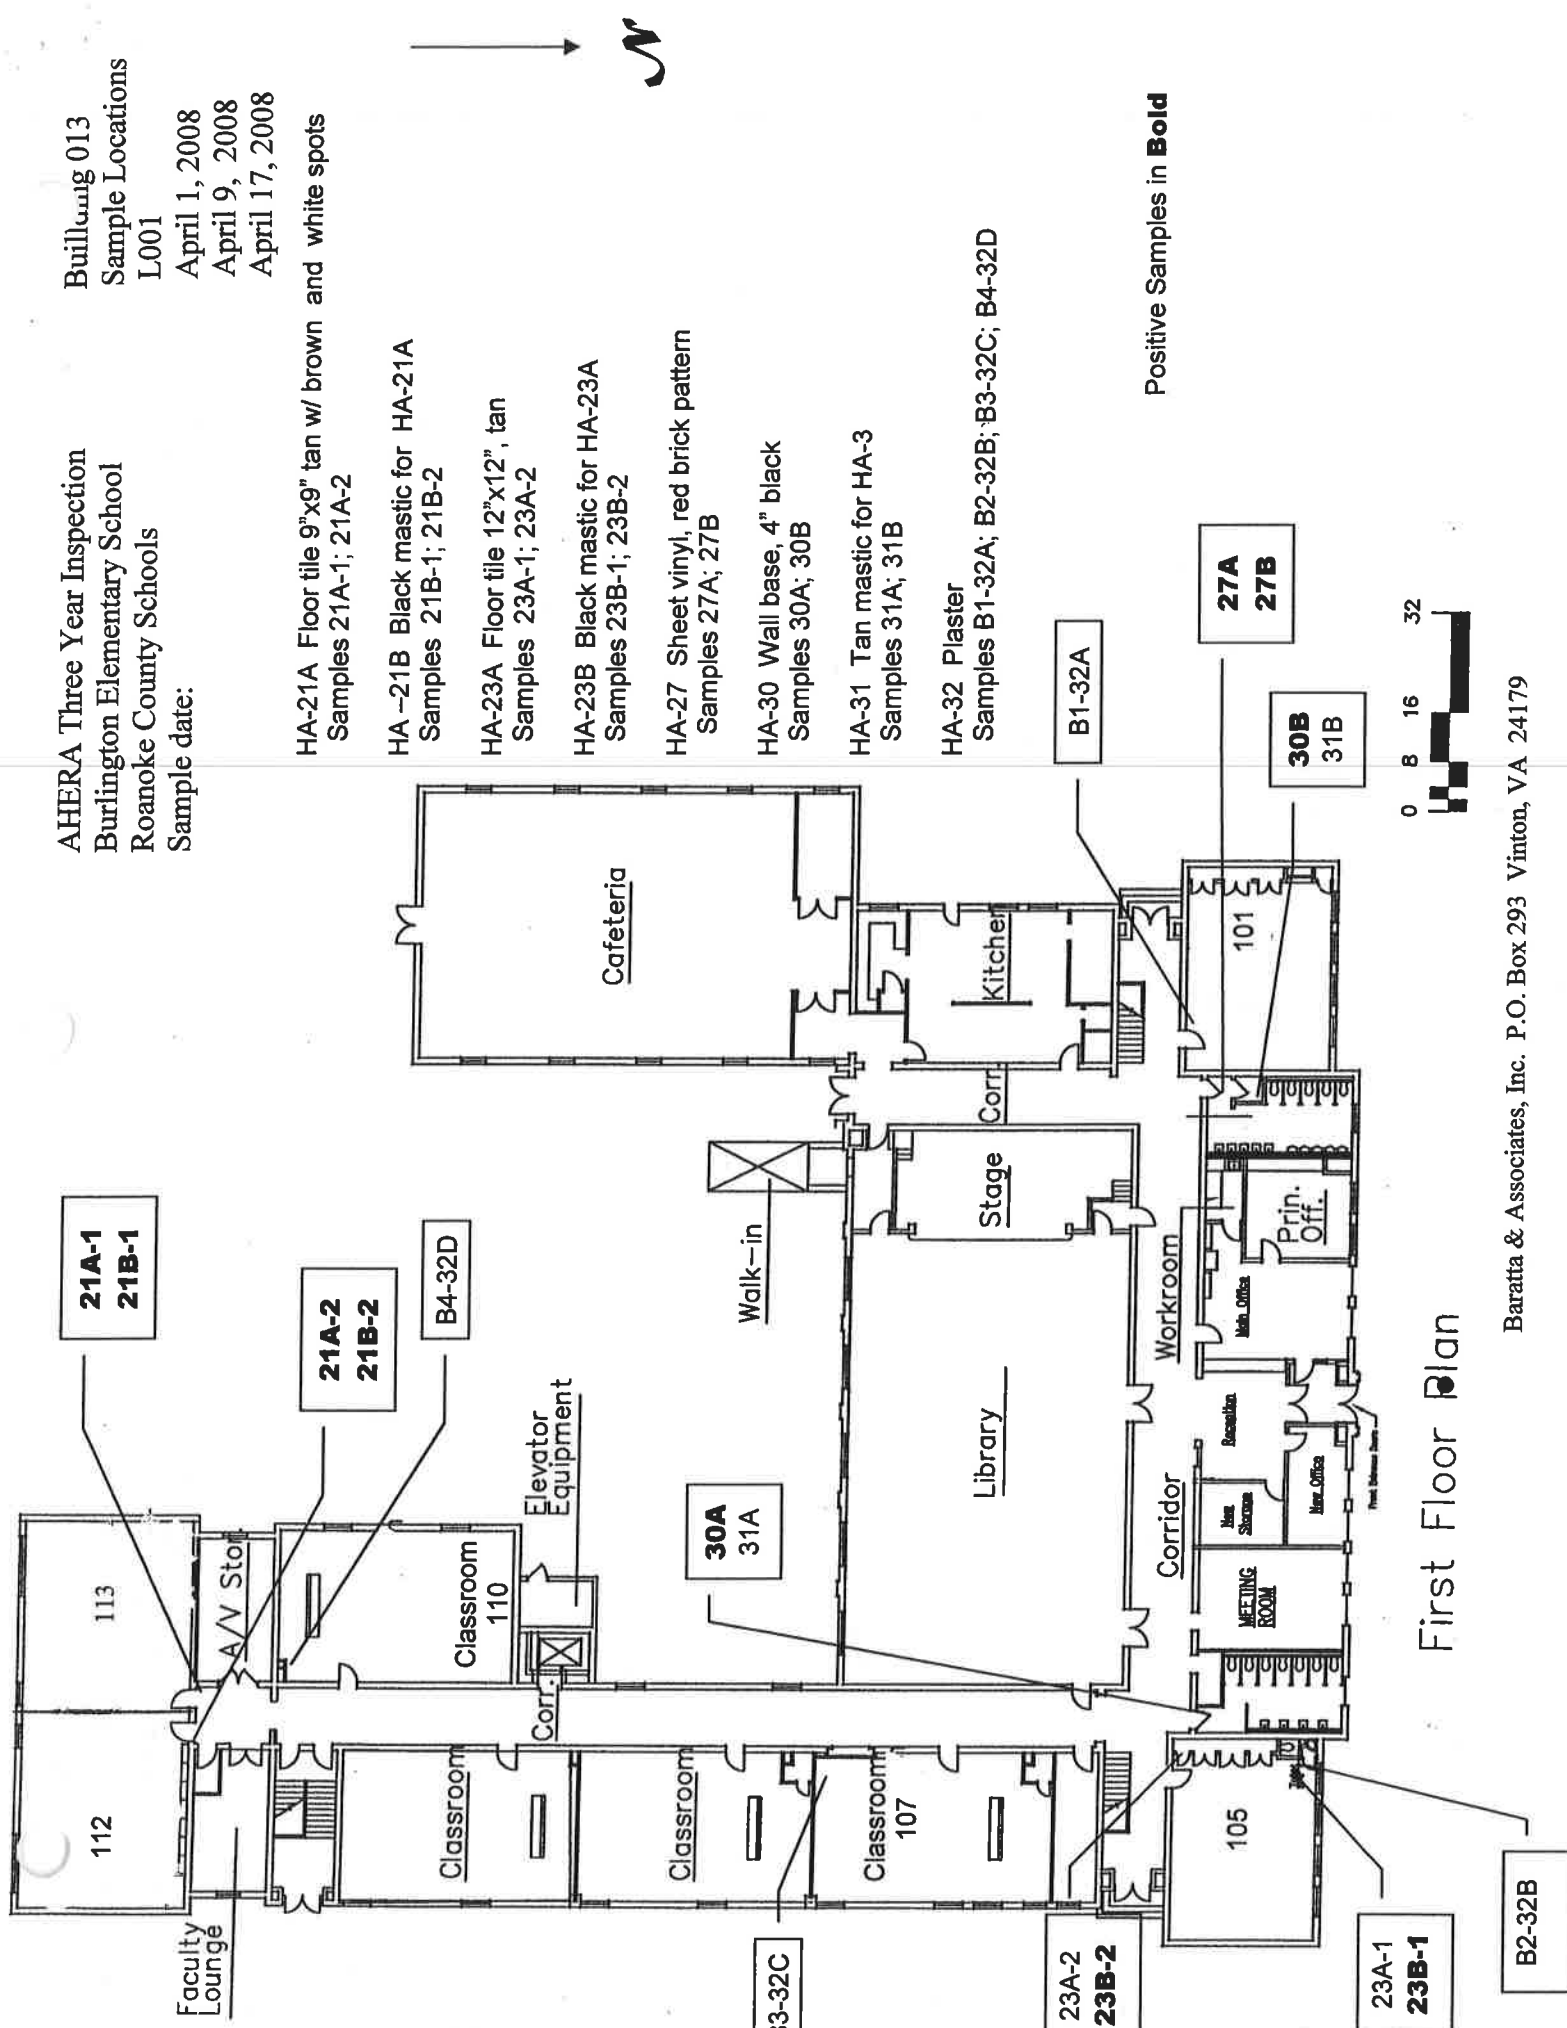
First Floor Plan

HA-21A Floor tile 9"x9" tan w/ brown and white spots  
 Samples 21A-1; 21A-2  
 HA -21B Black mastic for HA-21A  
 Samples 21B-1; 21B-2  
 HA-23A Floor tile 12"x12", tan  
 Samples 23A-1; 23A-2  
 HA-23B Black mastic for HA-23A  
 Samples 23B-1; 23B-2  
 HA-27 Sheet vinyl, red brick pattern  
 Samples 27A; 27B  
 HA-30 Wall base, 4" black  
 Samples 30A; 30B  
 HA-31 Tan mastic for HA-3  
 Samples 31A; 31B  
 HA-32 Plaster  
 Samples B1-32A; B2-32B; B3-32C; B4-32D

Positive Samples in **Bold**

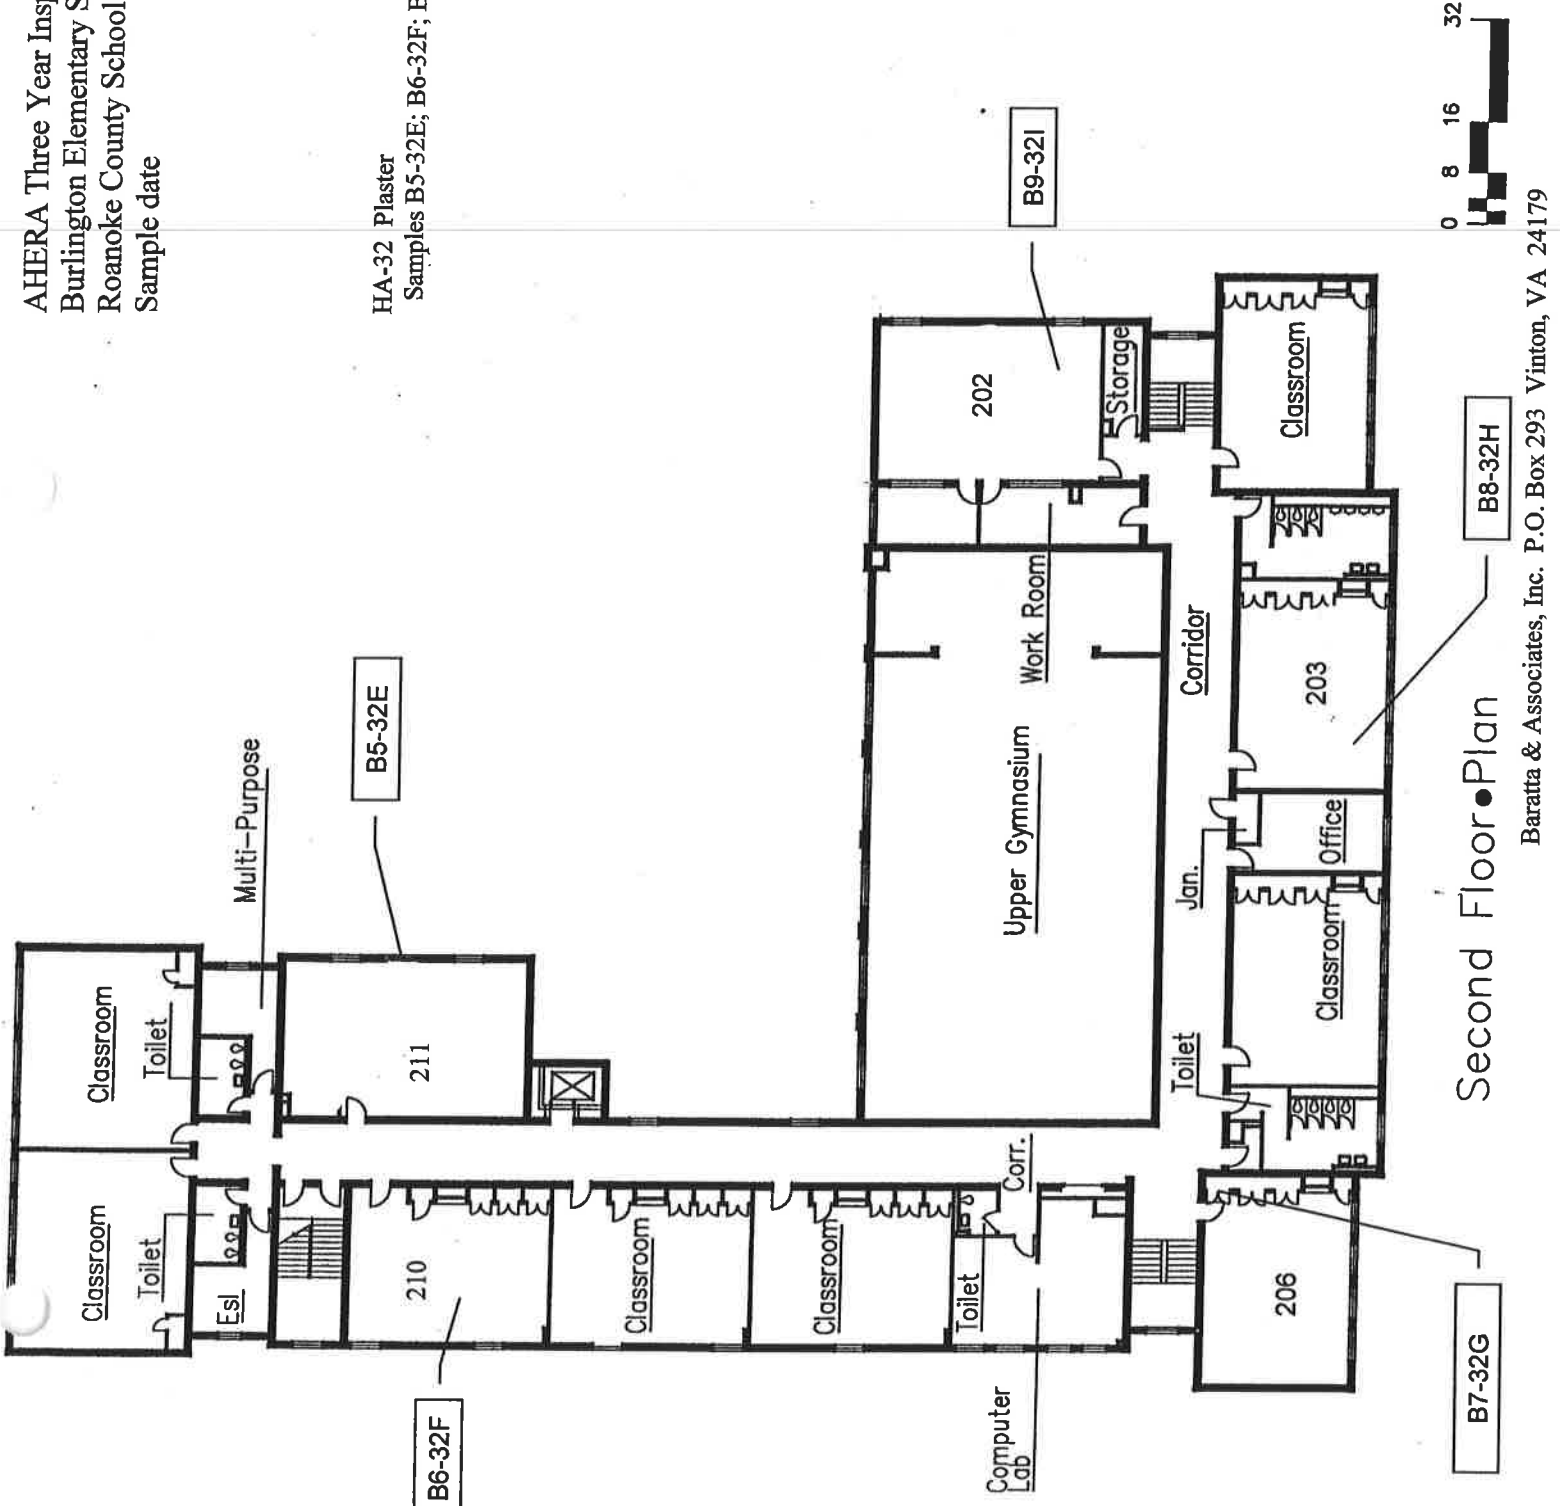
Second Floor Plan

HA-32 Plaster  
 Samples B5-32E; B6-32F; B7-32G; B8-32H; B9-32I

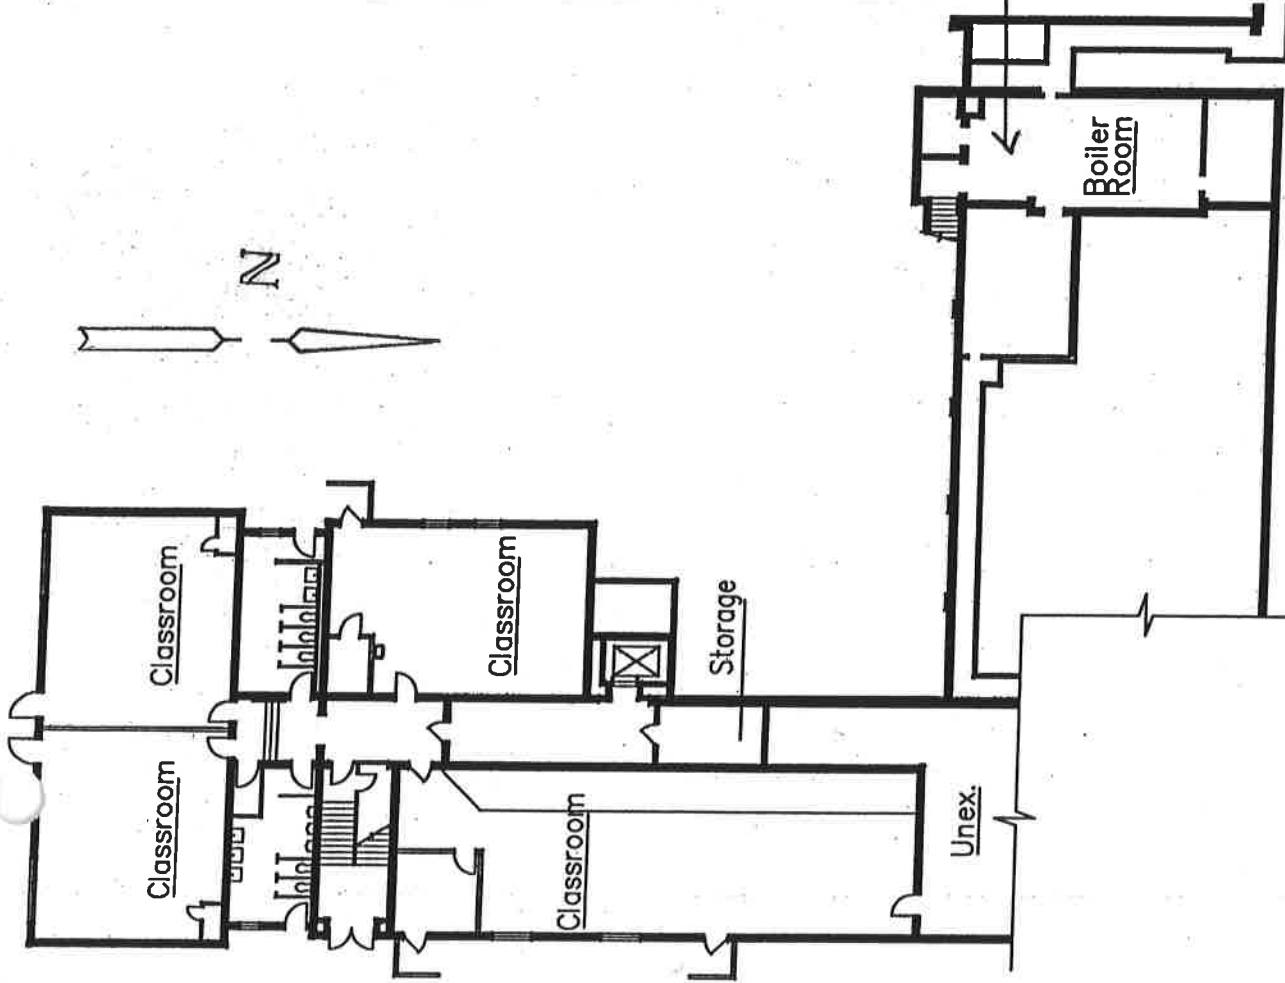
Basement Floor

No TSI-ACM in Boiler Room and Tunnels

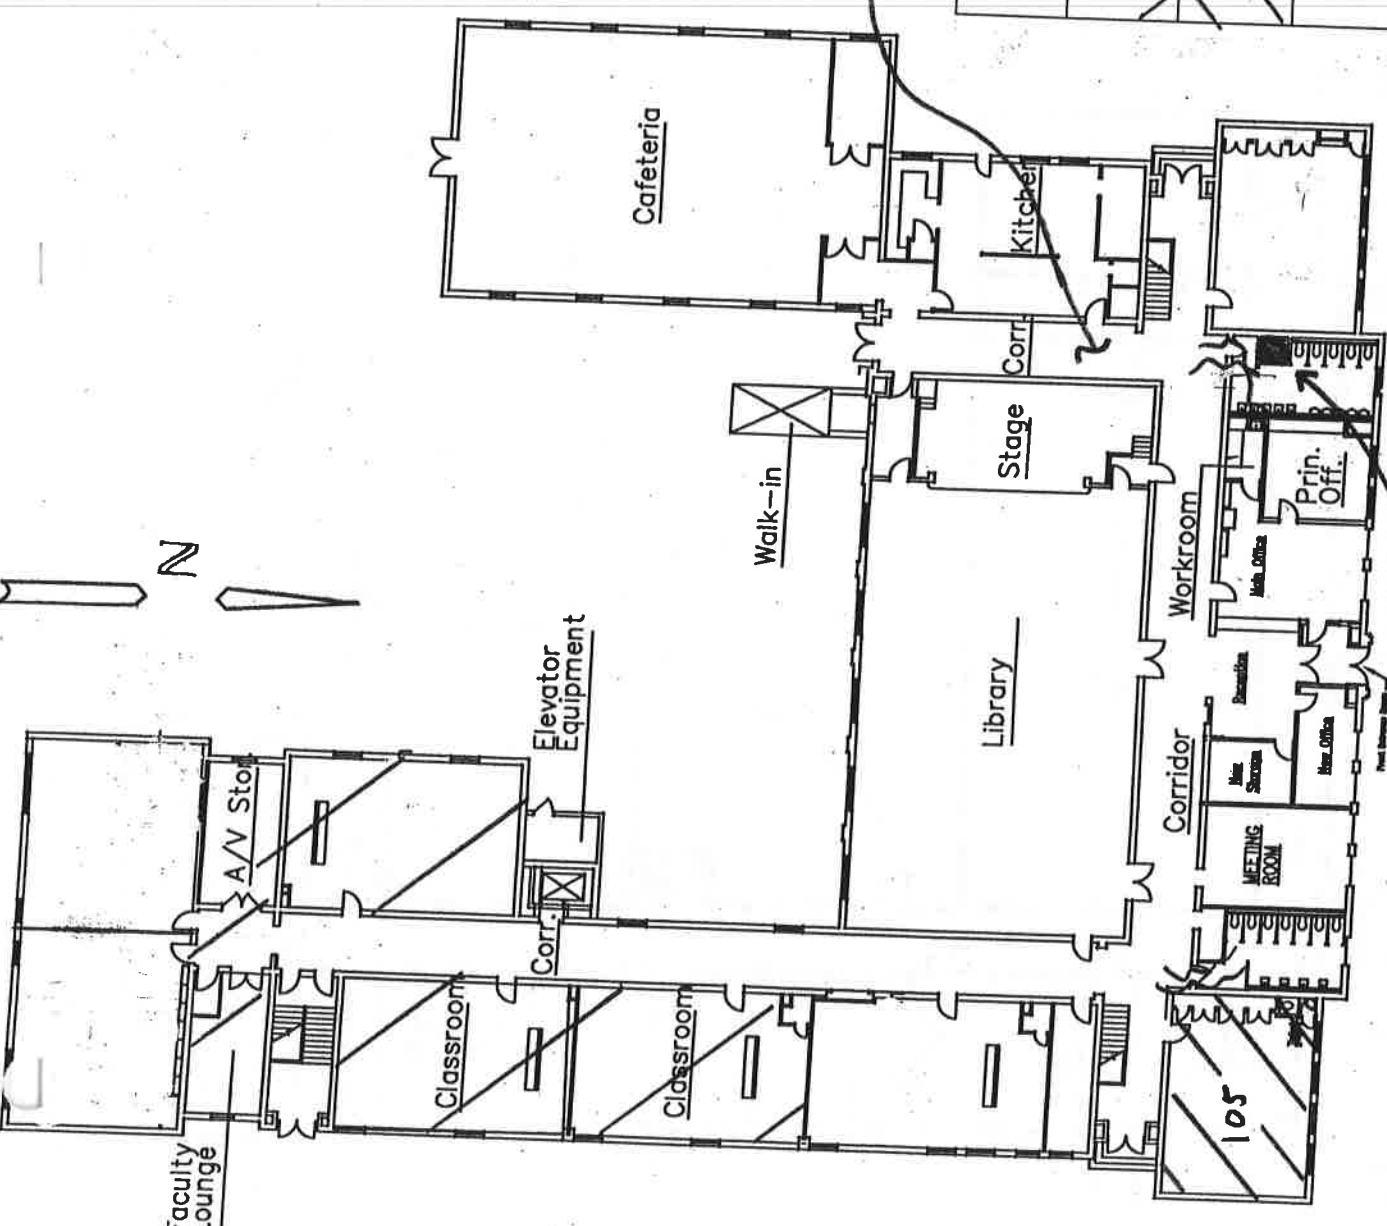
TSI-ACM hidden inside walls and ceiling spaces - Typical

Asbestos containing sheet vinyl (red brick pattern)

Asbestos containing floor tiles and mastics

Asbestos containing floor tile mastic, 12" x 12" floor tiles are non-ACM

Asbestos containing wall base, mastic is non-ACM

First Floor Asbestos containing sheet vinyl (red brick pattern)

No drilling, sanding, or other abrasive or penetrating activities shall be used on the asbestos containing floor tiles and sheet vinyls. To do so may release asbestos fibers into the environment.

Should you notice that the floor coverings are damaged or have loose tiles, please contact the principal so appropriate action can be taken.

These should be treated like the floor tiles.
