Roanoke County Schools

Three Year AHERA Reinspection

Arnold R Burton Vo-Tech
Facility 001

Reinspection Date: January 30, 2008

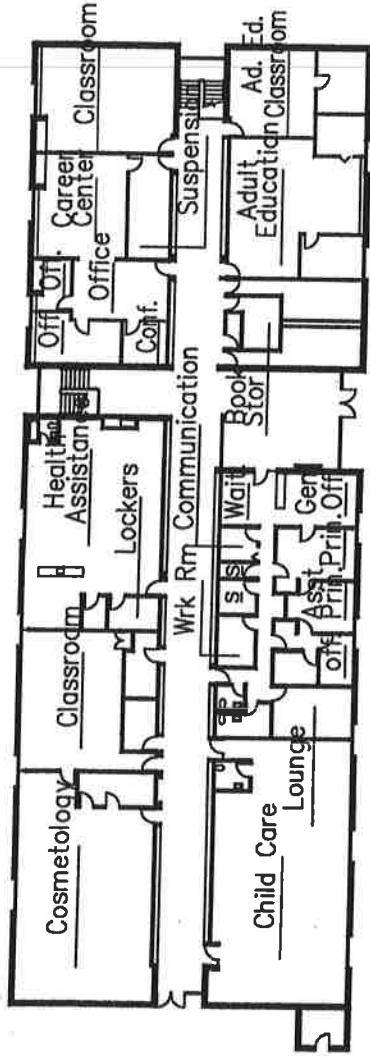
A01A Breaching TSI on HW heater pipe runs
 Samples A01A-1, A01A-2, A01A-3

A01B Breaching TSI on HW heater pipe fittings
 Samples A01B-1, A01B-2, A01B-3

A06 Fitting TSI
 Samples A06-1, A06-2, A06-3

H-K appeared to have ignored positive samples from the water heater breeching in the Building A Mechanical Room. We assigned the breeching pipe run TSI homogeneous area A01A and the breeching fitting TSI homogeneous area A01B.

The thermal system insulation (TSI) on the breeching for the gas fired hot water heater in the Building A Mechanical Room is an ACM. Some damaged areas were noted. We recommend the damaged areas be repaired.

Each Location	Recommended Response Actions	Scheduled To Begin	Scheduled To Be Completed	Est. Cost To Remove
Building A - Breeching from hot water heater in Mechanical Room (A01A & A01B)	Repair damaged TSI and place in O & M Plan until removed	none	none	\$2,500
Building B - Floor tile 12"x12" beige with tan and associated black mastic (B03A & B03B)	Place in O & M Plan until removed	none	none	\$16,000

Repair the damaged areas. Once the damaged areas are repaired, an asbestos warning sticker should be applied to the flue pipe.

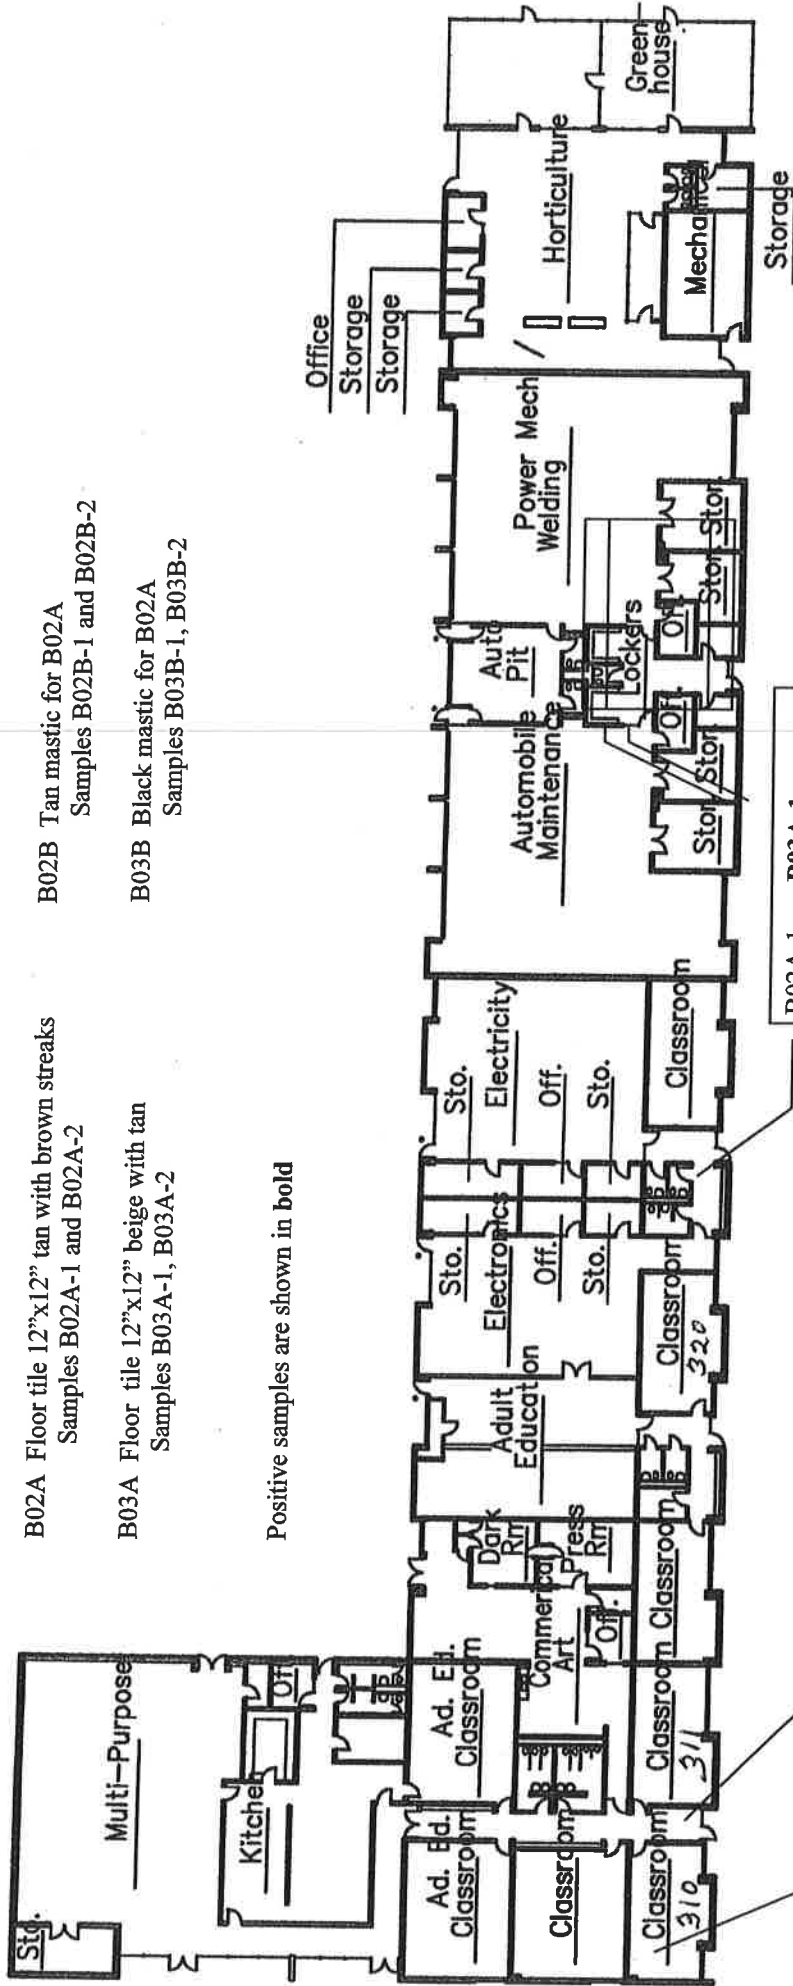
Floor Plan - Building B

B02A Floor tile 12"x12" tan with brown streaks
 Samples B02A-1 and B02A-2

B03A Floor tile 12"x12" beige with tan
 Samples B03A-1, B03A-2

B02B Tan mastic for B02A
 Samples B02B-1 and B02B-2

B03B Black mastic for B02A
 Samples B03B-1, B03B-2

The 12"x12" beige with tan floor tiles (and associated black mastic) used in some of the rooms in Building B (East Shop) also tested to be Asbestos Containing Materials. These floor coverings are in good condition. They do not currently present an asbestos related health risk to building occupants in their current condition.

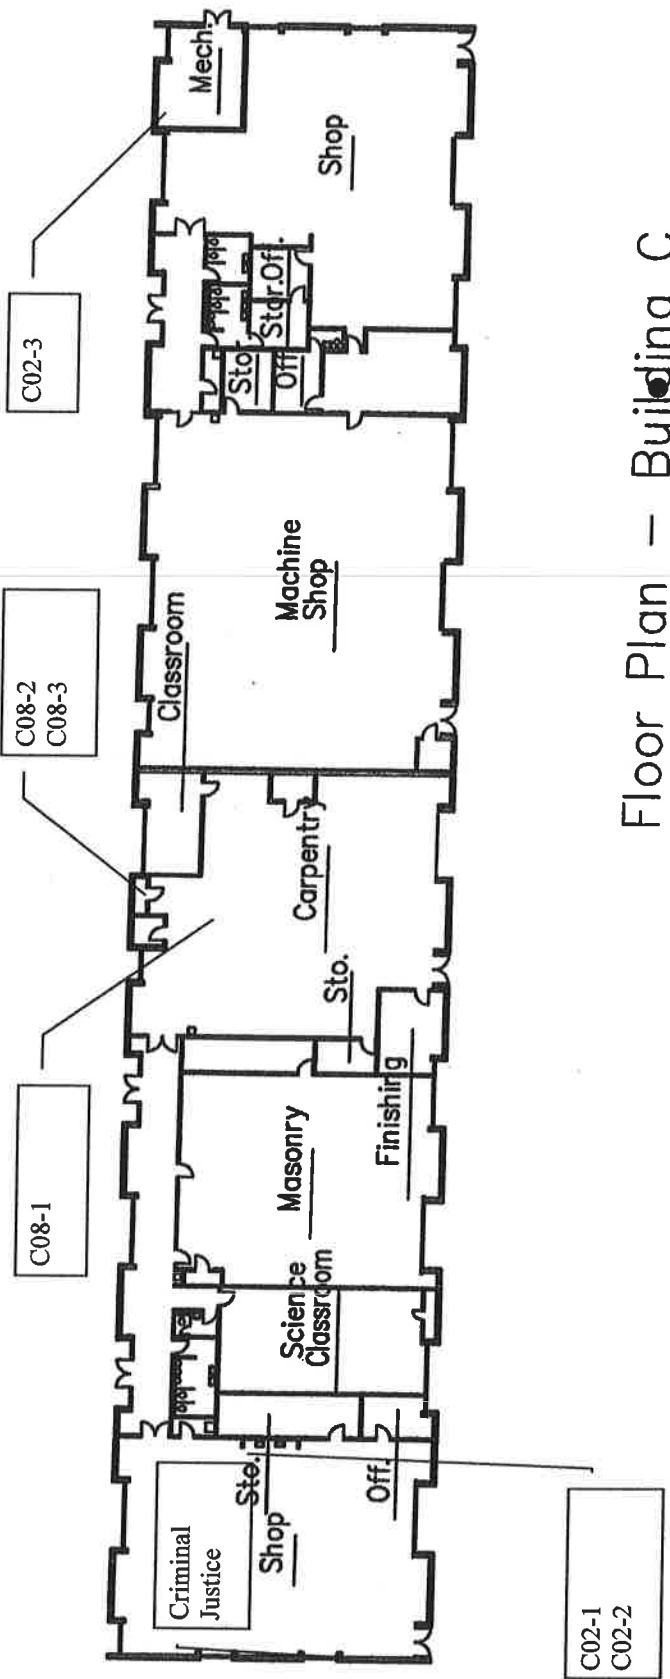
Floor Plan – Building C

C02 Domestic hot water fitting TSI
 Samples C02-1, C02-2, C02-3

C08 Other fitting TSI
 Samples C08-1, C08-2, C08-3

*C02 - Domestic HW fitting TSI on fiberglass insulate pipe runs in West Shop - H-K reported damaged fitting TSI in the Criminal Justice Janitor Closet. The TSI on the lower ELLs, servicing the sink, had been removed. We sampled the upper ELLs as well as one fitting in Room 458A. Our samples tested to be non-ACM. We therefore, deemed the remaining fittings on the domestic hot water system non-ACM.

No ACMs were found to exist in Building C (West Shop)

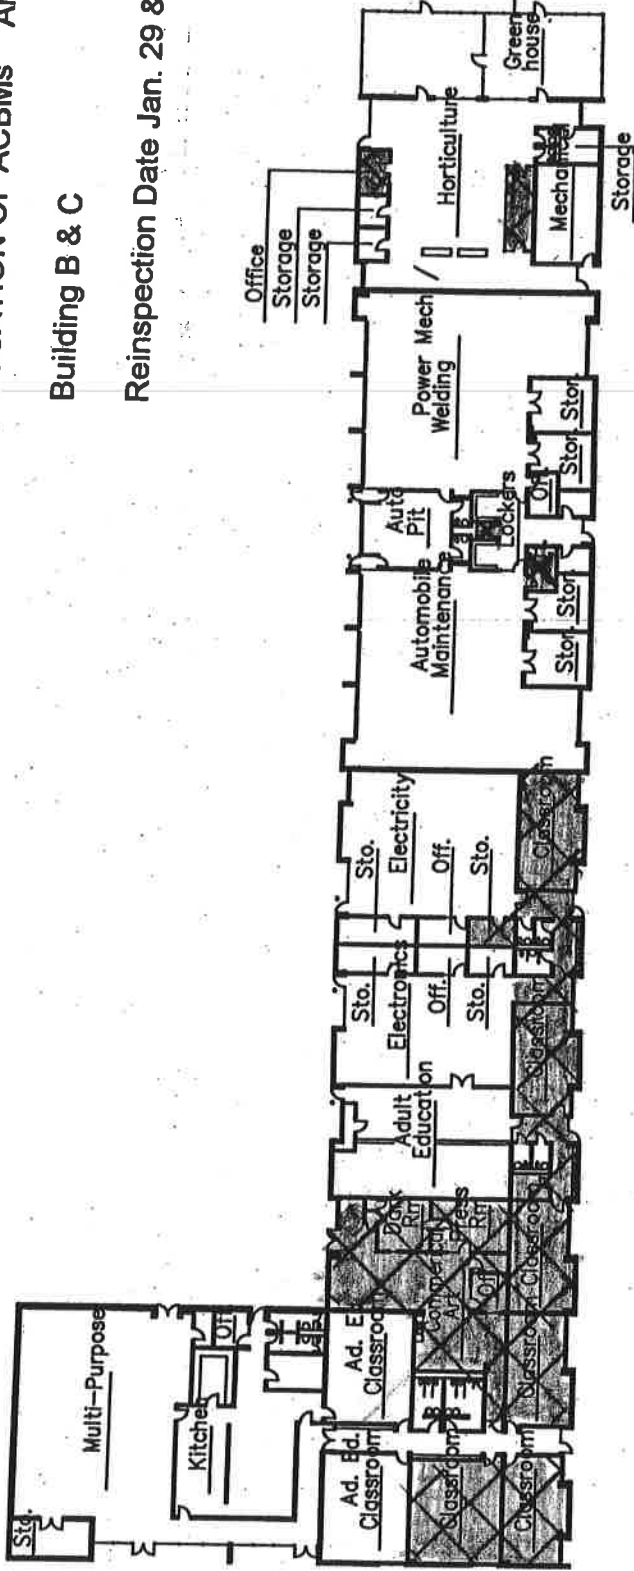
• Floor Plan – Building B

Note Floor Tile System B03A & B03B are confined mostly to the rooms and some halls. These ACMs also exist in some of the small rooms in the south section of Building B.

ACM floor tile 12"x12" beige with tan and associated black mastic

No drilling, sanding, or other abrasive or penetrating activities shall be used on the asbestos containing floor tiles. To do so may release asbestos fibers into the environment.
