# INITIAL AHERA SURVEY

BONSACK ELEMENTARY SCHOOL

ECS PROJECT NO. 47:3555

ROANOKE COUNTY SCHOOLS

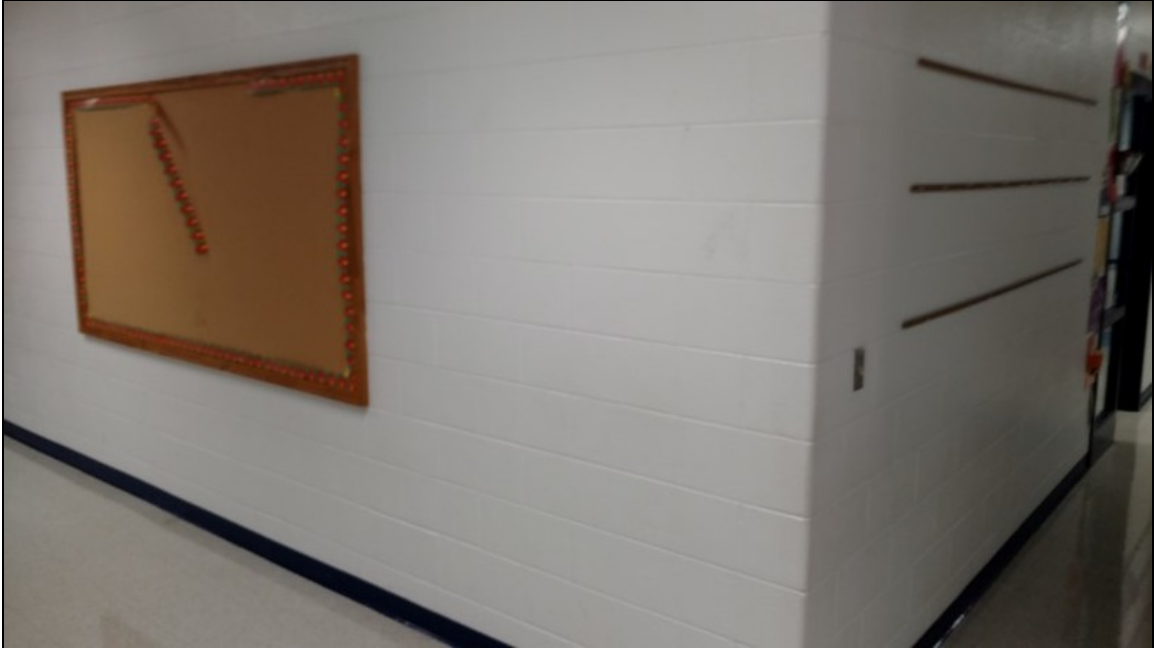
1 - View of typical CMU wall coating

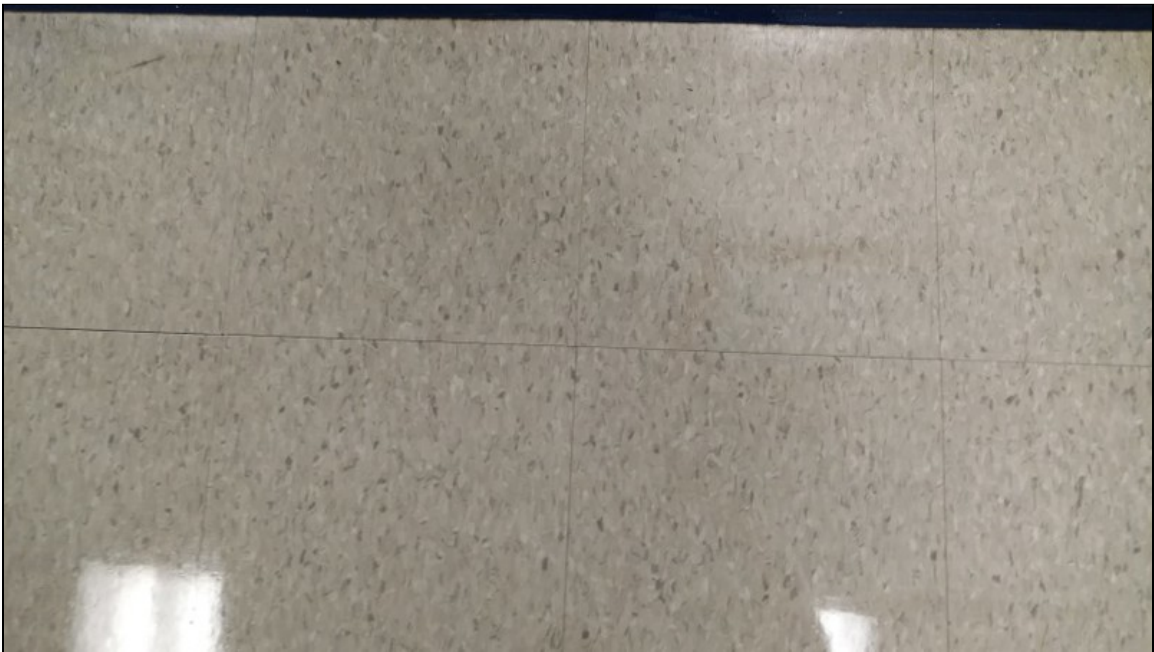
2 - View of typical grey mottled 12"x12" floor tile

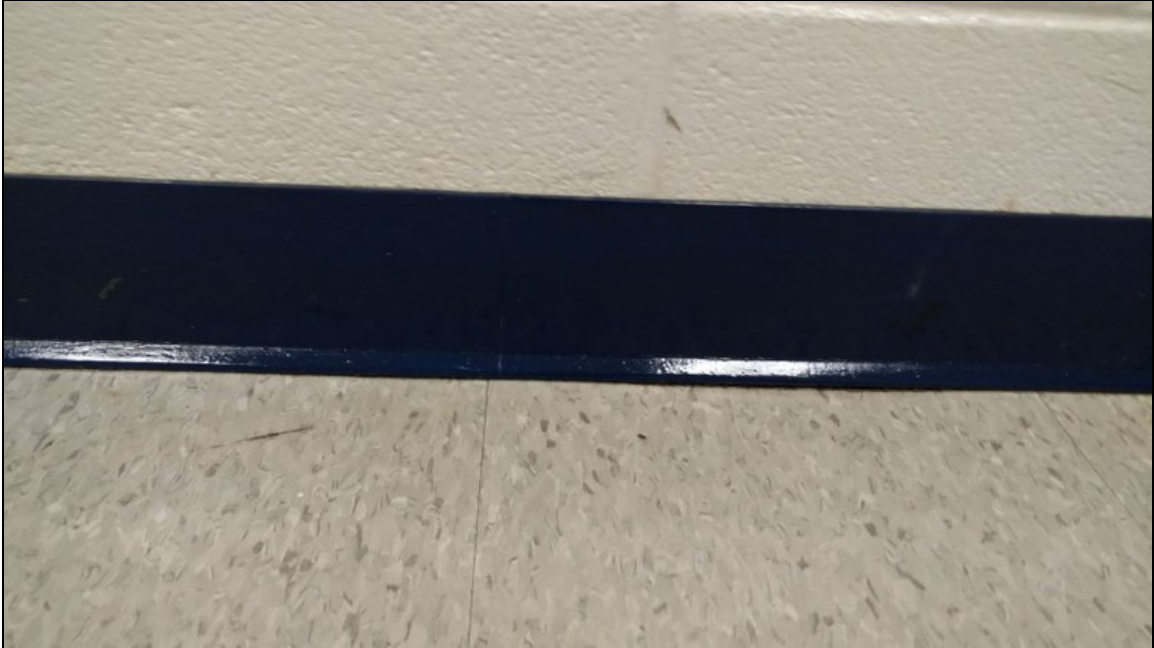
3 - View of typical 4" blue vinyl cove baseboard

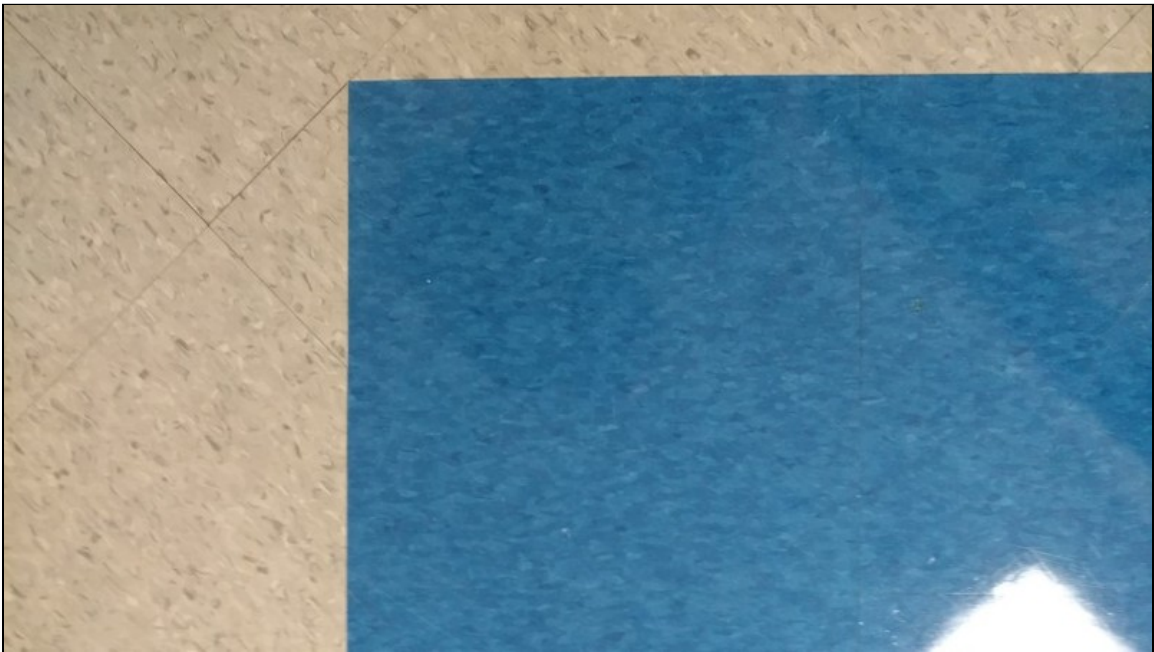
4 - View of typical blue mottled 12"x12" floor tile

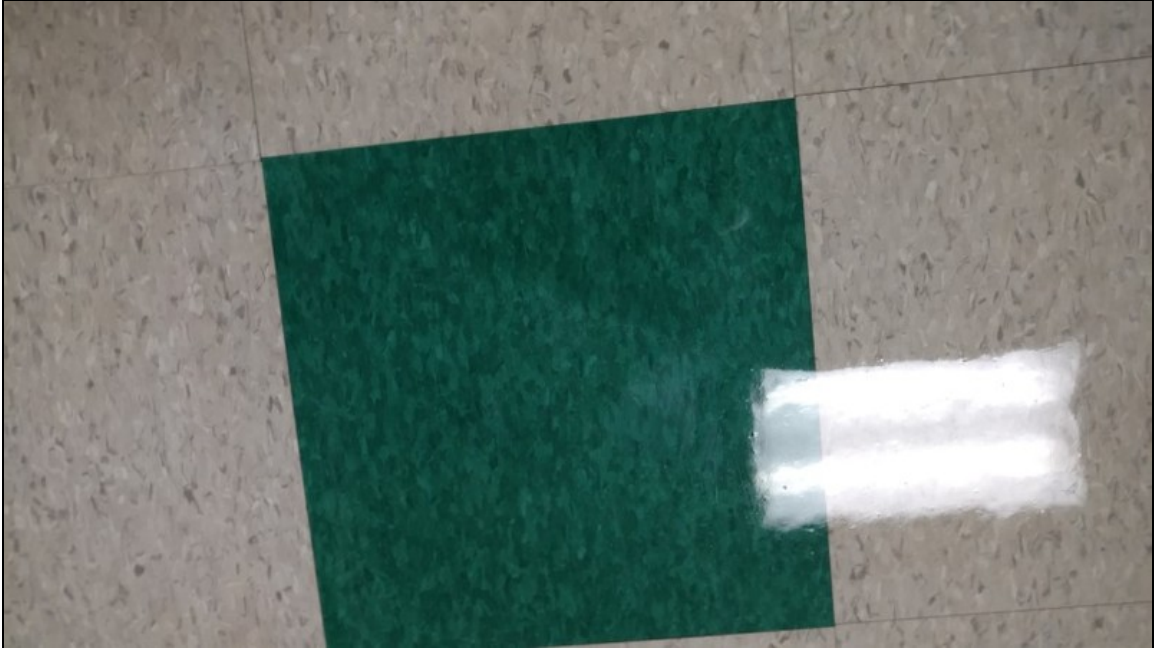
5 - View of typical green mottled 12"x12" floor tile

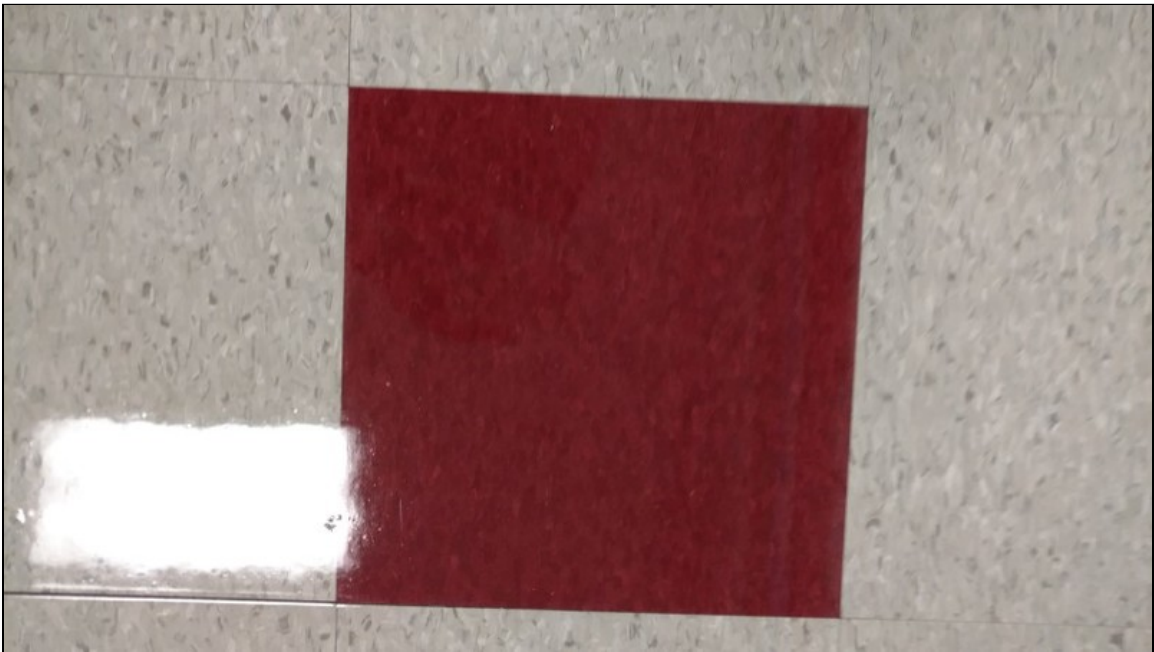
6 - View of typical red mottled 12"x12" floor tile

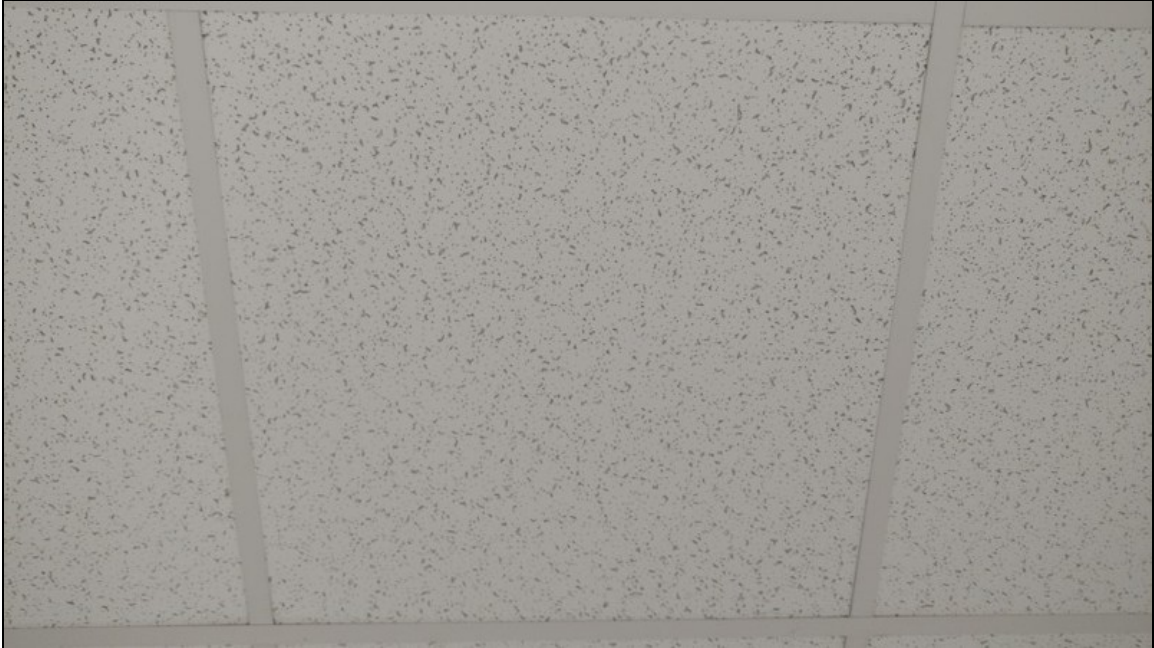
7 - View of typical fissure/pinhole ceiling tile

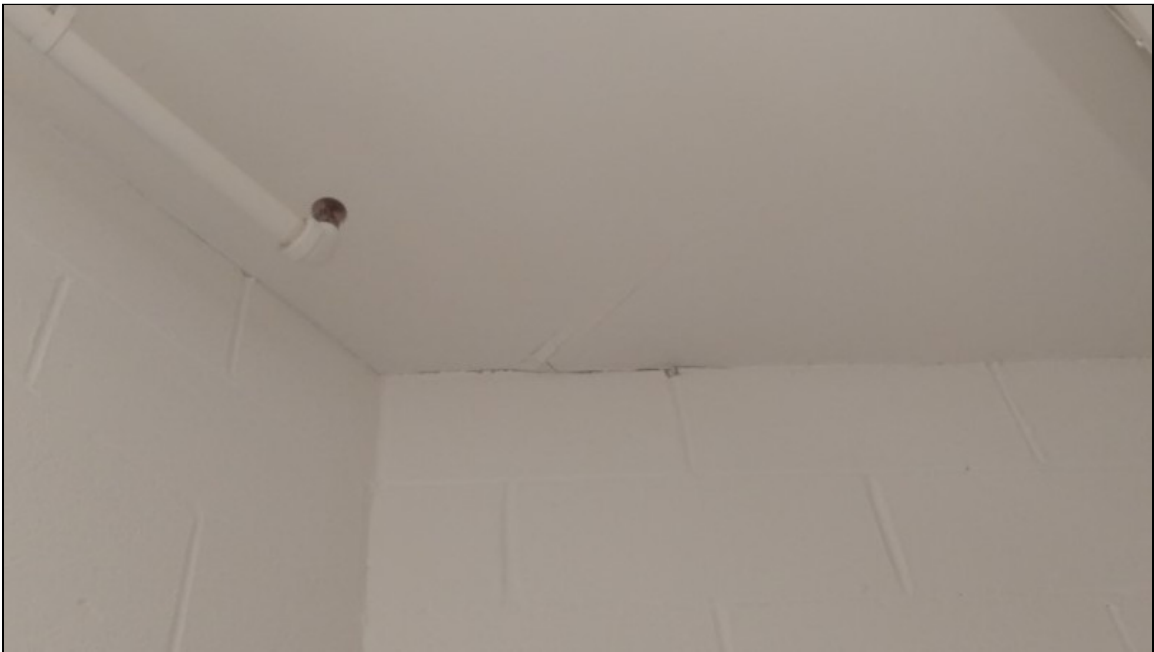
8 - View of typical drywall and joint compound ceiling

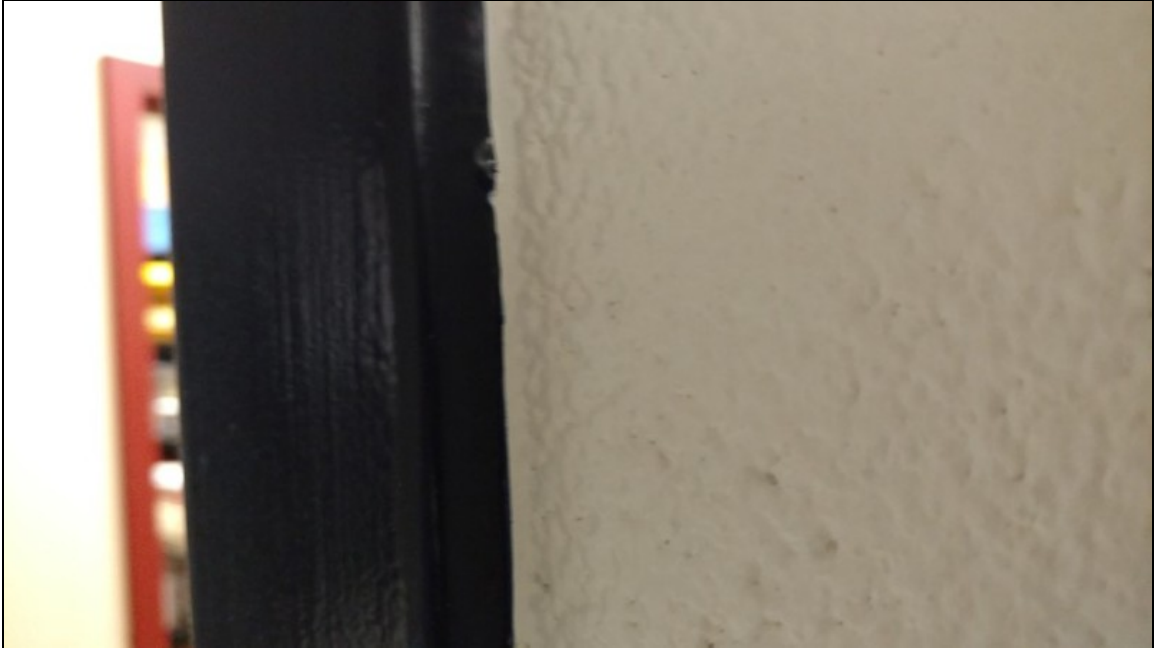
9 - View of typical interior metal door frame caulk

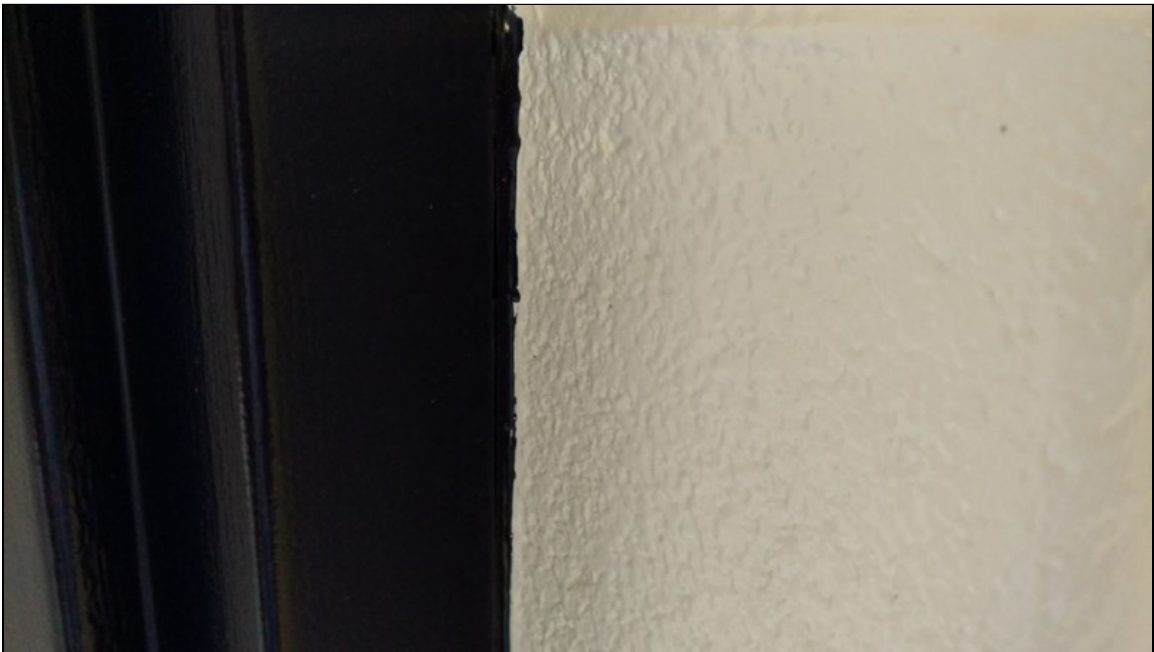
10 - View of typical perimeter door frame caulk

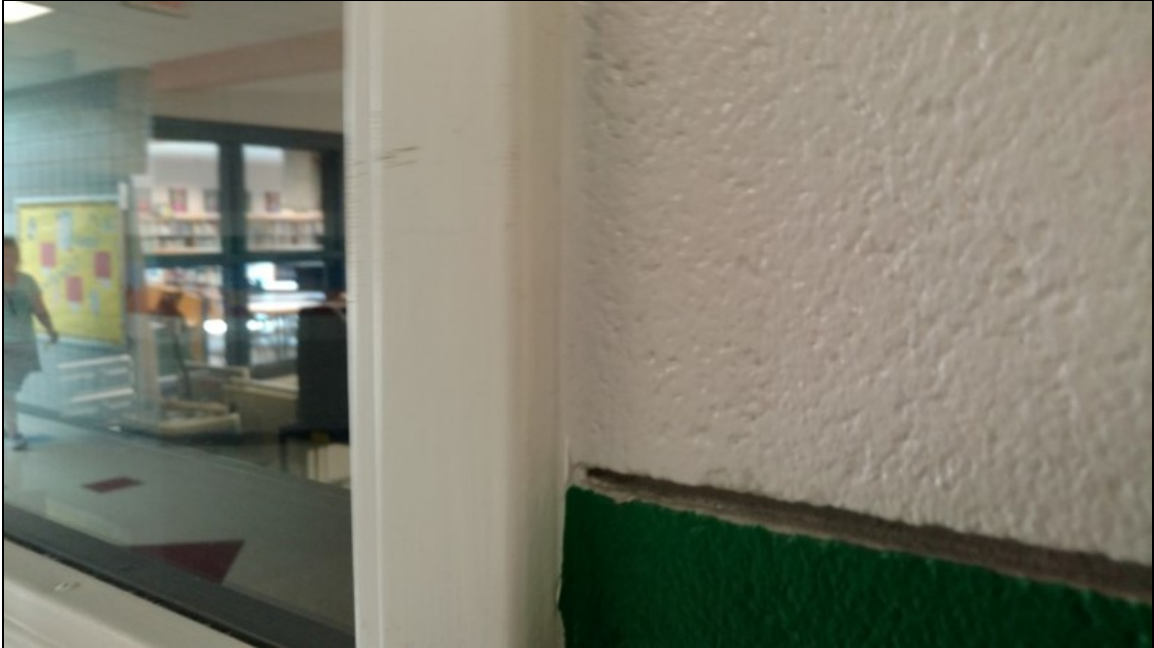
11 - View of typical interior metal window frame caulk

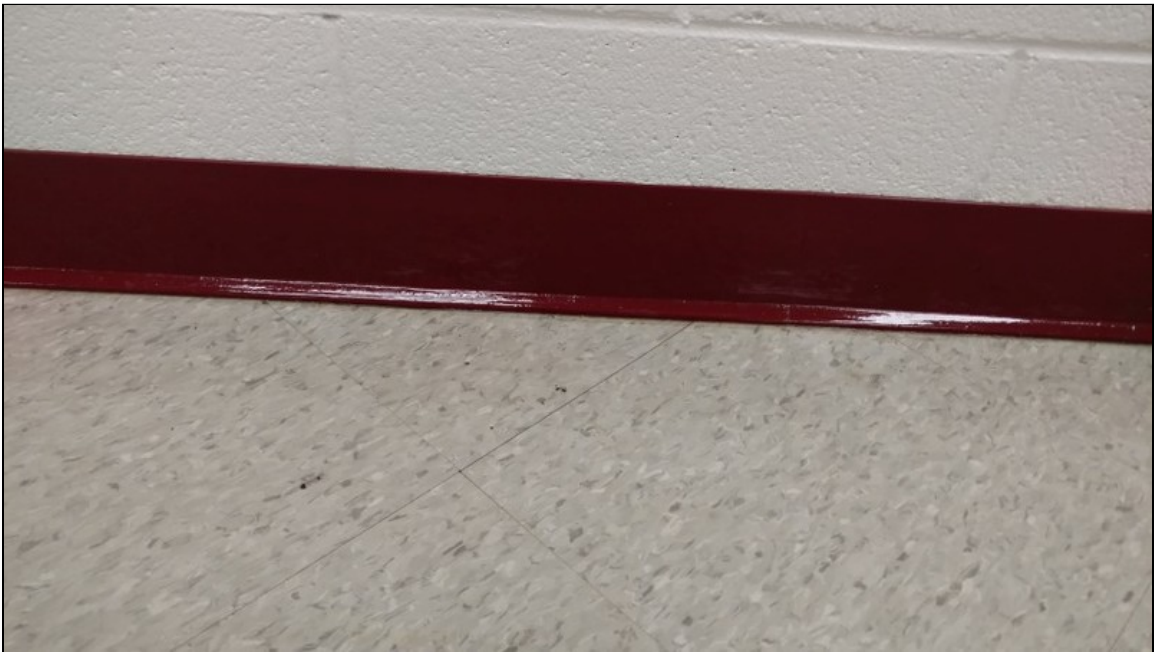
12 - View of typical 4" red vinyl cove baseboard

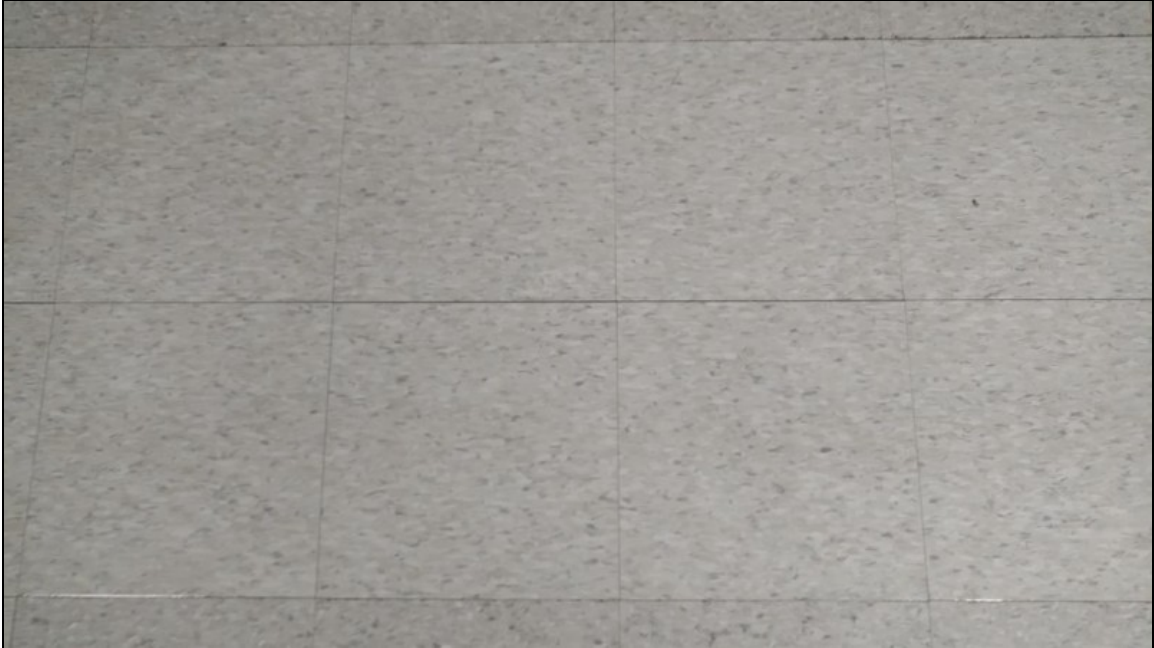
13 - View of typical grey/white mottled 12:x12: floor tile

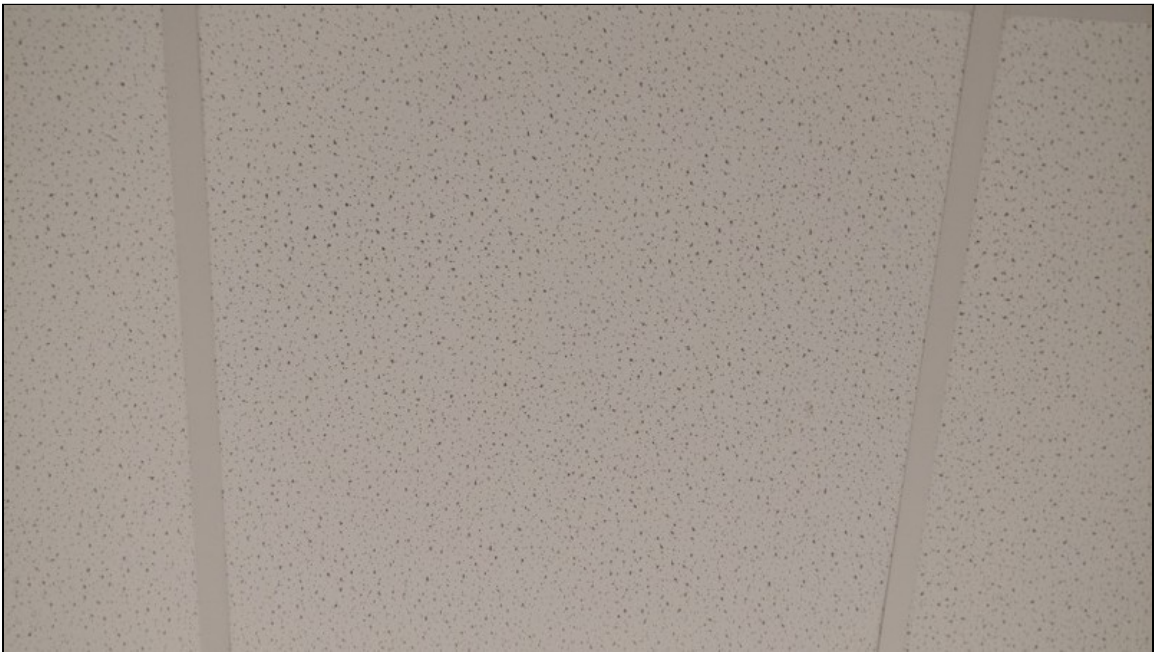
14 - View of typical pinhole ceiling tile

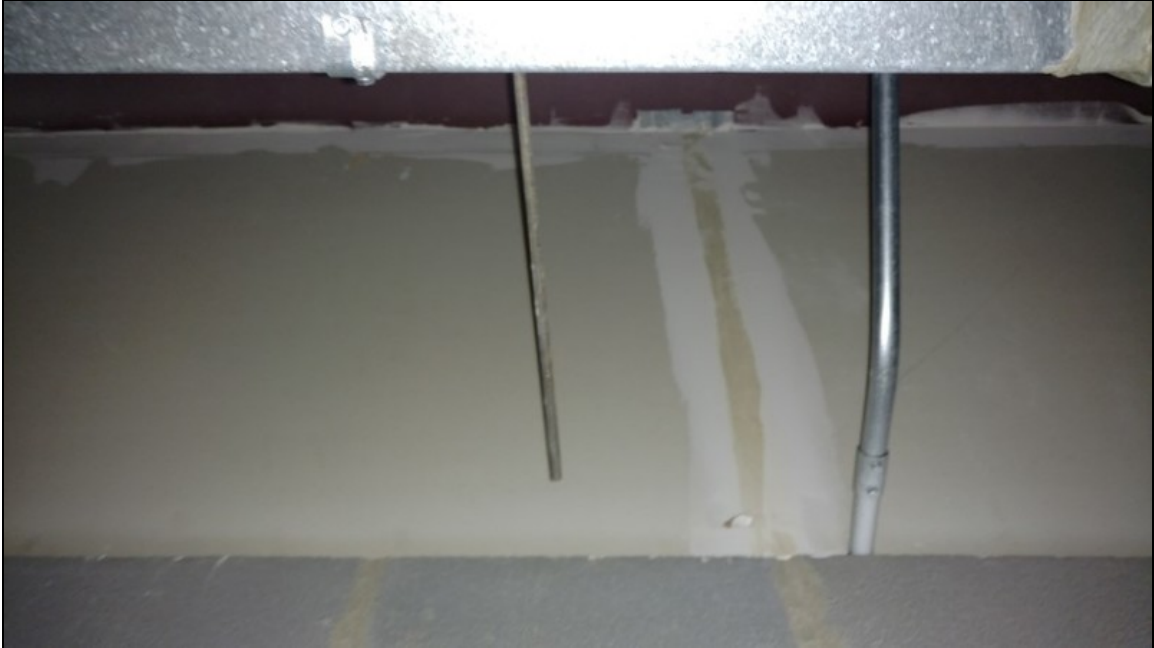
15 - View of typical drywall and joint compound wall

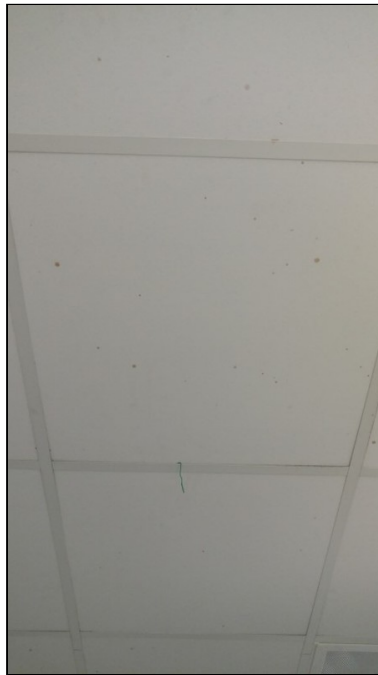
16 - View of typical gypsum ceiling tile

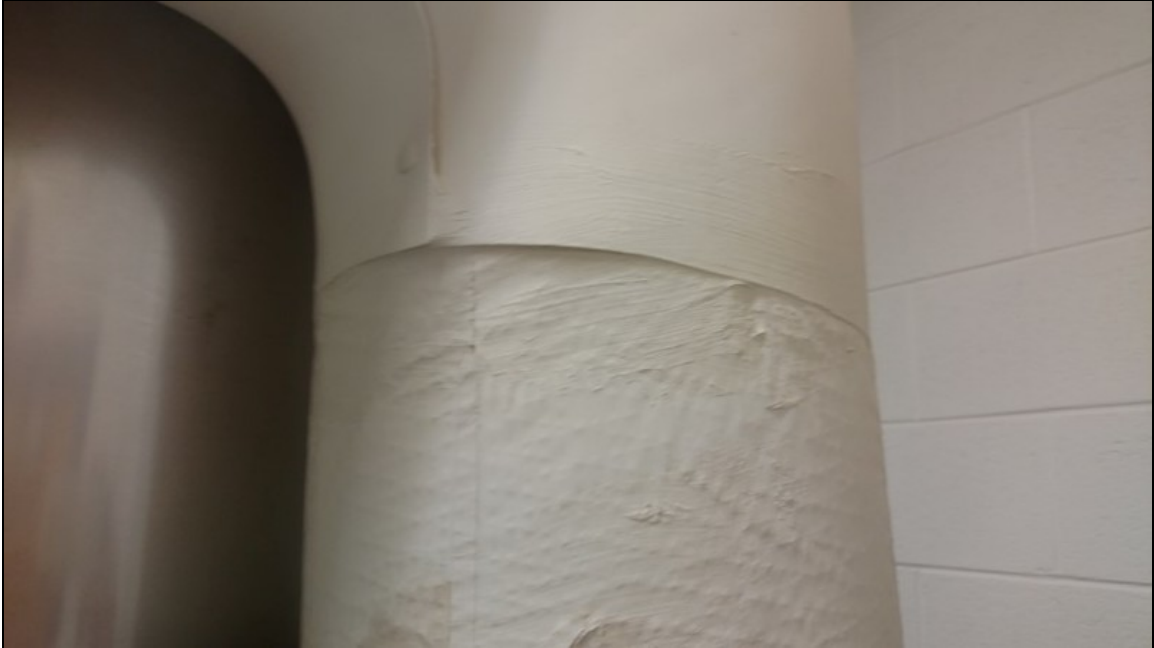
17 - View of typical white fiberglass pipe insulation mastic

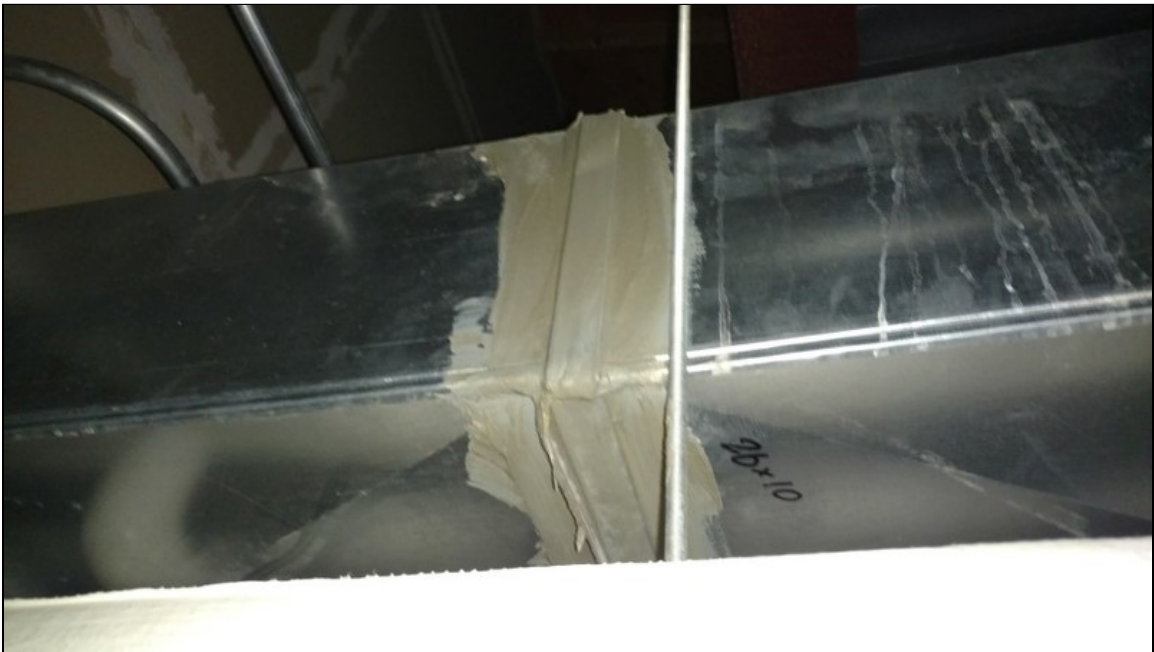
18 - View of typical grey HVAC duct mastic

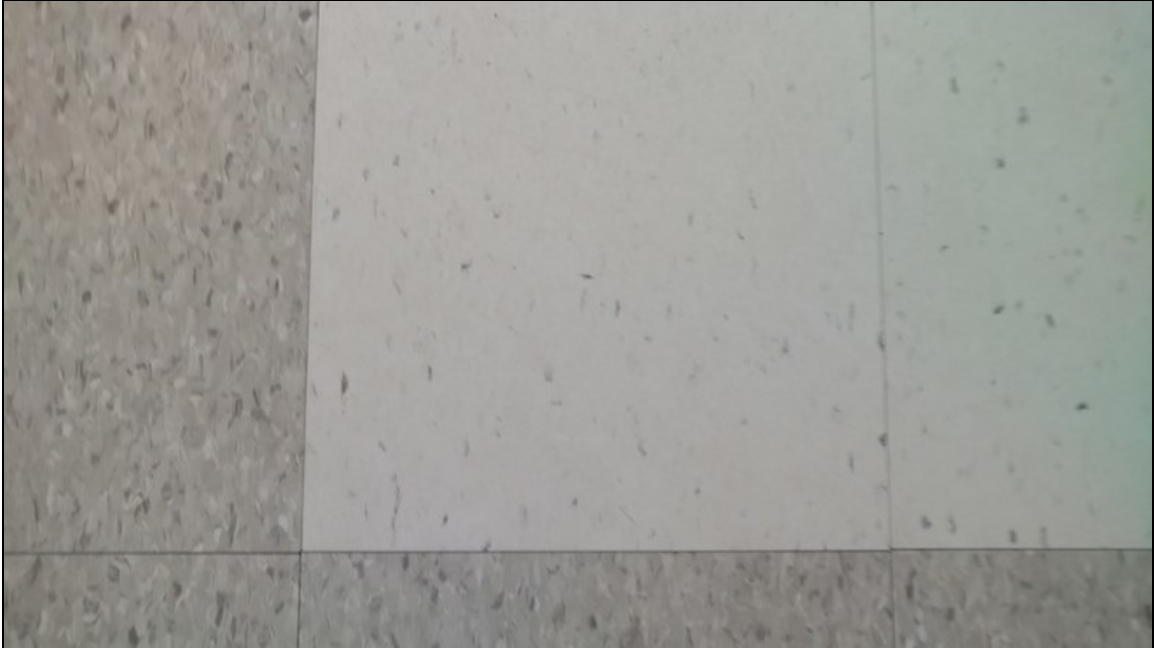
19 - View of typical white with black streak 12"x12" floor tile

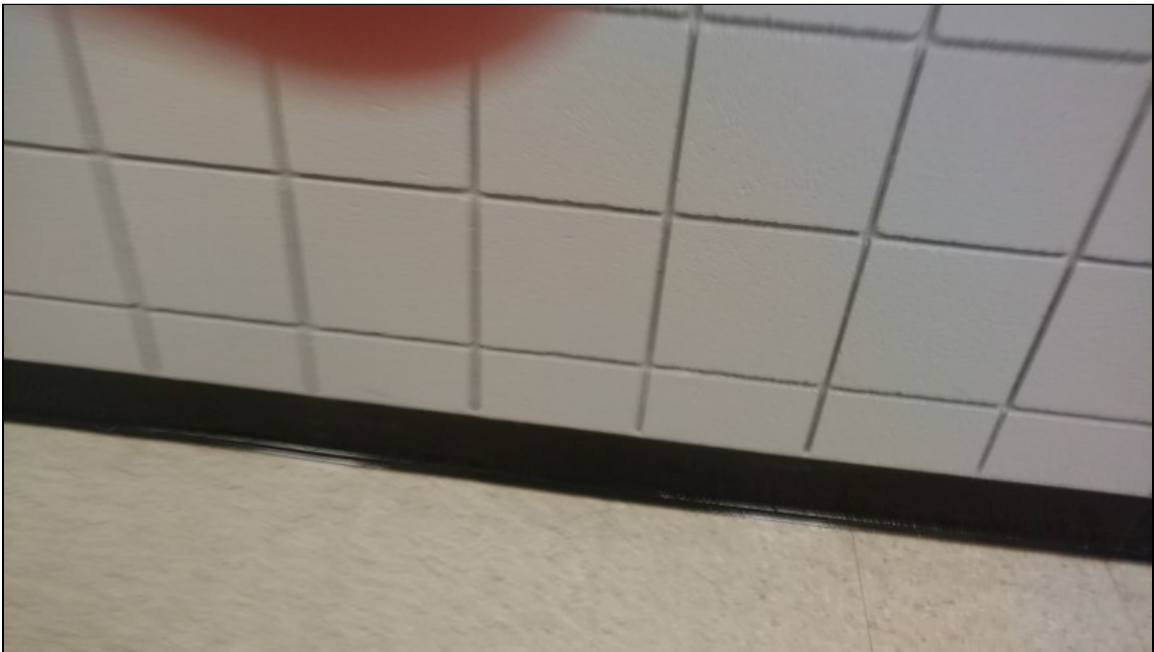
20 - View of typical black 4" vinyl cove baseboard
