# INITIAL AHERA ASBESTOS SURVEY

HIDDEN VALLEY HIGH SCHOOL

ECS PROJECT NO. 47:3555

NOVEMBER 17, 2017

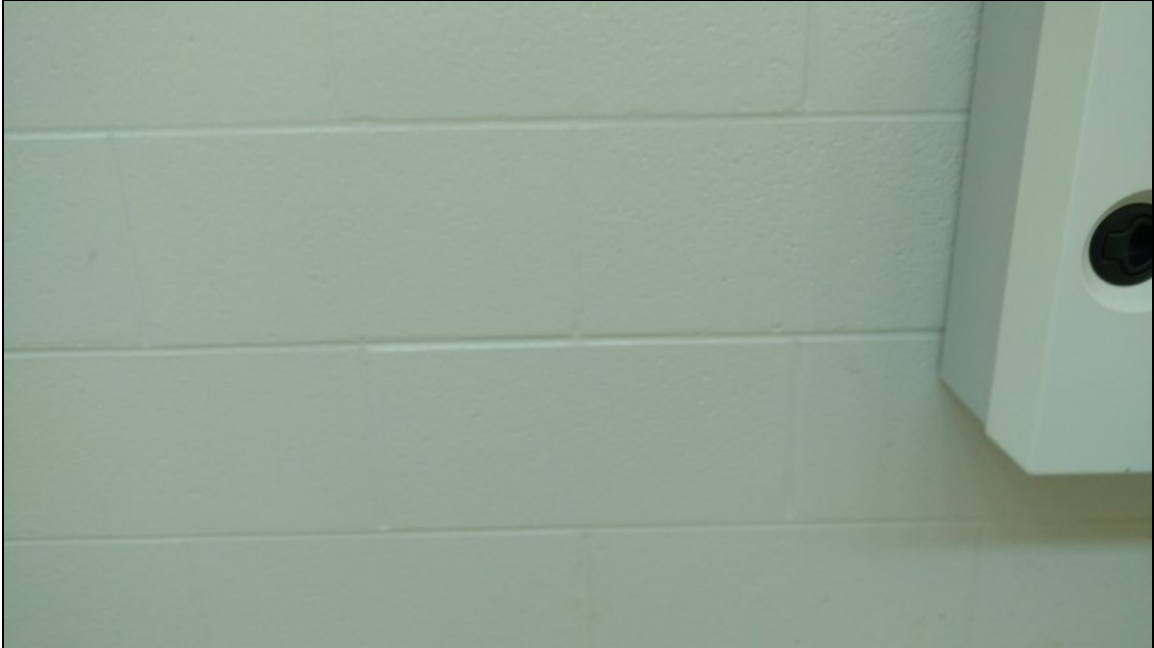
1 - View of typical CMU wall coating

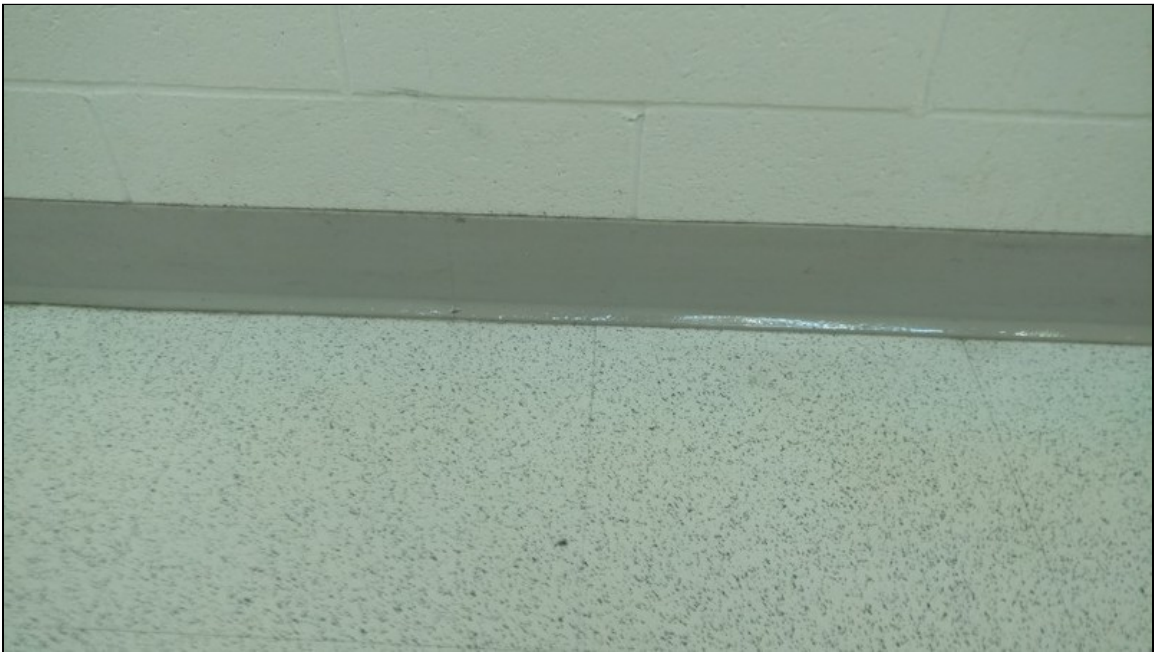
2 - View of typical grey 4" vinyl cove baseboard

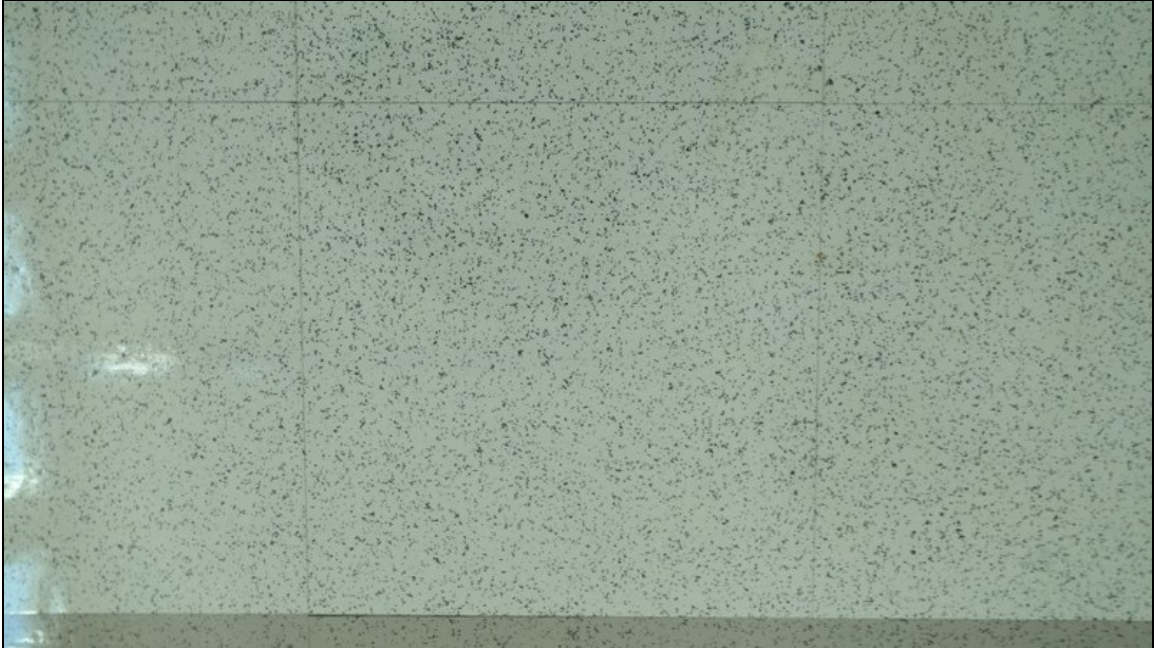
3 - View of typical white speckled 12"x12" floor tile

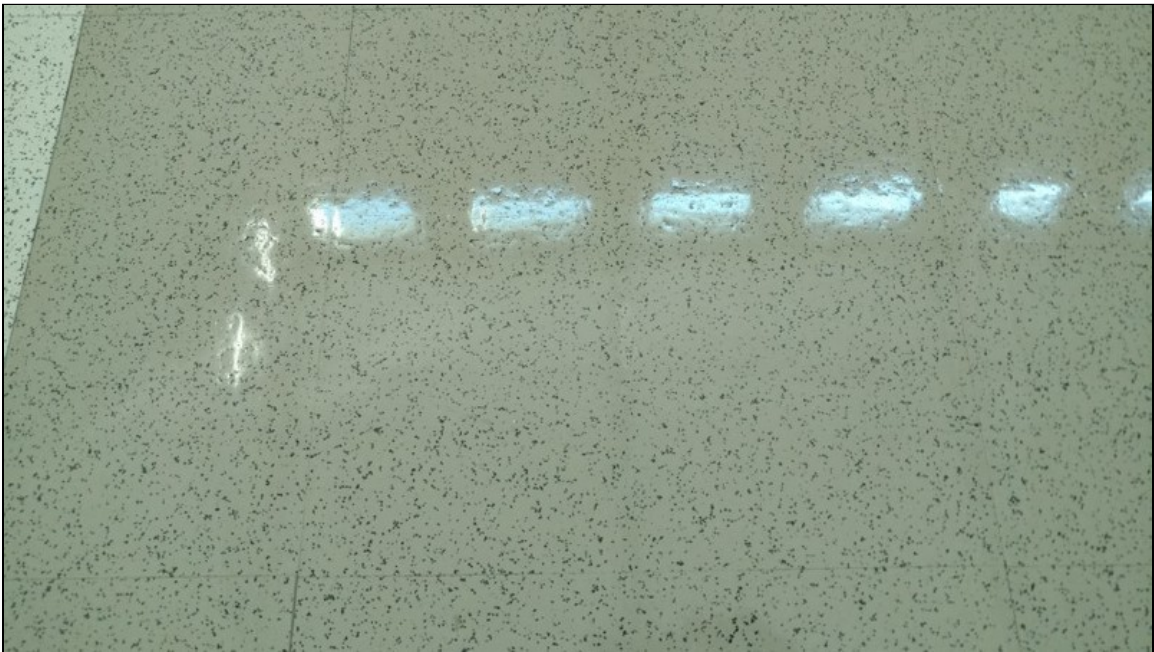
4 - View of typical grey speckled 12"x12" floor tile

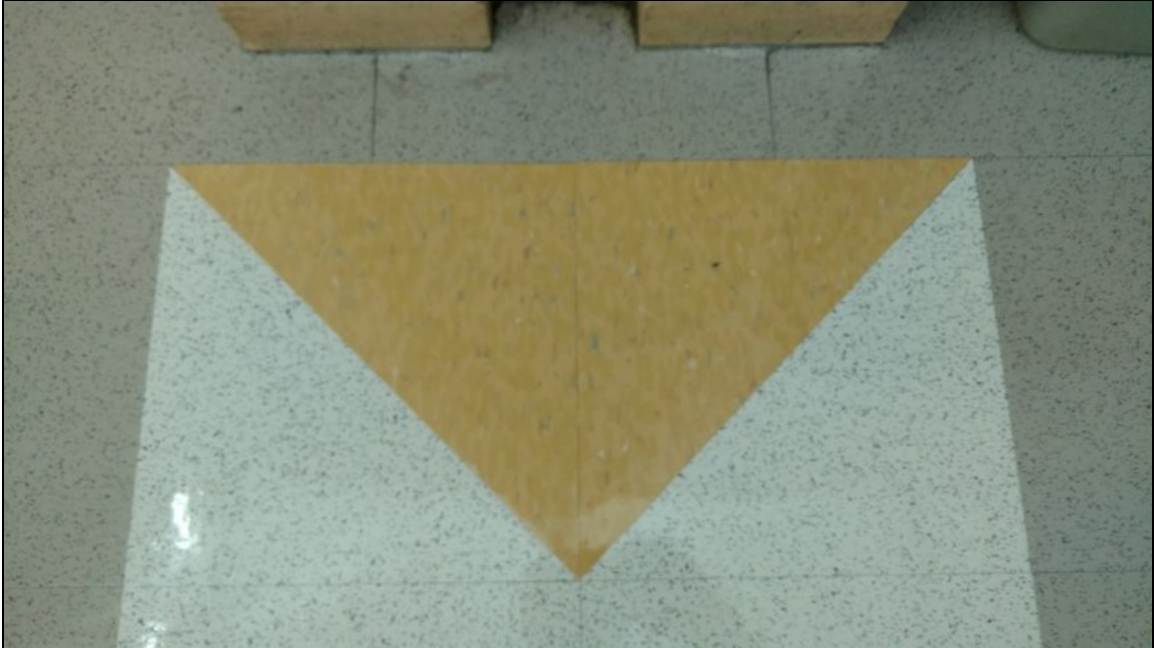
5 - View of typical yellow mottled floor tile

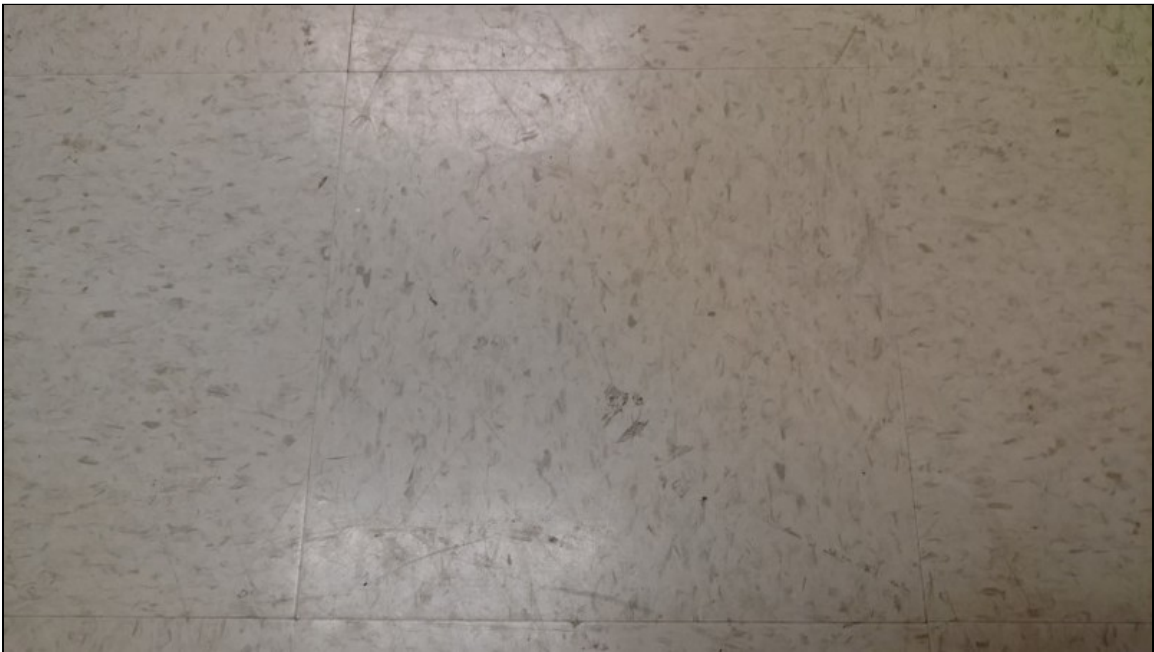
6 - View of typical white with grey smear 12"x12" floor tile

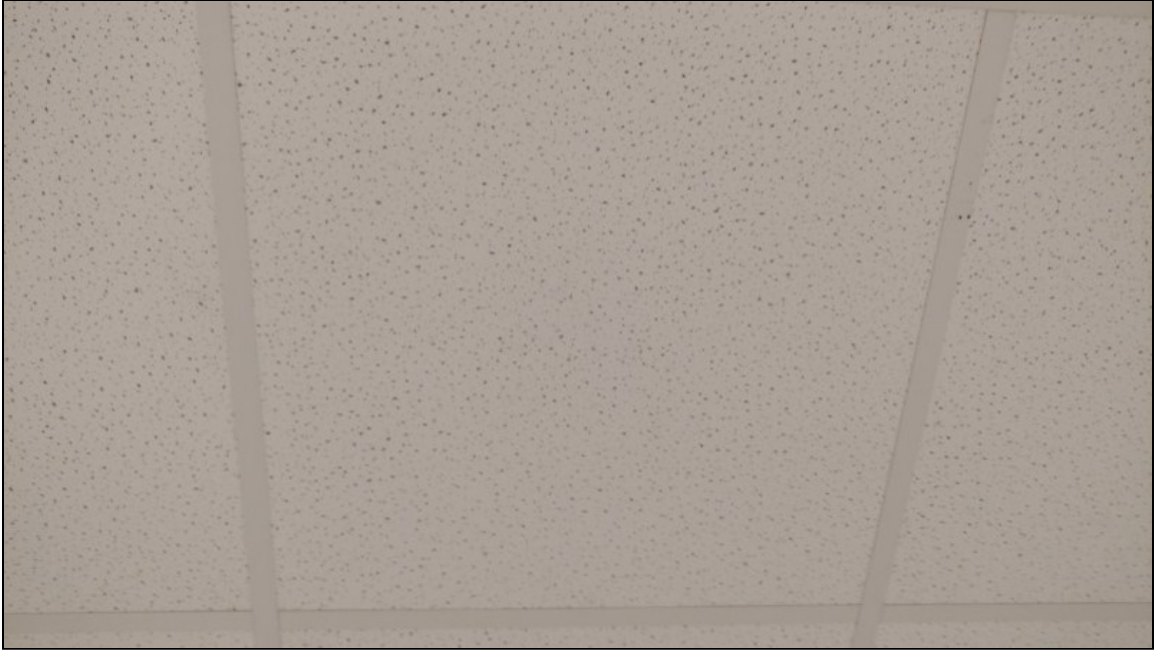
7 - View of typical pinhole/divot ceiling tile

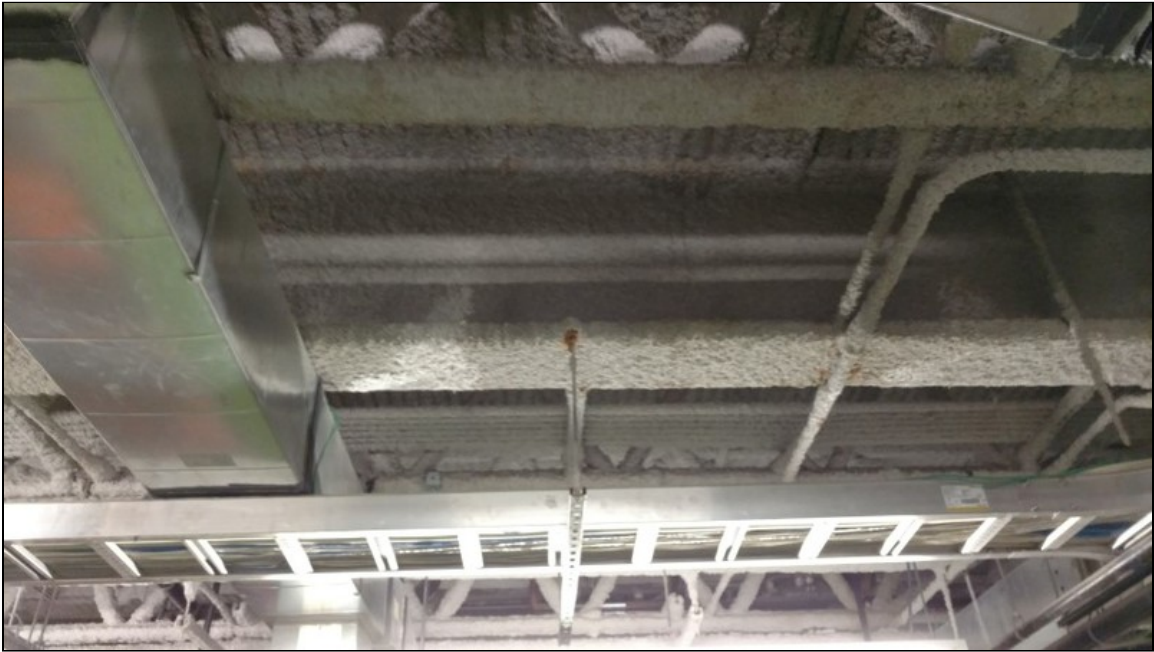
8 - View of typical spray-on fireproofing

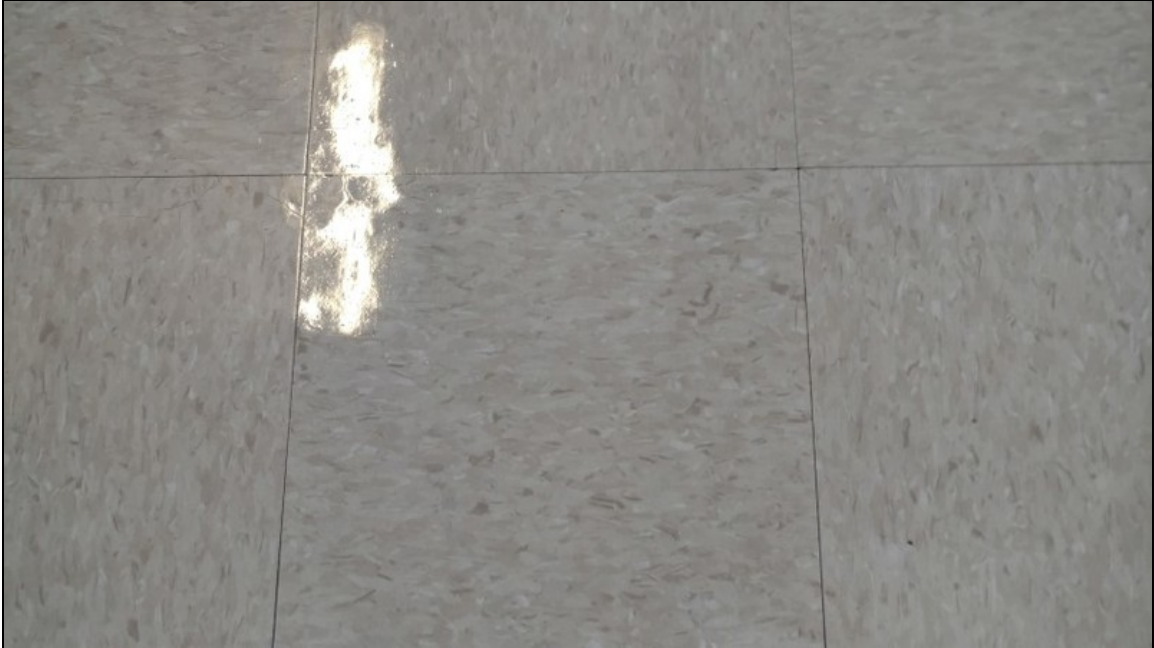
9 - View of typical grey mottled 12"x12" floor tile

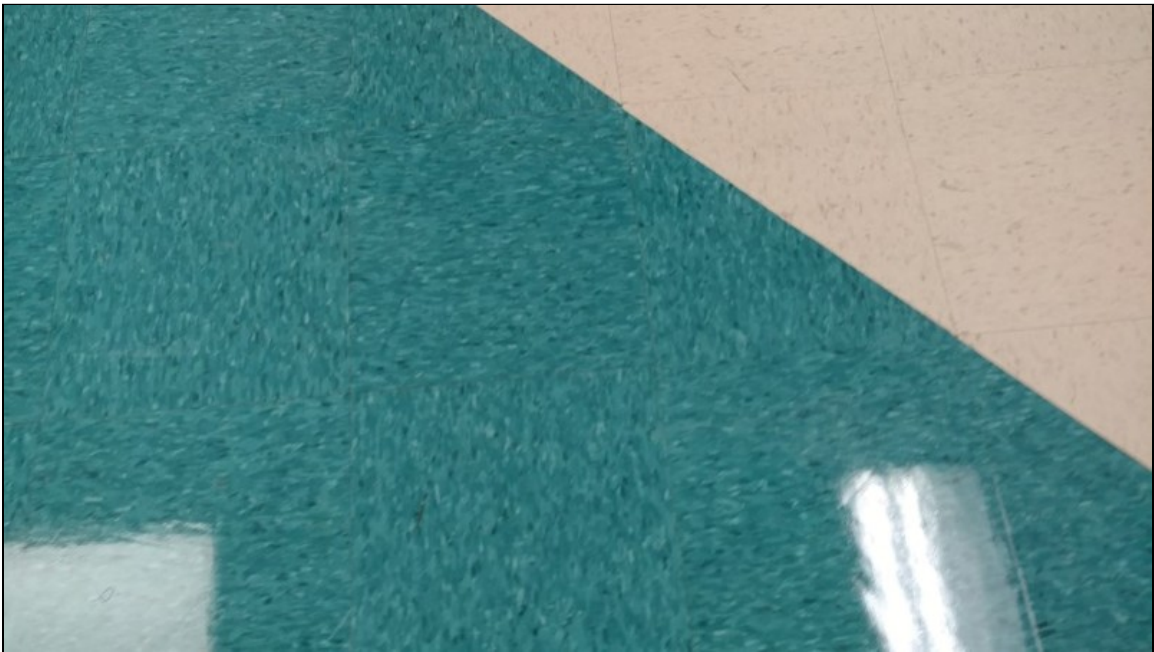
10 - View of blue mottled 12"x12" floor tile

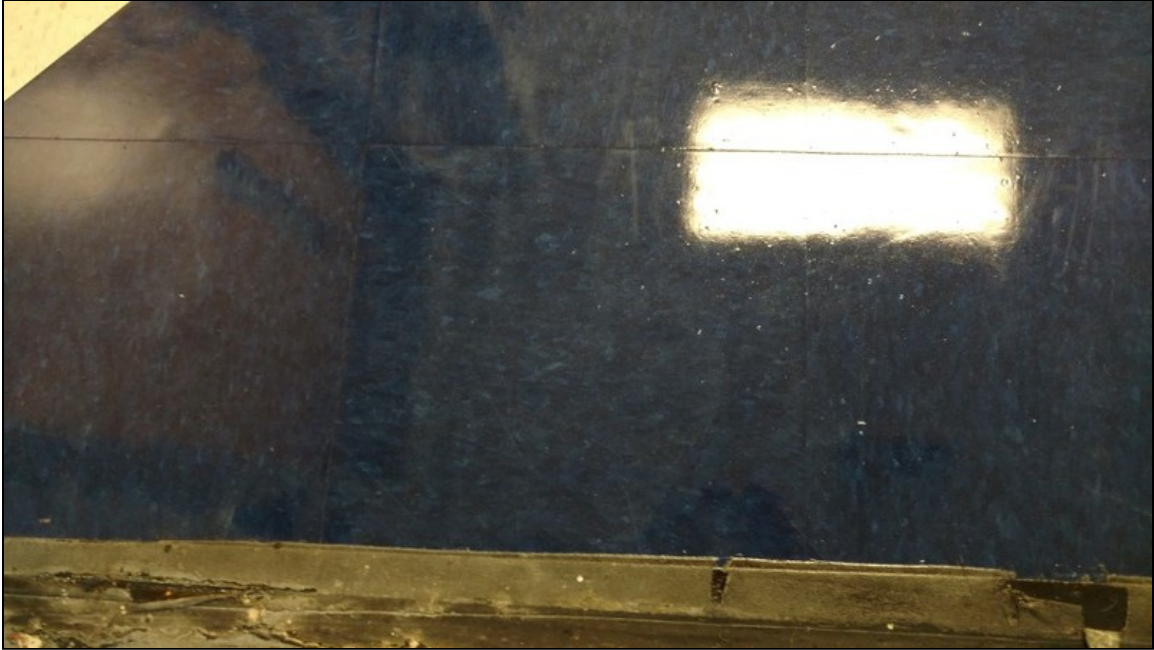
11 - View of typical dark blue mottled 12"x12" floor tile

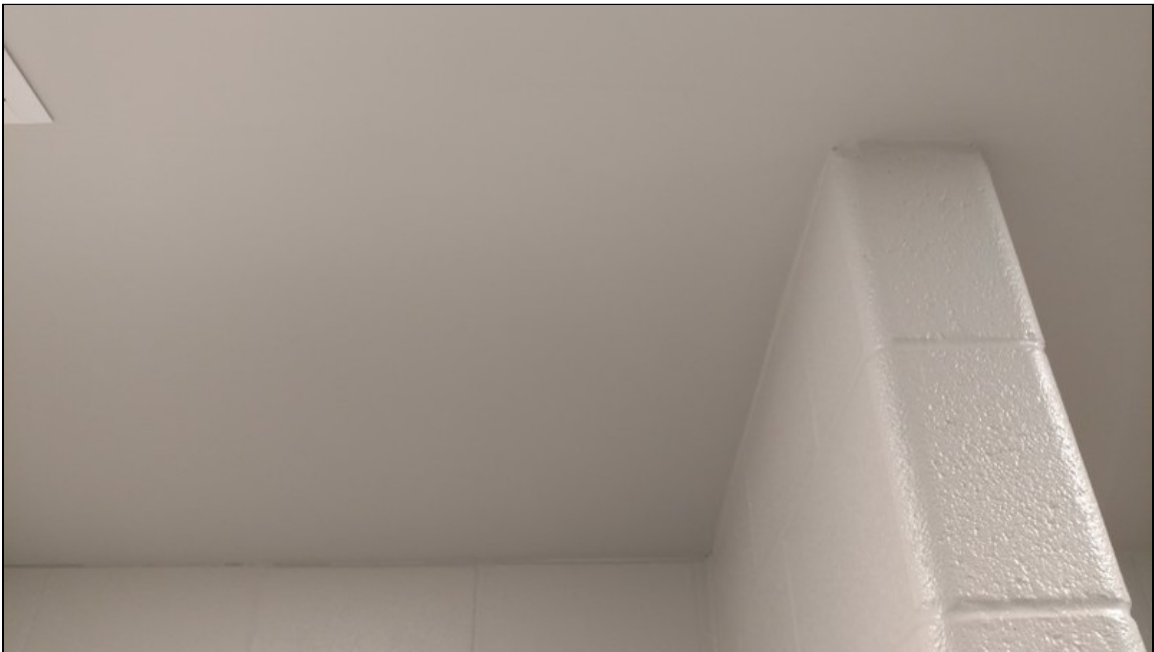
12 - view of typical drywall ceiling

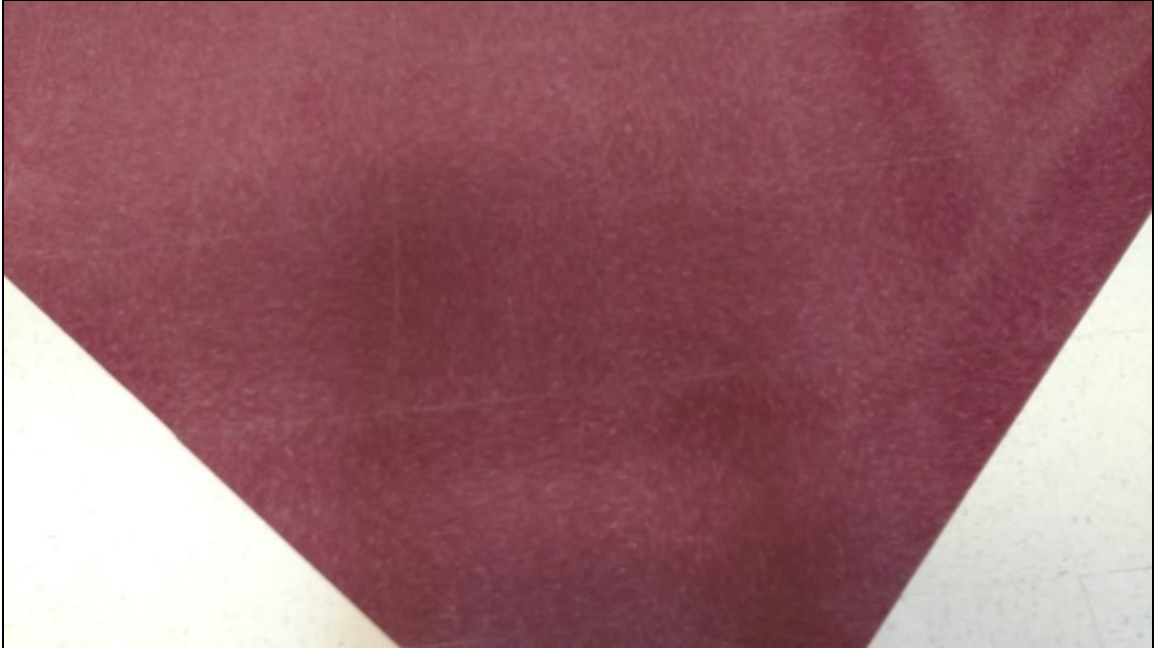
13 - View of typical red mottled 12"x12" floor tile

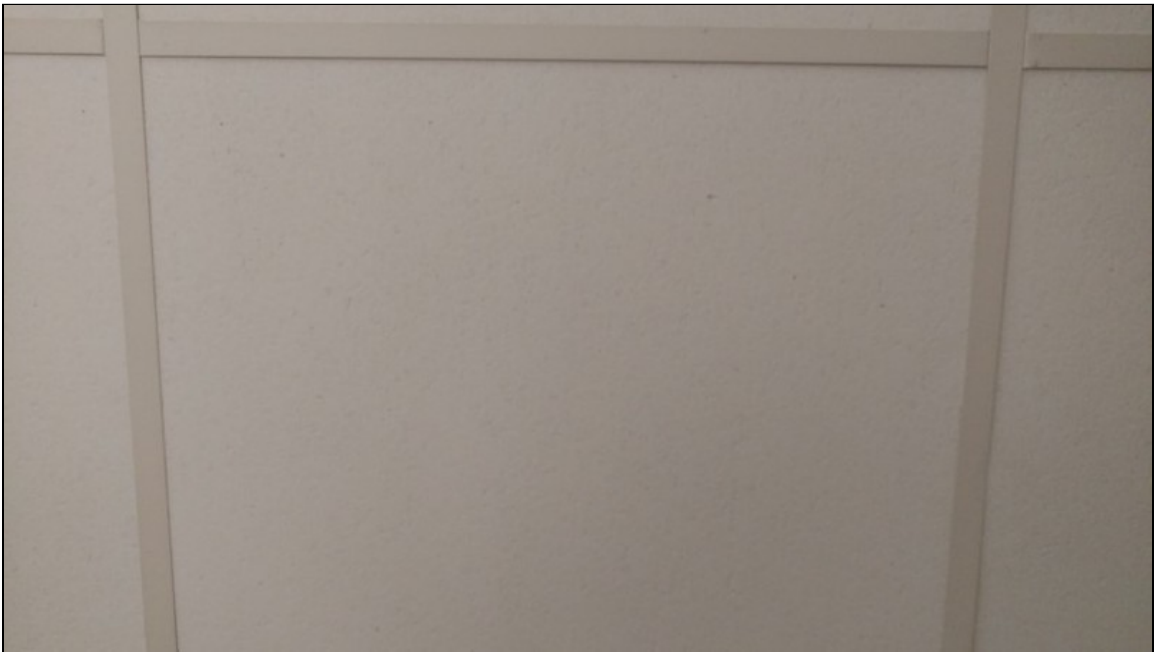
14 - View of typical smooth ceiling tile

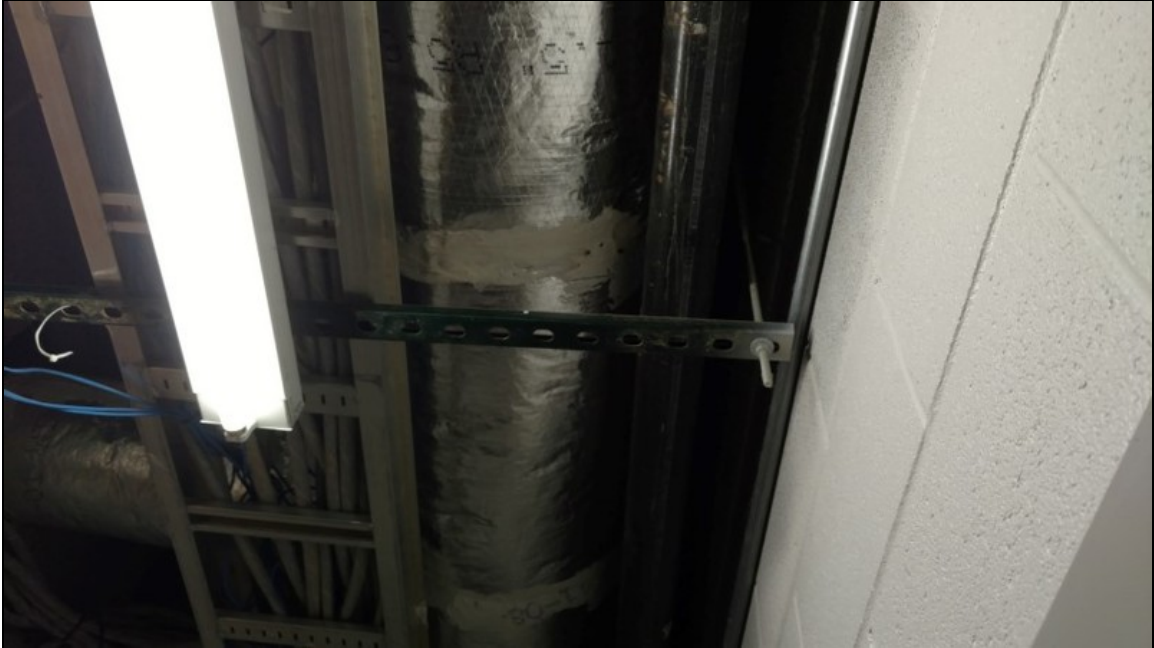
15 - View of typical white HVAC duct wrap mastic

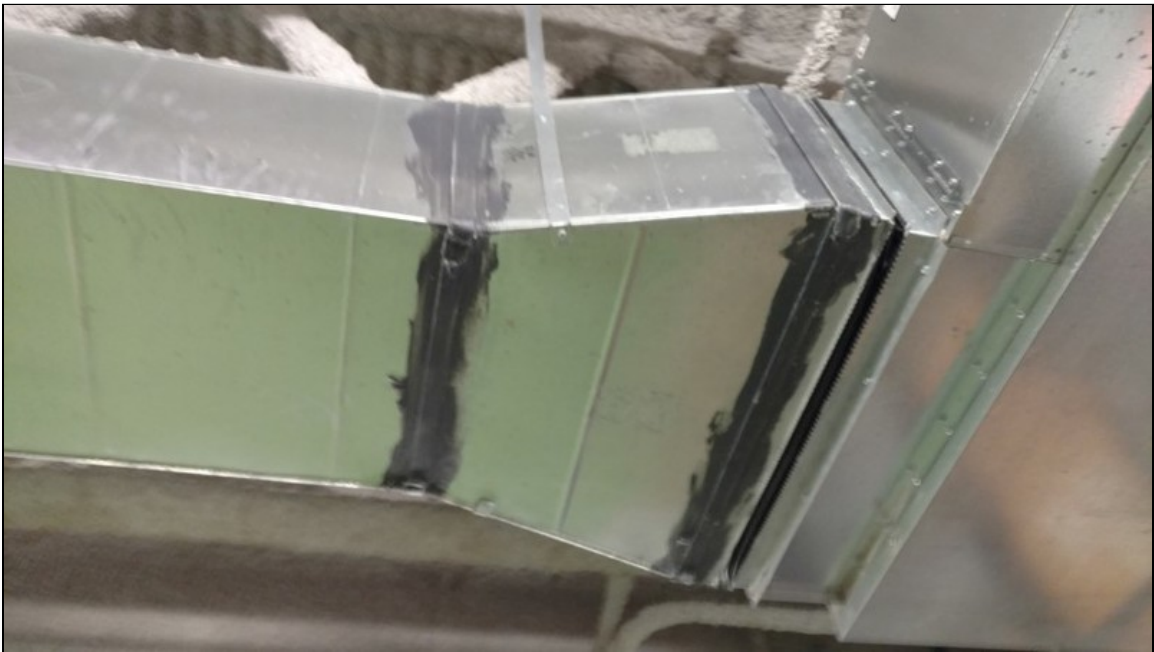
16 - View of typical grey metal HVAC duct mastic

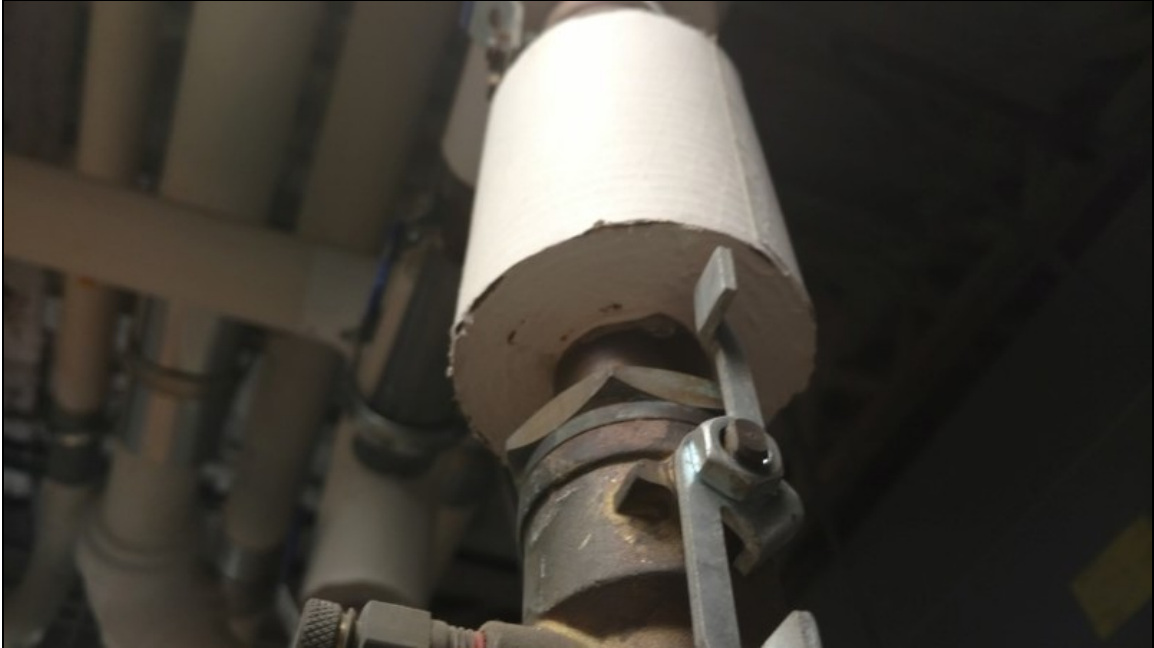
17 - View of typical white fiberglass pipe insulation mastic

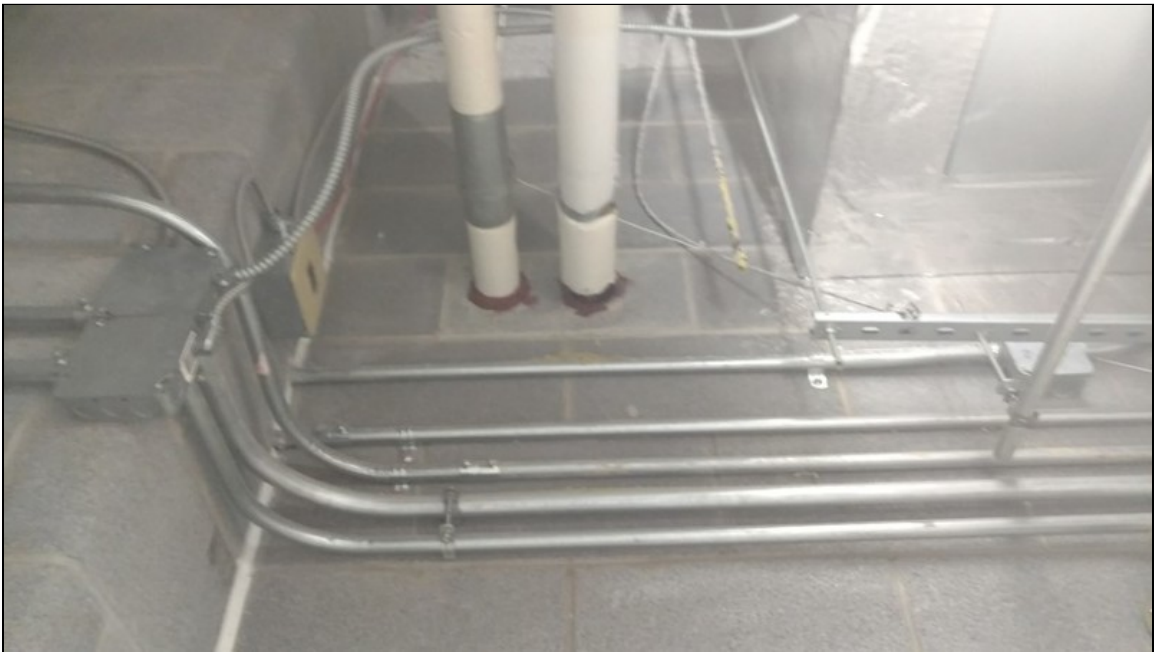
18 - View of typical red fire caulk

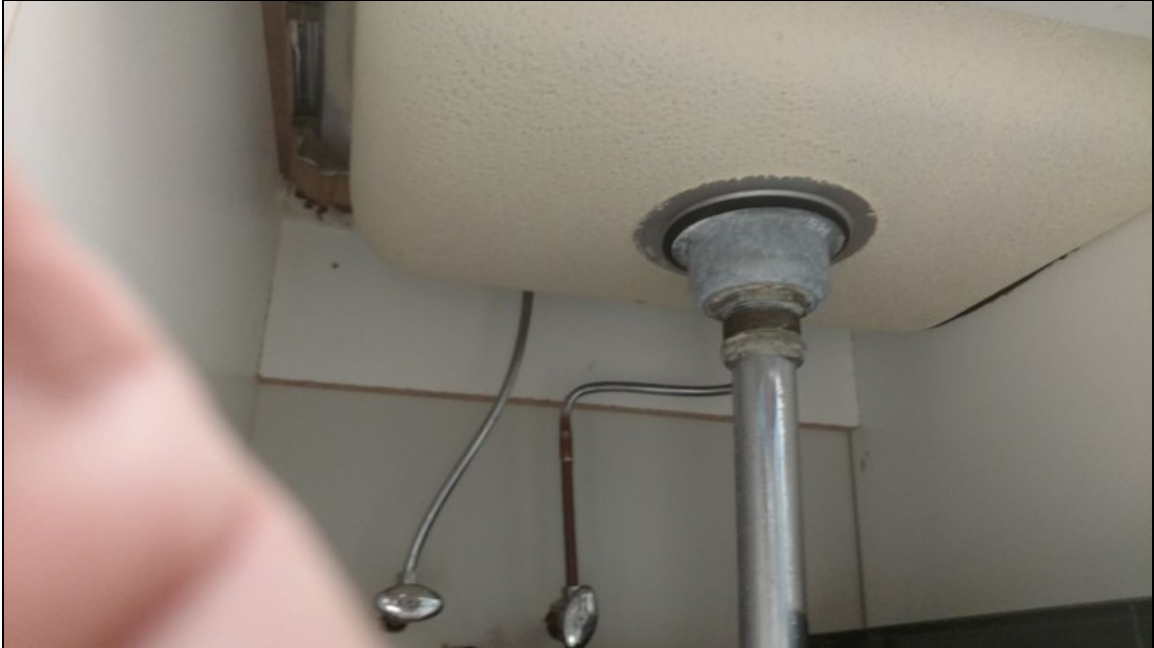
19 - View of typical white sink undercoating

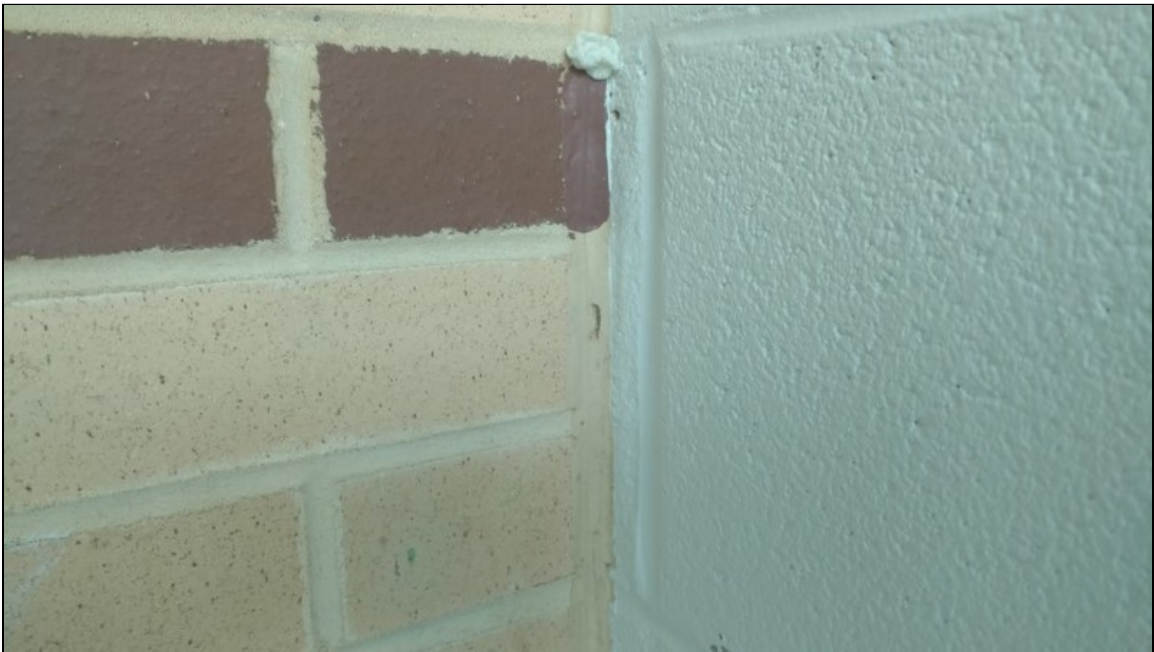
20 - View of typical interior column caulk

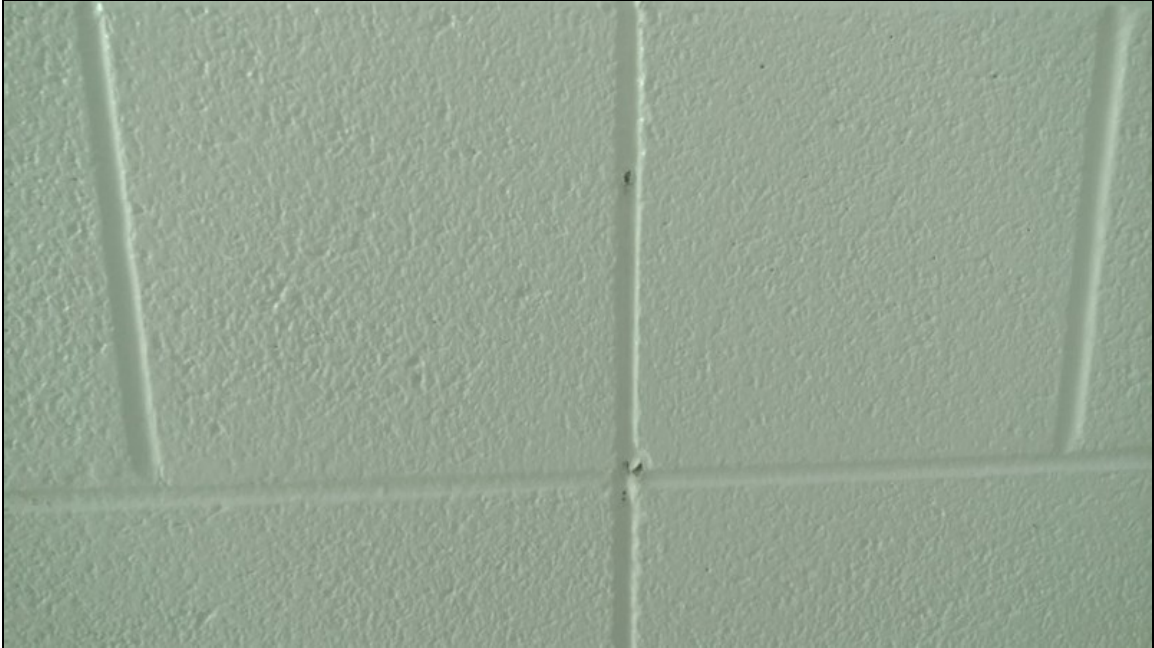
21 - View of typical interior wall expansion caulk

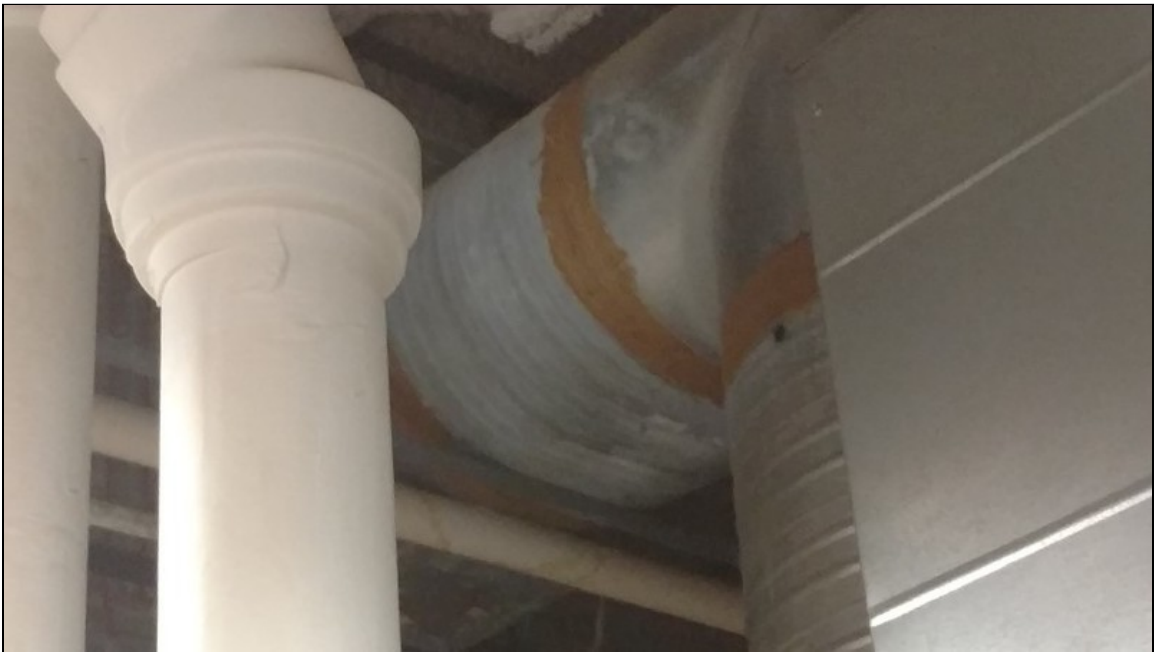
22 - View of typical brown HVAC duct mastic

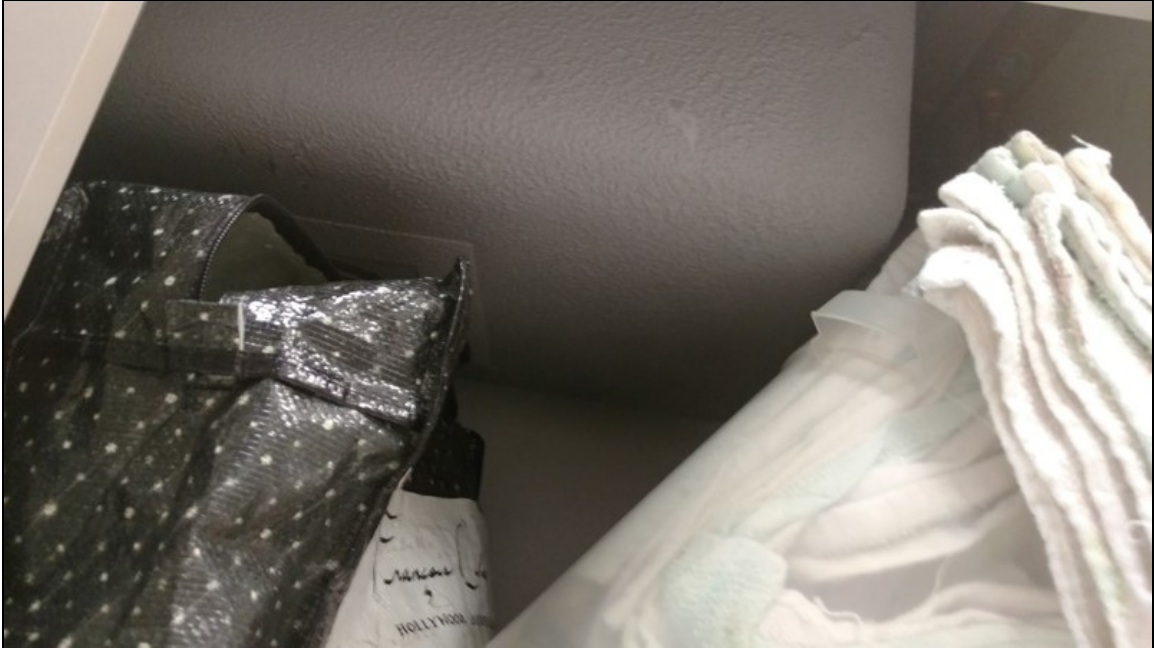
23 - View of typical grey sink undercoating
