# INITIAL AHERA ASBESTOS SURVEY

MASON'S COVE ELEMENTARY

ECS PROJECT NO. 47:3555

ROANOKE COUNTY SCHOOLS

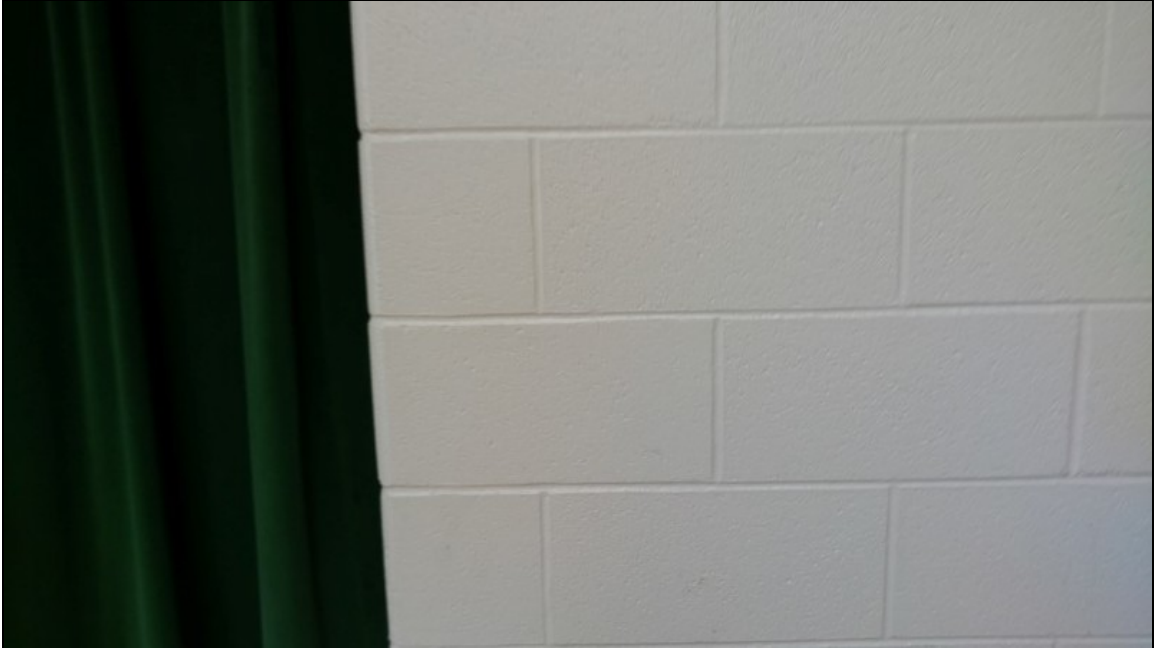
1 - View of typical CMU wall coating, homogenous group 1

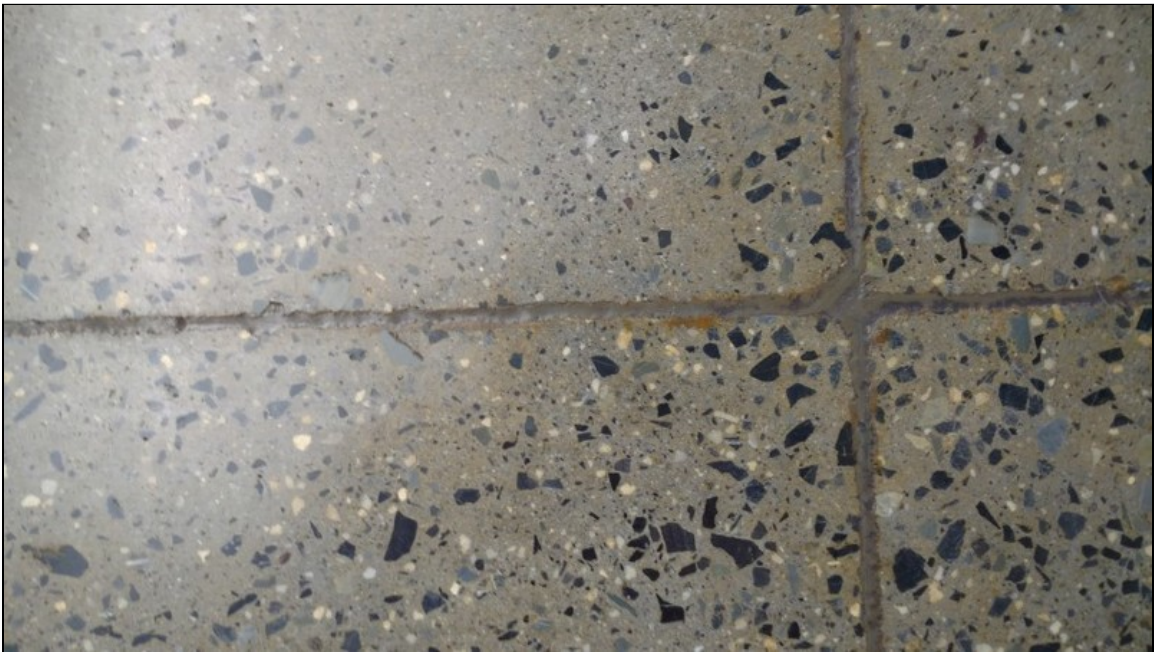
2 - View of typical concrete floor seam caulk, homogeneous group 2

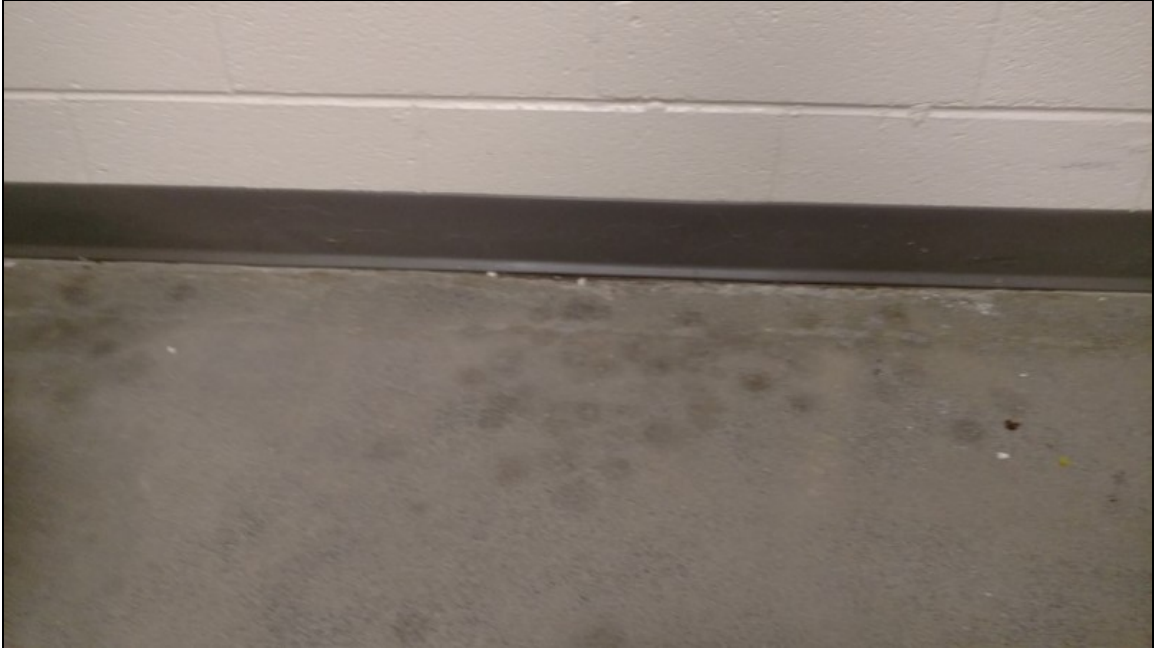
3 - View of typical 4" vinyl cove baseboard, homogeneous group 3

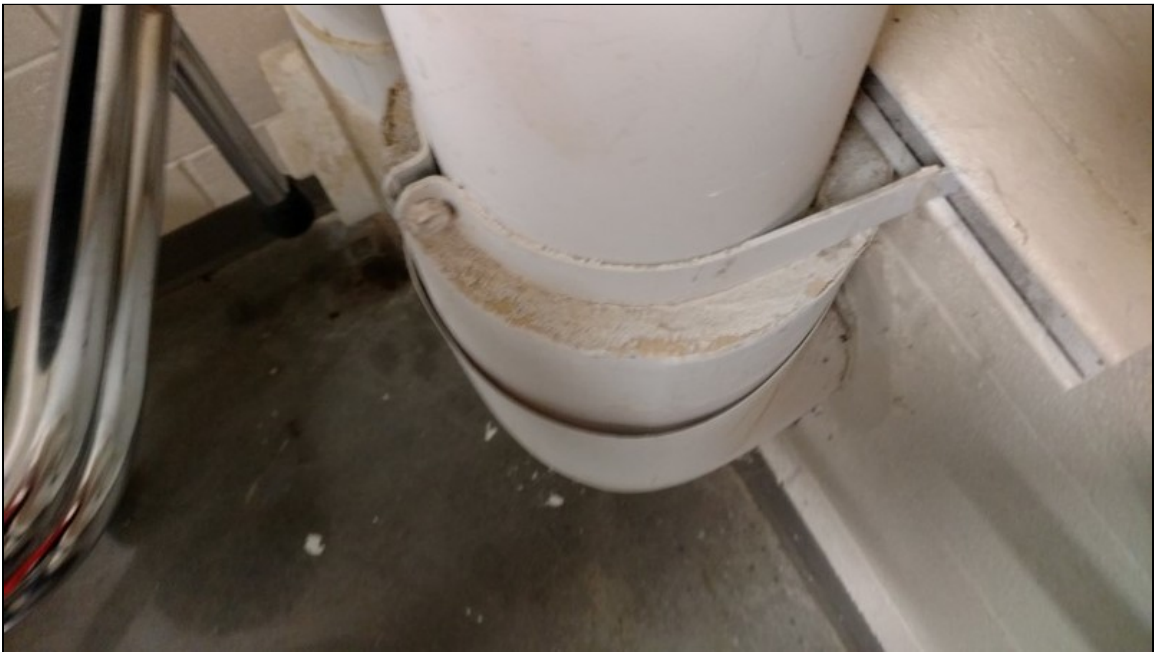
4 - View of typical white mastic on fiberglass pipe insulation, homogeneous group 4

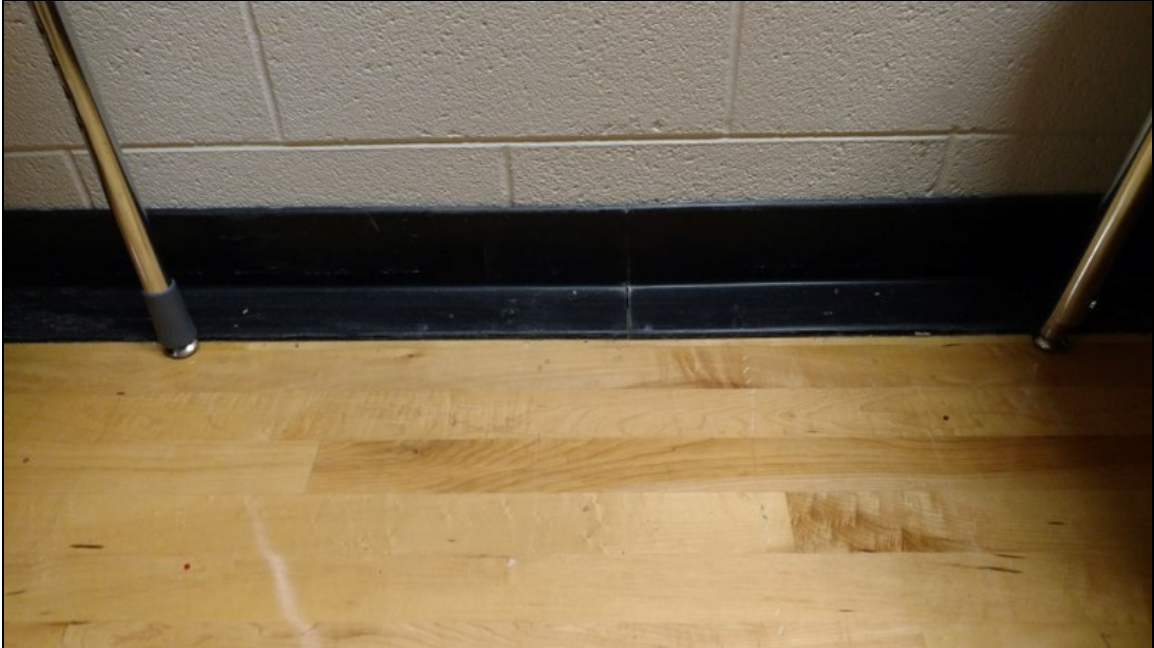
5 - View of typical black 90 degree vinyl cove baseboard, homogeneous group 5

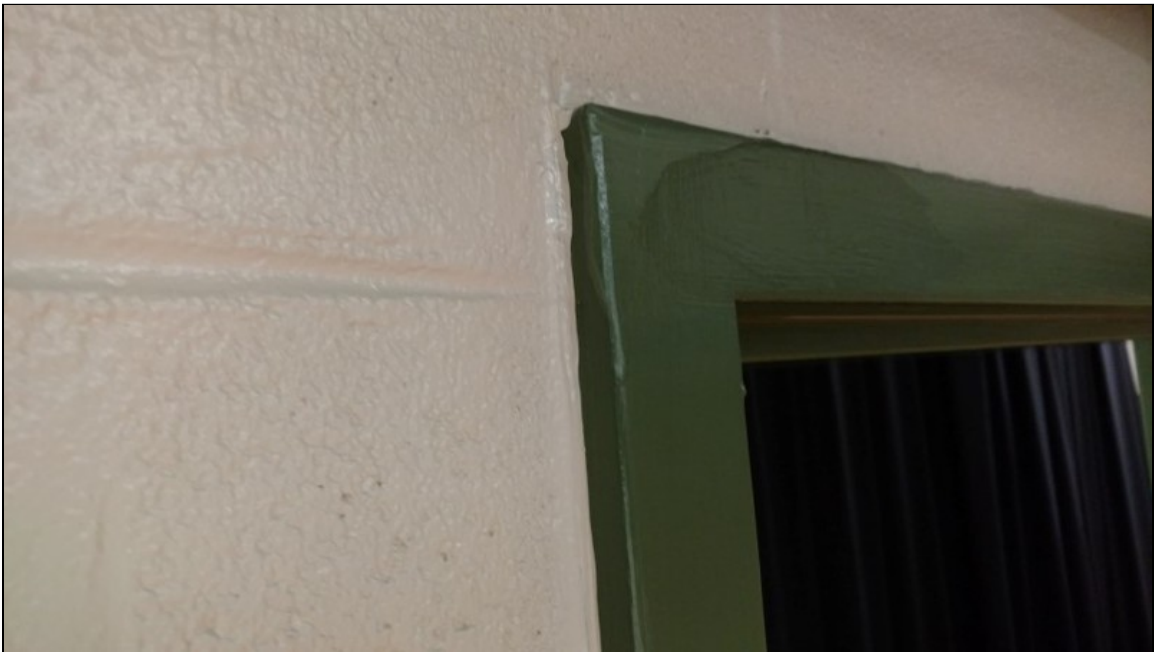
6 - View of typical interior metal door frame caulk, homogeneous group 6

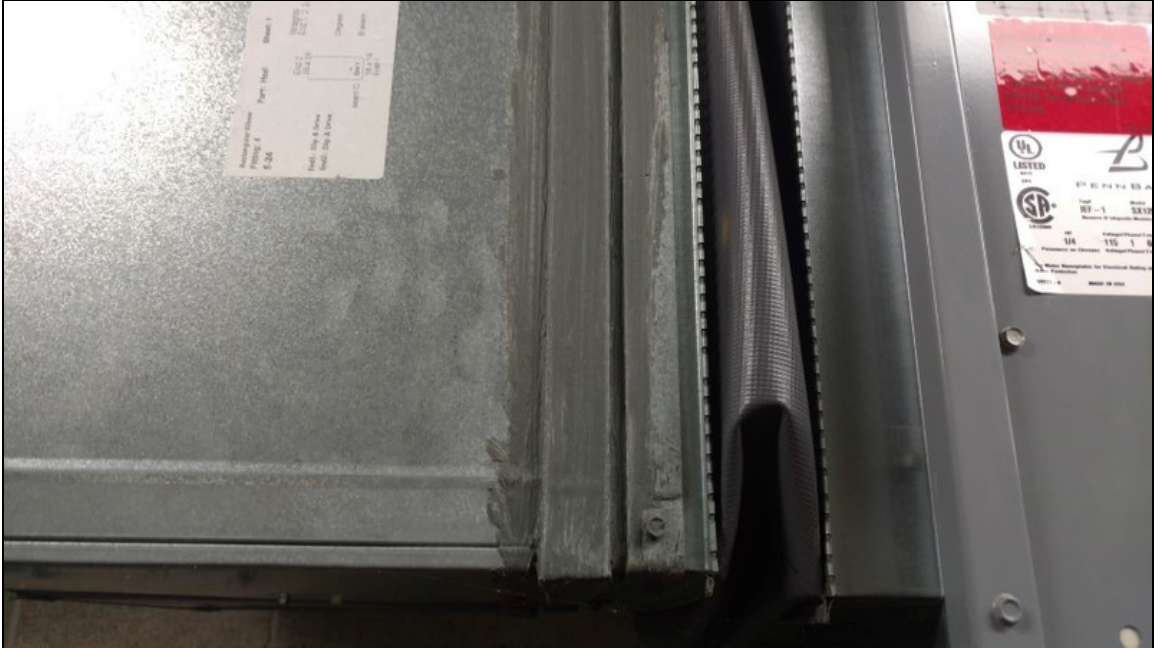
7 - View of typical grey HVAC duct mastic, homogeneous group 7

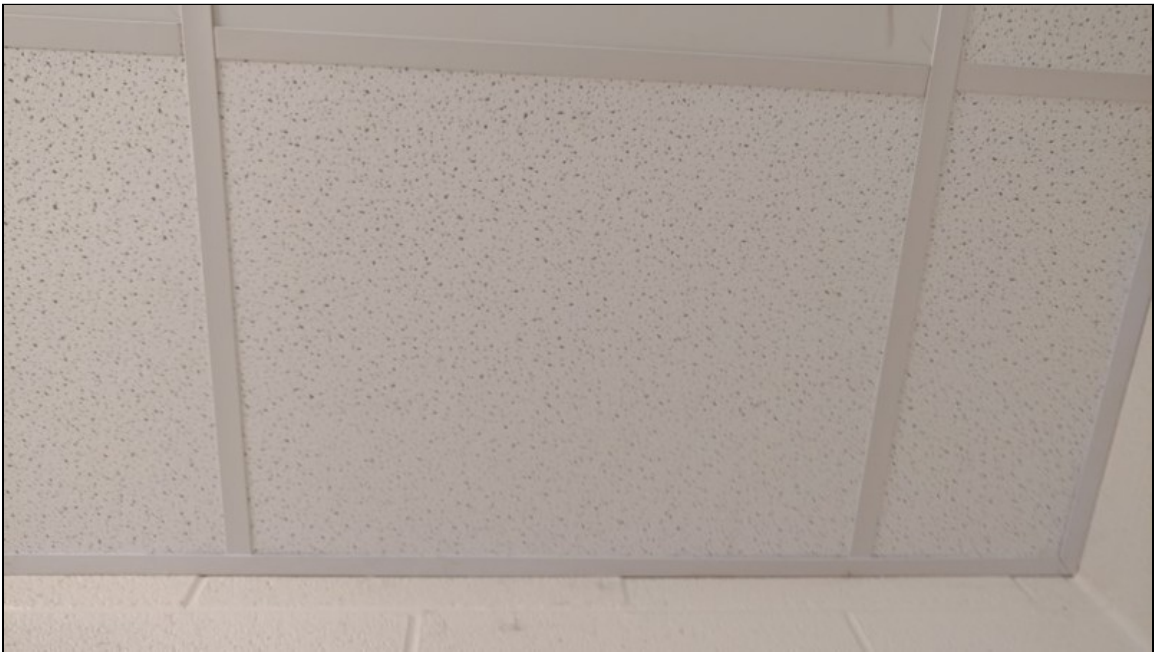
8 - View of typical pinhole/divot ceiling tile, homogeneous group 8

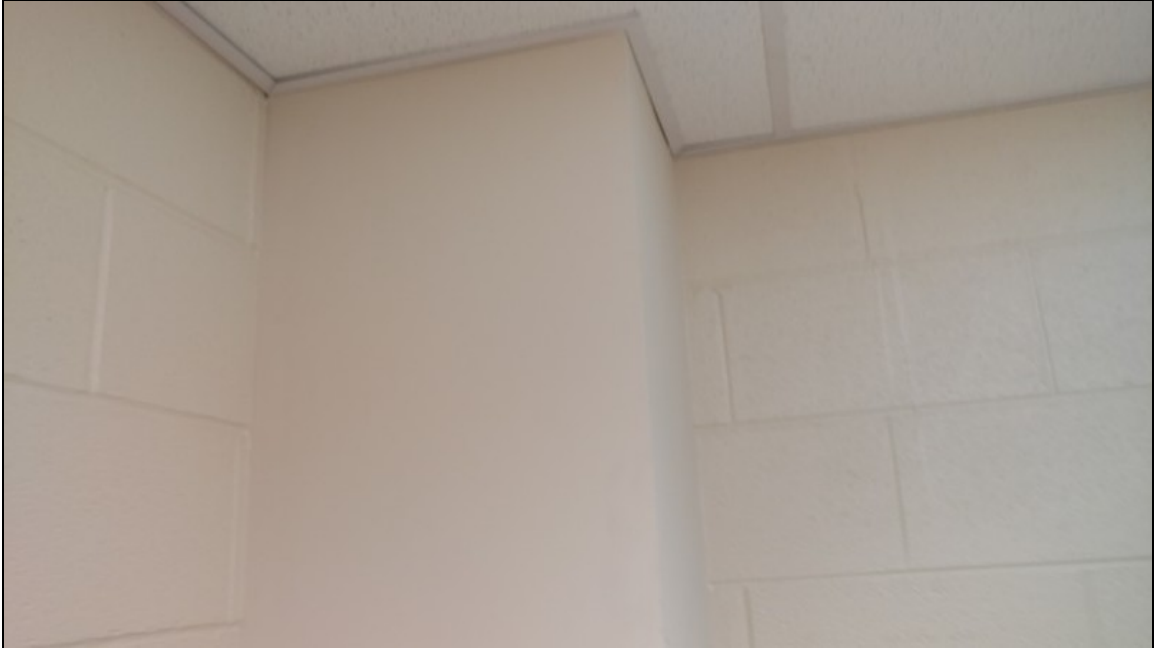
9 - View of typical drywall and joint compound wall, homogeneous group 9

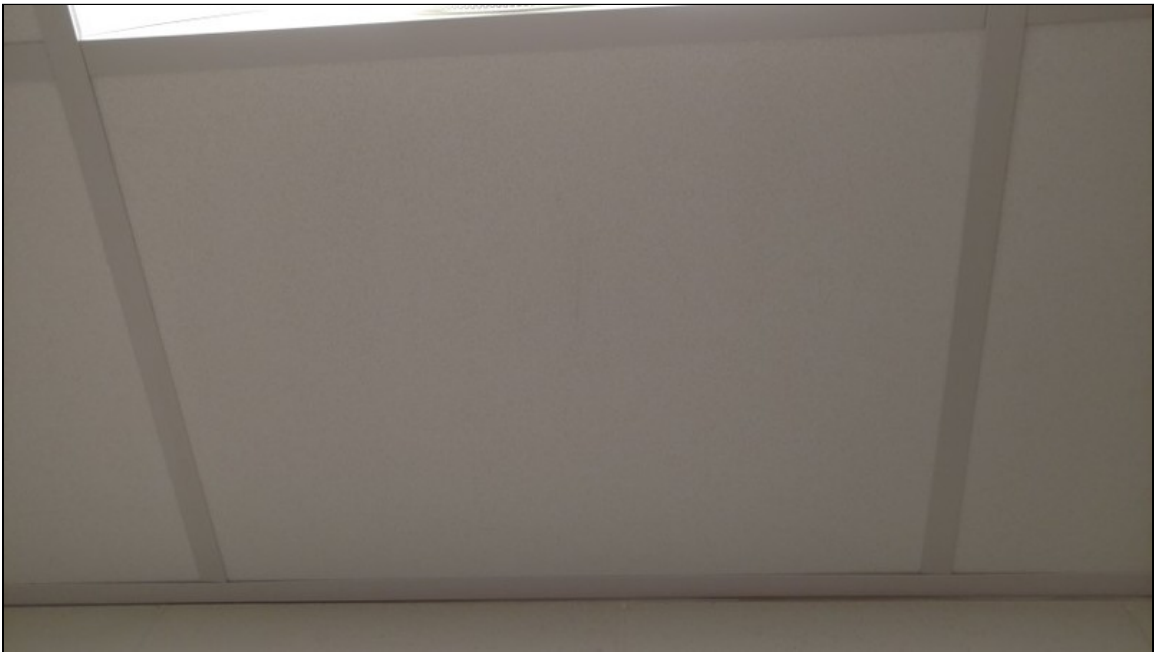
10 - View of typical smooth ceiling tile, homogeneous group 10

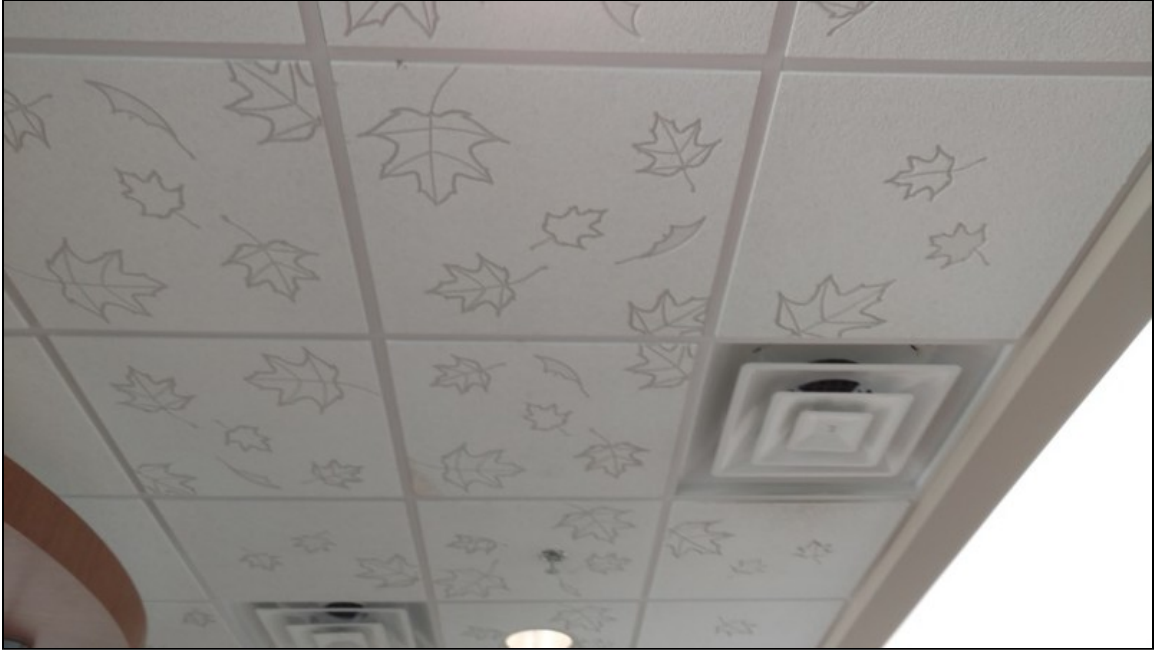
11 - View of typical leaf pattern ceiling tile, homogeneous group 11

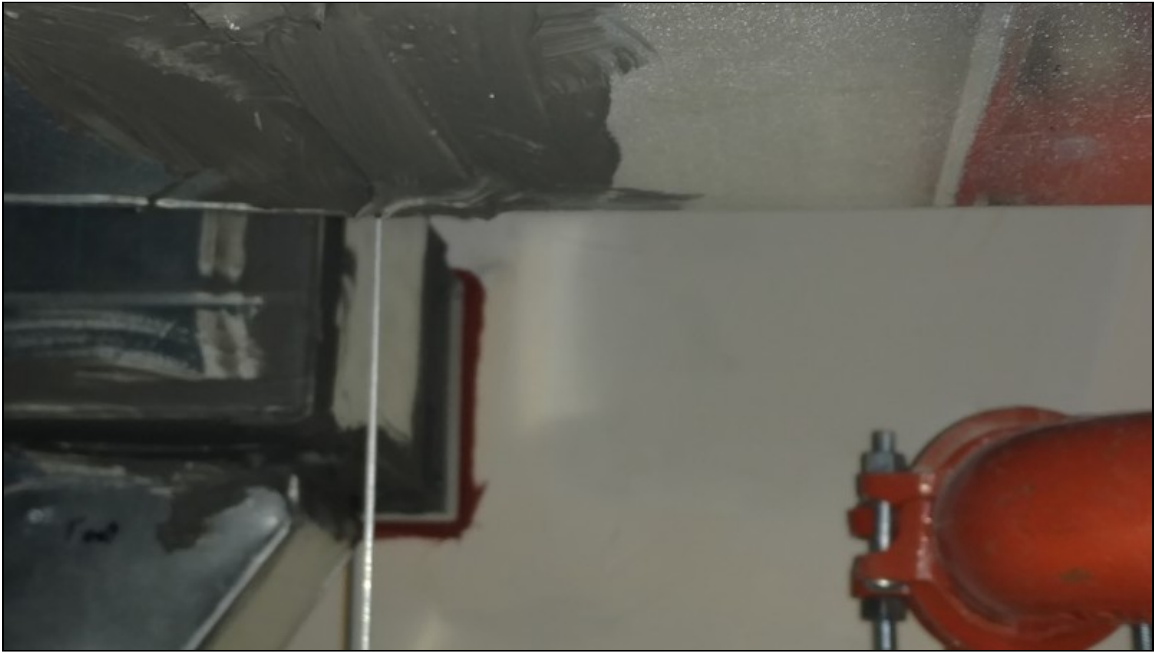
12 - Typical view of red fire stop caulk, homogeneous group 13

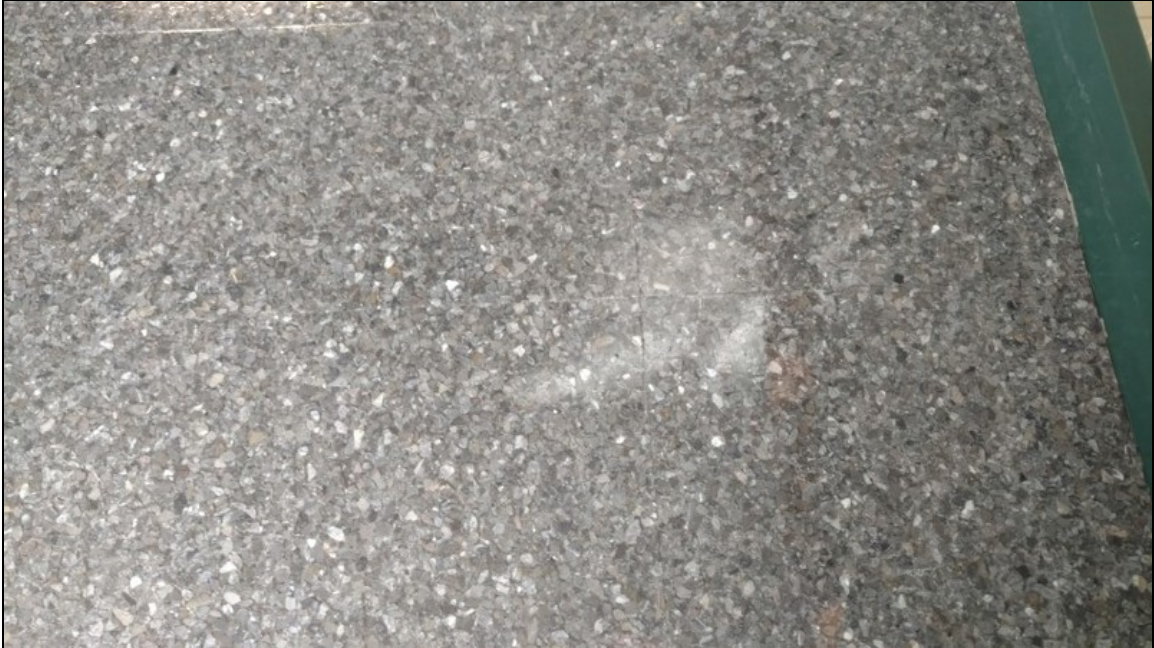
13 - View of typical grey aggregate 12"x12" floor tile, homogeneous group 13

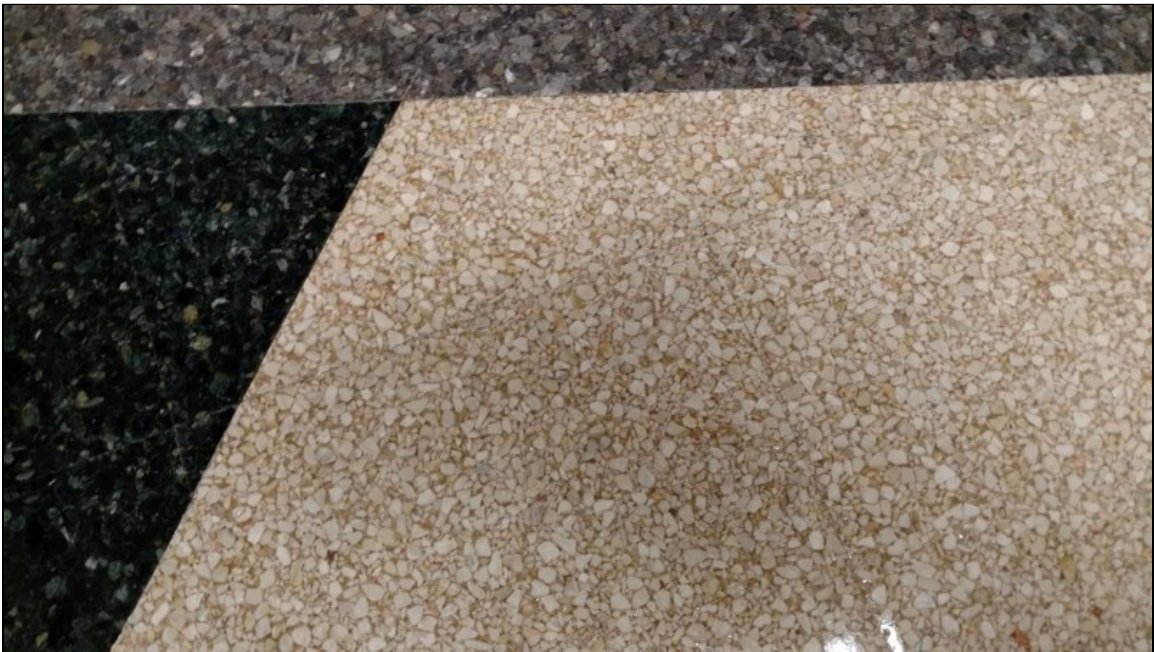
14 - View of typical tan pebble style floor tile, homogeneous group 14

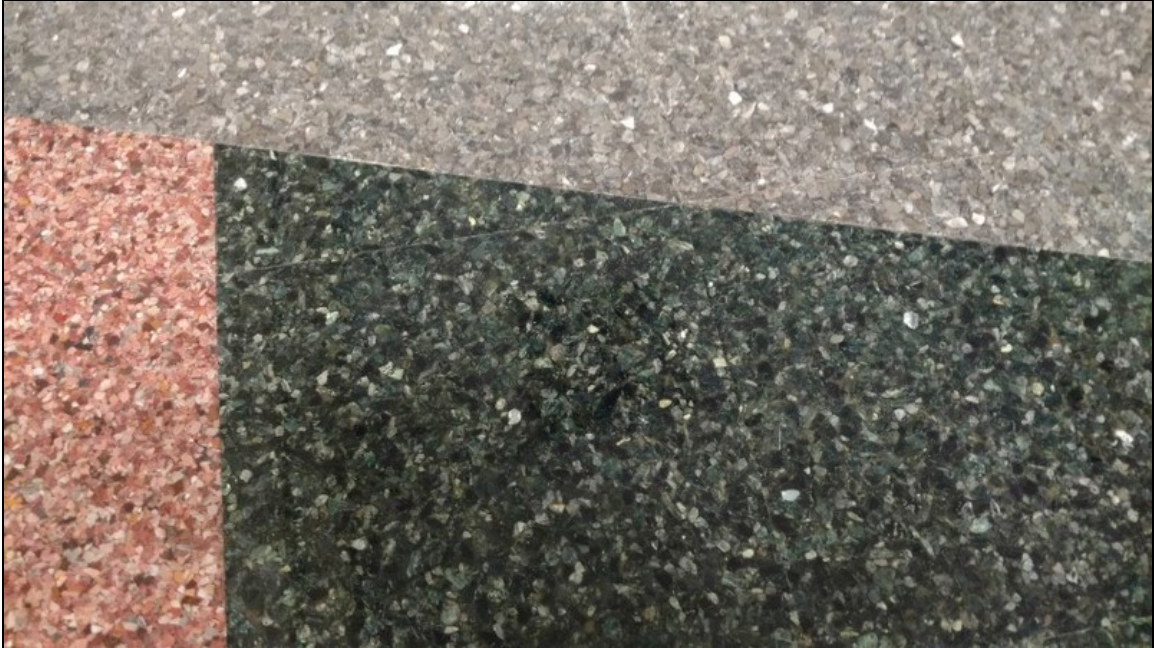
15 - View of typical green aggregate 12"x12" floor tile, homogeneous group 15

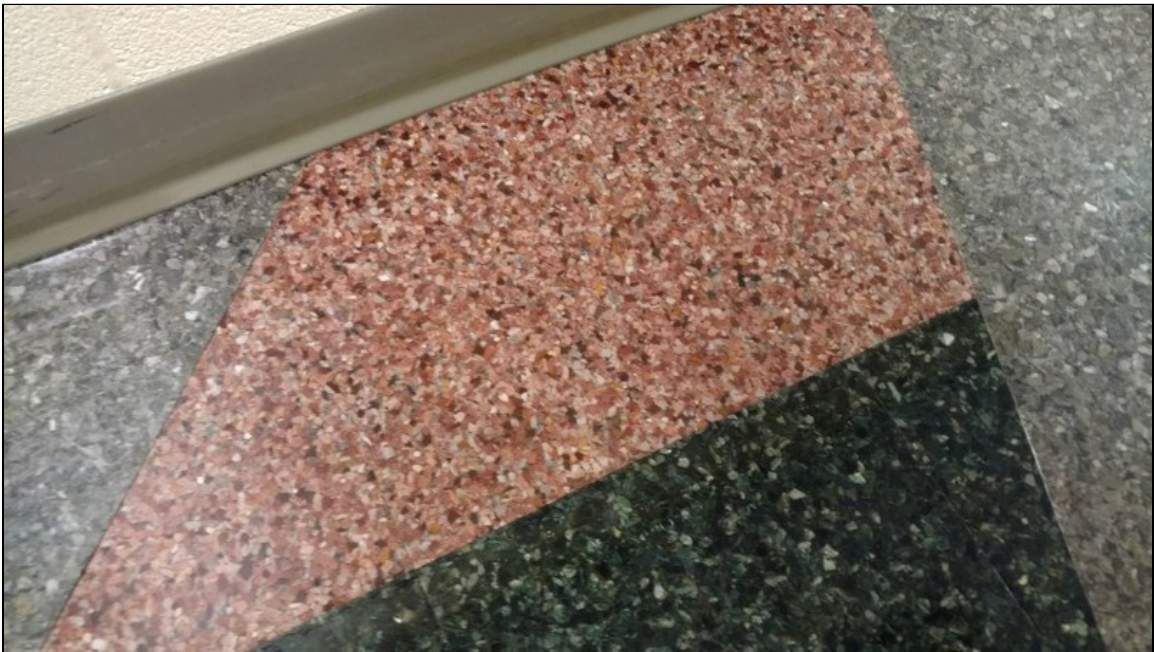
16 - View of typical red aggregate 12"x12" floor tile, homogeneous group 16

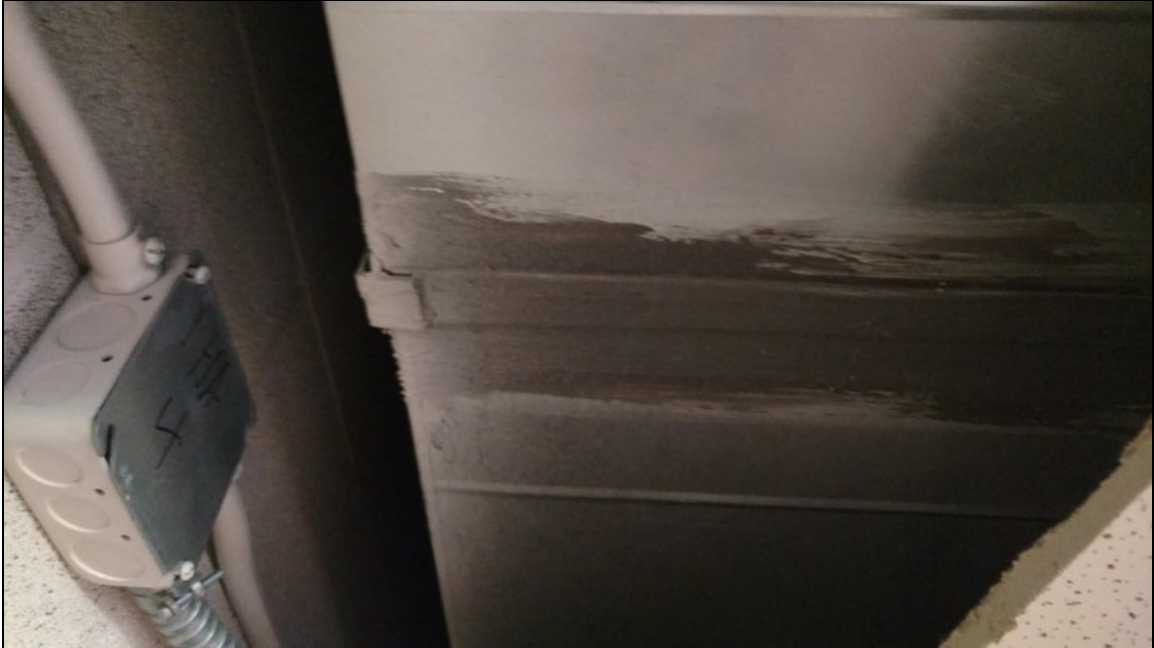
17 - View of typical grey HVAC duct mastic inside the school, homogeneous group 17

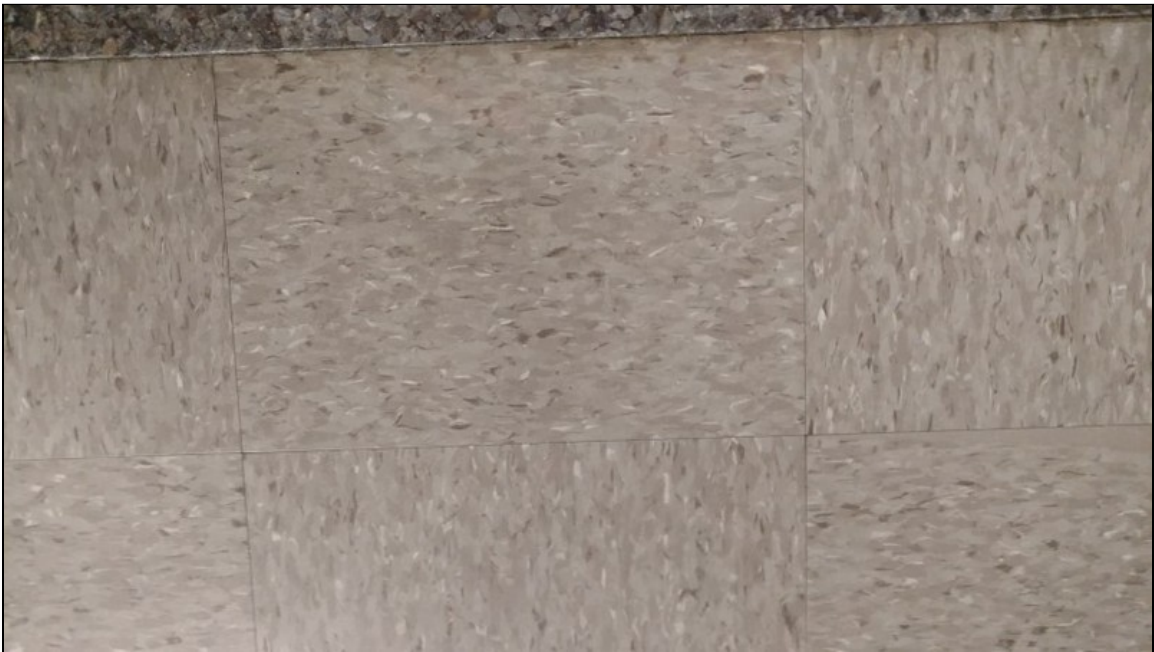
18 - View of typical grey mottled 12"x12" floor tile, homogeneous group 18

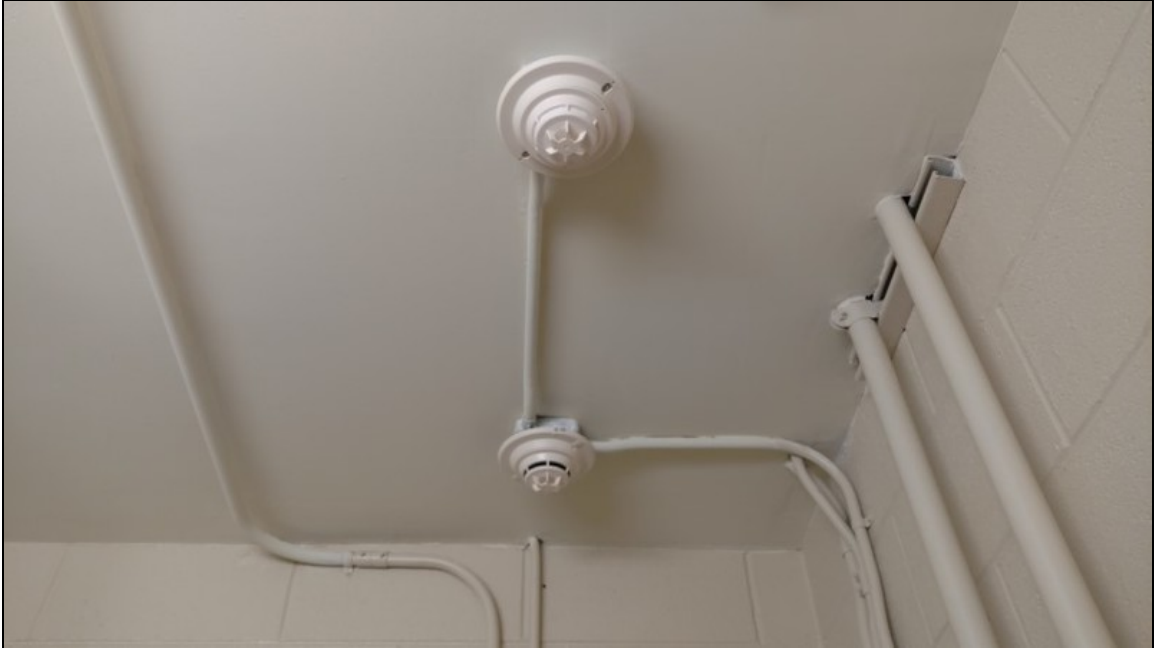
19 - View of typical drywall and joint compound ceiling, homogeneous group 19
