ATHLETIC FACILITIES CONDITION ASSESSMENT

Roanoke County Public Schools
Roanoke, Virginia

July 30, 2018

Draper Aden Associates
Engineering • Surveying • Environmental Services

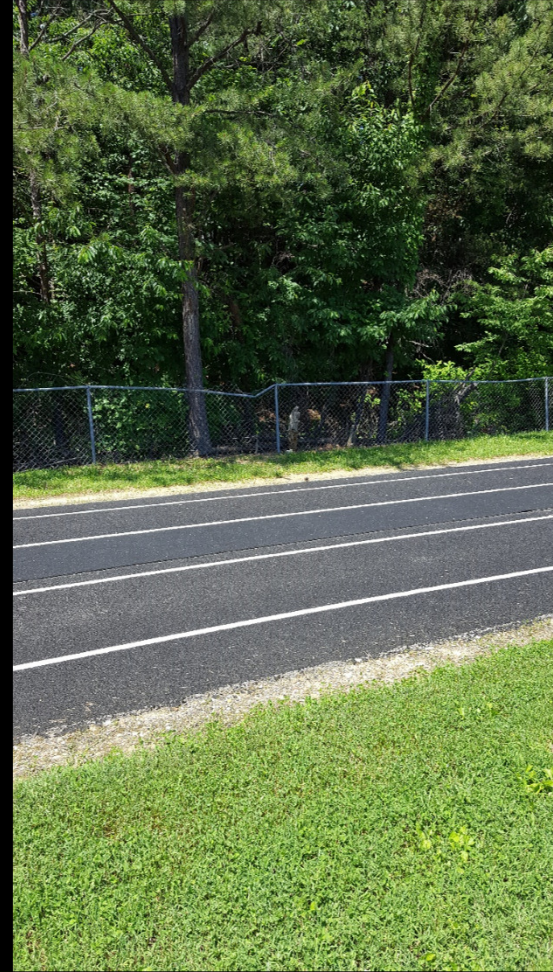
04. Damaged Perimeter Fence

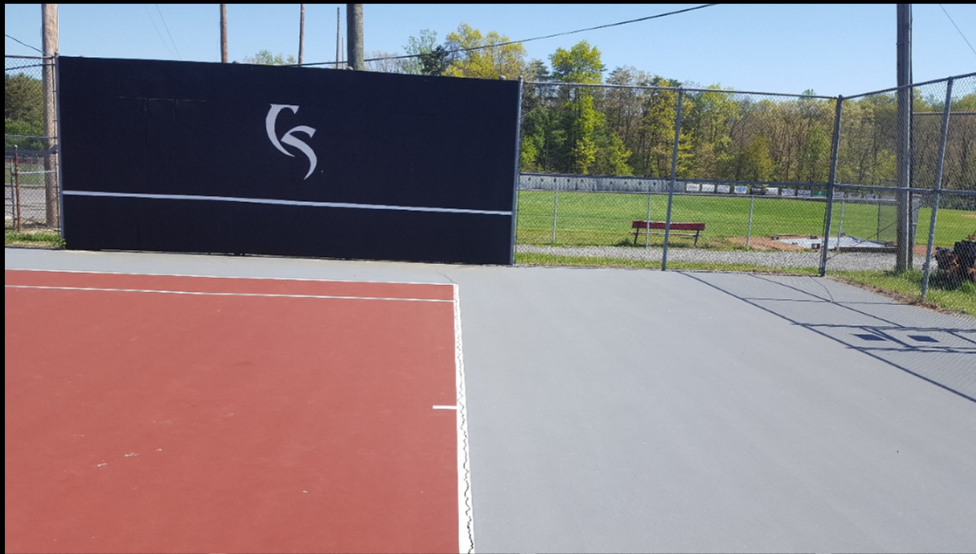
01. Surface Cracks

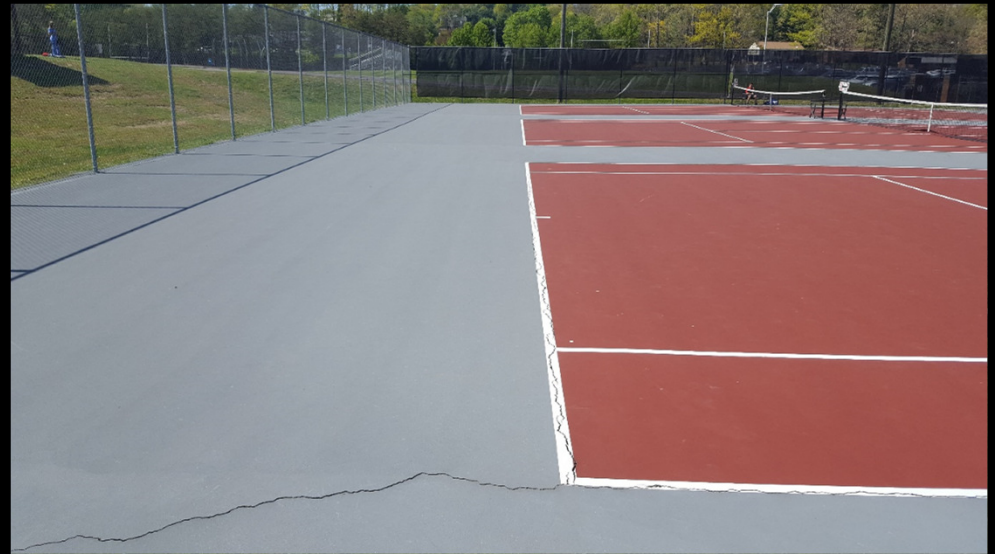
02. Surface Cracks

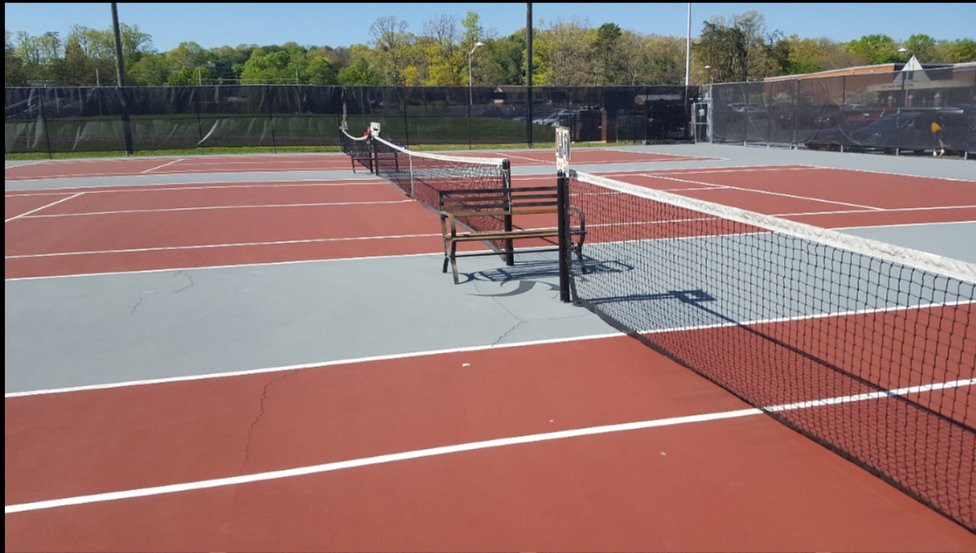
03. Net Post

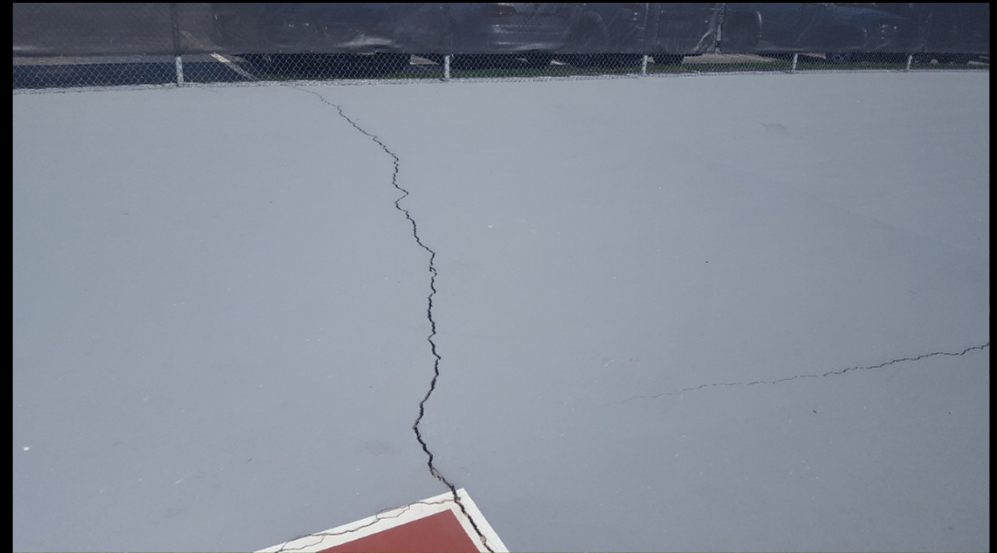
04. Surface Cracks

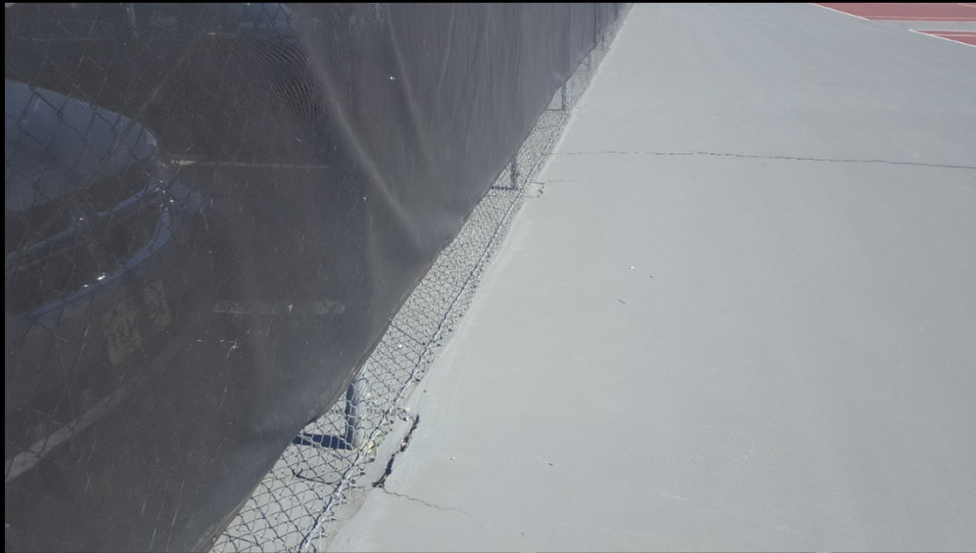
05. Perimeter Fence Foundation

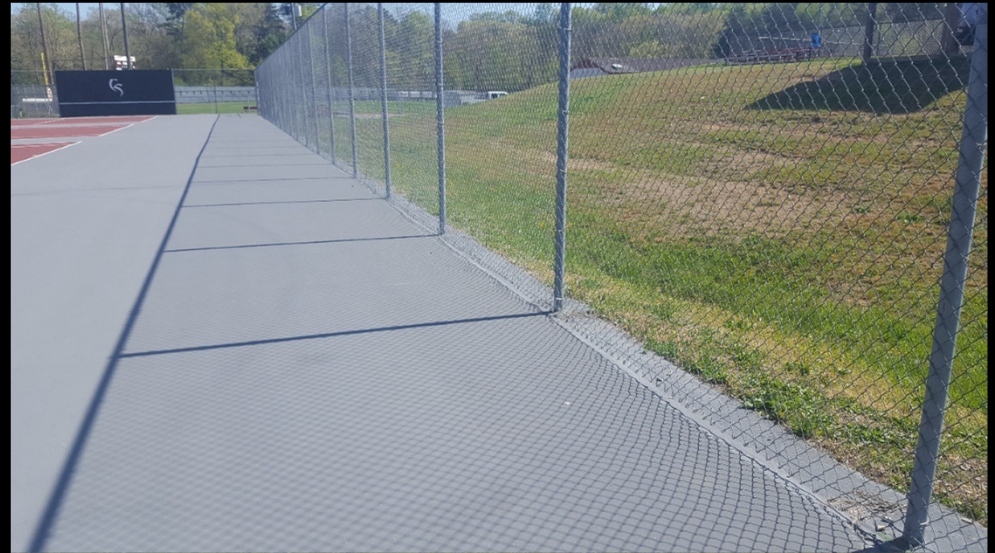
06. Perimeter Fence no Bottom or Mid Rail

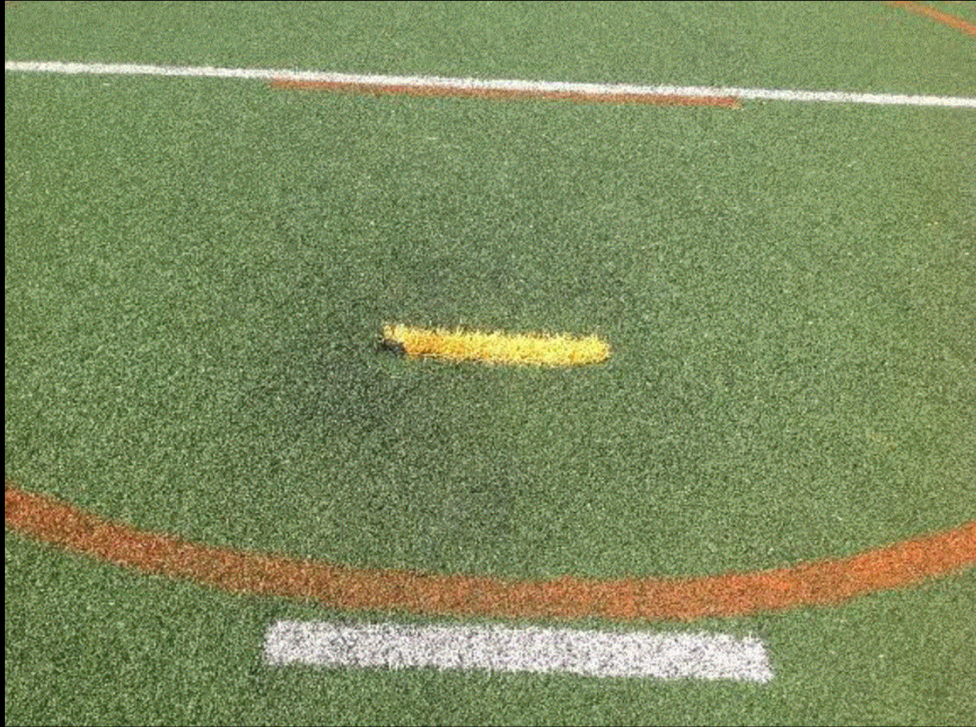
03. Penalty Kick Inlay Coming Loose

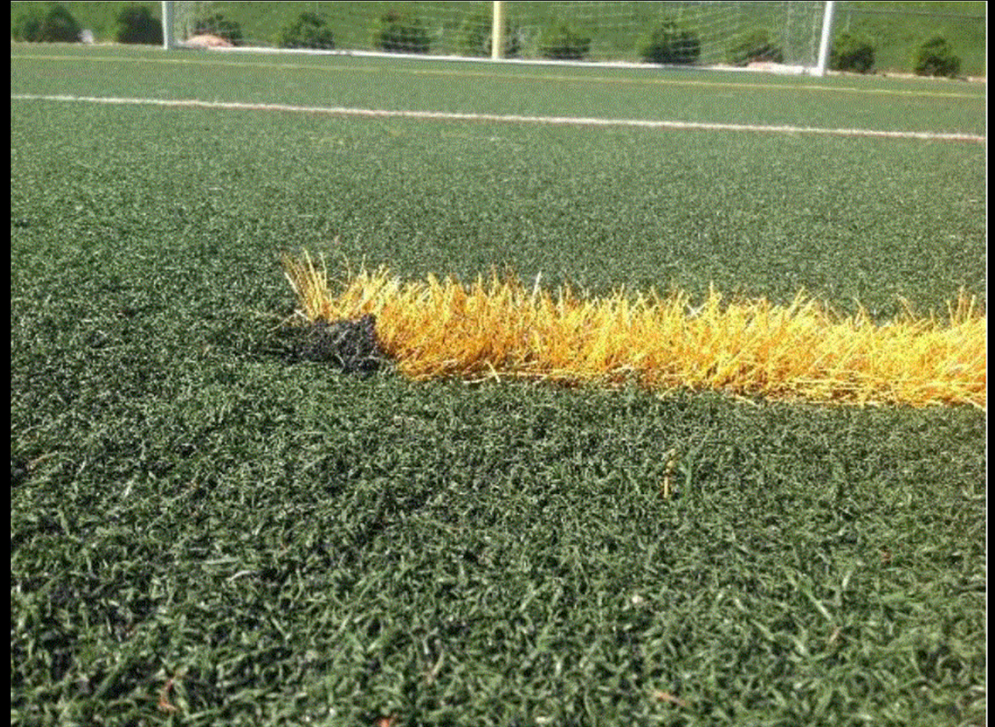
04. Penalty Kick Inlay Coming Loose

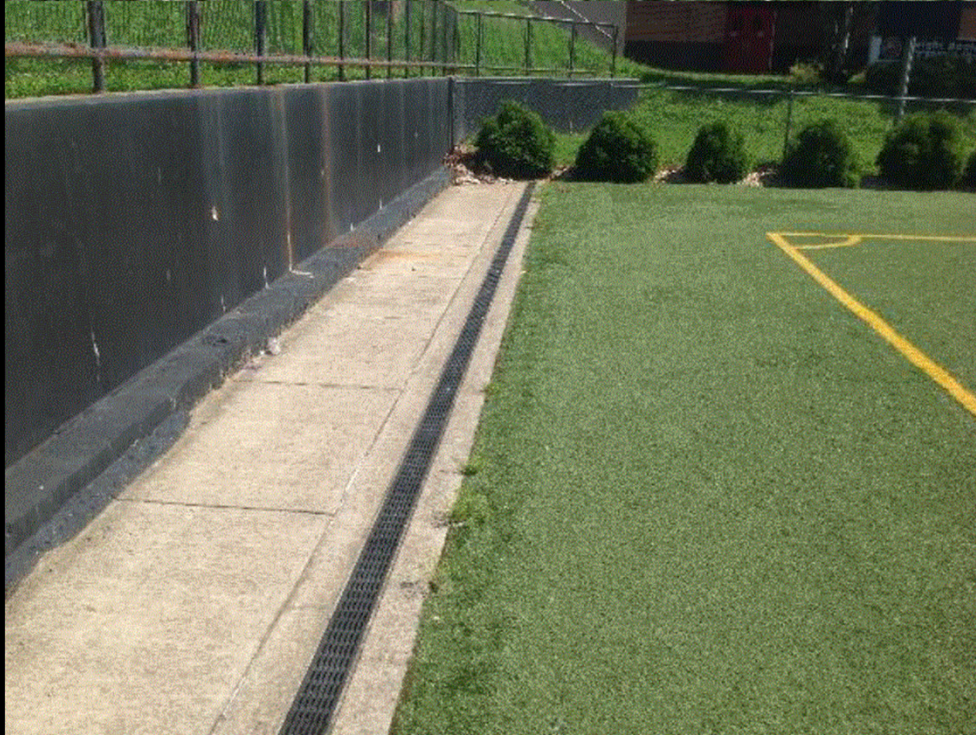
05. Weeds Growing Along the Edge

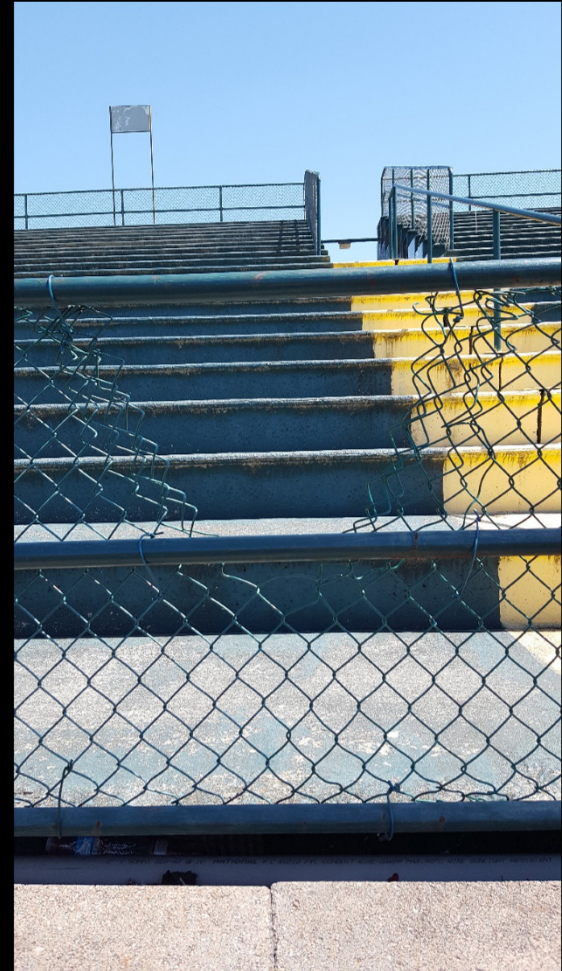
02. Bleacher Fence Needing Repair

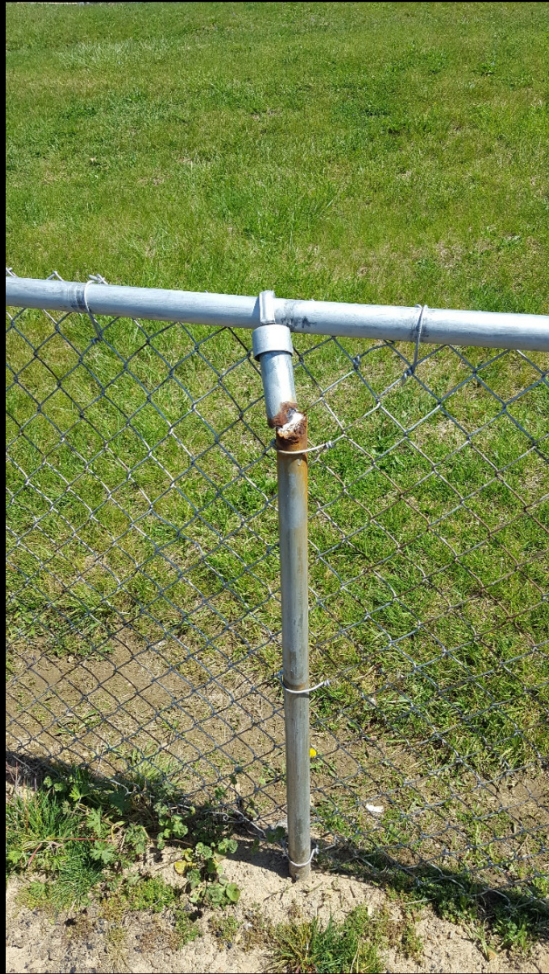
03. Perimeter Fence Needing Repair

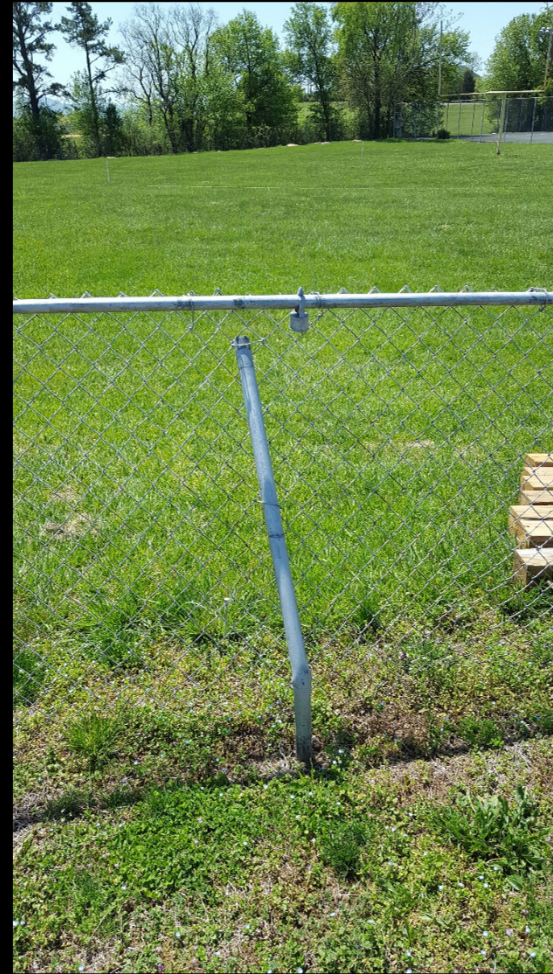
04. Perimeter Fence Needing Repair

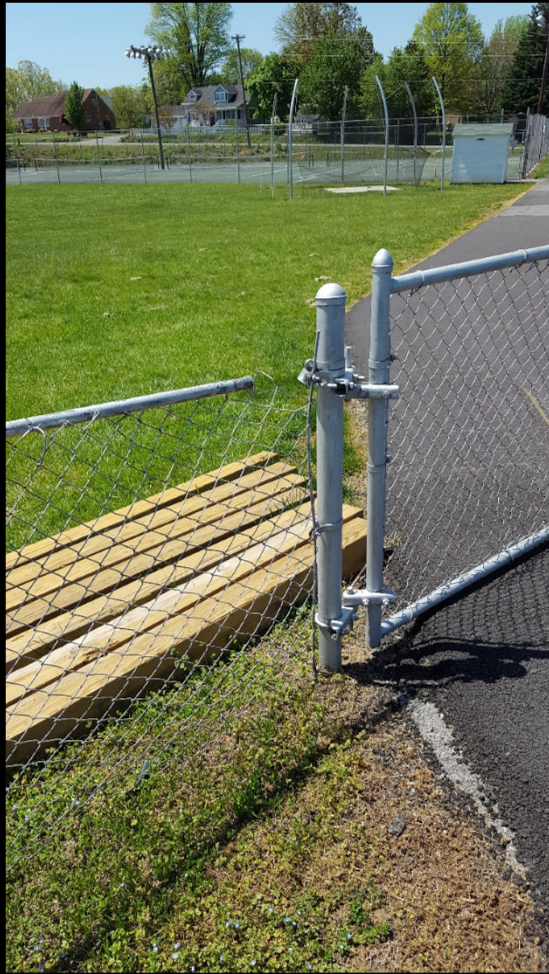
05. Perimeter Fence Needing Repair

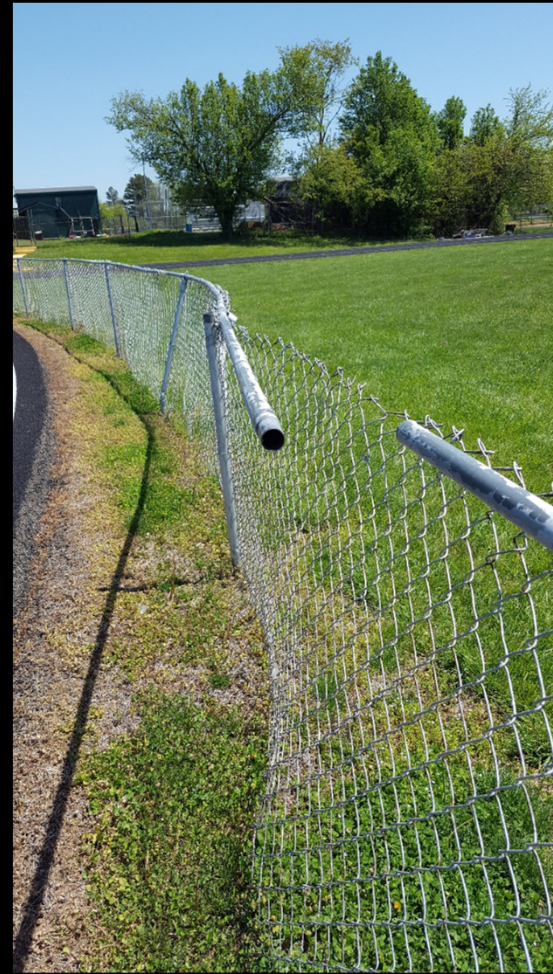
06. Perimeter Fence Needing Repair

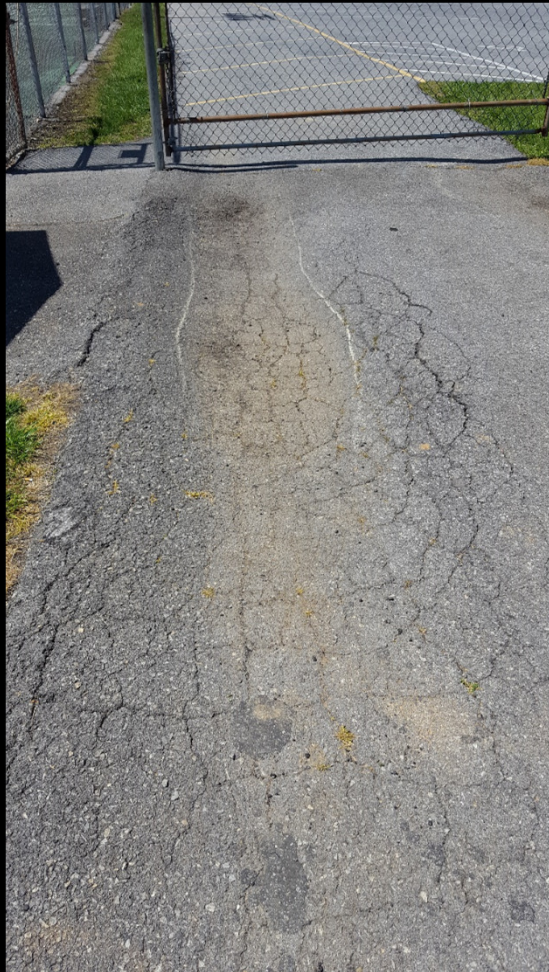
07. Asphalt Walk from Tennis Court Parking Lot

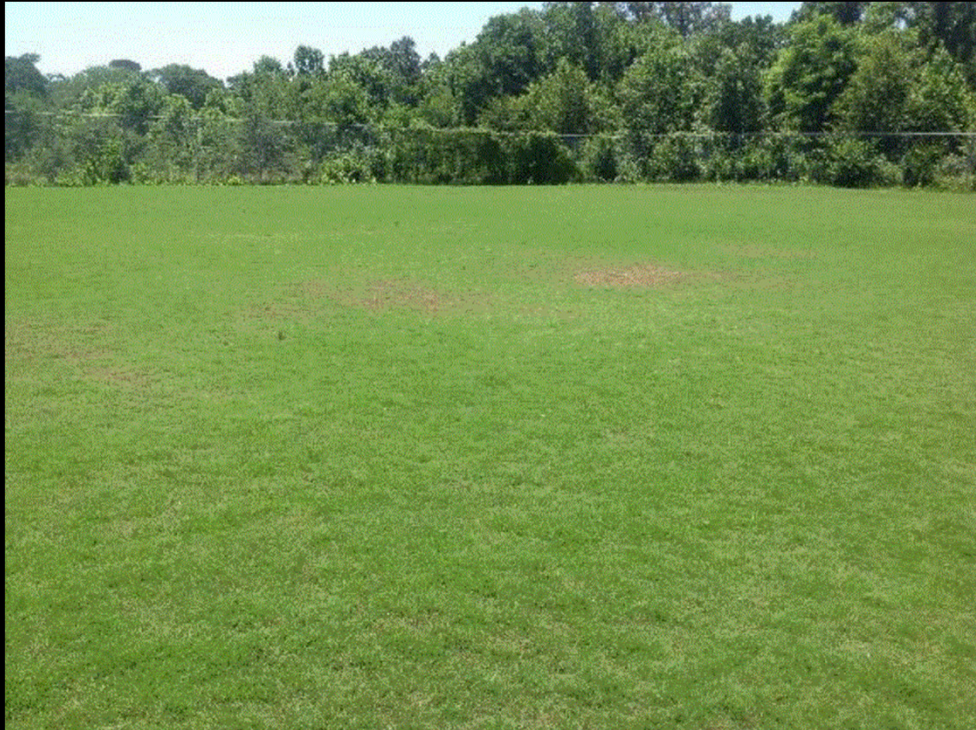
03. Fence Needing Repairs

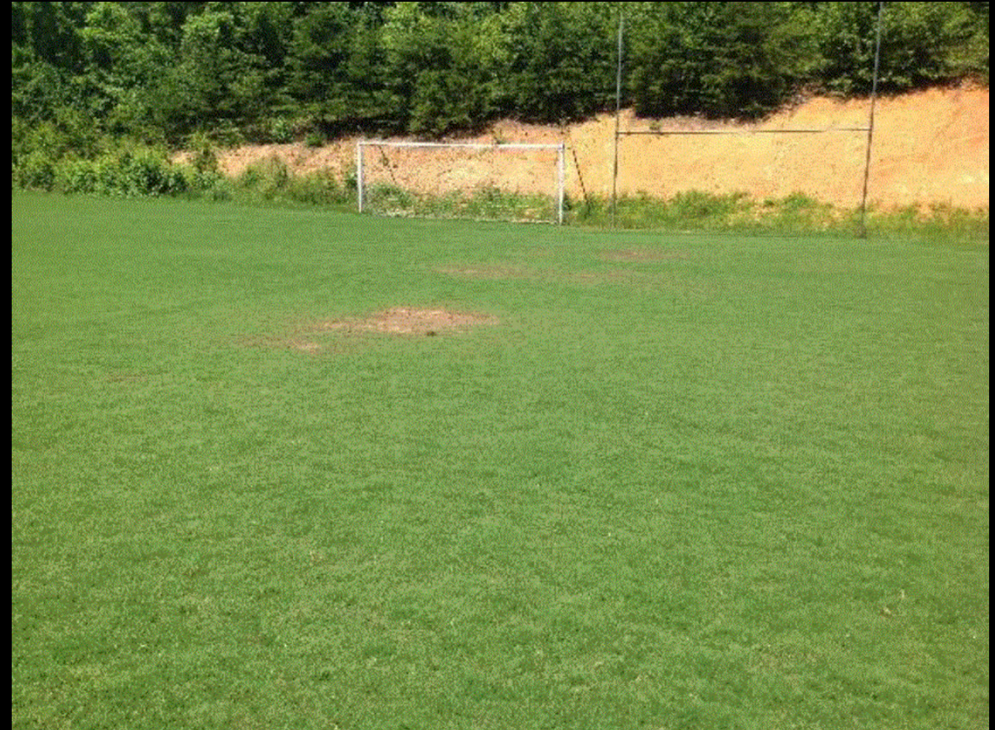
04. No End Netting

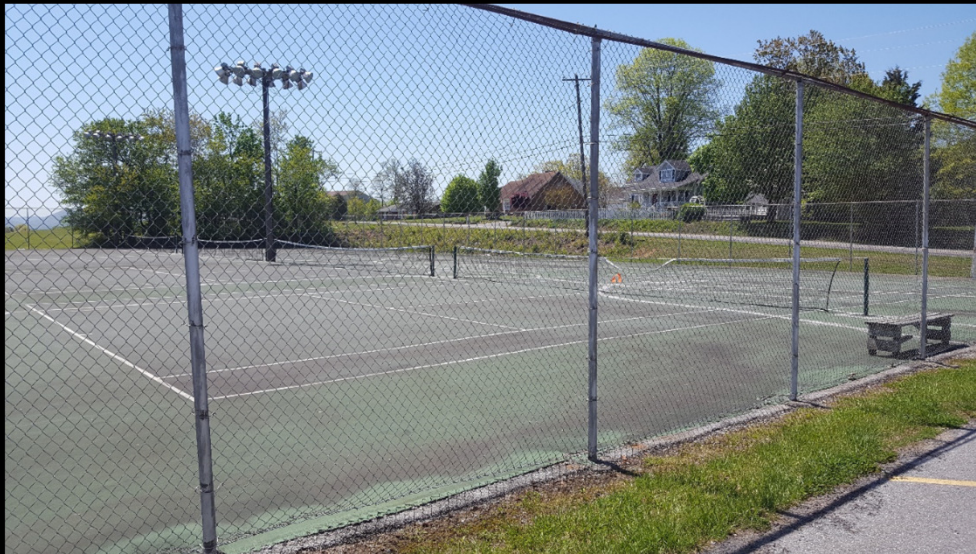
01. Perimeter Fence Condition

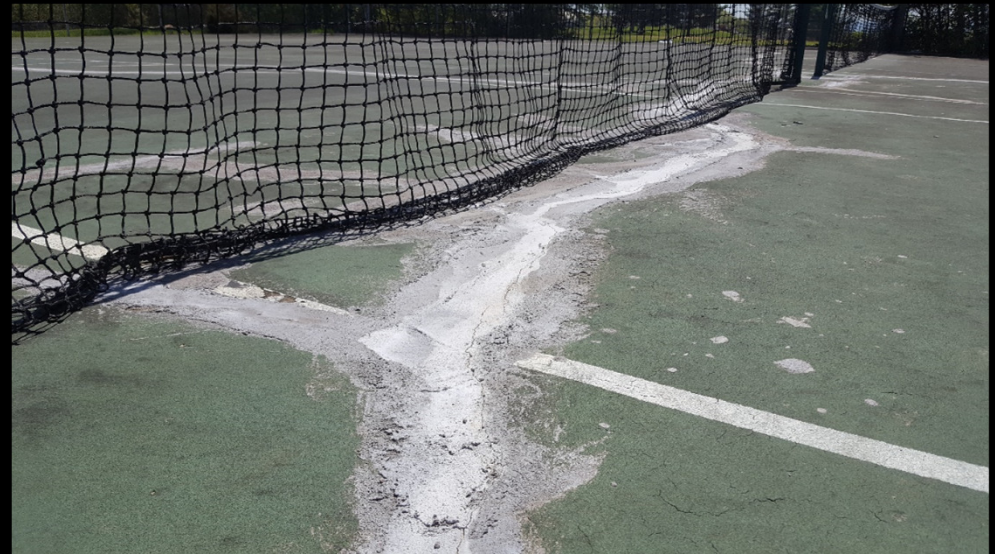
02. Cracks

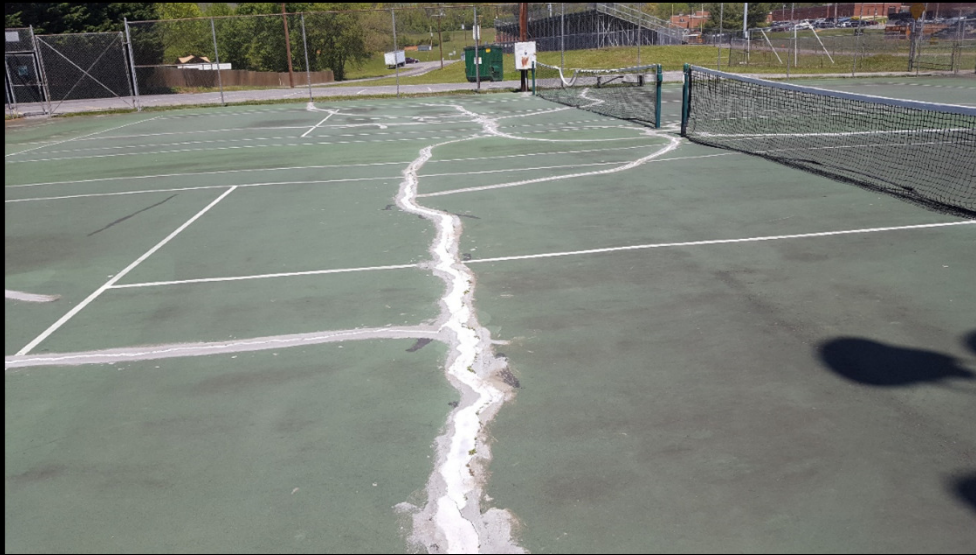
03. Cracks and Nets

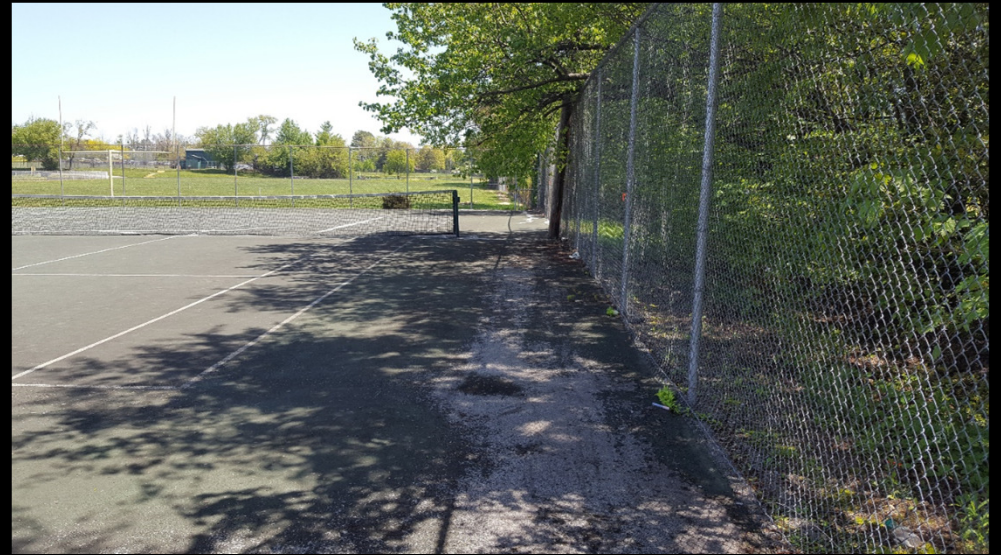
04. Surface and Tree Overhang

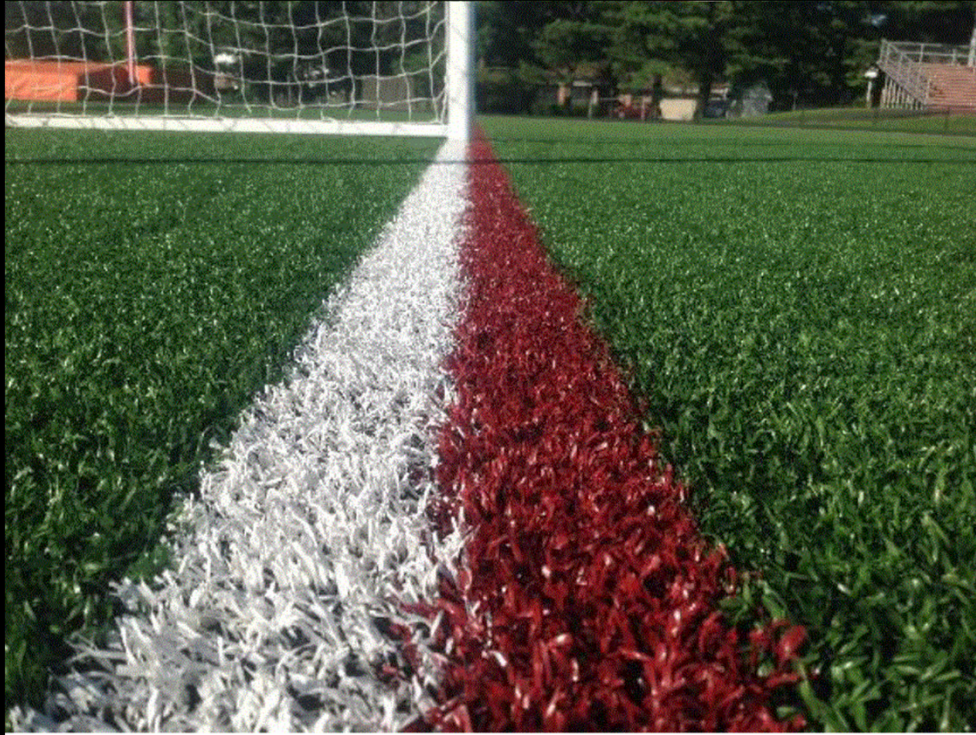
01. Fibers Standing Up in Good Condition

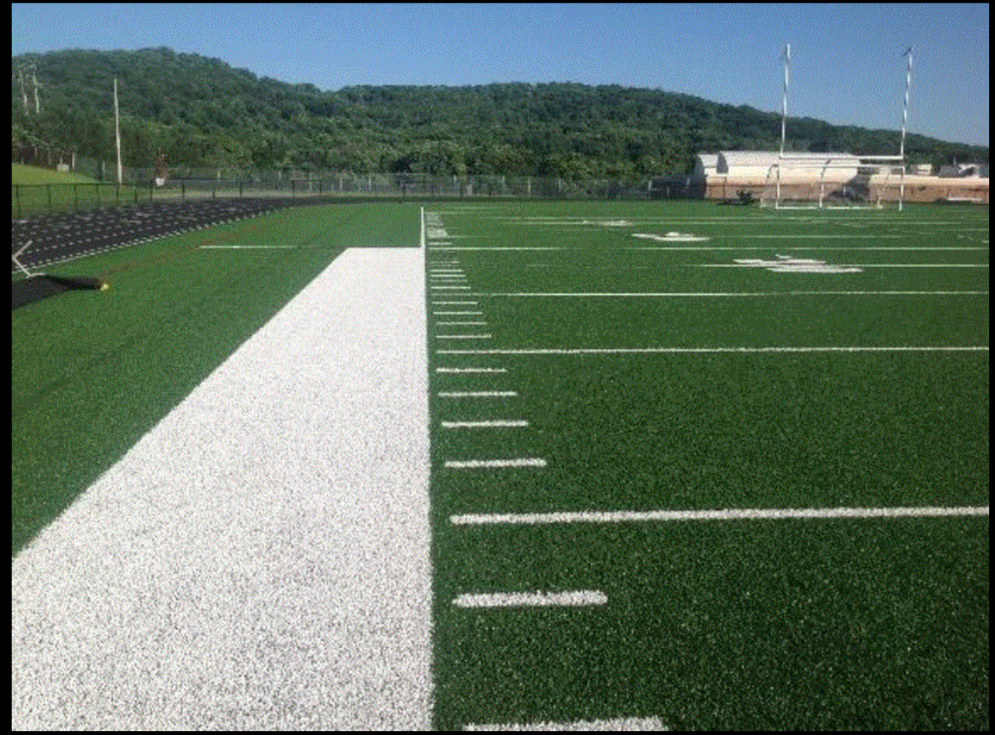
02. Striping Looks Good

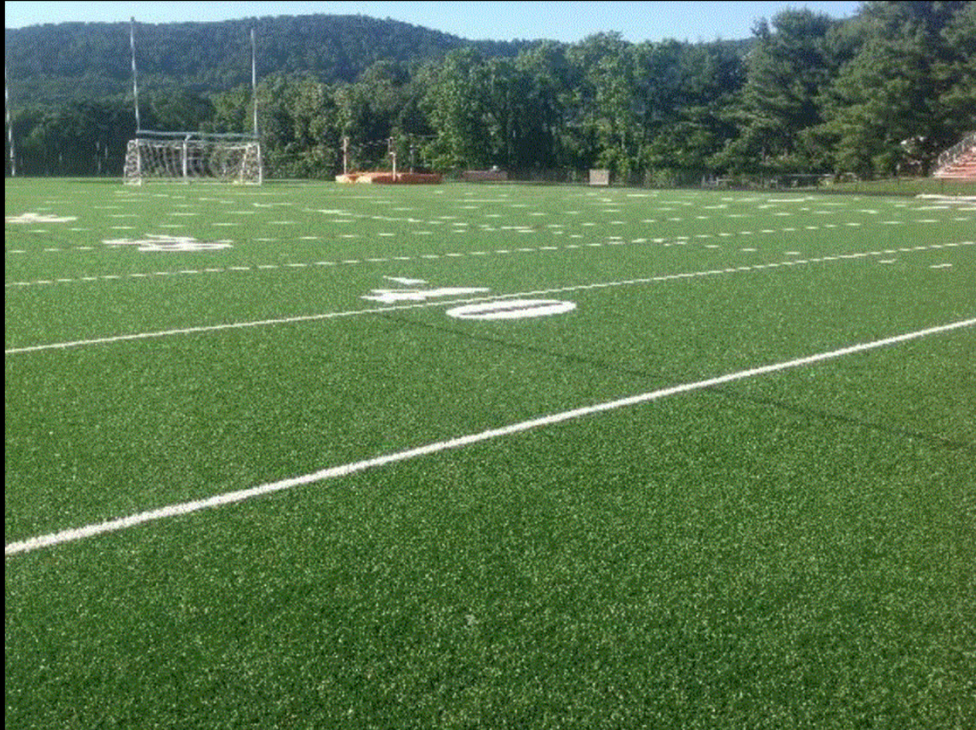
03. Numbering in Good Condition

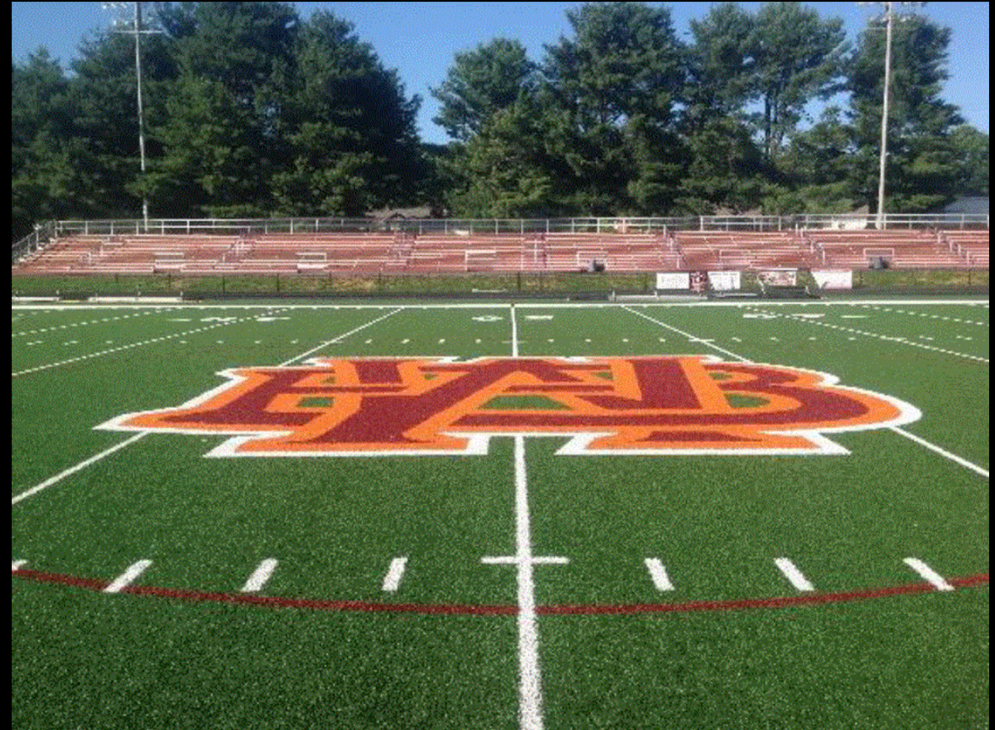
04. Logo in Good Condition

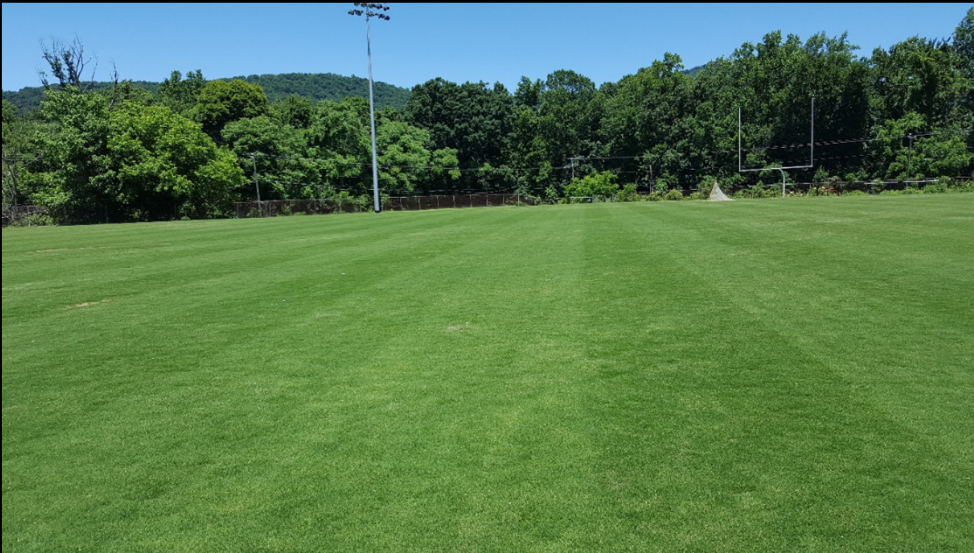
01. Grass in Good Condition

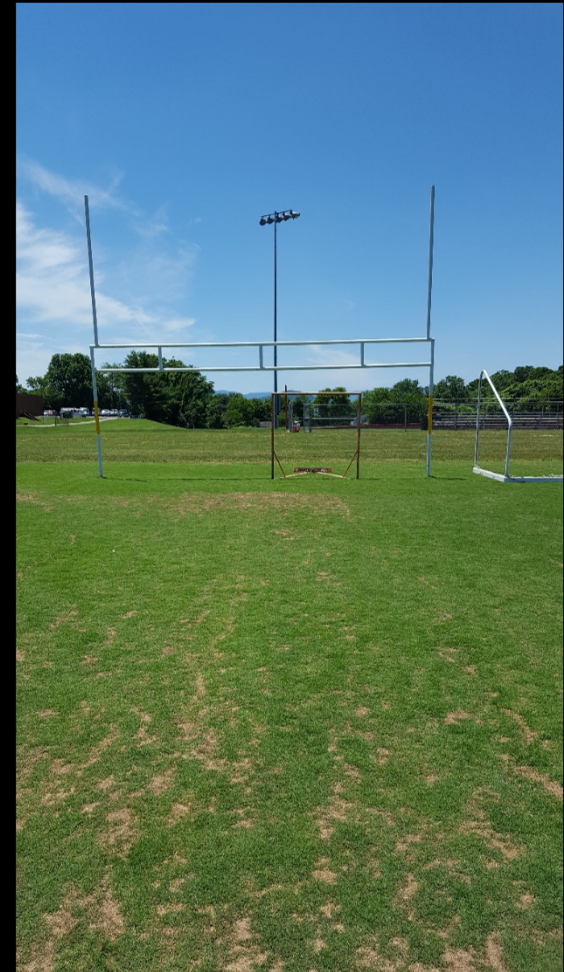
02. Upgrade Football Goal Posts

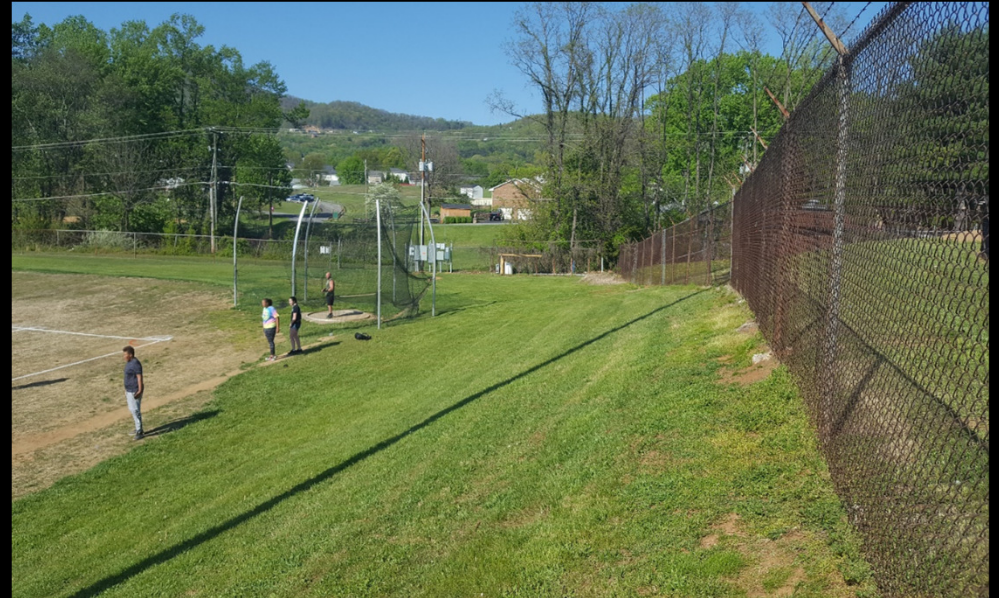
04. Discus Cage Netting Needs Repair

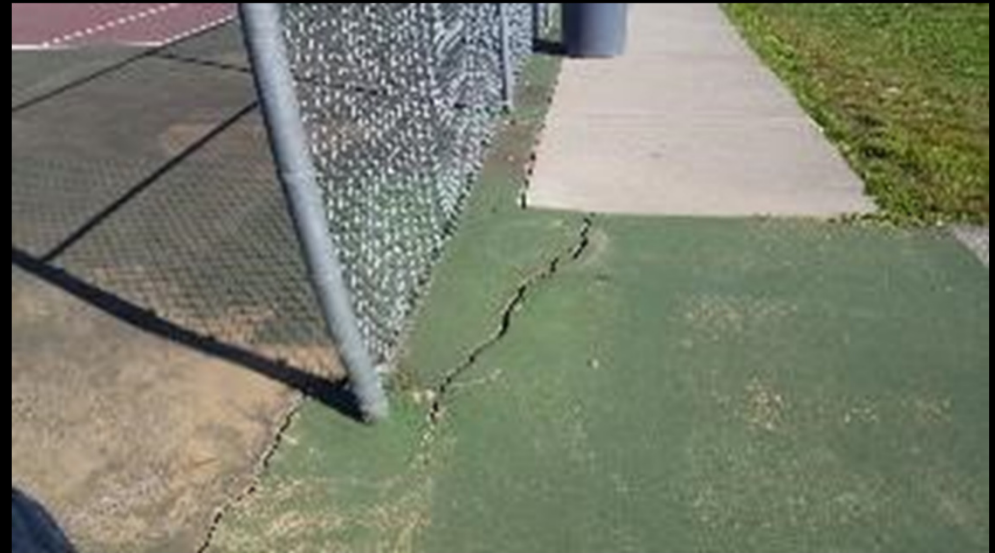
02. Crack at Northwest Corner Entrance

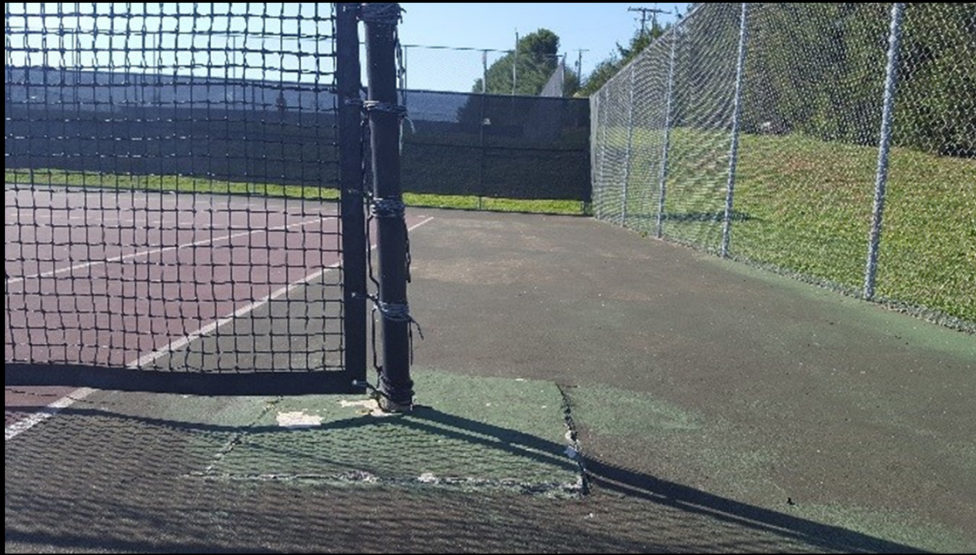
03. Net Post Foundation Heaving

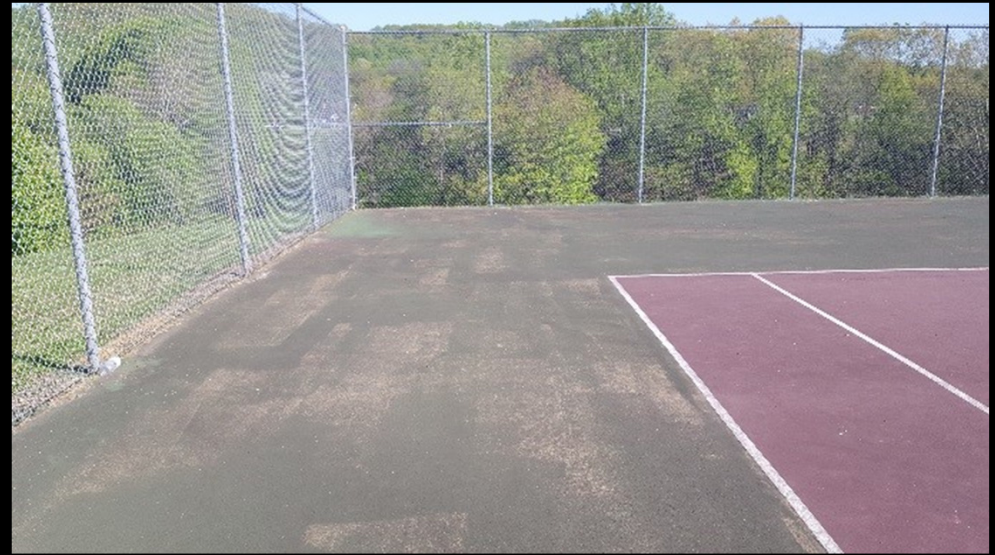
04. Areas of Delamination and Streaking

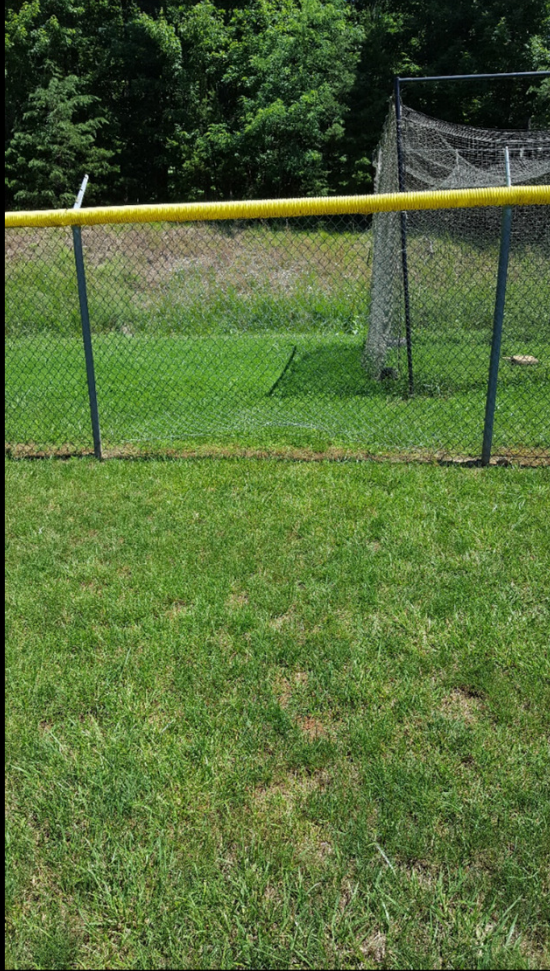
01. Outfield Fence Needing Repair

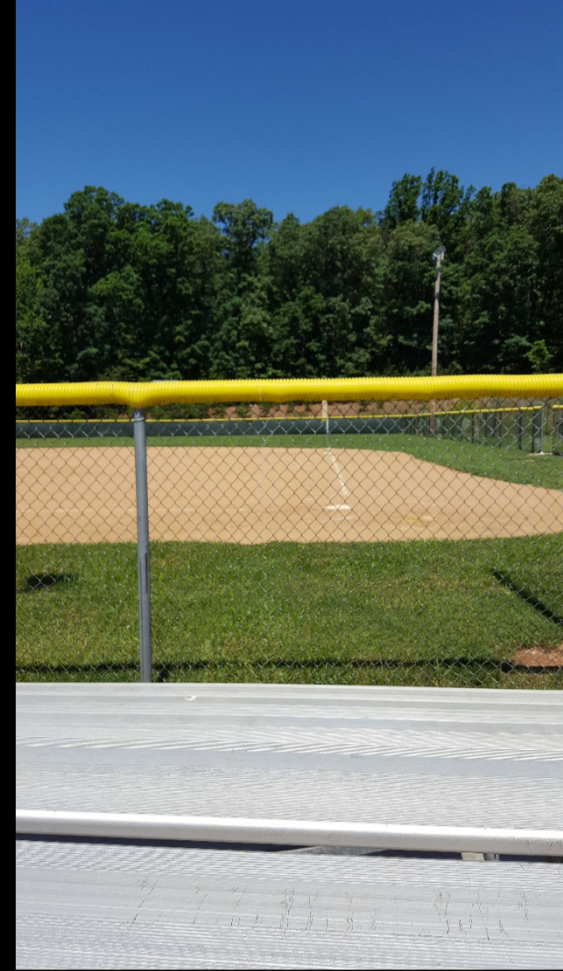
02. Install Taller Fence in Front of Bleachers

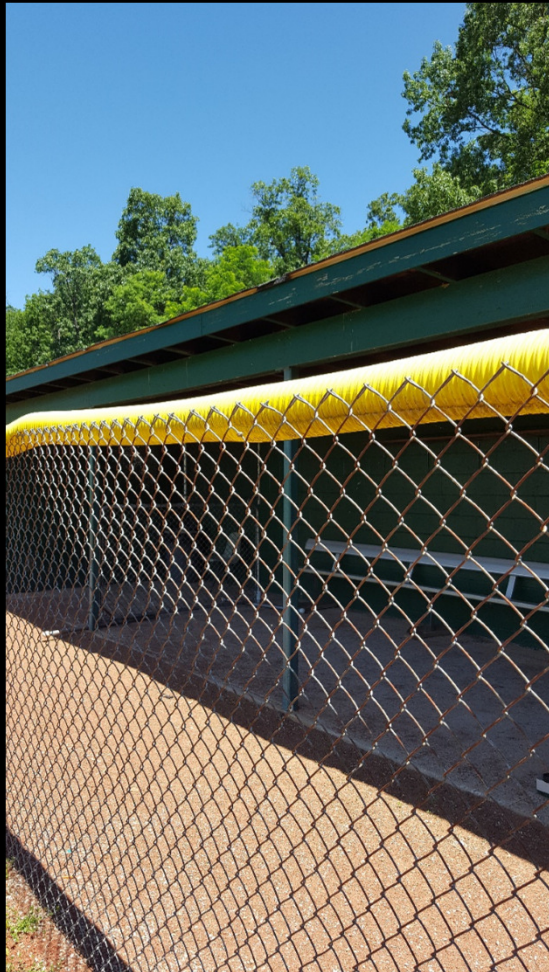
01. Fence Repair in Front of Dugout

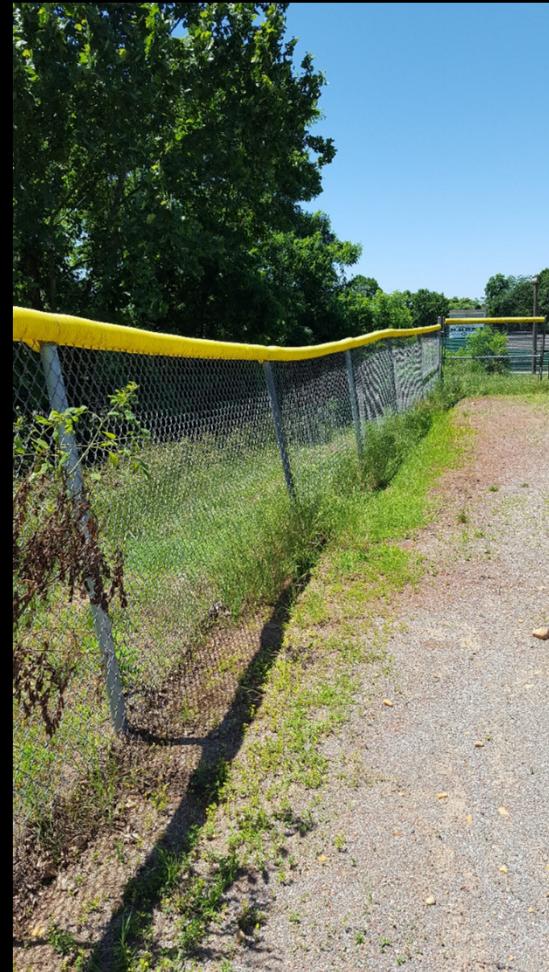
02. Fence Repair Along Left Field Line

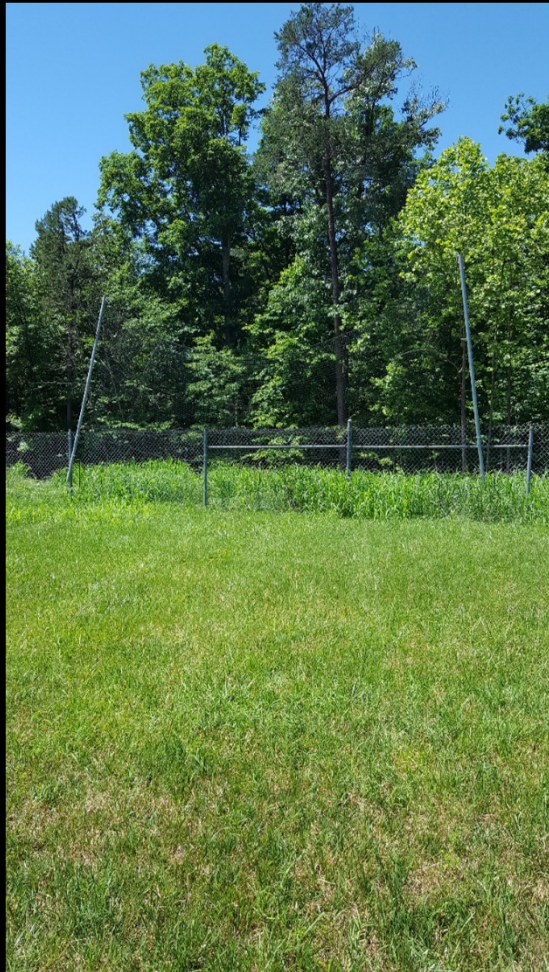
03. End Netting Needs Replaced

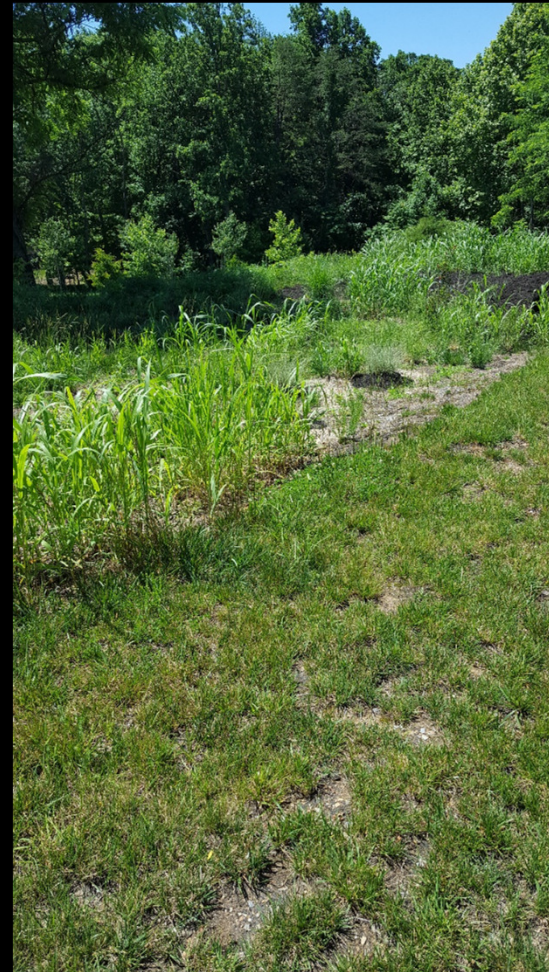
04. Weeds and Brush Along Perimeter of Field

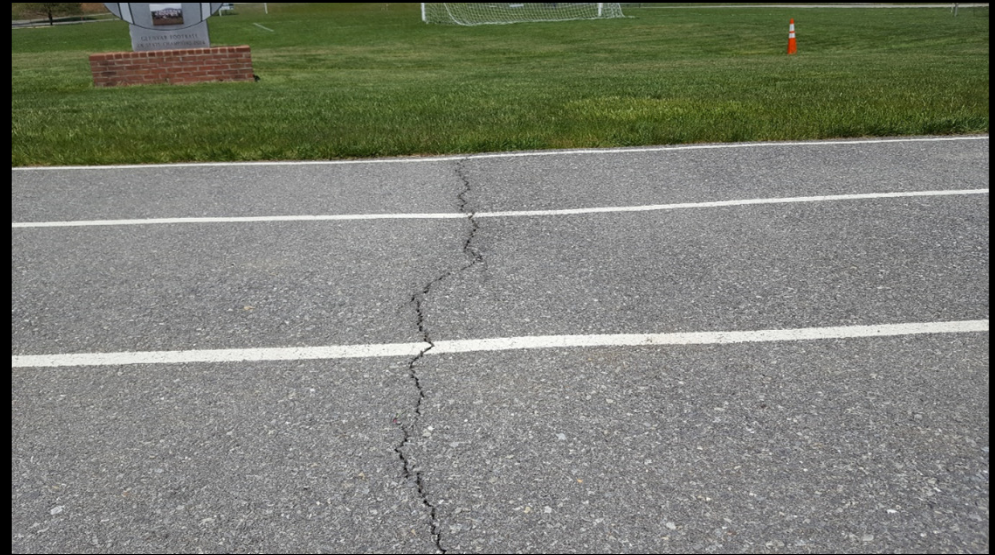
02. Crack in Asphalt
