ATHLETIC FACILITIES CONDITION ASSESSMENT

Roanoke County Public Schools
Roanoke, Virginia

July 30, 2018

Draper Aden Associates
Engineering • Surveying • Environmental Services

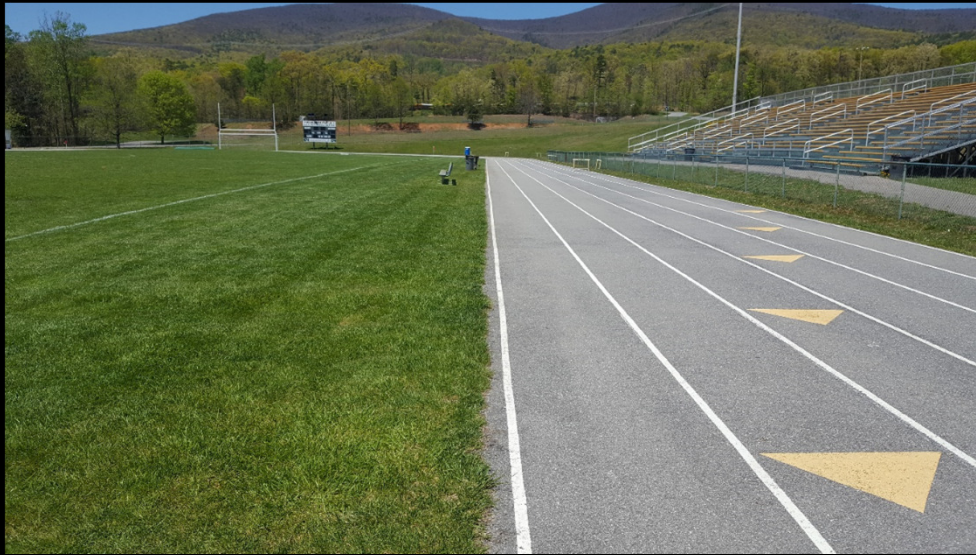
03. No Curb or Trench Drain Along Edge

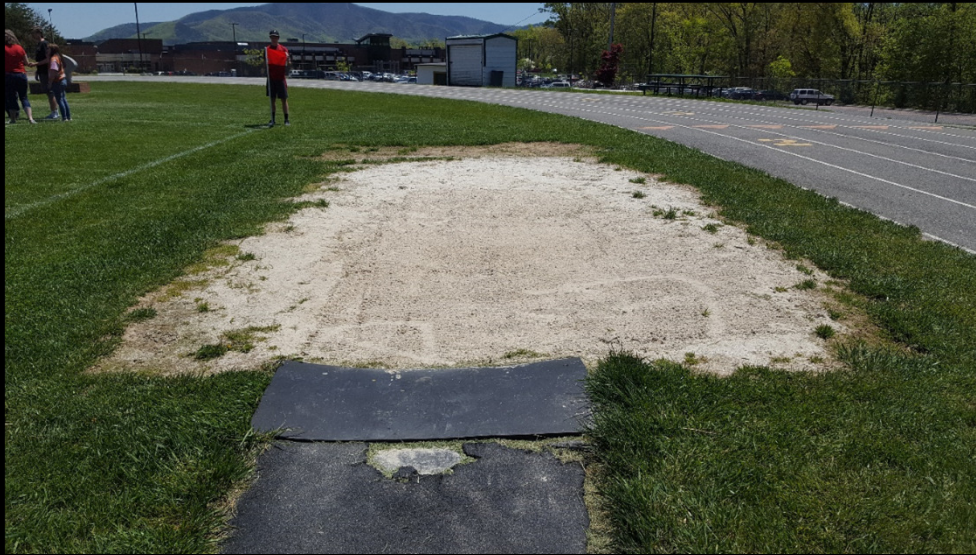
05. Long and Triple Jump in Poor Condition

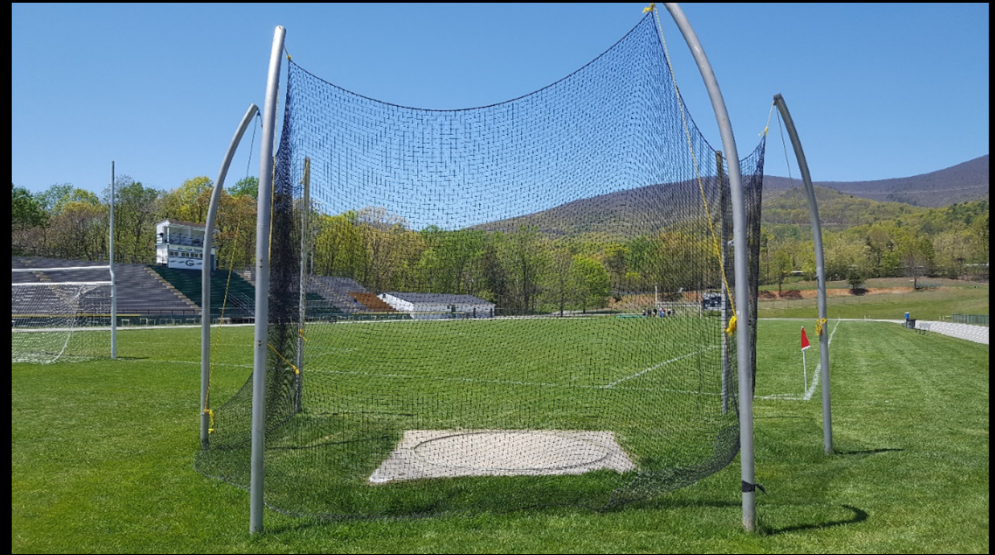
06. Discus Net in Fair Condition

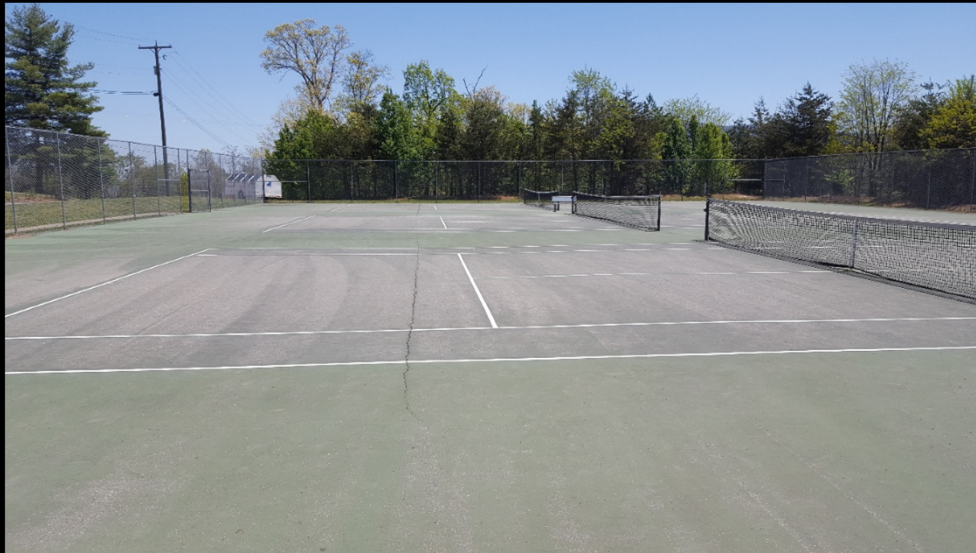
01. Surface Fading and Cracks

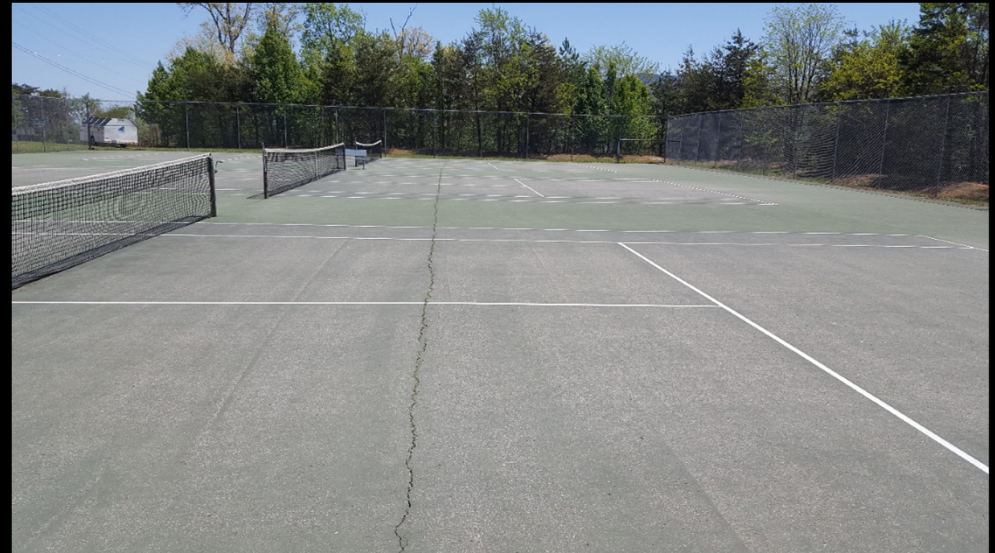
02. Surface Fading and Cracks

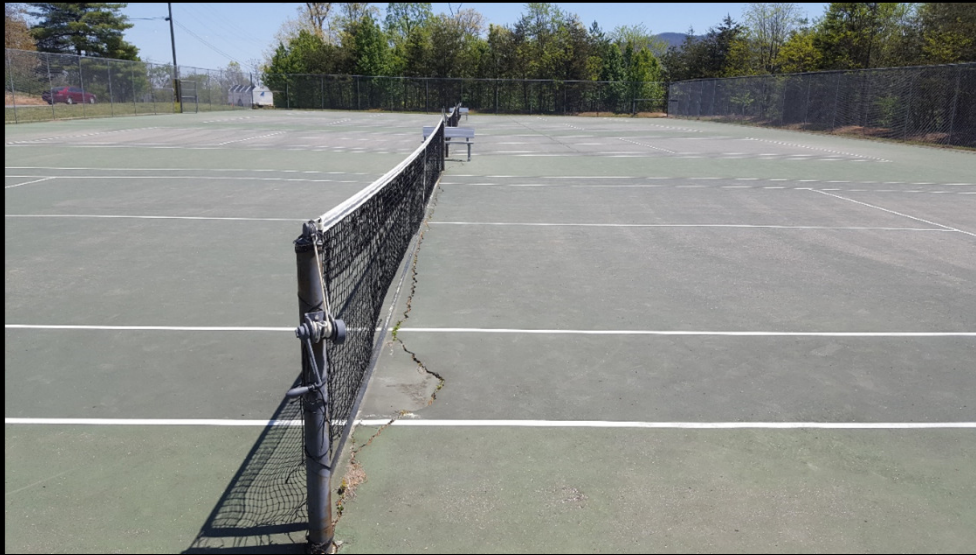
03. Bad Depression at Western Court Net

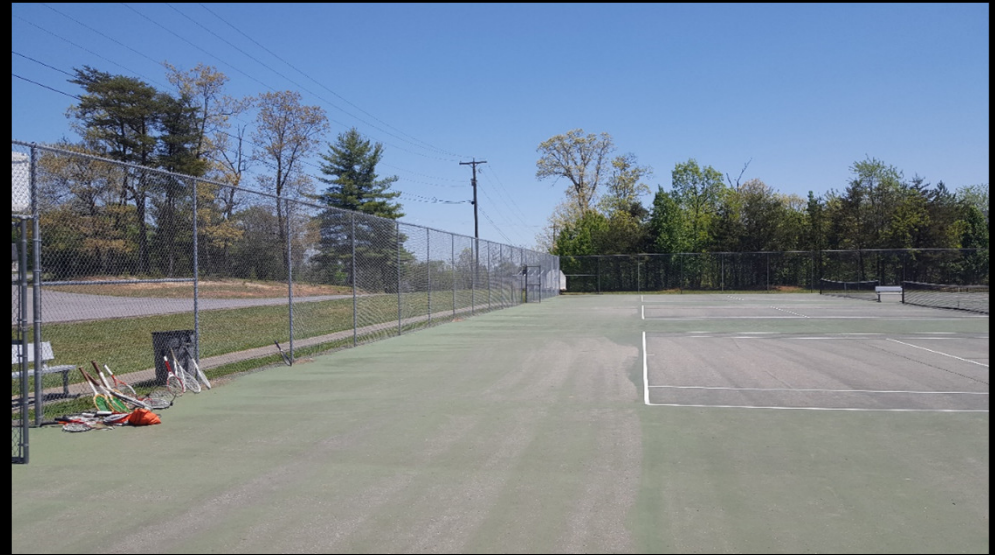
04. Fence in Good Condition

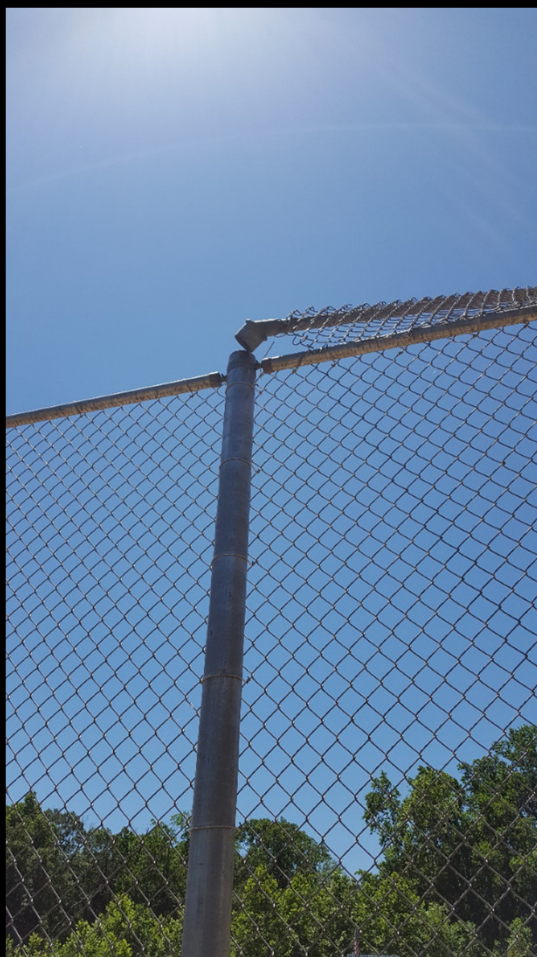
01. Backstop Needing Repair

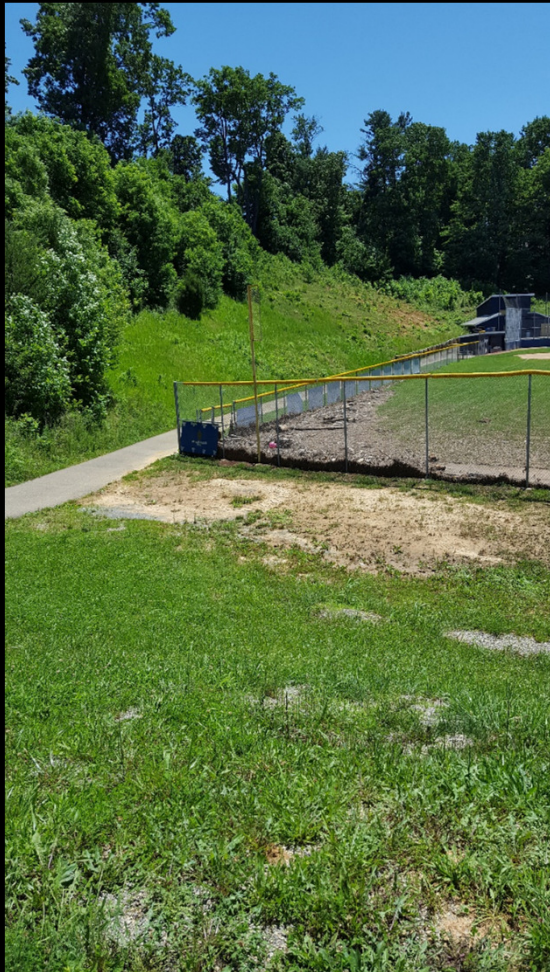
01. Flood Damage

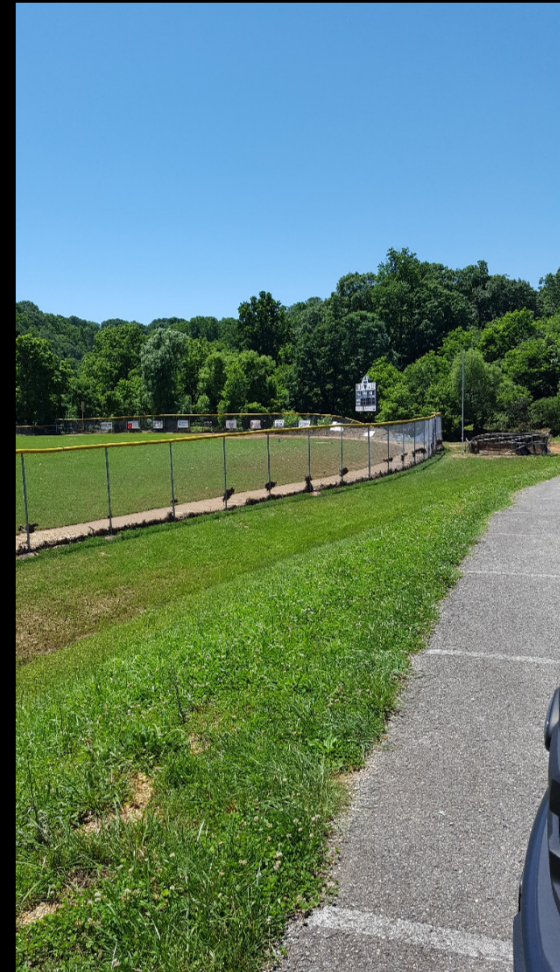
02. Flood Damage

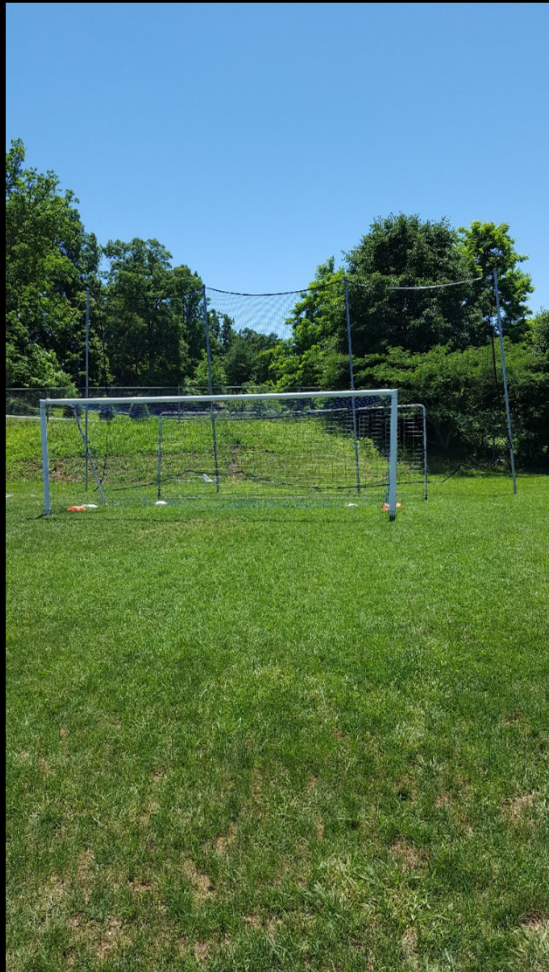
03. End Netting Needing Repair

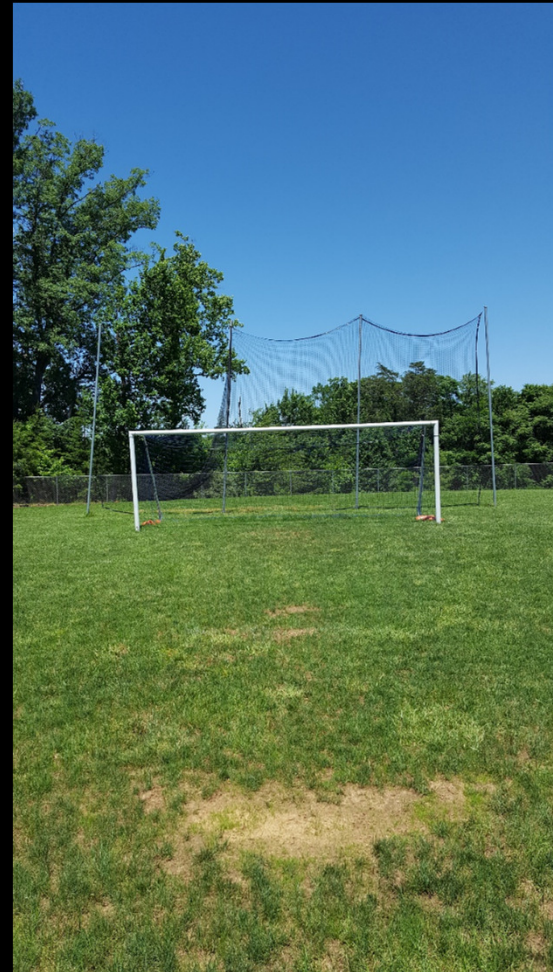
04. End Netting Needing Repair

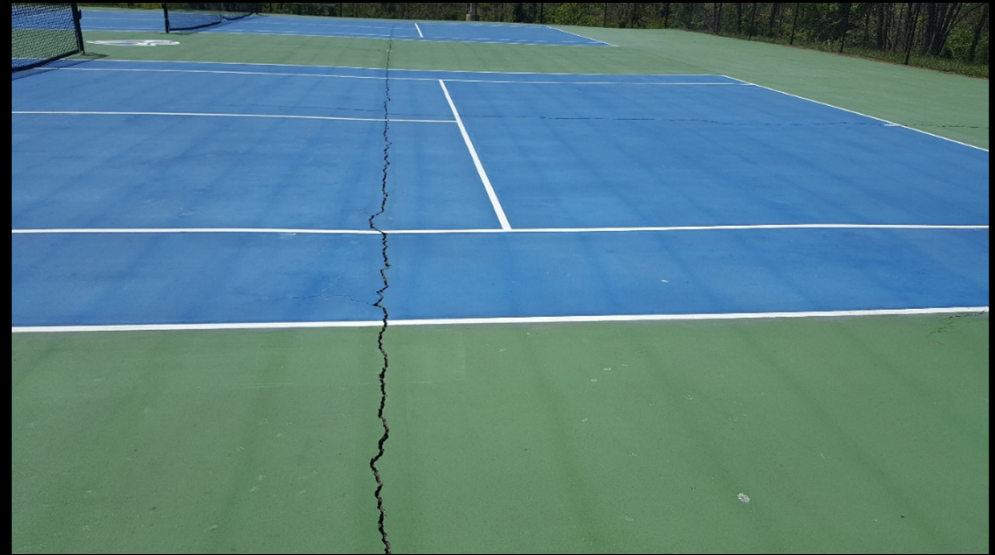
02. Large Crack

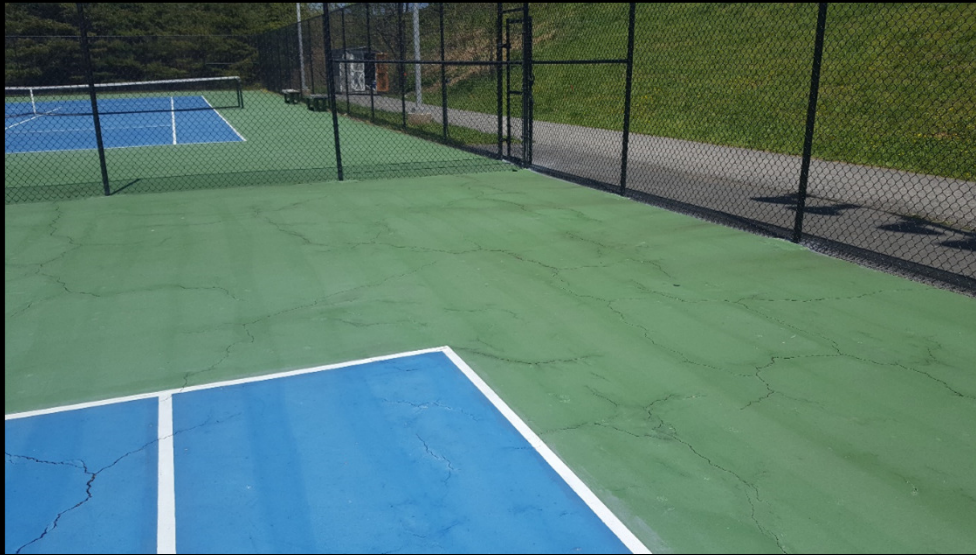
03. Multiple Cracks

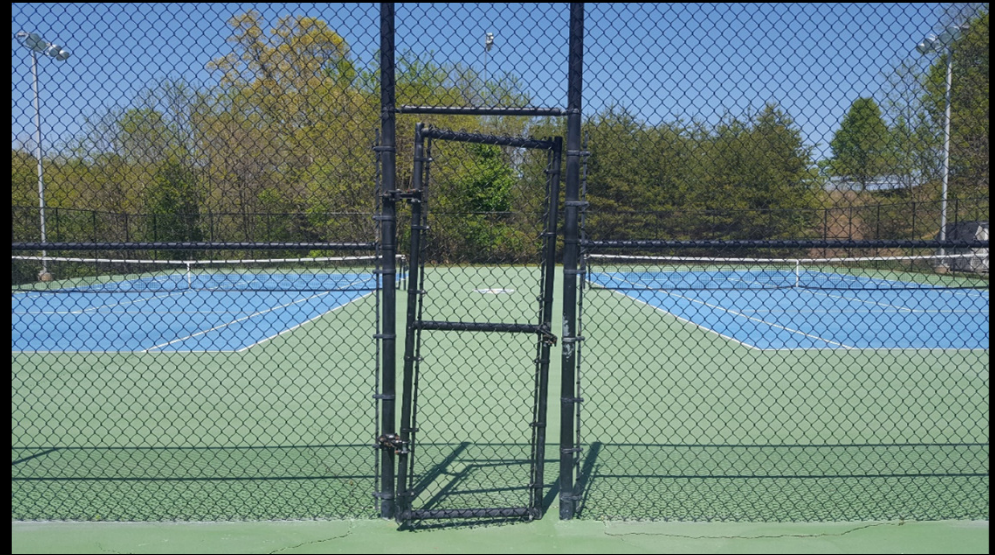
04. Entrance Gate Needs Replaced

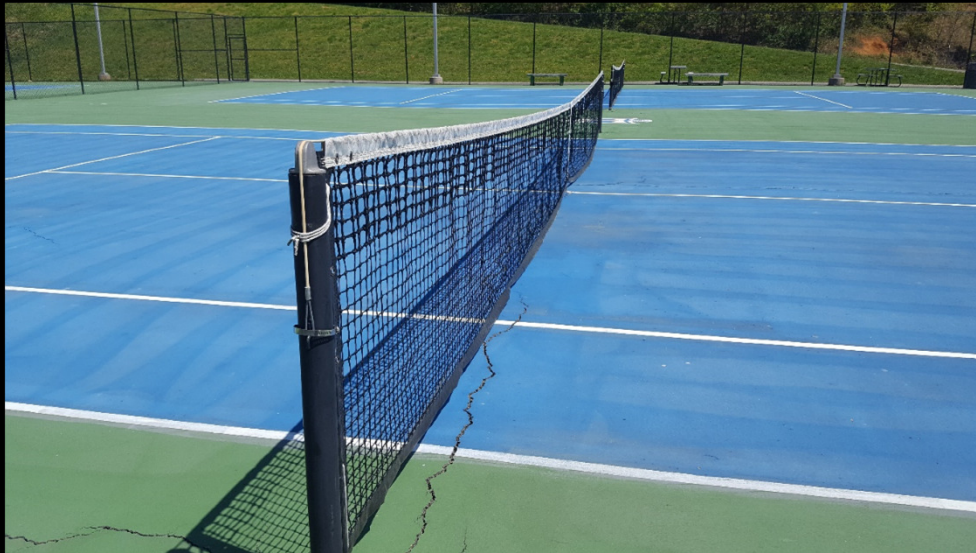
05. Net Post Foundation Heaving and Cracking

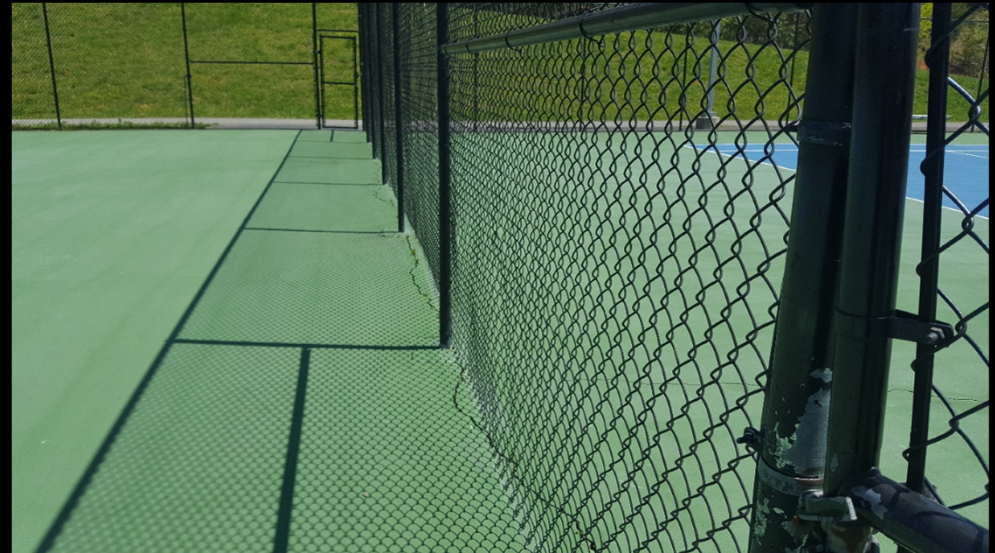
06. Fence Foundation Cracking
