BURTON CENTER FOR ARTS AND TECHNOLOGY

ARCHITECTURAL

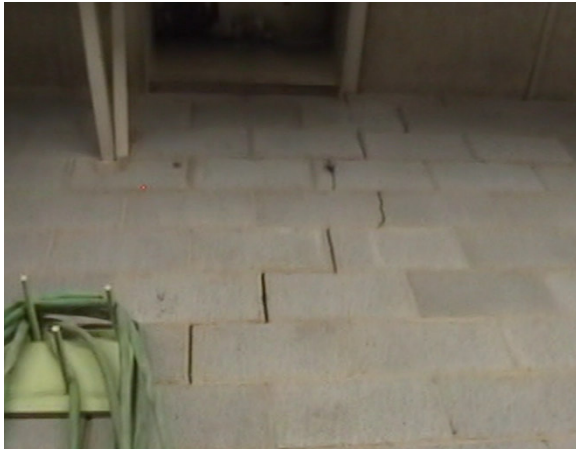
Cracks in Masonry Walls in the Masonry Class

In the storage area of the masonry class, a fairly significant stairstep crack was observed in the wall common to the masonry classroom. This crack seems to show

horizontal movement along with some less significant vertical movement. On the opposite wall of the storage area, another, less significant stairstep crack was observed. In addition to the cracks in the storage area, a crack over one of the doors to the corridor was also observed. Though unsightly, these cracks do not appear to pose a threat to the structural integrity of the building. However, due to the number of cracks in this general vicinity, it is recommended that, in addition to caulking, painting and observing the cracks for additional movement, these cracks should

be monitored with crack gages to determine the direction and extent of any additional movement. OWPR, Inc. is happy to assist with setting up a monitoring program for this building.
