CAVE SPRING ELEMENTARY SCHOOL

ARCHITECTURAL

STRUCTURAL

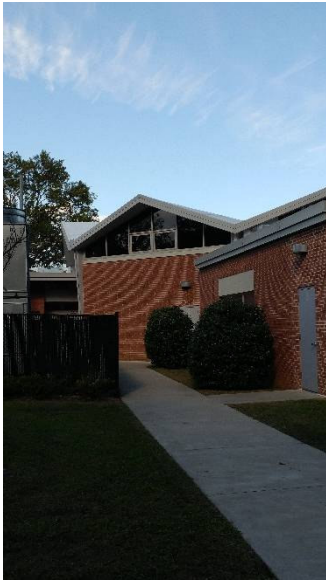
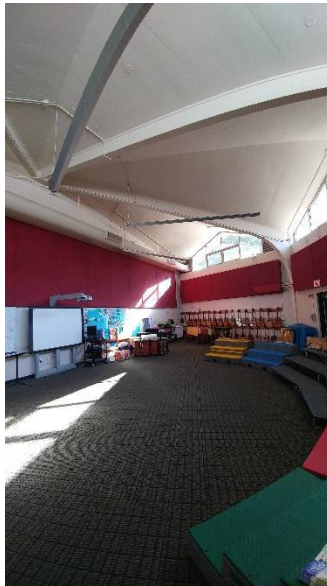
Cracks through Brick and Block in Art and Music Rooms

The Art and Music areas at Cave Spring Elementary School have a slightly higher roof, framed by a glued-laminated (glu-lam) system of wood beams and columns, similar to

to the ornate wood framing seen in many church sanctuaries. When the central portion of the roof receives gravity loading from the weight of the building or snow, the beams begin to deflect downward. Due to their slope, the downward deflection translates into a horizontal, outward force near the connections to the tops of the columns at the exterior of the frame. This horizontal force, and its related horizontal movement, are believed to be the source of the cracking observed at the upper levels of the brick and block, near the glu-lam columns. Cracking

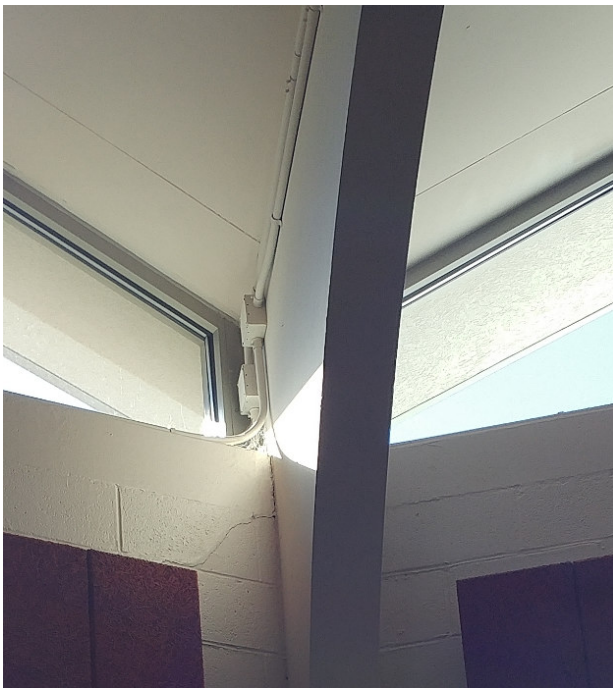
observed on the interior of the building in the vicinity of the columns is consistent with this type of movement. Though somewhat unsightly, this cracking does not appear to pose a threat to the structural integrity of the building. Movement of this nature is anticipated with a frame with this type of geometry. However, the amount of movement may be more than was anticipated during design. It is suggested that the exterior cracks be repointed, the interior cracks be caulked and painted, and all cracks observed for any additional movement – particularly after a heavy snow.
