# CLEARBROOK ELEMENTARY SCHOOL

## ARCHITECTURAL

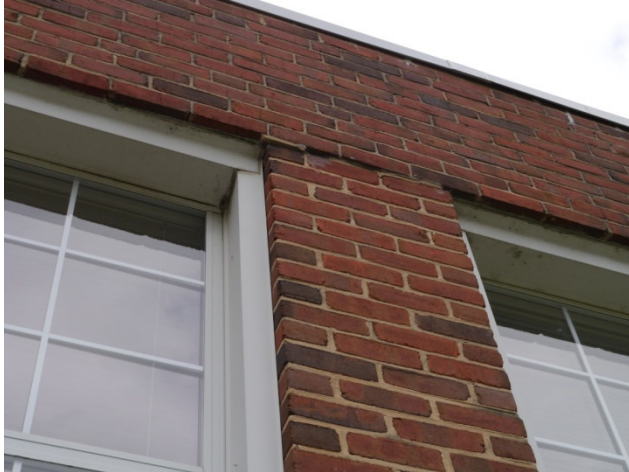
### Movement Near Window Heads of 1960's Wing

Movement of the brick wall above the windows appears to be pushing the wall outward from the building. This movement appears to be consistent along all three exposed faces of this wing of the building. The movement is somewhat unsightly but does not appear to pose a threat to the structural integrity of the building. Though the exact cause of the movement is unknown, it is anticipated that the movement is caused by an expansion of the roof and roof framing system creating movement

outward on all faces of the building. When the roof expands, the framing, which is likely rigidly attached to the supporting walls, expands also, creating a push against the inside face of the wall. Even though the forces are occurring above the window heads, the movement occurs at the tops of the windows because the window openings create a weakened horizontal plane through the building. The wall is able to resist the movement until the forces reach the weakened plane. Joints where the movement has occurred should be repointed to prevent excessive moisture from entering the wall system.
