# FORT LEWIS ELEMENTARY SCHOOL

## ARCHITECTURAL

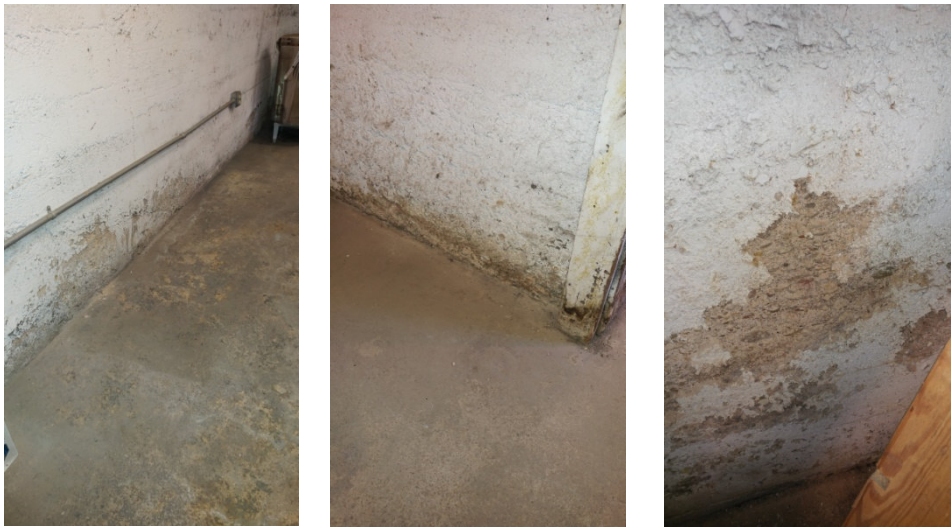
### **Concrete Spalling from Boiler Room Walls**

In the Boiler Room, several areas of concrete spalling from the base of the walls was observed. The remaining concrete appeared to be somewhat deteriorated and could be easily scraped from the face of the wall. The custodial staff member along during the inspection indicated that water / moisture is not normally an issue during wet weather. Therefore, that is not likely the issue. Incidentally, water should not damage concrete that has properly set up. Therefore, it is anticipated that there may have been issues during original placement of the concrete that caused it to be of sub-standard quality. Since the boiler room is only under a small area of the building, the lateral loading resisted by the boiler room walls should be relatively small. Therefore, the deteriorated concrete should not be cause for alarm. However, if the condition of the walls continues to deteriorate, some remedial measures may become necessary. It is recommended that these walls are closely observed and periodically photographed to document their condition for future reference and to determine if their condition worsens.

Water damage to lower portions of concrete walls. Faces have spalled off. Are probably still sound, but should be monitored over time.  
 Surface of concrete floor has popped off in places.  
 There is a pottery kiln stored in the boiler room area. It is plugged in, and per the custodian, is used by one of the teachers for projects. There is no exhaust system for the kiln.
