GLEN COVE ELEMENTARY SCHOOL

During the Architectural investigation of the Glen Cove Elementary School, several different issues were observed that warranted further investigation from a structural standpoint.

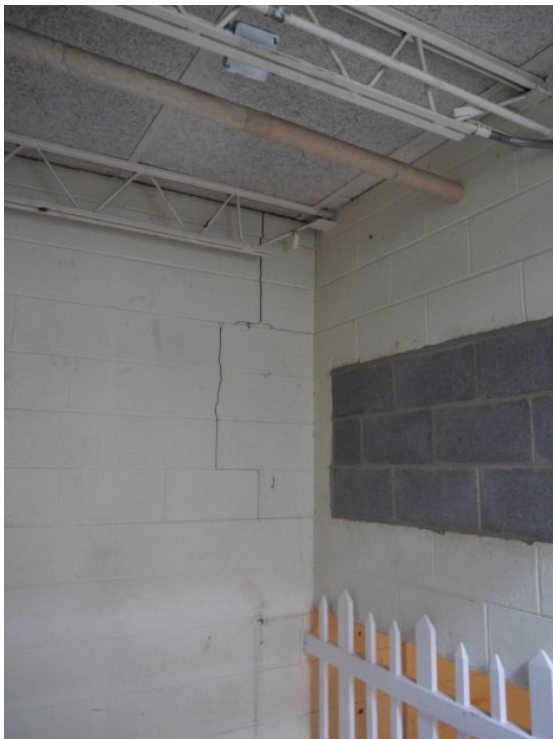
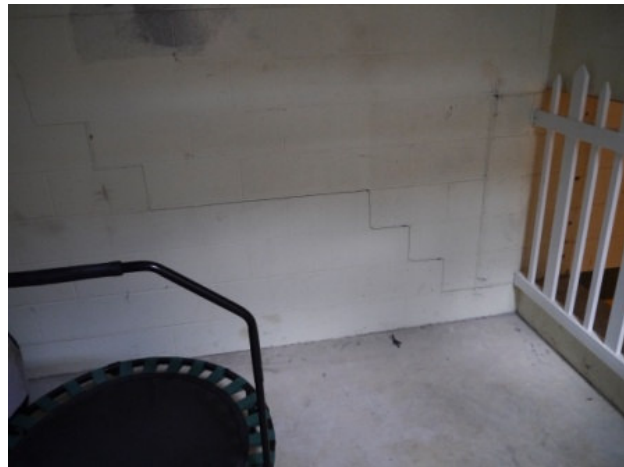
Cracks in Gym Storage Mezzanine

In the mezzanine on the northwest corner of the gym, accessed by ladder and hatch above the stage floor, stairstep cracks were observed in the north wall. The cracks seemed to be limited to the mezzanine area and were not visible from below. These cracks appeared to be minor settlement cracks and are not felt to pose a threat to the structural integrity of the building. It is suggested that the cracks are caulked, painted and then observed for additional movement.

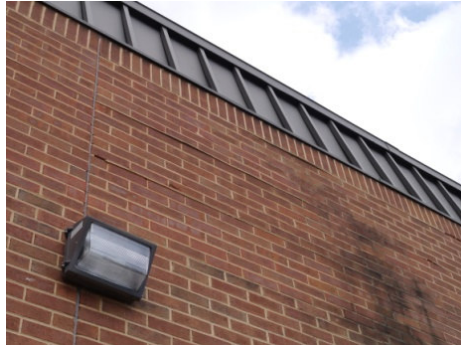
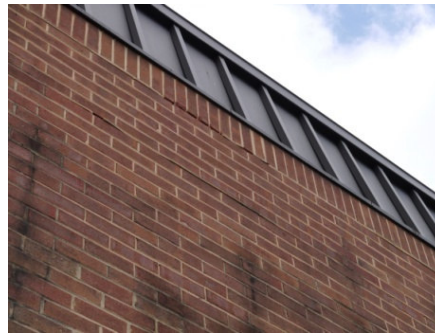
Mortar Being Pushed out of Horizontal Joints

At various locations around the building, brick mortar was observed being pushed out of the horizontal joints. This is likely due to corrosion or rusting of the horizontal joint

reinforcing that ties the brick to the concrete masonry portion of the wall. Rusted steel reinforcing has a tendency to “delaminate” and expand and this will push mortar out of

the joint. It is suggested that the joints be repointed.

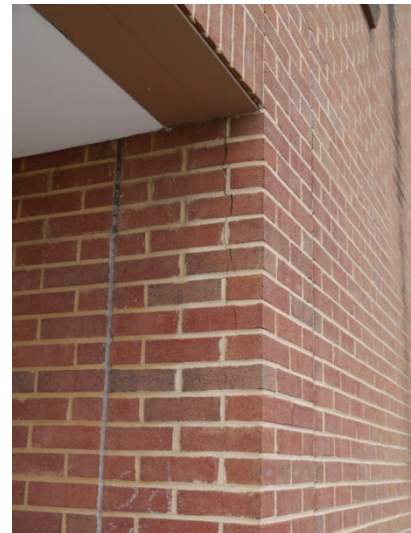
Brick Cracking Below Lintel at Exterior Door No. 10

Minor cracking was observed at the north end of the long opening at Door No. 10. This is potentially due to minor settlement in the area or possibly minor rotation of the lintel above this long opening placing unanticipated stresses on the brick below. These cracks should be sealed and observed for any additional movement.

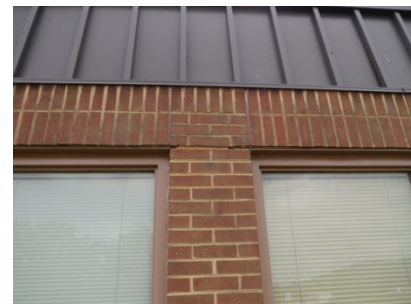
Random Cracks at Window Heads

At the heads of various windows around the perimeter of the building, mortar was observed being pushed out of the joint. This is very similar to the issue described above except at window heads, it is likely rusting of the steel angle lintel supporting the brick above the opening that is pushing the mortar out of the joint. If allowed to progress, this deterioration could lead to localized failure of the brick support and could allow some of the brick face to fall off the wall. Again, repointing of the joint is suggested in these instances along with continued monitoring. If additional brick cracking above the windows if observed, it should be reported to a design professional for remedial actions.

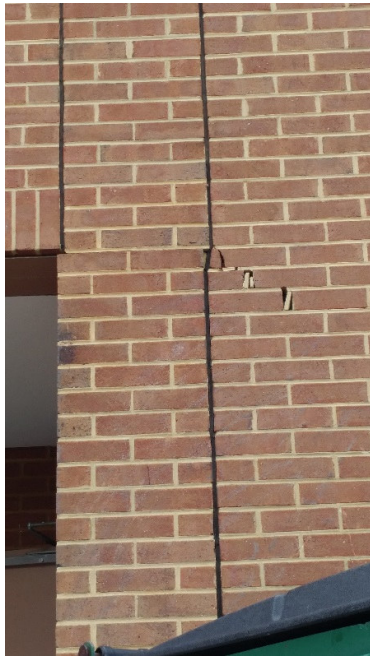
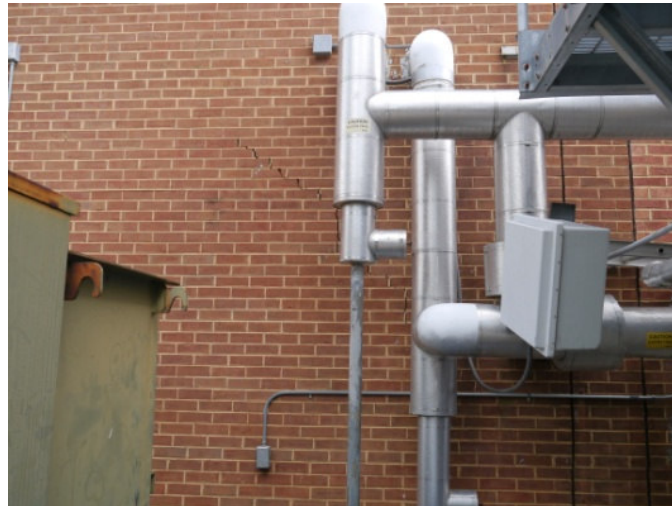
Horizontal Movement at Loading Dock

Several issues were observed at the loading dock area. There is some horizontal movement noted in the middle of the wall behind the chiller area. Likewise, there were cracks observed near the south end of the loading dock, near the top of the wall opening. These cracks are likely due to the same horizontal

movement. It is a bit strange that movement of the magnitude seen in some of the cracking, particularly in the middle of the wall behind the chiller, is isolated to the middle of the wall with no continuity of cracking observed extending to a building corner, base of the wall, etc. Likewise, it would not be unusual that the two locations of cracking would be somewhat connected by a smaller crack. However, these larger cracks seem to be isolated to their own areas of the same wall. Regardless of the cause, these cracks do not appear to be threatening the structural integrity of the building. It is recommended that they are repointed or otherwise sealed to prevent moisture from entering, then observed for additional movement.

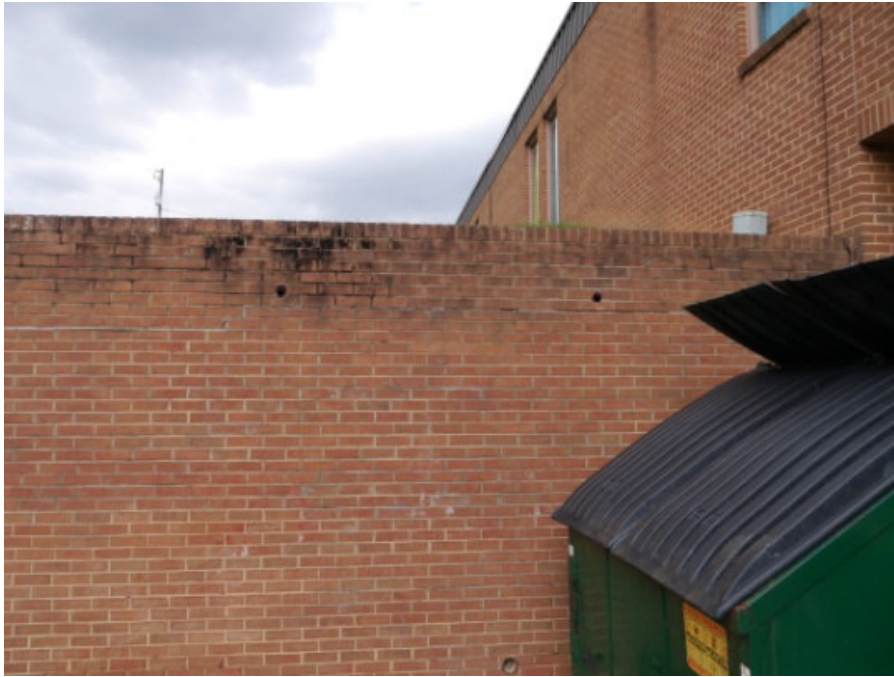
Retaining Wall Horizontal Joints

Similar to the joint reinforcing discussed on the main building, the loading dock appears to be experiencing some rusting of joint reinforcement pushing the mortar out of the joints. This deterioration appears to be occurring near the grade elevation on the retained fill side of the wall. The joints should be repointed and a means of draining water from behind the wall should be maintained to insure that surface drainage does not accumulate behind, and then soak into the wall.

Site Retaining Walls: Short 2' wall near main entrance is solid but showing signs of aging. 10' wall at service dock shows signs of initial failure. 10' wall does not have required railing or block at top to prevent falls.

Recommendation: Structural analysis of large wall and appropriate repairs are recommended. Provide a railing at the top of the high wall.
