HIDDEN VALLEY MIDDLE SCHOOL

ARCHITECTURAL

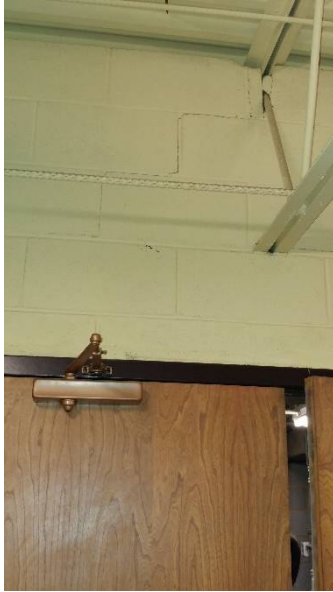
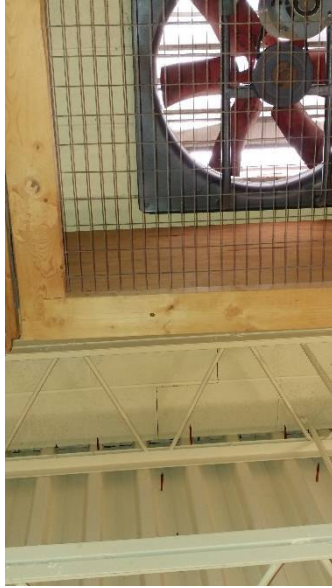
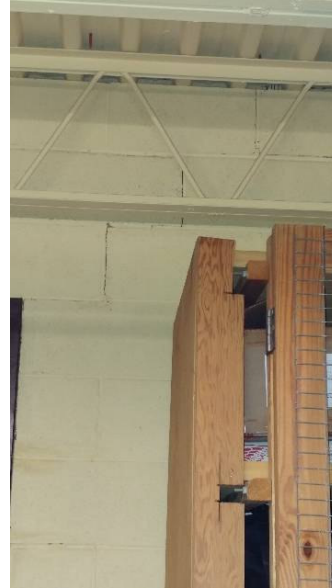
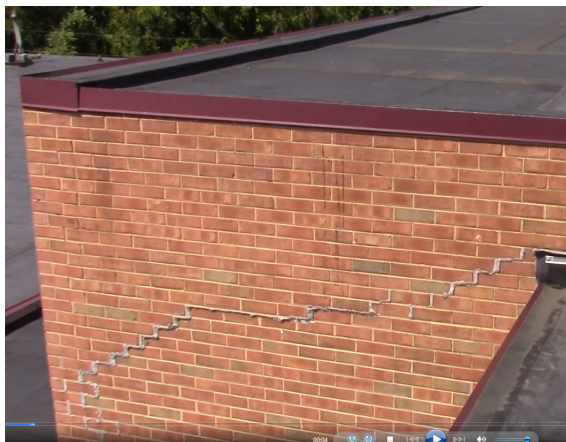
Cracks Near the Corners of the Gym

Stairstep cracks were observed on the exterior face of the gym, high on the walls, in the northeast and southeast corners, near the

stage openings. No indication of the cracks was observed in the interior face in the concrete masonry walls. However, upon investigation of the “mezzanine” areas above the stage, some cracking was observed in the “caged” in storage area. The cause of the cracking appears to be minor settlement. This movement is not a threat to the structural integrity of the building. However, should it progress beyond its current condition, it could become an issue that would need to be addressed at some point. It is suggested that the interior cracks be caulked and painted and

Additional minor cracks were observed over the exit doors at the opposite corners of the gym. These cracks were much less severe and should be caulked, painted and monitored for additional movement.

the exterior cracks be repointed with all cracks monitored for any additional movement. Due to the numerous cracks in this area, it is suggested that crack gages be installed on cracks in a few locations and monitored on a quarterly basis. OWPR, Inc. is happy to assist with setting up this monitoring program if so desired.

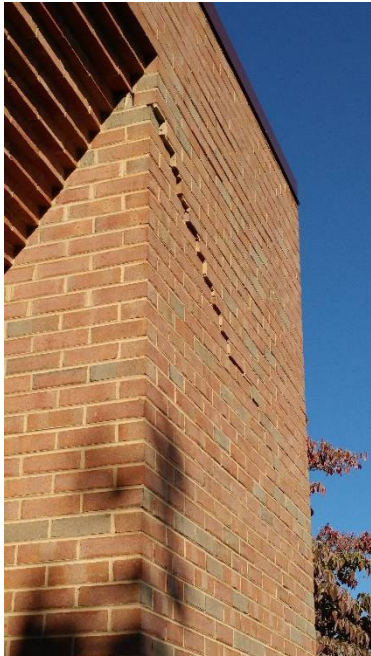
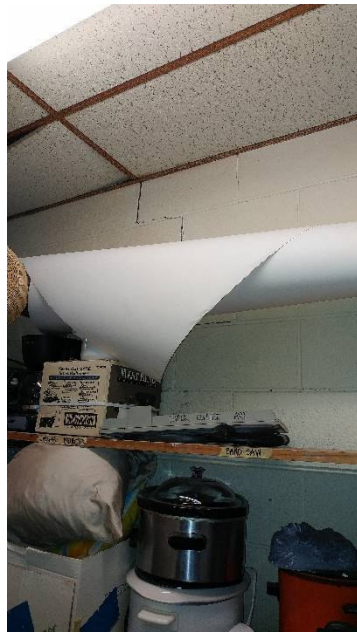
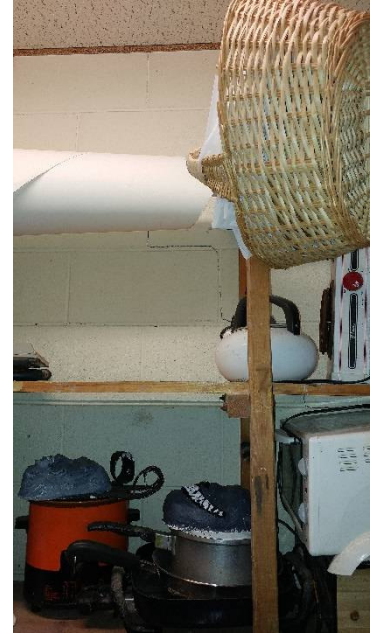
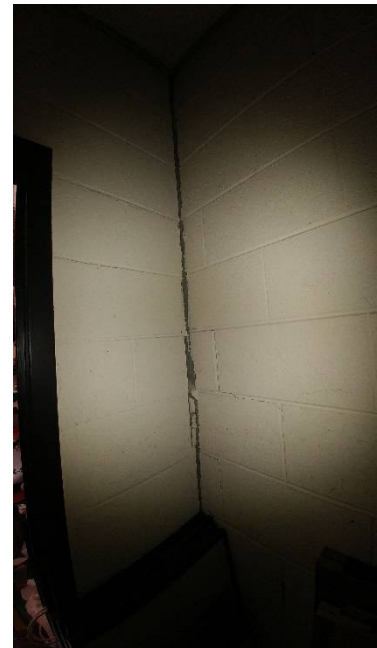
Stairstep Cracks Adjacent to Main Entrance

Cracking at the corner of the building, south of the main entrance was observed. This stairstep crack appears to indicate some type of horizontal movement, perpendicular to the plane of the wall. Around the corner of the building, no similar cracking was observed, however, inside the building in the storage room opposite the cracking on the exterior, some additional cracking was observed. It is unclear at this point, what the source of this movement is. It is recommended that the cracks be repaired as described above and monitored for any additional movement. In order to determine the rate and direction of movement, monitoring these cracks with crack gages is recommended. Again, OWPR, Inc. can assist with setting up the program.
