ROANOKE COUNTY PUBLIC SCHOOLS ADMINISTRATION BUILDING

ARCHITECTURAL

The Roanoke County Public Schools Administration Building was originally constructed as the Roanoke County Special Occupational School in 1971. It was renovated in 1994, but has seen multiple office fit-outs making overall ages of materials difficult to ascertain. Renovation work was on-going at the time of this visual inspection.

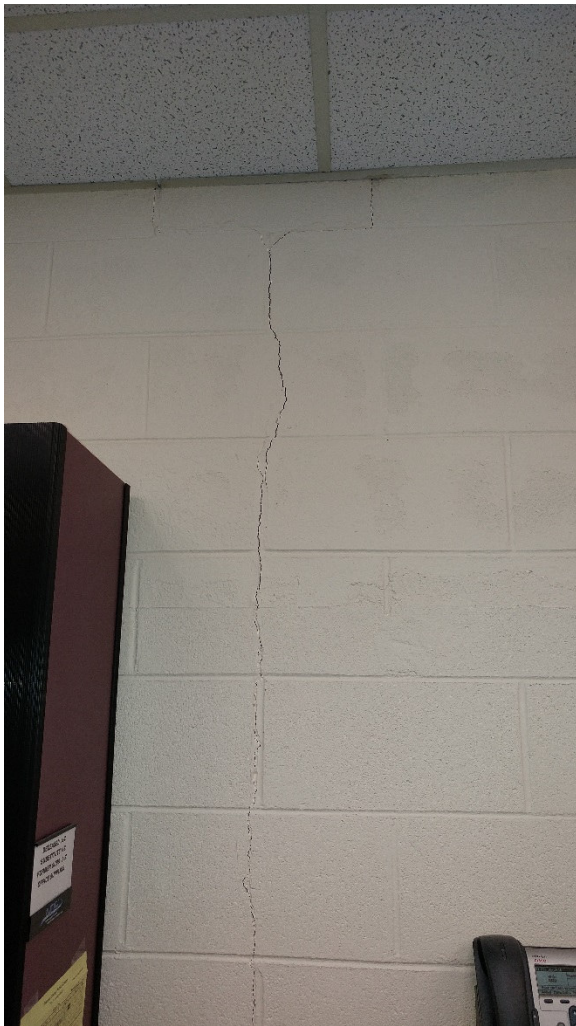
During the Architectural investigation of the Central Office, a fairly significant vertical crack was observed in the rolling file storage room. The crack appeared to be slightly wider at the top than at the bottom, indicating potential vertical rotation of at least one portion of the wall. This particular room is located at the south corner of the building with a recessed entrance at the northeast corner of the room. Therefore, it is anticipated that the rotation may be occurring as a result of minor settlement of the south building corner. It is recommended that the crack be caulked, painted and then observed for any additional movement. It is possible that the building has reached a point of equilibrium and movement may have stopped. If additional movement is observed, monitoring of the movement by means of a crack gage may be necessary.
