# ROANOKE COUNTY PUBLIC SCHOOLS TRANSPORTATION BUILDING

<b>Project Name: RCPS Facilities Assessment</b>		<b>Comm. #: 1637</b>
---	--	----------------------

<b>Subject: RCPS Transportation Building</b>	<b>Total Pages:</b>
<b>Date: 10/6/2016</b>	<b>Location: Salem, VA</b>
<b>Copies To:</b>	<b>Report Prepared By: AHW</b>

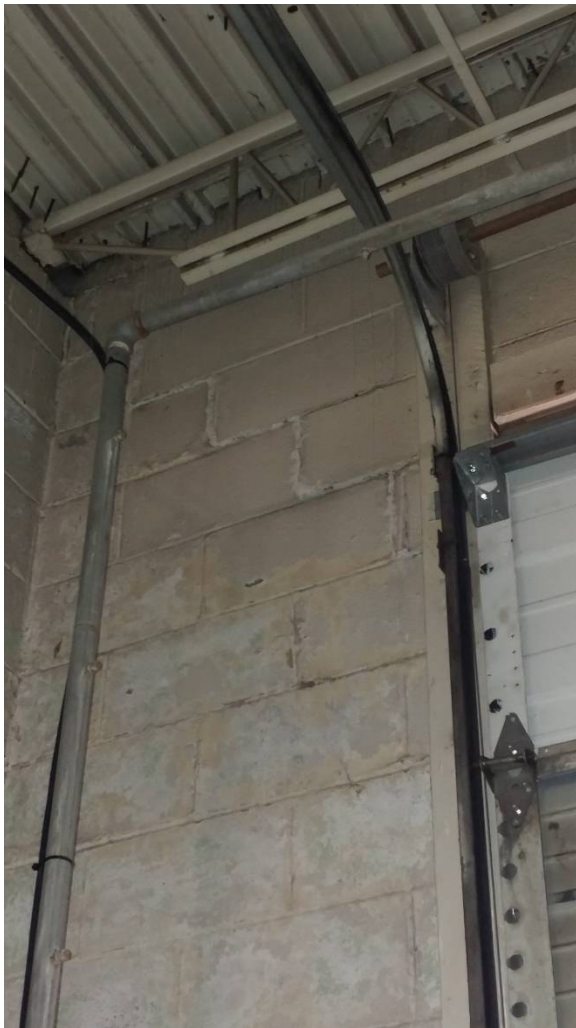
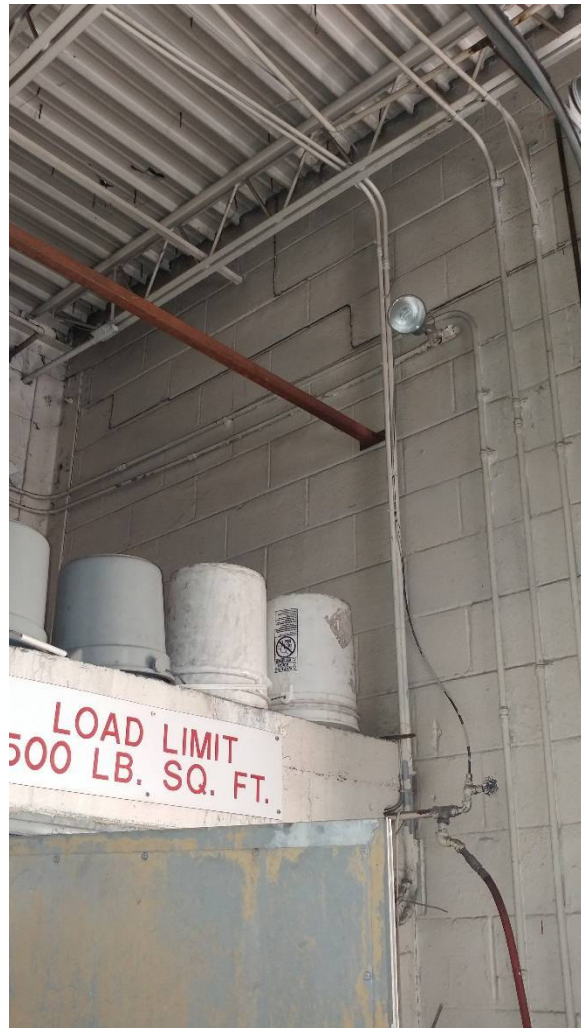
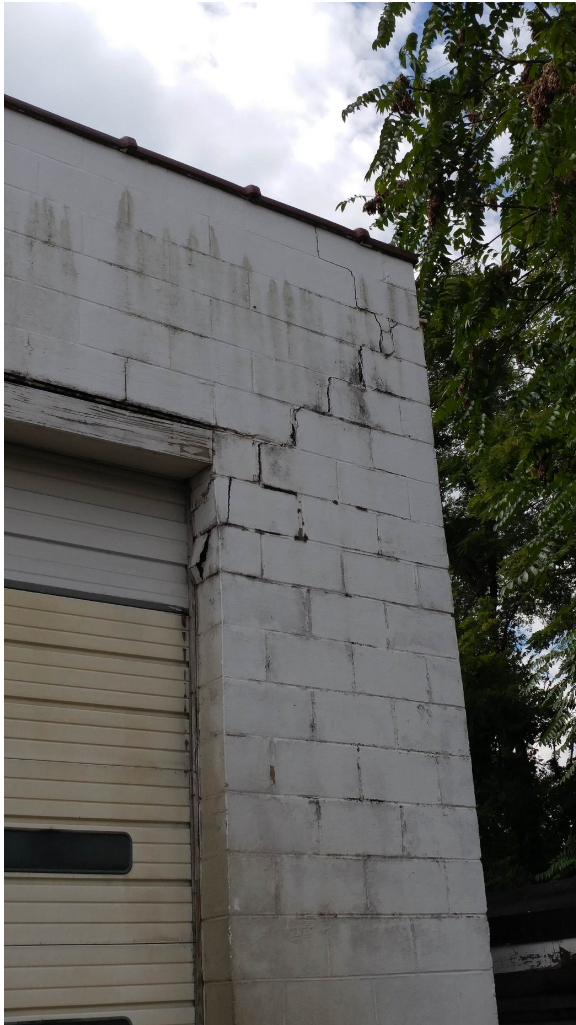
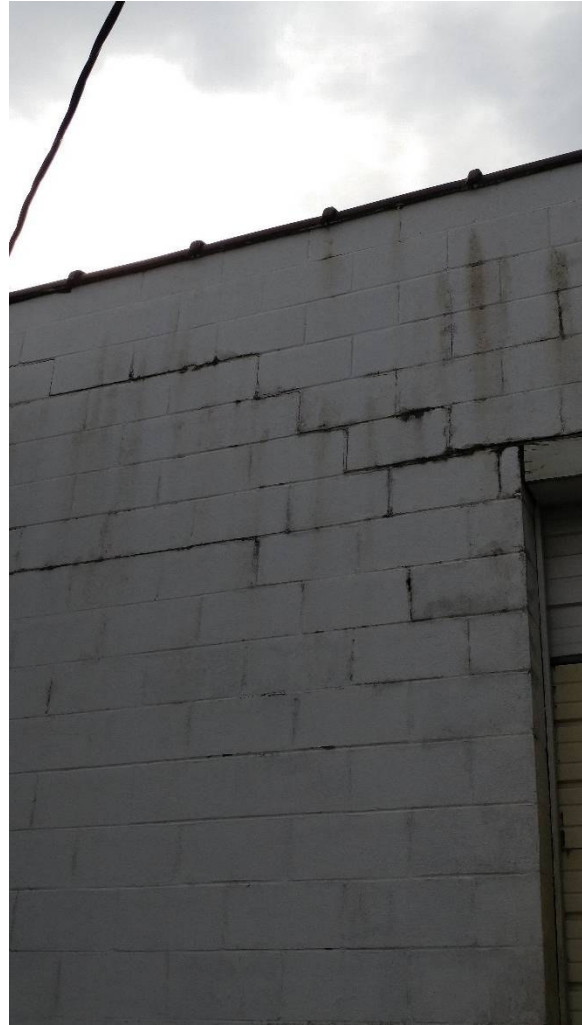
During the Architectural investigation of the Transportation / Bus Facility, some damage above the wash bay doors was noted. Upon a second, structural investigation, cracking was observed above both doors to the wash bay, on both the interior and exterior faces of the wall. The location and configuration of the cracking would seem to suggest that settlement is taking place on this end of the building.

It is suggested that the cracks be repointed, painted, then monitored for additional movement. Sealing the cracks is particularly important given that this wall is exposed to moisture from both the interior and exterior faces. During the winter, moisture entering the wall through these cracks can potentially freeze and expand and exacerbate the condition.
