W.E. CUNDIFF ELEMENTARY SCHOOL

ARCHITECTURAL

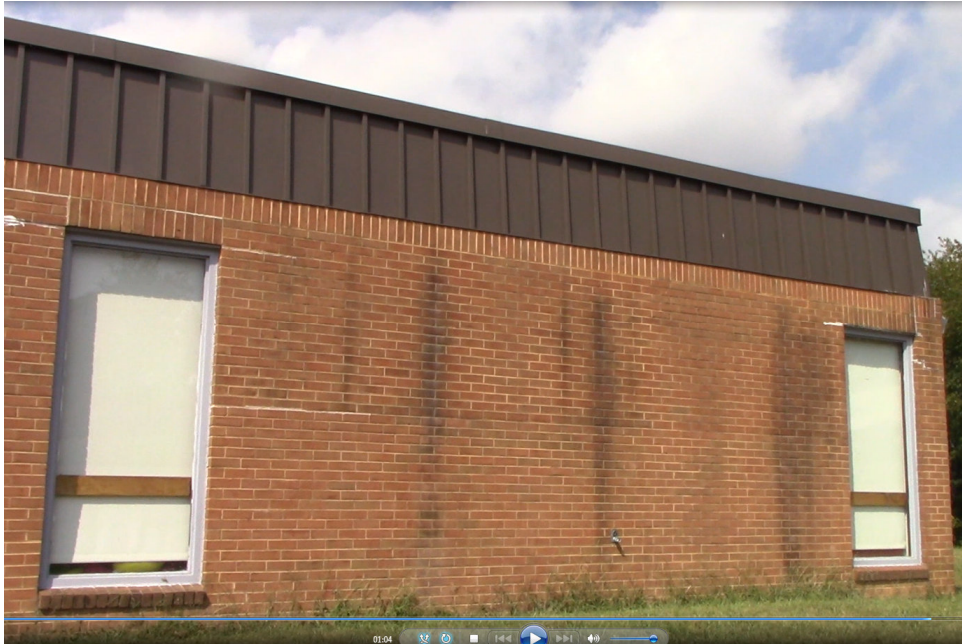
During the Architectural investigation of the W.E. Cundiff Elementary School, horizontal mortar joints in the face brick were observed with mortar being pushed out of the joint. As with other schools in the district, this is occurring due to rusted joint reinforcing “delaminating” and expanding, causing the mortar to be pushed out of the joint. This condition does not pose a threat to the structural system of the building but it should be repaired to help slow the deterioration of the joint reinforcement and keep the brick face solidly attached to the face of the building. It is suggested that the joints be cleaned out and repointed.
