WILLIAM BYRD HIGH SCHOOL

ARCHITECTURAL

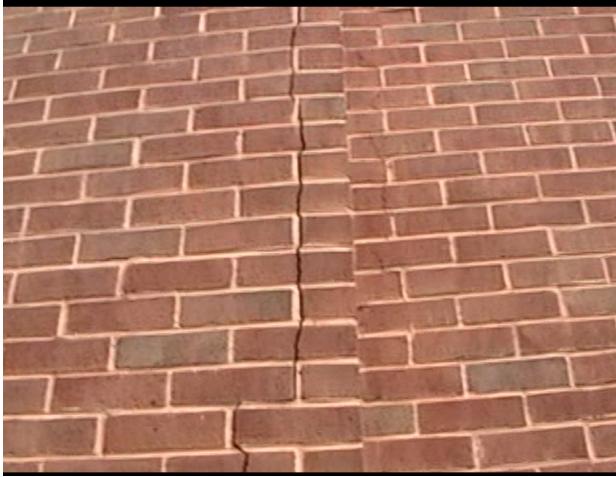
Vertical Crack Outside Mechanical Room

Near the mechanical room at the center of the building, a vertical crack in the brick face was observed. This crack appeared at a small (+/- 12") offset in the brick. The crack appears approximately 4" off the corner of the wall at the offset. It is anticipated that this crack is the result of expansion of the brick along the face of the wall containing the crack. The offset corner creates a stiff point in the middle of the wall where the movement is resisted creating a slight rotation and crack on the brick face. Not shown in photos, this

crack also occurs at a transition between two roof levels. The crack occurs up to the point of the lower roof level where movement restraint is present. Once the wall goes above the lower roof level, the restraint is no longer present and the wall is free to move without cracking. This crack should be sealed with flexible sealant to keep any excess moisture out of the wall system. The sealant needs to be flexible because it is anticipated that this joint will continue to open and close with temperature changes.
