WILLIAM BYRD MIDDLE SCHOOL

ARCHITECTURAL

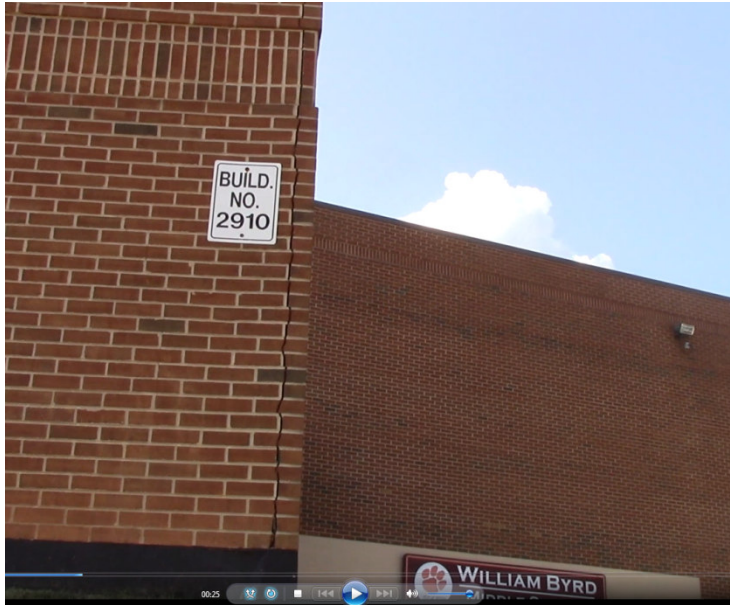
Vertical Crack at Building Corner Exterior

At the south end of the school, the entrance facing William Byrd High School, a vertical crack was observed at a building corner, approximately 4" off the corner. Additionally, the northeast face of this corner appears to have rotated to the northeast (in the adjacent photo, that would be the face of the wall extending back into the page, rotating to the right). It is believed that the southeast face of the building (the face containing the white sign in the adjacent photo) expanded, creating movement to the northeast at this end of the wall

(to the right in the adjacent photo) creating the rotation in the northeast face of the wall. Then, as cooler temperatures occurred, the face of the wall contracted, creating the crack. Significant temperature swings are expected in this wall since it is a southeast facing wall which will absorb significant amounts of heat from the sun – particularly during the summer - but then cool at night – becoming particularly cold during winter nights. This condition was not visible on the interior of the building and does not pose a threat to the structural system of the building. However, it should be sealed with some flexible sealant to keep moisture from entering the crack. The sealant needs to be flexible as it is anticipated that this crack will continue to open and close with temperature swings.

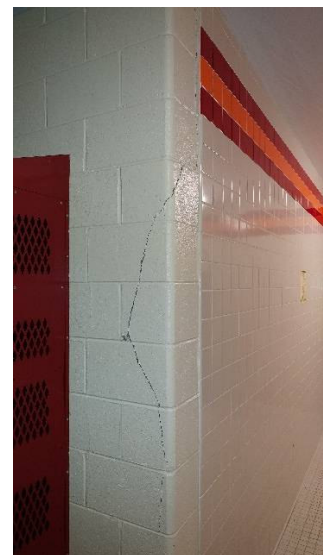
Crack in Team Room Near Shower

On a wall corner, entering the shower area of the Team Room, a crack was observed “wrapping” the corner. The cause of this movement is somewhat unclear. It could be related to some differential movement between the masonry and the glazed tile material of the intersecting wall. It could also be related to the relatively widespread movement noted at the nearby mechanical room. This should be caulked and painted and closely observed for any additional movement. This crack, in its current state, does not pose a threat to the structural integrity of the building.

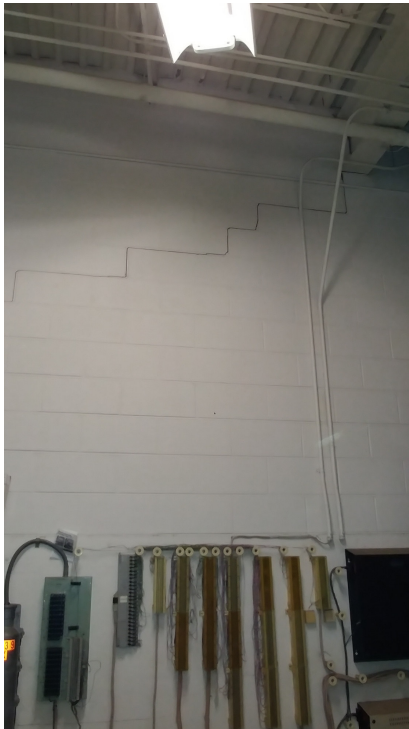
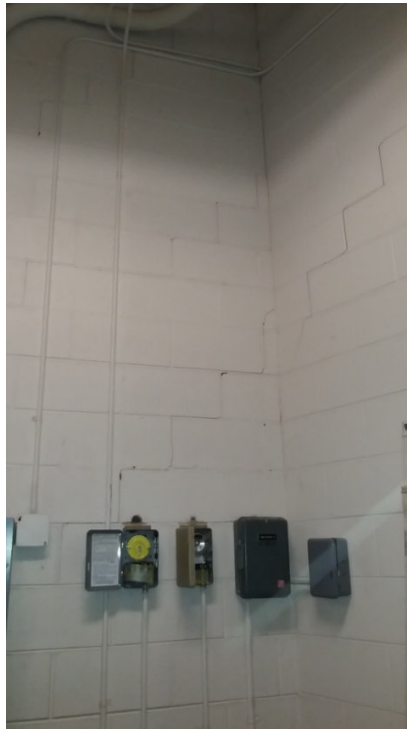
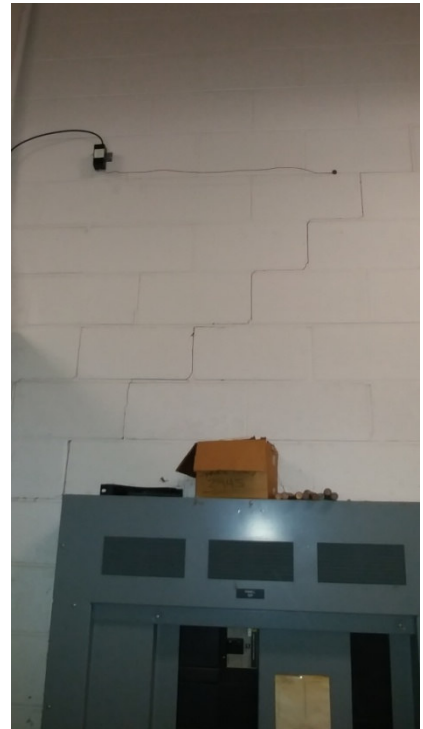
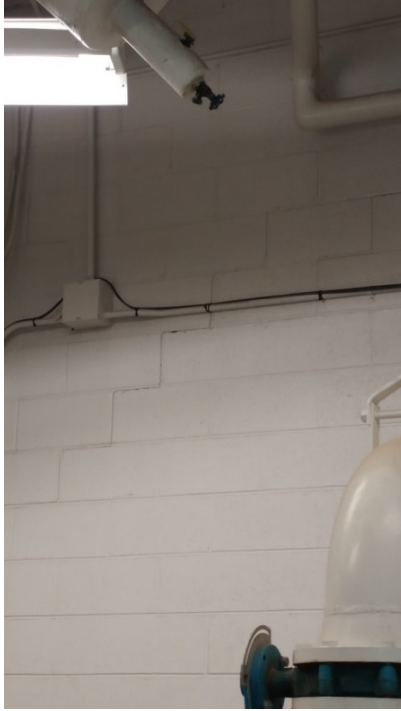
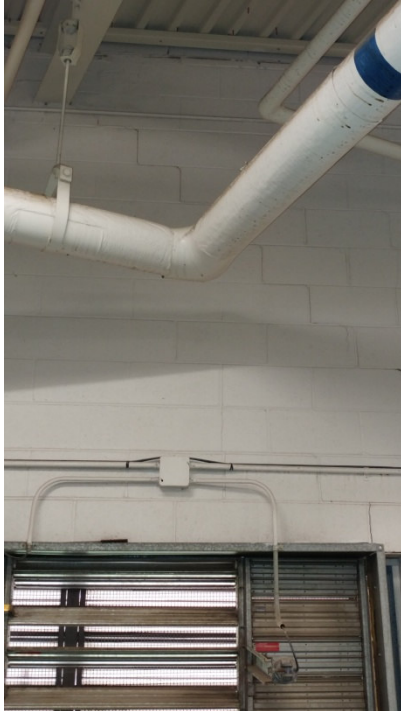
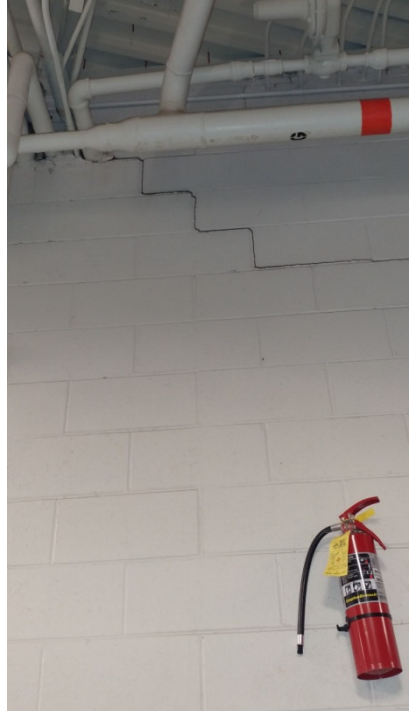
Cracks in Many Mechanical Room Walls

While searching for a crack observed by the architectural team, many, if not all, of the mechanical rooms were visited. Each room visited exhibited significant cracking in the masonry walls. Where the exterior of the wall was investigated, the cracking did not appear in the exterior face brick. Most of the cracks appeared to be settlement cracks. Cracking in adjacent areas was not reported. It is assumed that this cracking is isolated to the mechanical rooms observed. These cracks, while somewhat unsightly, do not pose a threat to the structural integrity of the building. However, they should be caulked, painted and observed for additional movement. Due to the number of cracks, particularly in the second floor mechanical rooms, it would be wise to begin a monitoring program using crack gages installed across the most severe cracks. Monitoring on a quarterly basis with detailed documentation of readings is recommended. Further information regarding a monitoring program can be provided if desired.
