# Hazardous Building Materials Survey Report

Osborn Hill  
Elementary School

0235320.00  
**BL Companies**  
January 2024

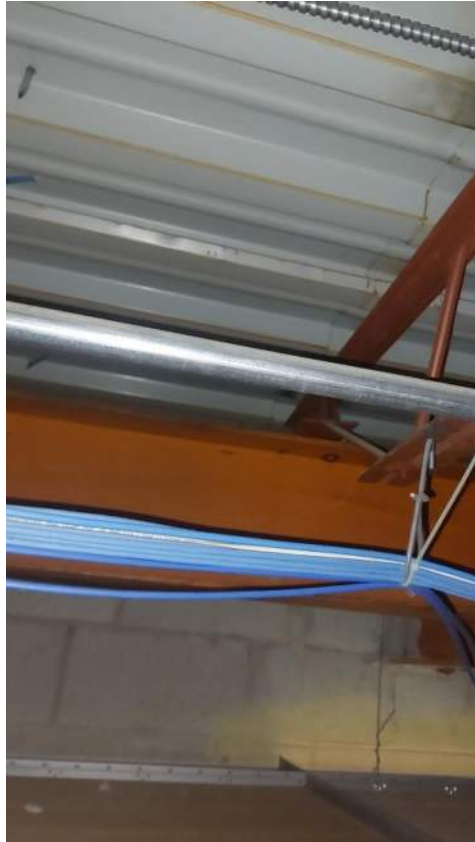
**Hallway Outside Room 183/ 189- Above Ceiling  
Tile Perimeter I Beam**

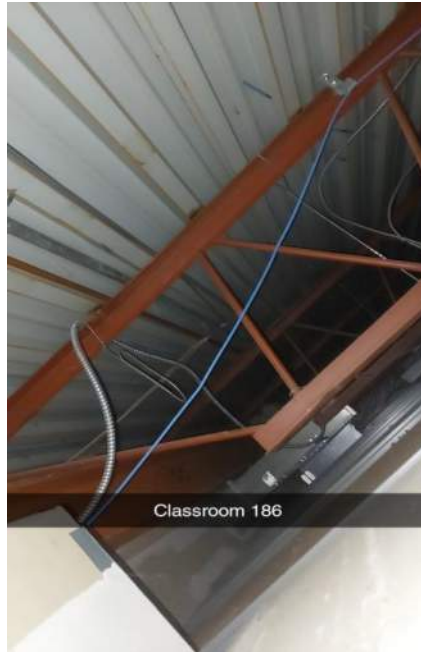
**Joist & Ceiling Deck- Classroom 186**

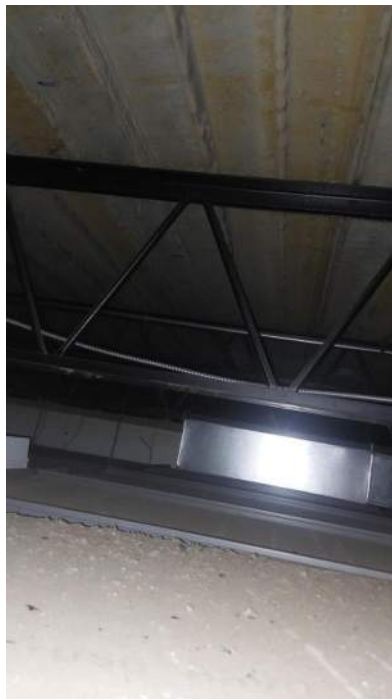
**Support Member Metal Decking/ Joist C (Classroom 118)**

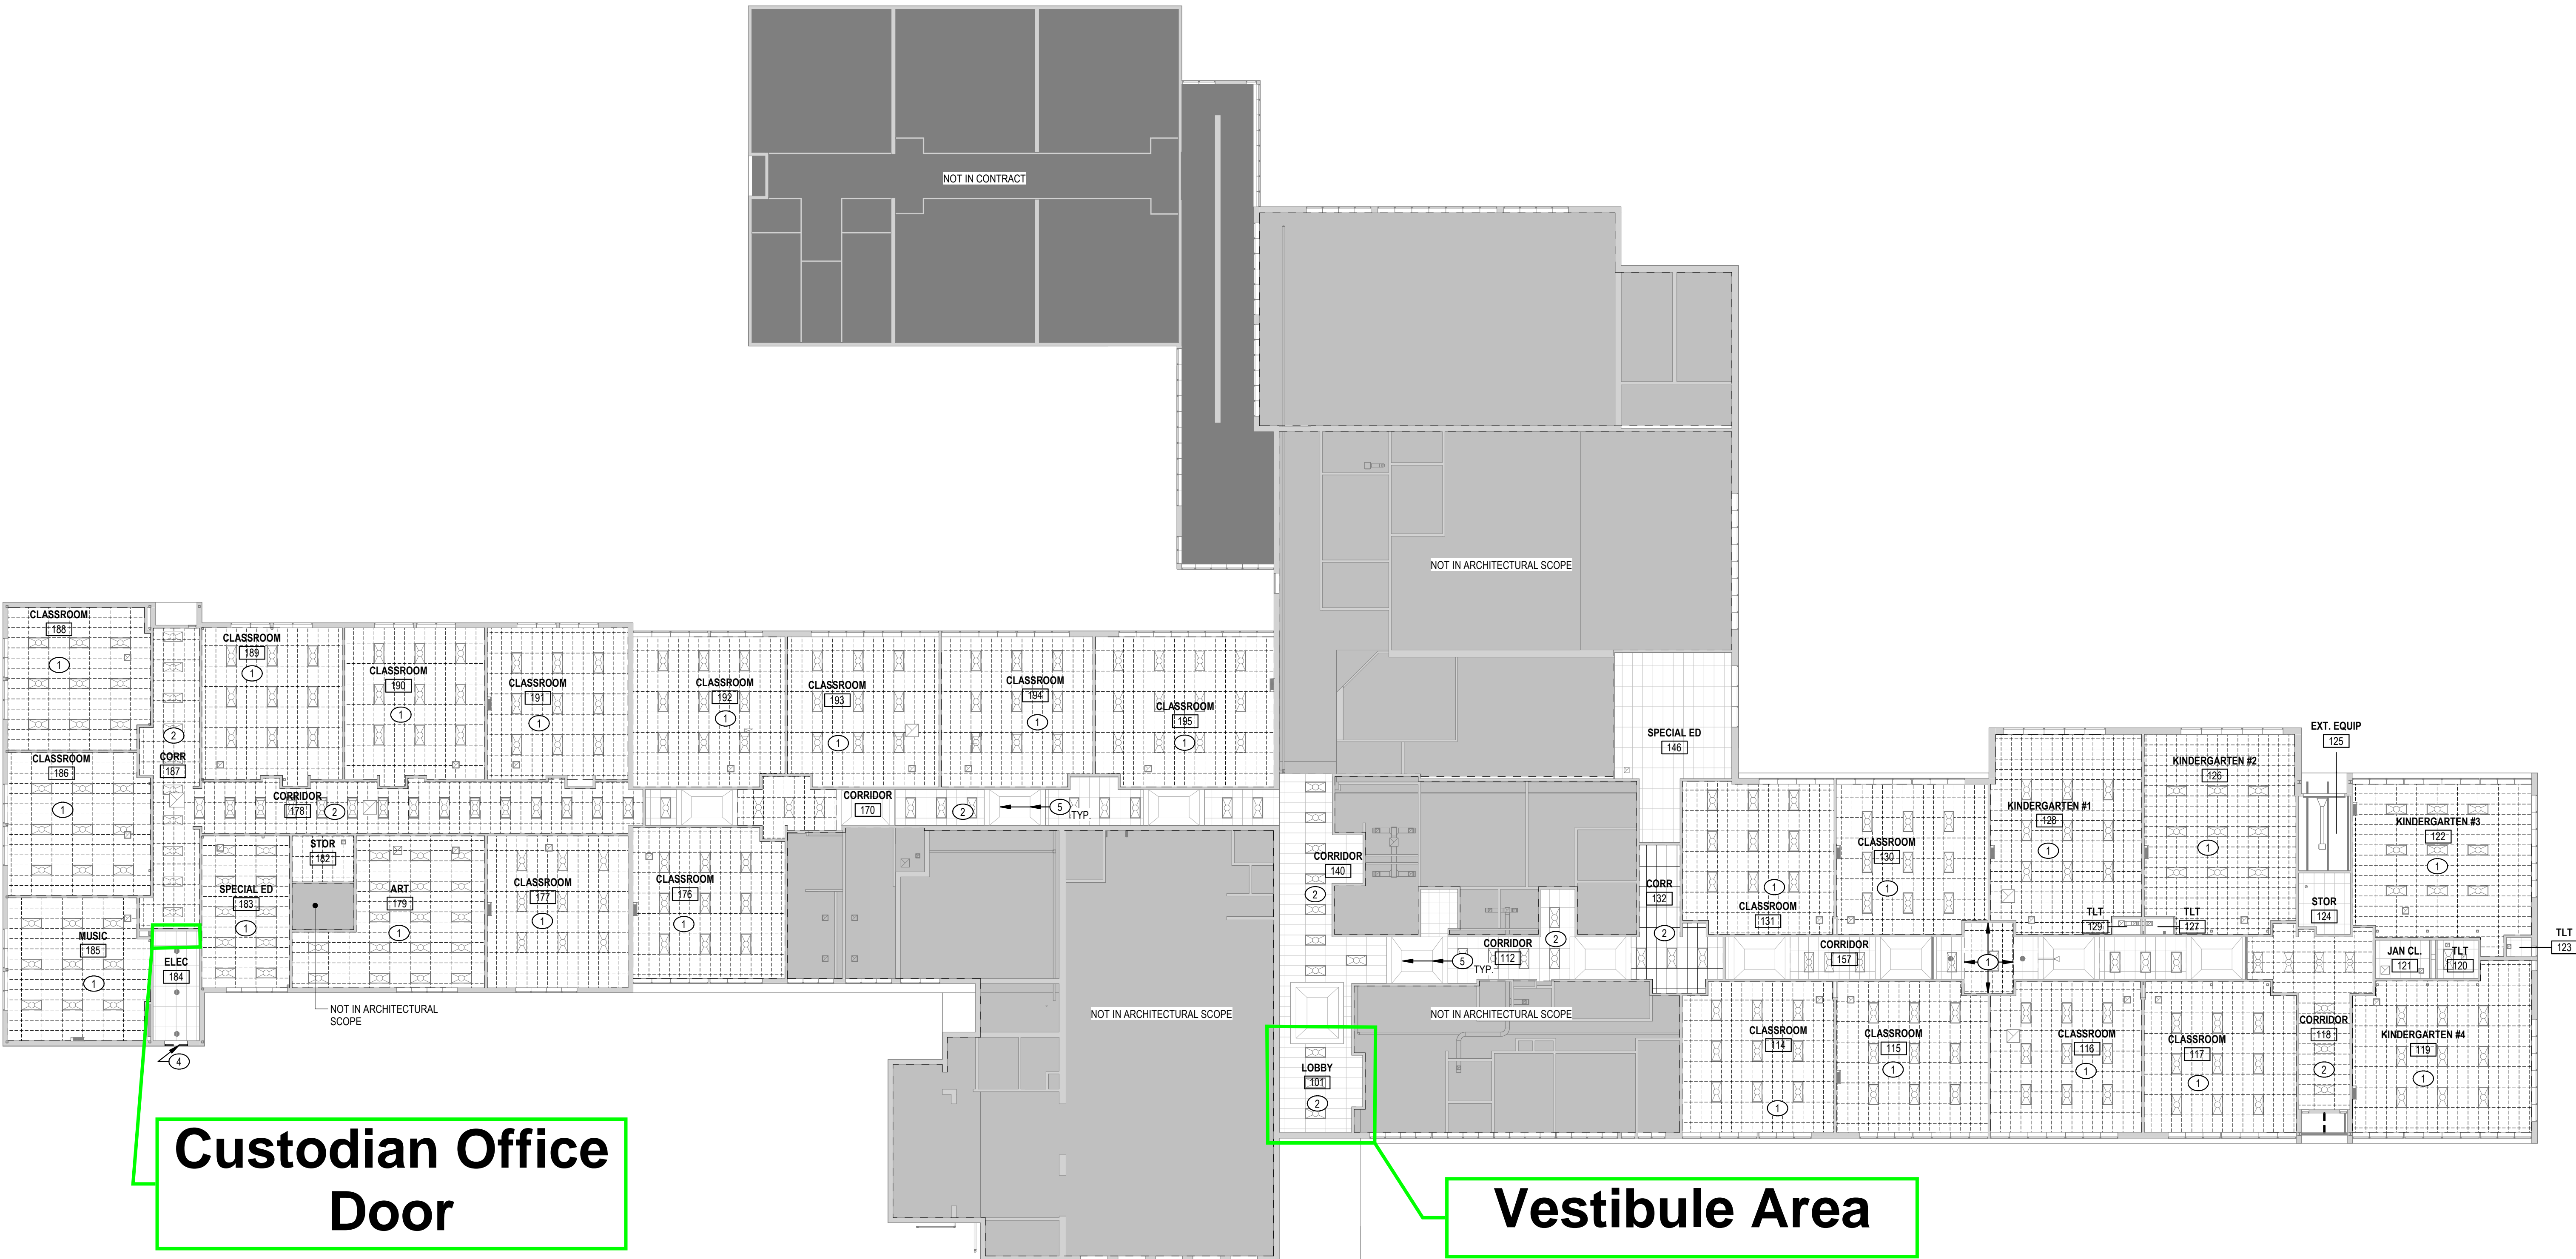
# Appendix C - Summary of Observed Suspect PCB-Containing Building Materials

1. Painted CMU block walls present in hallways, classrooms, and other areas throughout the building; paint identified as suspect PCB-containing building material based on the date of construction.
2. Paint on structural steel components observed in overhead areas throughout the building; materials identified as suspect PCB-containing building material based on the date of construction.
2. Suspect PCB-containing caulking/sealants observed on windows between classrooms and hallways.
3. Suspect PCB-containing caulking observed on door of custodian office to be removed.
4. Suspect PCB-containing caulking and sealants observed on main entry vestibule and cafeteria doors.

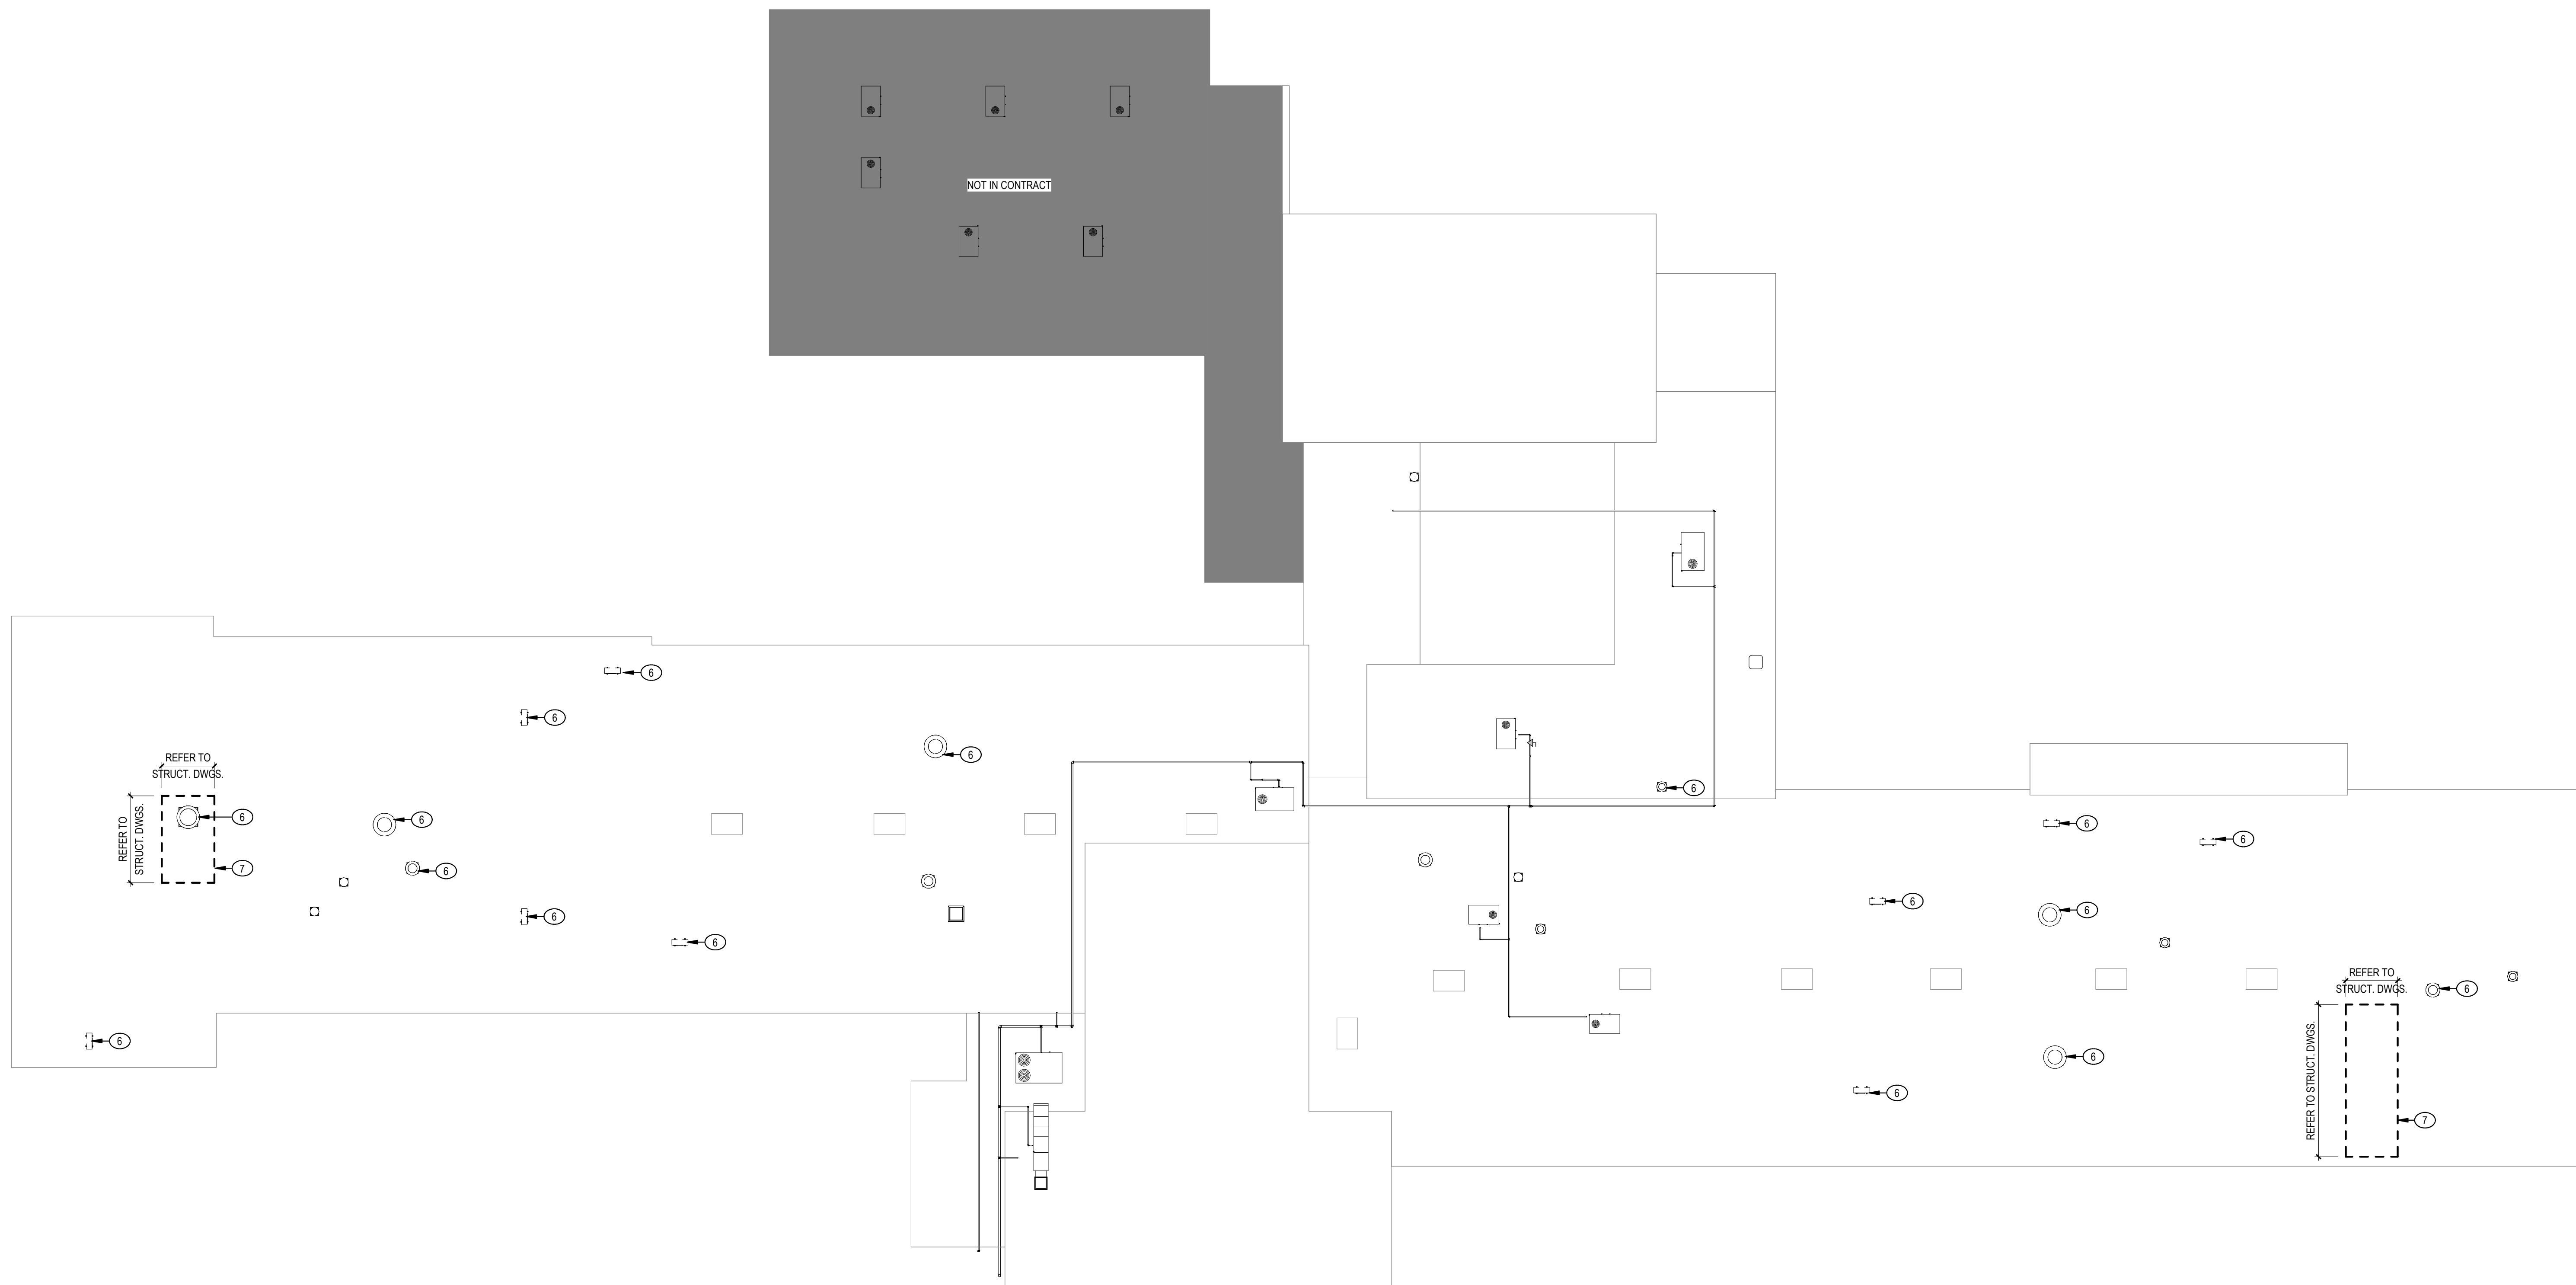
## Appendix C - Summary of Observed Suspect PCB-Containing Building Materials

1. Caulking sealants on roof area, including flashing and penetration points not considered suspect PCB-containing building materials based on reported date of construction (2020).

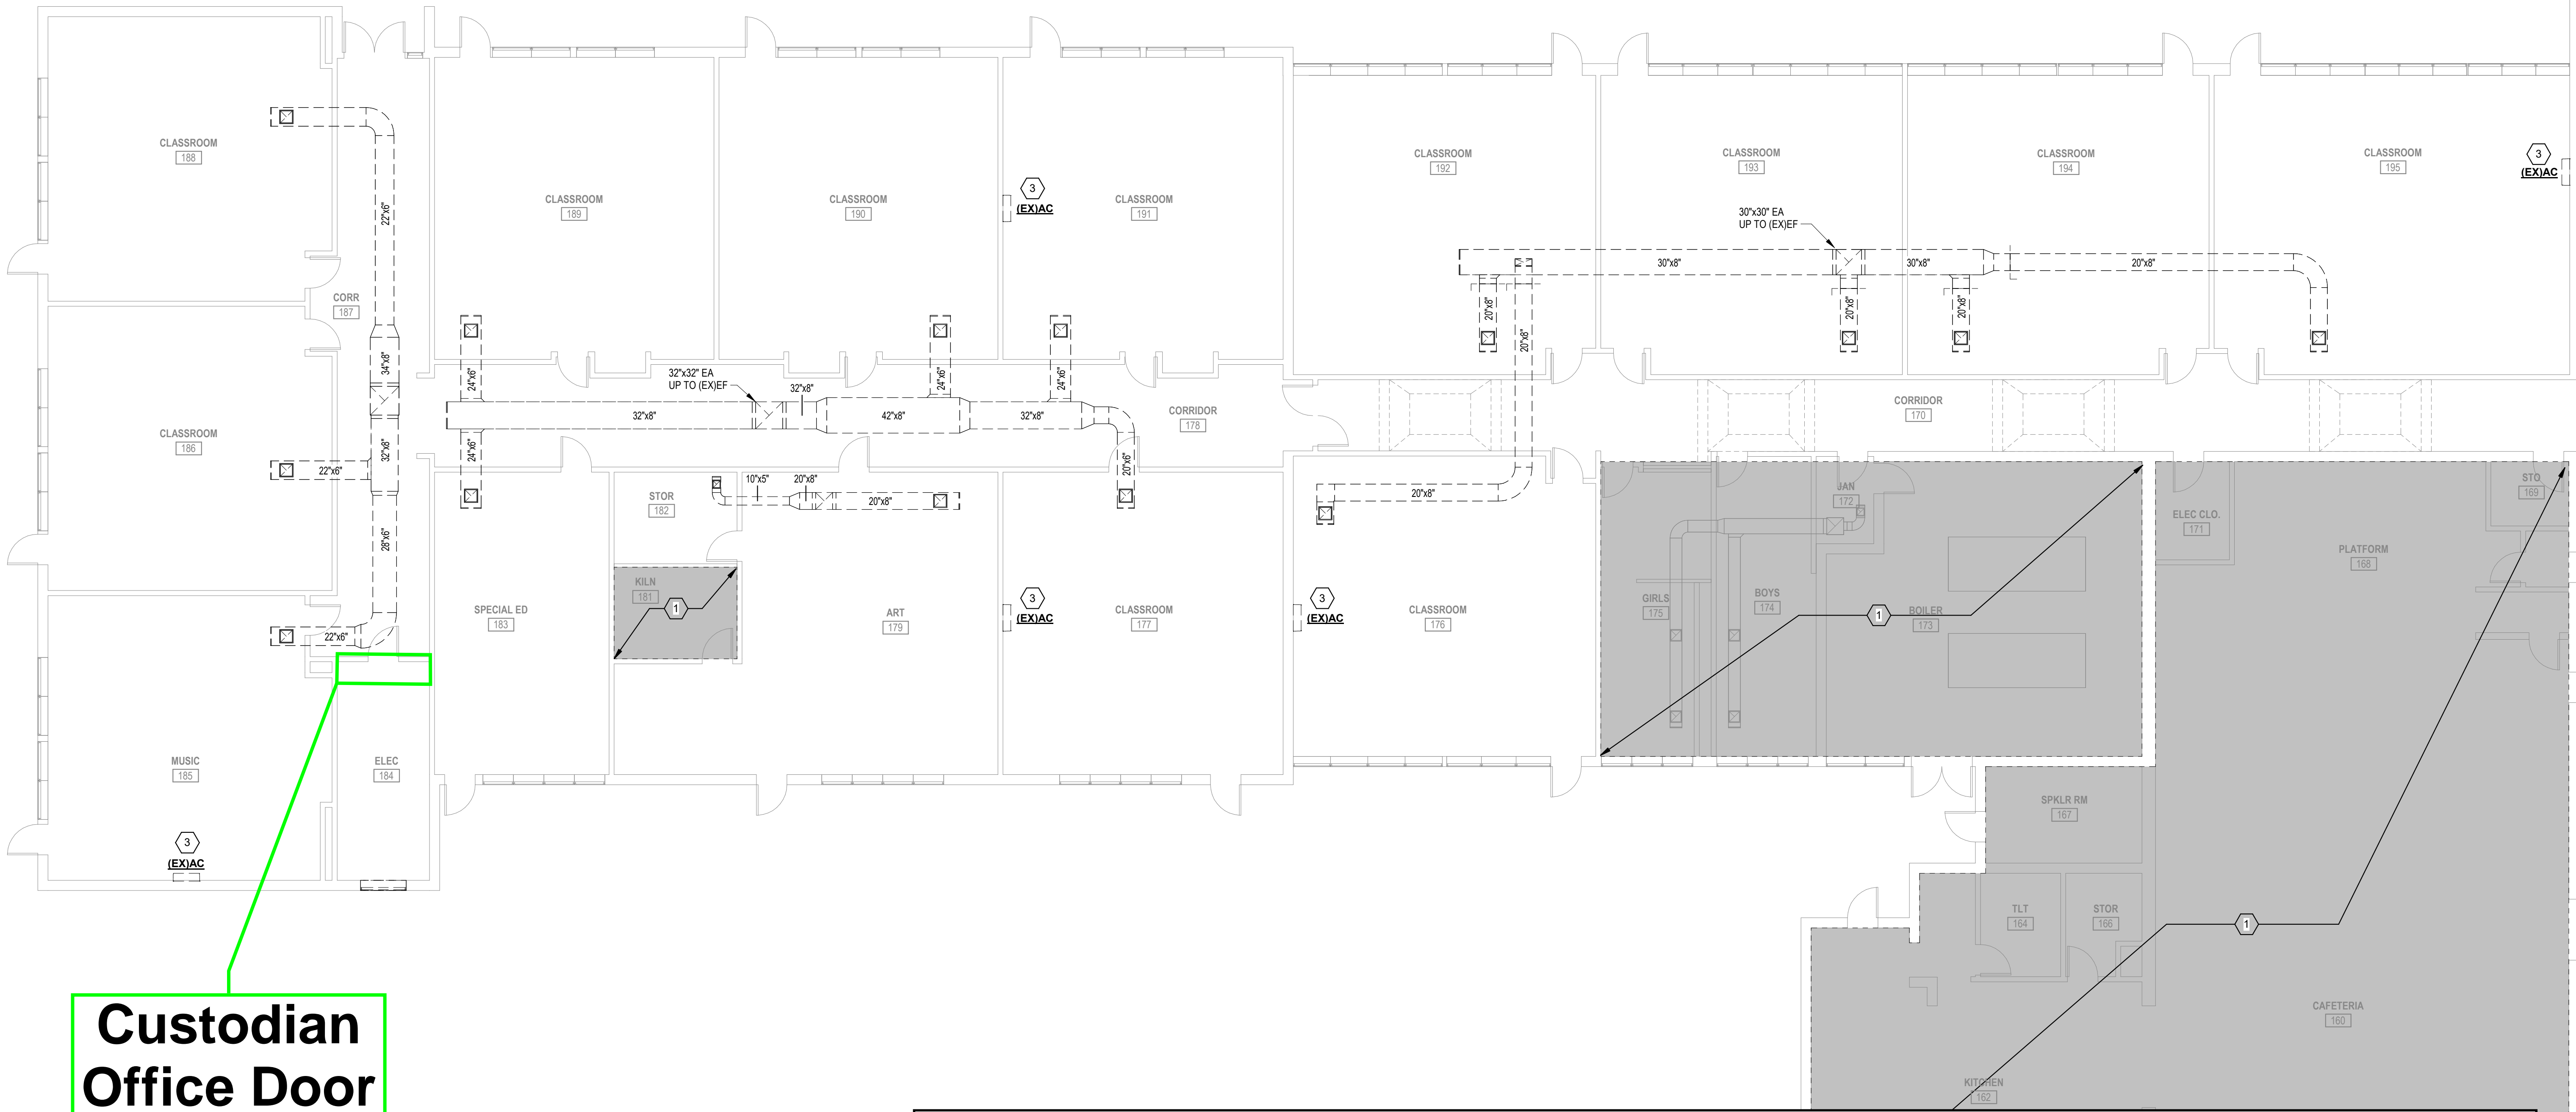
# Appendix C - Summary of Observed Suspect PCB-Containing Building Materials

1. Painted CMU block walls present in hallways, classrooms, and other areas throughout the building; paint identified as suspect PCB-containing building material based on the date of construction.
2. Paint on structural steel components observed in overhead areas throughout the building; materials identified as suspect PCB-containing building material based on teh date of construction.
2. Suspect PCB-containing caulking/sealants observed on windows between classrooms and hallways.
3. Suspect PCB-containing caulking observed on door of custodian office to be removed.
4. Suspect PCB-containing caulking and sealants observed on main entry vestibule and cafeteria doors.
5. Sealants associated with ventilation ductwork not considered suspect for PCBs based on reported date on installation (1995/1996).

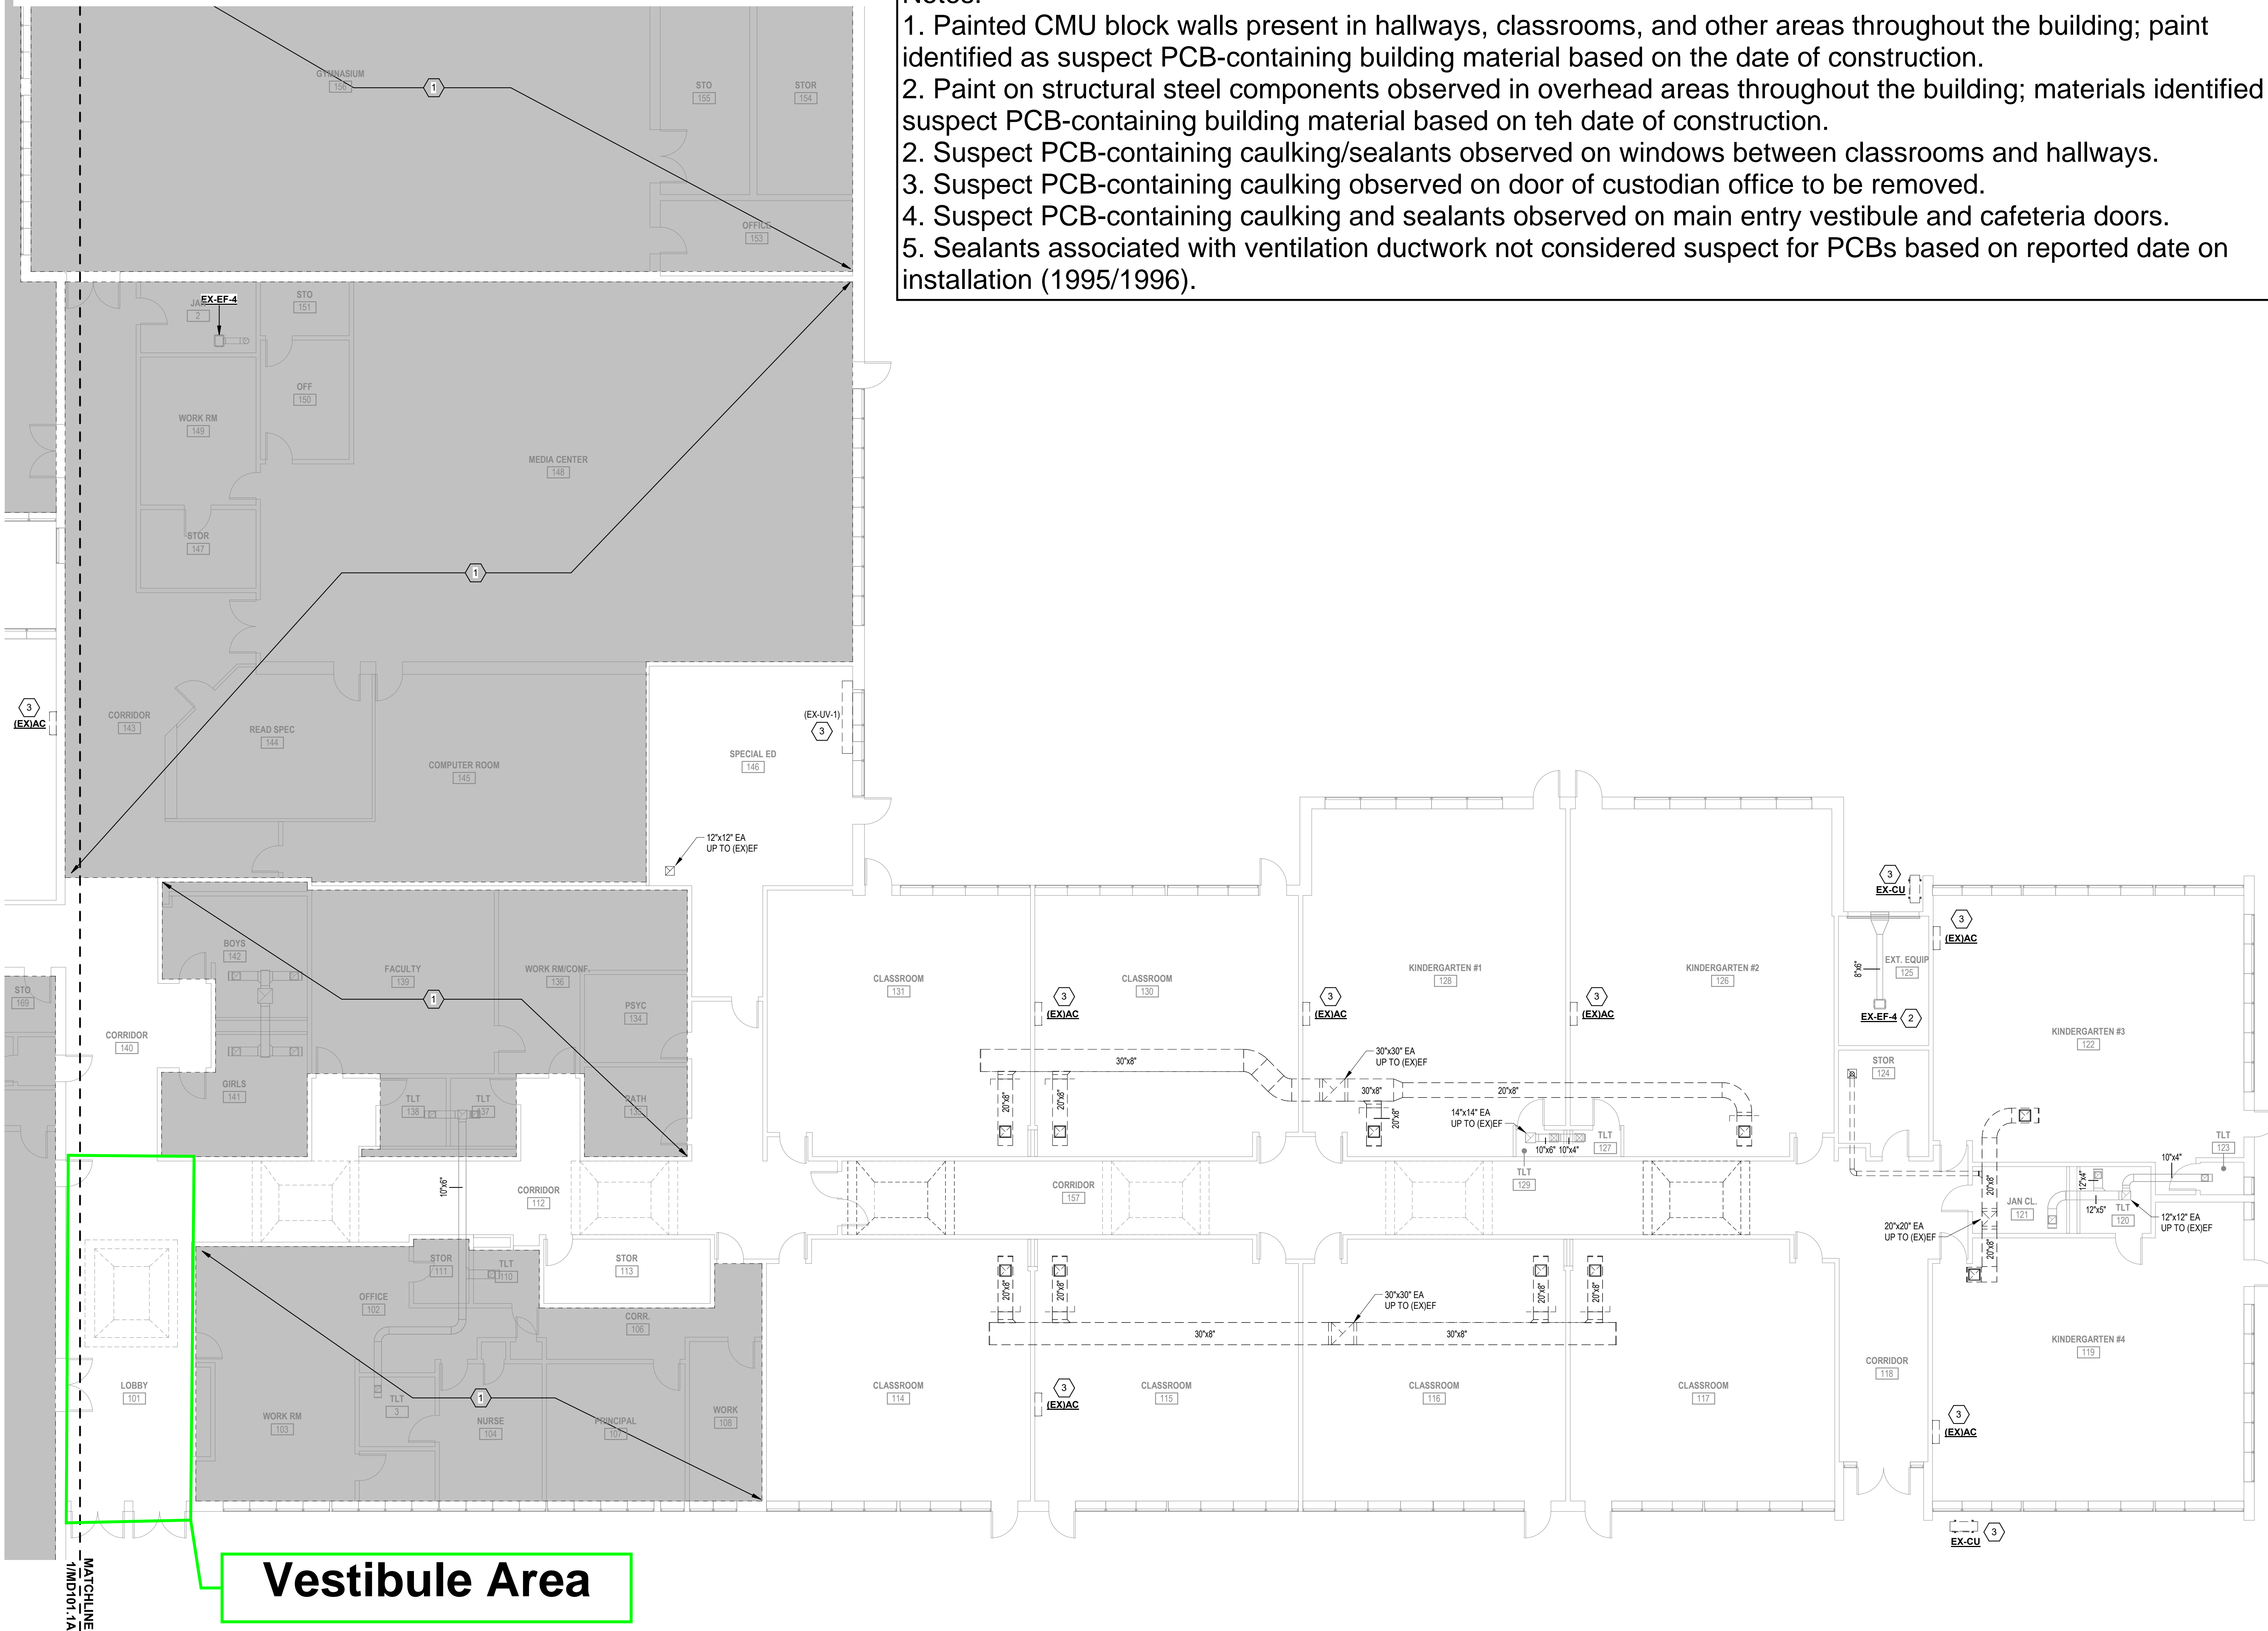
## Appendix C - Summary of Observed Suspect PCB-Containing Building Materials

1. Painted CMU block walls present in hallways, classrooms, and other areas throughout the building; paint identified as suspect PCB-containing building material based on the date of construction.
2. Paint on structural steel components observed in overhead areas throughout the building; materials identified as suspect PCB-containing building material based on the date of construction.
2. Suspect PCB-containing caulking/sealants observed on windows between classrooms and hallways.
3. Suspect PCB-containing caulking observed on door of custodian office to be removed.
4. Suspect PCB-containing caulking and sealants observed on main entry vestibule and cafeteria doors.
5. Sealants associated with ventilation ductwork not considered suspect for PCBs based on reported date of installation (1995/1996).

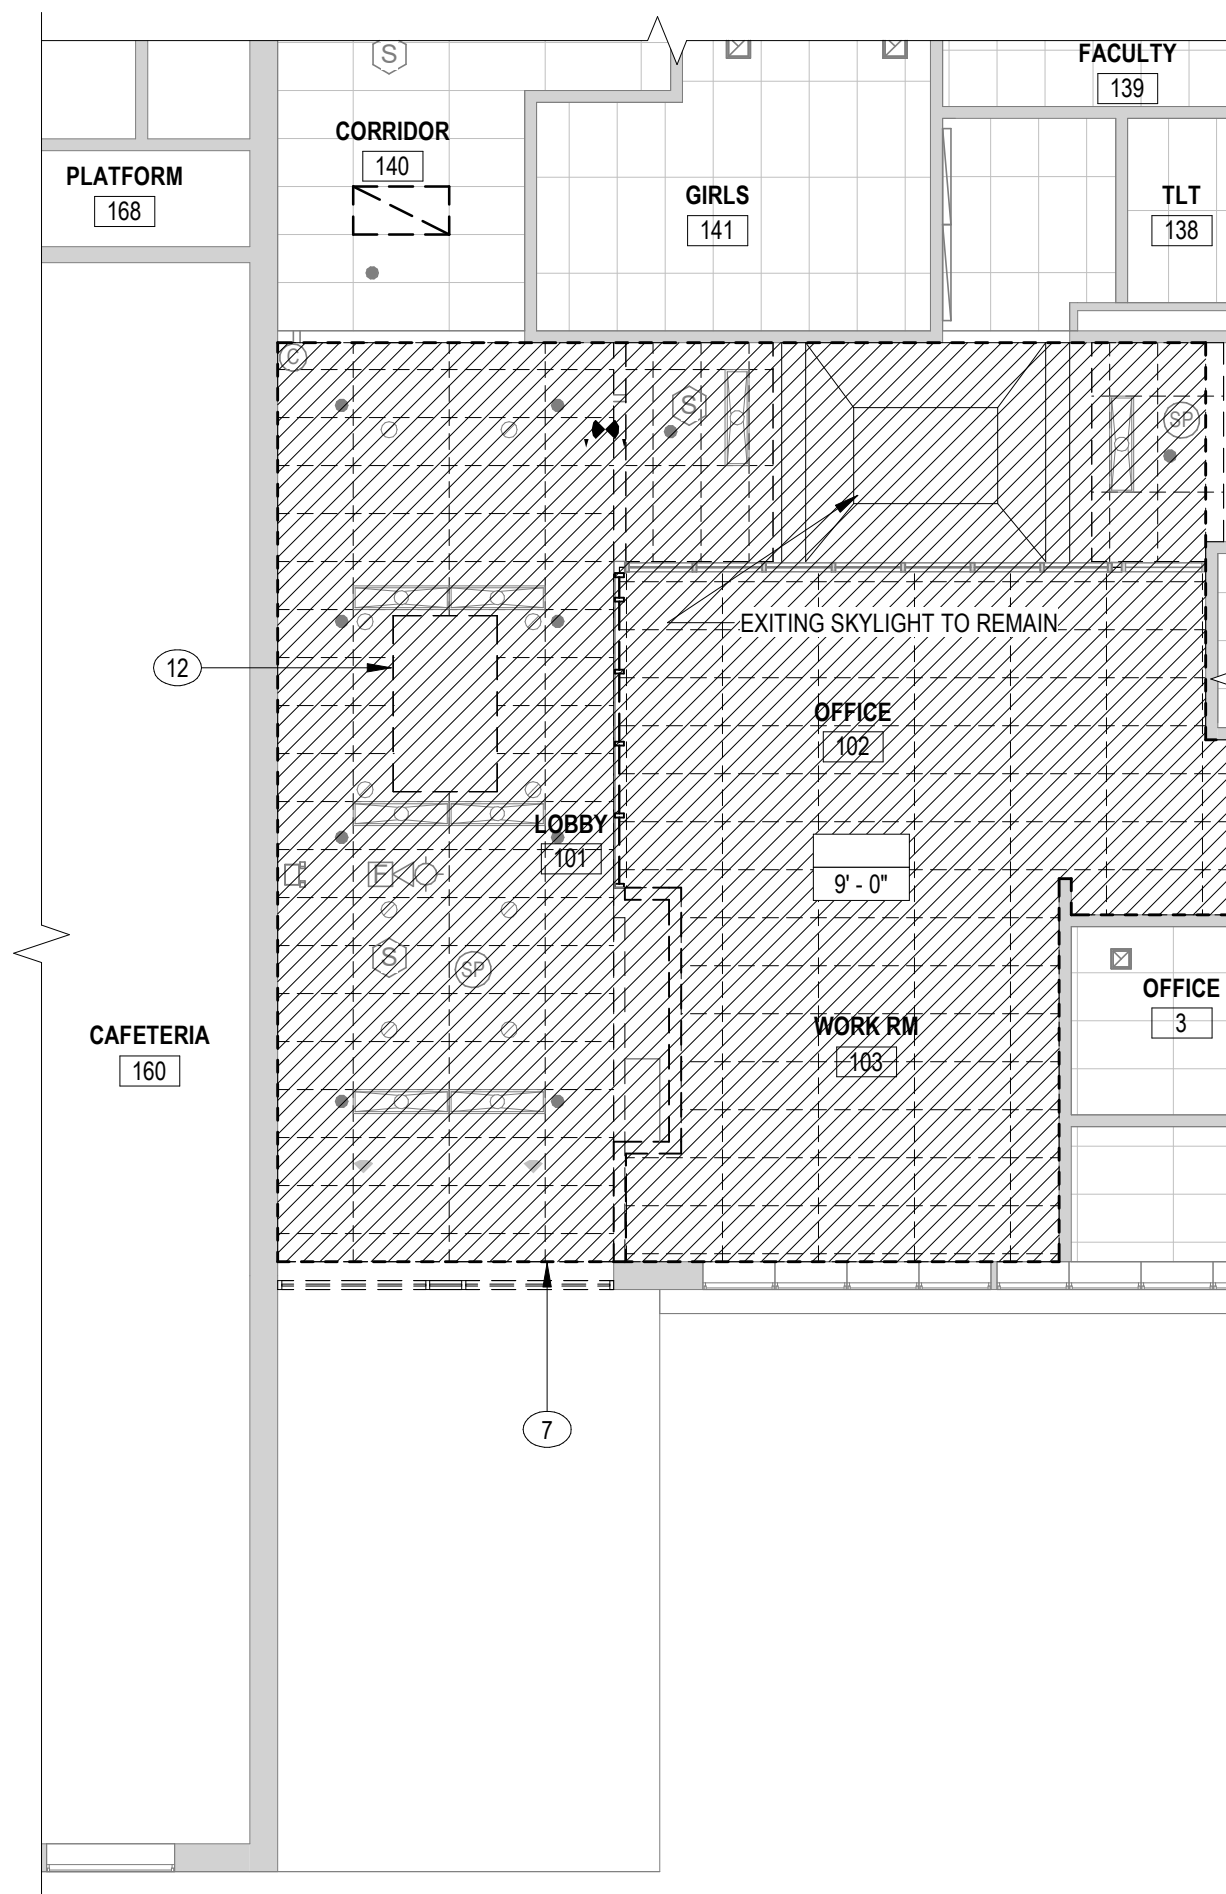
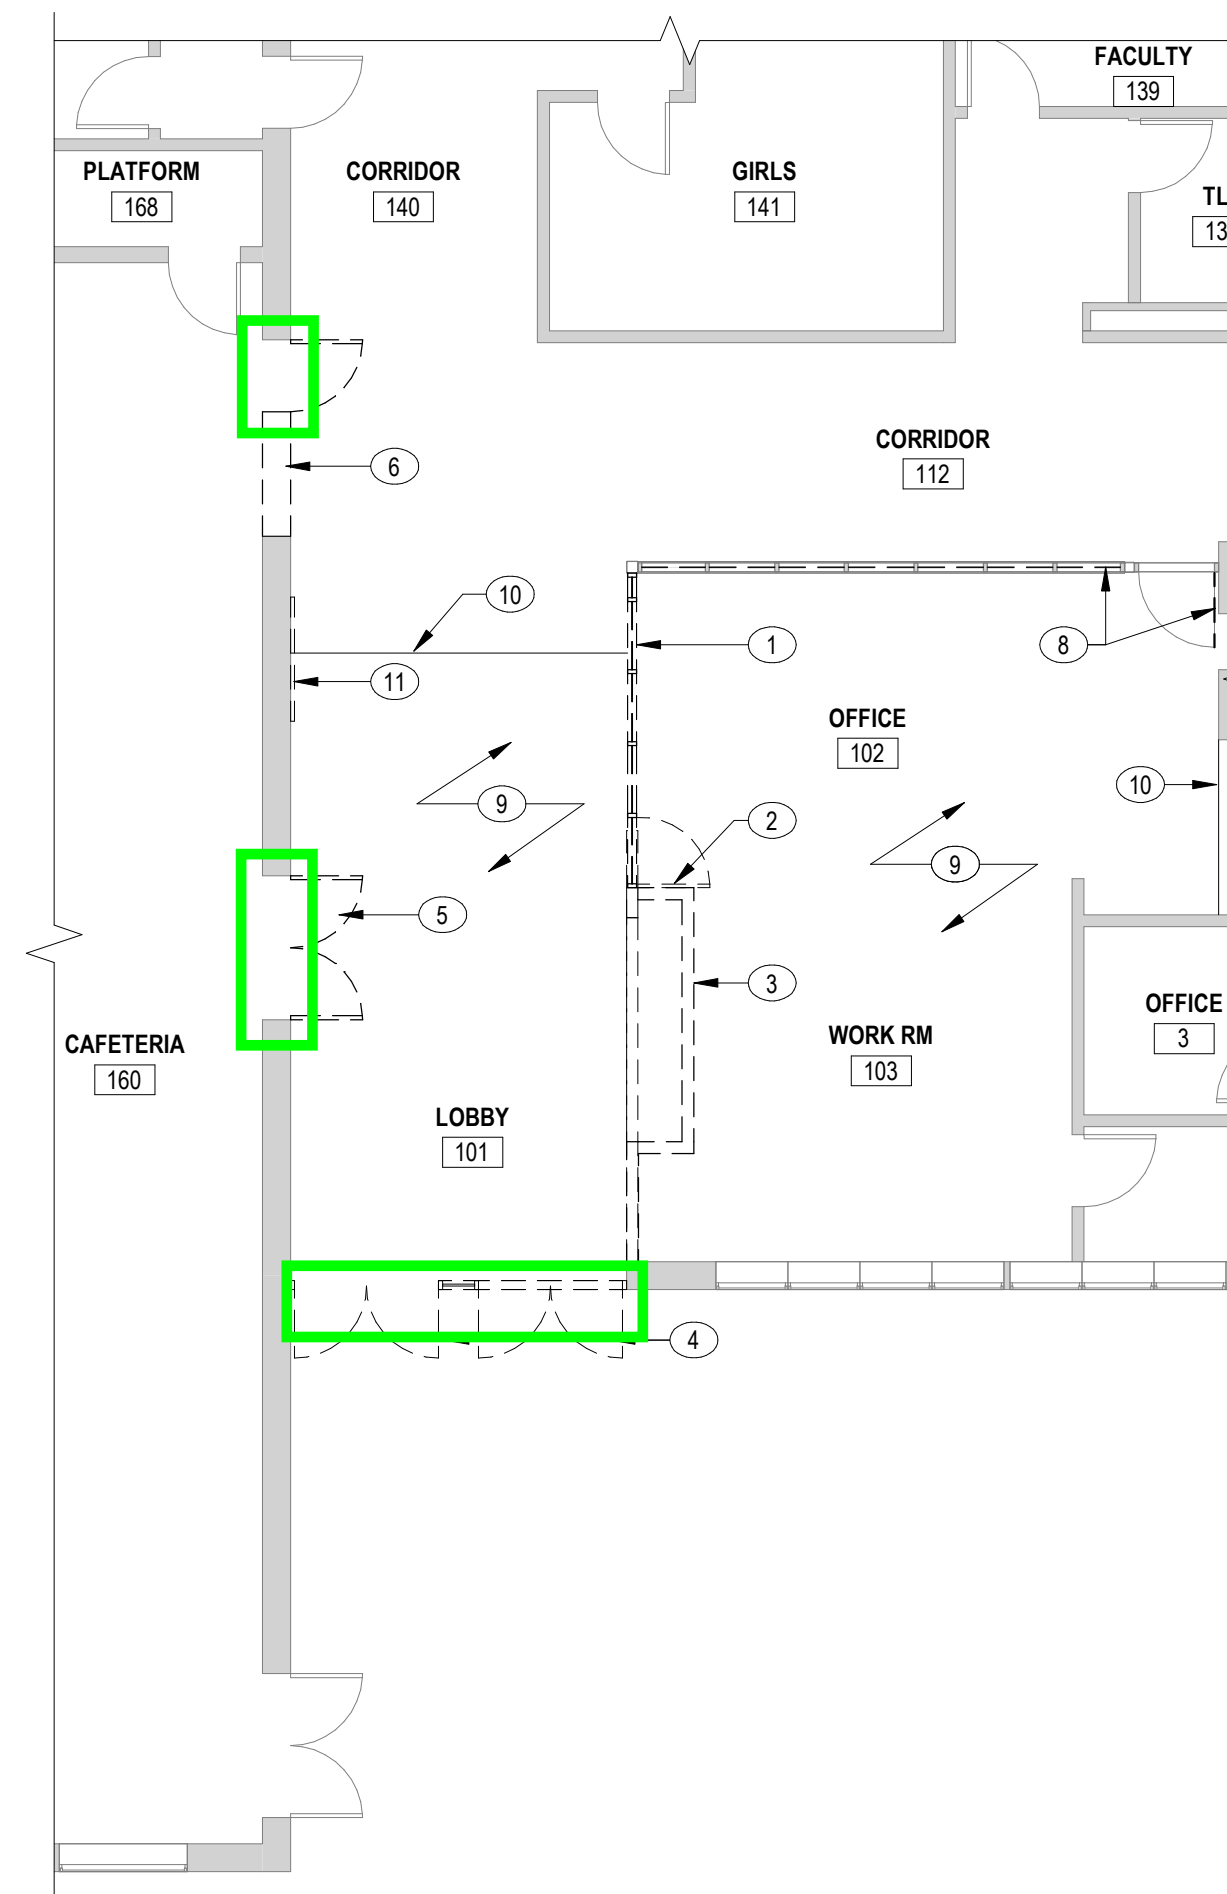
## Appendix C - Summary of Observed Suspect PCB-Containing Building Materials

1. Painted CMU block walls present in hallways, classrooms, and other areas throughout the building; paint identified as suspect PCB-containing building material based on the date of construction.
2. Paint on structural steel components observed in overhead areas throughout the building; materials identified as suspect PCB-containing building material based on the date of construction.
2. Suspect PCB-containing caulking/sealants observed on windows between classrooms and hallways.
3. Suspect PCB-containing caulking observed on door of custodian office to be removed.
4. Suspect PCB-containing caulking and sealants observed on main entry vestibule and cafeteria doors.
5. Sealants associated with ventilation ductwork not considered suspect for PCBs based on reported date on installation (1995/1996).
