Hazardous Building Materials Survey Report

North Stratfield
Elementary School

0235319.00
BL Companies
January 2024

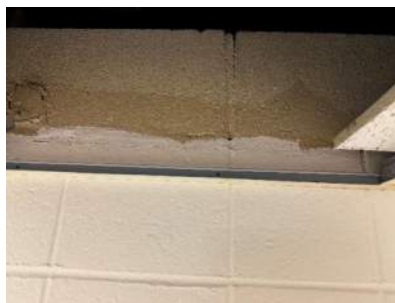
- Office Windows and Doors – no caulking or glazing sealants were observed.
- CMU Block Walls – Walls throughout the school were primarily painted CMU block (brick walls were located in the main entry area). CMU walls were painted yellow, white or off-white. Multiple layers of paint (some of differing colors) were observed in some areas. At the majority of locations observed, paint had been present on the walls up to the drop ceiling with bare CMU above (the upper 8 to 10 inches of wall). In some locations, the paint was observed above the drop ceiling.

Paint on CMU Walls

Based on the limited scope of work associated with the above materials, the design team has decided to manage those portions of the above materials disturbed by the planned renovations as an assumed PCB Bulk Product Waste in accordance with 40 CFR Interior 761.62 (i.e., assumed to contain PCBs ≥ 50 ppm for removal and disposal purposes). During the survey, representative samples of the above materials were collected; however, they have not been submitted for laboratory analysis and are currently being held in our dedicated sample freezer. These samples may be held for a period of up to one year to allow for future analysis if the project team reevaluates the decision to assume that PCBs are present in the materials.

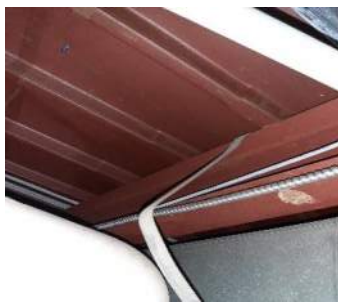
- Structural Steel and Metal Decking – Structural steel cross beams and the bottom side of metal roof decking were coated with red paint.
- Electrical Room Door – grey, soft, flexible caulking over black, soft, flexible caulking was observed between the metal door frame and brick wall.

Painted Steel and Roof Decking

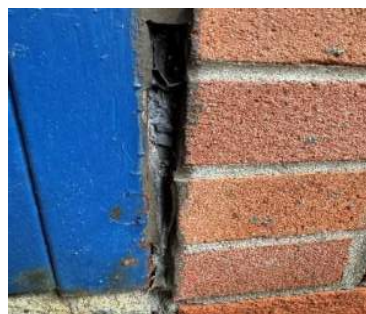
Electrical Room Door Caulking

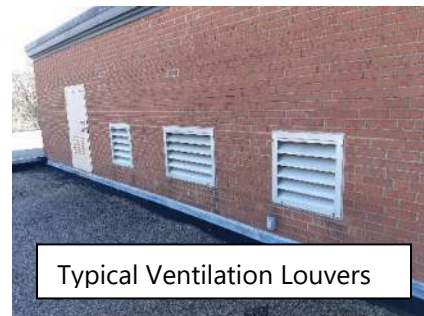
- **Rooftop Ventilation Louver Caulking (100 LF)** – caulking was observed along the metal louver frame to brick façade joints on the roof top penthouse structures. A total of 8 louvers were observed and are designated for removal as part of the project.

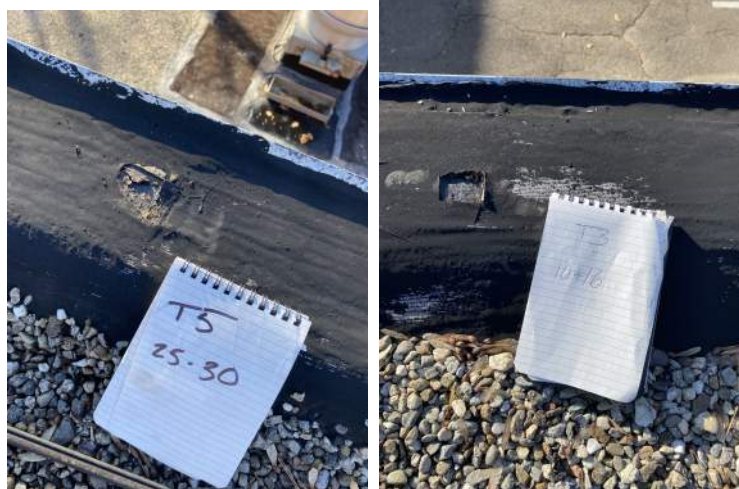
EnviroMed Services Inc. accredited asbestos laboratory analyzed the bulk samples. The complete laboratory report can be found in Section III. The following asbestos-containing ($\geq 1\%$ asbestos) roofing materials were found on the roof sections surveyed:

Quantity: 1,400 SF

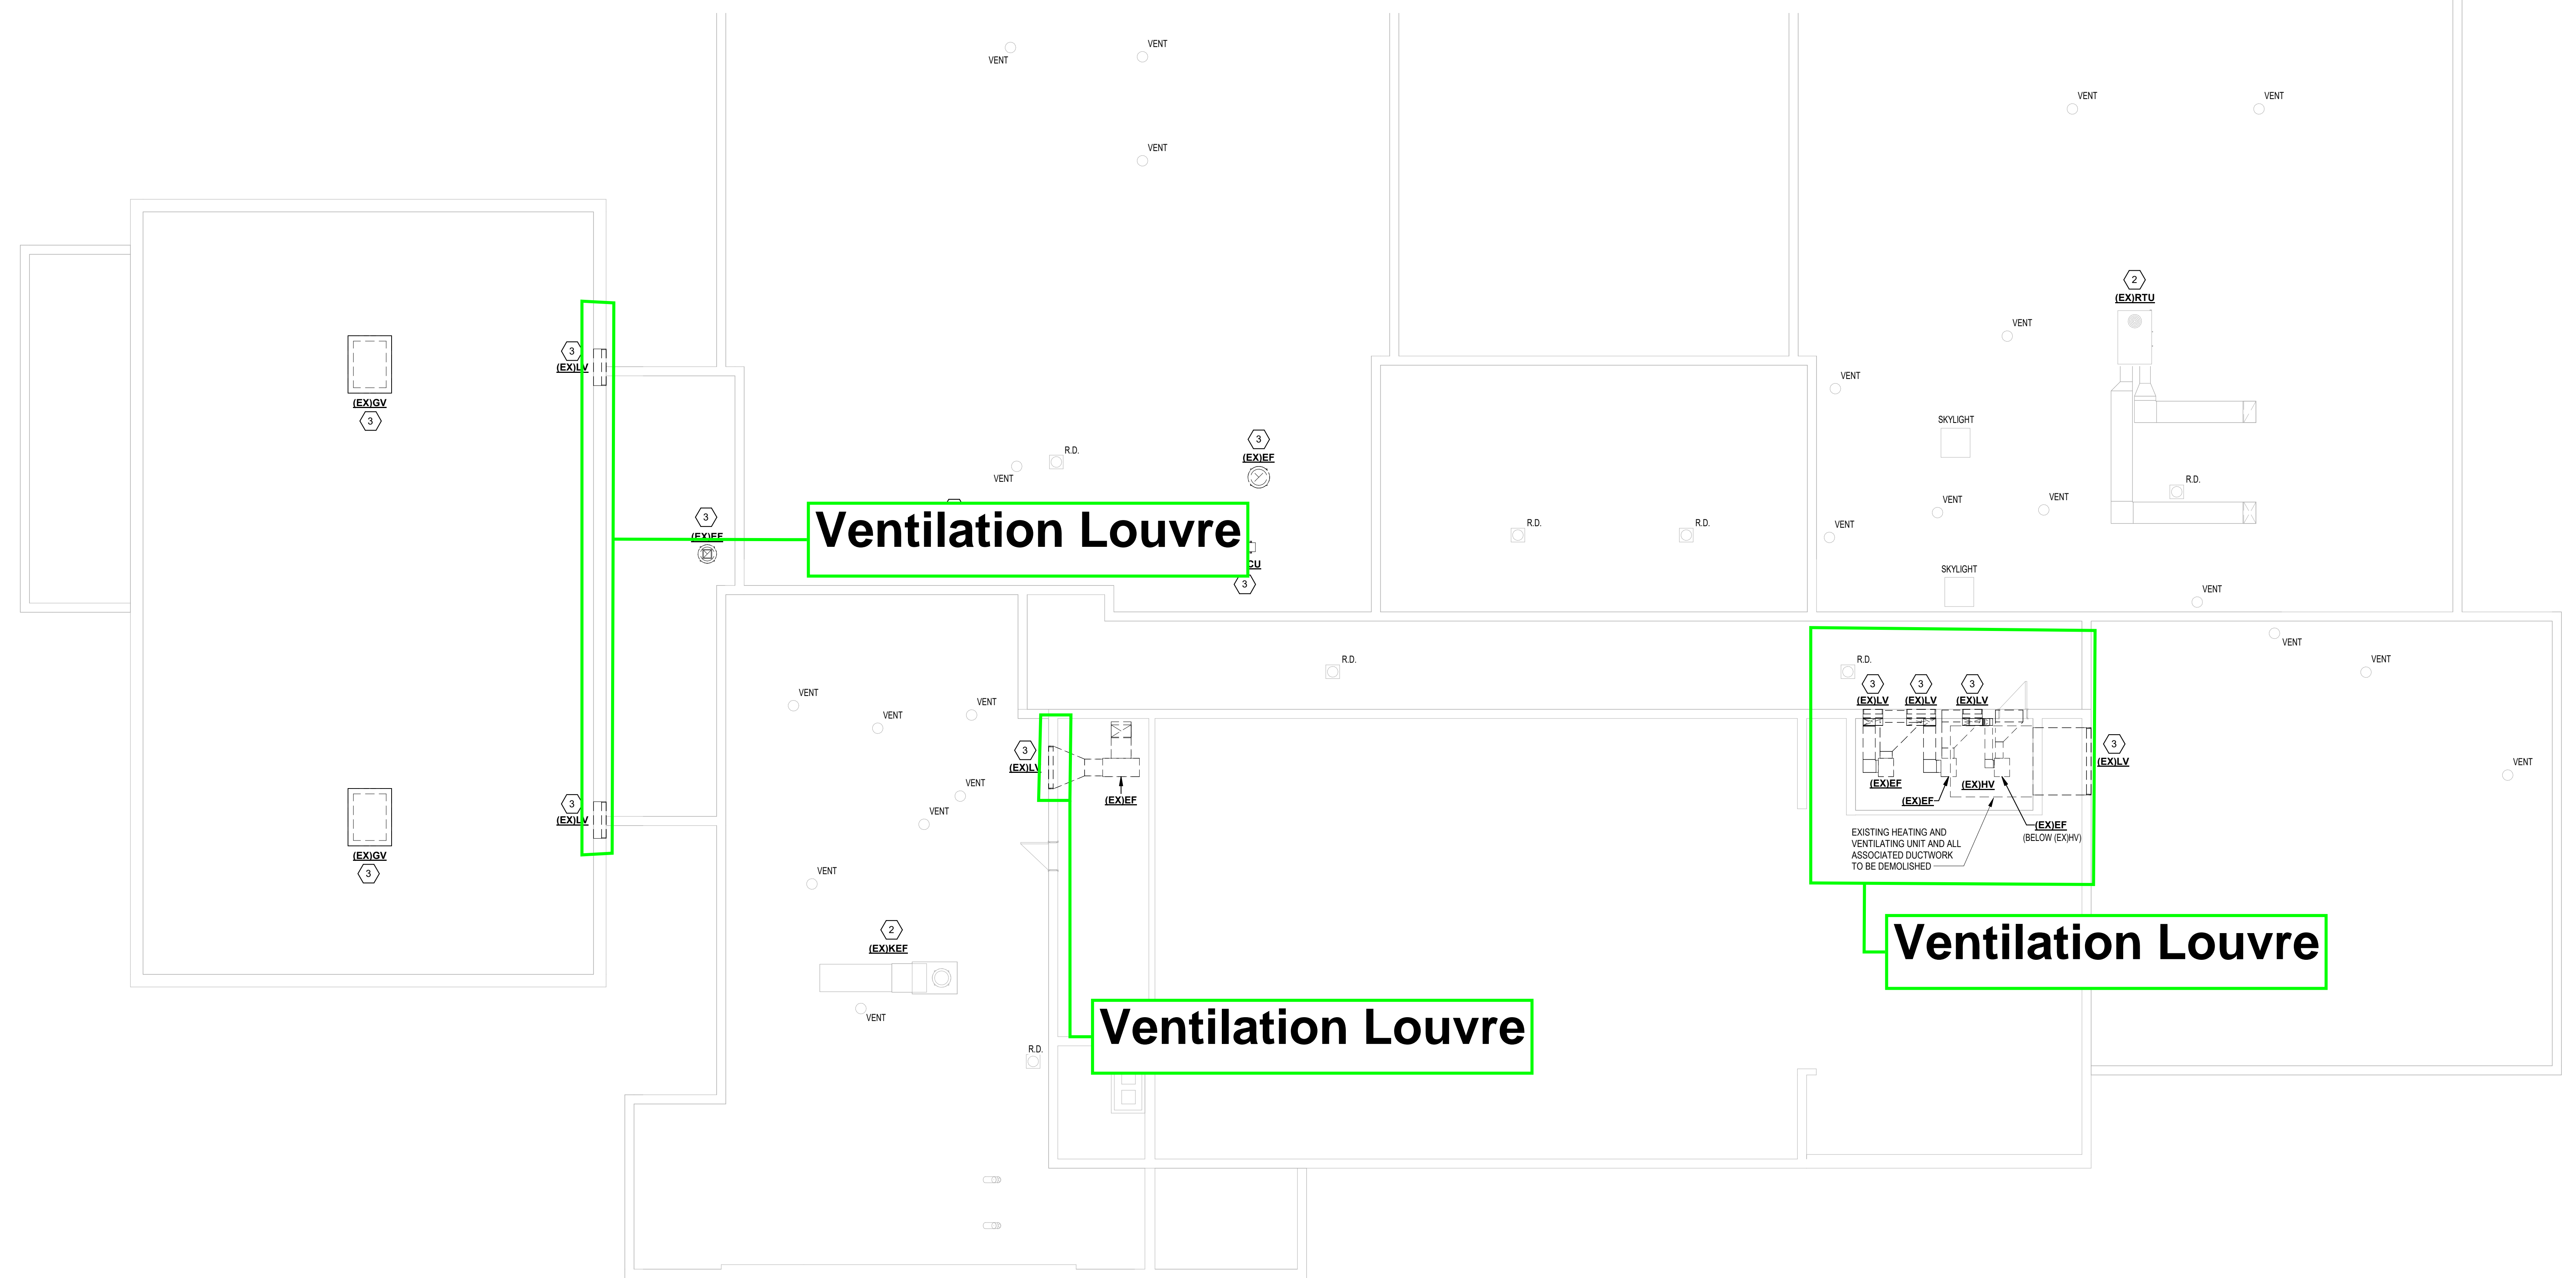
1 PARTIAL ROOF MECHANICAL DEMOLITION PLAN - PART A

1. Caulking on ventilation louver frames to facade joints identified as suspect PCB-containing building material.
2. Paint on structural steel components and metal roof decking observed in overhead areas throughout the building; materials identified as suspect PCB-containing building material based on the date of construction.
3. Sealants associated with the roof (flashing sealants, sealants at penetration points), not considered suspect for PCBs based on reported date on installation (1996 and 2000).
4. Sealants associated with ventilation ductwork not considered suspect for PCBs based on reported date on installation (1995/1996).

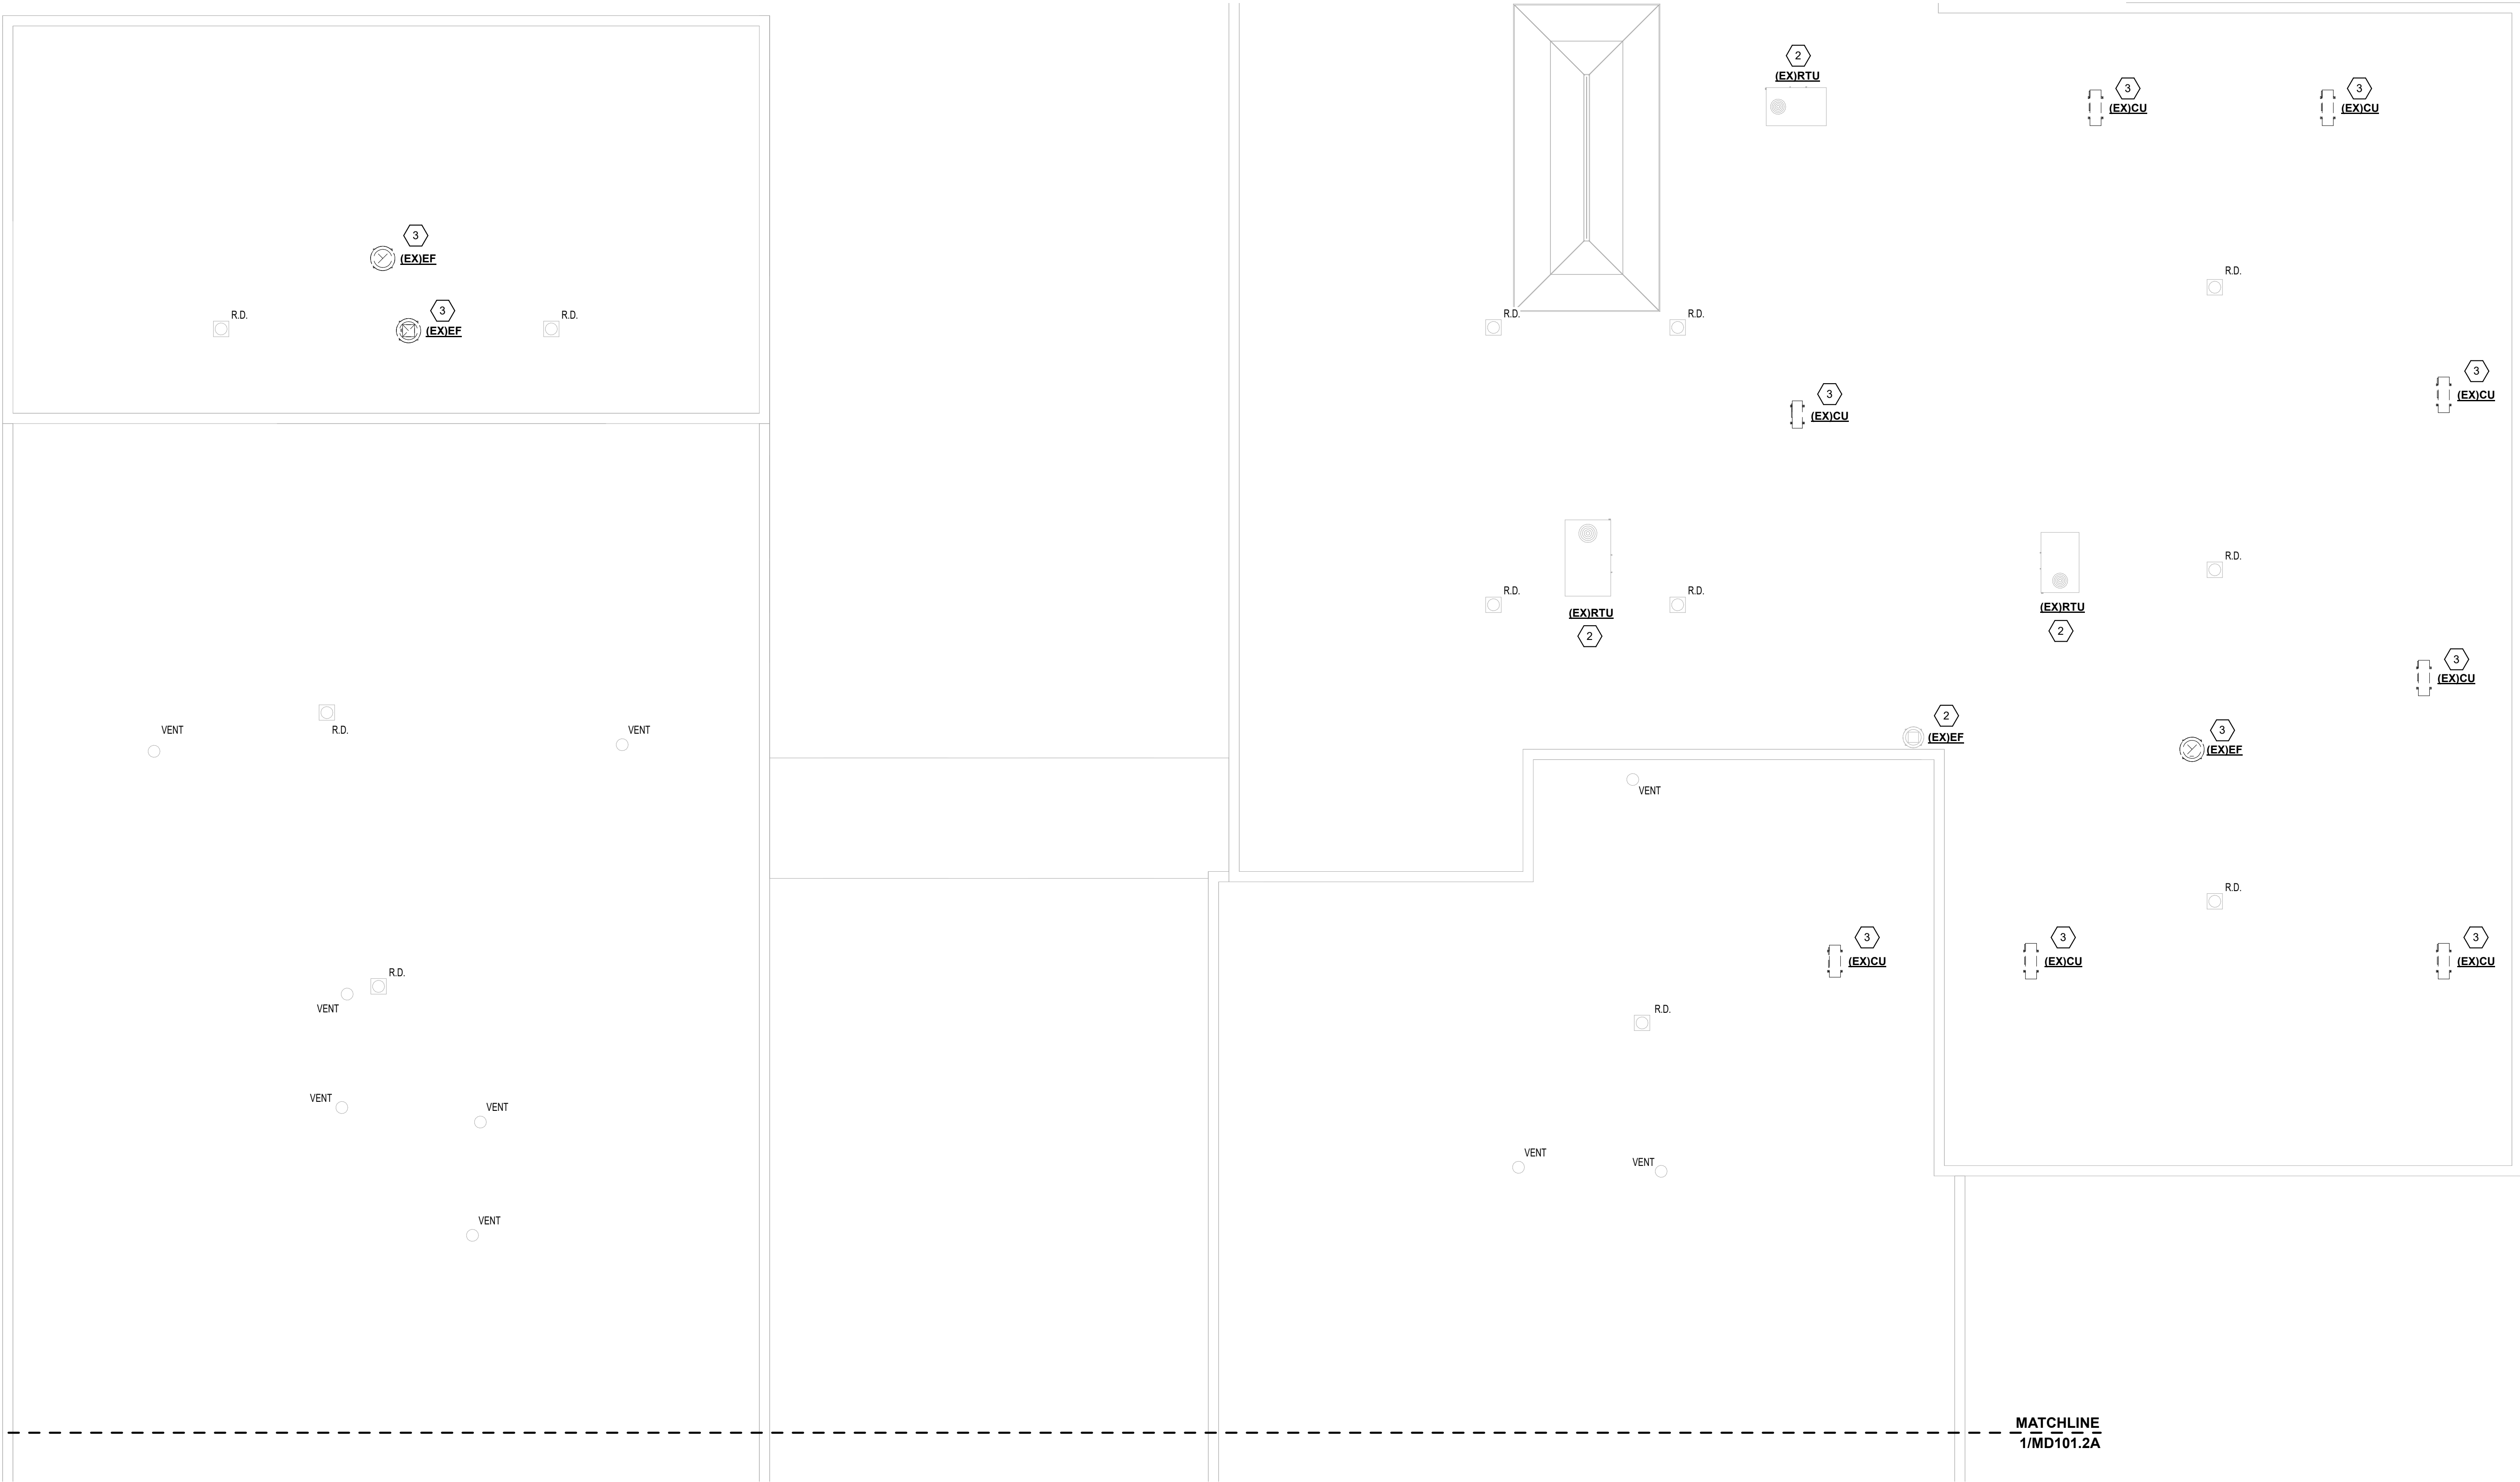
1 PARTIAL ROOF MECHANICAL DEMOLITION PLAN - PART B
1/8" = 1'-0"
0 4' 8' 16'
Scale: 1/8" = 1'-0"

Notes:
1. Caulking sealants on roof area, including flashing and penetration points not considered suspect PCB-containing building materials based on reported date of construction.

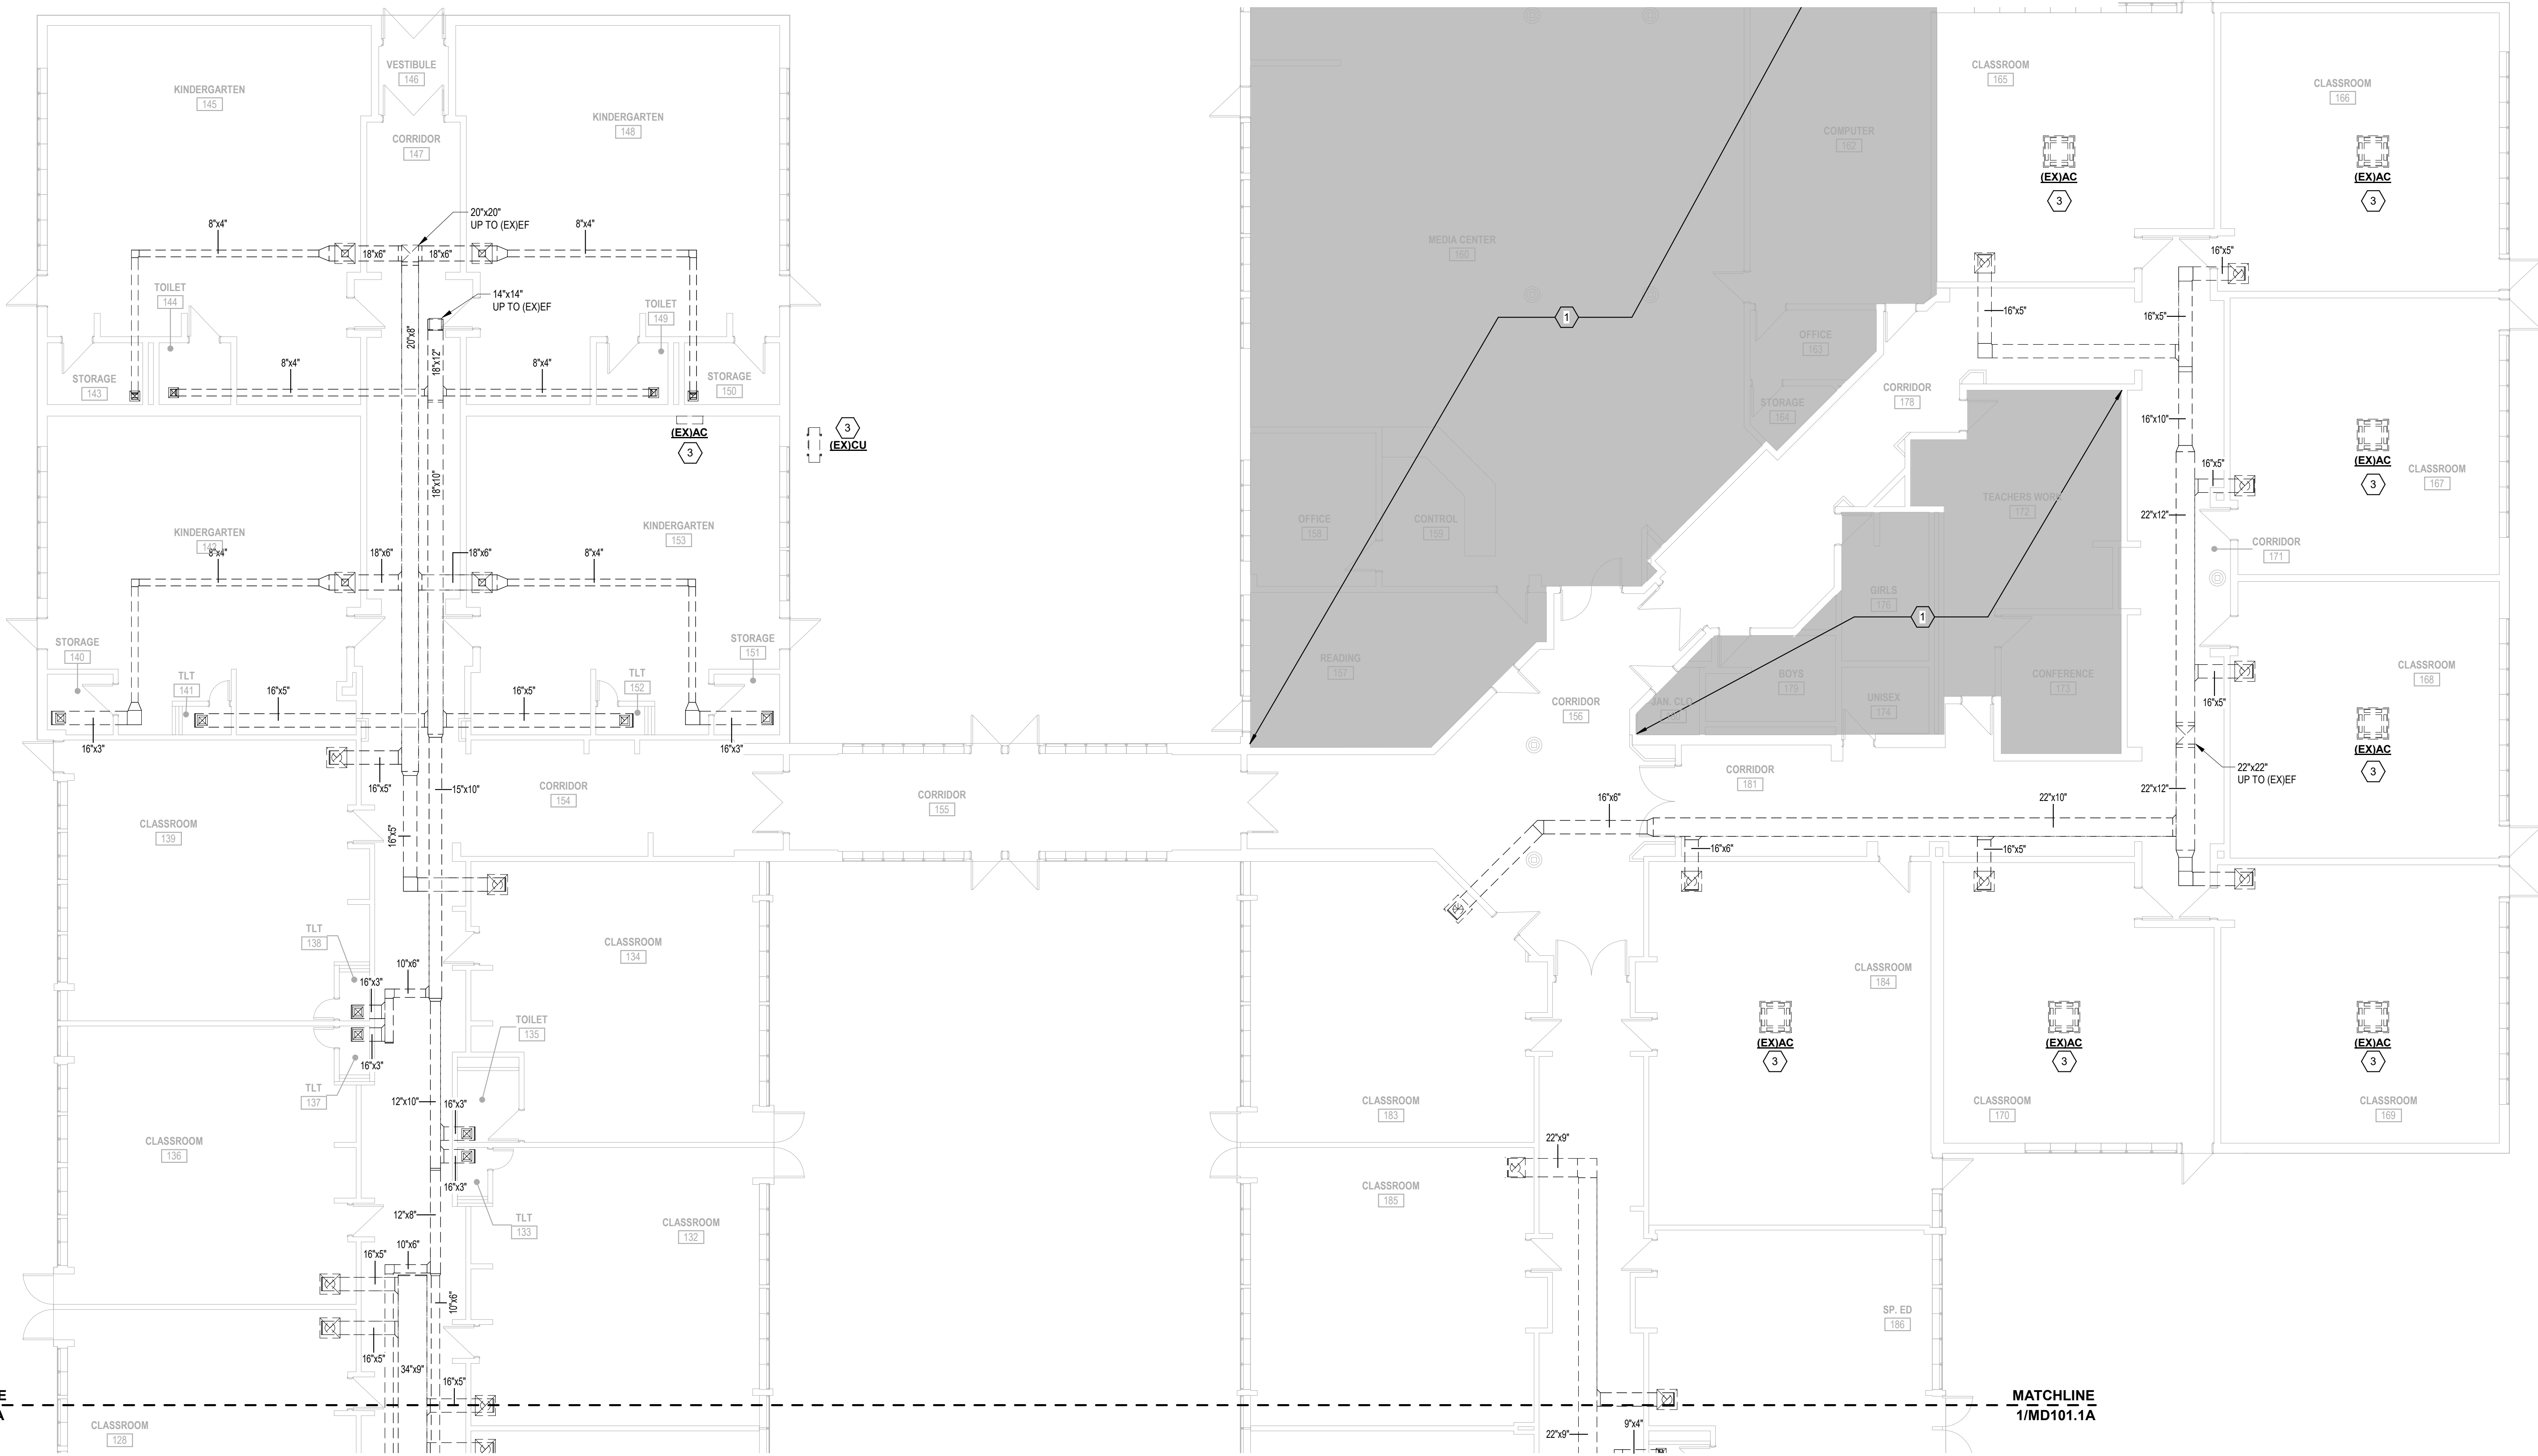
- Painted CMU block walls present in hallways, classrooms, and other areas throughout the building; paint identified as suspect PCB-containing building material based on the date of construction.
- Paint on structural steel components and metal roof decking observed in overhead areas throughout the building; materials identified as suspect PCB-containing building material based on the date of construction.
- Suspect PCB-containing caulking/sealants observed on doors and windows of main entry vestibule.
- Suspect PCB-containing caulking observed on partition doors including door to the electrical room.
- Sealants associated with ventilation ductwork not considered suspect for PCBs based on reported date on installation (1995/1996).
