Hazardous Building Materials Survey Report

Fairfield Woods
Middle School

0235318.00
BL Companies
January 2024

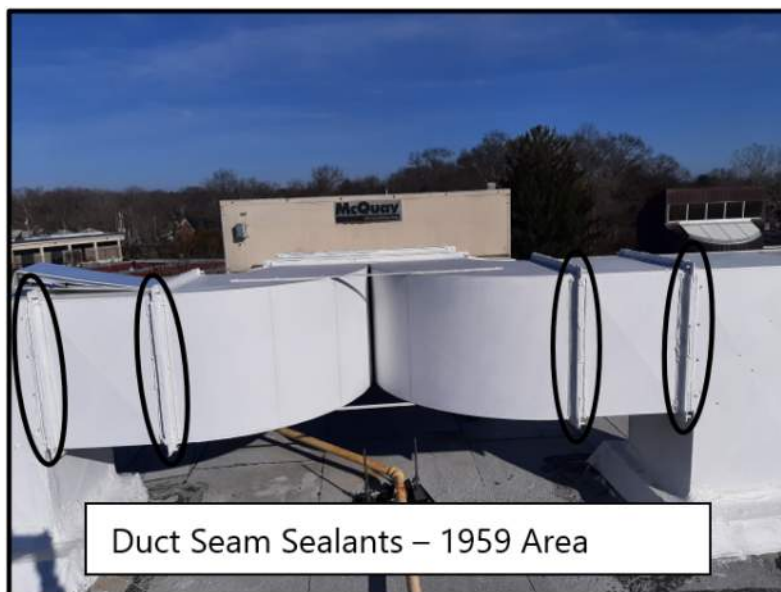
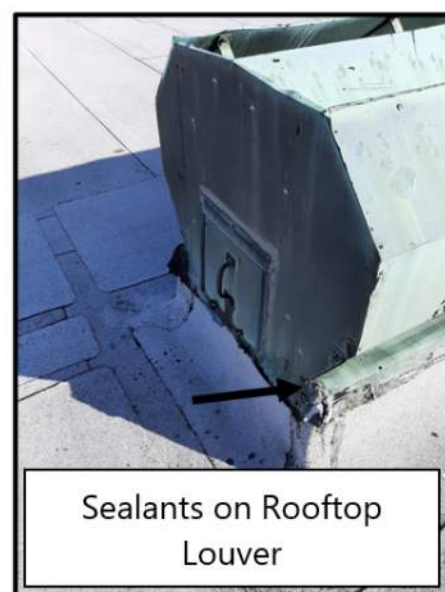
On the roof, ventilation ductwork sealants and caulking sealants associated with ventilation louvers and HVAC units were observed in the 1959 portion of the building (designated as Area C on the 95% Construction Drawings – see photographs below). Information provided by the design team indicated that roofing was replaced in the 2000's; however, no information regarding the date of installation for the HVAC or louvers has been provided. If these items were also installed after 1980, they would not be considered suspect for PCBs. Sealants were not observed on roof top vents or penetration points at other areas of the roof, including the northern 1953 section of the building.

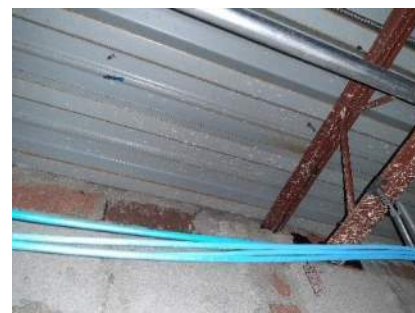
Structural steel cross beams were coated with red/orange paint or primer. Metal decking was observed to be unpainted corrugated panels. Based on the 95% Construction Drawings, these materials may be disturbed to create roof openings in support of structural renovations associated with new HVAC unit installations within both the 1953/54 and the 1959 portions of the building. The paint on the structural steel is considered to be a suspect PCB-containing building material.

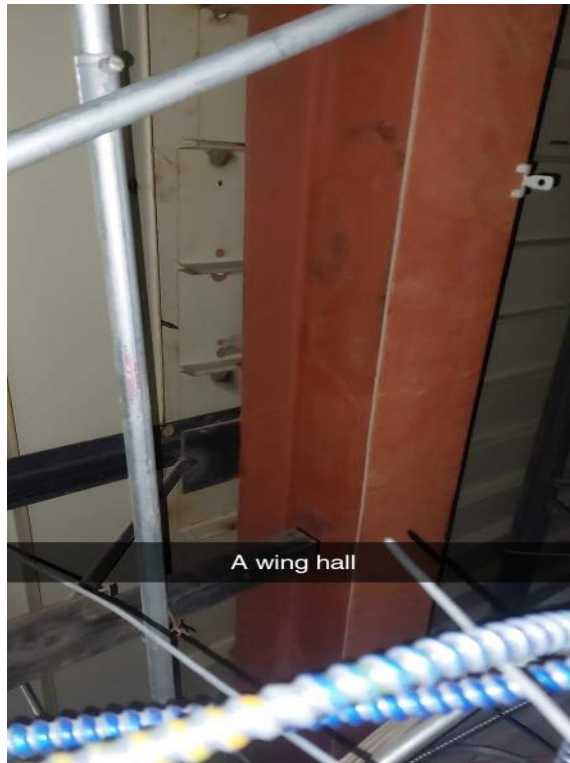
A wing hall

Red I- Beam A Wing Hall

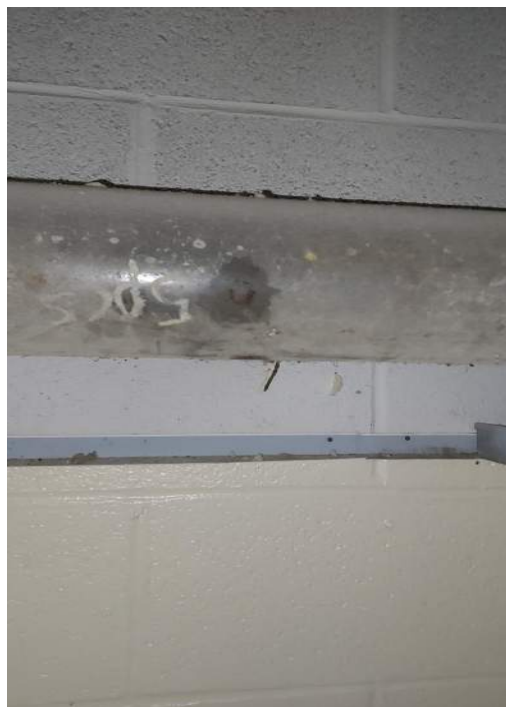
CMU Wall Above Ceiling Tiles

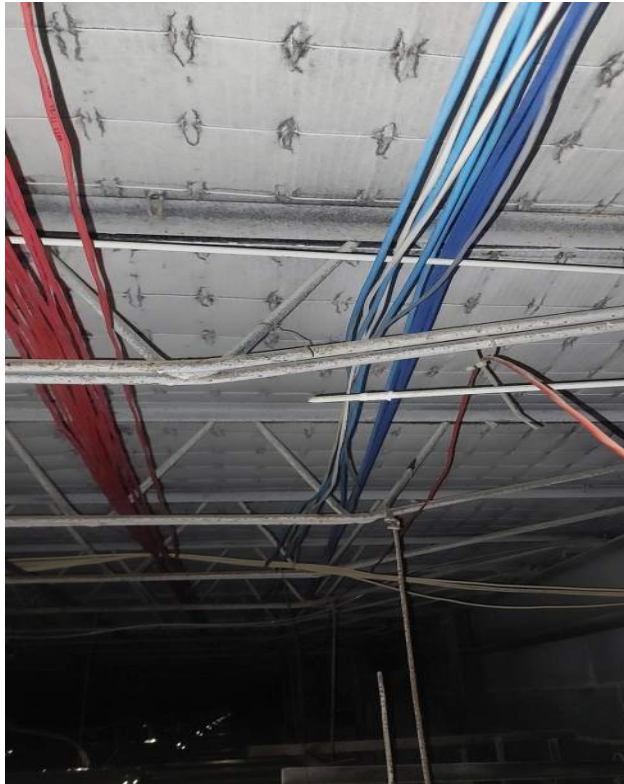
Gray Ceiling Decking- Hallway B

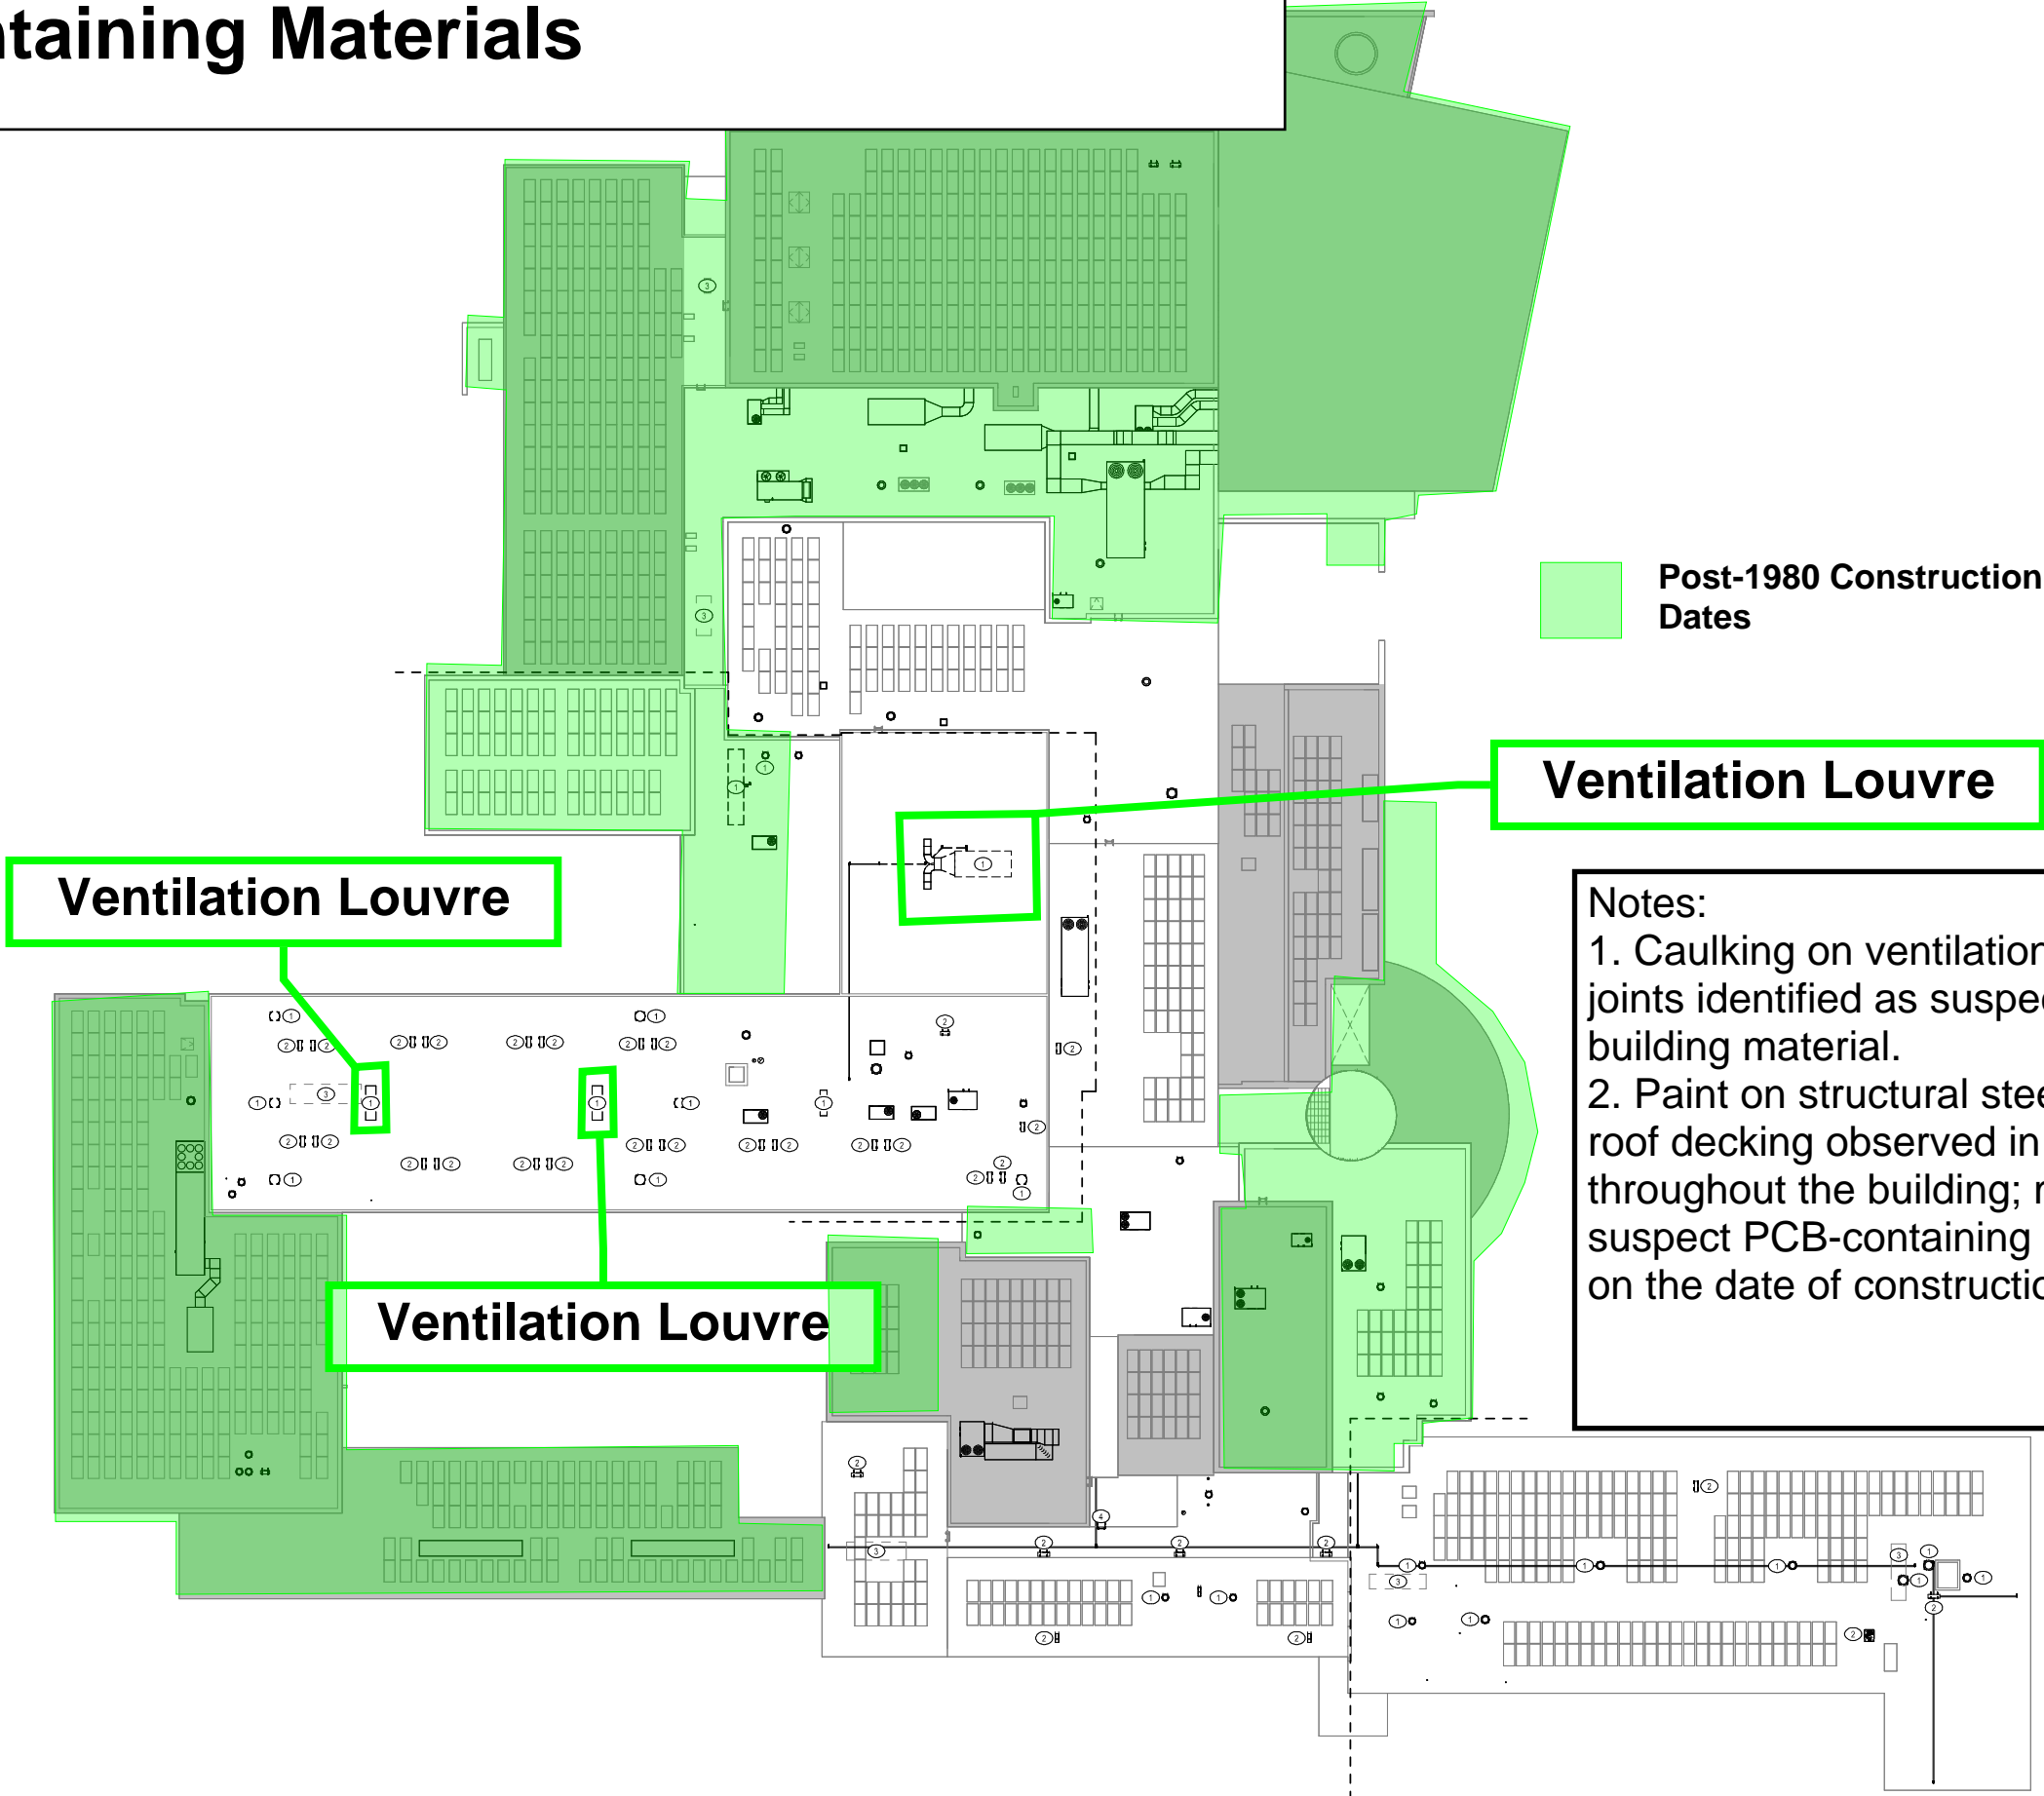
1 OVERALL ROOF PLAN
1" = 20'-0"

1. Caulking on ventilation louver frames to facade joints identified as suspect PCB-containing building material.
2. Paint on structural steel components and metal roof decking observed in overhead areas throughout the building; materials identified as suspect PCB-containing building material based on the date of construction.

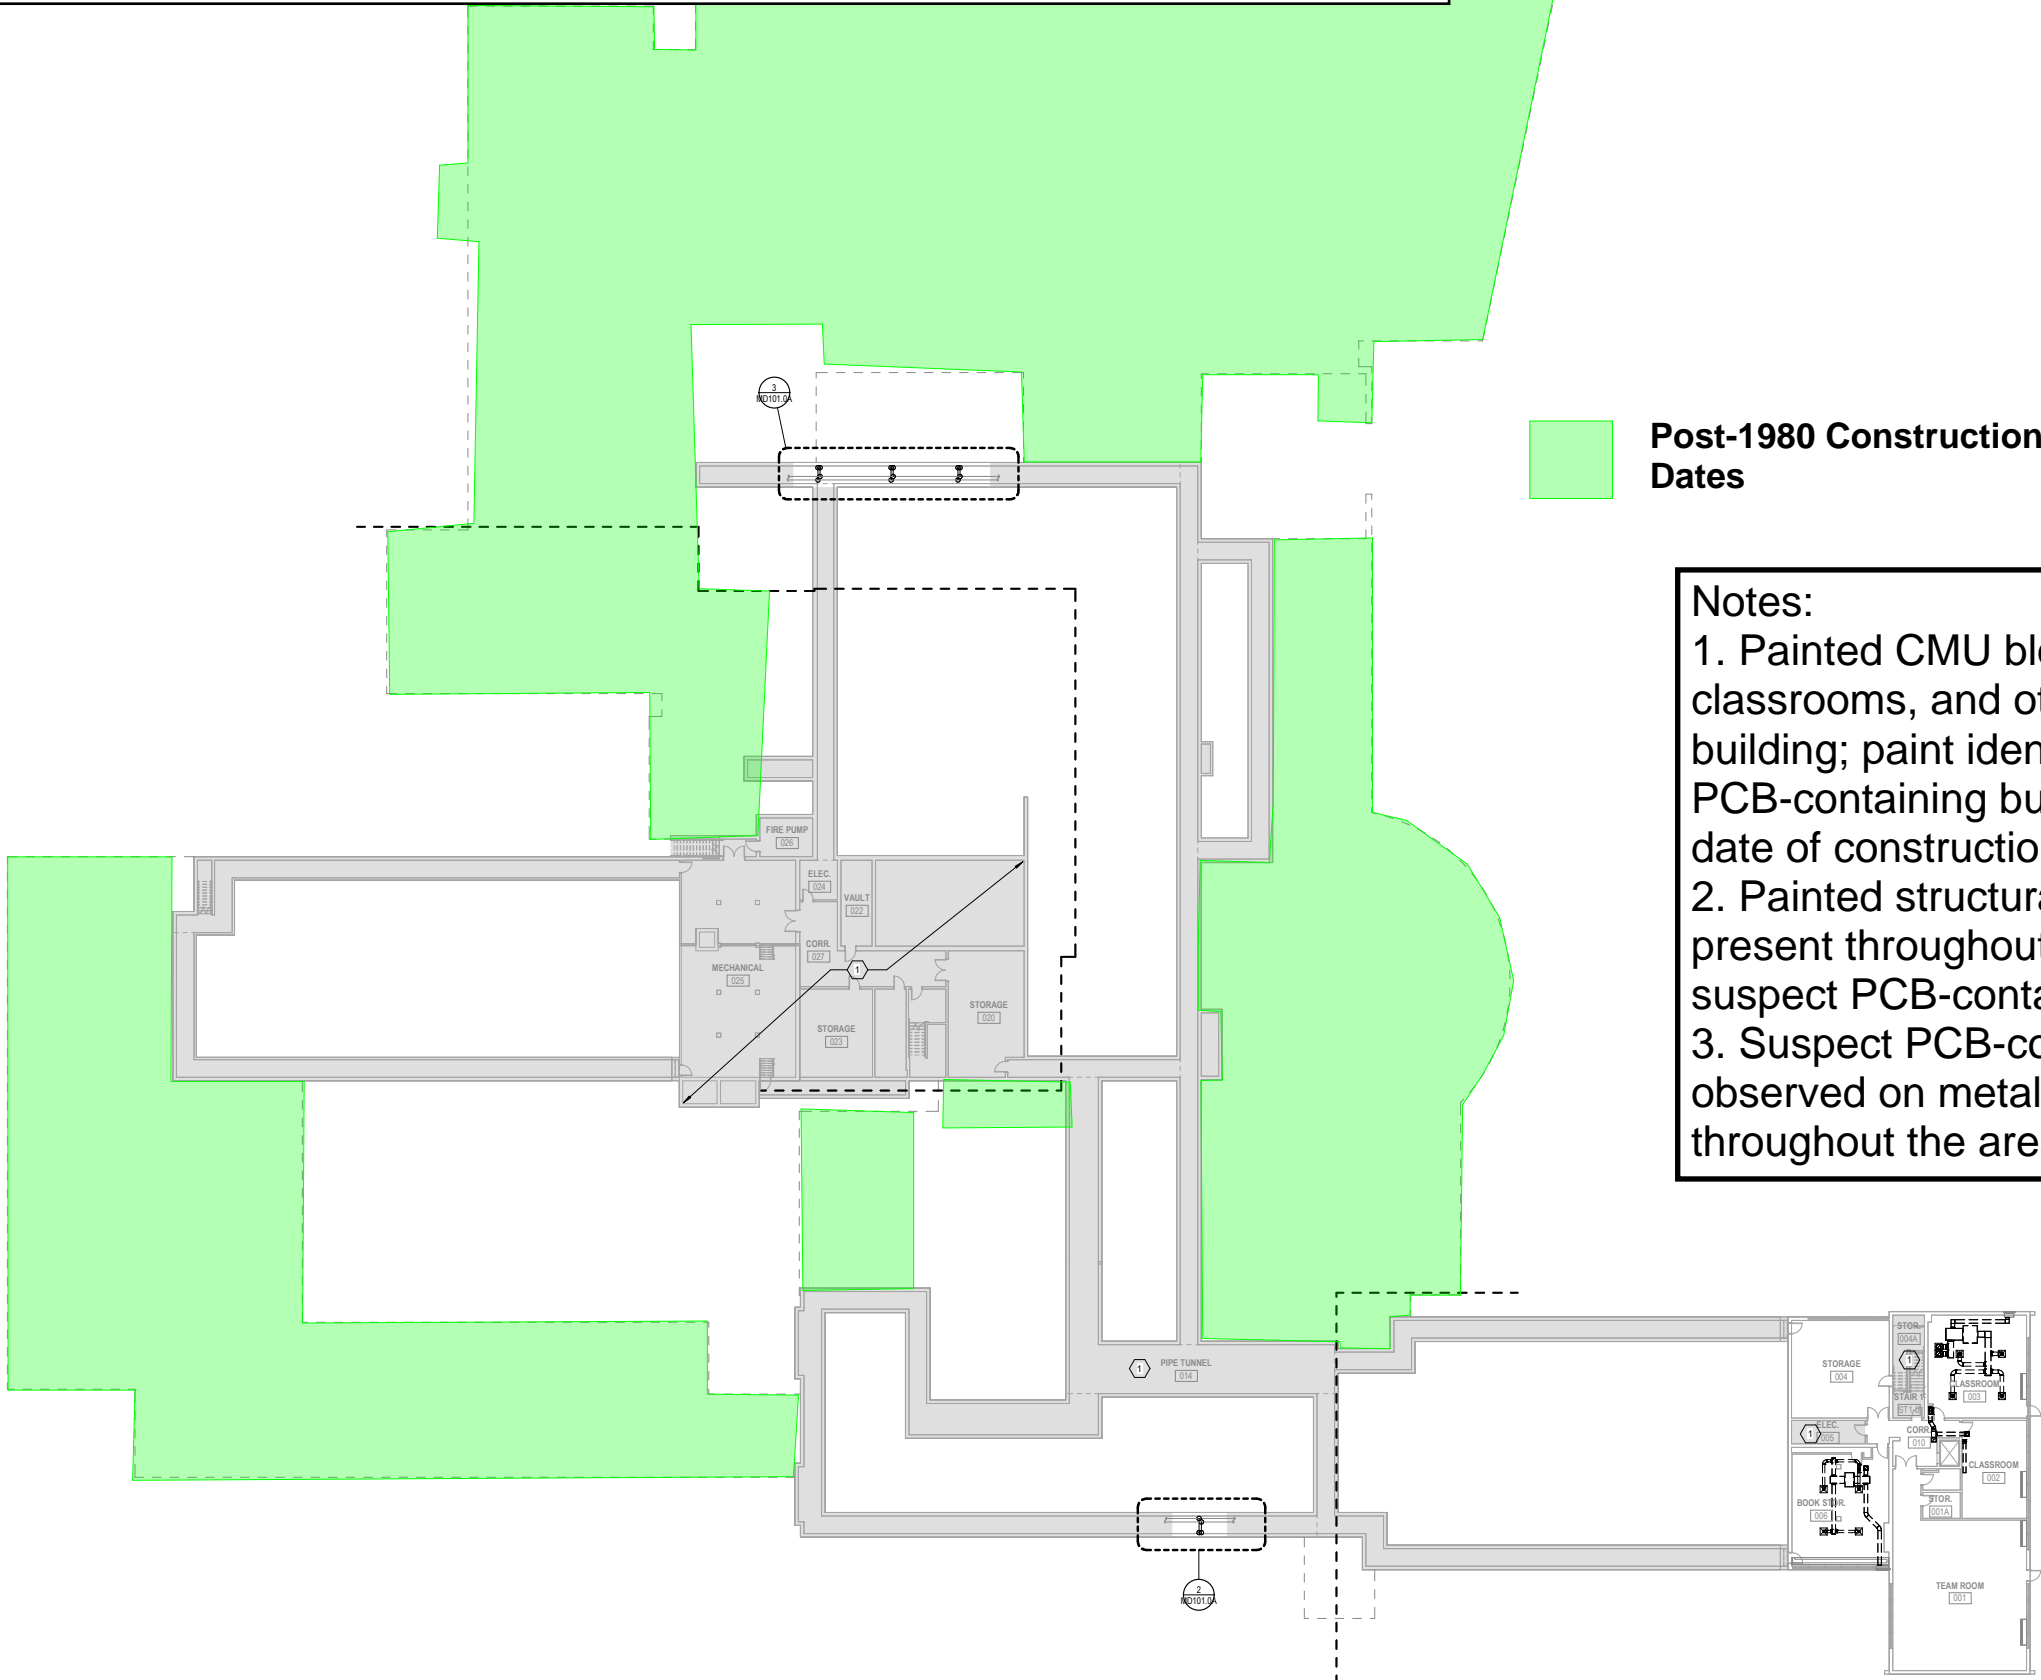
- Notes:
- 1. Painted CMU block walls present in hallways, classrooms, and other areas throughout the building; paint identified as suspect PCB-containing building material based on the date of construction.
 - 2. Painted structural steel and decking materials present throughout the building; paint identified as suspect PCB-containing building material.
 - 3. Suspect PCB-containing ductwork sealant observed on metal to metal joints of ducts throughout the area.
