# Inspection Report

Location: Pittsford Mendon High School – Pool Shell

Date: February 7, 2023

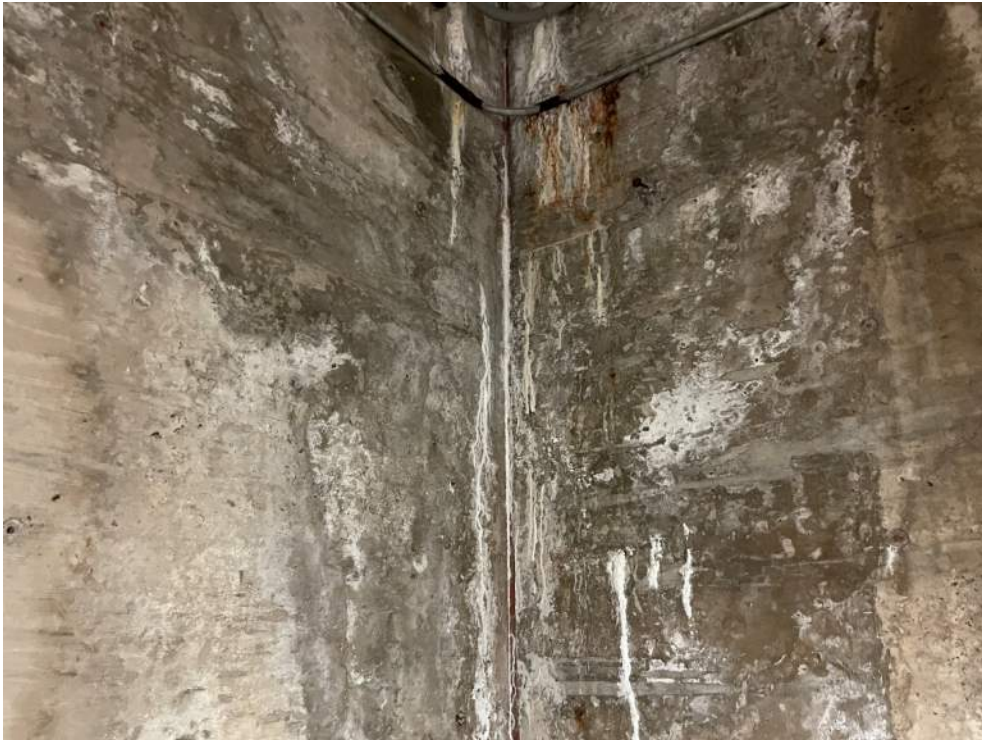
4. Some areas showed efflorescence, which is evidence of water working its way through the pool walls and leaving salt deposits on the surface. Although not ideal, this is not an unusual or extreme condition. It is consistent with what would be expected for a pool structure of this age.

**Efflorescence**

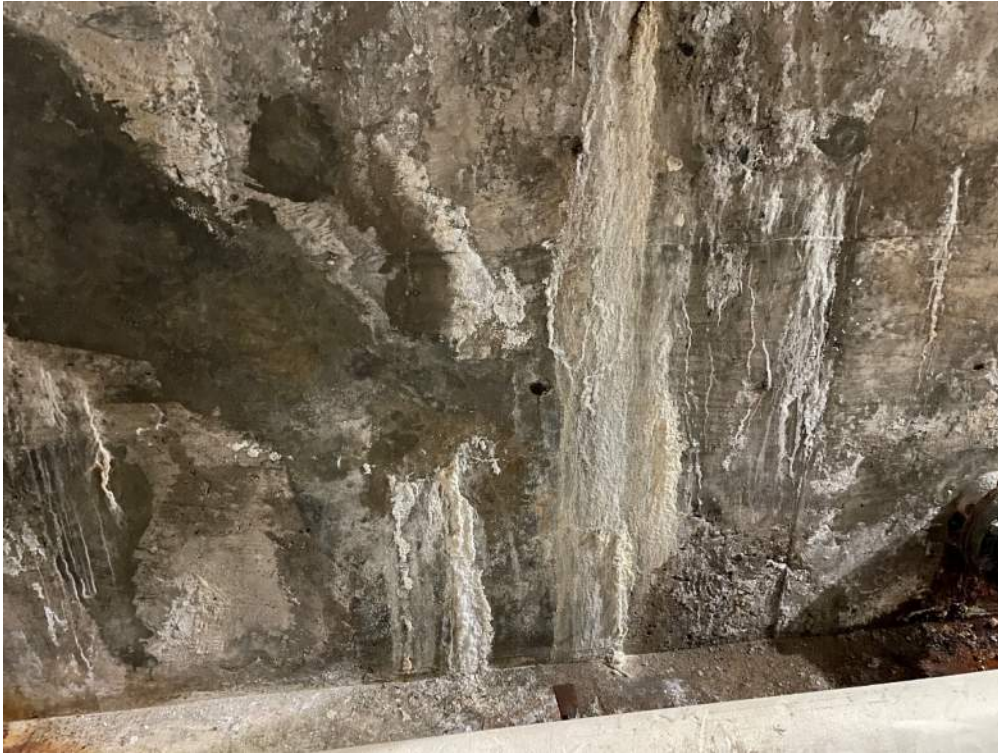
**Efflorescence**

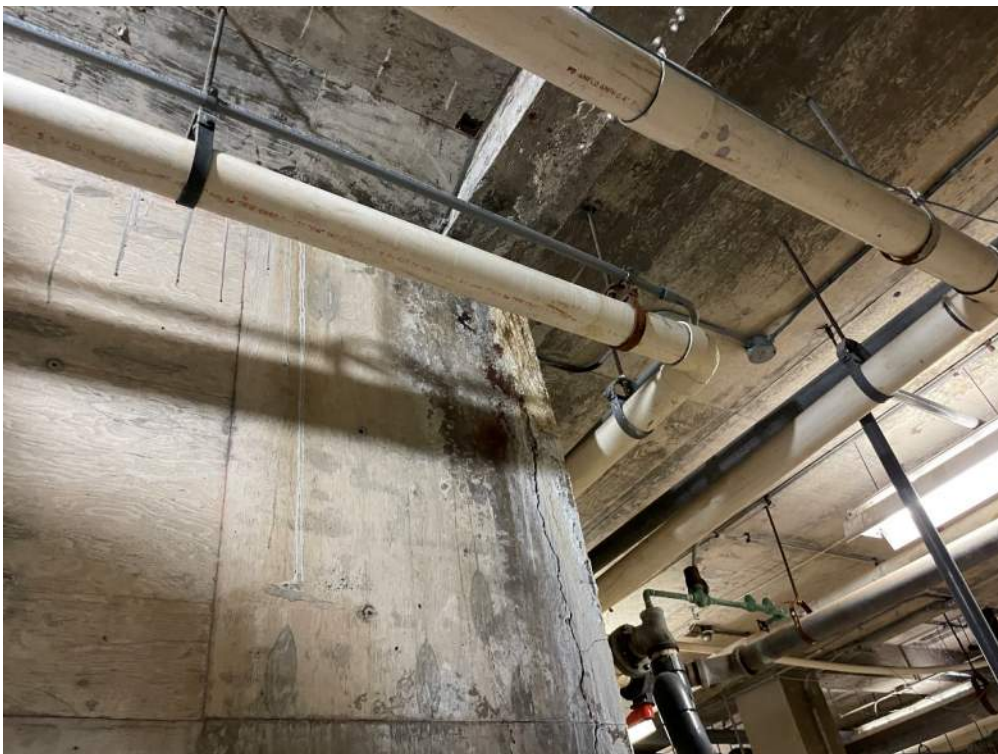
5. We discovered a few areas that we'd recommend repairing. This included some cracking & some miscellaneous small areas of spalling. One particular area had a larger section of spalling where the outer face of the concrete was fully separated from the inner section of concrete.

6. Spalling and cracking conditions like this are typically caused by steel reinforcing corrosion. When steel corrodes, even if it's just surface corrosion, it will expand. This expansion/pressure will often cause the surrounding concrete near the surface to crack and spall.

**Corner Crack**

2. There are obvious isolated concrete issues, but those conditions are not extreme and can be readily repaired. The few areas of spalling and cracking can be repaired with standard rehabilitation measures. For the spalling, this would include removing any loose concrete, cleaning up exposed surface corroded steel, coating with a bonding and corrosion inhibiting agent and then patching the concrete to its original shape/thickness. The crack repair would include adding injection ports, sealing the surface of the crack and injecting it with a structural epoxy.

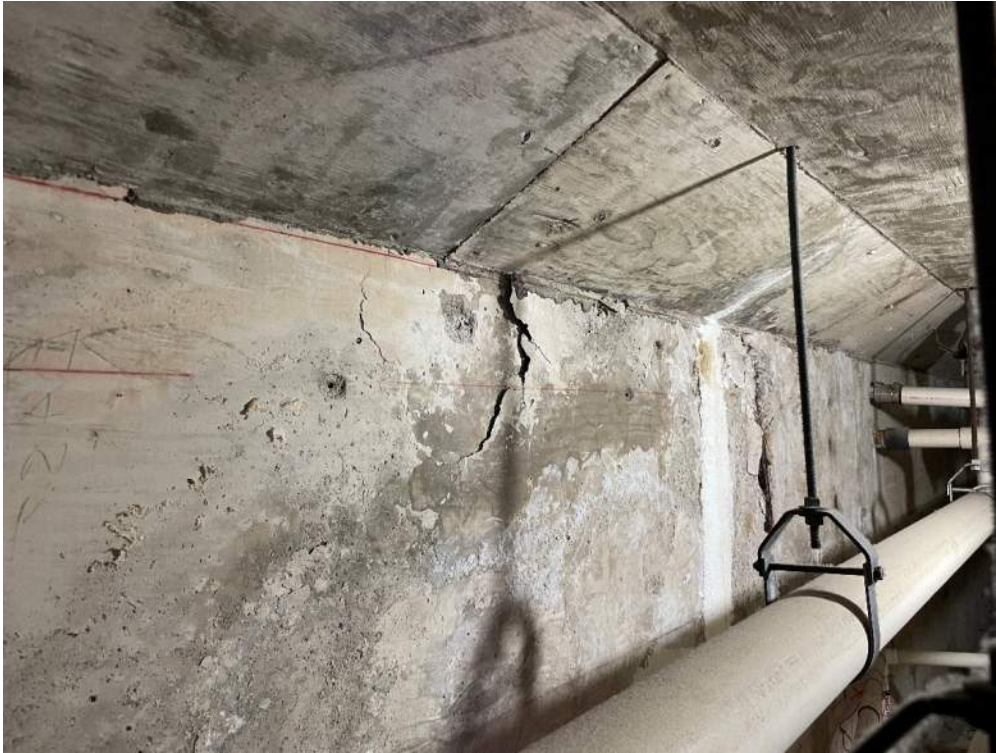
**Small Spalling Area**

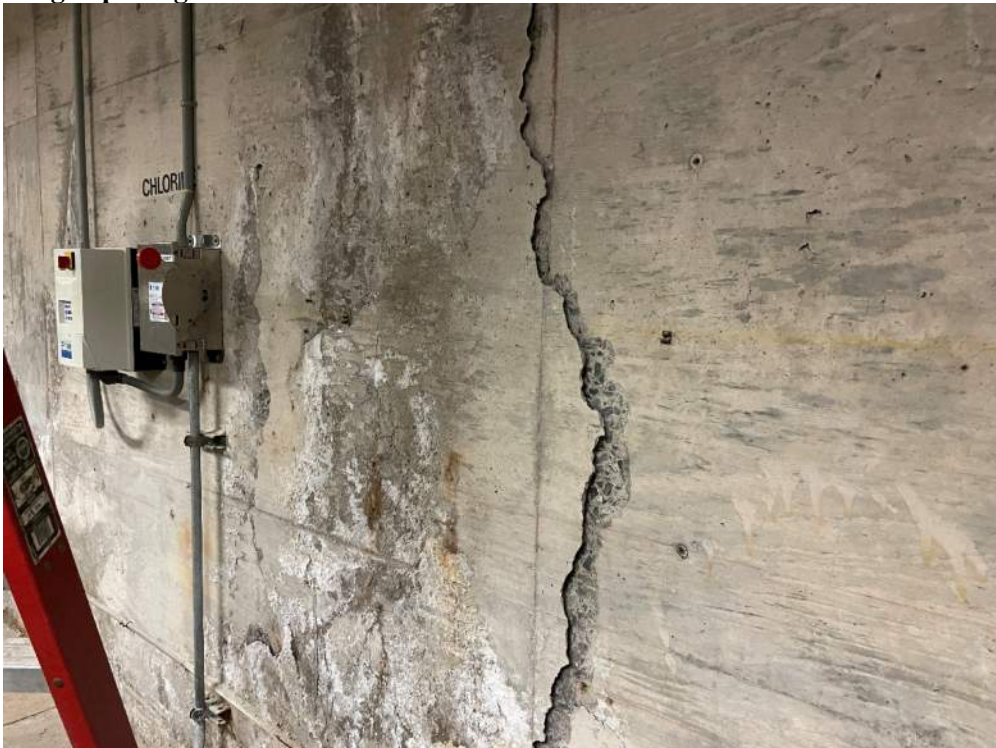
**Large Spalling Area**

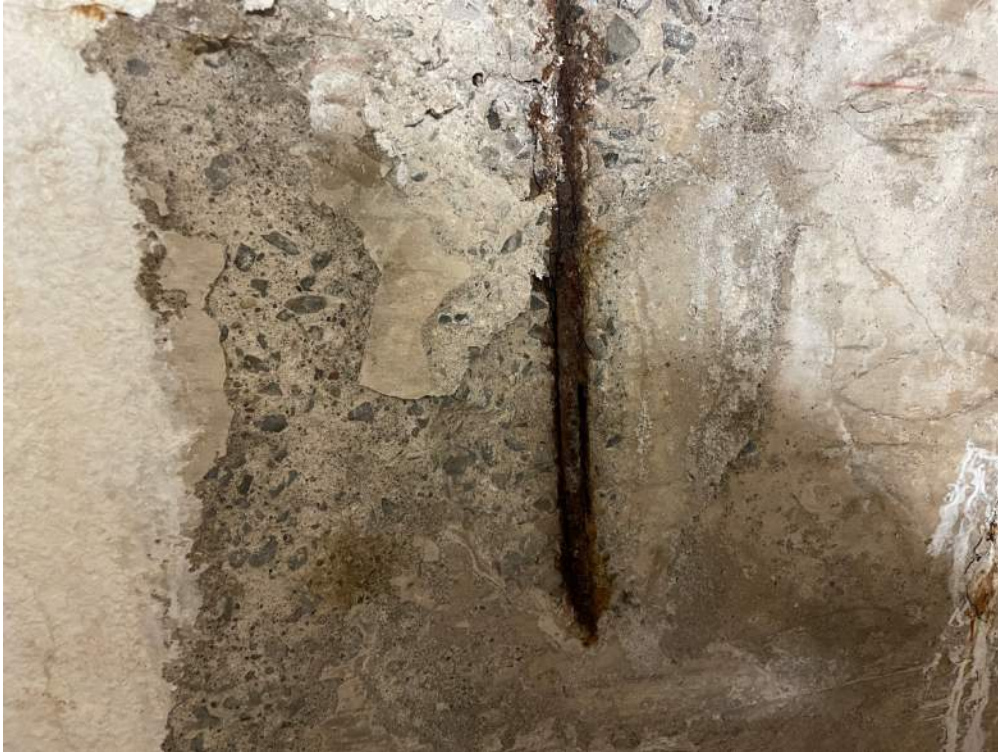
7. In a few spalled areas, the steel reinforcing was partially exposed. The steel was corroded but it was not excessive. The surface corrosion could be scraped off to reveal a fully intact steel section.

**Spalling & Exposed Partially Corroded Steel Reinforcing**

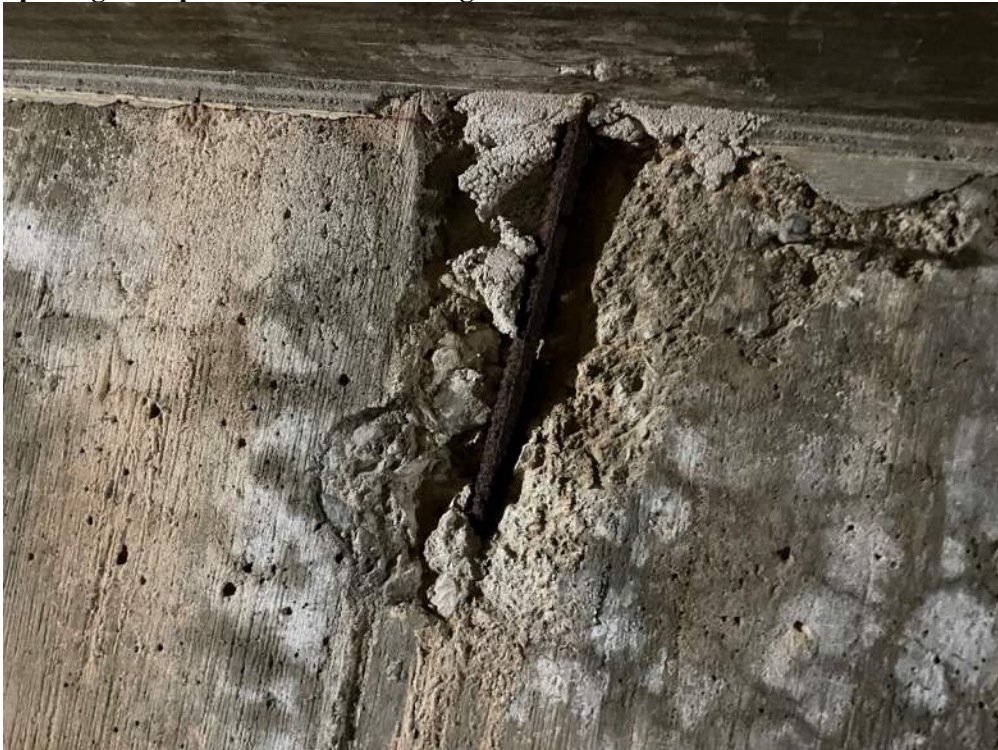
**Spalling & Exposed Steel Reinforcing**

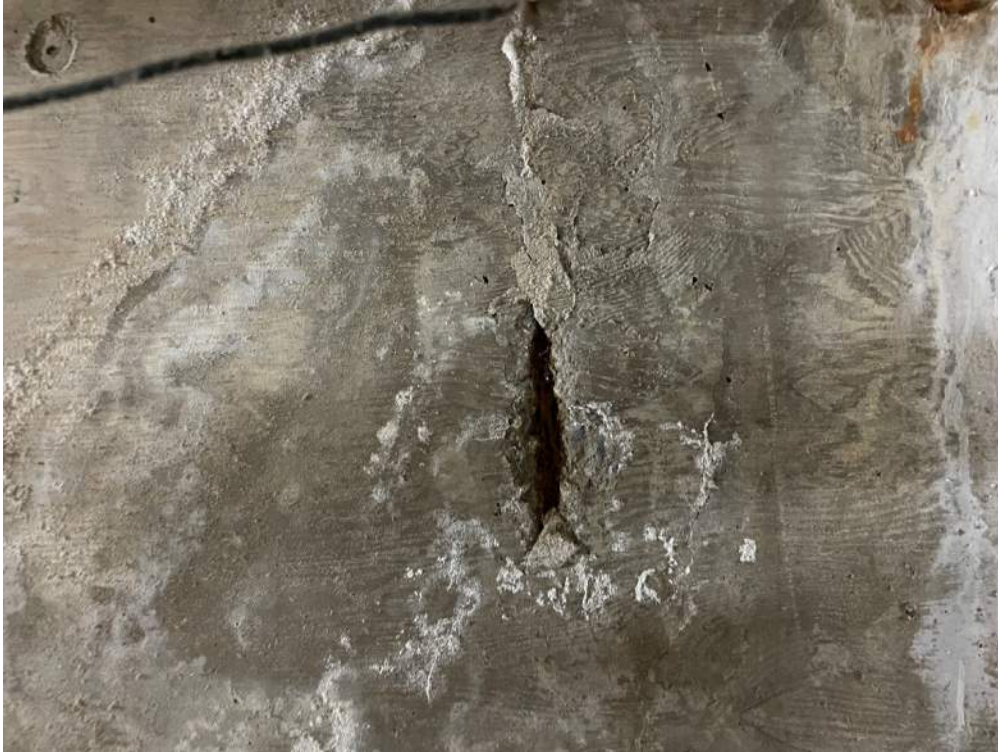
**Spalling & Exposed Partially Corroded Steel Reinforcing**

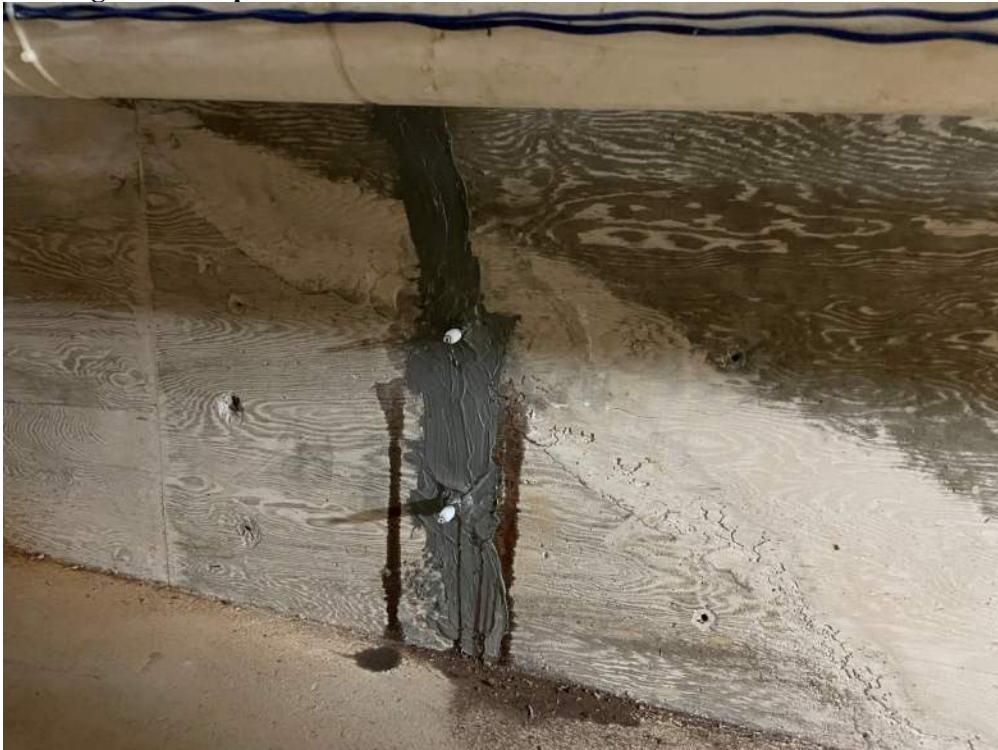
8. We did note that there were several areas where cracks had been previously repaired. It's our understanding that the repair work was done many years ago. The repairs were in good shape and appeared to be functioning adequately. No signs of structural deterioration or distress were noted in the areas of the repairs.

**Existing Crack Repair – Good Condition**

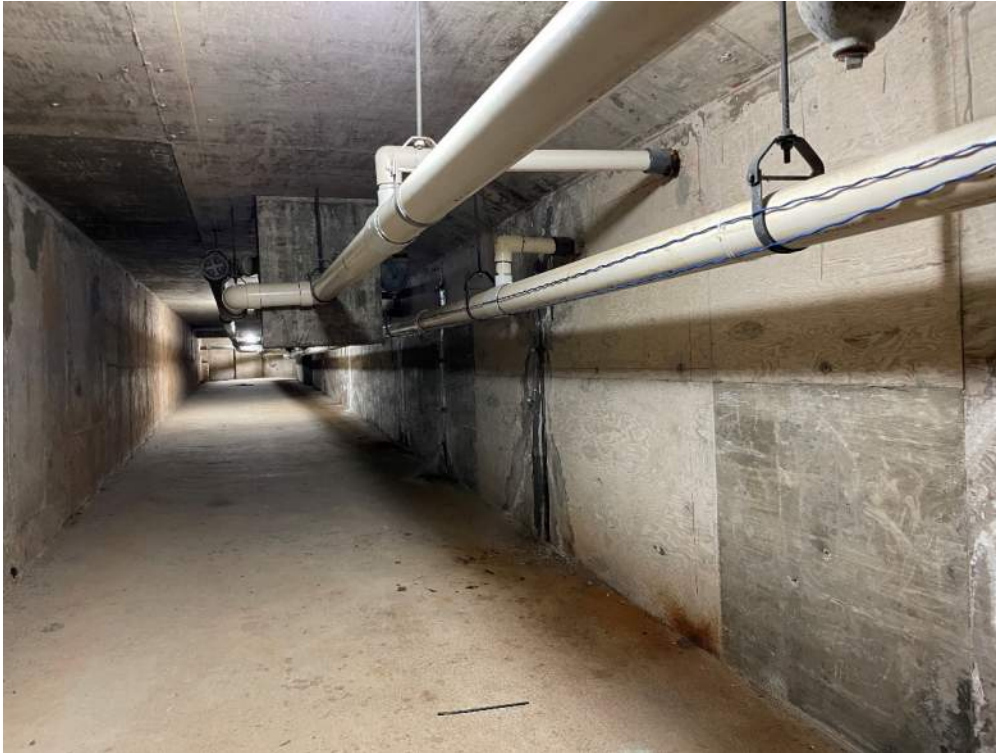
**Existing Crack Repairs & Overall Good Conditions**

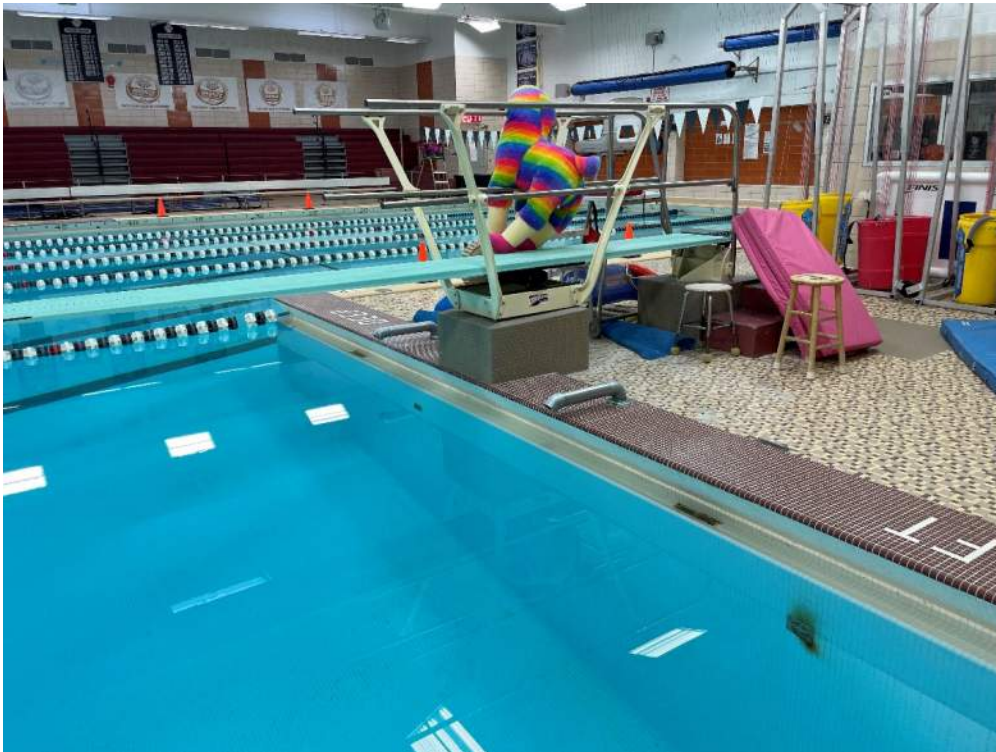
9. We also inspected the pool structure from above, paying particular attention to the few areas where we noted the spalling and cracking from below. We did not note any structural issues and the tile work in those areas (and in all areas) was in good serviceable condition.

**Pool Wall & Tile – Good Condition**

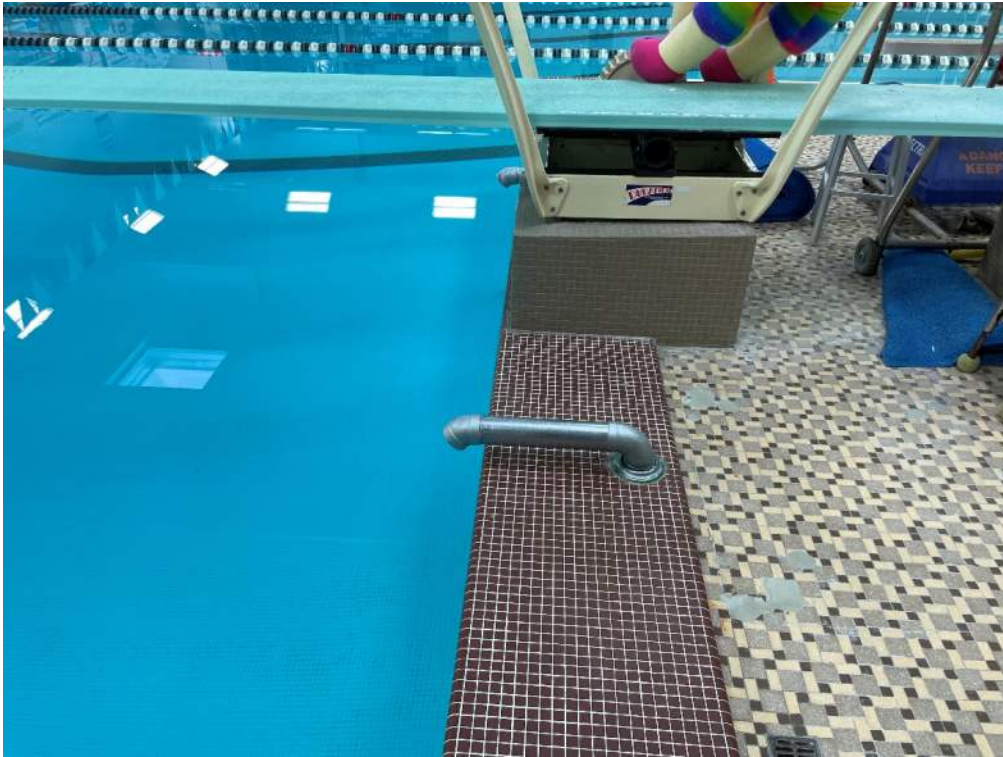
**Pool Wall & Tile – Good Condition**

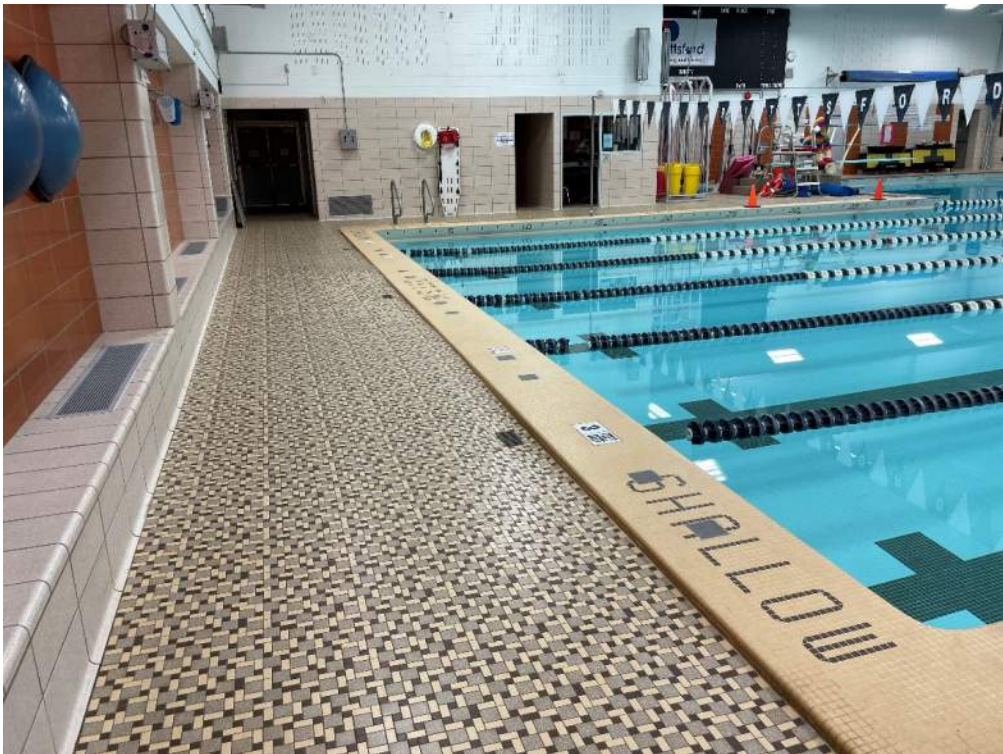
**Pool Wall & Tile – Good Condition**
