TRAVIS UNIFIED SCHOOL DISTRICT

District-wide Facility Condition Assessment FINAL REPORT

OCTOBER 4, 2023

PREPARED BY **KITCHELL**

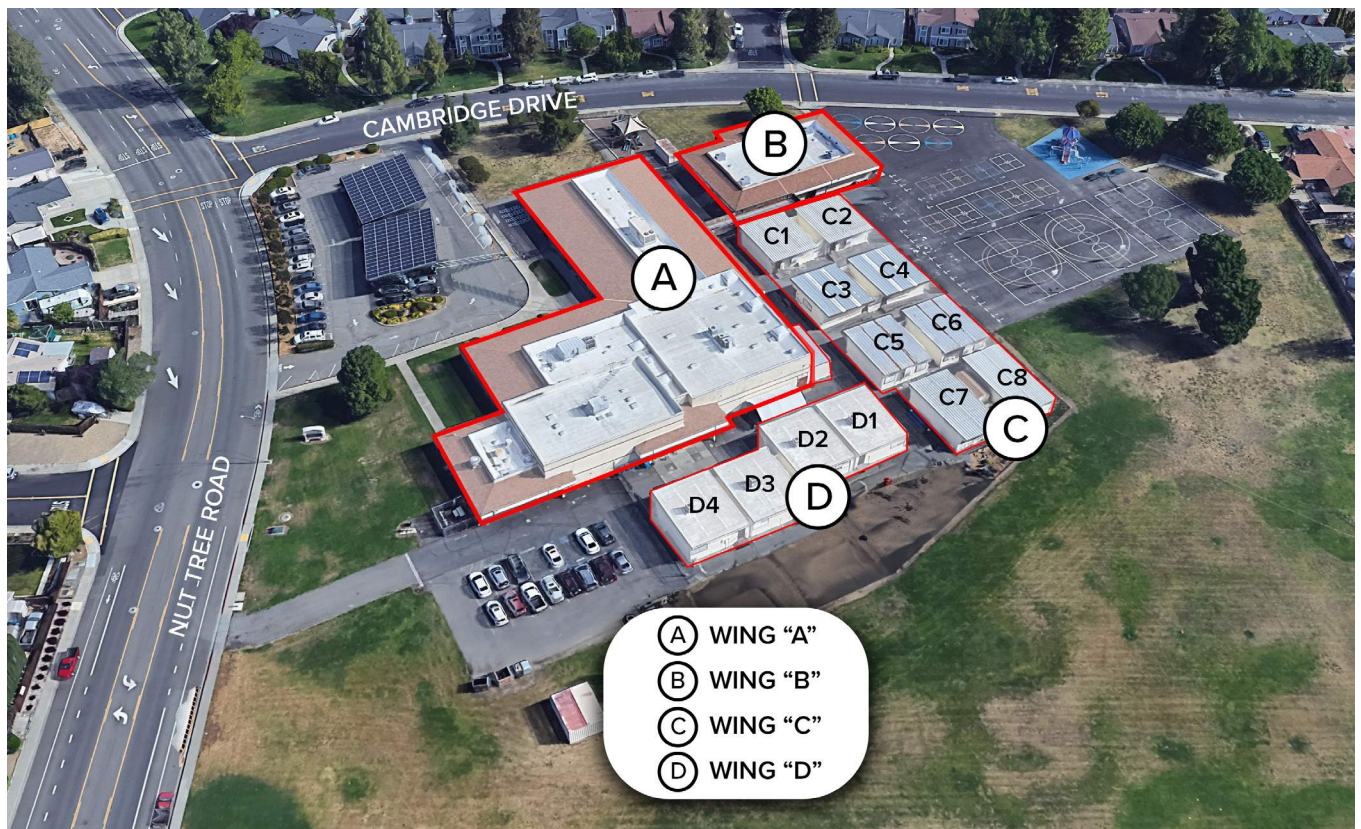
Overall Campus

Capital Renewal Cost: \$6,308,466
FCI: 0.137
Condition Score: C
Condition Rating: Poor
Replacement Cost: \$46,040,000

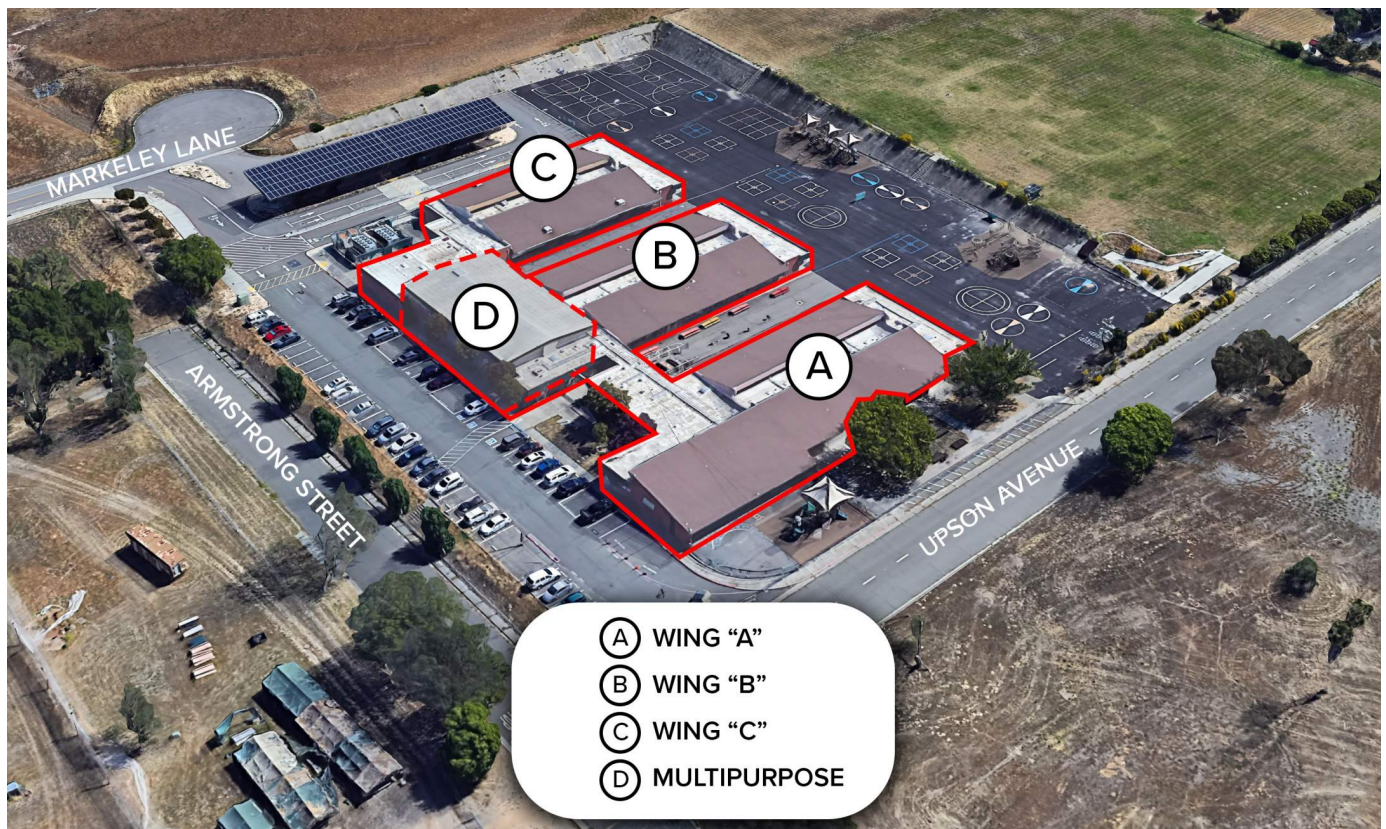
Overall Campus

Capital Renewal Cost: **\$10,234,848**
FCI: 0.145
Condition Score: C
Condition Rating: Poor
Replacement Cost: \$70,576,000

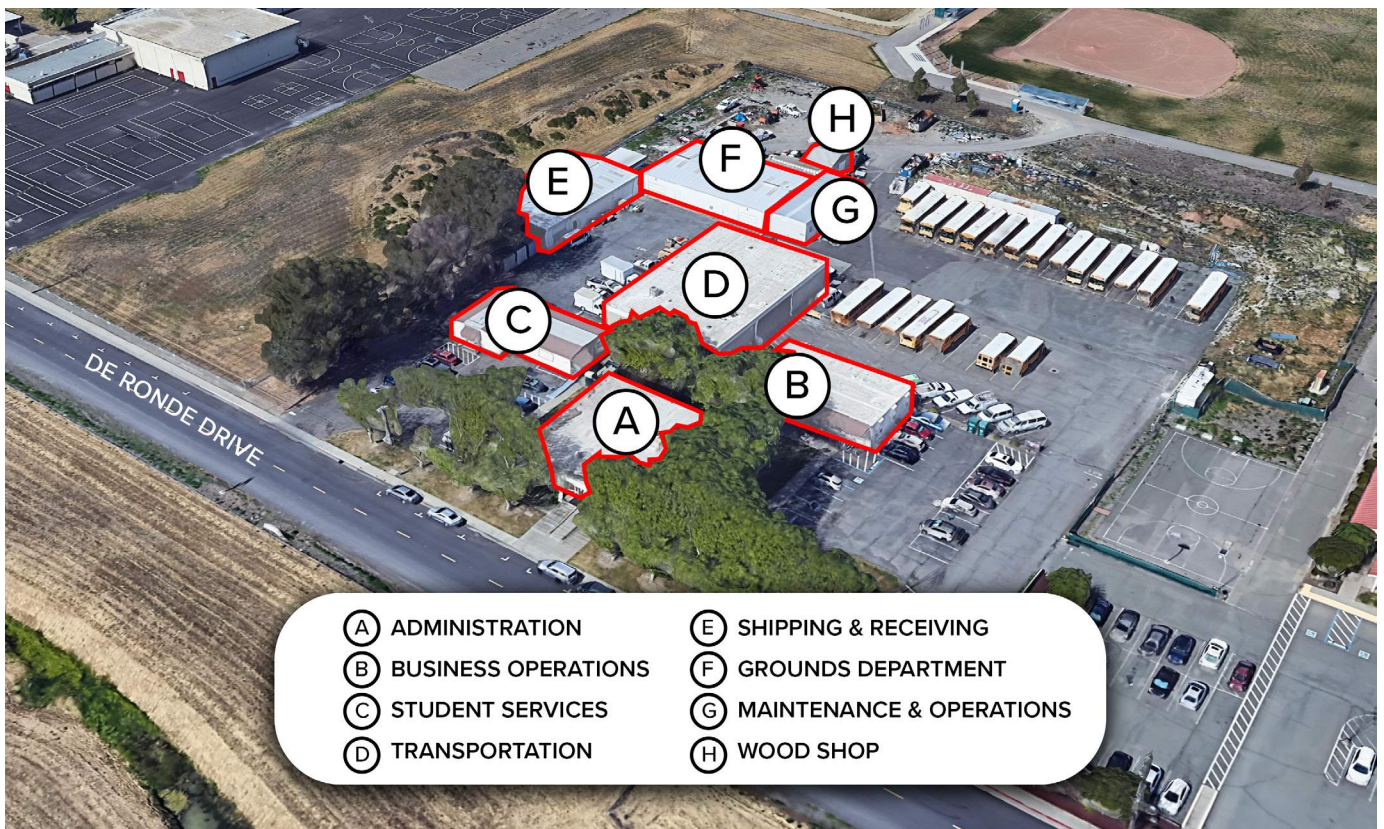
Overall Campus

Capital Renewal Cost: **\$3,775,970**
FCI: 0.153
Condition Score: C
Condition Rating: Poor
Replacement Cost: \$24,672,000

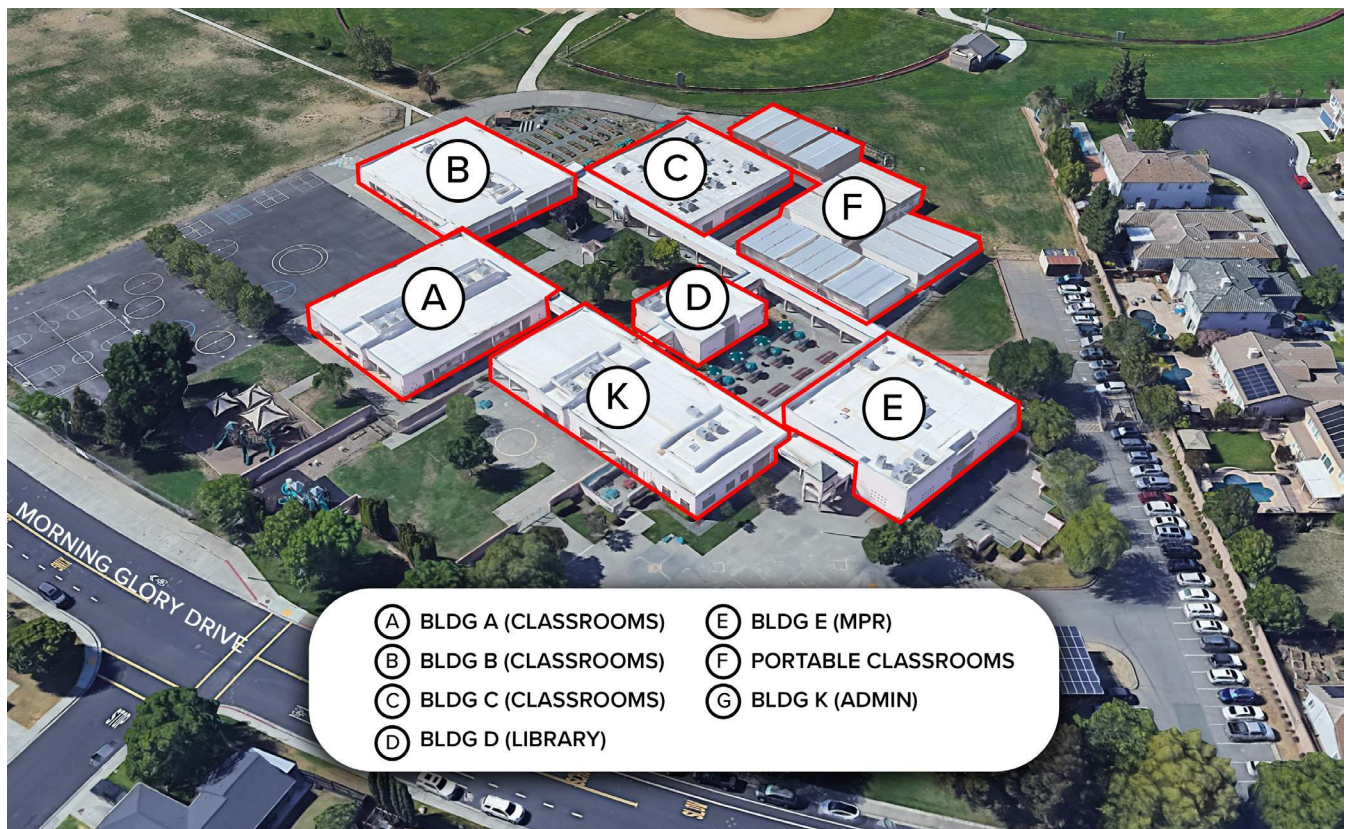
Overall Campus

Capital Renewal Cost: **\$7,878,184**
FCI: 0.144
Condition Score: C
Condition Rating: Poor
Replacement Cost: \$54,628,000

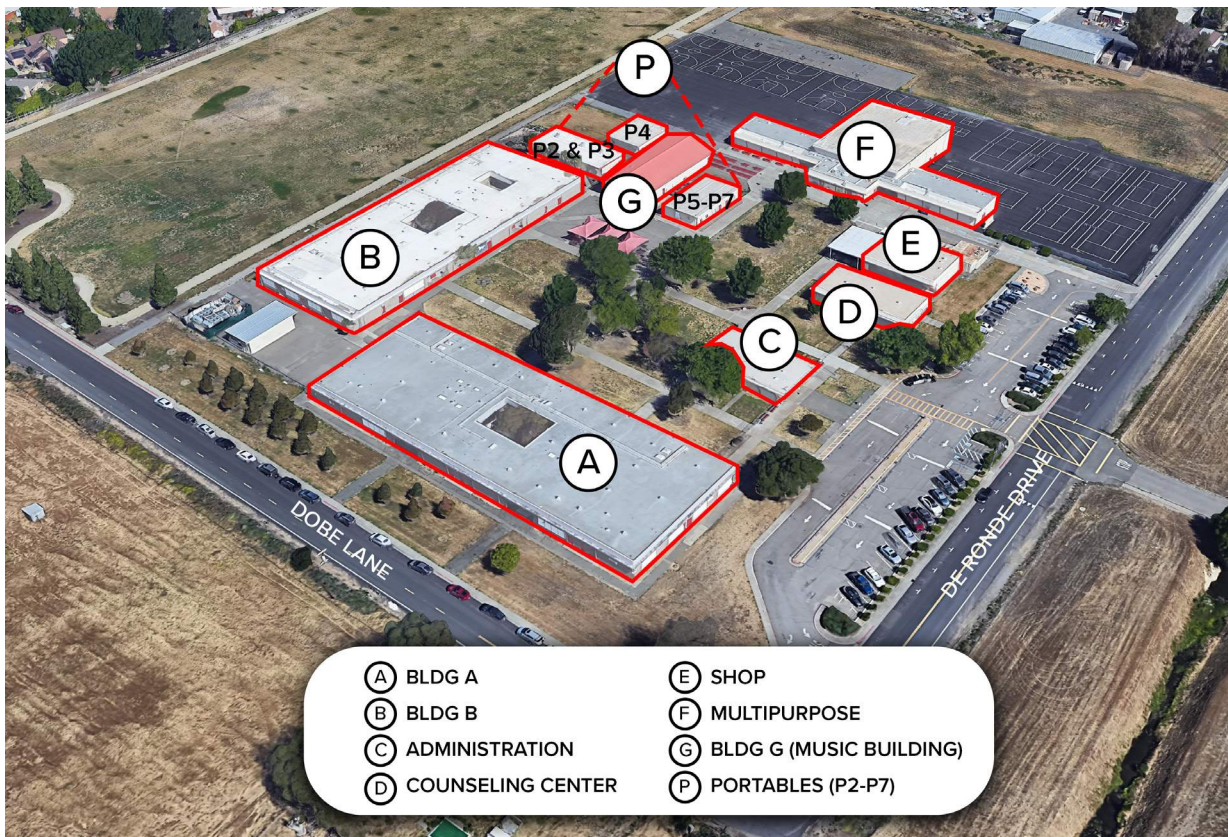
Overall Campus

Capital Renewal Cost: **\$12,574,951**
FCI: 0.120
Condition Score: C
Condition Rating: Poor
Replacement Cost: \$104,744,000

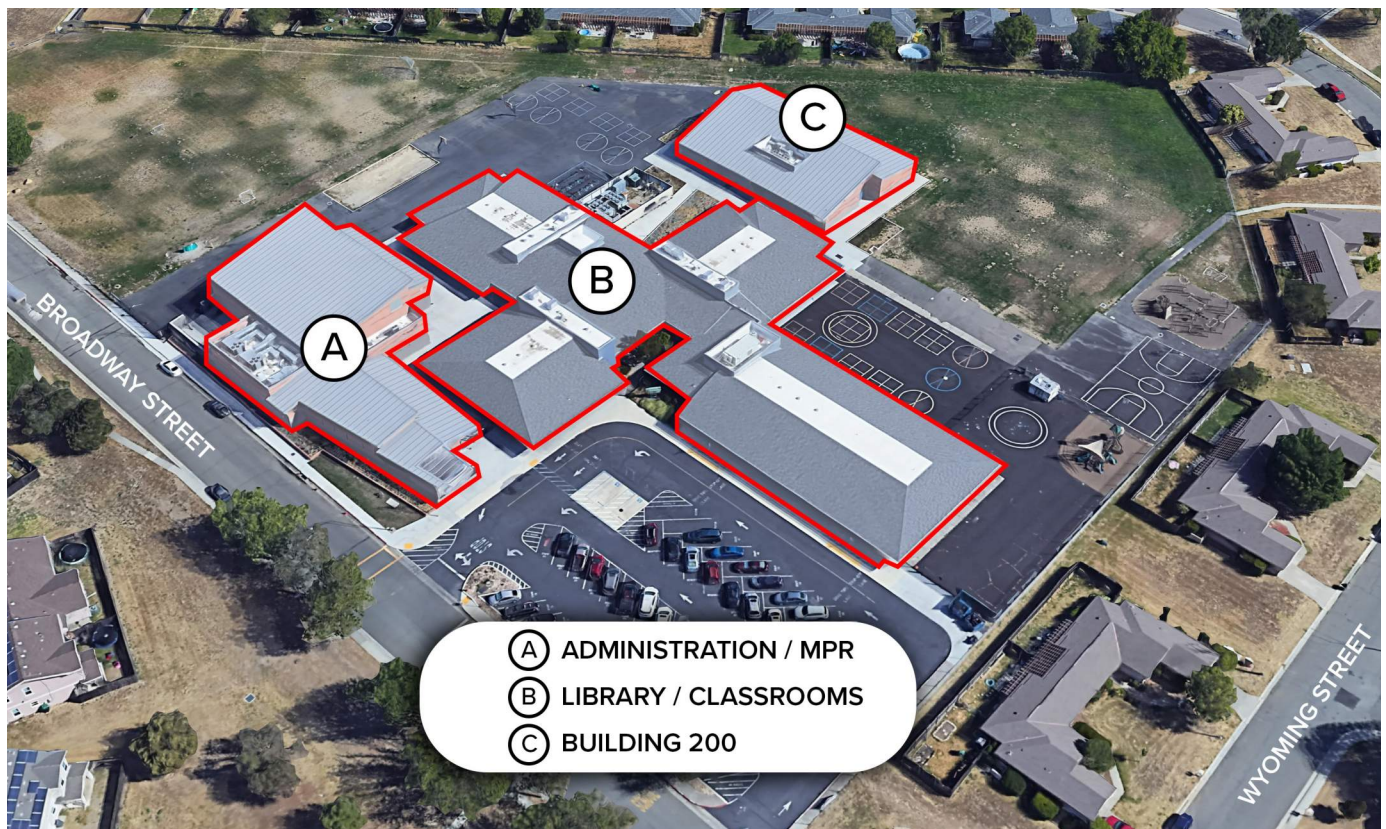
Overall Campus

Capital Renewal Cost: \$2,824,401
FCI: 0.041
Condition Score: B
Condition Rating: Fair
Replacement Cost: \$68,871,000

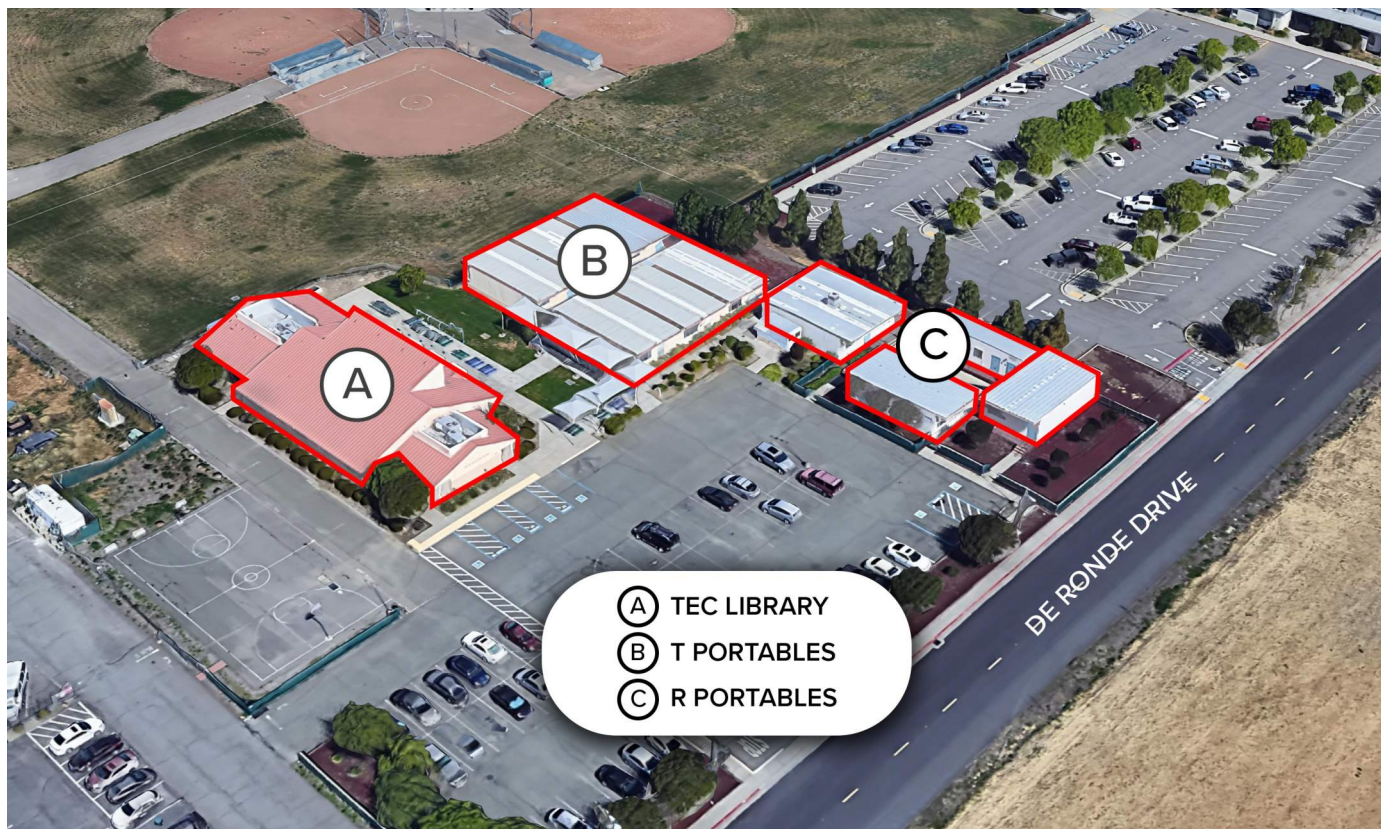
Overall Campus

Capital Renewal Cost: \$1,948,565
FCI: 0.127
Condition Score: C
Condition Rating: Poor
Replacement Cost: \$15,401,000

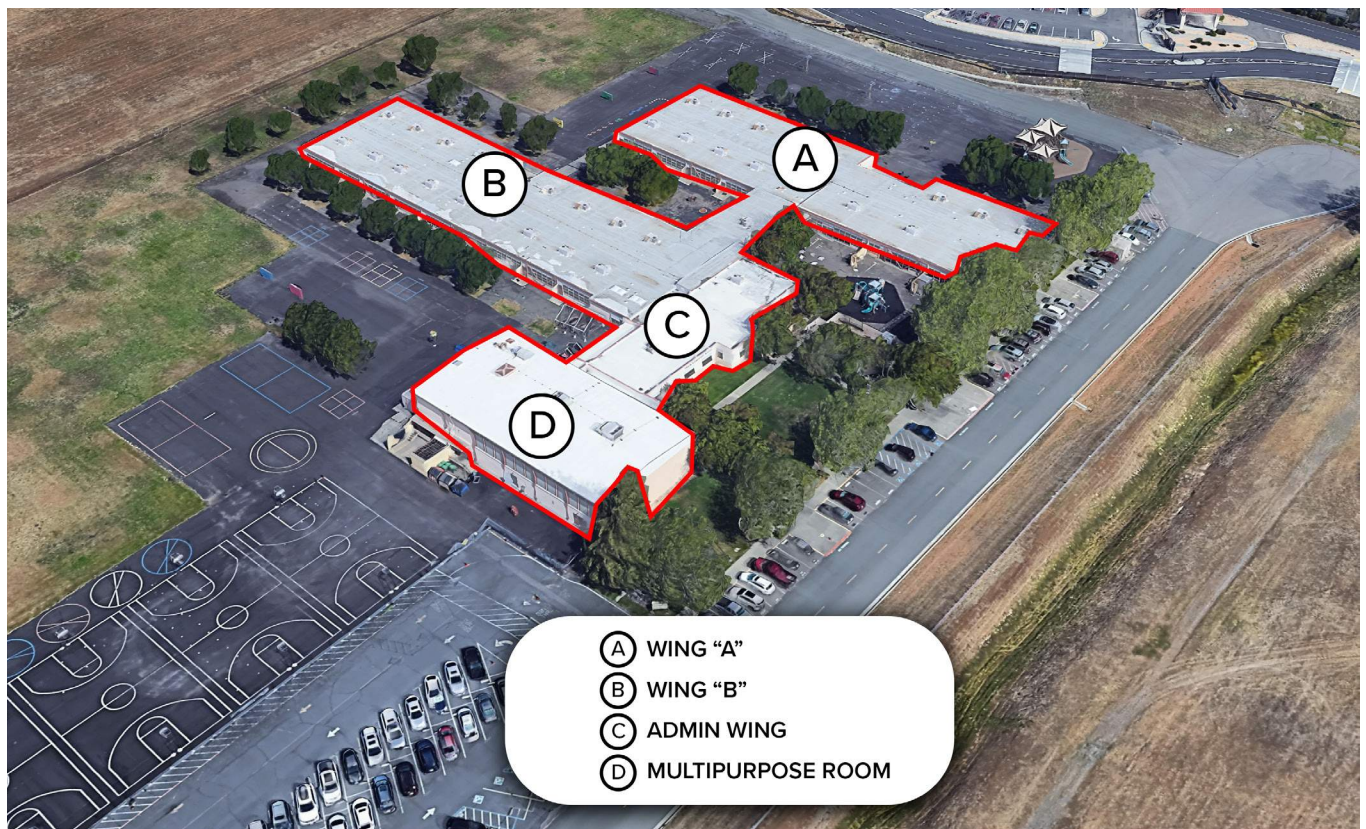
Overall Campus

Capital Renewal Cost: \$10,186,217
FCI: 0.126
Condition Score: C
Condition Rating: Poor
Replacement Cost: \$80,950,000

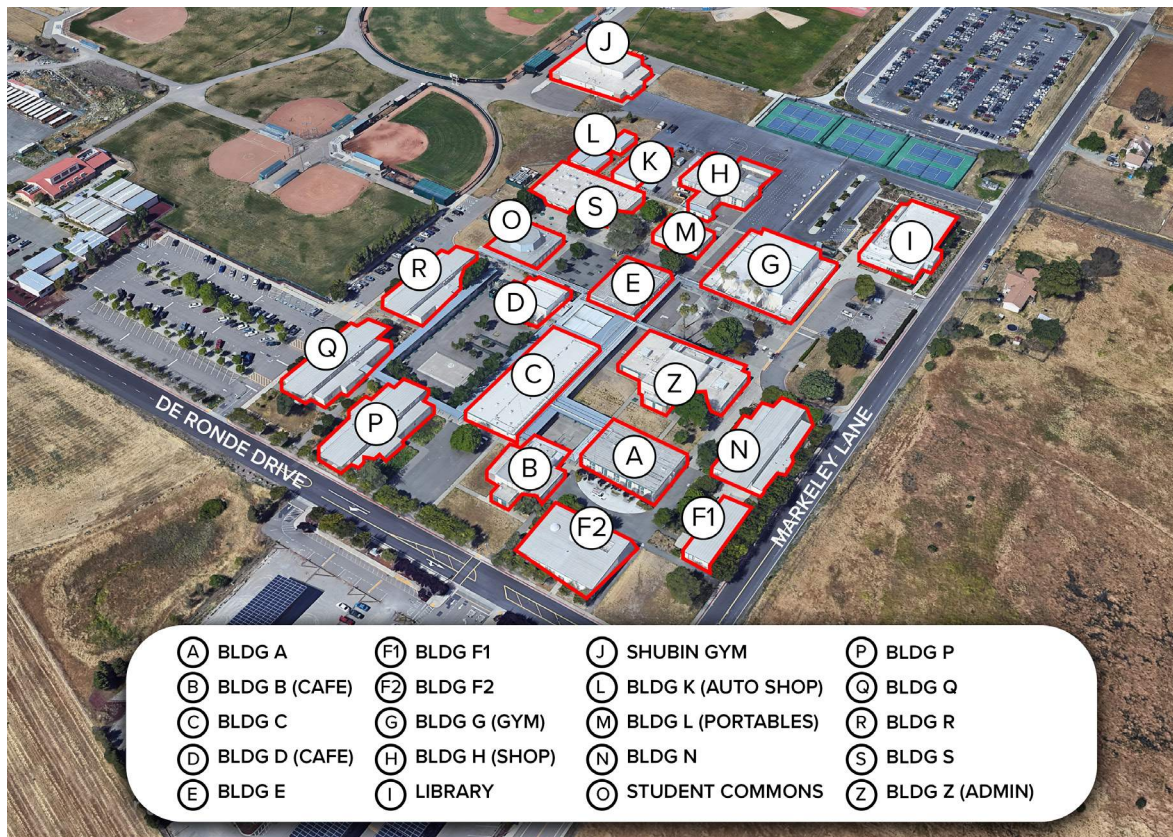
Overall Campus

Capital Renewal Cost: **\$28,658,129**
FCI: 0.143
Condition Score: C
Condition Rating: Poor
Replacement Cost: \$200,234,000
