Medford Public Schools

Re: Statement of Interest - Medford High School - Core Program

Report of Findings: Focused Facility Condition Review

Medford High School

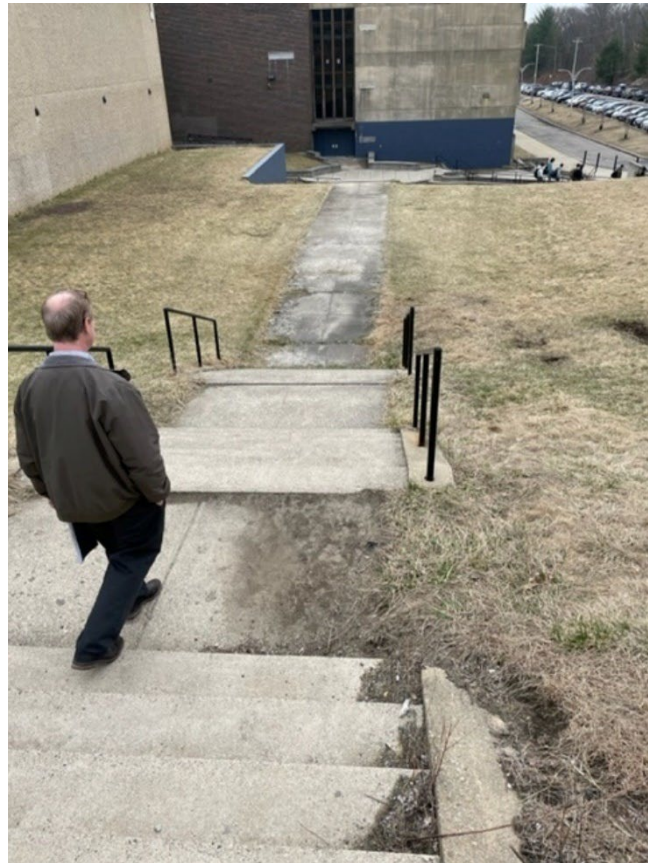
The site walkways around the perimeter of the facility are beyond their useful life expectancy, and pose safety and accessibility challenges, specifically on the west elevation noted in the picture to the right.

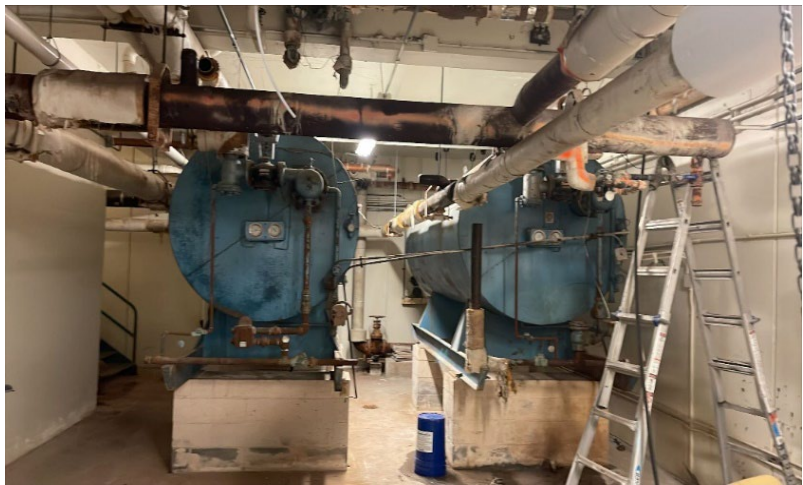
The main mechanical room located in Building D houses infrastructure for buildings A, B and D. The walls were observed to be painted concrete and CMU. Firestopping was observed to be incomplete on some of the wall elevations. The slab on grade is concrete with 3-4" equipment pads. On each day during the field inspection period significant amounts of

water had pooled on the floor. It was reported that the origin of the water was a combination of equipment leaks and ground water seepage. **This standing water is of particular concern. Its origin is possibly related to hydraulic pressure from below the slab system. The under-slab drainage system should be assessed to confirm whether pockets of water or artesian wells are present below the building and are a contributing factor to the standing water in the main mechanical room.** Key pieces of equipment within the room included heat exchangers for buildings A, B and D; two decommissioned air tanks and pumps, boilers, electric motor control panels and transformers, the main chemical waste tank, the sprinkler standpipe servicing the new science wing on the third floor, and an obsolete pneumatic control system. All but the new domestic water equipment was observed to be installed at the time the Building was constructed, in poor condition and beyond useful life expectancy.

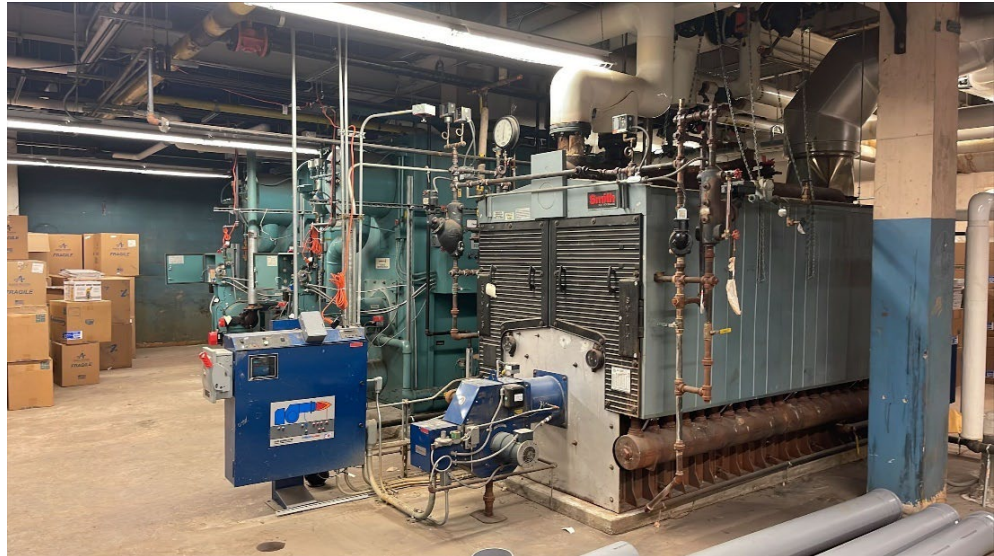
The school's boiler room provides hot water through facility. Three replacement boilers (2008, 2016) and a hot water system under construction during the site tour are housed within the space. The walls were observed to be painted concrete and CMU. The slab on grade is concrete with 3-4" equipment pads. The condition of the room and the existing equipment was poor the equipment is beyond its useful life expectancy.

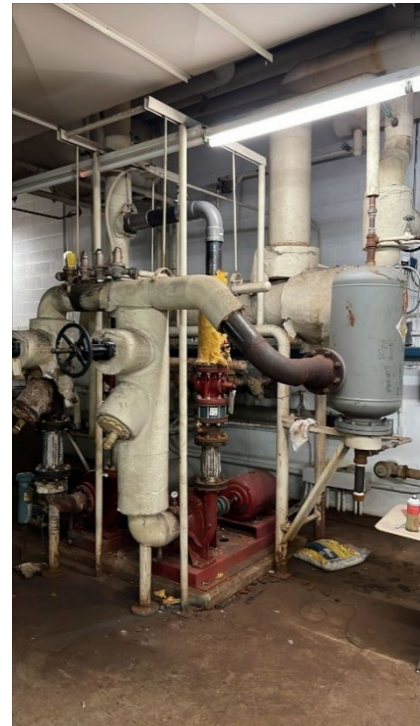
The interior, or core area of each quadrant originally had cooling but no longer functions, due to lack of the central chiller being operational. The chiller, which was a steam absorption type, has failed in recent years and has not been repaired or replaced.

Reported deficiencies include dirty ductwork and clogged reheat coils which are contributing to poor indoor air quality. The classroom spaces also overheat in the warmer weather due to lack of air conditioning.

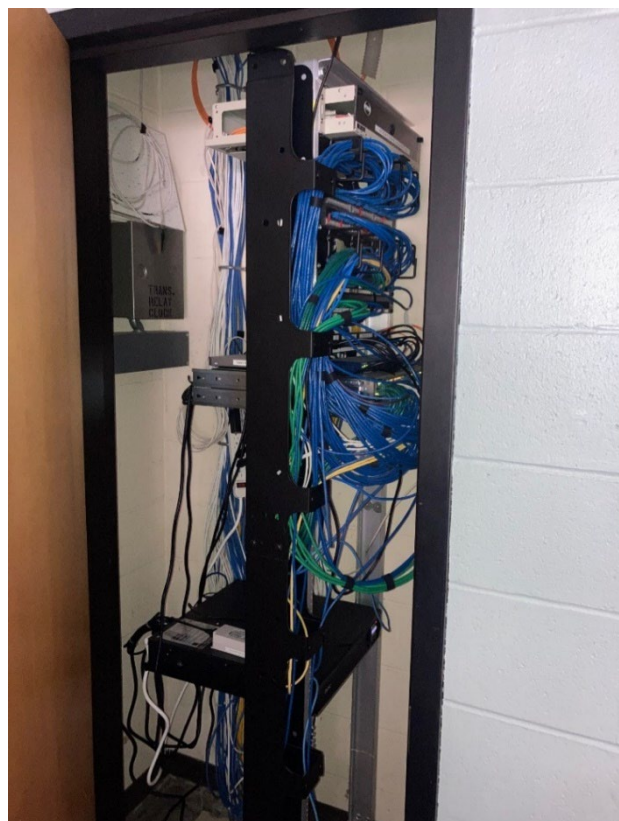
The Building's IDF closets have been added to the structure ad-hoc and are not located in the optimal locations, do not have appropriate cooling/HVAC, and do not have enough dedicated power to support the infrastructure as it stands and cannot be upgraded. These deficiencies are liable to result in future outages and issues directly as a result of the ad-hoc nature of the installations (e.g., unshielded CAT5/6 cables running directly over equipment causing melting/breaks). The Building and will result in major infrastructure problems down the line.

As noted in other sections, the Building's construction is aging and beyond its useful life expectancy. This is also reflected in many of the IDF rooms where leaks are present. This jeopardizes both the infrastructure and the health of the employees, due to the noted hazardous material condition referenced in Appendix A.
