# Orting School District Facility Condition Assessment Phase 1 Preliminary Findings

September 14, 2021

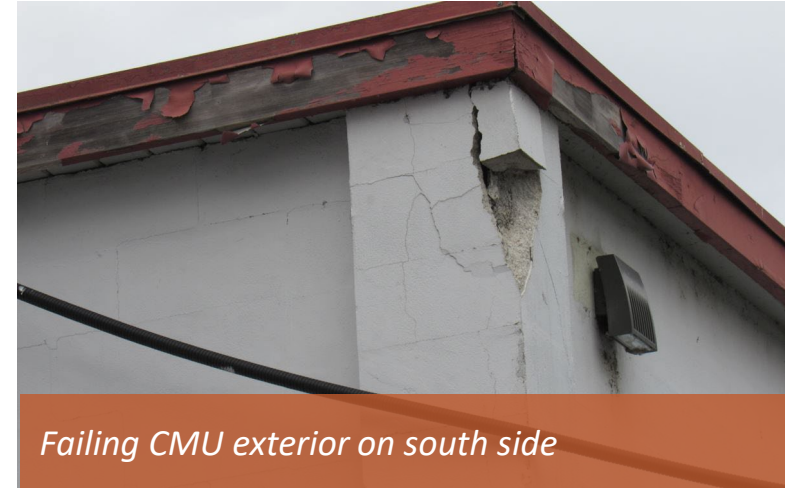
- If facility remains, seismic assessment recommended
- Concrete masonry exterior cracked and falling (safety hazard)
- Roof in poor condition

*Failing CMU exterior on south side*

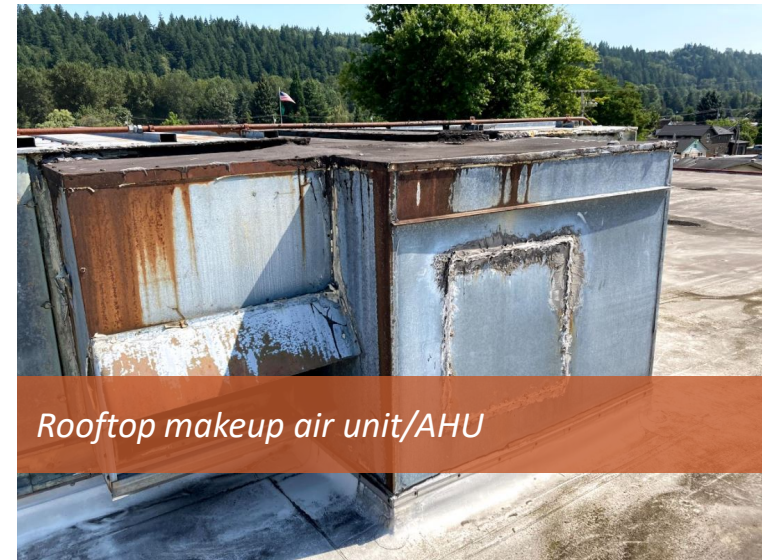
- Make-up air unit on roof has by far exceeded useful life (pictured)

*Rooftop makeup air unit/AHU*

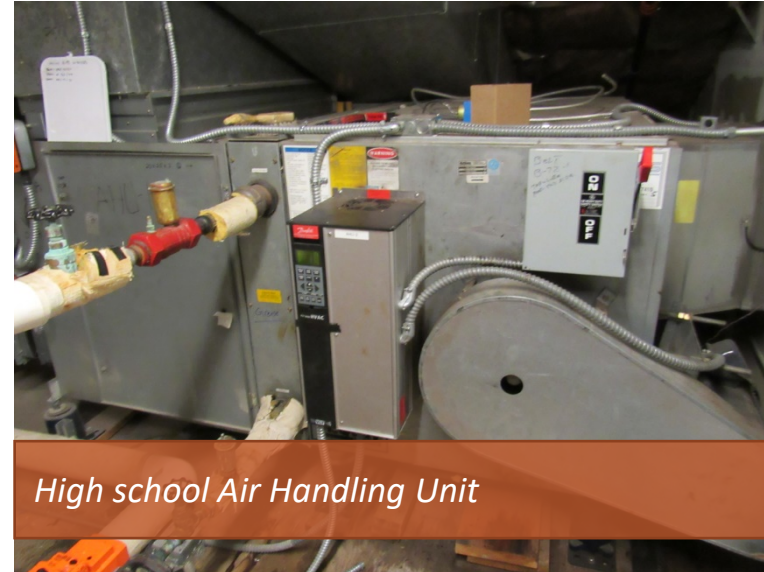
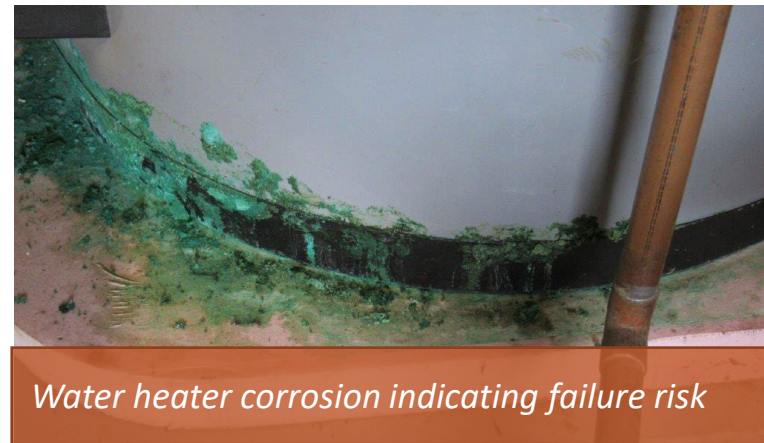
- AHUs in old section have exceeded expected useful life
- Water heater in newer section nearing failure

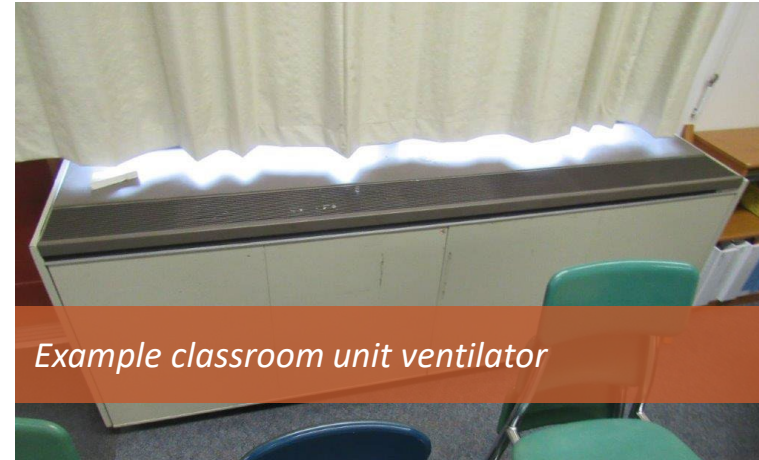
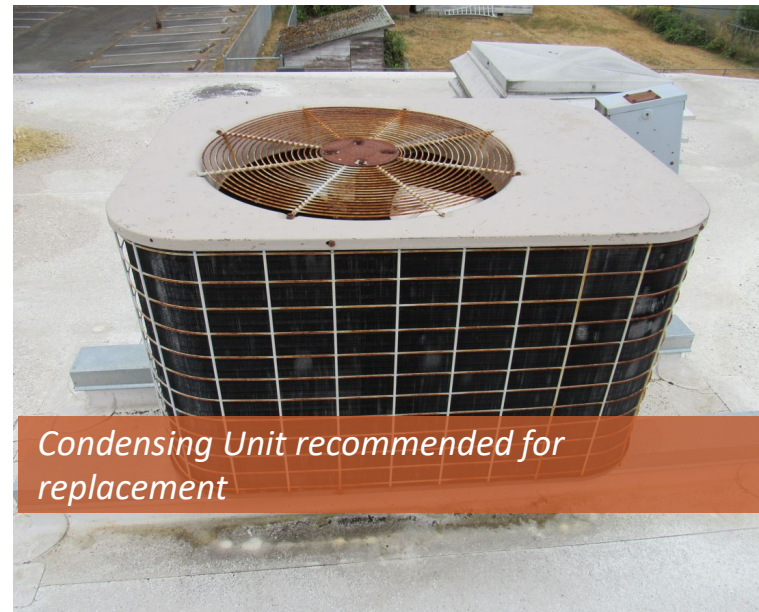
- Classroom unit ventilators well past useful life and less capable than modern systems
- Condensing units on roof have met expected life

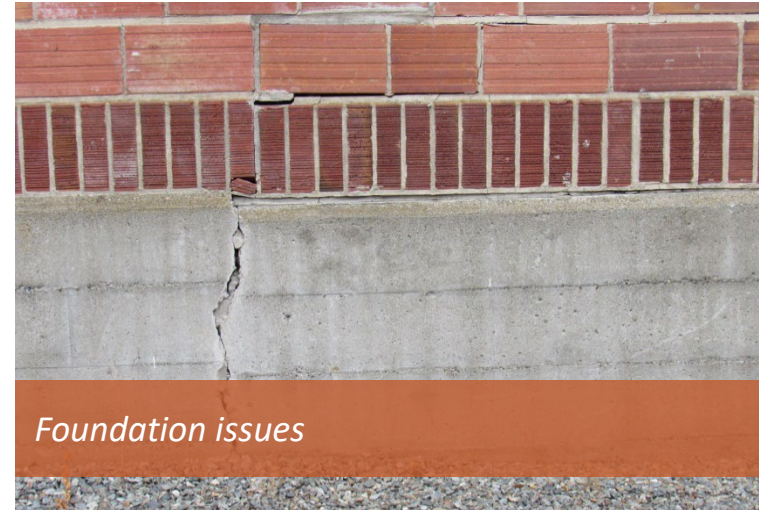
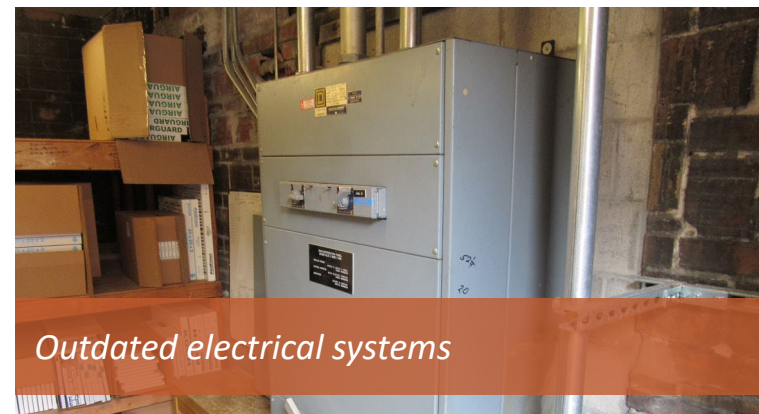
- Building settling in multiple locations
- Single pane windows throughout facility (energy and comfort impact), glazing failing in several locations

- Heating relies on portable AC units and unit ventilators, struggle to maintain comfort with single pane windows

- Main switchgear estimated install in 1950-60s. High risk of failure, fire/safety impacts, and long lead time for component replacement/repair

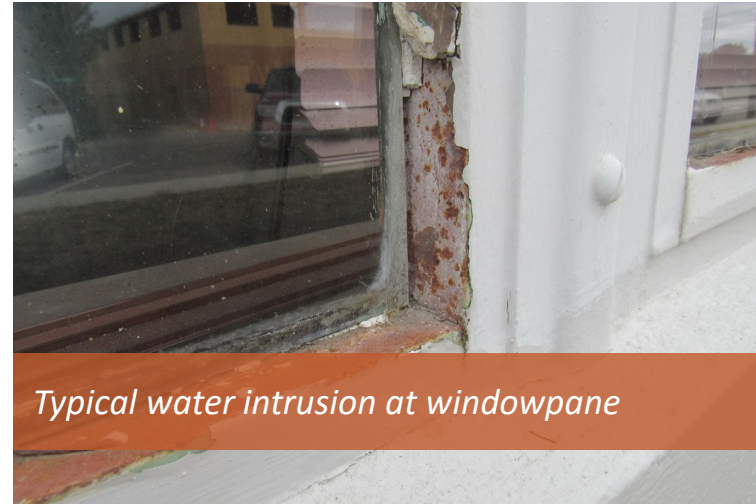
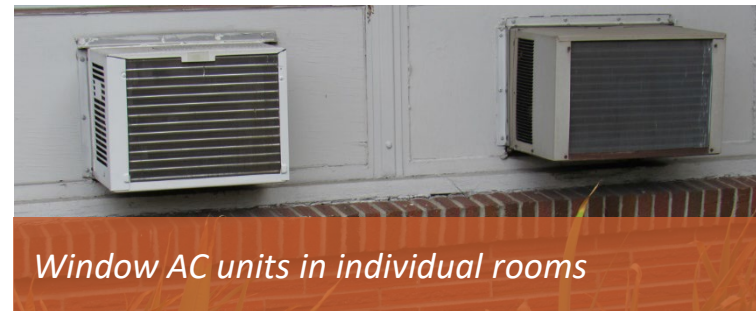
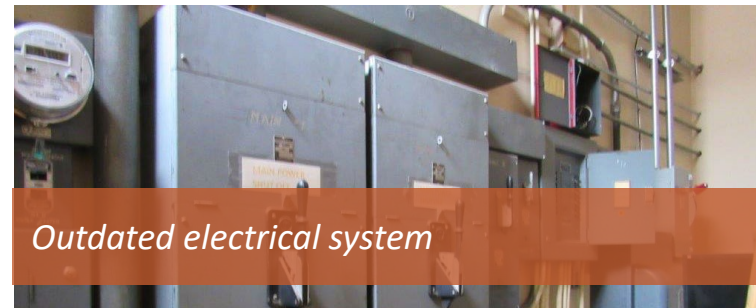
- Original single pane window glazing failing, showing signs of water intrusion. Roof past expected useful life.

- Heating relies on portable AC units and small electric heaters, struggle to maintain comfort

- Building electrical service is original from 1950. High risk of failure, fire/safety impacts, and long lead time for component replacement/repair
