Existing Conditions Study
Cohasset Public Schools

Town of Cohasset, MA

Prepared by:
Ai3 Architects, LLC
526 Boston Post Road
Wayland, MA 01778

April 2022

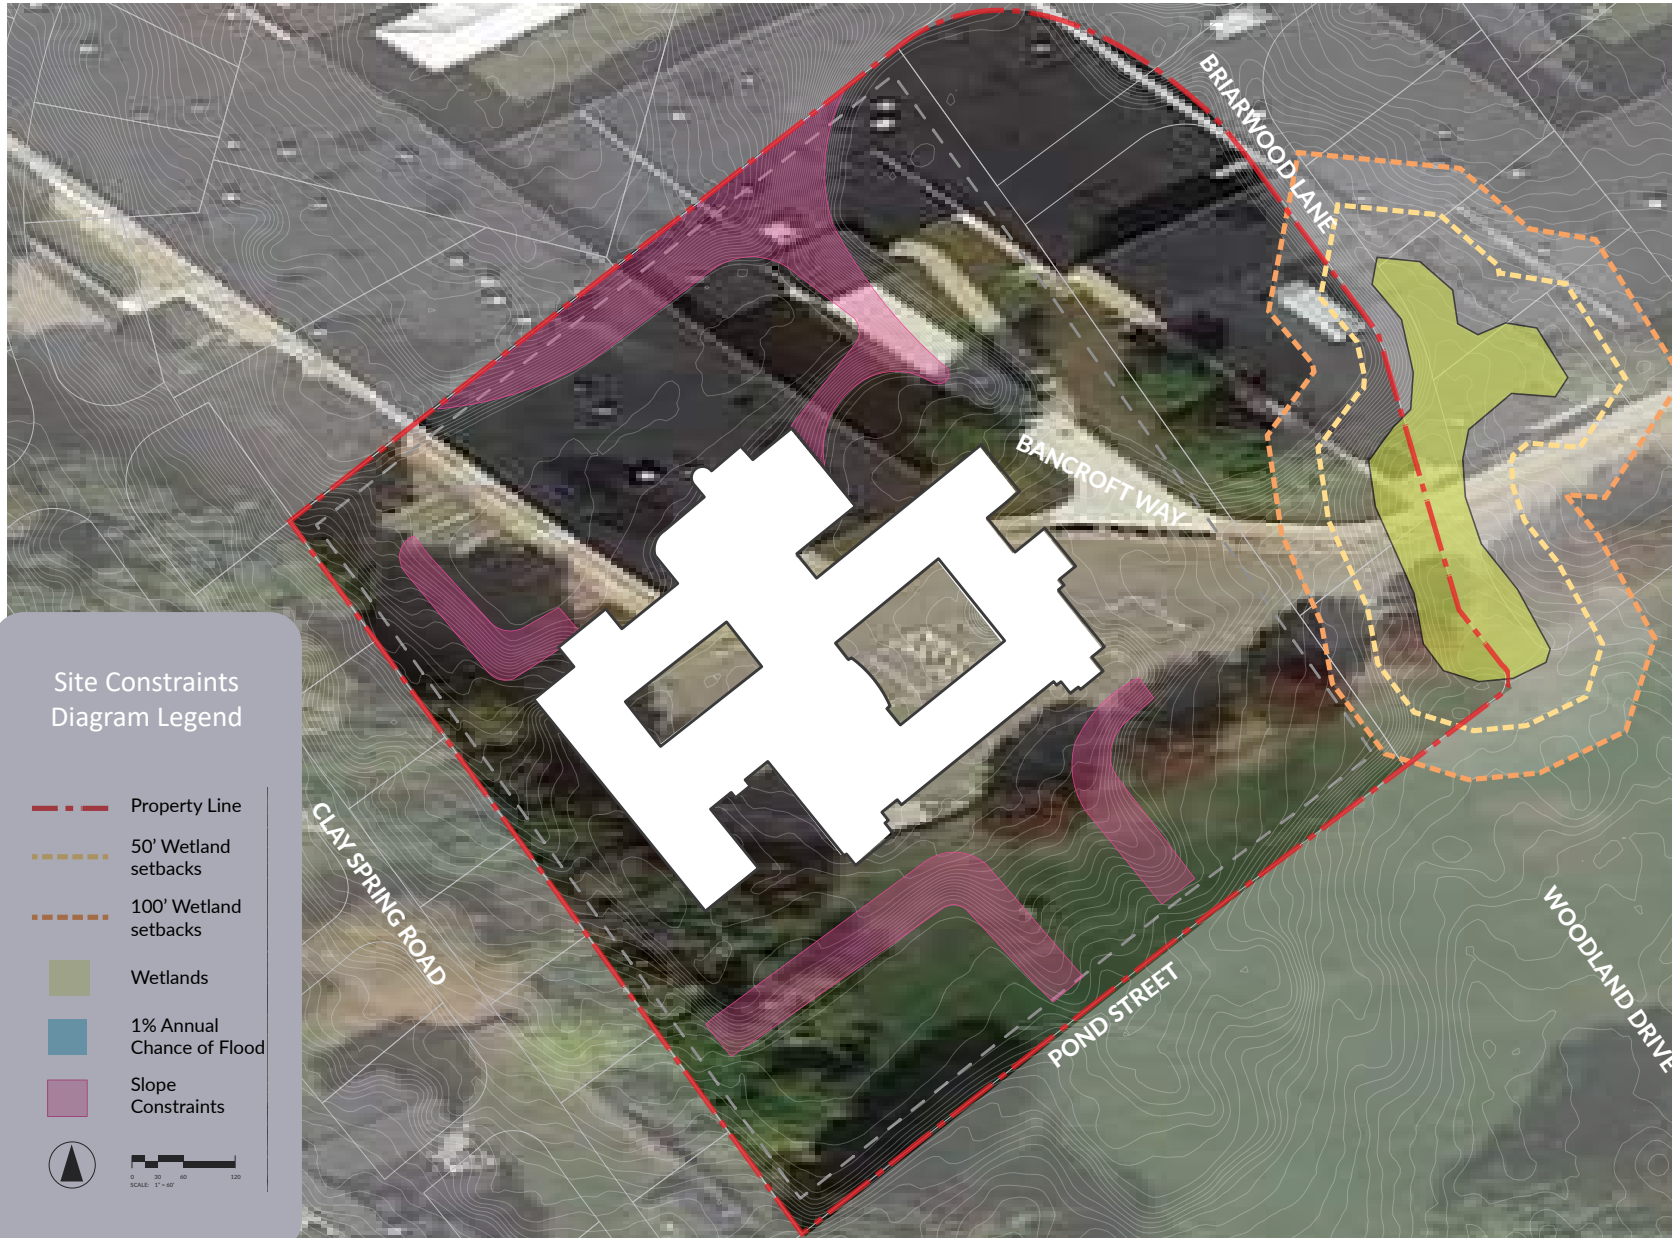
Orientation Diagram

There is areas along the high school and middle school entrance where the landscape should be pruned and trimmed to create safe secure access.
