# Old Rochester Regional School District Junior and Senior High School

Facilities Condition Assessment  
February 2024

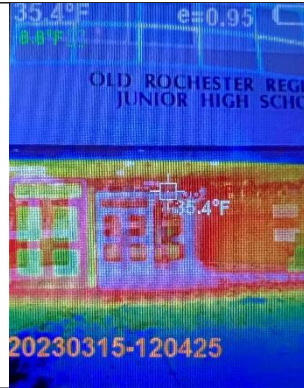
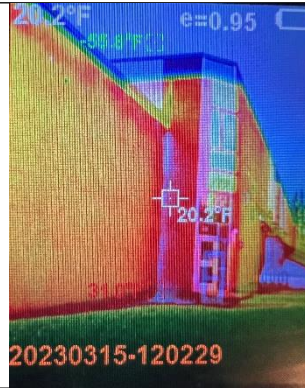
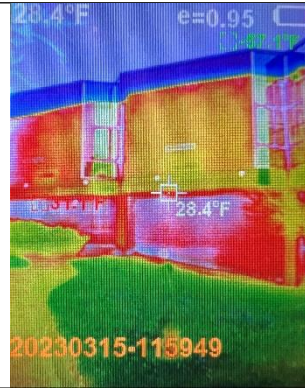
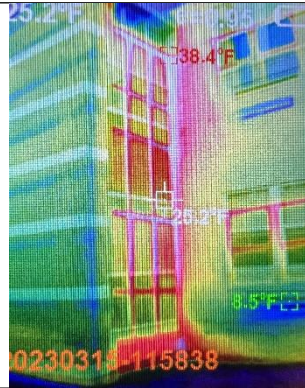
Thermal Imaging

The review team performed thermal imaging of the exterior envelope to help identify any deficiencies such as water infiltration, air leakage, and lack of insulation. The imaging identifies thermal anomalies where either water infiltration or unanticipated air leakage is occurring on the envelope system. The thermal imaging showed only minimal heat loss across the envelope.

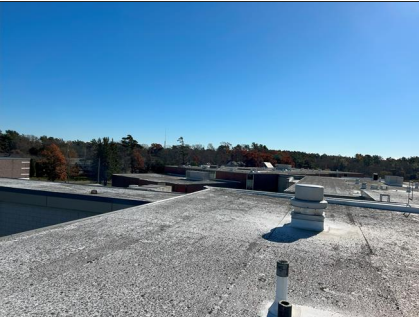
Examples of Roof Conditions

The entire roof of both the junior and senior high school is a low slope, single-ply, roof membrane system. The roofing system is in good condition with no evidence of membrane damage and minimal signs of patching and repair work at both the flat areas as well as all flashing transition points. A large quantity of lichen was observed to be covering the roof membrane. During a site visit following a day of heavy rain, water collection was observed near the edges of the roof causing overflow onto the exterior walls. This appears to be causing the staining observed during the exterior façade inspection. Near the High School Auditorium, trees have overgrown onto the roof surface and causing abrasion and potential damage to the roof membrane.

Additionally, the Junior High Cafetorium Roof shows some evidence of leaking. Although the majority of the roof appears to be intact and professionally installed, there are a couple of areas where the roof transitions from the cafetorium into the main dwelling where roof leaks (we noted two) have occurred. There is evidence of water infiltration along the ceiling area and puddles form on the floor after a raining event. Repairs should be made as soon as possible.

<b>Example A</b> Typical edge condition where a ridge in the roof surface prevents water from flowing towards internal drains.	<b>Example B</b> Continuous water overflow from roof edge onto the masonry below	<b>Example C</b> Tree branches have grown over the top of the roof and causing abrasion on the membrane.	<b>Example D</b> Presence of lichen across the roof membrane

*The PVC roof membrane appears to be in fair condition. At just over 20 years of age, The District could expect up to another 10-20 years of life from this roof with proper maintenance including the following measures:*

- *Fully cleaning the lichen observed across the PVC membrane*
- *Trimming back any overgrown trees that are now touching the PVC roof surface*
- *Consider addressing the ponding issue near the edges of the roof by reinstalling the tapered insulation to properly pitch to drain.*
- *Immediately repair the above described leaking issues at the Junior High School Cafetorium*

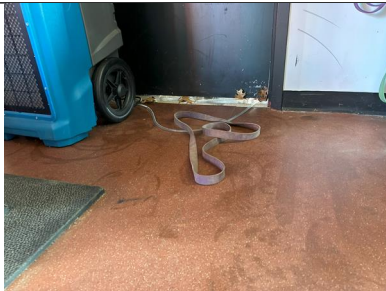
Examples of Exterior Hollow Metal Door Deterioration

The exterior hollow metal doors are exhibiting deterioration as evidenced by significant daylight coming through gaps around the panel edges, and noticeable rusting, particularly near the thresholds. Currently, this issue presents outdoor infiltration into the building, creating HVAC operation inefficiencies and thermal comfort issues. The issue is exacerbated by negative air pressure inside the building as noted in the review of the HVAC system below. The negative pressure continuously draws outdoor air into the building through openings in the exterior envelope such as the gaps at the exterior doors.

Further deterioration of the doors at the panel edges, jambs, and thresholds will ultimately result in the inability to properly open and close. This will create significant safety and security issues if doors cannot be properly opened for emergency egress and if intruders can access the interior through a door that does not fully close due to warpage.

<b>Example A</b> Exterior Hollow Metal Doors exhibiting substantial daylight between and underneath panels	<b>Example B</b> Exterior Hollow Metal Doors exhibiting substantial daylight between and underneath panels	<b>Example C</b> Exterior Hollow Metal Door exhibiting substantial daylight between panel and threshold	<b>Example D</b> Evidence of erosion at the bottom of exterior hollow metal doors

*Replace all exterior hollow metal doors and frames and seal with weatherstripping at bottoms and jambs. This will help improve the building's energy efficiency and prevent future safety and security issues. There should also be some consideration of installing or creating air locks, double sets of doors, foyer entrances with cabinet heaters to help mitigate the energy losses when opening a highly used exterior door used for frequent access.*

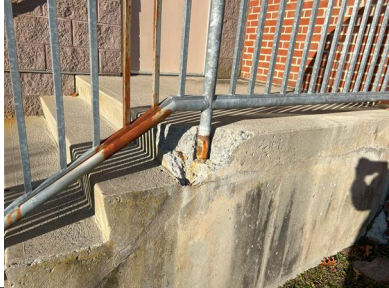
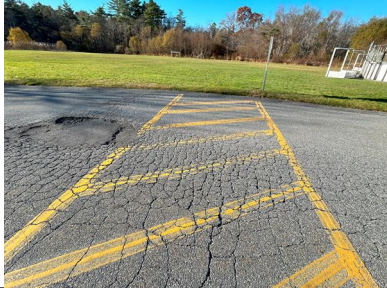
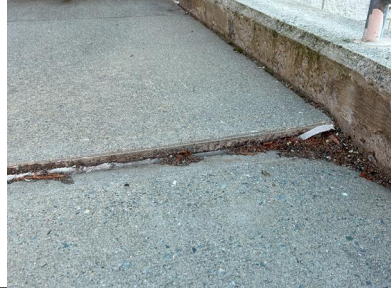
Examples of Cracking, Spalling and Settlement

There is some evidence of cracking, spalling and settlement at exterior concrete steps and walkways due to typical wear and tear and freeze/thaw cyclic expansion. The asphalt parking areas are beginning to deteriorate. Some areas are exhibiting signs of gross failure (i.e., “alligator” cracks) and this will continue to progress as the asphalt ages.

<b>Example A</b> Cracked/spalling concrete at exterior stairs outside of ORCTV	<b>Example B</b> Alligator cracking and potholes at drive aisle	<b>Example C</b> Concrete settlement causing a height differential and potential tripping hazard

*The District should plan on mill and overlay upgrades to paved parking areas and repairs to asphalt curbing in certain areas. In addition, repairs and maintenance to exterior concrete steps and walkways will be necessary to maintain safe building access.*

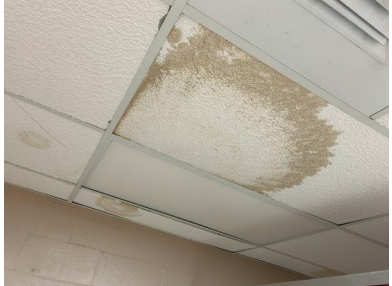
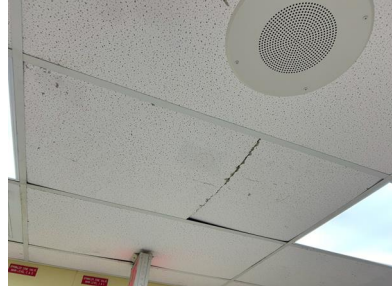
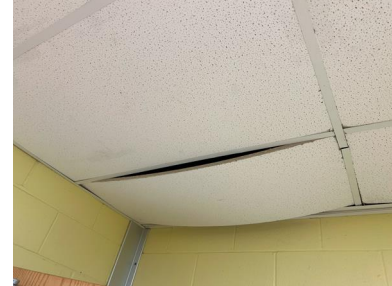
Typical Examples of Ceiling Damage

The ceiling finishes vary from gypsum board in offices and certain rooms to 2'x4' acoustical ceiling tile (ACT) and grid system. The 2'x4' ACT grid system is generally in good condition, but there is some water staining and sagging on ceiling tiles throughout the building. Maintenance reports that much of the moisture staining is due to expansion and contraction of above ceiling piping during seasonal changes. Ongoing cyclic building maintenance will continue to include the replacement of damaged individual ceiling tiles.

*The District should consider preparing for the replacement of large areas of flooring finishes as age, wear, and tear continue. Although not an immediate need, within 5+ years, some areas will require larger scale updating beyond regular patch/repair work. Similarly, the acoustical ceiling tile and grid system will only continue to wear as time goes on. Without a major renovation or new building project in the foreseeable future, The District may consider large scale replacement of ceiling systems to prevent the appearance of age and deterioration throughout the building.*

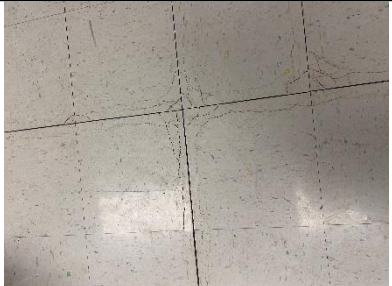
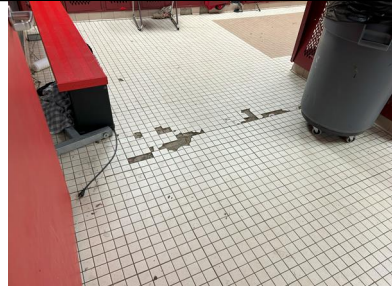
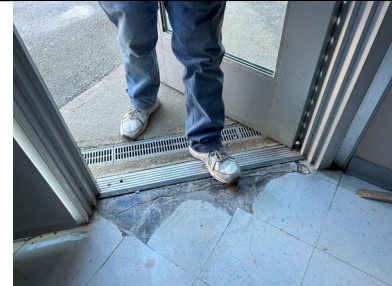
Examples of Flooring Damage

Much of the existing flooring is either VCT, carpeting or ceramic tile. The existing flooring is generally in good condition. There are some areas of worn, damaged or missing VCT and tile in heavy use areas like corridors, near door thresholds, and in the locker rooms.

<b>Example A</b> Cracking/lifting VCT in the Junior HS Art Classroom	<b>Example B</b> Missing tiles in the Boy's Locker Room	<b>Example C</b> Missing VCT from water damage at entrance to Junior HS cafetorium

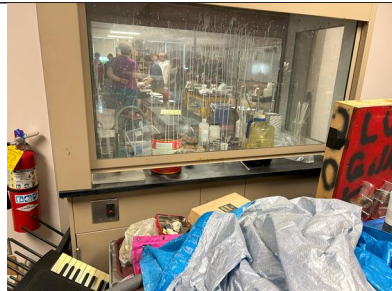
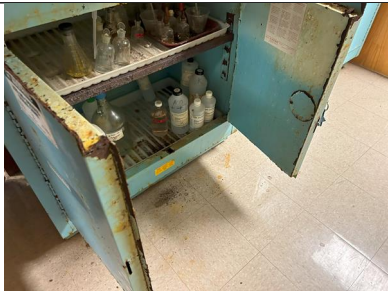
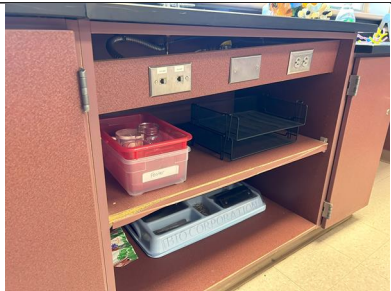
Science Classrooms

HS Science Rooms 300, 301,302,303,304,305,308,309 – Combination of: fume hood issues (non-operational when tested), lack of master Emergency Power Off (EPO) solenoid switch to disable the natural gas supply piping feeding into the classrooms in the event of an emergency. There are currently manually operated ball valves under a protective cover with poor labeling in the classrooms but seem inadequate should a need arise to quickly cease gas flow discharge. There are also numerous classroom student access gas jets without protective covers. Several of the satellite storage cabinets lacked the required ventilation. We also observed that the science room casework and counters are generally aged and worn.

<b>Example A</b> Fume hood – non-operational when tested	<b>Example B</b> Rusting acid storage cabinet will no longer close securely	<b>Example C</b> Science room casework in deteriorated condition

- All fume hoods should be replaced with new.
- The lab gas delivery system should either have emergency shut off buttons installed, or if the school does not plan to use the gas going forward, the gas piping should be capped.
- The lab casework and countertops should eventually be replaced.

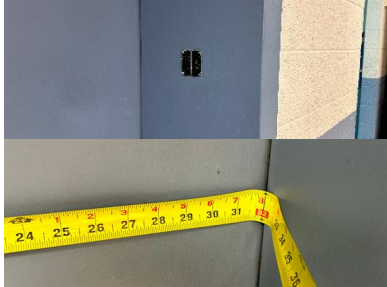
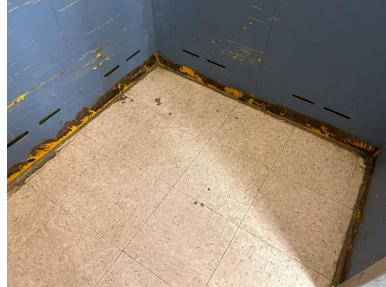
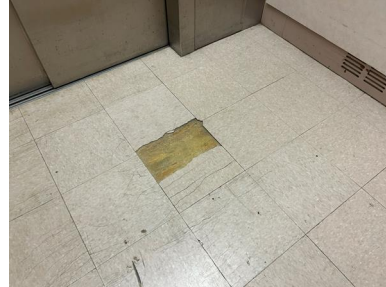
Elevators

<b>Example A</b> JHS elevator does not meet all current ADA/MAAB requirements	<b>Example B</b> JHS elevator cab's interior is aged and beyond its useful life.	<b>Example C</b> The main passenger elevator cab finishes are near the end of their serviceable life

*If a major renovation were to occur, The District may consider upgrading/replacing the Junior High School Elevator, signage, and well as repair any damage/openings in elevator shaft and headhouse to prevent outdoor air infiltration.*
