RE: Follow-Up Structural Condition Assessment  
Stonington Middle School – 204 Mistuxet Avenue, Mystic, CT 06355  
Fuss & O'Neill Reference No. 20240408.A10

**Stonington Middle School – Follow-up Structural Evaluation of Concrete Slabs**

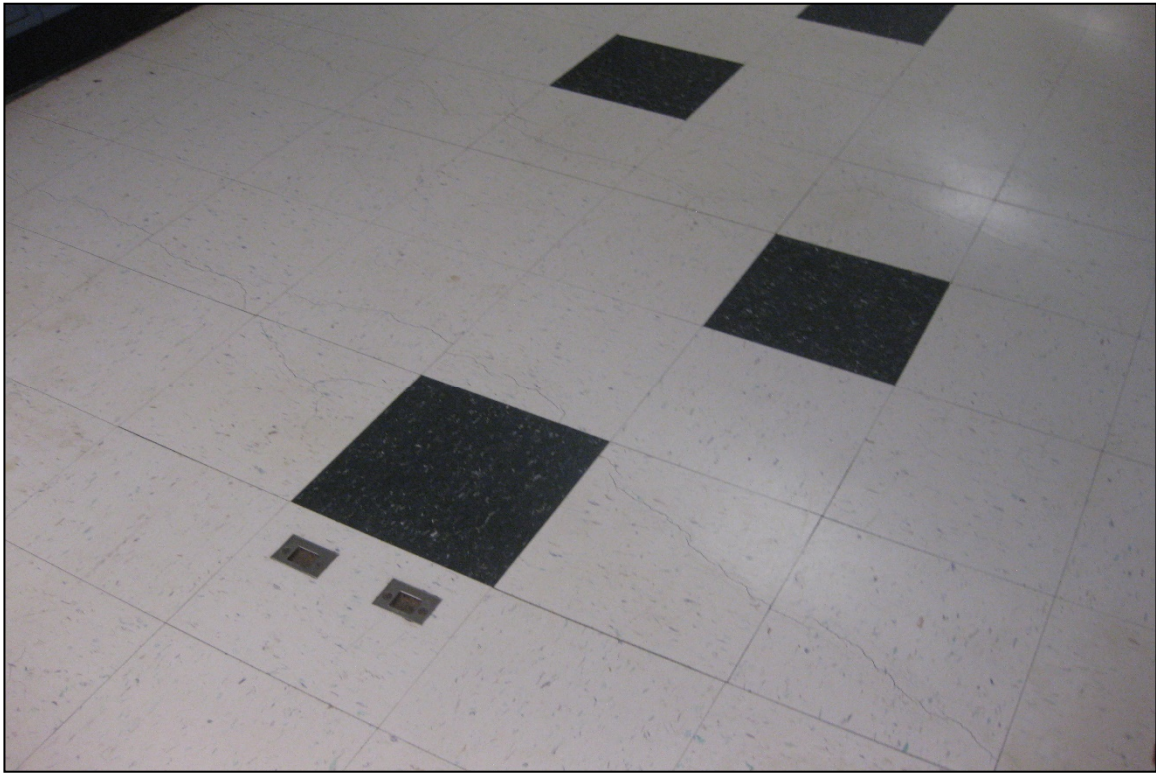
- The southern end of the 1<sup>st</sup> floor corridor slab has VCT flooring that is cracked and generates a hollow sound and vibrates with a different frequency when conducting a heel drop test. Additionally, we observed multiple transverse cracks along the underside of the

Photo 1: Typical Cracking in VCT Flooring at Southern End of 1<sup>st</sup> Floor Corridor

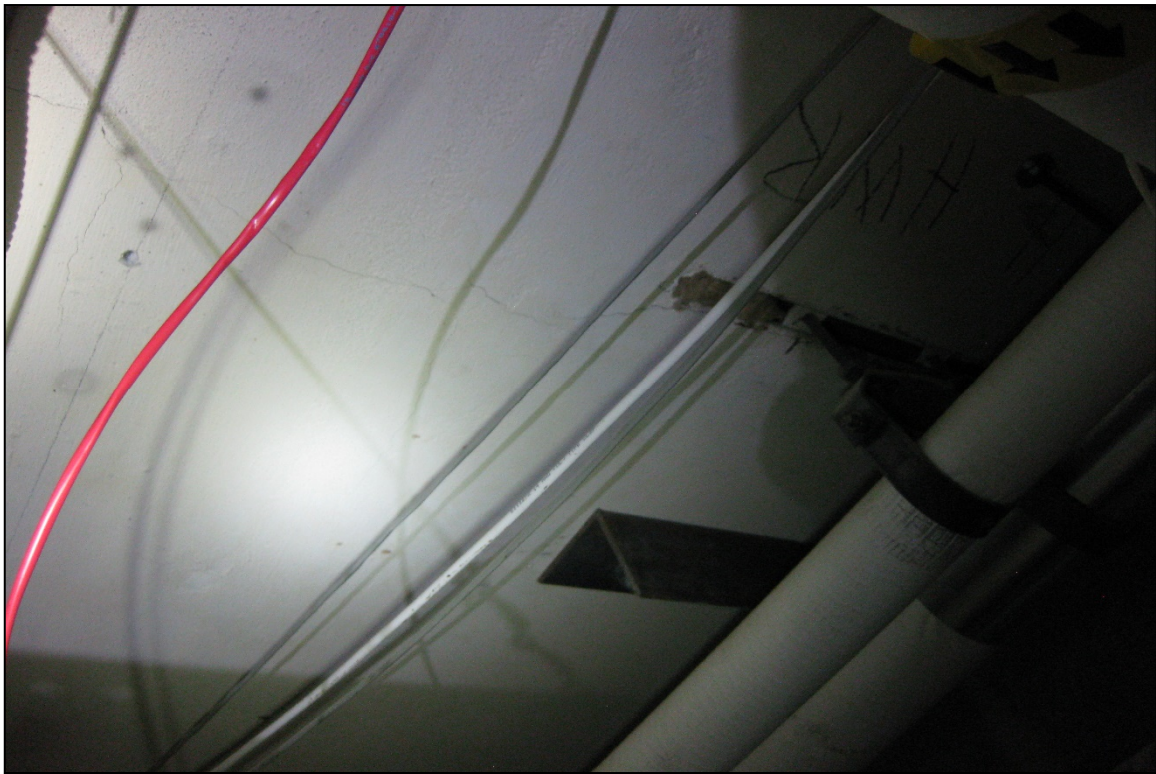
slab. We noted a heavy concentration of utility pipe supports anchored into this area of the slab.

Photo 2: Cracking at Underside of 1<sup>st</sup> Floor Corridor Slab

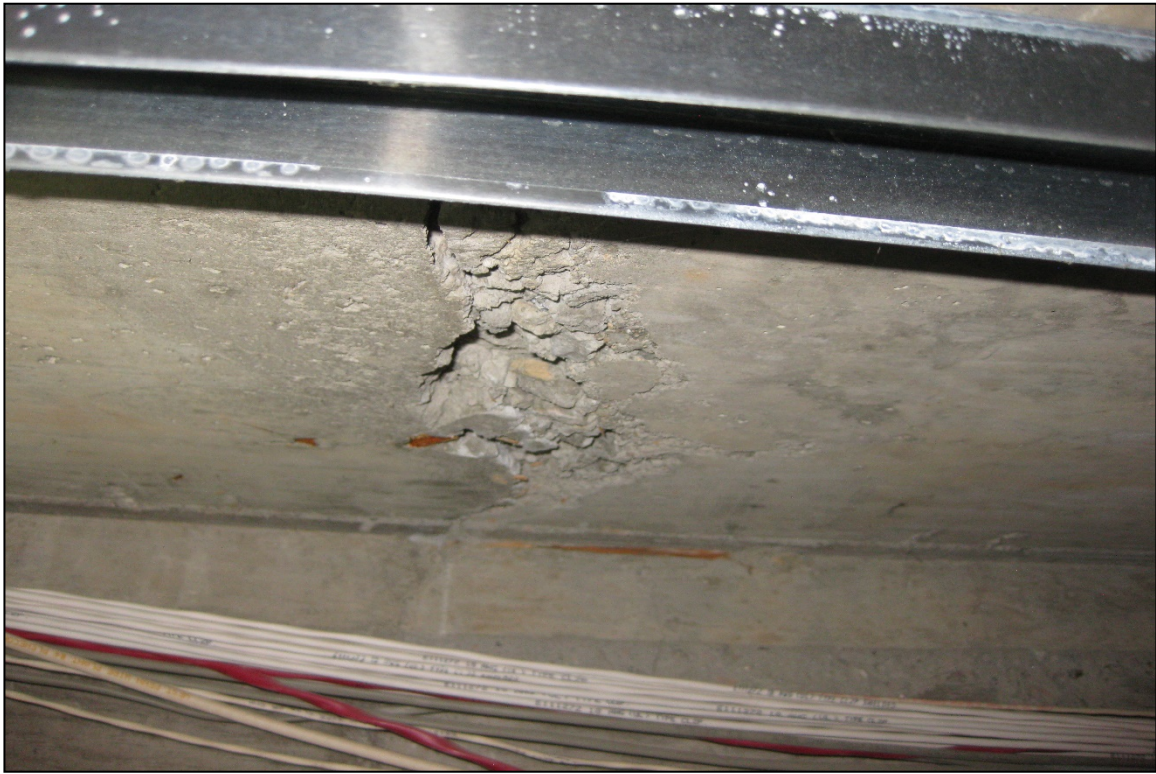
- There are multiple locations throughout the 2<sup>nd</sup> floor corridor where void spaces along the underside of the concrete slab are present. These voids appear to result from poor consolidation during the original placement of the concrete and there were no observed conditions that would suggest the poor consolidation is actively progressing.
- In some locations, the original steel chairs (used to space reinforcing steel during concrete pours) are visible at the underside of the slabs and show signs of minor corrosion/rusting. These locations often coincide with areas of poor consolidation noted above.
- There appears to be mild efflorescence in some cracks and areas of poor consolidation; however, there are no indications that these areas of deterioration are active.

Photo 3: Typical Voids at Areas of Poor Consolidation

F&O previously reviewed, in detail, the northern end of the 2<sup>nd</sup> floor corridor slab and recommended replacement. Our additional observations have confirmed this recommendation. The other conditions noted above do not require immediate corrective action or repair and are safe to continue to occupy; however, we do recommend installing crack monitors on the transverse cracks observed at the southern end of the 1<sup>st</sup> floor corridor to track any changes in their condition and possible progression of any structural concerns.

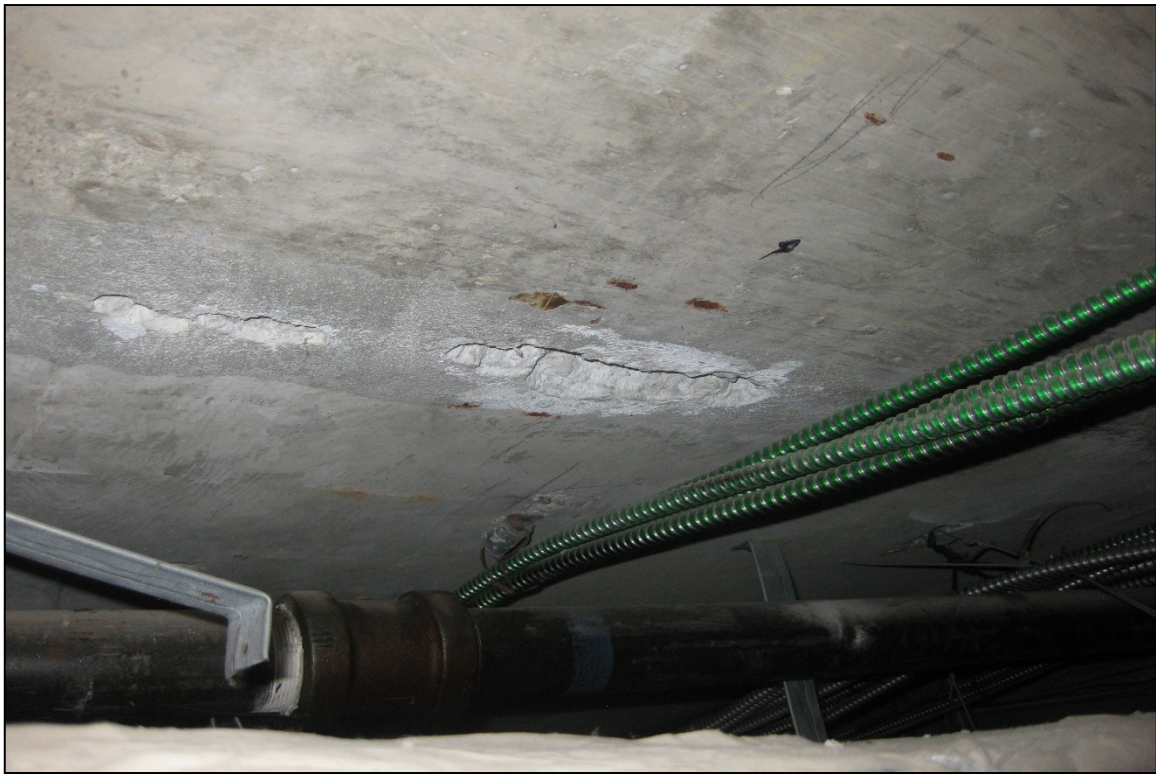
Photo 4: Exposed Rebar Chairs at Bottom of Concrete Slab

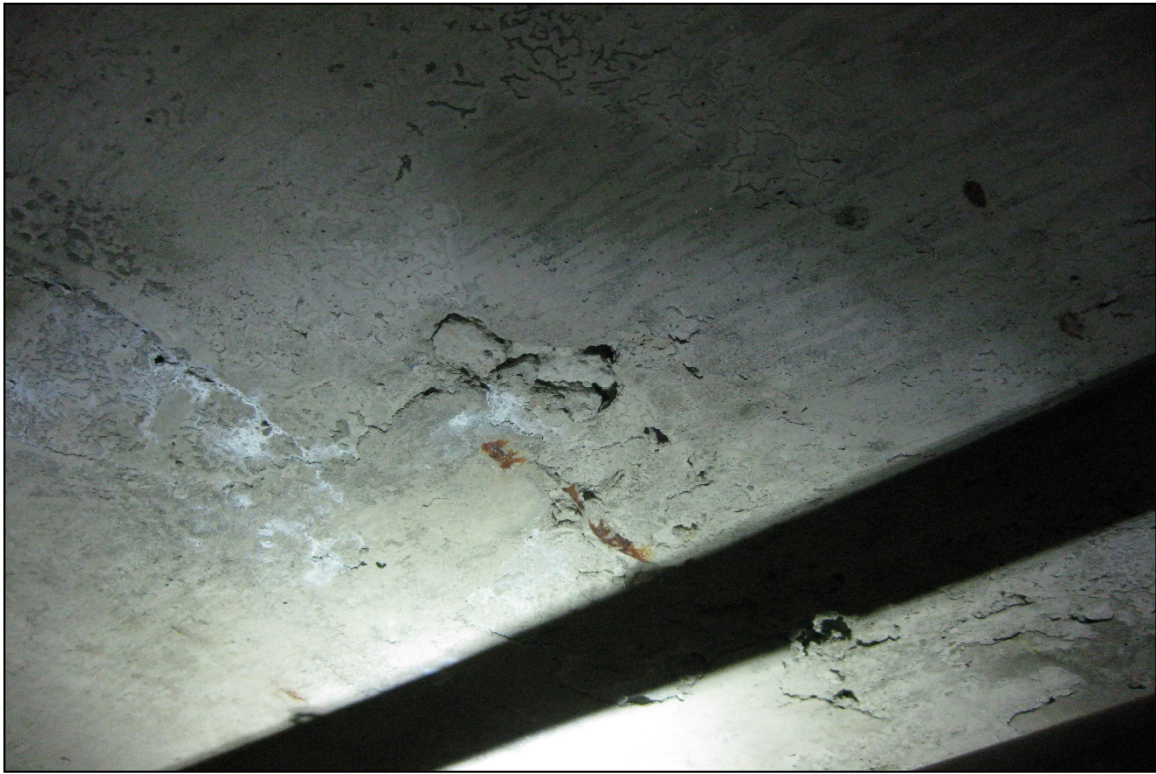
Photo 5: Mild Efflorescence and Exposed Rebar at Bottom of Concrete Slab

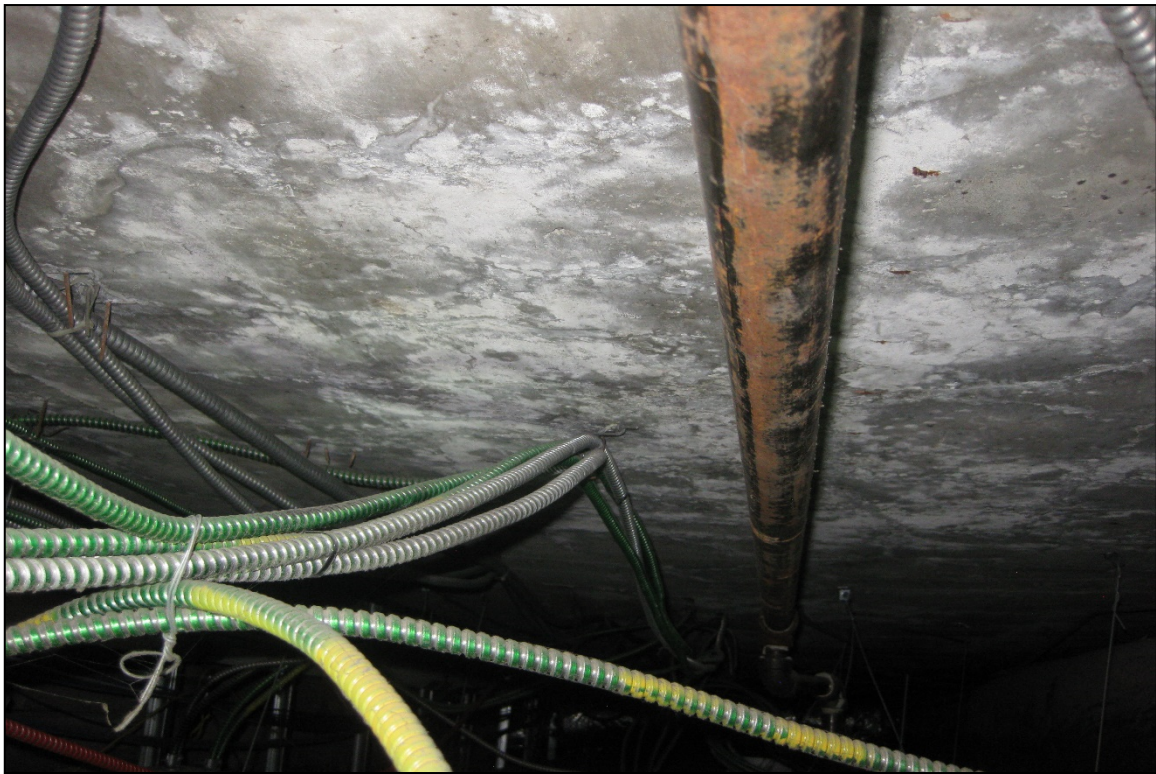
Fuss & O'Neill, Inc. (F&O) has completed a follow-up assessment of the existing 1<sup>st</sup> and 2<sup>nd</sup> floor concrete slabs for the original 1961 portion of the Stonington Middle School located in Mystic, CT. During our initial assessment in April of 2024, a portion of the 2<sup>nd</sup> floor corridor slab in the northern wing of the building was observed to be deflected with noticeably cracked VCT flooring and cracks and efflorescence on the underside of the concrete slab. The purpose of this follow-up assessment was to determine if there are additional areas of concern that require corrective action.

Photo 6: Previously Observed Significant Deterioration at Northern End of 2<sup>nd</sup> Floor Corridor
