LONG RANGE FACILITY ASSESSMENT AND EDUCATIONAL ADEQUACY STUDY 2022

VOLUME 2C

FACILITY ASSESSMENT - INDIVIDUAL BUILDING INFORMATION:
MIDDLE SCHOOLS, HIGH SCHOOLS, AND OTHER BUILDINGS

A T S + R

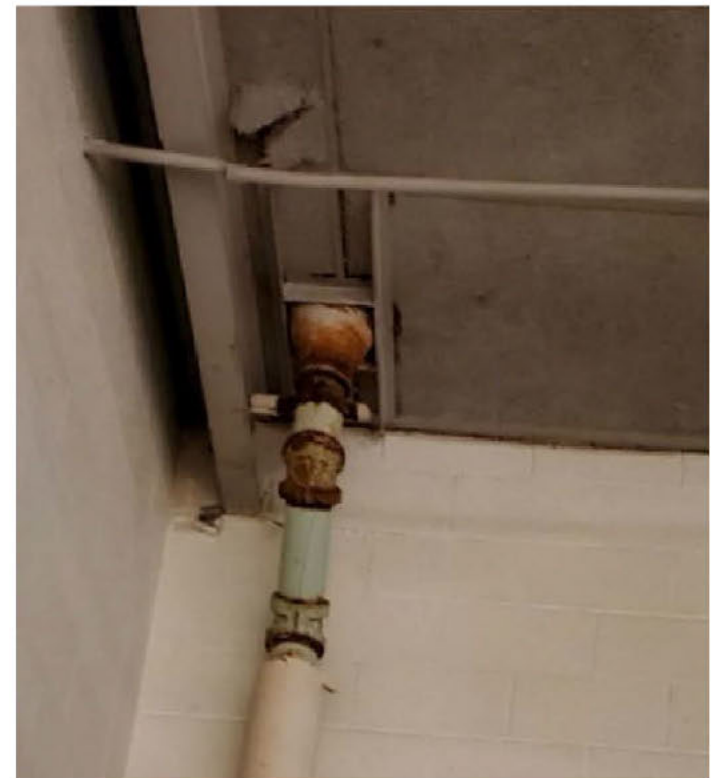
- **Roofing:** Several roof areas are leaking and/or are well past their anticipated life span and should be replaced.
- There is a damaged portion of Tectum roof deck and leaking roof drain at the northeast corner of the gym roof. These should be replaced.

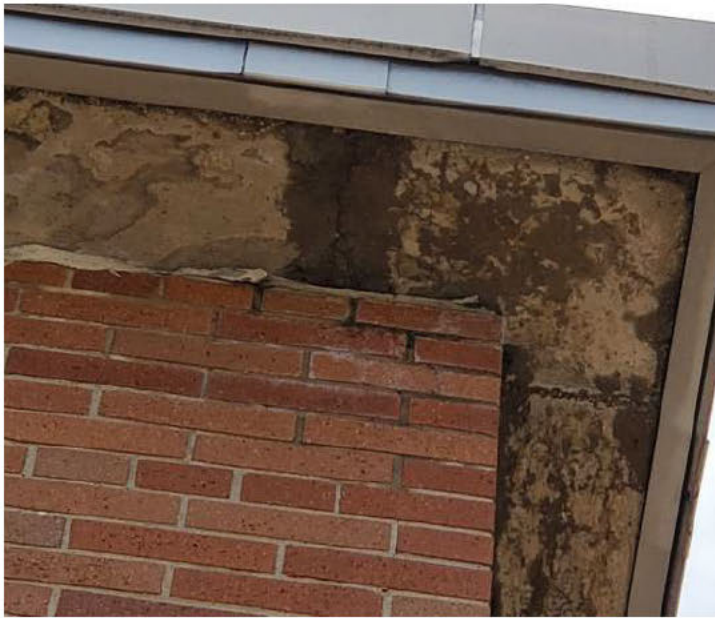
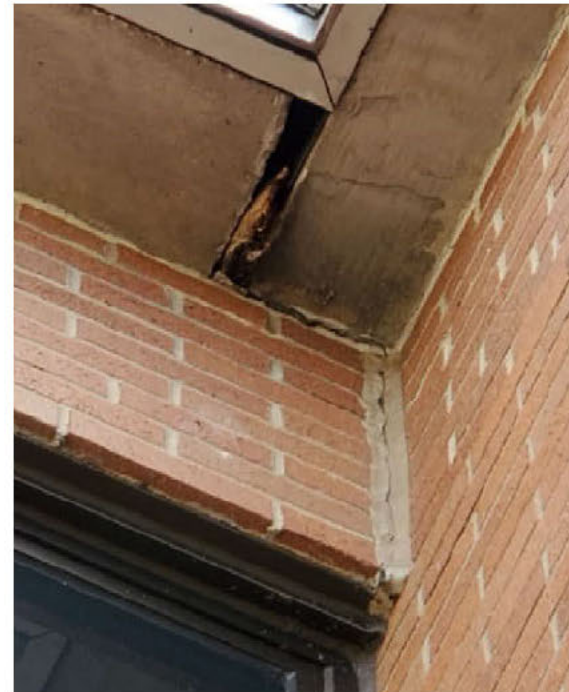
- In the original 1958 classrooms portion of the building, the existing top-of-masonry wall to concrete roof deck intersection, with roof deck projection, relies on only a sealant joint between for watertightness. The underside of the deck, and its joints, are exposed. The sealant joint is failing, likely allowing water to enter into the building by action of wind-driven rain. This detail should be corrected by installing prefinished metal flashing under the projection, extending down onto the face brick with a drip, thus protecting both the underside of the concrete and the intersection.

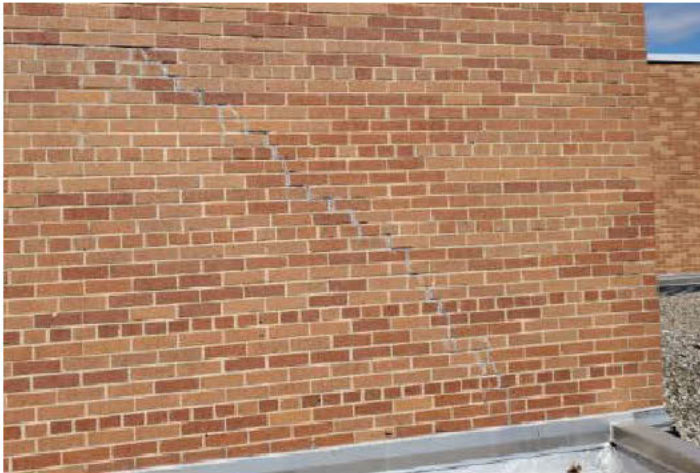
- **Tuckpointing** is required on several areas of the building, especially around the gym. There also some cracks that should be repaired.

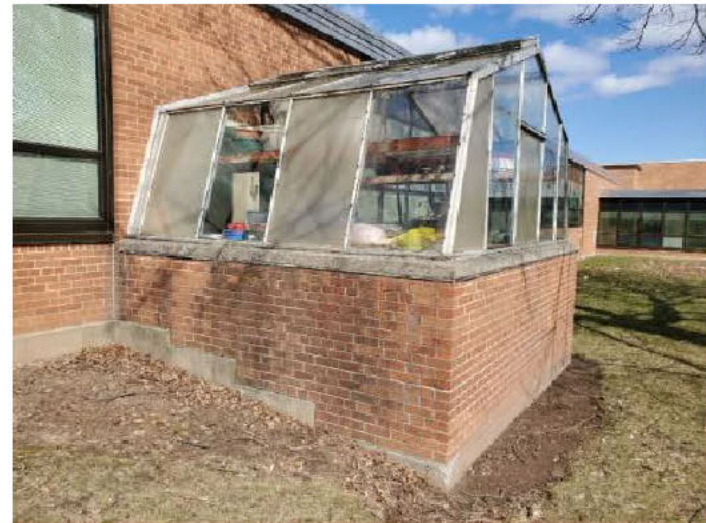
- **Greenhouse:** The greenhouse is original and is in poor condition. The greenhouse structure should be replaced and the walls tuckpointed.

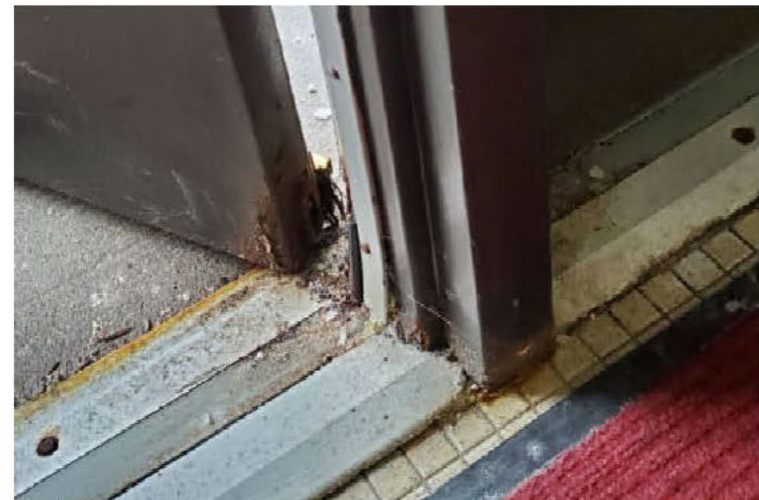
- **Exterior doors:** Several exterior doors and frames are rusted on the bottom and should be replaced with aluminum storefront entrance frames (some can wait 6-10 years) .

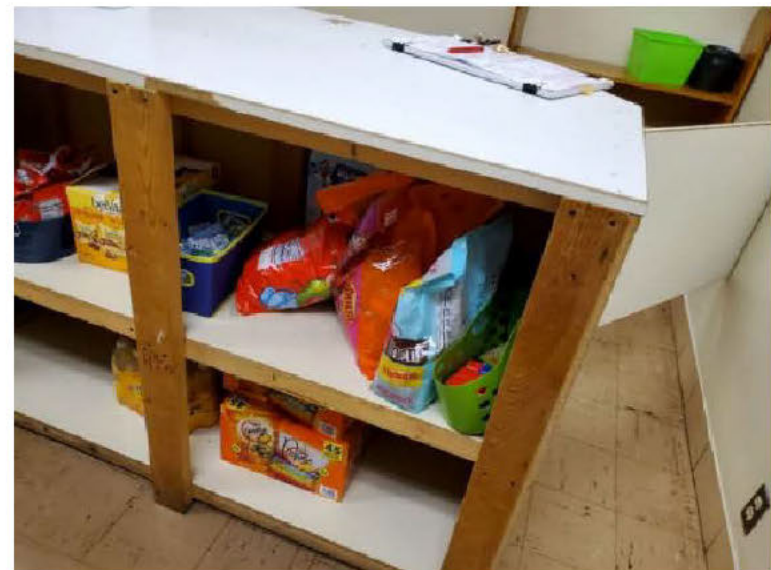
- **Flooring:** Many classrooms still have VAT flooring that should be abated, and some VCT floors in the 1993 addition rooms are very worn. All flooring that has not recently been replaced should be replaced.

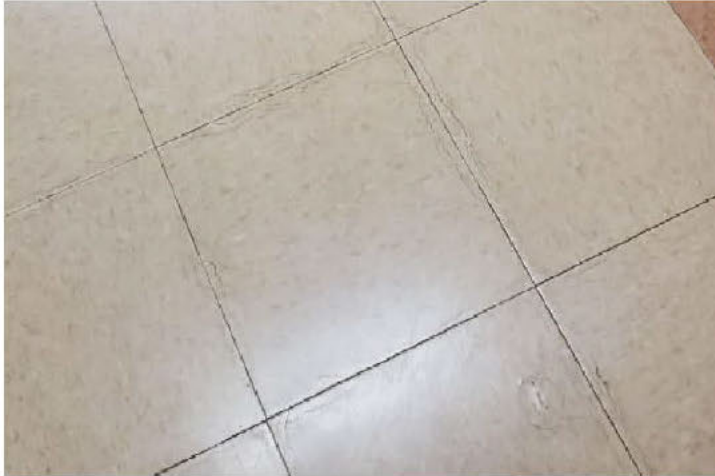
- The VCT flooring in the cafeteria is failing – cracking around the perimeter of each tile.

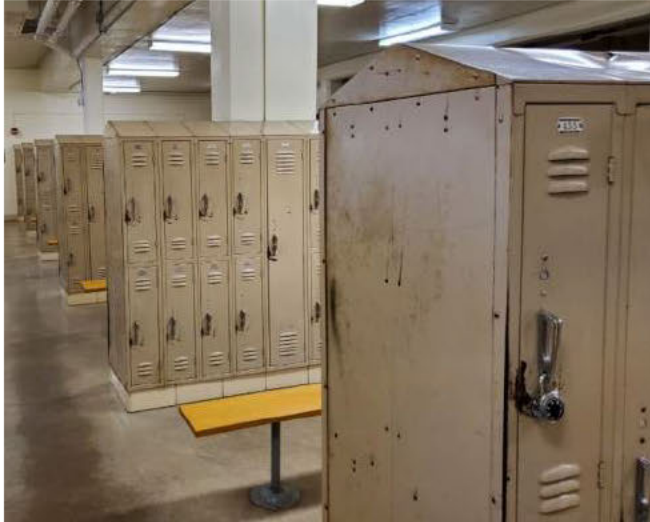
- **Lockers:** The lockers in the girls phy-ed locker room are in poor condition and should be replaced.

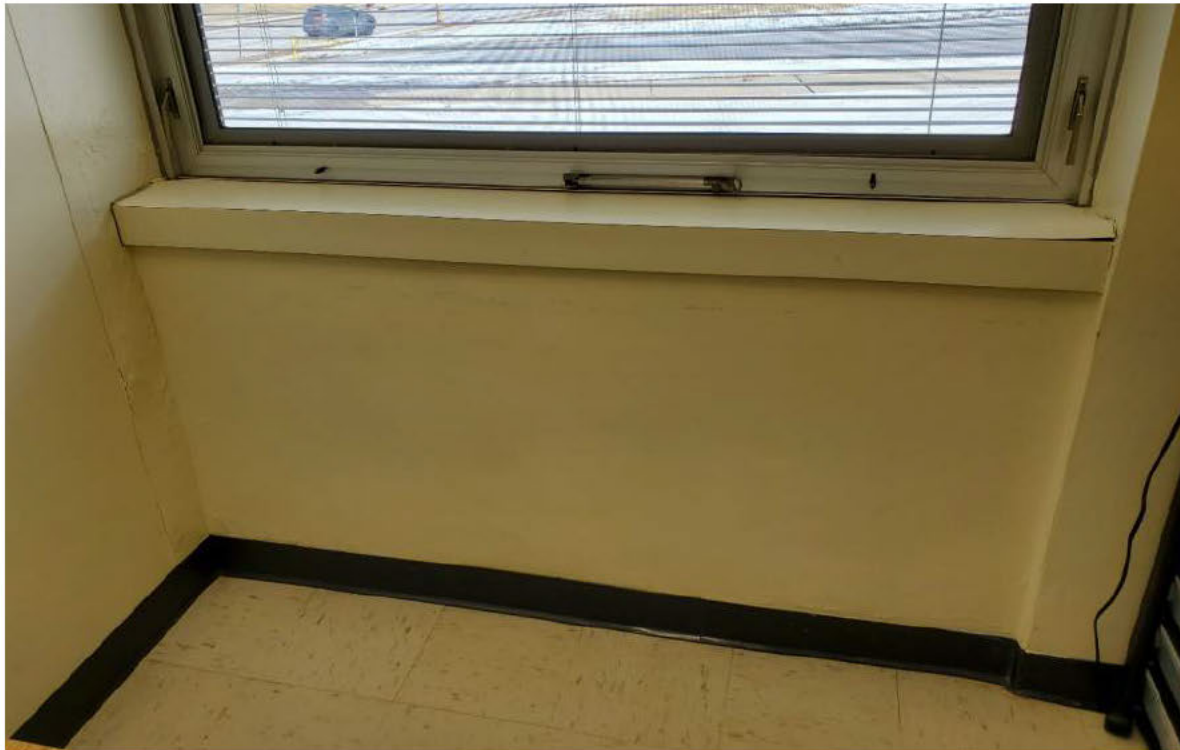
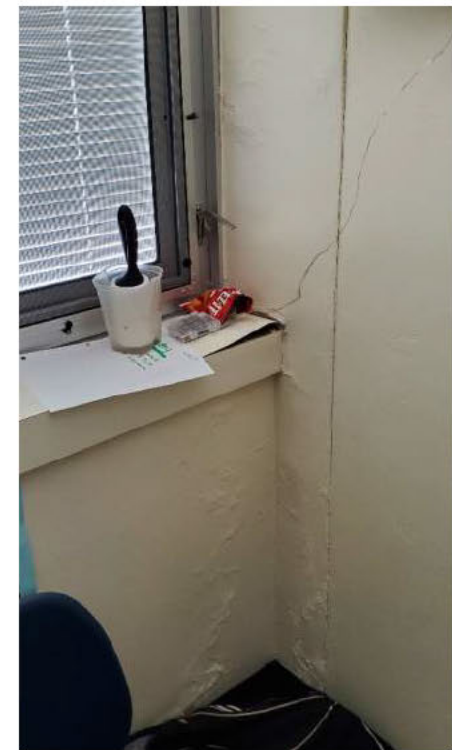
- Building engineer reports many windows (older aluminum with integral blinds, not triple glazed) in the original 1964 building are leaking, especially on the east side. There has been damage to interior plaster and plastic laminate sills. Recommend window replacement.

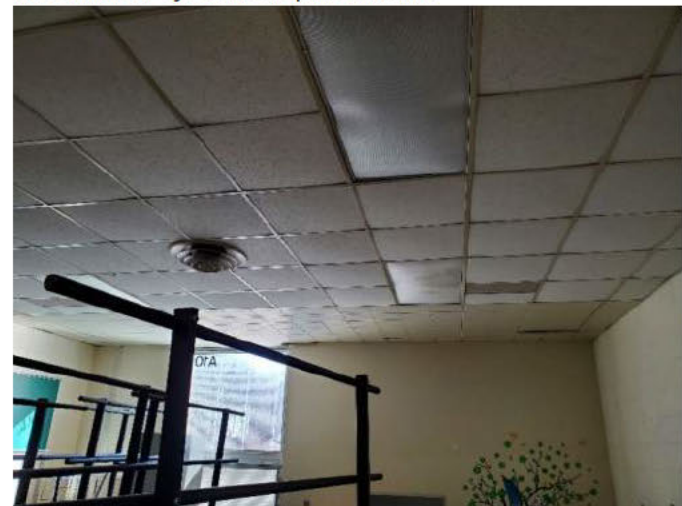
- ACT ceilings in the entire 1964 building are in poor condition and/or need to be replaced due to required mechanical systems replacement.

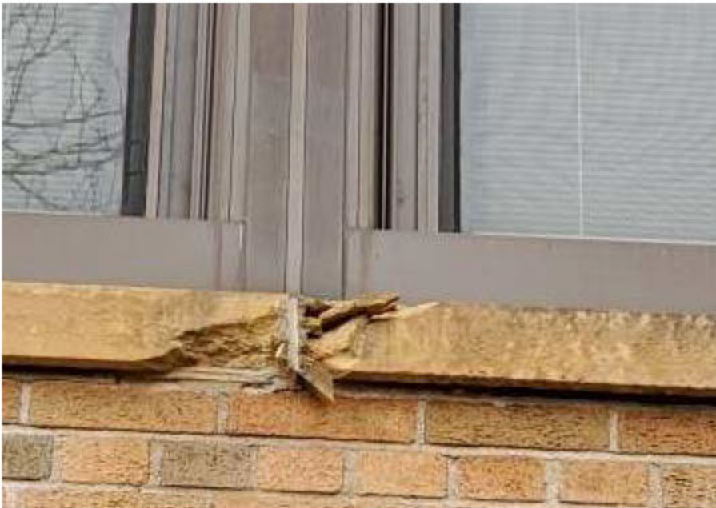
- Exterior window sills are showing a variety of deterioration. Unable to determine level of degradation. Monitor and replace stone sill at windows as required.

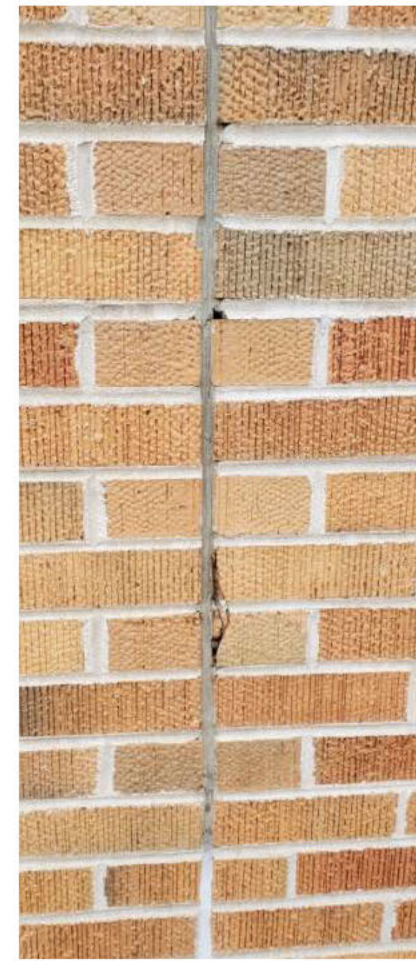
- Control joint sealant in some locations is missing and separated. Replace control joint sealant at these locations.

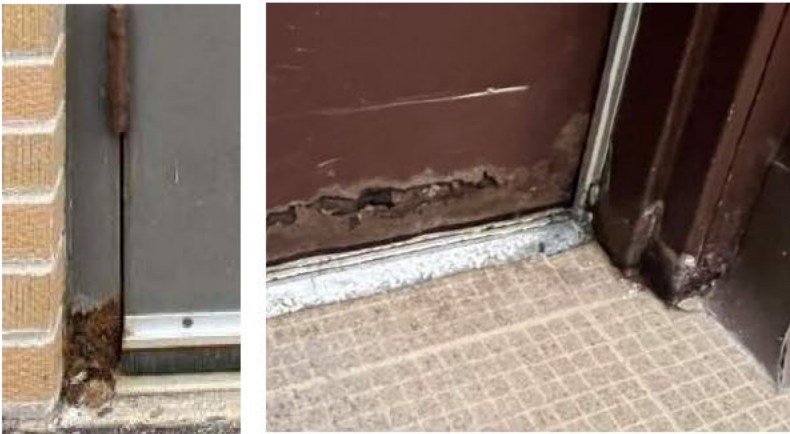
- There are several doors and frames around the exterior of building that are rusting. Replace doors and frames

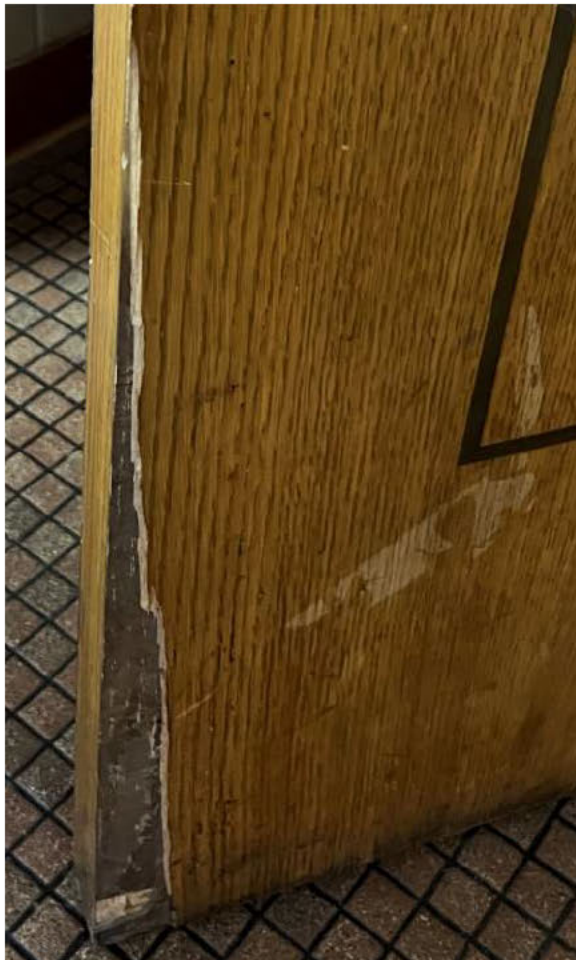
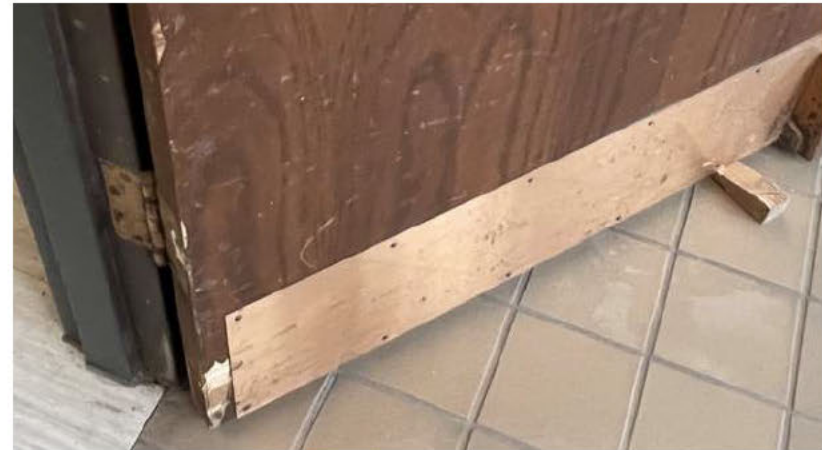
- Wood doors throughout the building are delaminating, damaged and have old hardware.

Replace these doors with new wood doors and hardware.

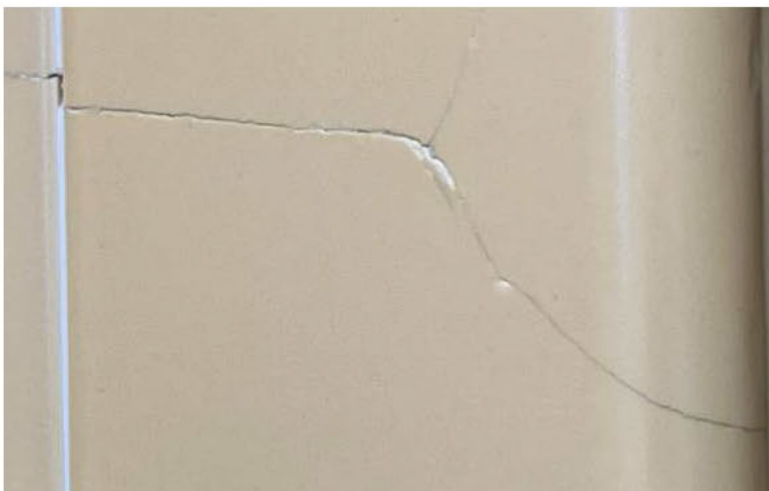
- On the third-floor boys and girls bathrooms the wall tile is cracked, toilet partitions are damaged and equipment missing from bathroom. Replace toilet finishes, equipment and install VACT ceilings.

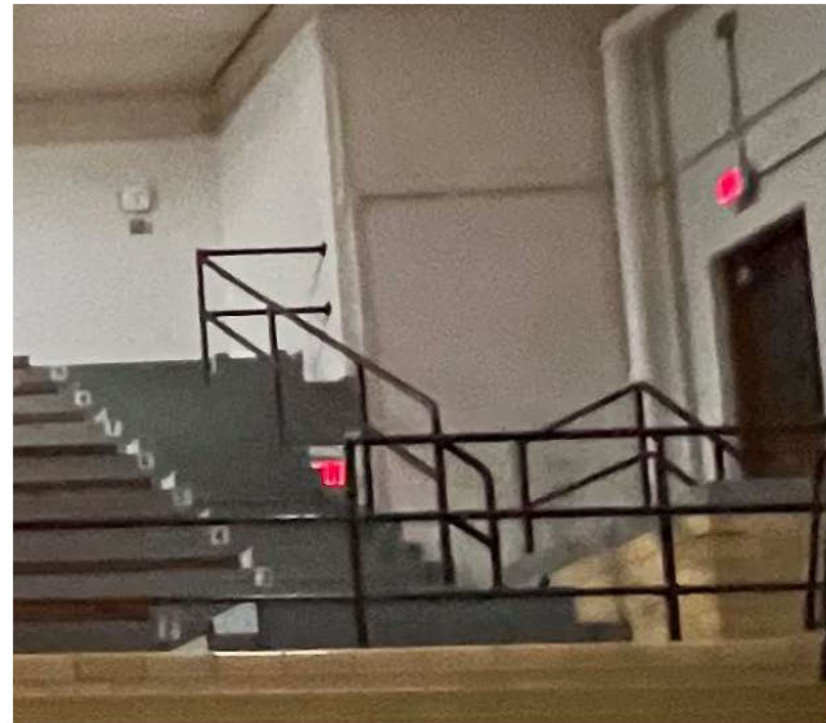
- In the gym balcony mezzanine, the stairs at the bleachers are 32" high and not in compliance with code. Replace guardrails with separate handrails.

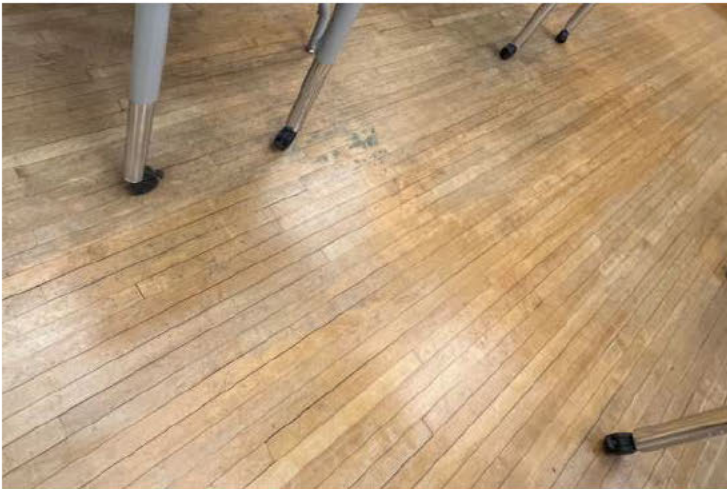
- Many classrooms have worn wood floors, countertops that are delaminating and worn, chalkboards installed. Ceilings are in good condition and can remain. Replace finishes, resurface wood floors, replace chalkboards with markerboards, replace casework.

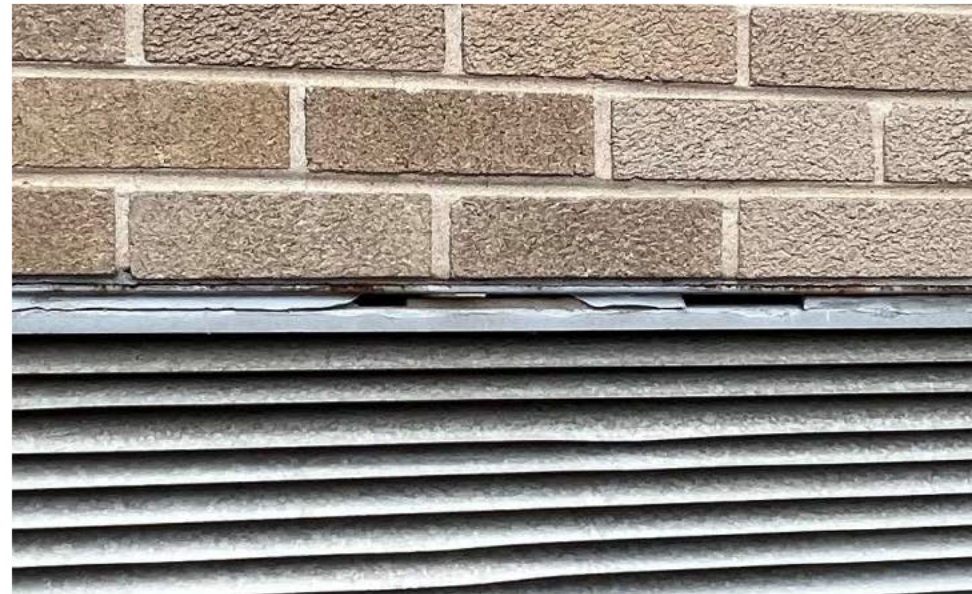
- There are building vent and control joints where the sealant is cracked, separated, and missing. Replace vent and control joint sealant

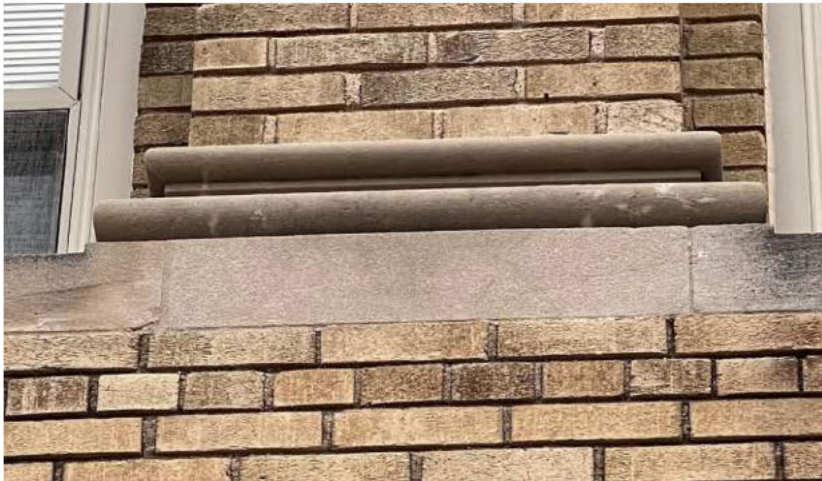
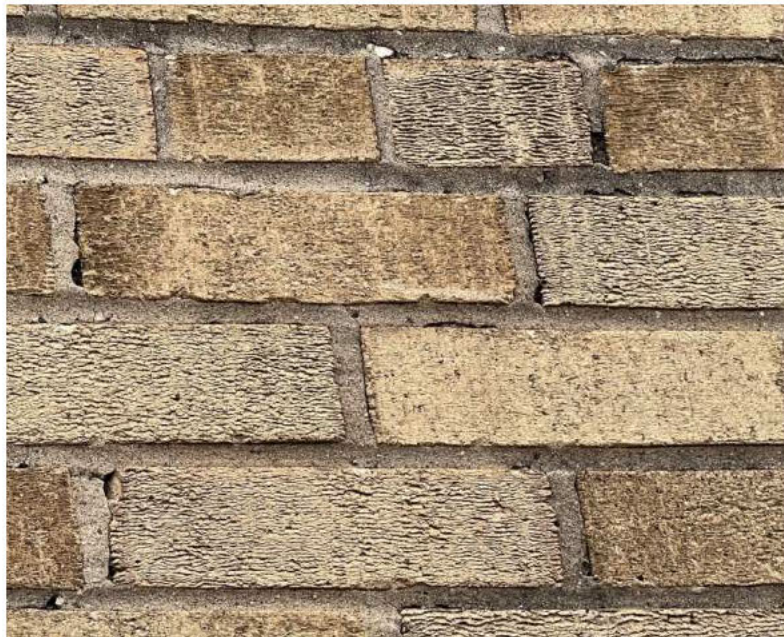
- There are some locations, particularly at 1924 and 1967 portions of the building where the face brick joints are recessed and deteriorating. The face brick joints should be repointed.

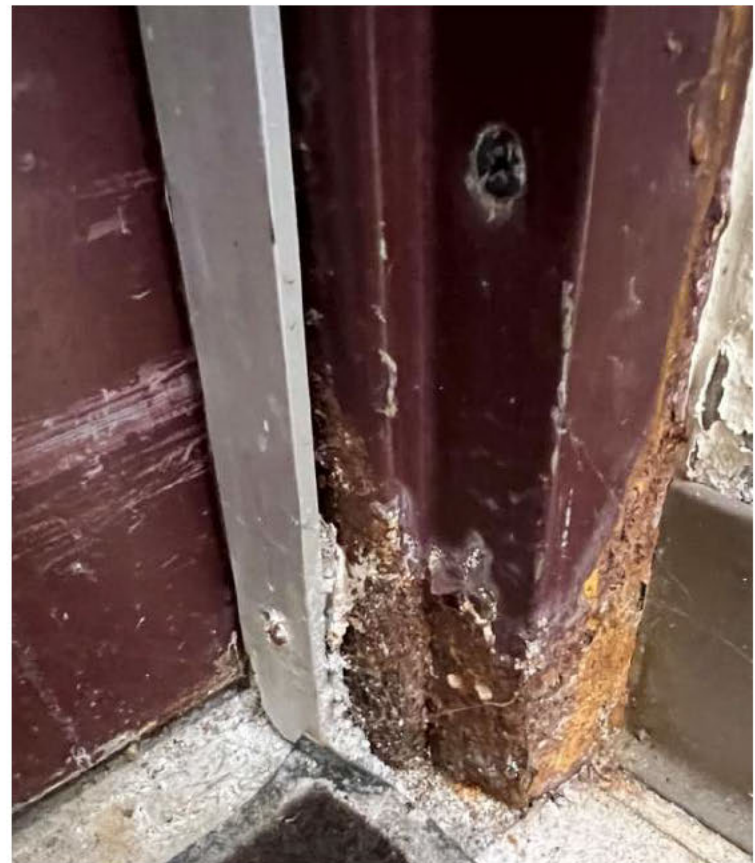
- There are several hollow metal doors and frames that are rusted and damaged. Replace with aluminum doors and frames.

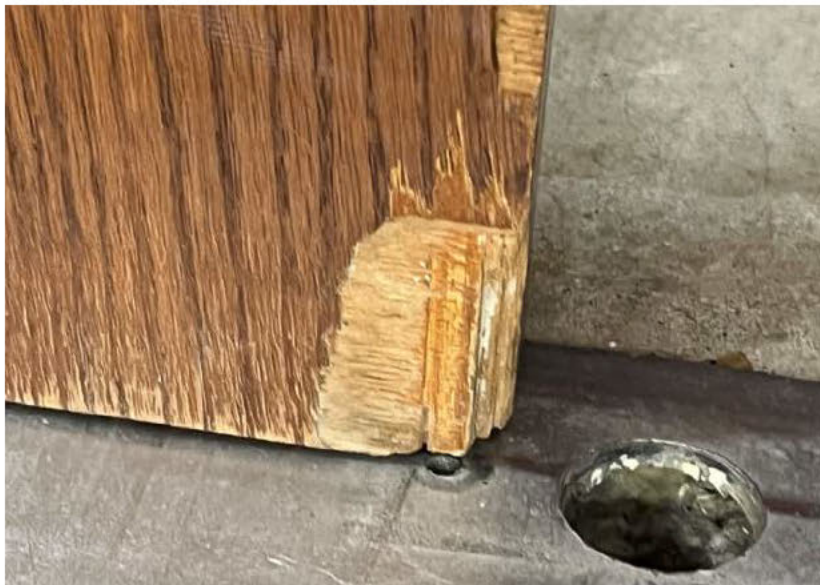
- Throughout the building there are damaged wood doors

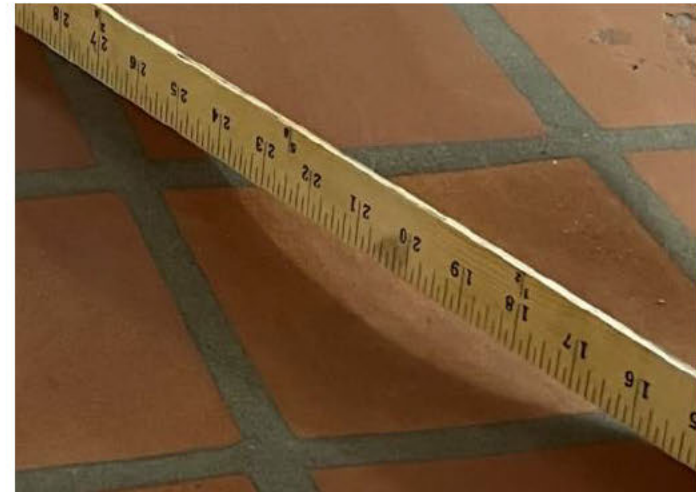
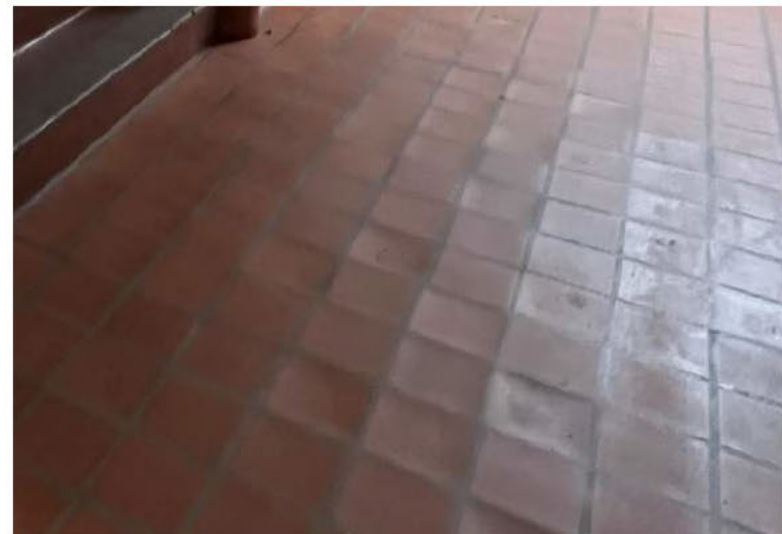
- At all three floors of the 1924 building corridors, the quarry tile is worn, cupping and has dips in the floor. Remove and replace the quarry tile in corridors

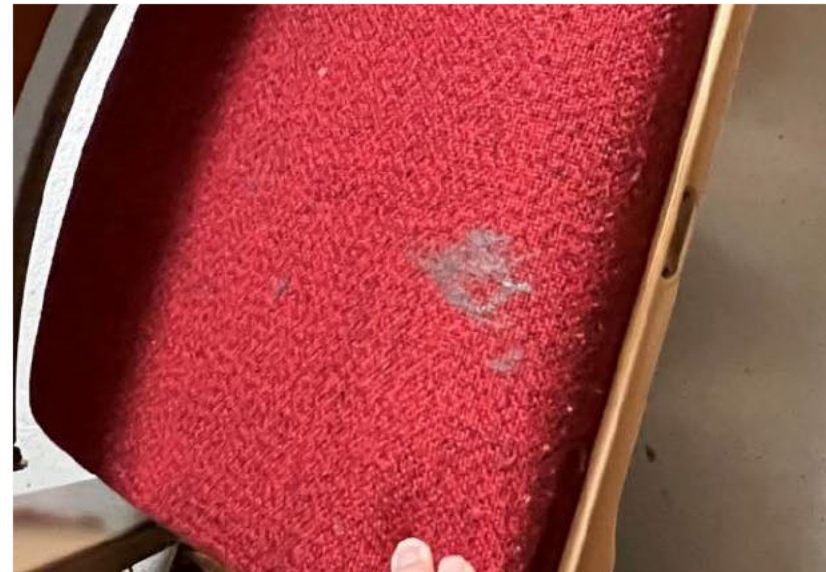
- **Interior Fixed Seating**
 - In the auditorium at all levels, the seat standards are showing signs of rust, chairs are damaged and worn. Replace auditorium seating.

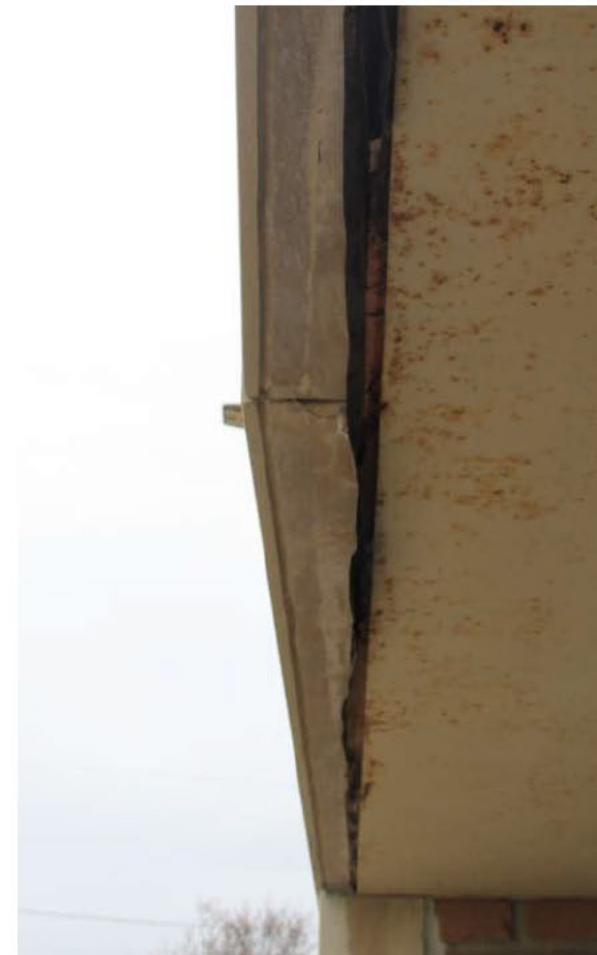
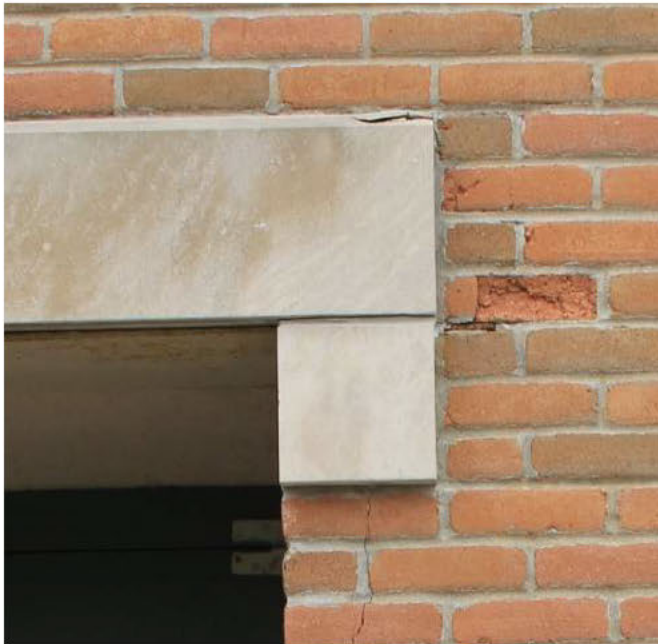
- **Wall Systems**
 - Door 15 Cast Stone on lintel is bowing out and face brick damaged. Remove stone and replace face brick.

- Lintels are bowing down, rusting and deteriorating (rust jacking) due to water infiltration into walls.

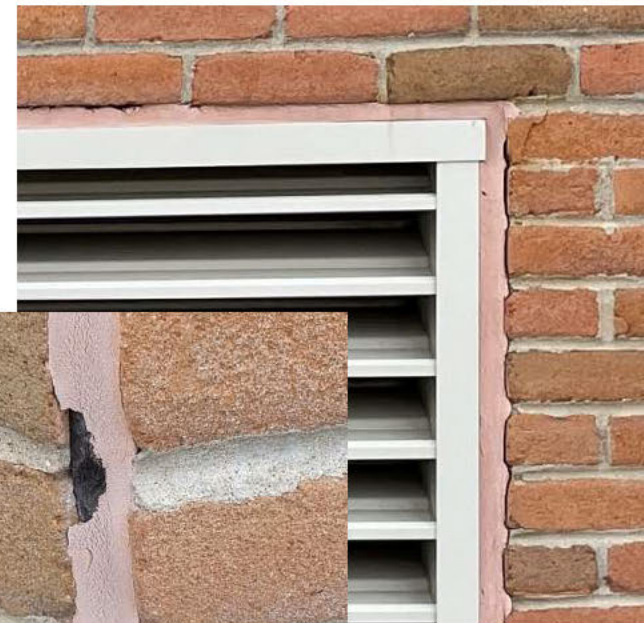
- **Tuckpointing/Sealant**
 - At multiple locations the control joint and vent sealant is cracked, separated, or missing. It is recommended to replace the control joint and vent sealant.

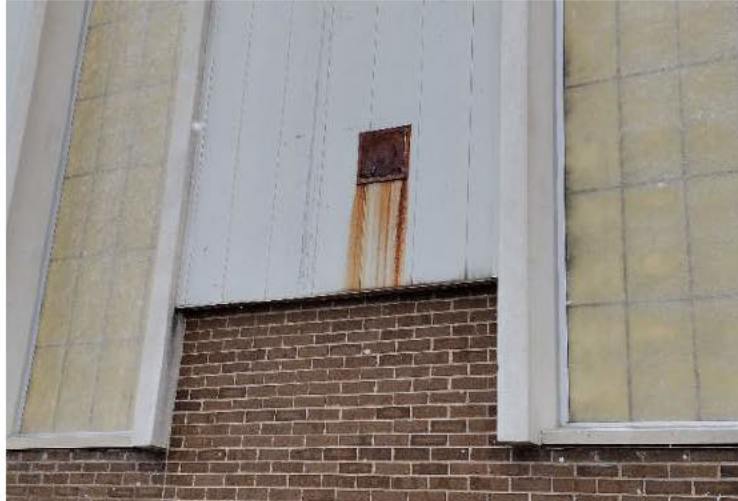
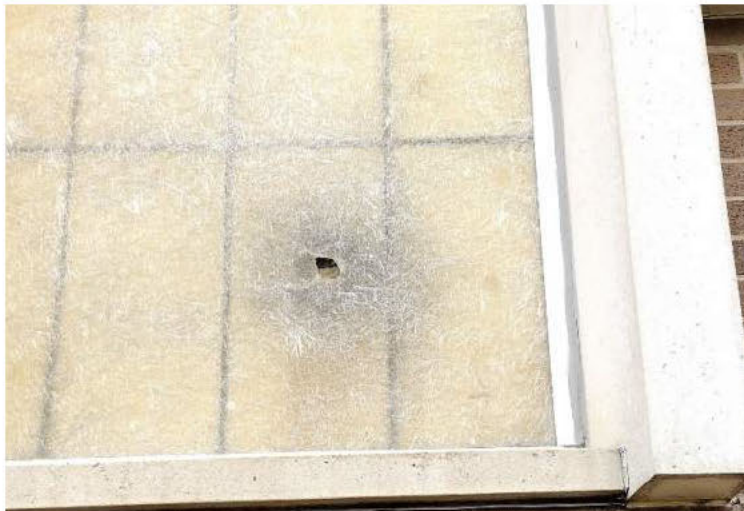
- Translucent panels in poor condition.
- Replace translucent panels.

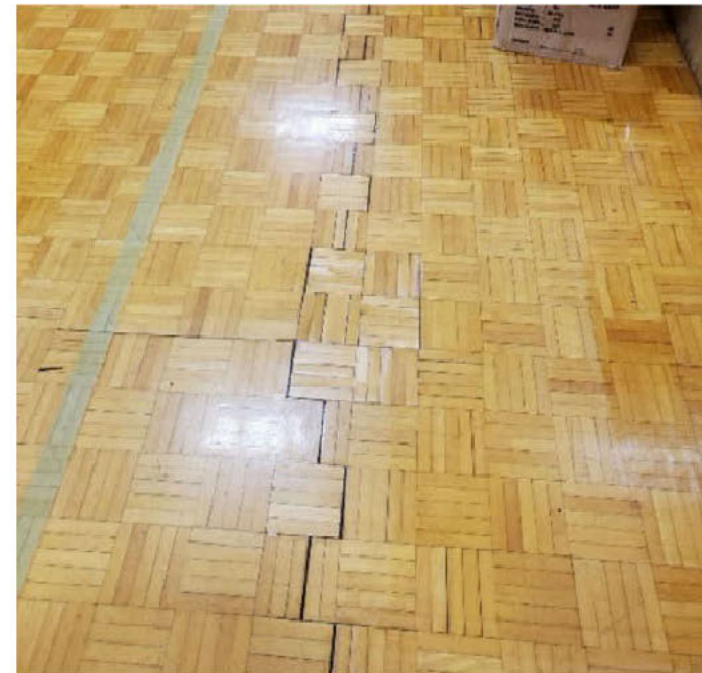
- **Small Gym Flooring**
 - Recommend replacing original 1928 parquet flooring with synthetic gym flooring (parquet pieces have to be reglued every year, not good DIN rating).

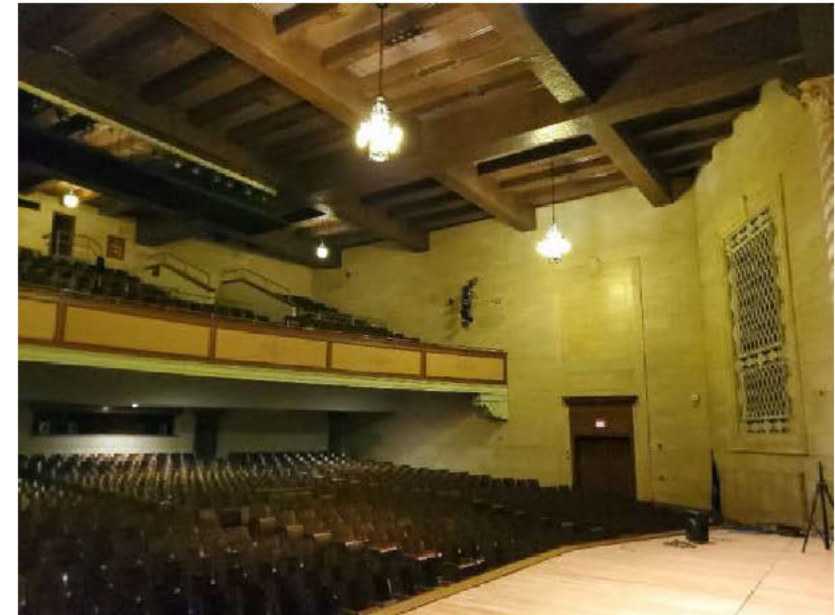
- Recommend remodeling auditorium – orig seats (reupholstered poor cond), aging curtains/lighting, questionable acoustic design, orig lighting/mech) verify scope/intent with historic features.

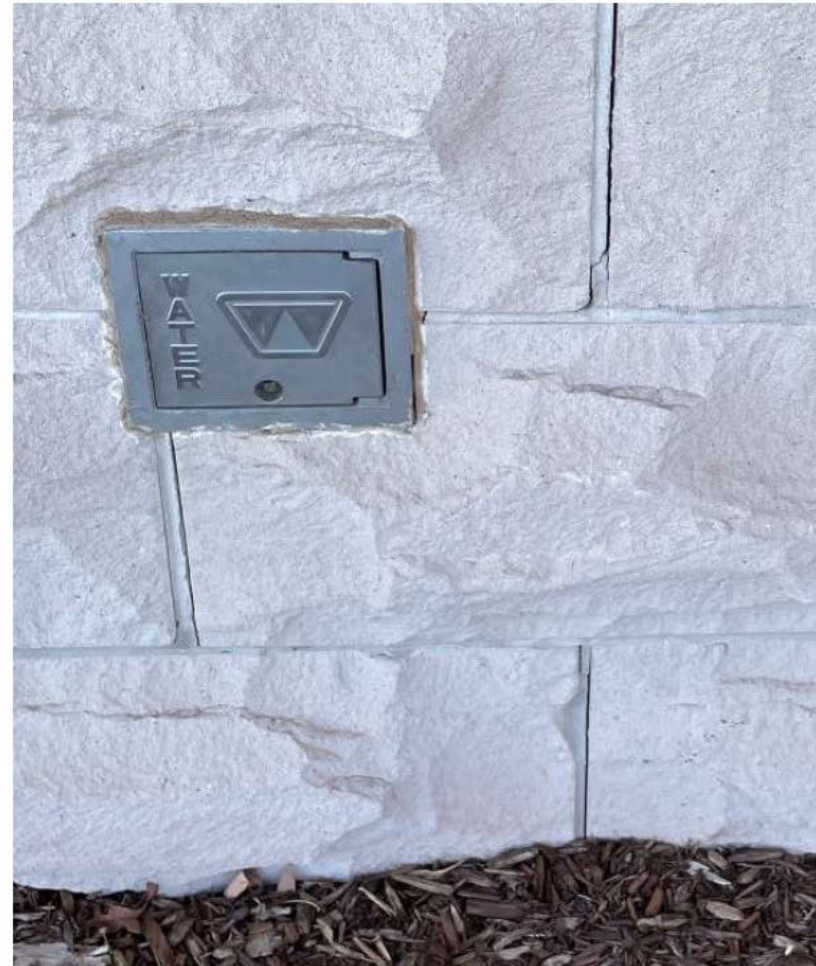
- **Wall Systems**
 - There are some areas where the split face block is cracked and damaged. These areas of damaged block should be repaired.

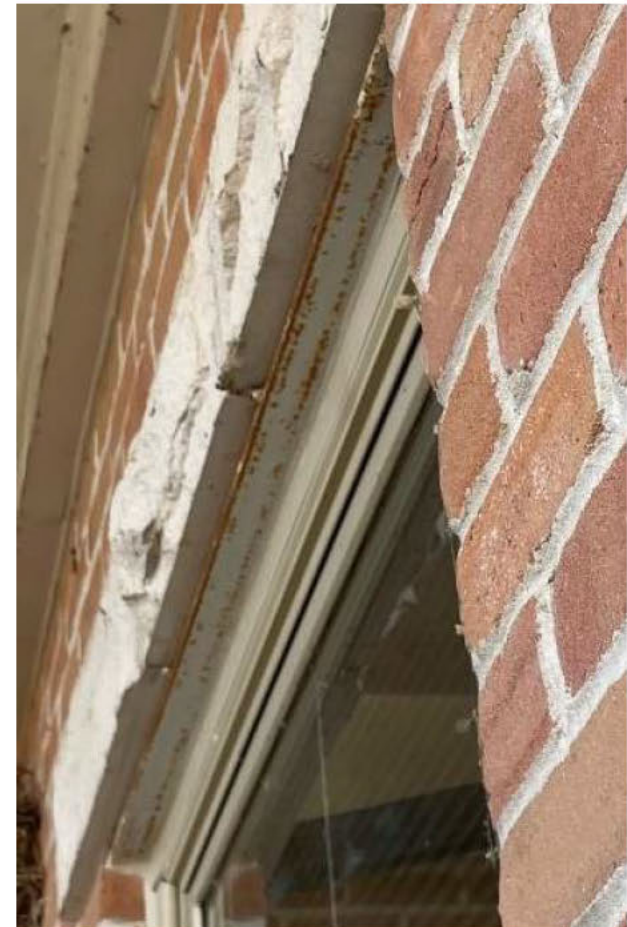
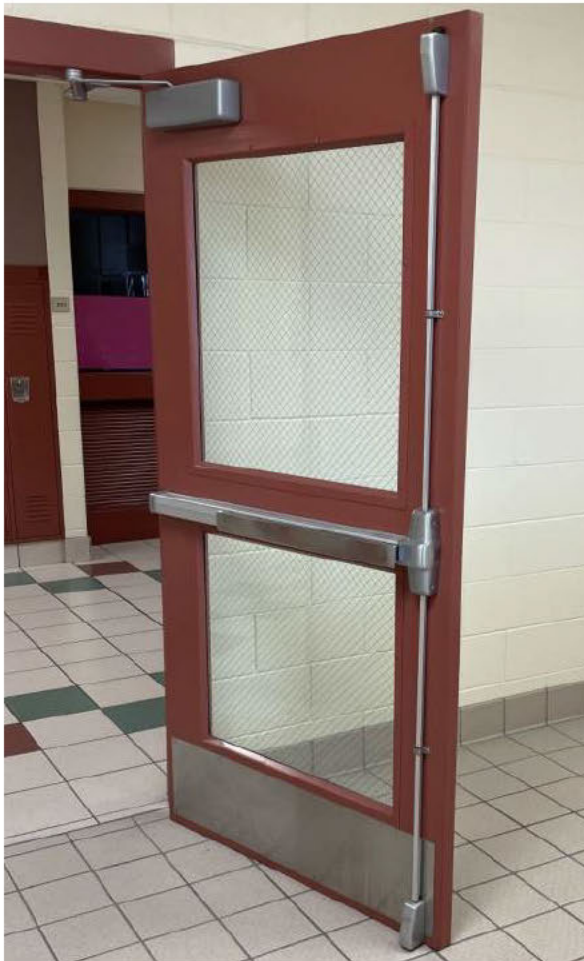
- Monitor aluminum clad wood windows for future rot and replacement
- The lintels at the windows are starting to show rust. The window lintels should be scraped and repainted.

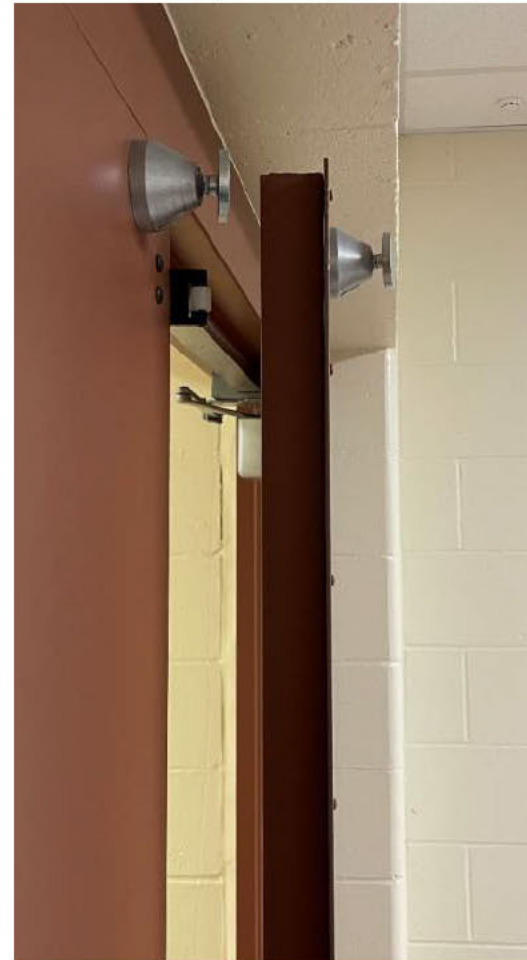
latch, flush bolts drag and get hung up on tile floor. These are rated doors and need to be re-swung and hardware replaced

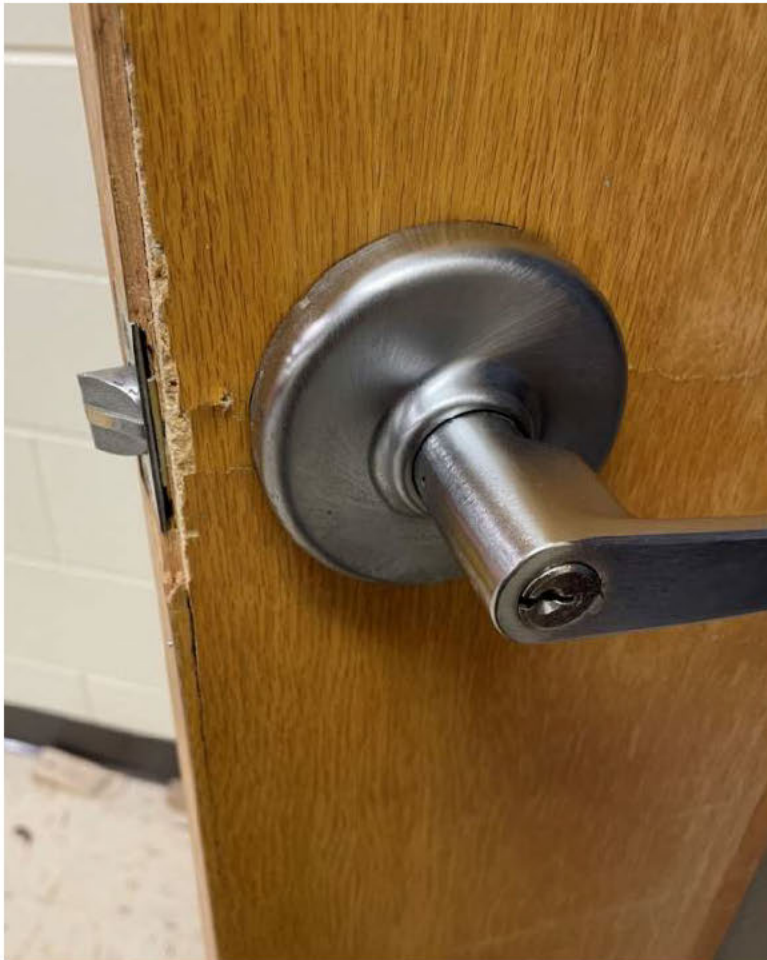
- Several wood doors are chipped, cracked and have extensive wear. The wood doors and hardware should be replaced

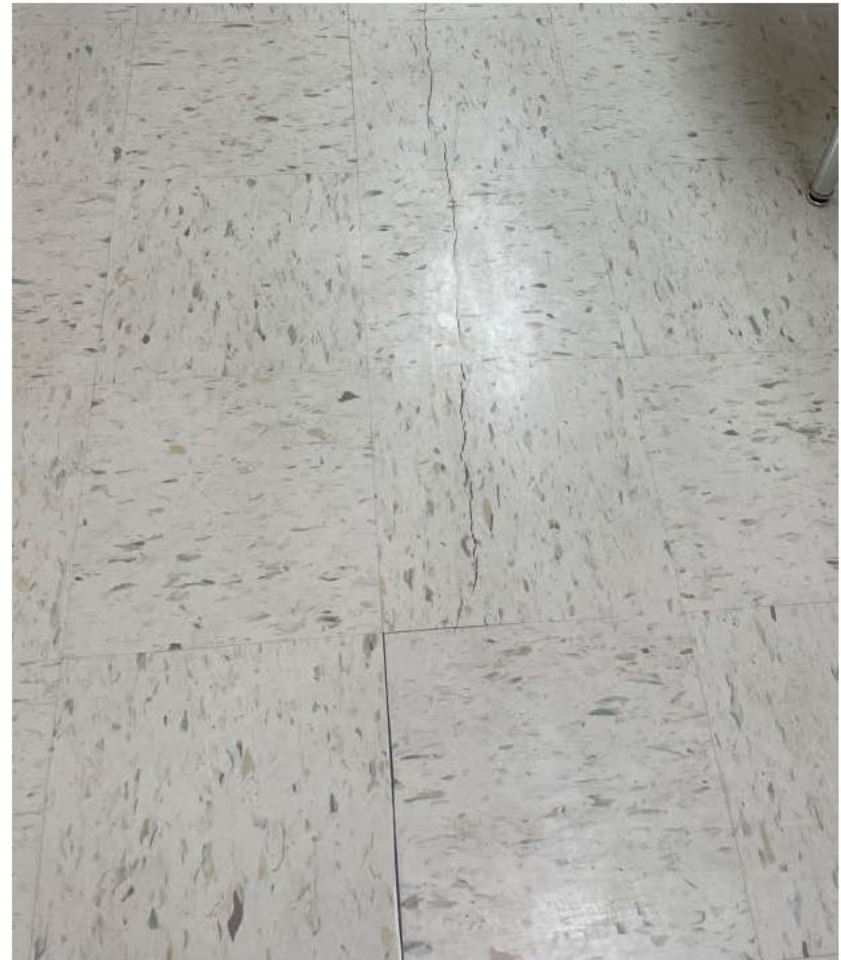
- **Flooring**
- Several rooms the VCT flooring is showing seams, worn and is cracked. The VCT flooring should be replaced.

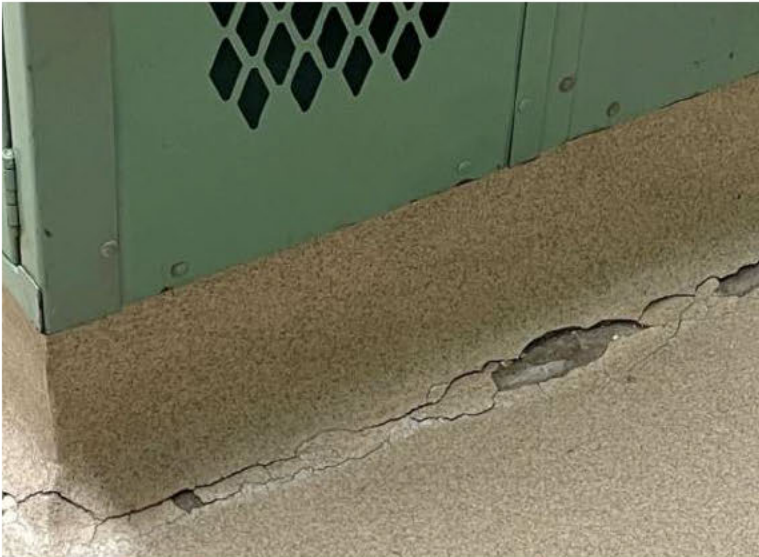
- Sheet flooring in the boys and girls locker room is worn and cracking at the integral cove at locker bases. Replace with epoxy quartz flooring with formed epoxy quartz base.

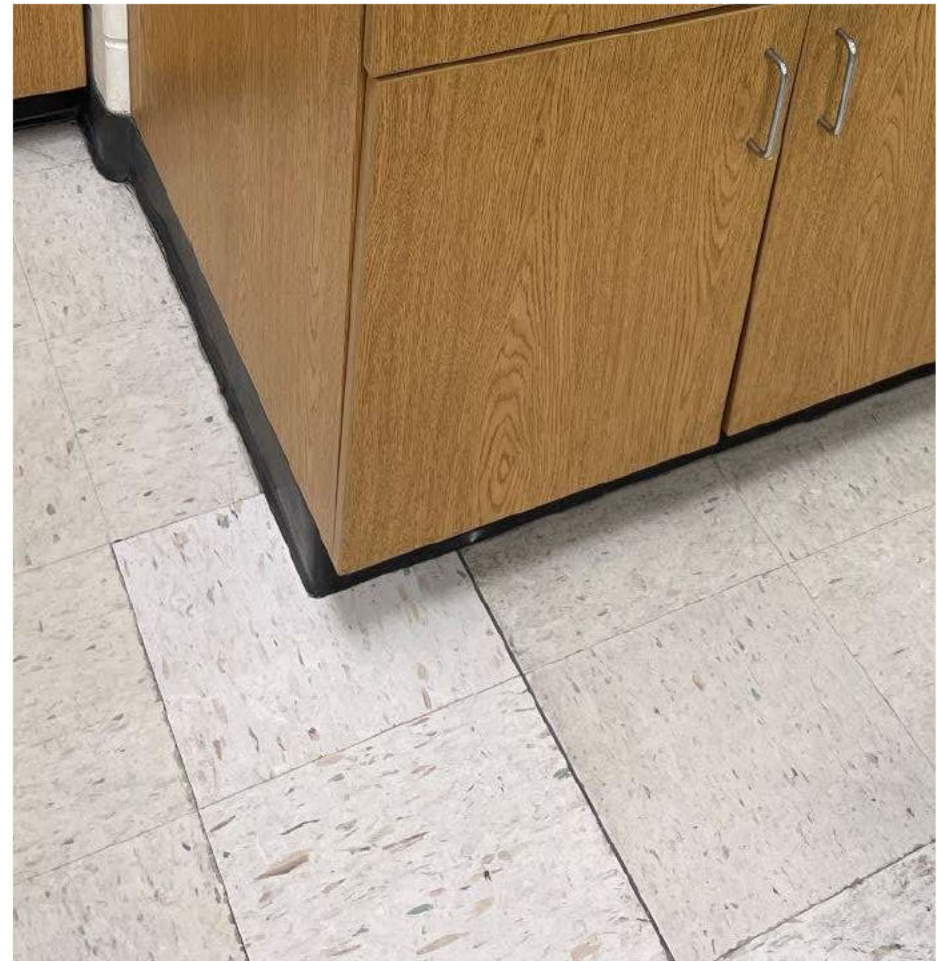
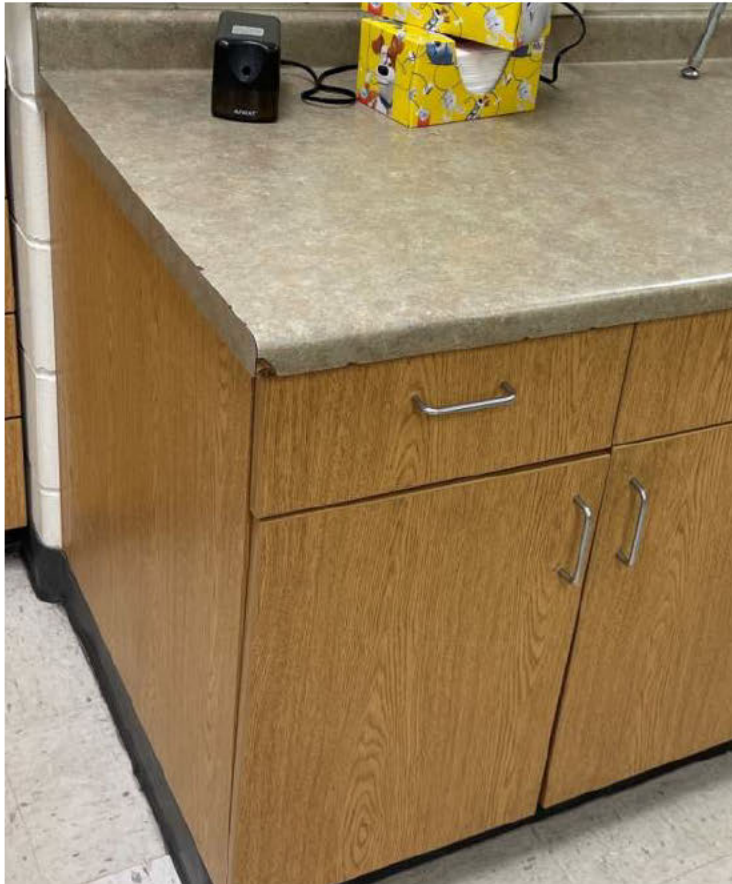
- Many rooms on 1st and 2nd floor have VCT floors that are worn and seams separating, casework chipped and delaminating. Ceilings are 2x2 ceiling tile and in good condition. Replace finishes, casework and chalkboards with new finishes and equipment.
