LONG RANGE FACILITY ASSESSMENT AND EDUCATIONAL ADEQUACY STUDY 2022

VOLUME 2C

FACILITY ASSESSMENT - INDIVIDUAL BUILDING INFORMATION:
MIDDLE SCHOOLS, HIGH SCHOOLS, AND OTHER BUILDINGS

A T S + R

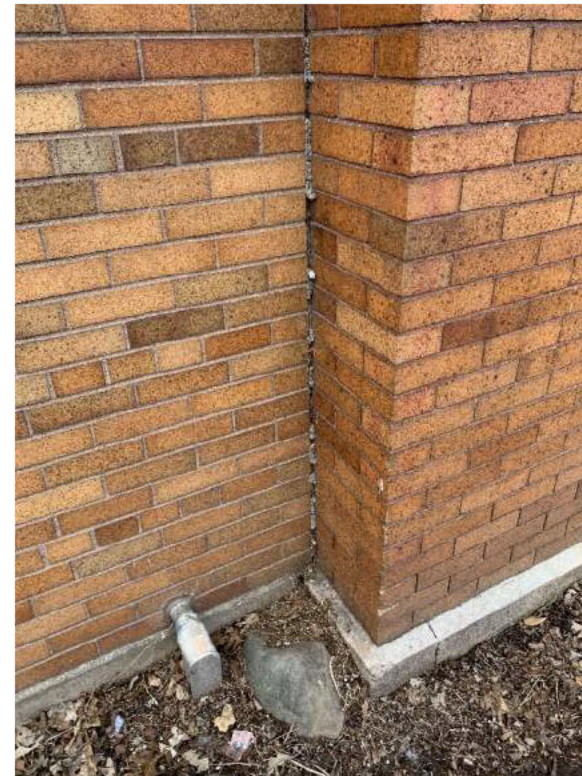
- **Tuckpointing / Sealant**
 - Worn out grout in multiple areas. Repair with tuckpointing
 - Loose sealant at building control joints, exterior wall louvers, windows and doors in multiple locations. Replace sealant

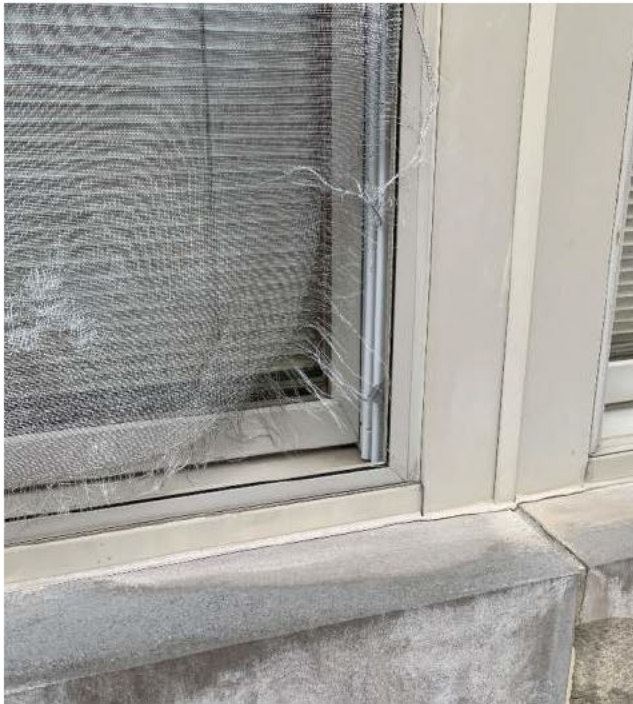
- **Window Systems**
 - Existing Pella alum clad windows. Monitor for future rot and replacement
 - Broken window mesh screen in multiple locations. Replace mesh screen.

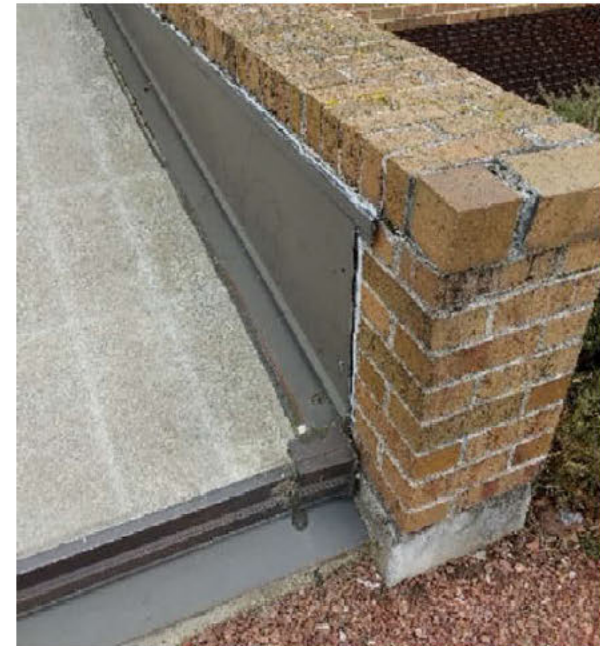
- Repair brick at translucent panel (Kalwal) knee wall

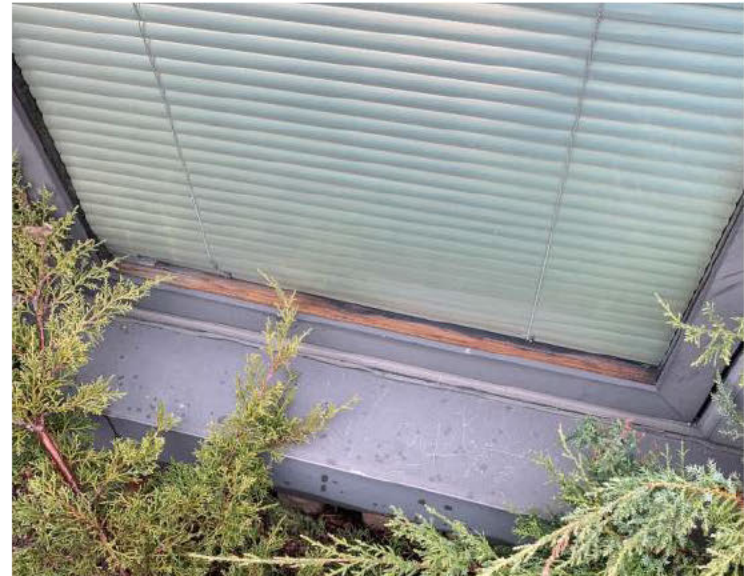
- **Tuckpointing / Sealant**
 - Sealant and caulk peeling away at control joints and around louvers in multiple locations. Replace sealant / caulk
- **Window Systems**
 - Exterior wood Pella windows – some color fading at exterior. Monitor for future rot and replacement.

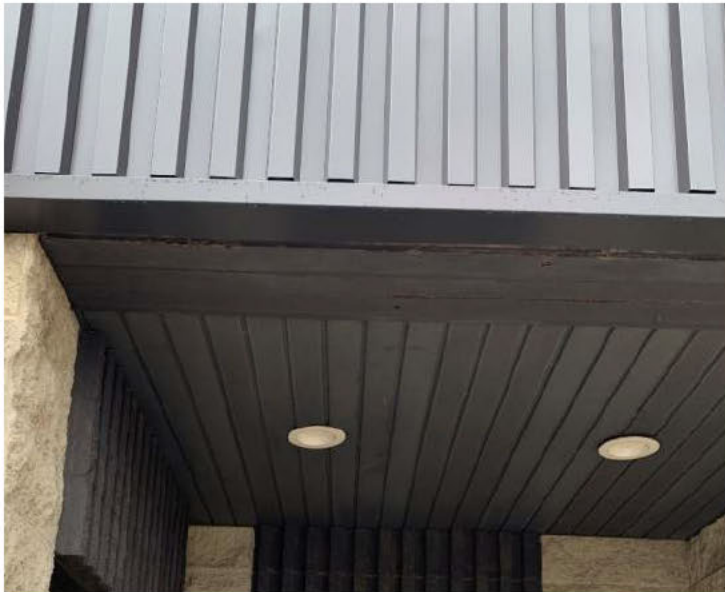
- Rusting and paint peeling at exterior window lintels and exit door soffit. Repaint Lintels

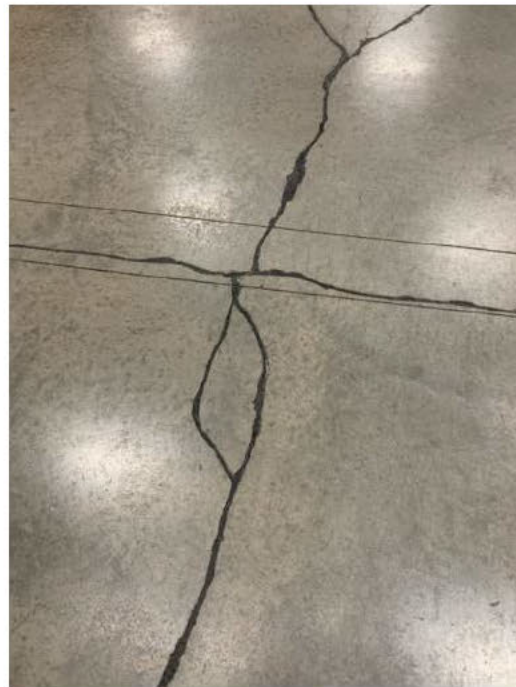
- Cracks on concrete floor in multiple locations. Repair concrete floor.

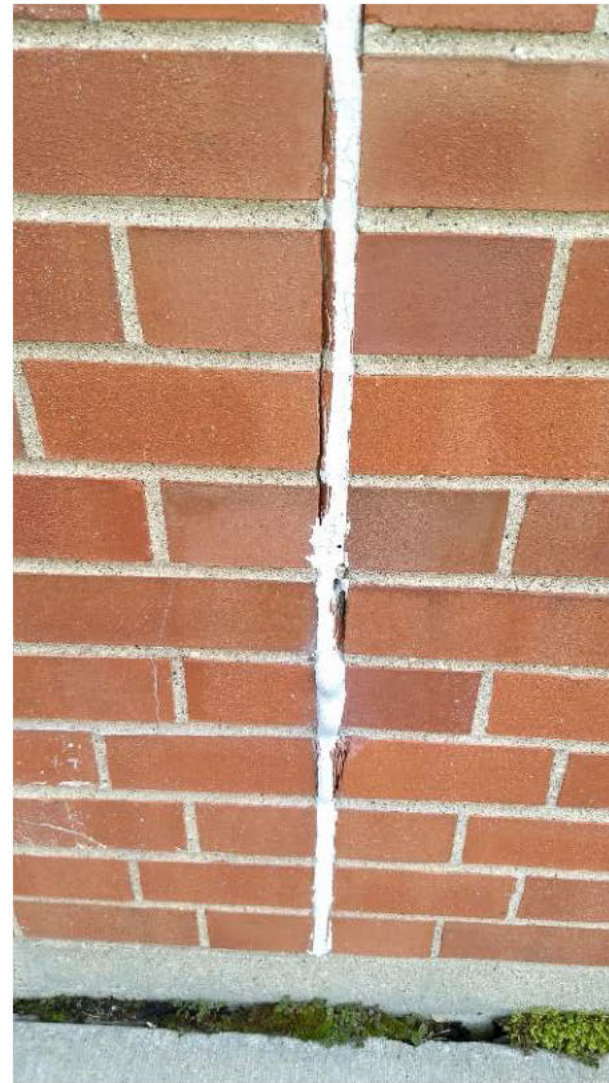
- Building control joints sealant needs to be replaced.

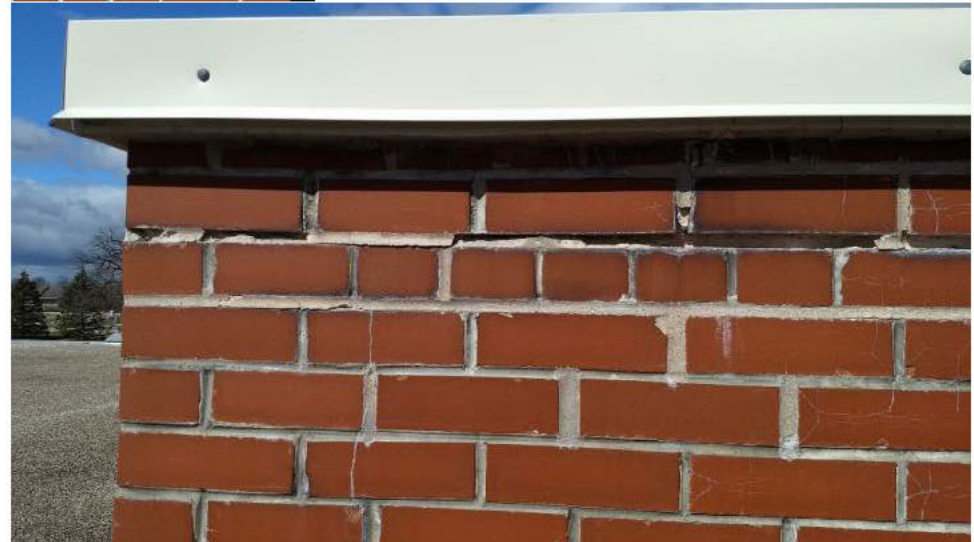
- Repaint hollow metal doors and frames – typical.
- Masonry restoration is needed at the chimney to repair cracked face brick
- Re tucking of the masonry at the chimney is also needed to prevent water migration.

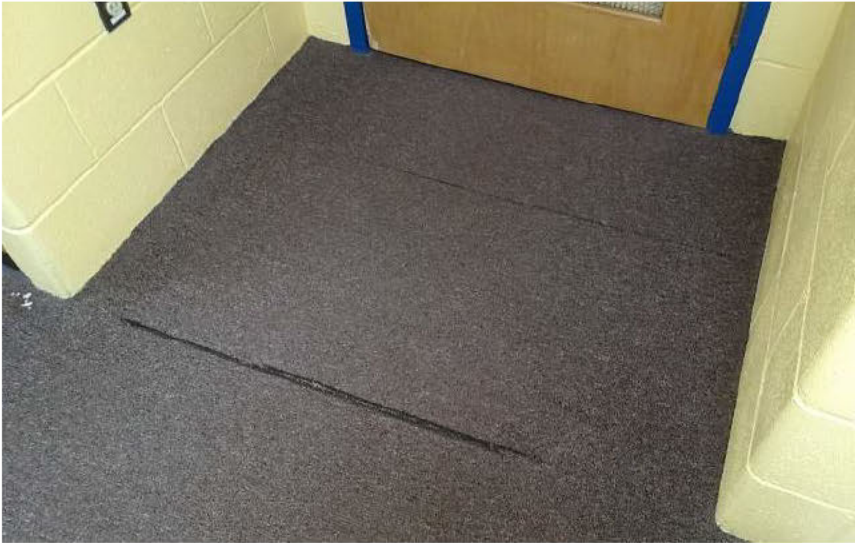
- The fraying broad loom carpeting in the corridor needs to be replaced.
