ADDENDUM TO THE BID DOCUMENTS		Page: 1	Total Pages: 19
Addendum No: # 2		Date this Addendum Issued: January 5, 2024	
<u>Issuing Office:</u> Matanuska-Susitna Borough School District (MSBSD) Purchasing Department 690 Cope Industrial Way Palmer, Alaska 99645 Phone: (907) 861-5120 Facsimile: (907) 861-5184		<u>Previous Addenda Issued:</u> One <u>1</u> <u>December 19, 2023</u> _____ _____ _____ _____ _____	
<u>Return Acknowledgment To:</u> Issuing Department <u>Bid Title:</u> Security Upgrades at the MSBSD Administration Building <u>Bid No:</u> B24-03		<u>Date and Hour of Bid Due Date:</u> December 29, 2023 at 2:00 P.M. January 12, 2024 at 2:00 P.M. <u>As Advertised (Frontiersman):</u> December 1 and 3, 2023 <u>As Advertised (ADN):</u> December 1 and 3, 2023	
<p>The following corrections, changes, additions, deletions, revisions, and/or clarifications are hereby made a part of the contract documents. In case of conflicts between this addendum and previously issued documents, this addendum shall take precedence. The bidder must acknowledge receipt of this addendum in the space provided on Appendix #1. Failure to do so may subject the bidder to disqualification.</p> <p>Questions 1. Q: On

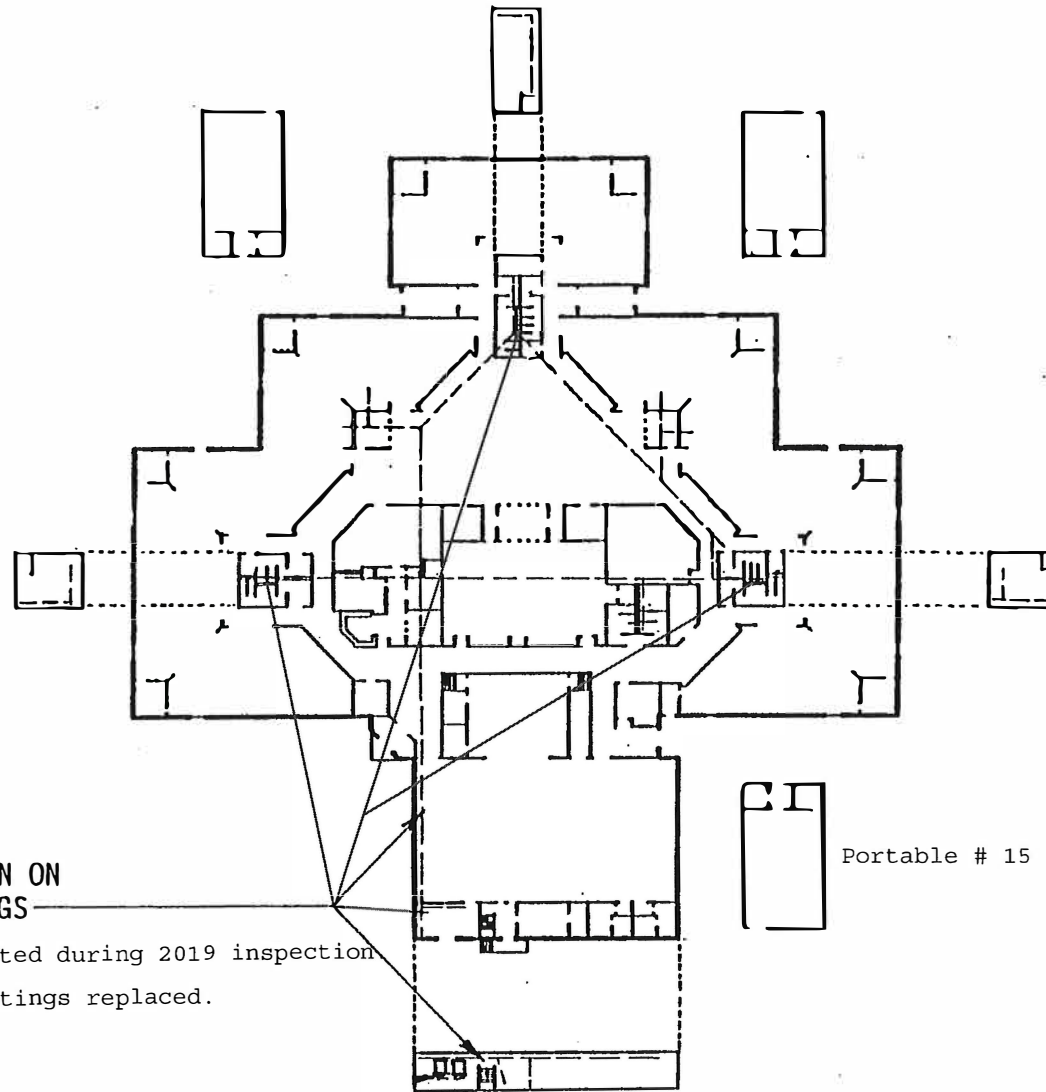
Category of Material	Mgmt. Plan Reference	Homogeneous Area & Description	Approx. Quantity	Functional Space(s)	%Asbestos / Friable? (Yes/No)	Reassessment Category /Condition	Comment
Thermal System Insulation	Figure 6-1	Area B – TSI Cementitious Insulation on Pipe Elbows and Fittings	700 Each	Fan Rooms, Boiler Room, Throughout Building	15% Chrysotile / Yes	1a / Damaged Insulation on Heating Pipes in fan rooms noted.	Identified 1989 Inspection / *Damage present during 2019 reinspection
Miscellaneous Material	Figure 7-1	Area F – Cement Asbestos Board	700 SF	Gym and Shower Rooms	30% Chrysotile / No	5 / Good	Identified 1989 Inspection / *Unable to locate CAB in Gym. CAB in Shower Rooms was covered by GWB or FRP
Miscellaneous Material	Figure 7-1	Throughout – Buried underground ducts	Unknown	Throughout	Assumed	5 / Good	Assumed present, concealed during 2019 reinspection
Miscellaneous Material	Figure 7-2	Area H – Sheet Vinyl Flooring	3,500 SF	Offices, Storage	5% Chrysotile / No	5 / Good	Identified 1989 Inspection *No change in status as of 2019 reinspection

CEMENTITIOUS INSULATION ON
PIPE ELBOWS AND FITTINGS

Damaged hard fittings noted during 2019 inspection.
Some pipe elbows and fittings replaced.

- i. Remove and/or encapsulate the damage friable TSI “hard fittings” in the fan rooms and adjacent spaces. This response action and associated cleaning should take place as soon as possible.

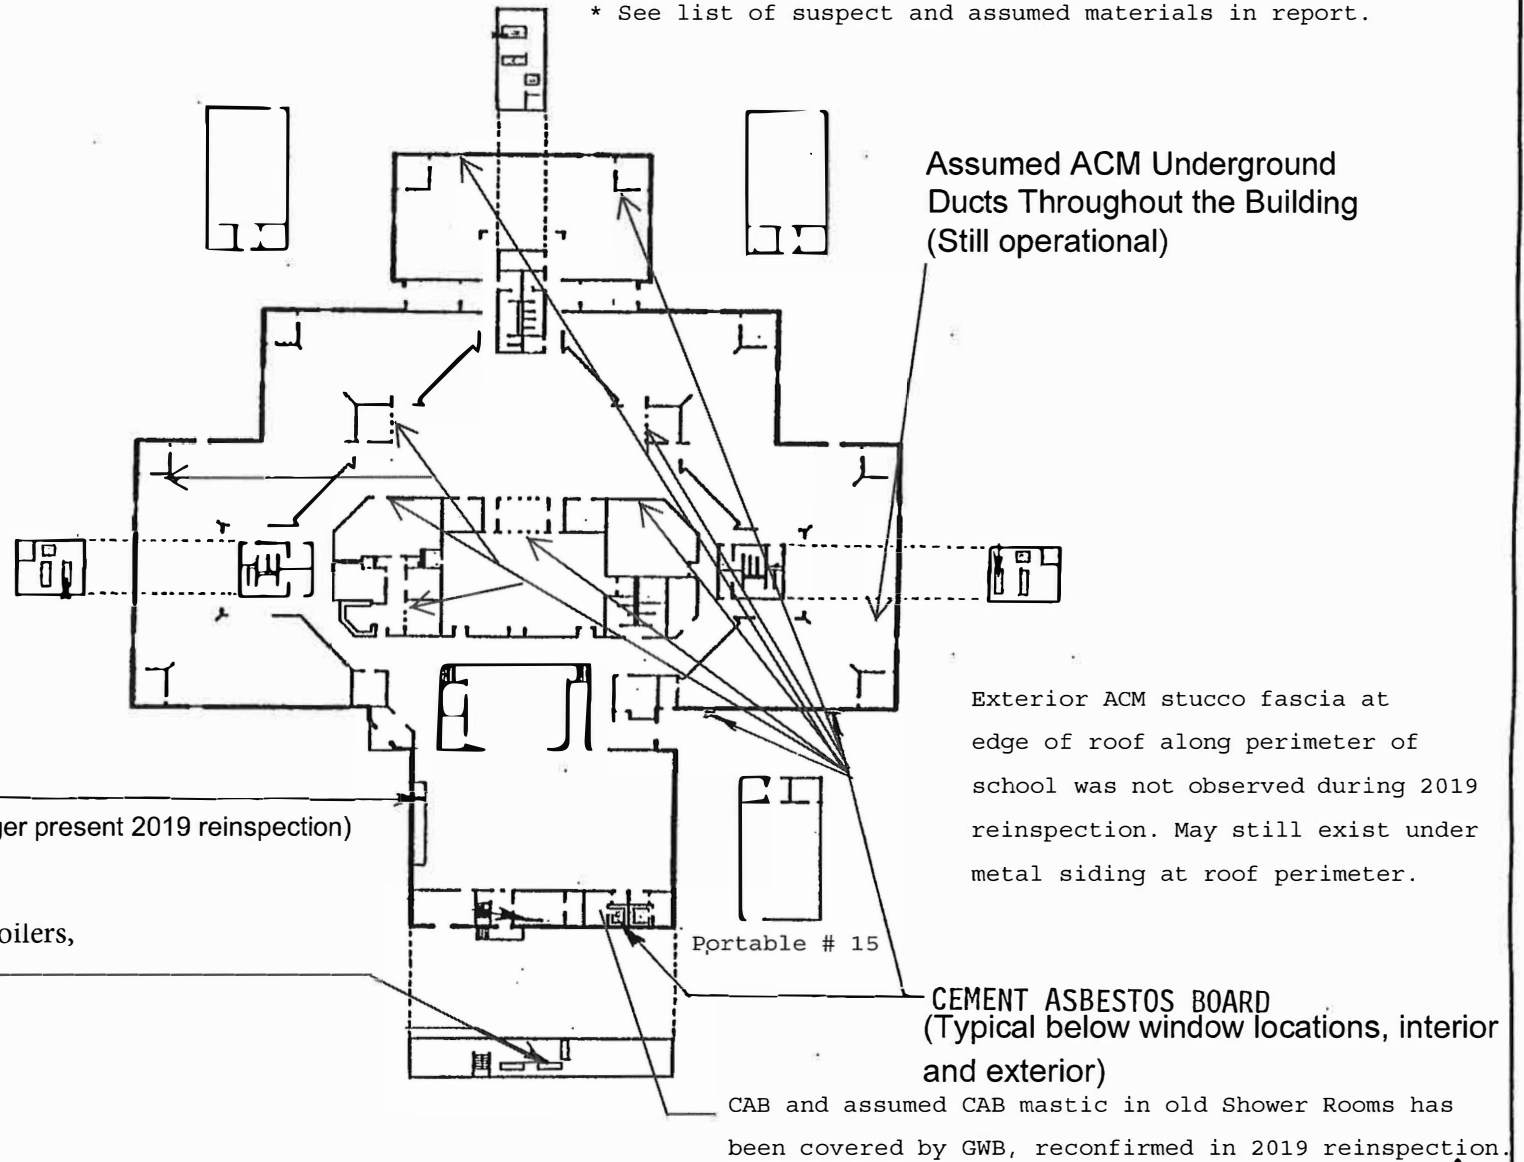
**FIG.
7-1**

Miscellaneous Material	Figure 7-1	Grey/green duct sealant	Fan room and throughout	Fan room on metal ducting	2.4% Chrysotile / No	5 / Good	Identified 2010 Survey *No change in status as of 2019 reinspection

Non-AHERA	Figure 7-1	Roof sealants and tars	Roof	Patching tars at roof penetrations, flashings, etc.	4.8% Chrysotile / No	Not Observed	Identified 2010 Survey *Most has been removed by 2011 abatement
Non-AHERA	Figure 7-1	Exterior gravel coated stucco fascia panels	Exterior at roof line	Exterior at edge of roof	1.8% Chrysotile	Not Observed	Confirmed 2010 Survey Reinspection *May still be present under metal siding at roof perimeter

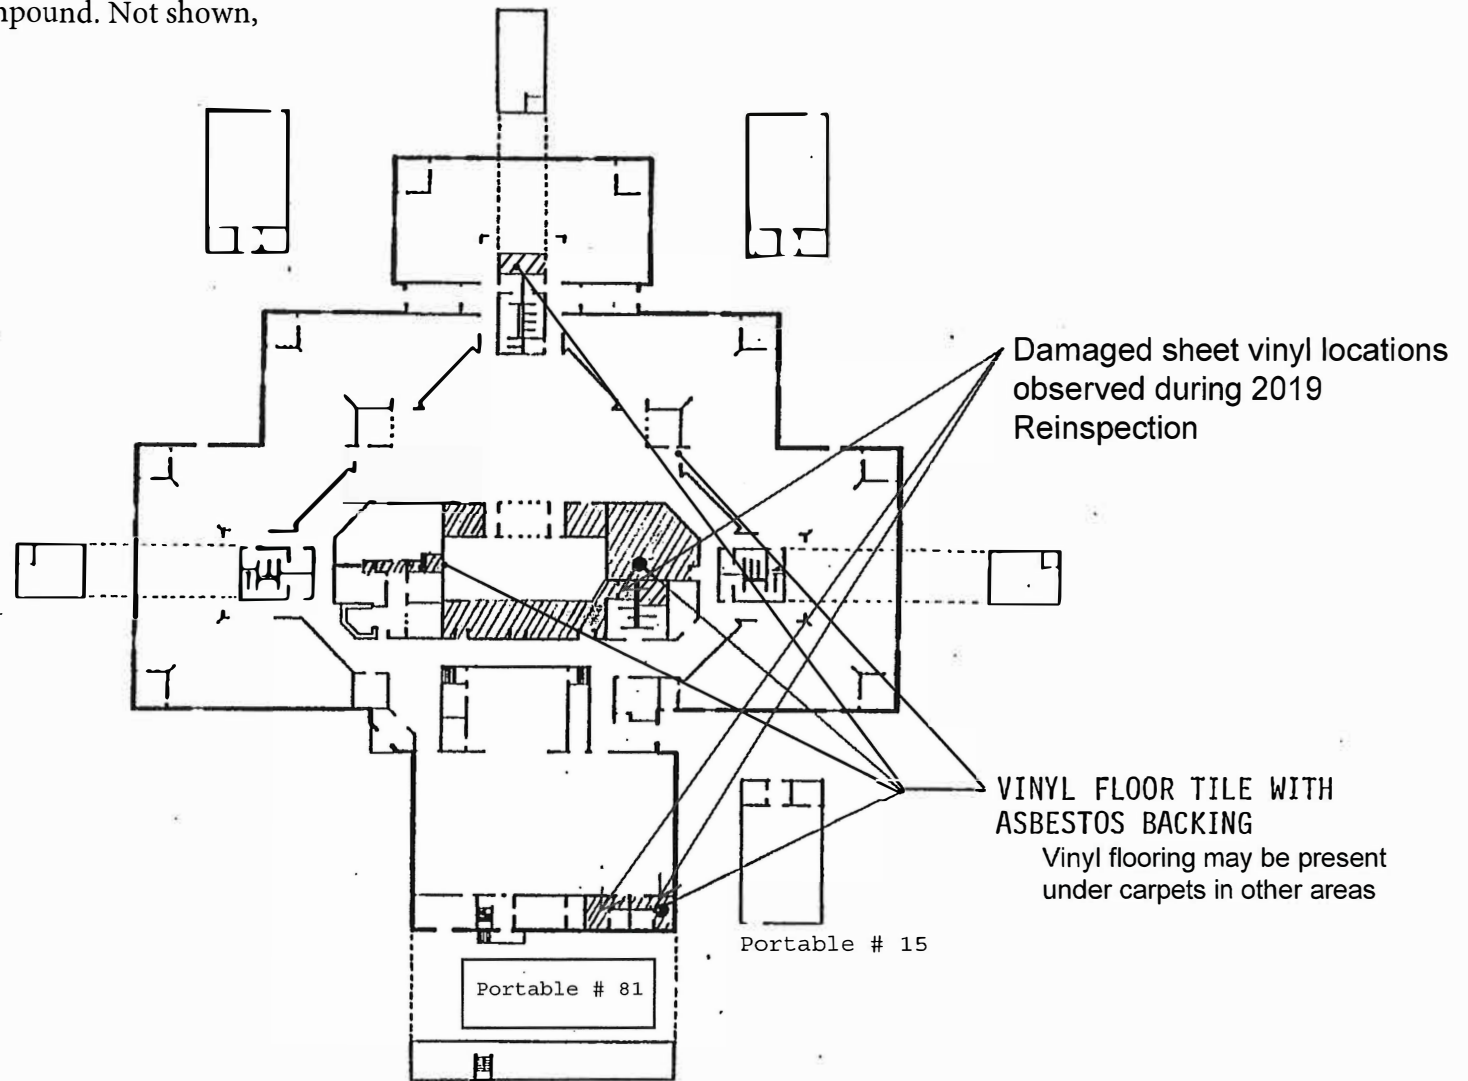
BID #B24-03 7-2

Miscellaneous Material	Figure 7-2	Joint compound	Unknown	Throughout 1971 era, possibly other eras	Assumed	5 / Good	Added to this report in 2019

Miscellaneous Material	Figure 7-2	Area H – Sheet Vinyl Flooring	500 SF	Gym Restrooms, Server	5% Chrysotile / Yes, where backing is exposed	4b / Fair	Identified 1989 Inspection *Damage present during 2019 reinspection. Remnants of SV backing and mastic present in small server room adjacent center offices. Damage found in bathroom of gym pod.
Miscellaneous Material	Figure 6-1	Area M – Gaskets and valve packings on Boilers, water heaters, pumps, and flanges	6 Each	Boiler Room	Assumed / No	5 / Good	Assumed 1989 Inspection *No change in status as of 2019 reinspection
Miscellaneous Material	Figure 7-1	Brown Mastic of CAB	Sampling Recom'd.	Boys Shower Room off Gym	Assumed / No	Not Observed	Assumed 2007 Reinspection *No change in status as of 2019 reinspection
Miscellaneous Material	Figure 7-1	CAB insulated sandwich panels	Sampling Recom'd.	Typically under exterior windows, also present at interior relites	Assumed / No	5 / Some Cracks and dents observed	Assumed 2004 Reinspection *No change in status as of 2019 reinspection

- C. Damaged miscellaneous ACM was found in the shower room off the Gymnasium and in the small server room at the center offices. The shower room was being used for storage of paper documents. Approximately 6 square feet of sheet vinyl flooring was damaged in the shower room. Approximately 60 square feet of sheet vinyl flooring had been removed from the small server room. Remnant sheet vinyl backing and mastic was still present on the concrete floor and should be properly removed and the area “cleared” in accordance with AHERA regulations. This response action should take place as soon as possible.
