May 16, 2024

**SUBJECT: IEQ Assessment, Fox Lane Gymnasium Building**

<b>Bedford Central School District</b>	<b>Fox Lane Gymnasium Building</b>	<b>US0024227</b>
--	------------------------------------	------------------

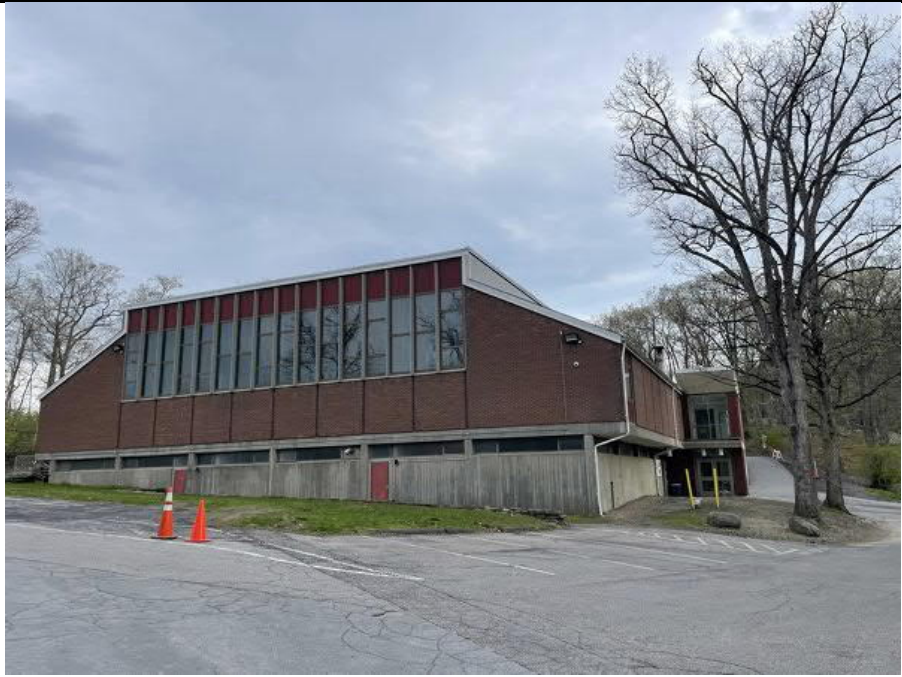
<b>Photo No.</b>	<b>Date</b>
1	April 28 2024
Fox Lane Gymnasium Building, North face of the building. View is looking south.

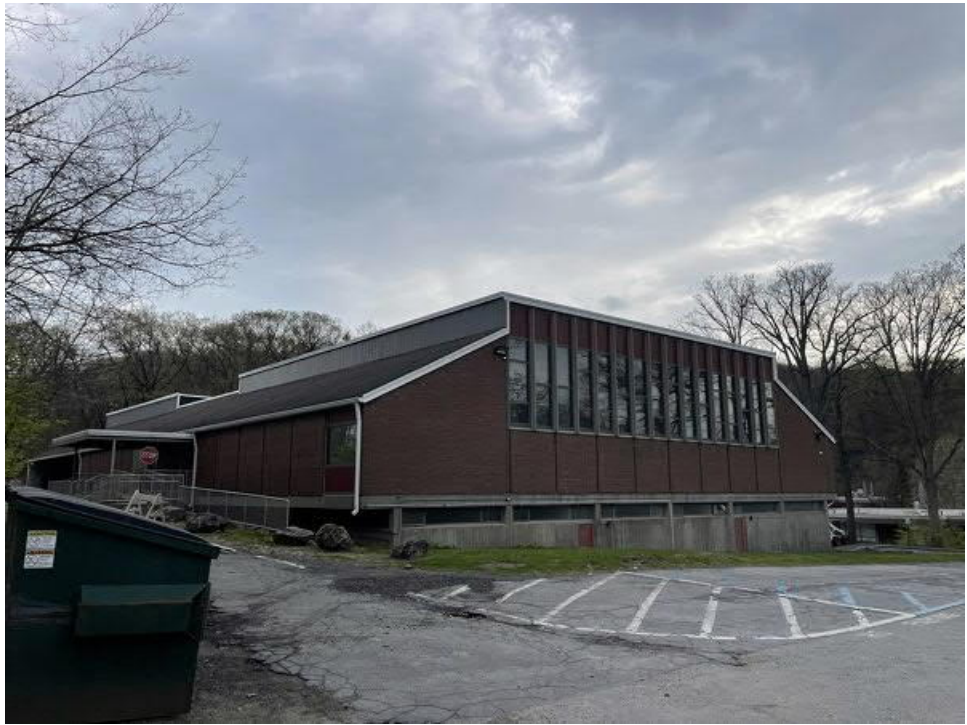
<b>Photo No.</b>	<b>Date</b>
2	April 28 2024
Fox Lane Gymnasium building, east and north face. View is looking south west.

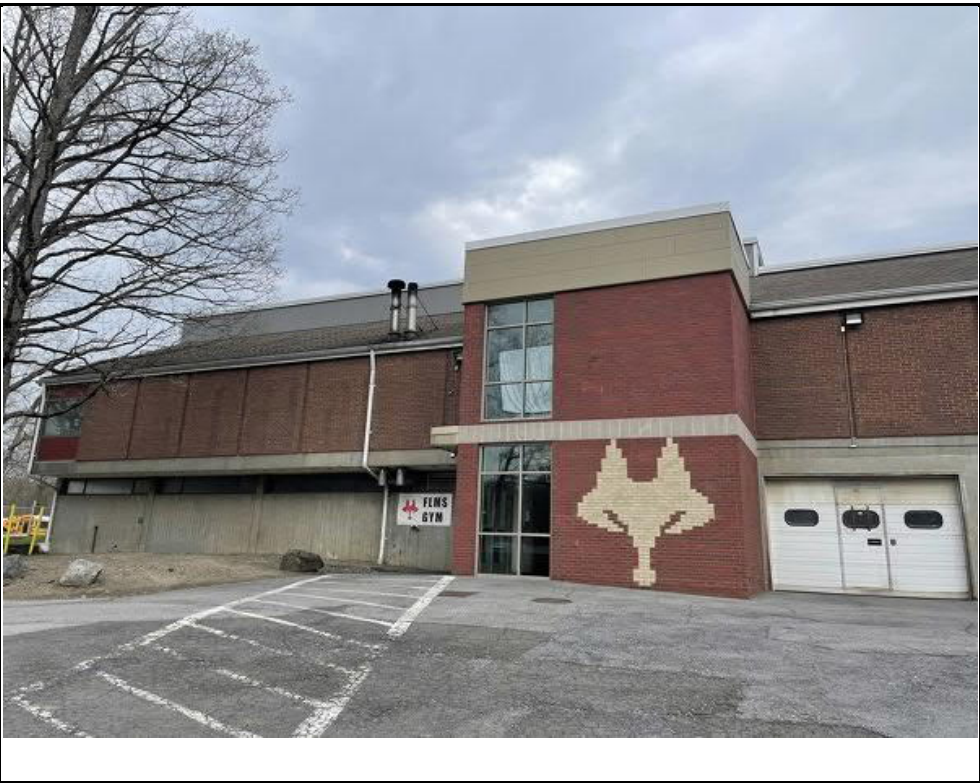
West face entrance. Boiler flue stacks on roof. Boiler #1 flue stack on right. Cap was removed by fire department and discarded. Boiler maintenance contractor parked diesel truck to left of the dark rock.

Grounds crew garage door to the right.

5. **Flue stack integrity:** After the burner cleaning and testing, a flue draft measurement should be taken to ensure proper updraft. Confirm the flue integrity and that they were not damage by fire or poor maintenance.

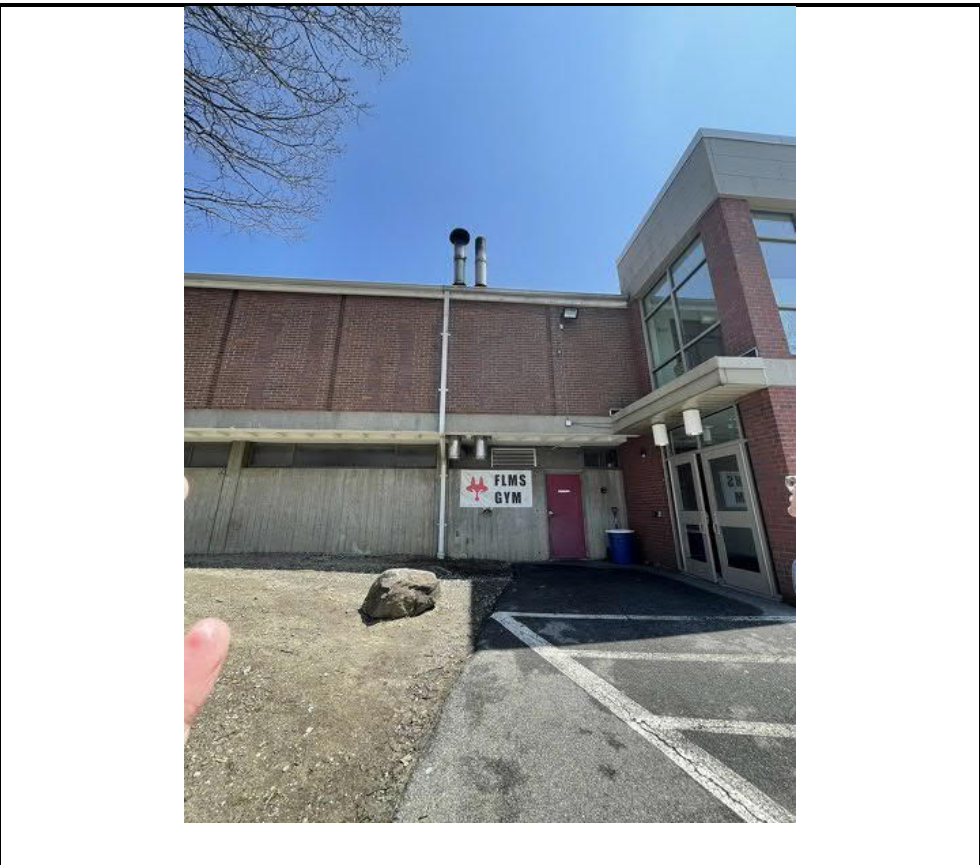
<b>Photo No.</b>	<b>Date</b>
4	April 28, 2024

Main entrance on west side of gymnasium. The boiler room door is and boiler vent is in center of picture. Contractor accessed building from this boiler room door. The contractor diesel truck was parked on the dirt to the left of the walkway.

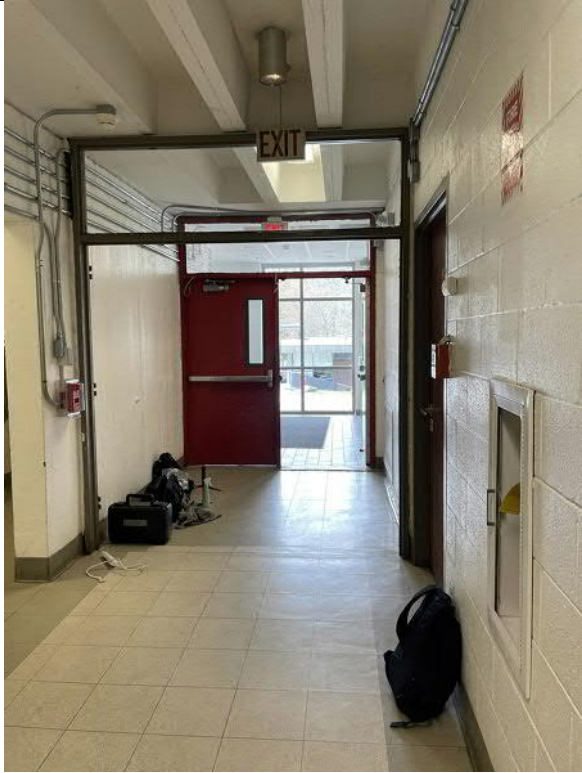
<b>Photo No.</b>	<b>Date</b>	
5	April 28, 2024

<p>Main entrance hallway. Boiler room door is on right. Access to stairs and grounds garage is to the left.</p>

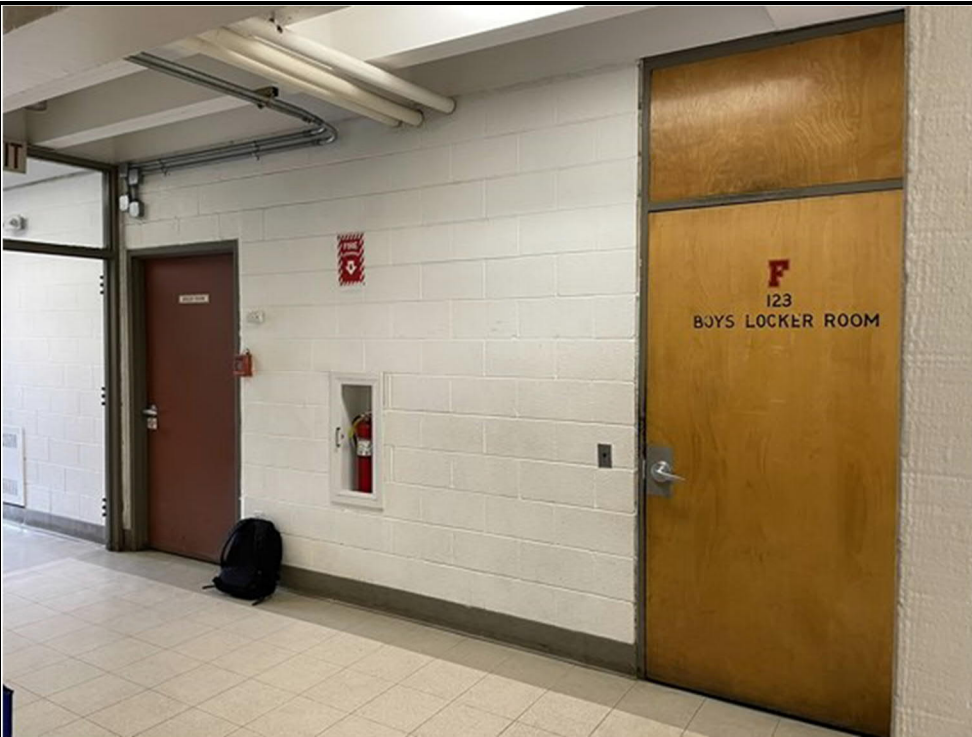
<b>Photo No.</b>	<b>Date</b>	
6	April 28, 2024

<p>Boiler room door from hallway. Boys locker room door.</p>

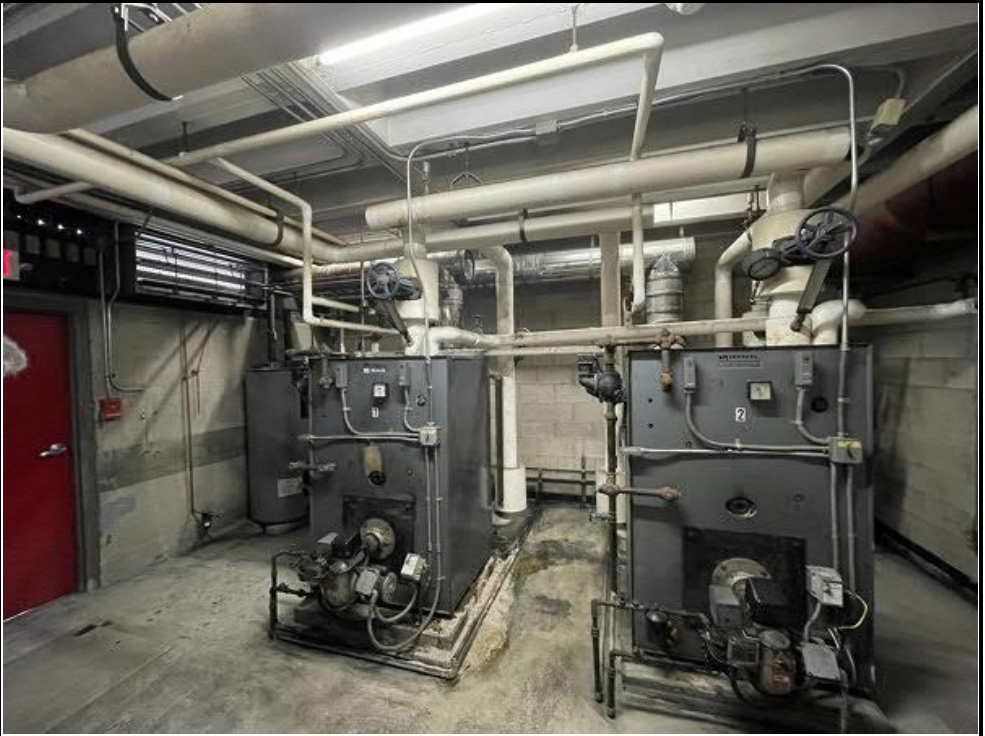
\*\*Boiler room-Exterior air vent (louver) was in fully open position and secured by a chain in the open position.

<b>Photo No.</b>	<b>Date</b>
7	April 28, 2024
Boiler room. Boiler #1 on left, #2 on right. Combustion air vent on left wall in open position. Boiler room door to the outside on left.

4. **Boiler Commissioning:** Boiler services should be completed to include burner assembly cleaning, nozzle and filter replacement, internal heat exchanger inspection and cleaning, flue pipe vacuuming, re-seal the combustion inspection covers that were removed to clean the fireside, and checking for water or flue gas leaks.

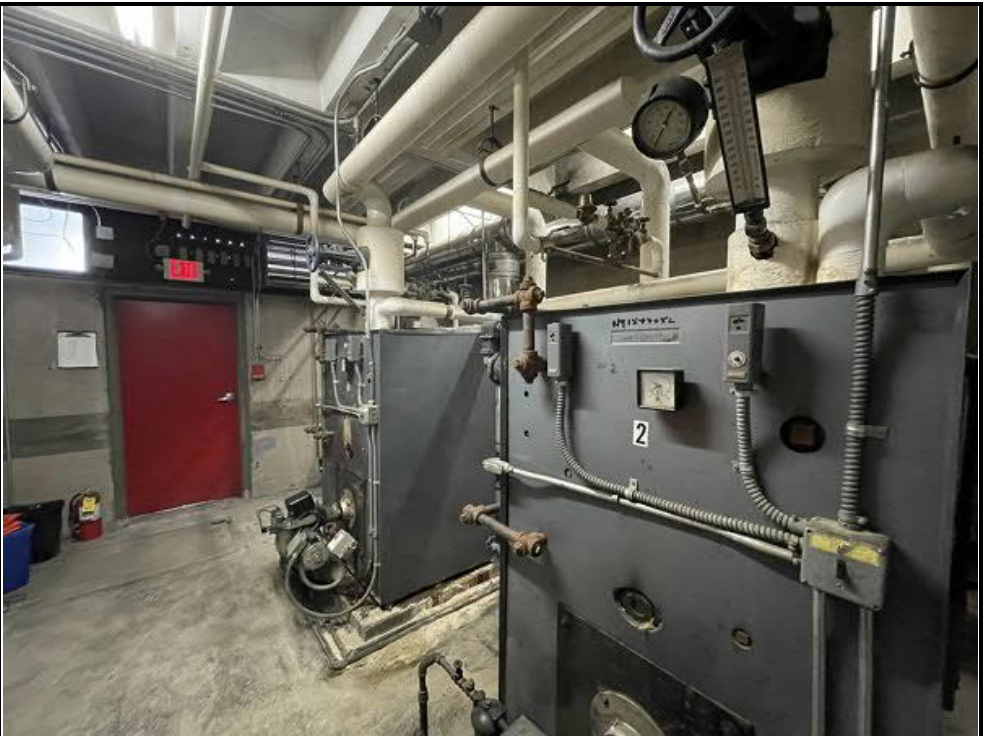
<b>Photo No.</b>	<b>Date</b>
8	April 28, 2024
Boiler room exit door to the outside.

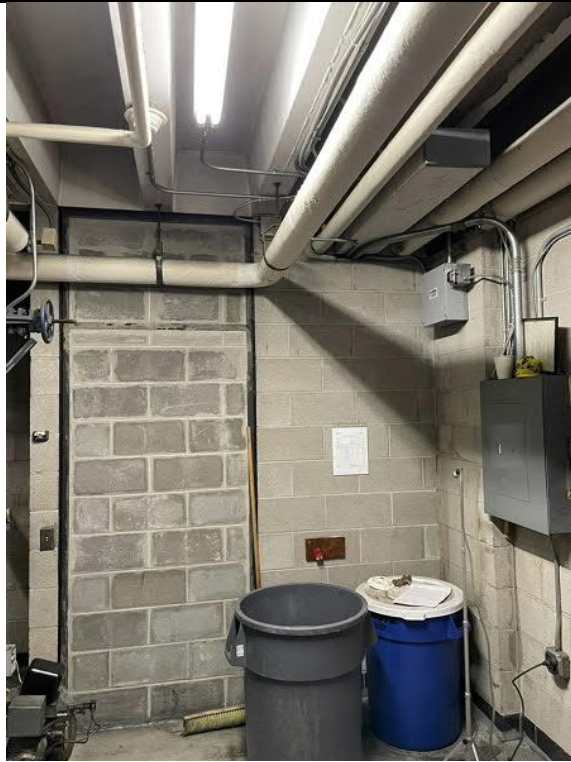
<b>Photo No.</b>	<b>Date</b>
11	April 28, 2024
Pipe chases and wall leading to boys locker room.

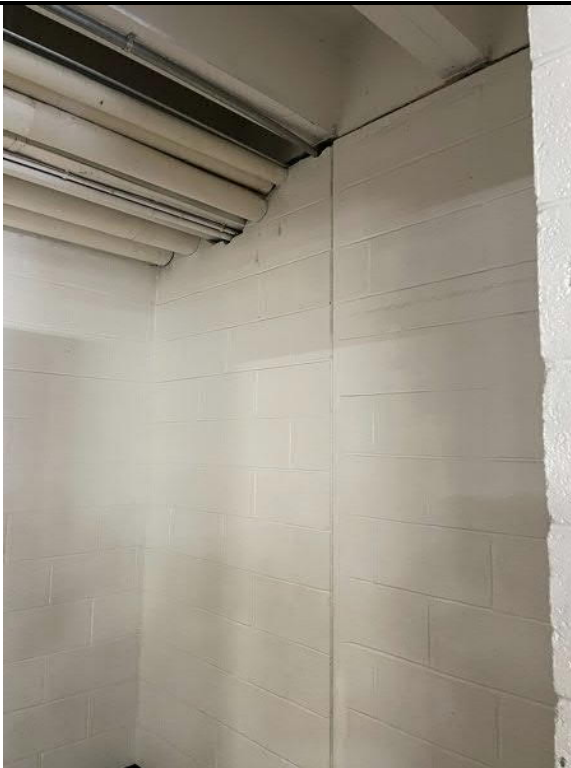
<b>Photo No.</b>	<b>Date</b>
12	April 28, 2024
Pipe coming into the boys locker room from the boiler room. No indication of soot or fire residue on walls near the pipe chase through the cinderblock wall.

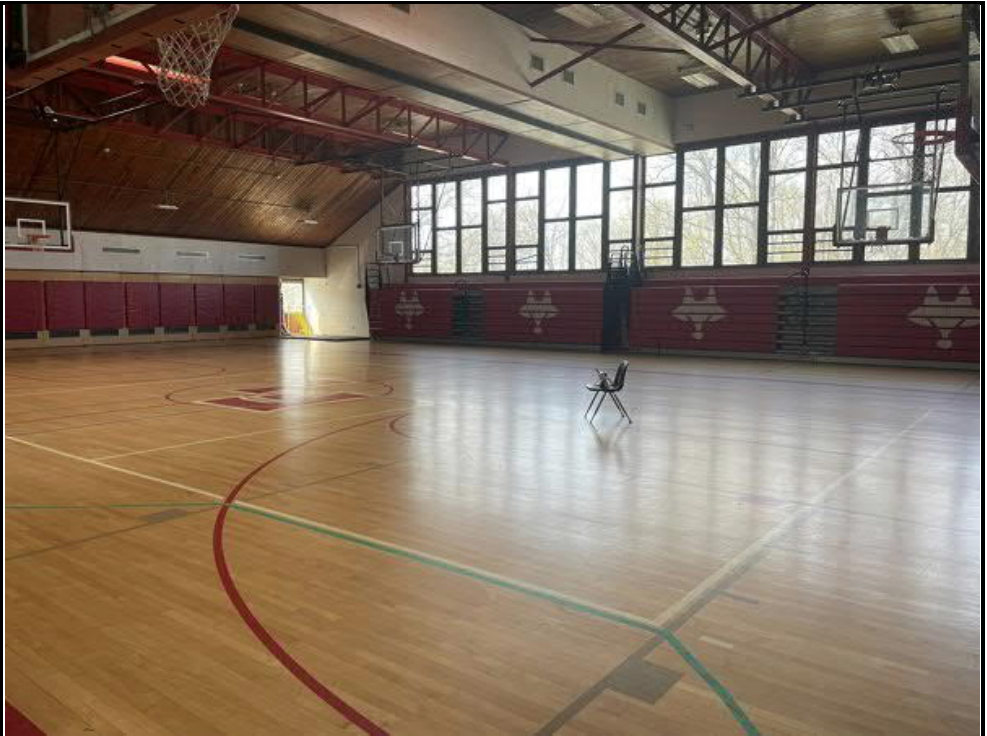
Photo No.	Date
13	April 28, 2024
Main gym, 2 <sup>nd</sup> Floor. View looking north.

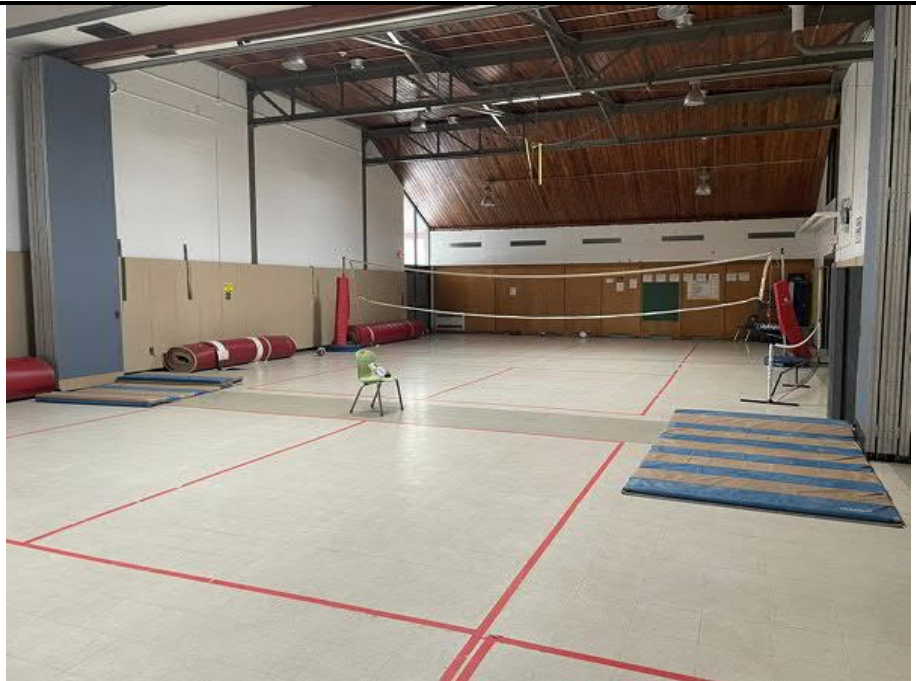
Photo No.	Date
14	April 28, 2024
Small gym, 2 <sup>nd</sup> floor.

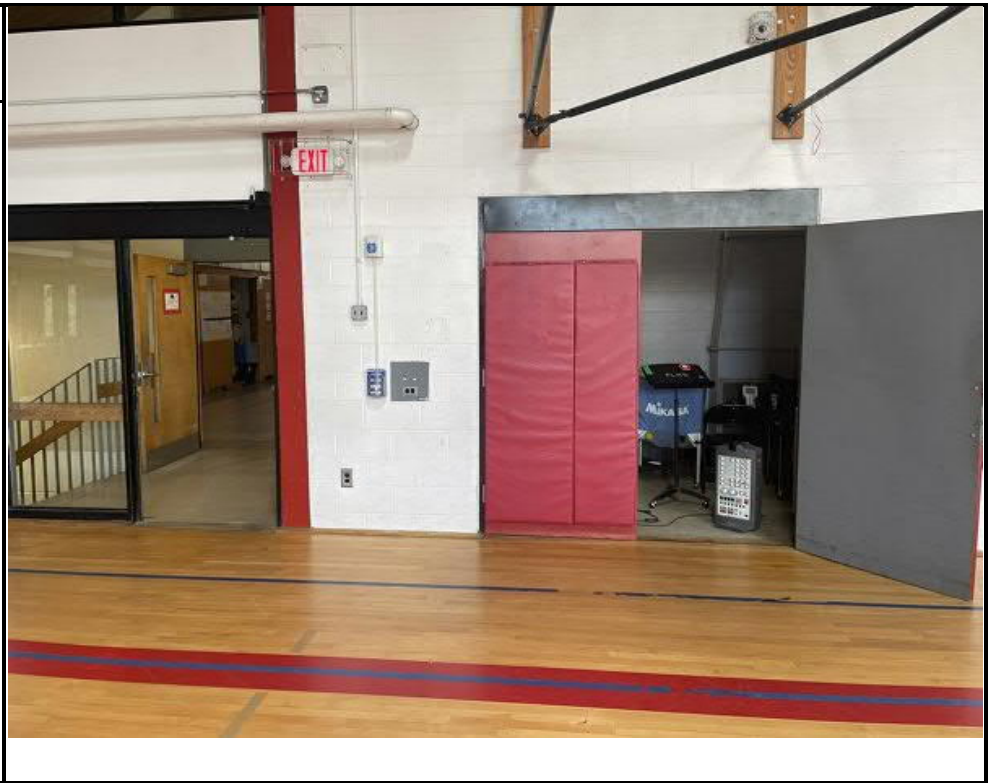
<b>Photo No.</b>	<b>Date</b>
15	April 28, 2024
Stairway leading up from 1 <sup>st</sup> floor hallway to gyms. Return air ducts for gym is in the closet(s).

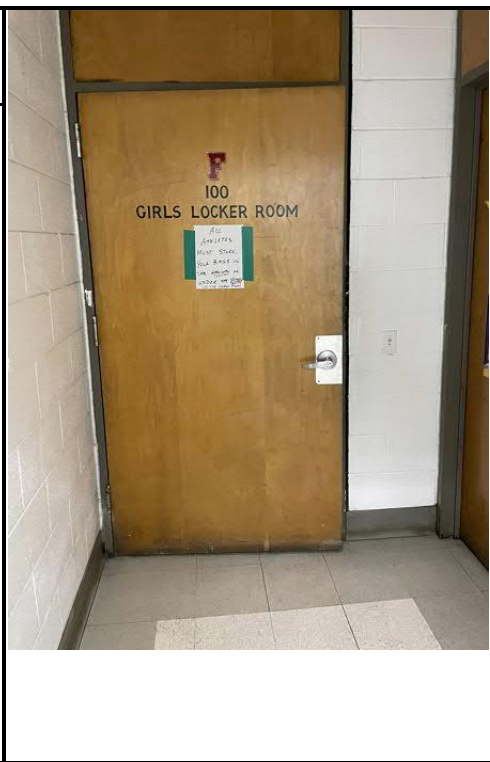
<b>Photo No.</b>	<b>Date</b>
16	April 28, 2024
Entrance to girls locker room on the 1 <sup>st</sup> floor.

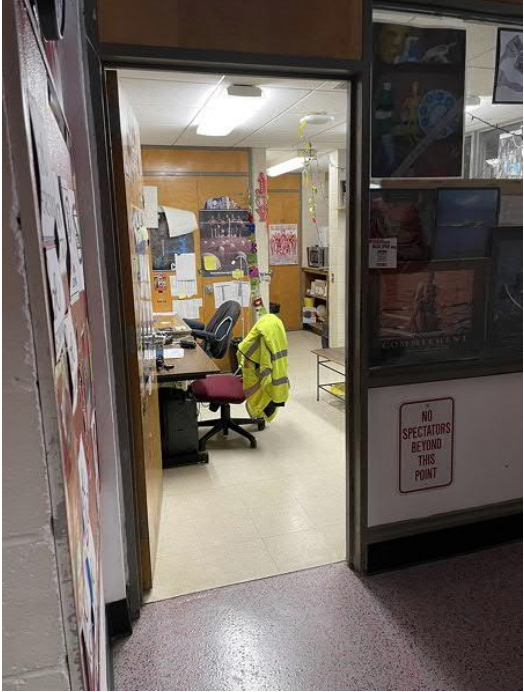
<b>Photo No.</b>	<b>Date</b>	
17	April 28, 2024	
Gym teacher offices in girls locker room.

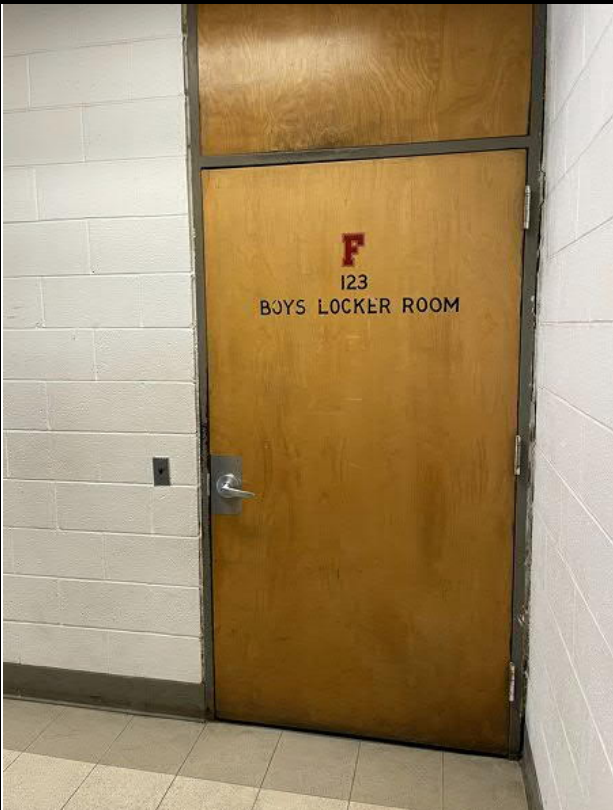
<b>Photo No.</b>	<b>Date</b>	
18	April 28, 2024	
Entrance to boys locker room on the first floor.

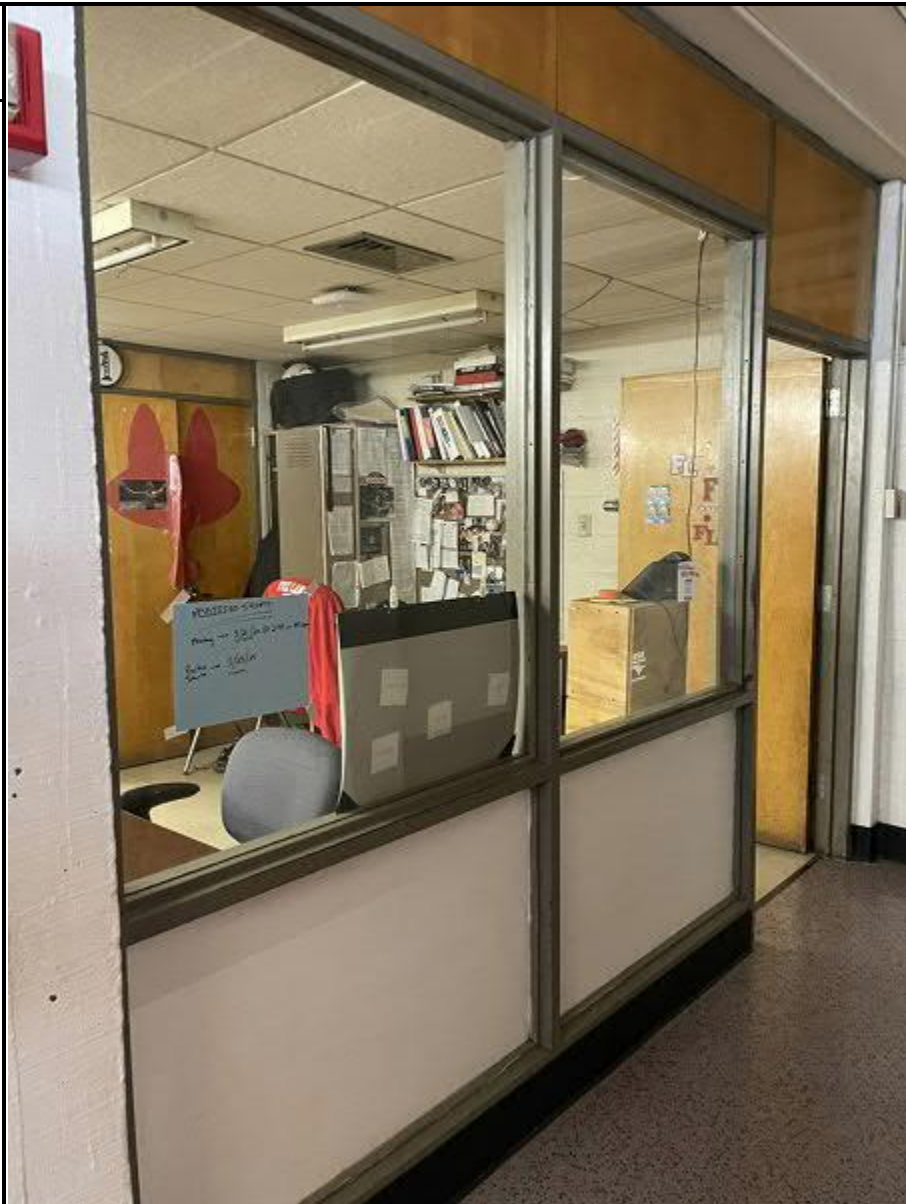
<b>Photo No.</b>	<b>Date</b>
19	April 28, 2024

Gym teacher office in boys locker room. Air supply diffuser in ceiling.

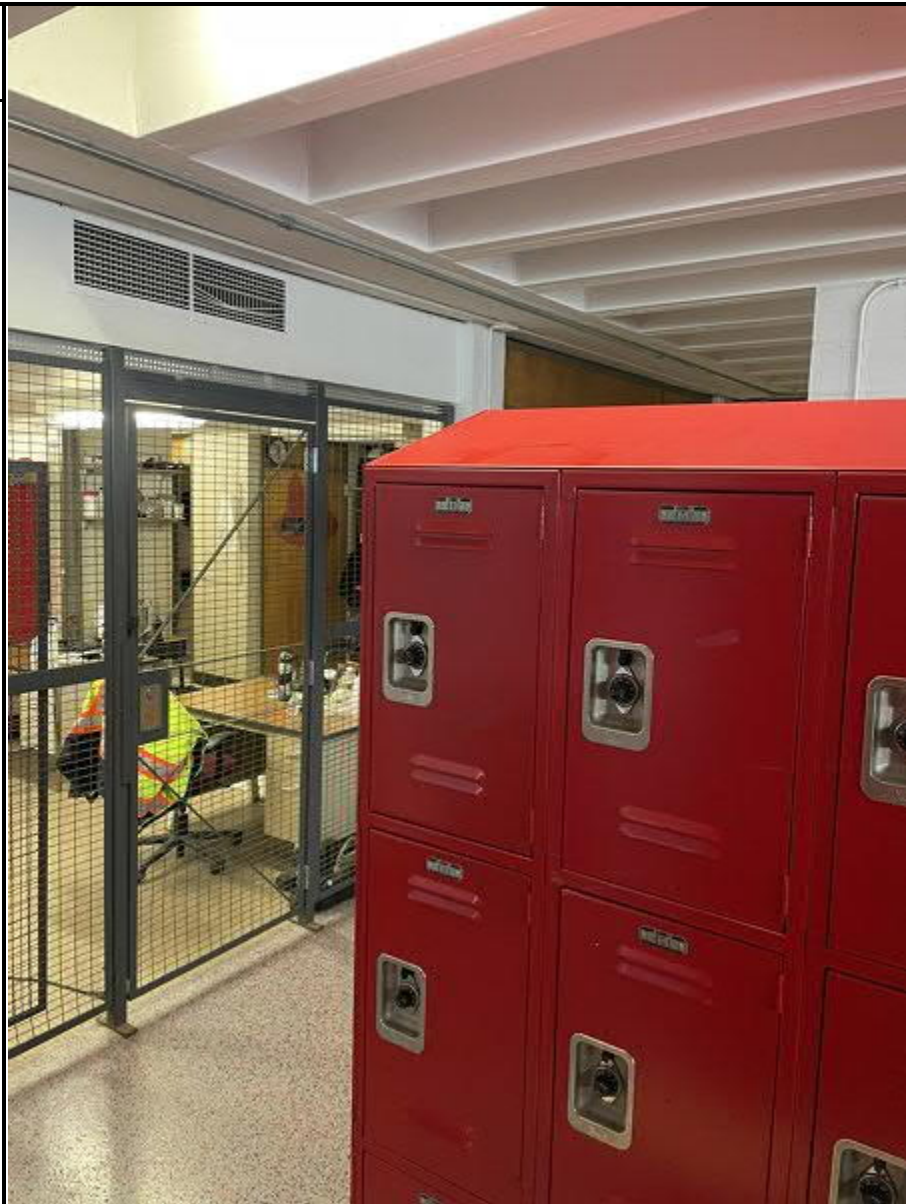
<b>Photo No.</b>	<b>Date</b>
20	April 28, 2024

Boys locker room office cage and locker room. Air conditioning vent in center top of picture.

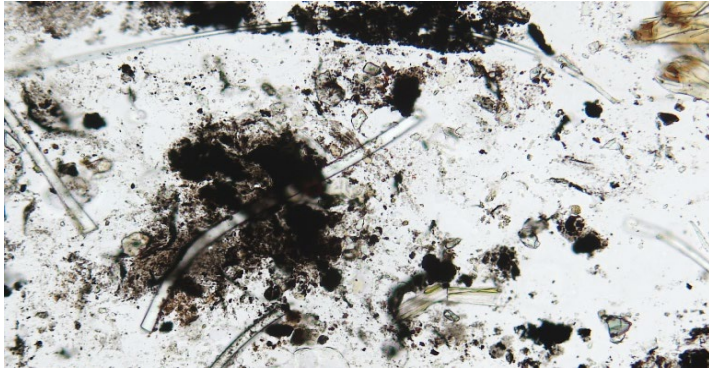
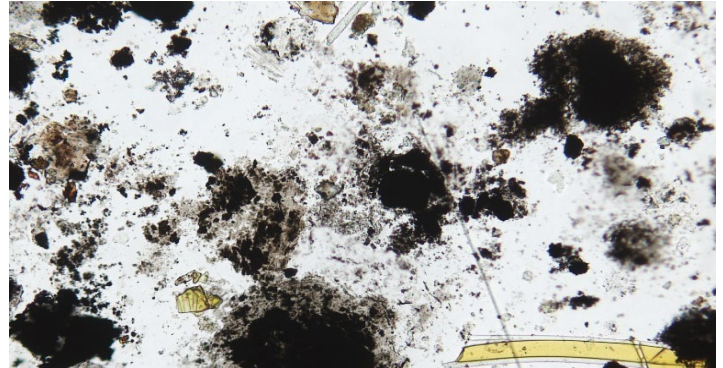
1-BR  
Tape lift - top of boiler #1 (black soot visible)  
200x

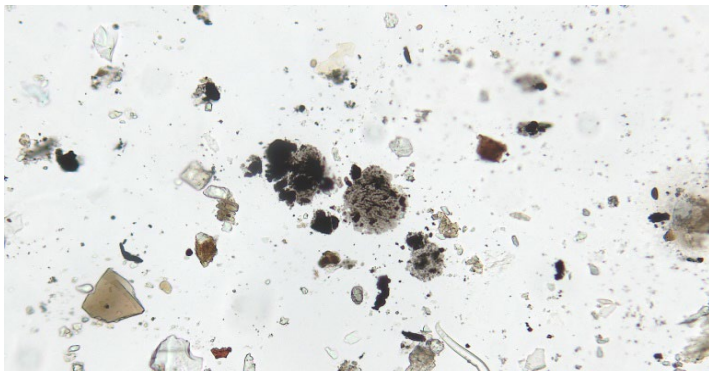
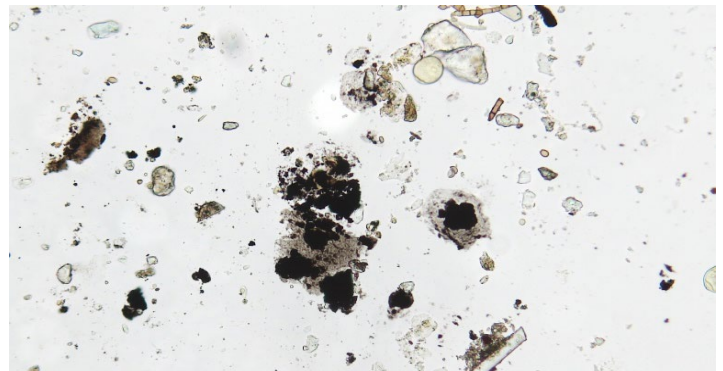
2-BR  
Tape lift - reset switch box boiler #1 (black soot visible)  
200x

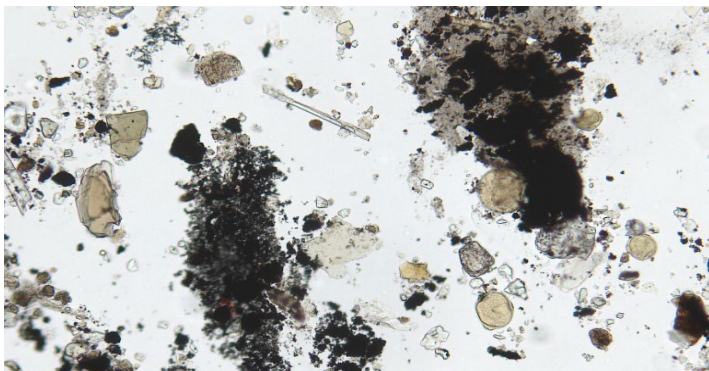
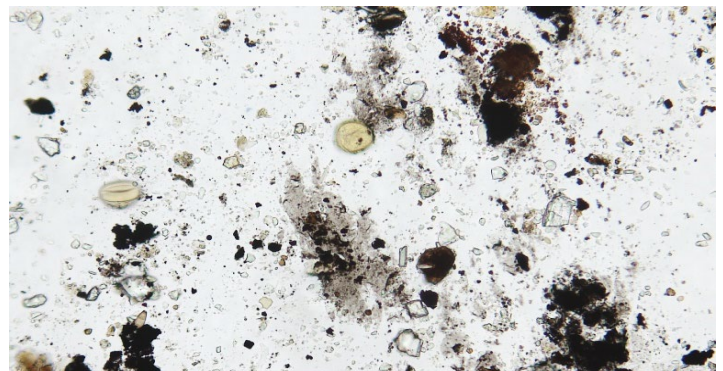
3-BR 2  
Tape lift - vent duct at rear of boiler #2 (black soot visible)  
200x

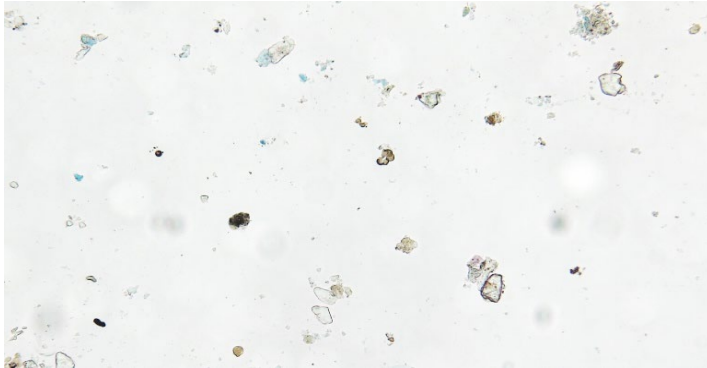
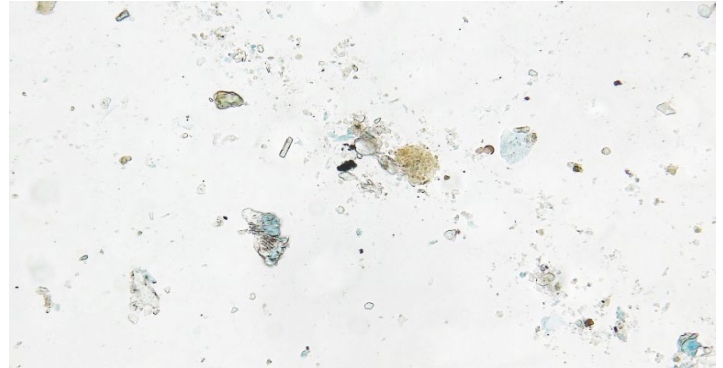
4-Boys LR Desk  
Tape lift - boys locker room desk #1 (no visible soot/dust)  
200x

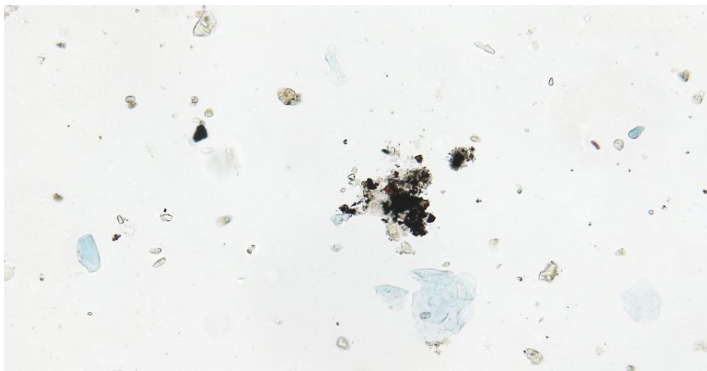
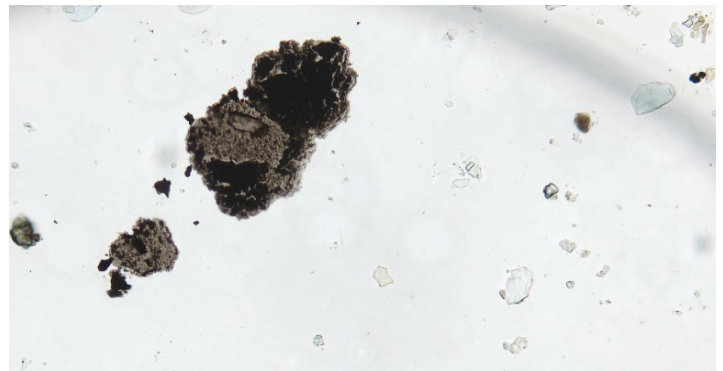
5-Boys LR Desk 2  
Tape lift - boys locker room desk #2 (visible dust, not cleaned, no soot)  
200x

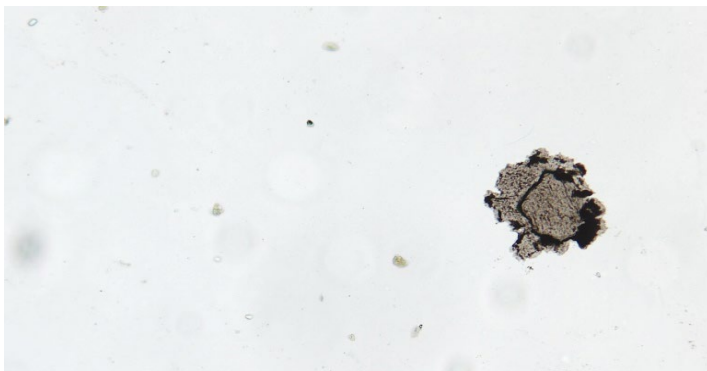
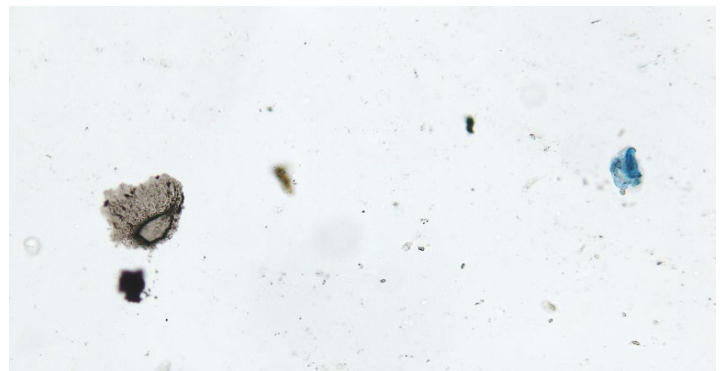
6-Boys LR-ext Locker  
Tape lift - top of locker #447 (visible dust, no soot)  
200x

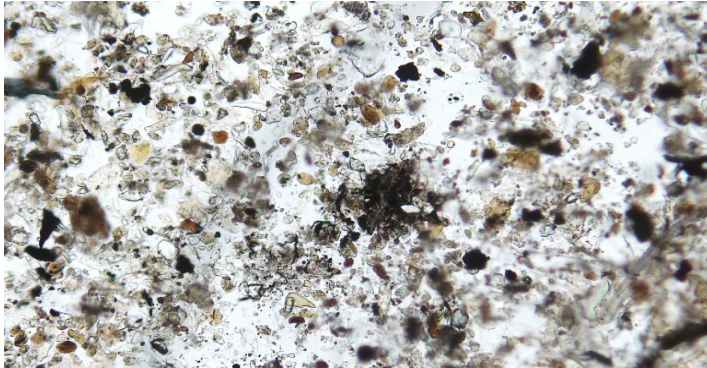
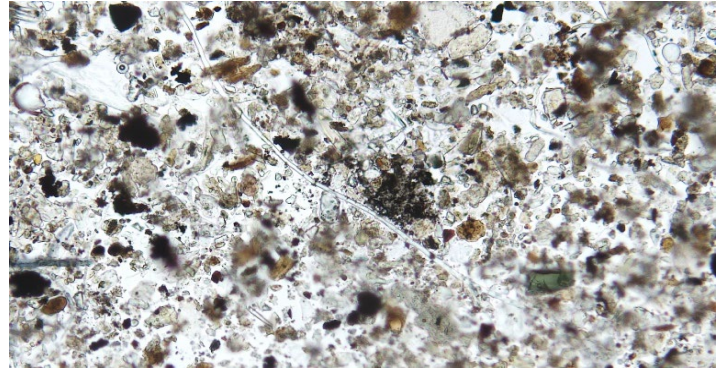
7-AH Room 113 (*)	Air handler room #113-fan belt guard #3 (black dust visible)	<b>5.5</b> (Atypical 3-10x background)	3.9	1.6	ND	94.5	Yes-Soot (isolated)
8-Girls LR, Rm 109	Girls locker room, Office 109, 2 <sup>nd</sup> desk (no visible dust)	1.1 (Typical-upper background ≥ 1-3%)	1.1	ND	ND	98.9	No
9-AHU Vent-Gym (*)	AHU Vent-Main Gym closet, SE corner of gym (no visible dust or soot)	0.6 (Typical-low < 1%)	0.4	0.2	ND	99.4	No
10-Gym bleacher	Main Gym bleacher-top seat (no visible dust or soot)	ND (Typical-low < 1%)	ND	ND	ND	100	No
11-Hall floor o/s Boiler Room	Hall floor (vinyl tile) outside boiler room (no visible dust or soot accumulation)	<b>3.4</b> (Atypical 3-10x background)	3.4	ND	ND	96.6	Yes-Soot (isolated)

Tape lift - air handler room 113 - fan belt guard #3 (black soot dust)  
200x

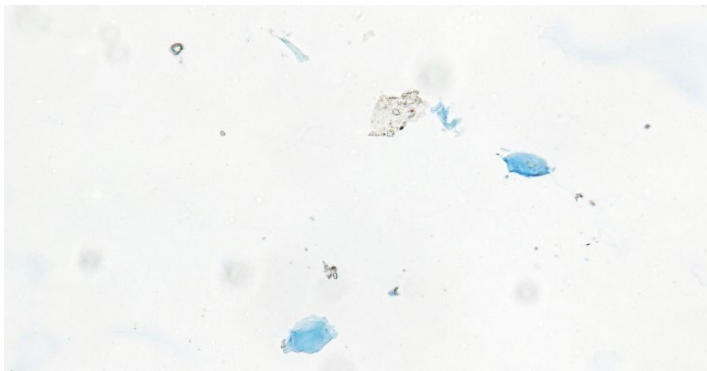
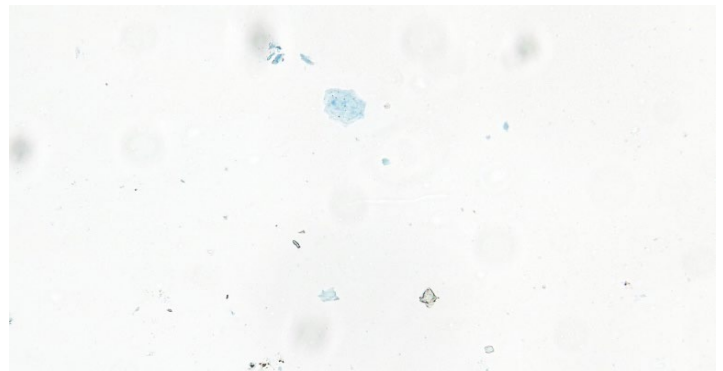
8-Girls LR, Rm 109

Tape lift - girls locker room, office 109, 2nd desk (no visible dust)  
200x

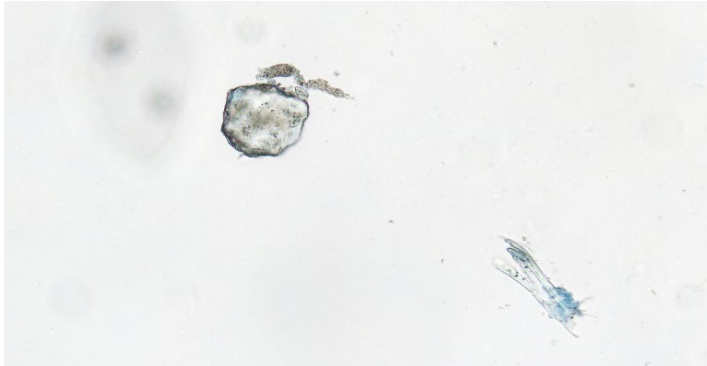
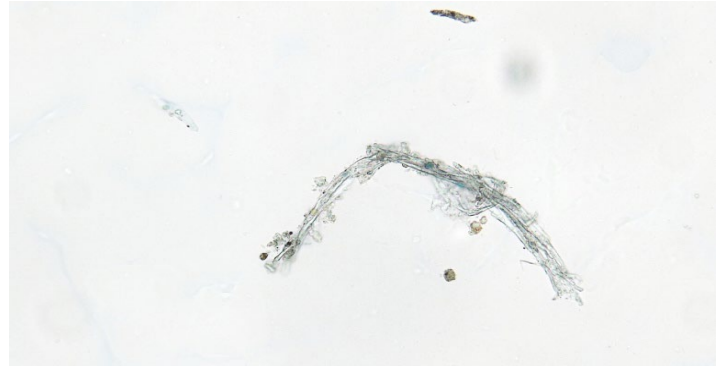
10-Gym Bleacher  
Main gym bleacher - top seat (no visible dust or soot)  
200x

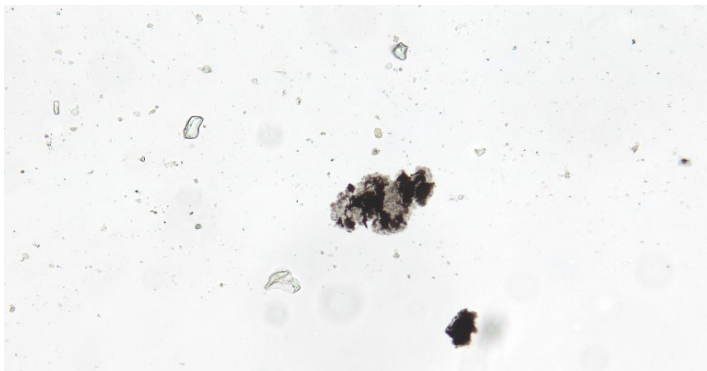
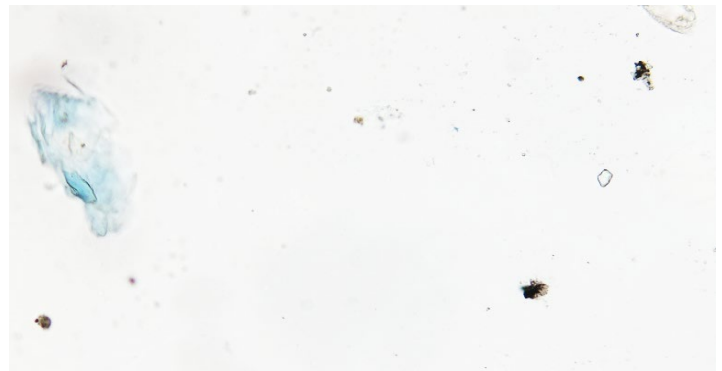
11-Hall floor o/s BR  
Hall floor (vinyl tile) outside boiler room (no visible dust or soot accu  
200x
