PRELIMINARY ASSESSMENT  
RIVER VALLEY LOCAL SCHOOL DISTRICT  
ROOF REPLACEMENT PROJECT  
CALEDONIA, OHIO  
ISSUE DATE: 03-01-2024  
ROH50-001

Prepared by:  
Dan Lawrence, P.E., R.B.E.C.

**River Valley Local School District  
Roof Replacement  
Preliminary Assessment  
Caledonia, Ohio**

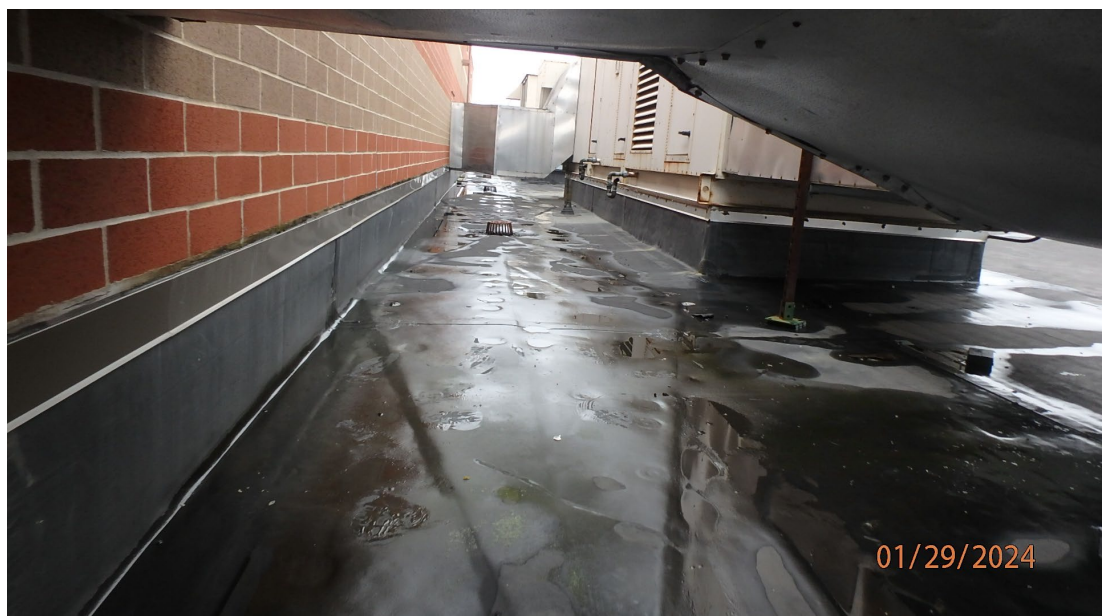
1.1.1.1 Overall view of Roof Area A, along a line of roof drains showing there is no significant ponding water at this area.

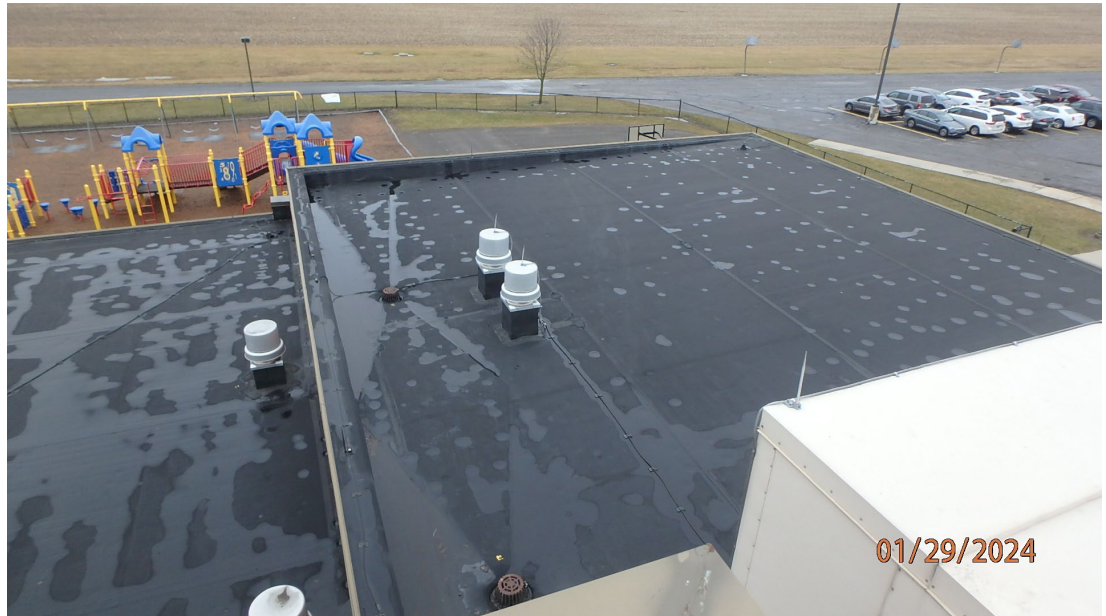
1.1.1.2 Overall view of Roof Area A, where tapered insulation is needed to create back slope and improve the roof drainage on this area.

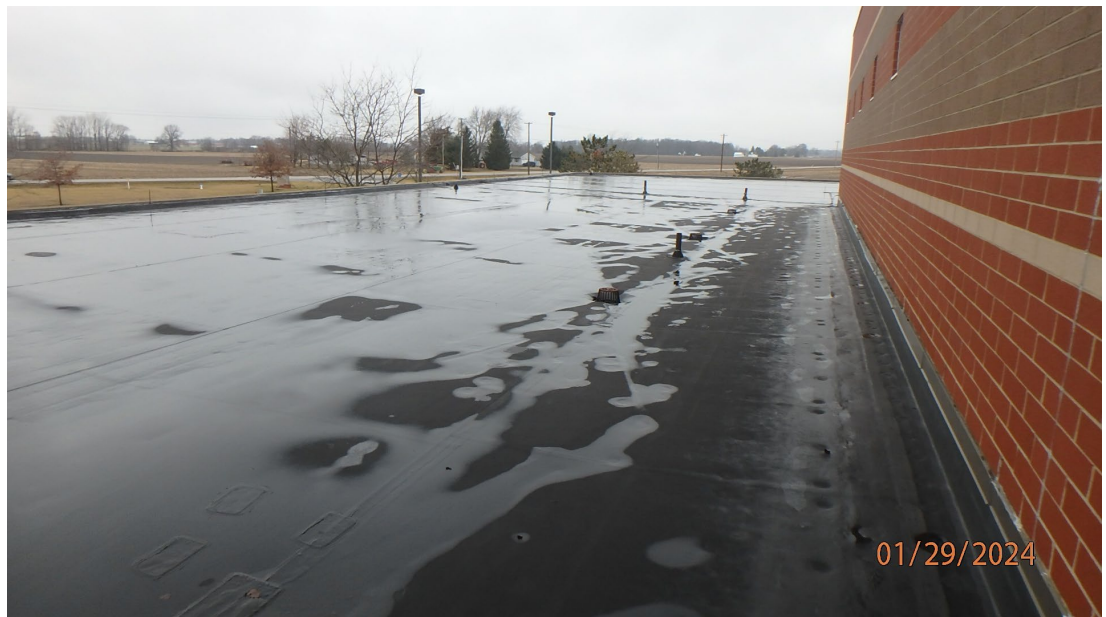
1.1.1.3 Overall view of Roof Area B showing there is no significant ponding water.

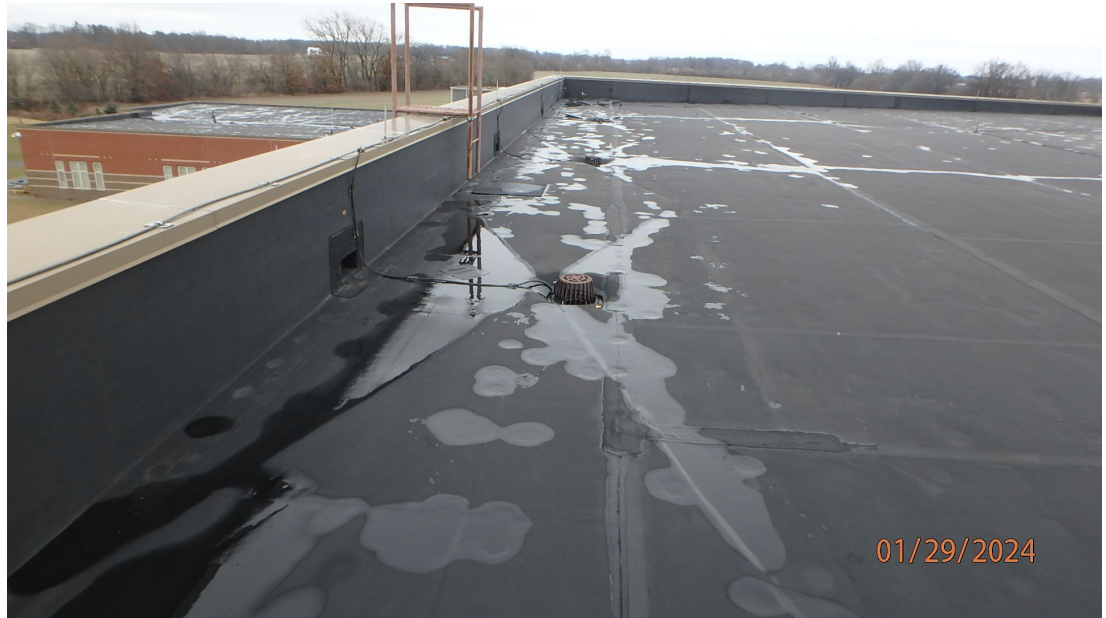
1.1.1.4 Overall view of Roof Area C showing there is no significant ponding water. There is some minor ponding water near the roof drains. This can be corrected with addition of tapered insulation around the roof drains.

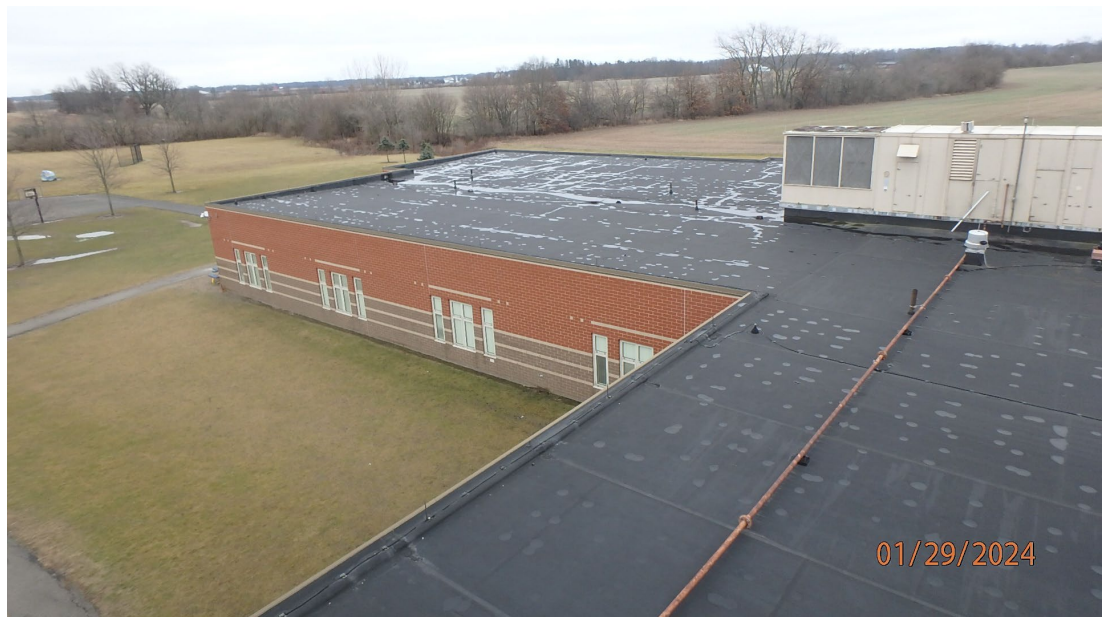
1.1.1.5 Overall view of roof area D showing there is no significant ponding water.

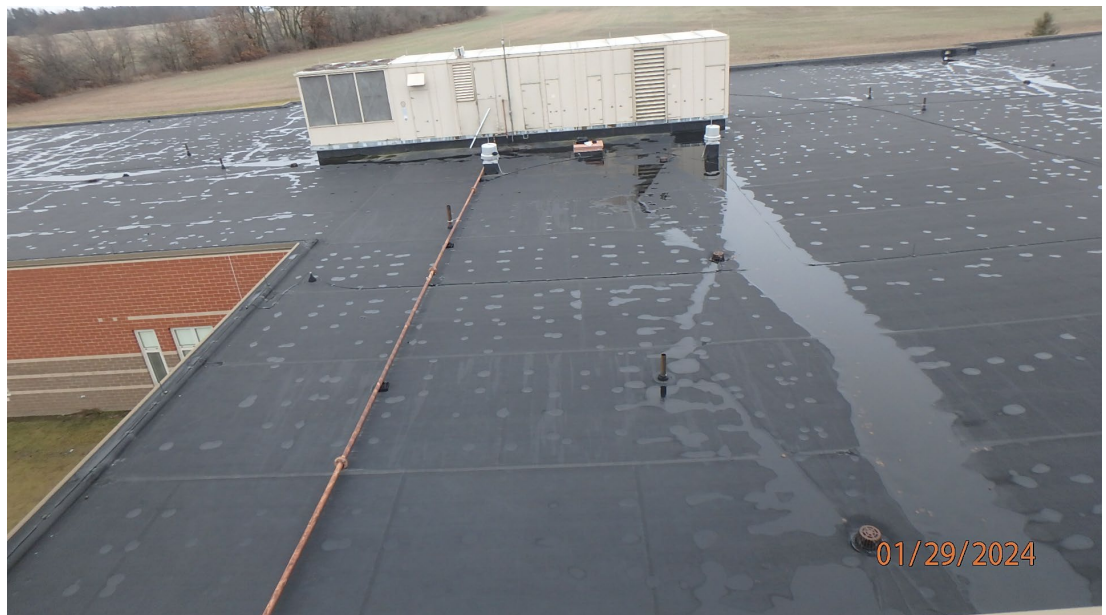
1.1.1.7 Another overall view of Roof Area D. There is ponding along this line of roof drains that can be addressed during the roof replacement by adding tapered insulation around the roof drains and adding larger tapered insulation crickets.

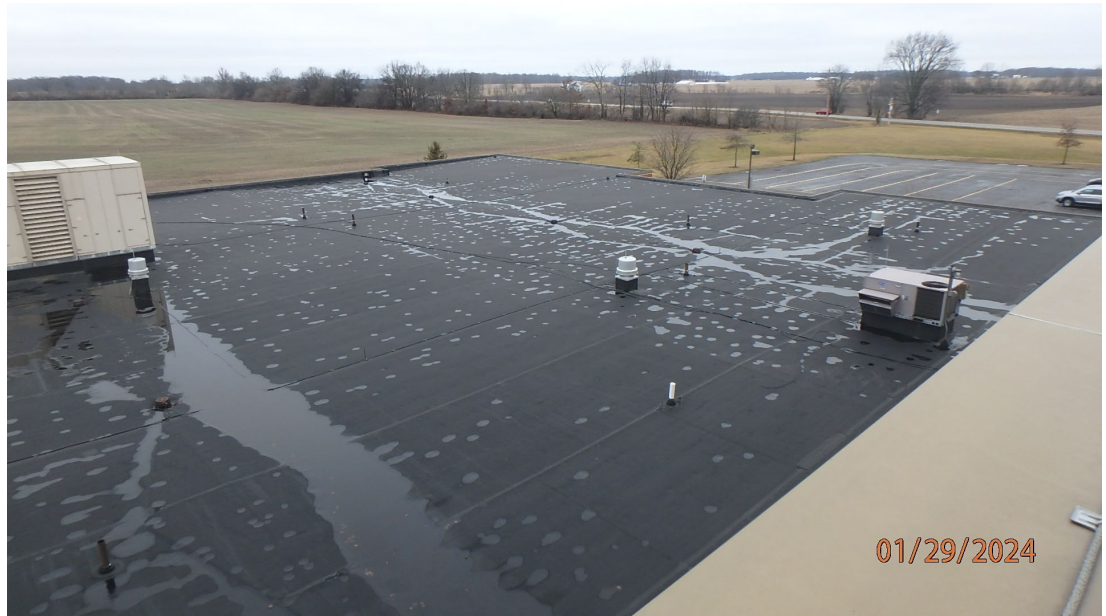
1.1.1.8 Another overall view of Roof Area D, showing another line of roof drains with minor ponding. This ponding can be reduced by adding tapered insulation around the roof drains.

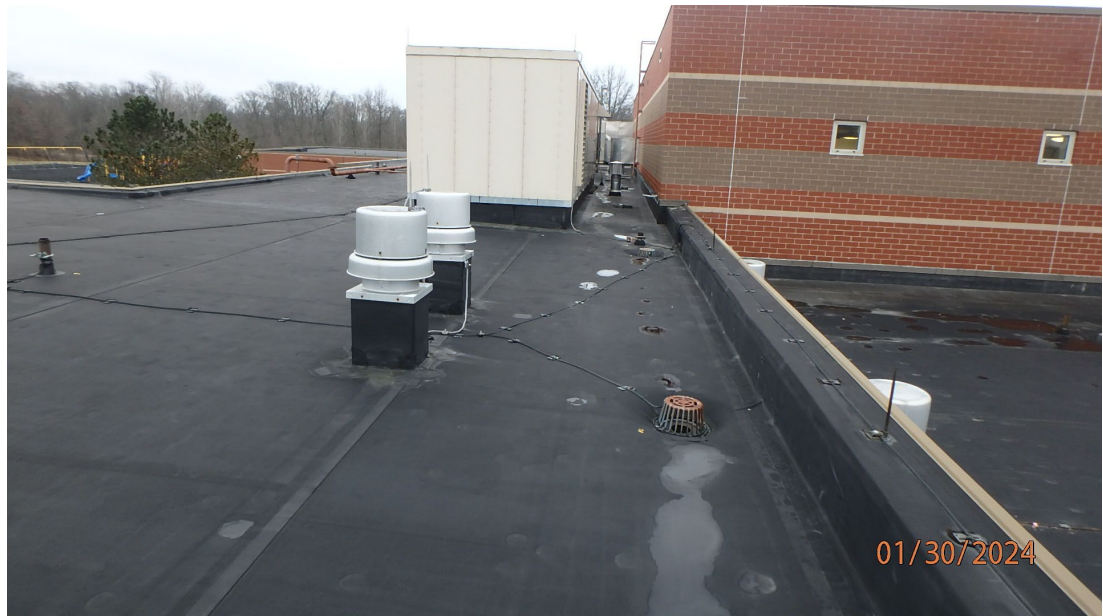
1.1.2.1 View of a line of roof drains on Roof Area A showing there is no significant ponding water.

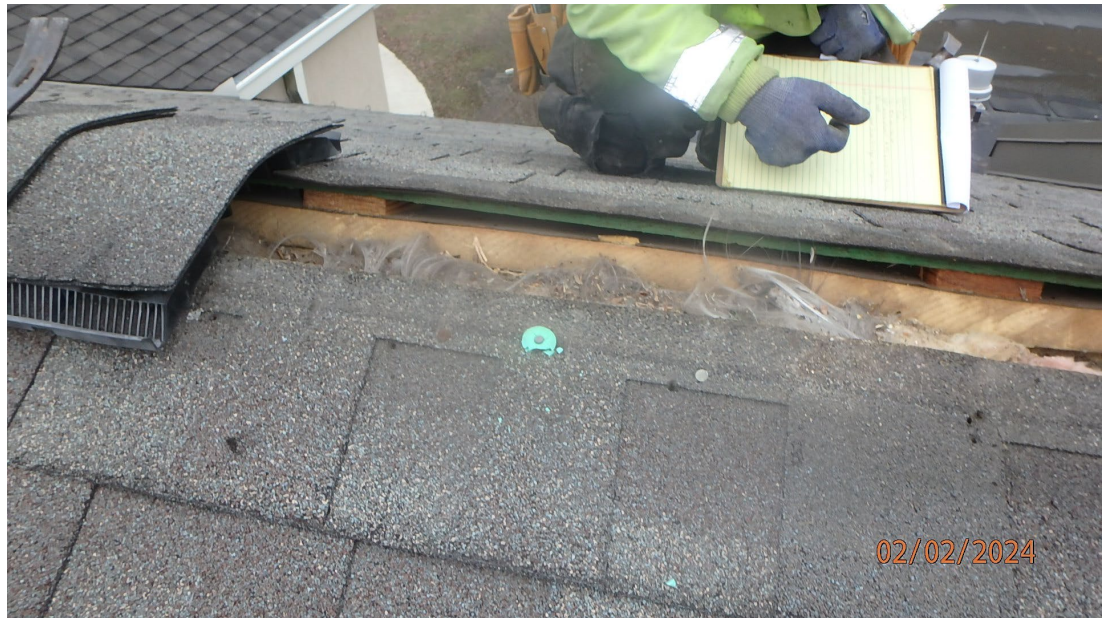
1.1.3.1 Overall view of the typical steep slope shingle roof area construction.

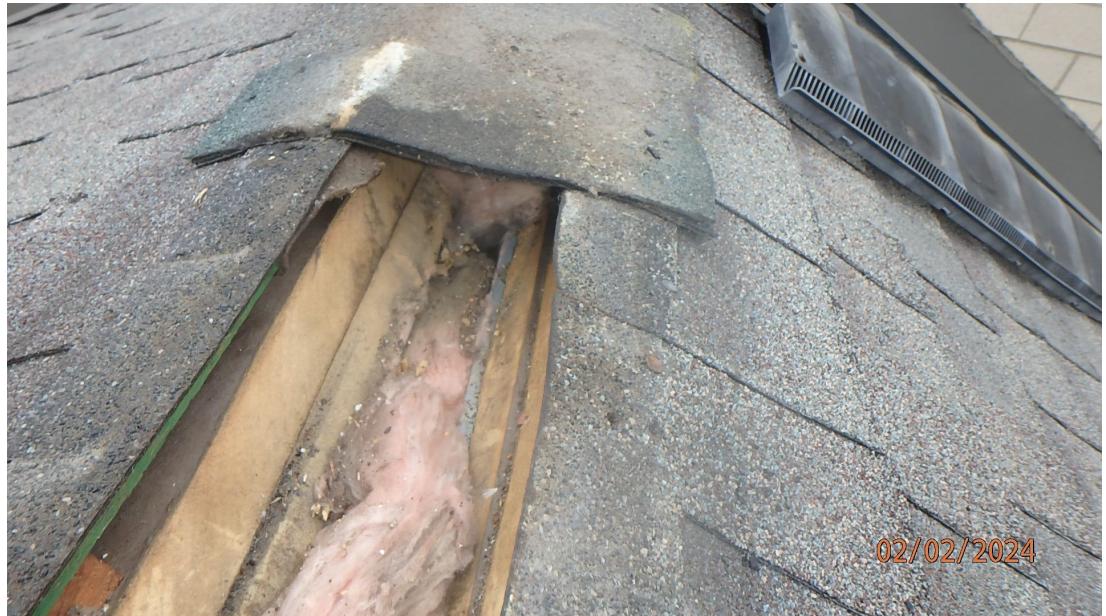
1.1.3.2 View showing fiberglass batt insulation has been installed between the rigid insulation, which was not continuous at the ridge.

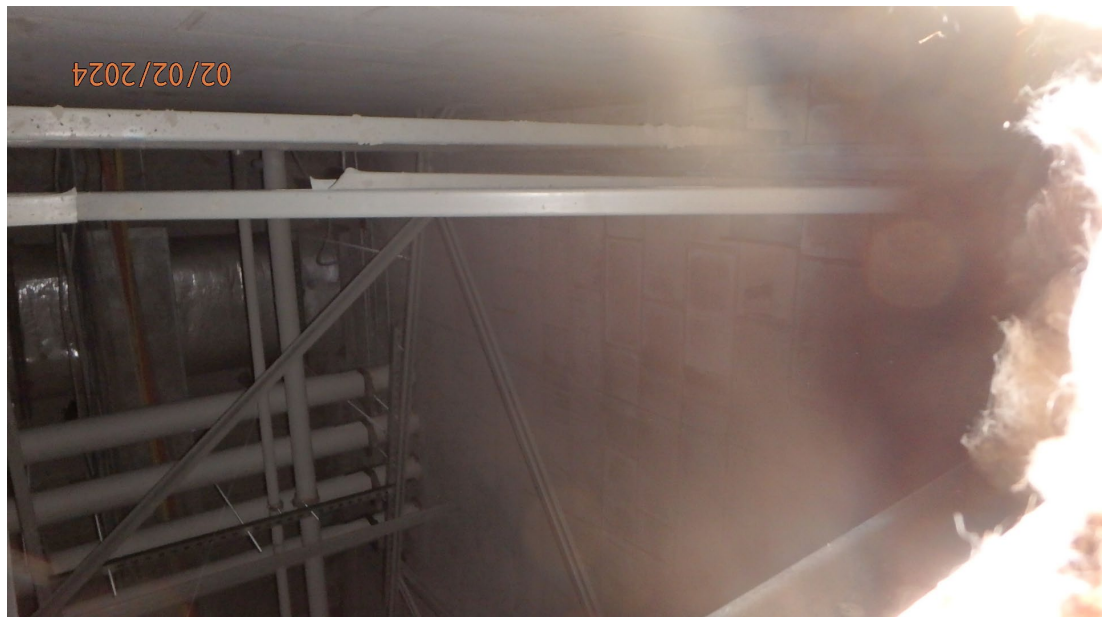
1.1.3.3 View looking down into the building when a section of the fiberglass batt insulation was removed. This is the interior of the building where there is mechanical, plumbing, and fire suppression equipment and piping.

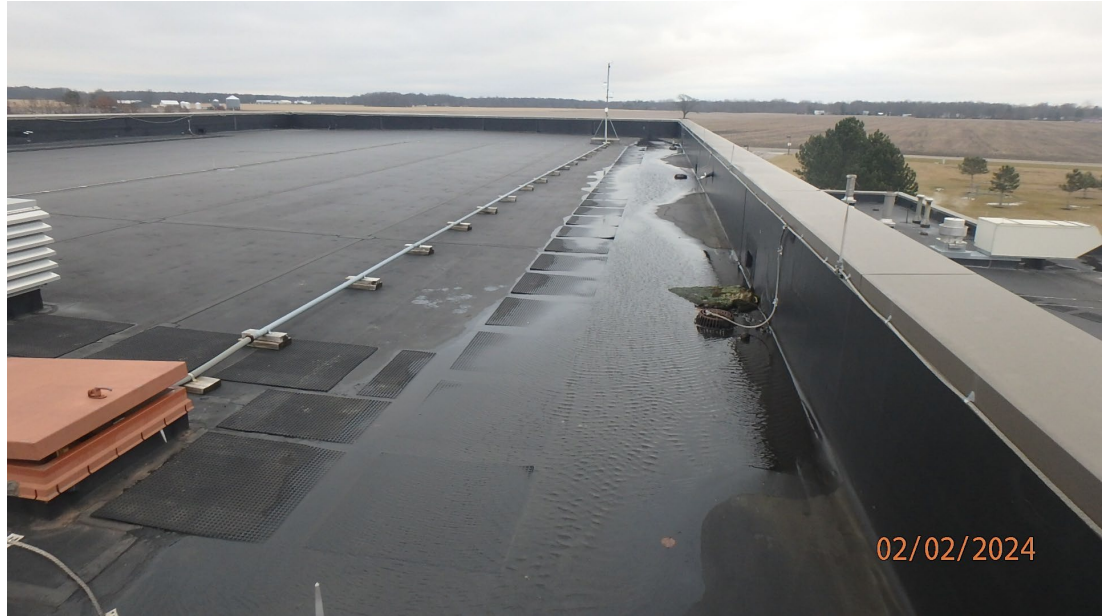
1.1.3.4 Overall view of the drain lines along Roof Area A showing there is significant ponding along the roof drain line that needs to be corrected. This can be reduced by the addition of tapered insulation around the roof drains and larger tapered insulation crickets.

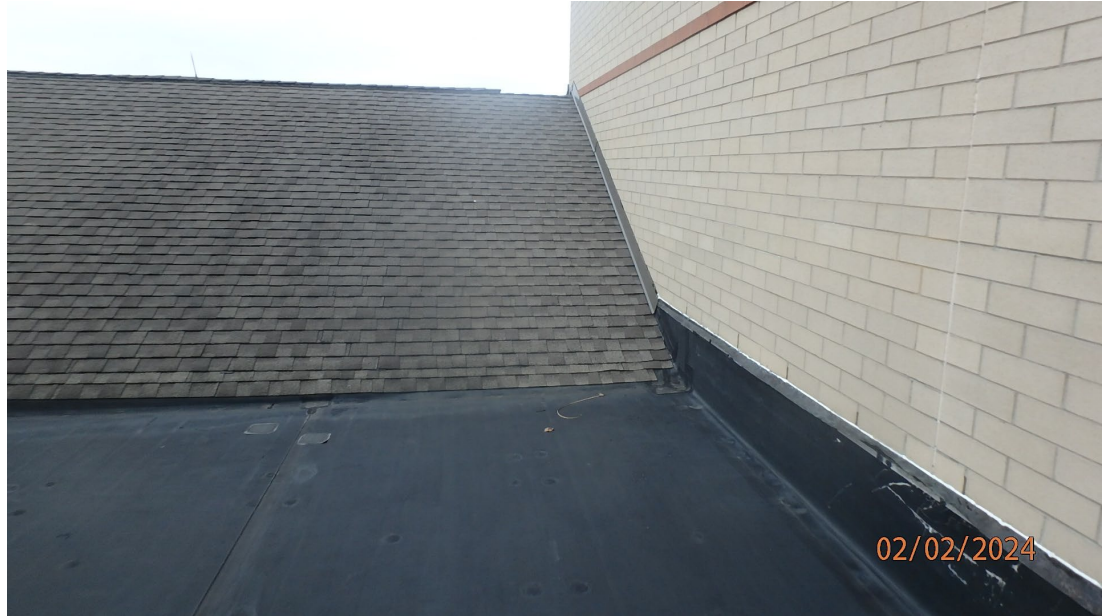
1.1.3.6 Overall view showing that a portion of Roof Area E1 (steep sloped shingle area) ties directly into Roof Area B (low sloped EPDM roof area).

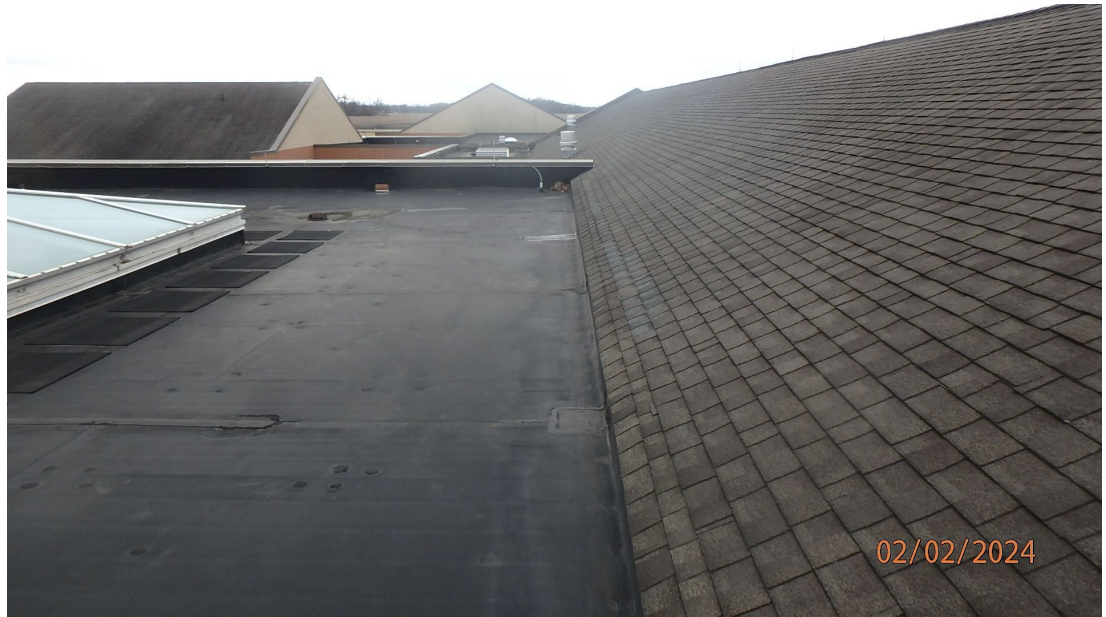
1.1.3.7 View along this tie-in area showing steep slope roof extends beyond Roof Area B.

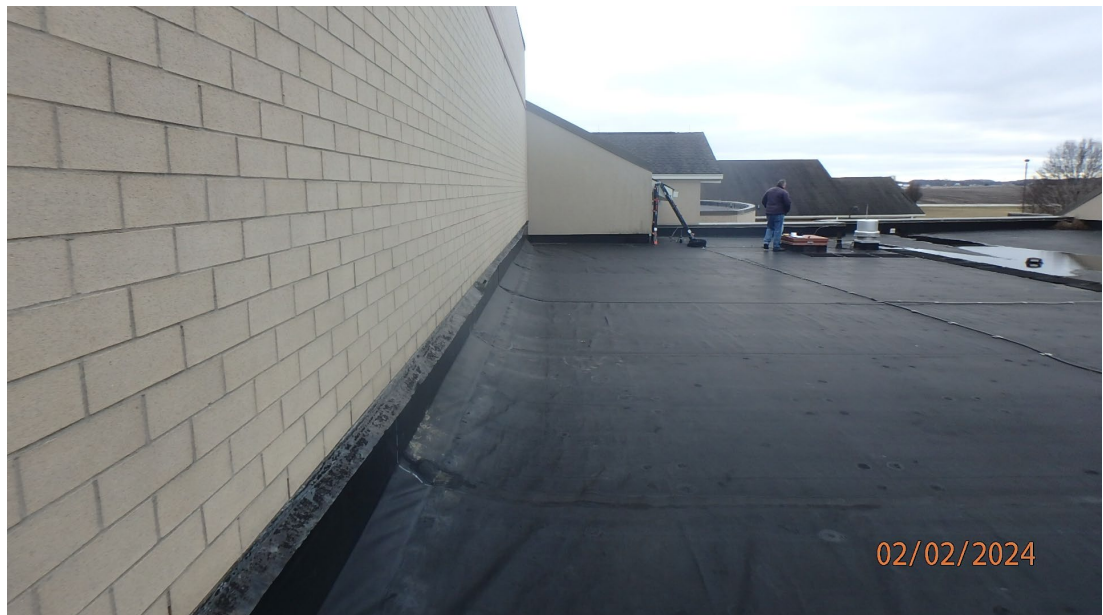
Generally, the low sloped roofs appear to have been maintained, but are near the end of their useful life, with periodic roof leaks reported. There was one (1) roof area on Roof Area C where the base securement has been compromised and a portion of the roof membrane has become unadhered. We recommend temporary securement be installed to help prevent more significant damage prior to the planned roof replacement.

1.1.3.9 View of an area on Roof Area C where the roof membrane perimeter securement has been compromised and the roof membrane has started to become unadhered. This area should have some temporary securement installed to prevent further (and possibly severe) wind damage prior to the roof replacement being implemented.

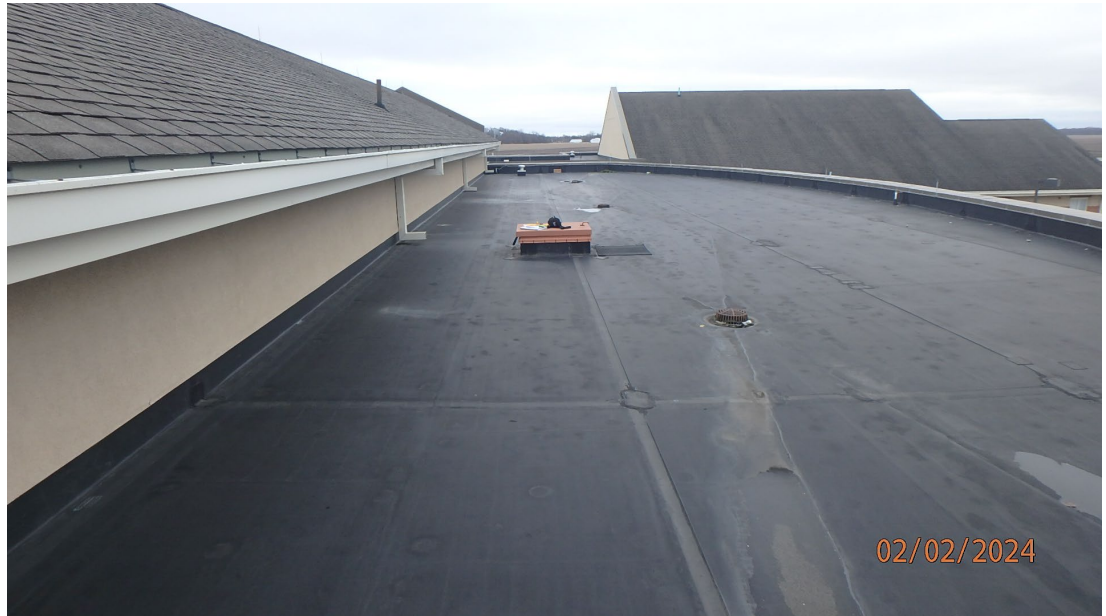
1.1.3.10 View of an area on Roof Area F showing there is no significant ponding on this roof area.

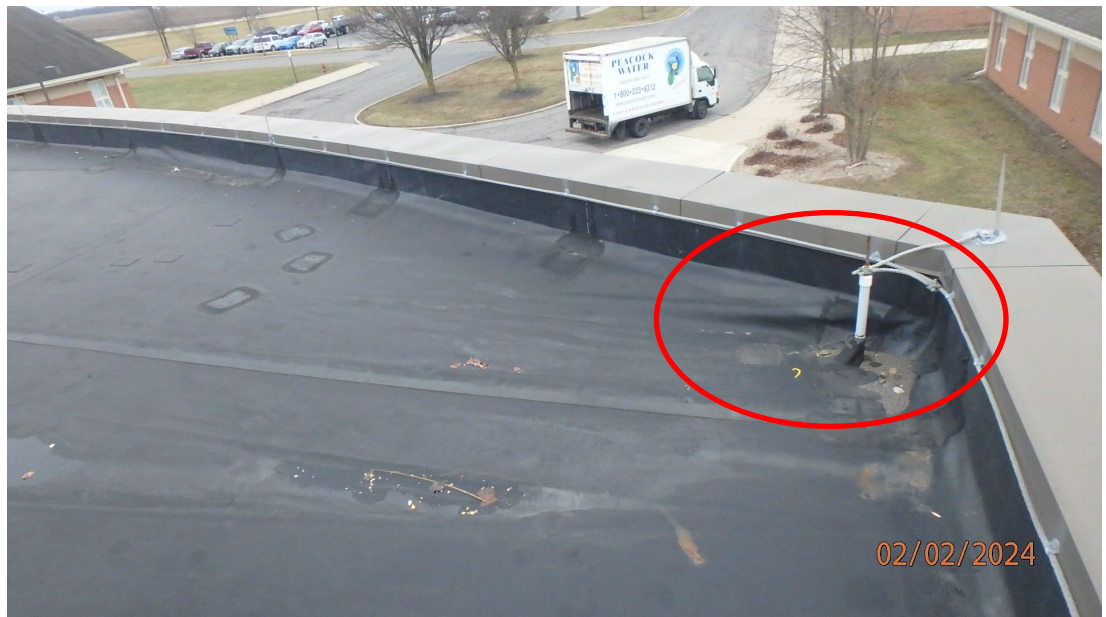
1.1.3.11 View of an area on Roof Area F where the roof membrane shrinkage is starting to pull the roof membrane off of the wall. This type of failure starts to occur as the roof membrane ages.

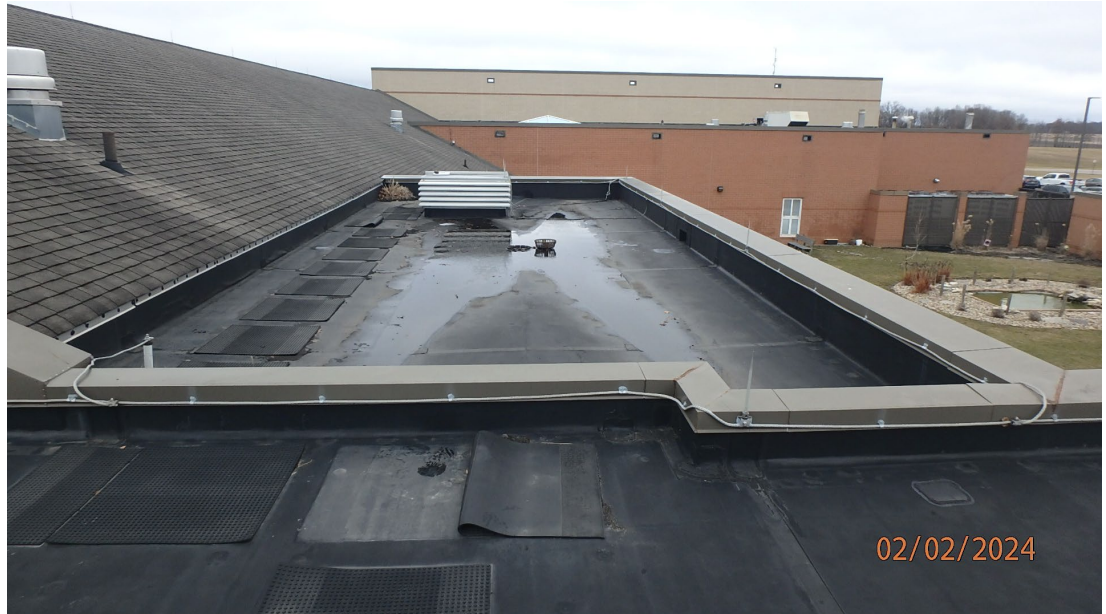
1.1.3.12 Overall view showing there is significant ponding along the drain line on Roof Area G. This will need to be corrected by the addition of tapered insulation around the roof drains and possibly larger tapered insulation crickets.

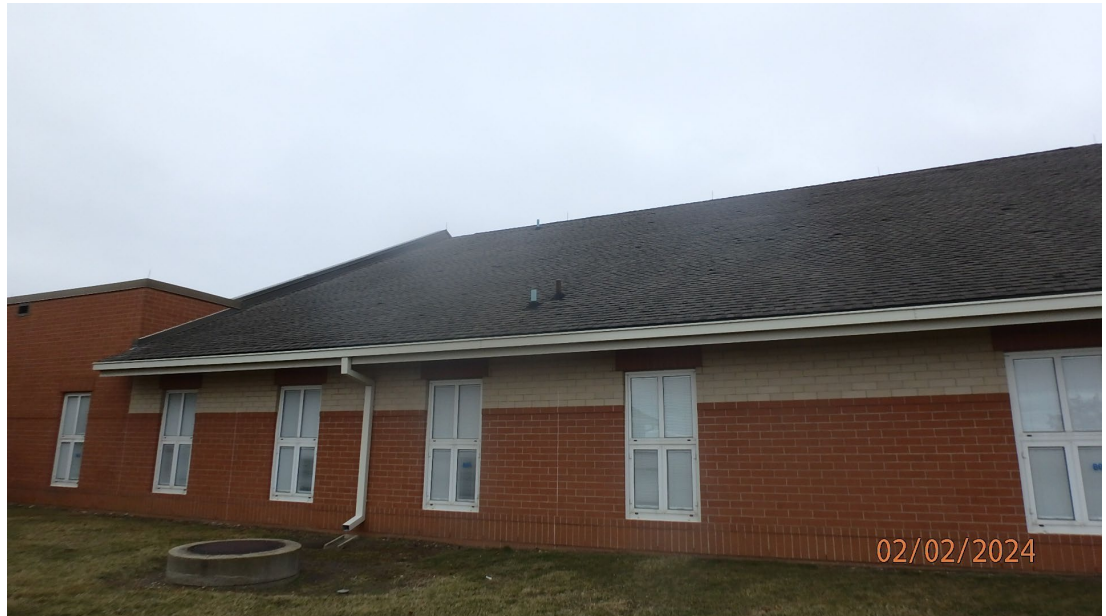
1.1.3.14 Overall view of Roof Area H2 there are numerous raised shingles on this roof area.

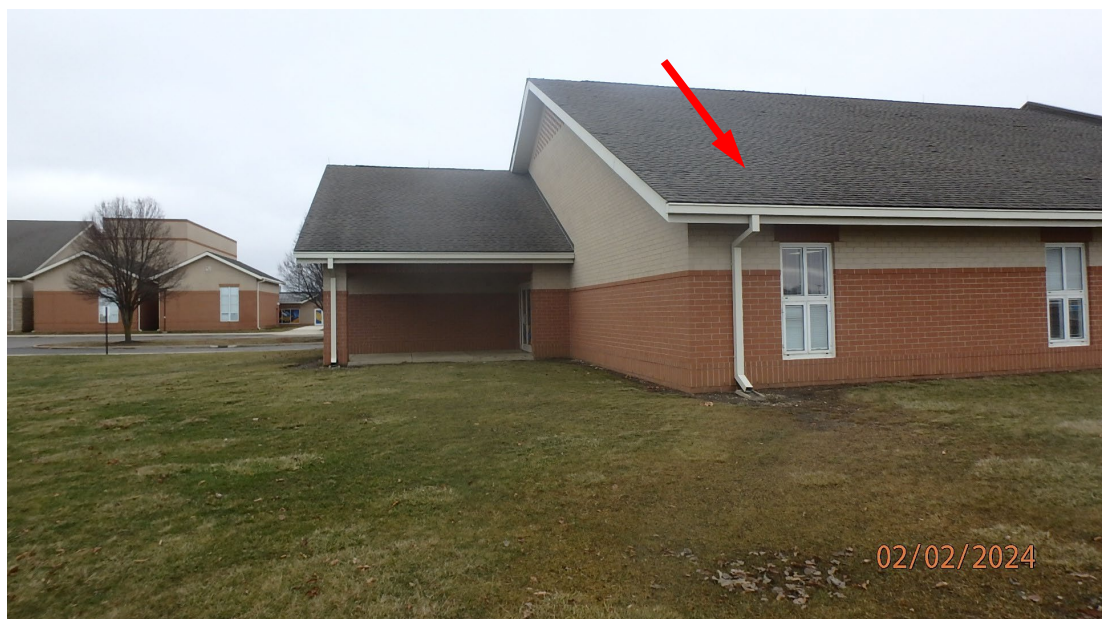
1.1.3.15 Overall view of Roof Area J2 there are numerous raised shingles on this roof area.

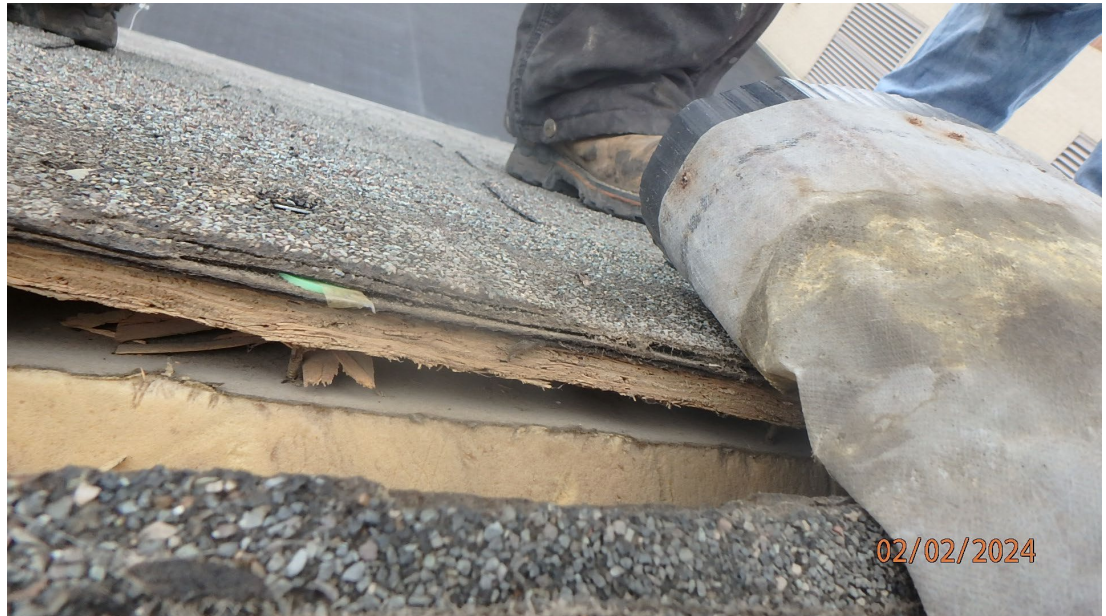
1.1.4.1 Overall view of the typical steep slope shingle roof area construction.

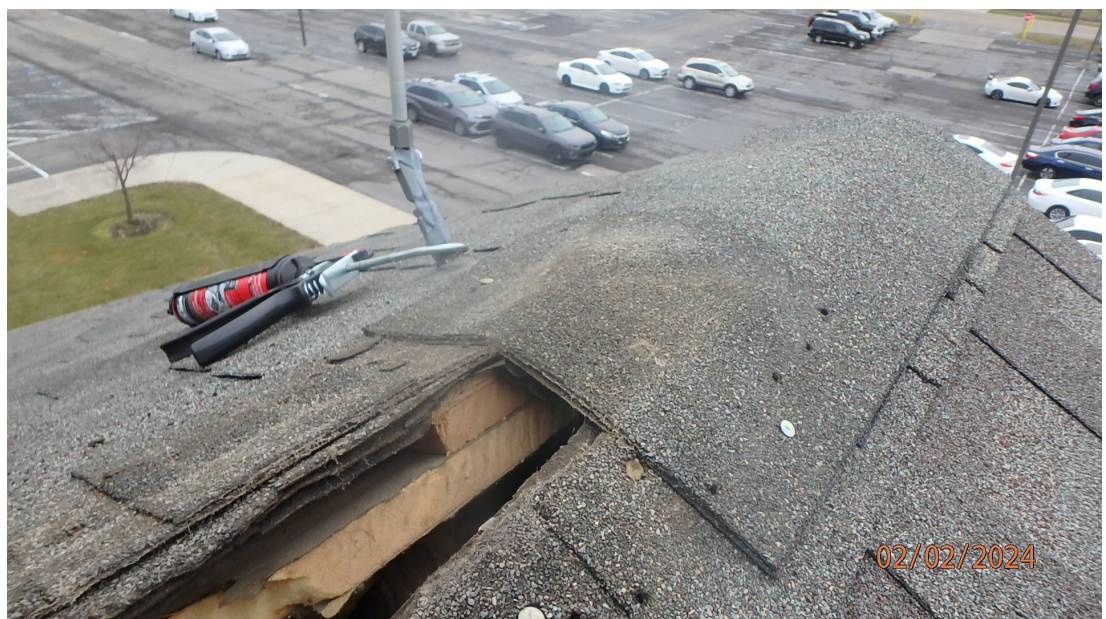
1.1.4.2 View showing that the rigid insulation was not tightly mitered together and there was no fiberglass batt insulation installed between the rigid insulation at the ridge on this building. There was a gap between the rigid insulation of approximately 6" at this location.

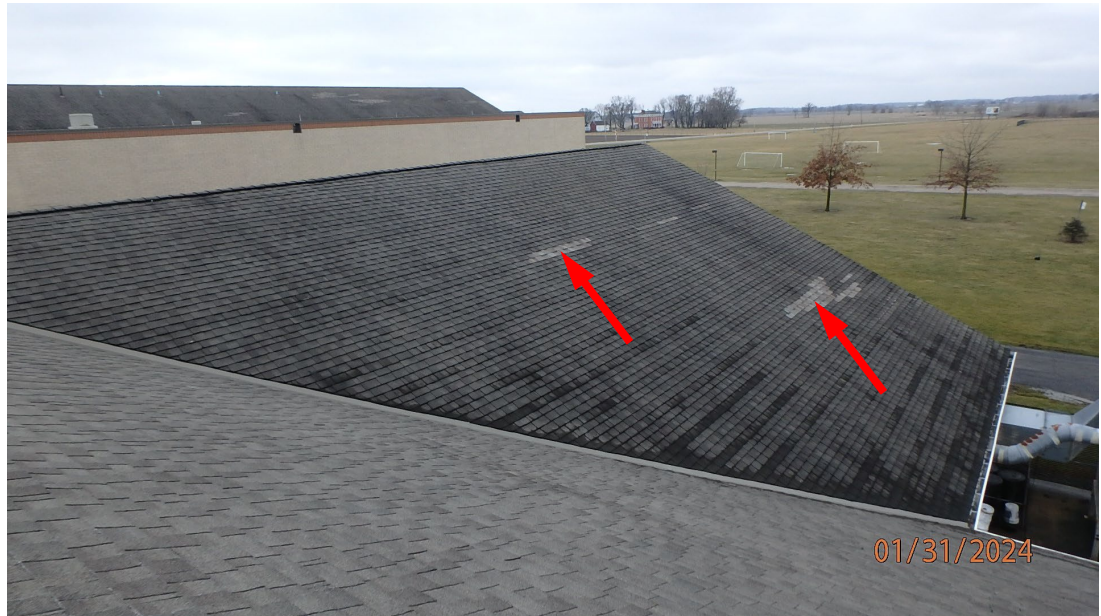
1.1.4.3 Overall view of Roof Area B3 where there has been shingle replacement due to shingles blowing off during high winds.

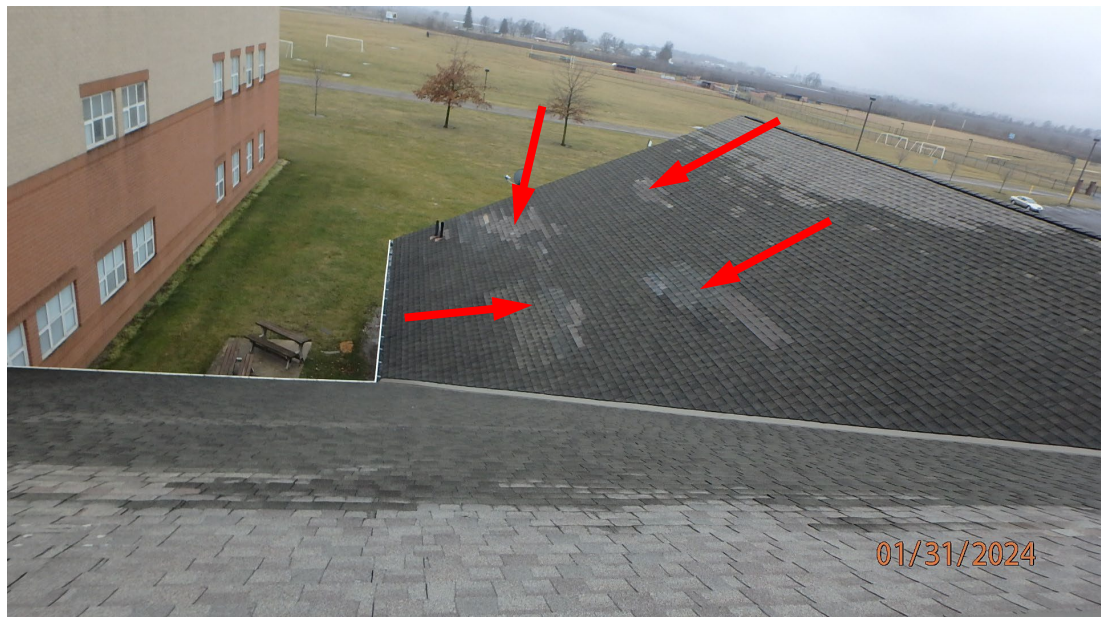
1.1.4.4 Overall view of Roof Area B4 where there has been significant shingle replacement due to shingles blowing off during high winds.

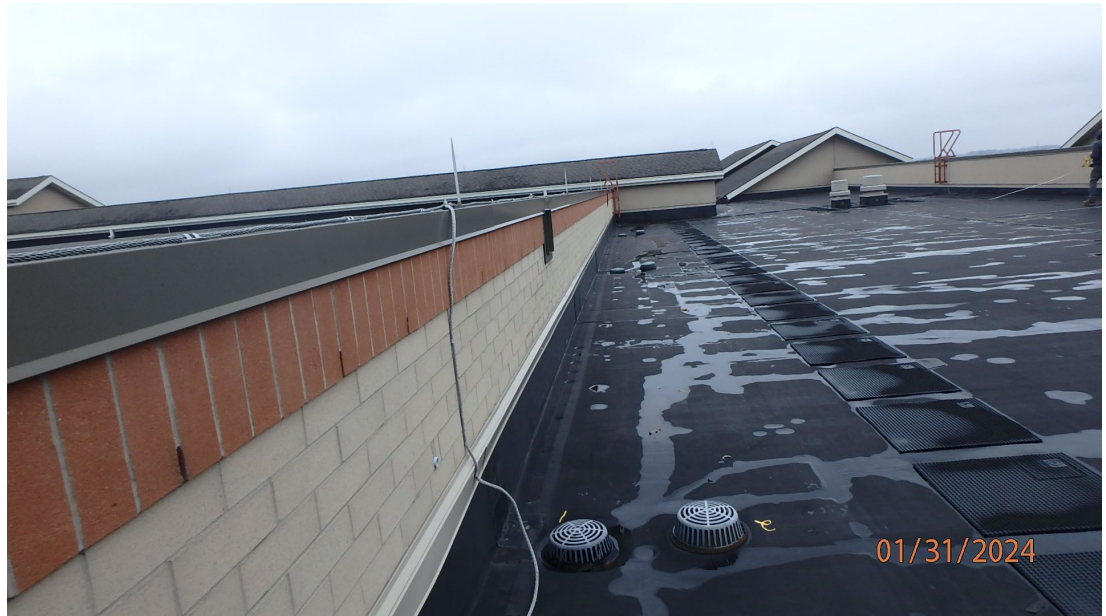
1.1.4.5 View of an area on Roof Area D2 showing there is no significant ponding on this roof area.

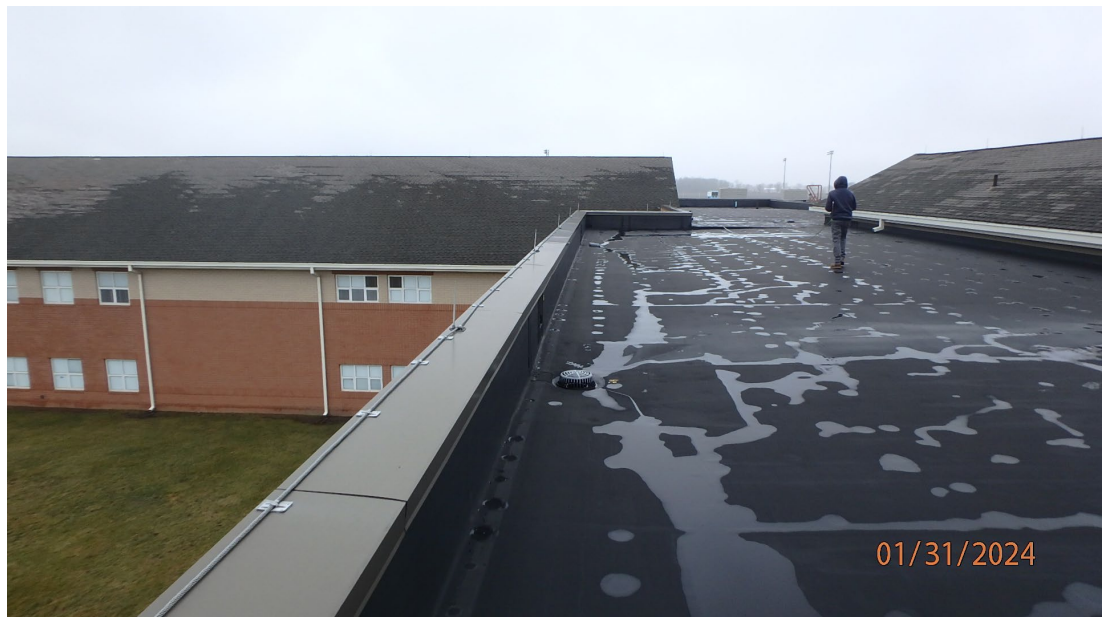
1.1.4.6 View of an area on Roof Area E showing there is no significant ponding on this roof area. Additional tapered insulation would be installed around the drains and larger crickets installed between the roof drains to improve the drainage.

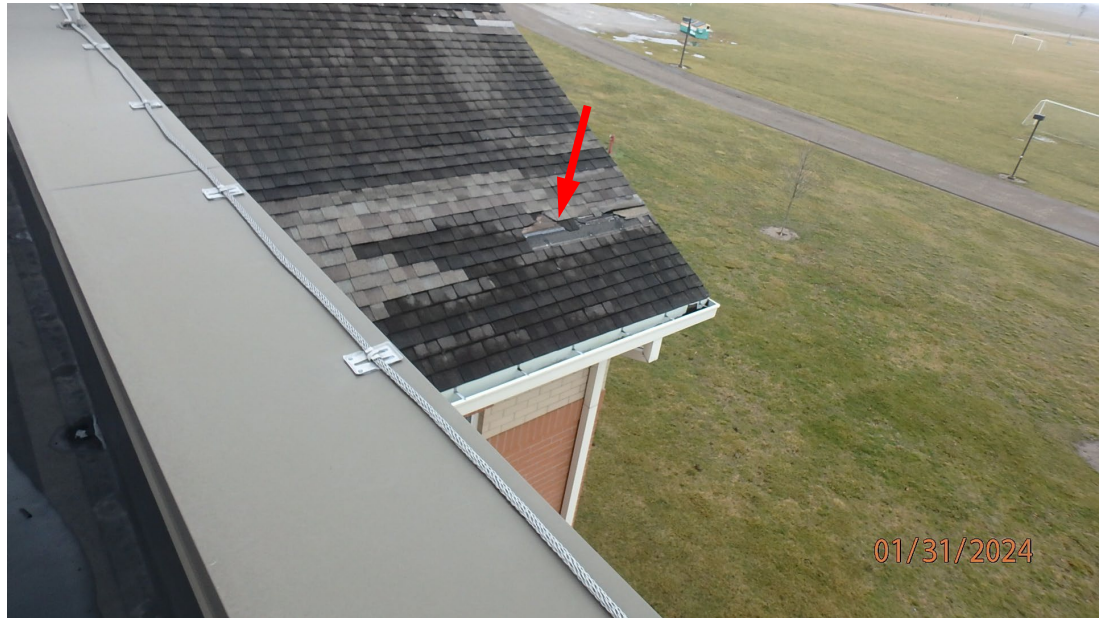
1.1.4.7 Overall view of Roof Area F1 where there has been shingle replacement due to shingles blowing off during high winds. There are currently additional shingles that have blown off and need to be replaced.

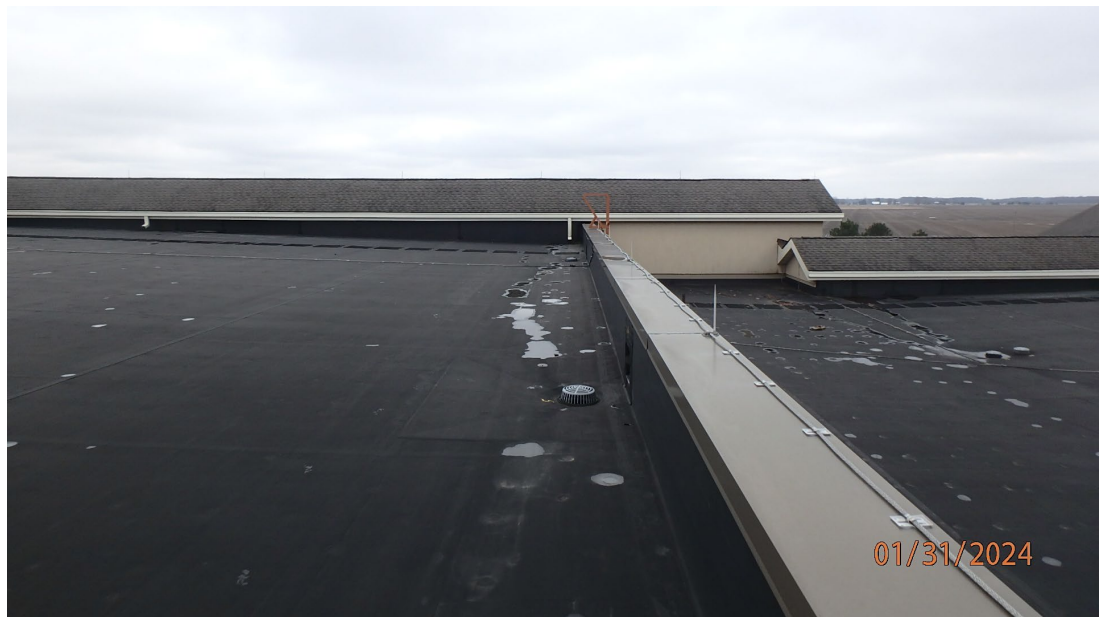
1.1.4.8 View of an area on Roof Area L showing there is no significant ponding on this roof area.

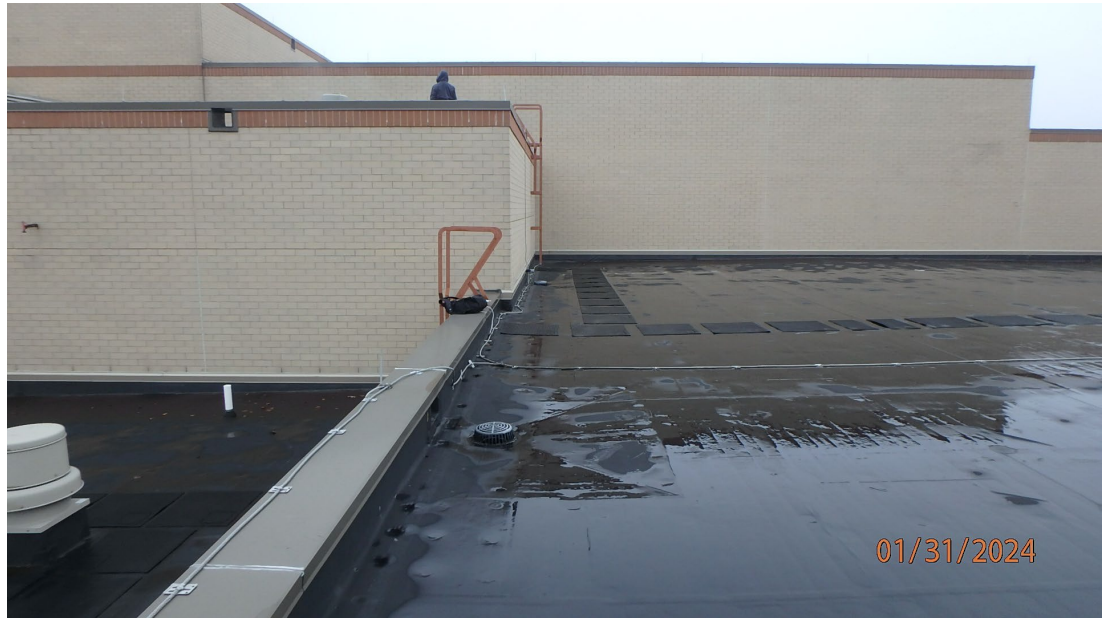
1.1.4.11 View of an area on Roof Area N showing there is no significant ponding on this roof area.

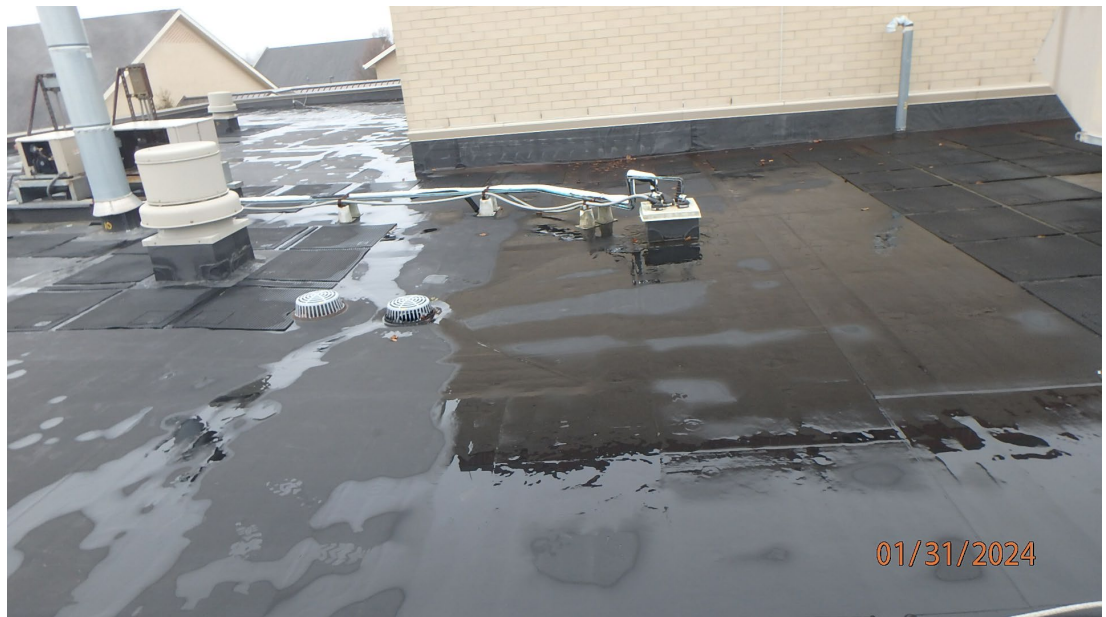
1.1.4.12 View of an area on Roof Area N showing there is no significant ponding on this roof area.

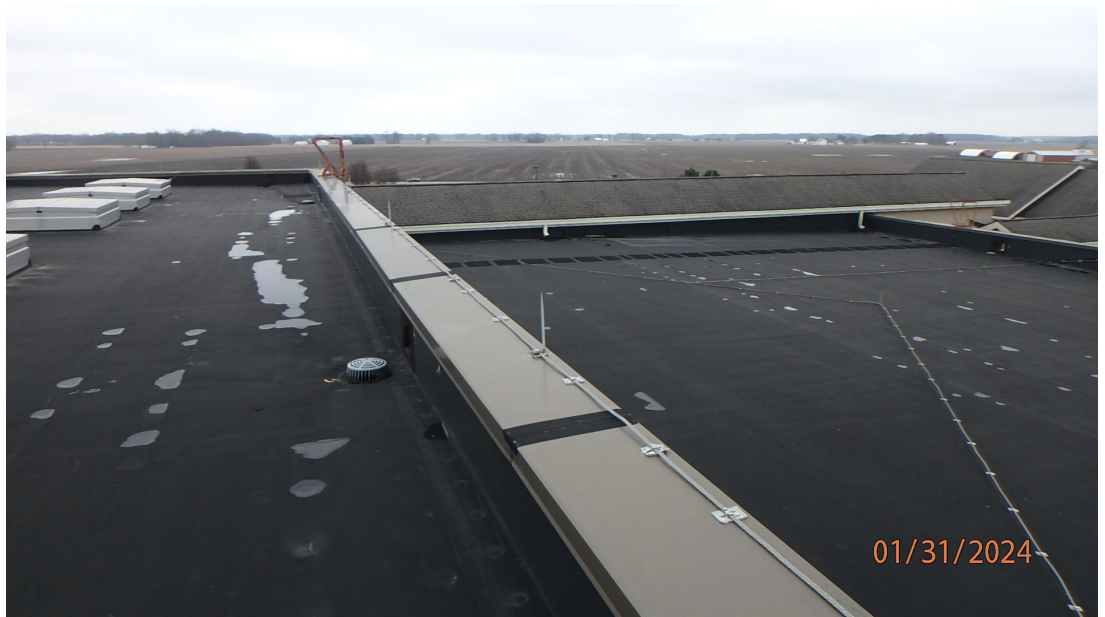
1.1.4.14 View of an area on Roof Area P showing there is no significant ponding on this roof area.
