PRELIMINARY ASSESSMENT  
RIVER VALLEY LOCAL SCHOOL DISTRICT  
ROOF REPLACEMENT PROJECT  
CALEDONIA, OHIO  
ISSUE DATE: 03-01-2024  
ROH50-001

Prepared by:  
Dan Lawrence, P.E., R.B.E.C.

**River Valley Local School District  
Roof Replacement  
Preliminary Assessment  
Caledonia, Ohio**

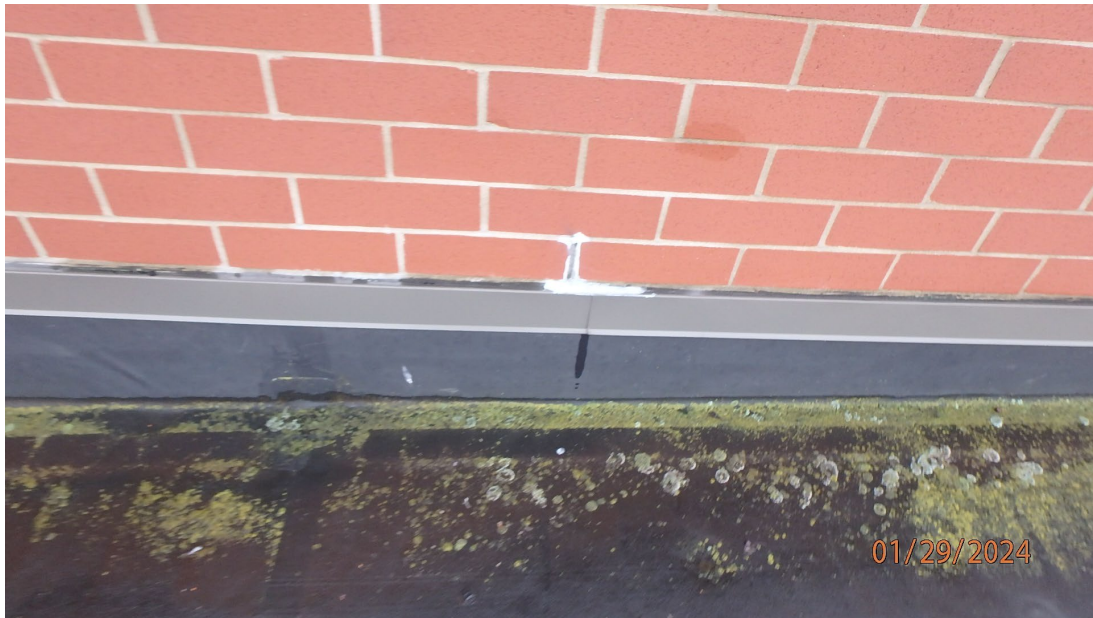
- 1.3.2 **Heritage Elementary** - View showing a sheet metal flashing has been installed at the masonry through wall flashing location, but it is not a 2-piece flashing that allows it to be removed to replace the roof base flashing. In addition, sealant has been installed (then removed) from the weeps.

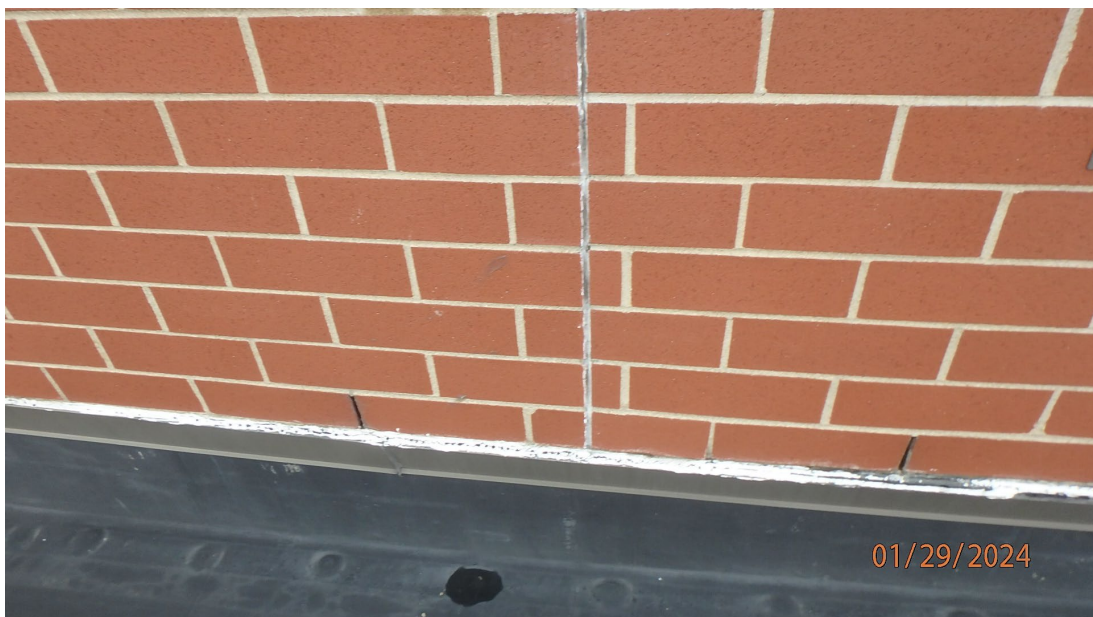
- 1.3.3 **Heritage Elementary** - View showing additional sealant has been applied to the joint between the sheet metal flashing and the brick masonry.

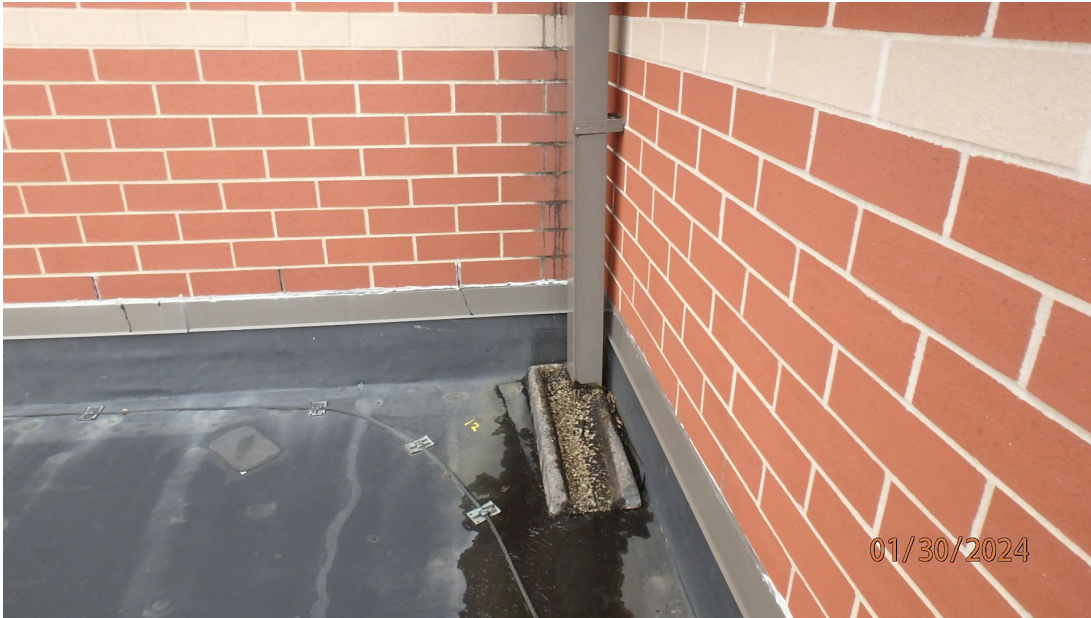
1.3.4 **Liberty Elementary** - View showing a sheet metal flashing has been installed at the masonry through wall flashing location, but it is not a 2-piece flashing that allows it to be removed to replace the roof base flashing.

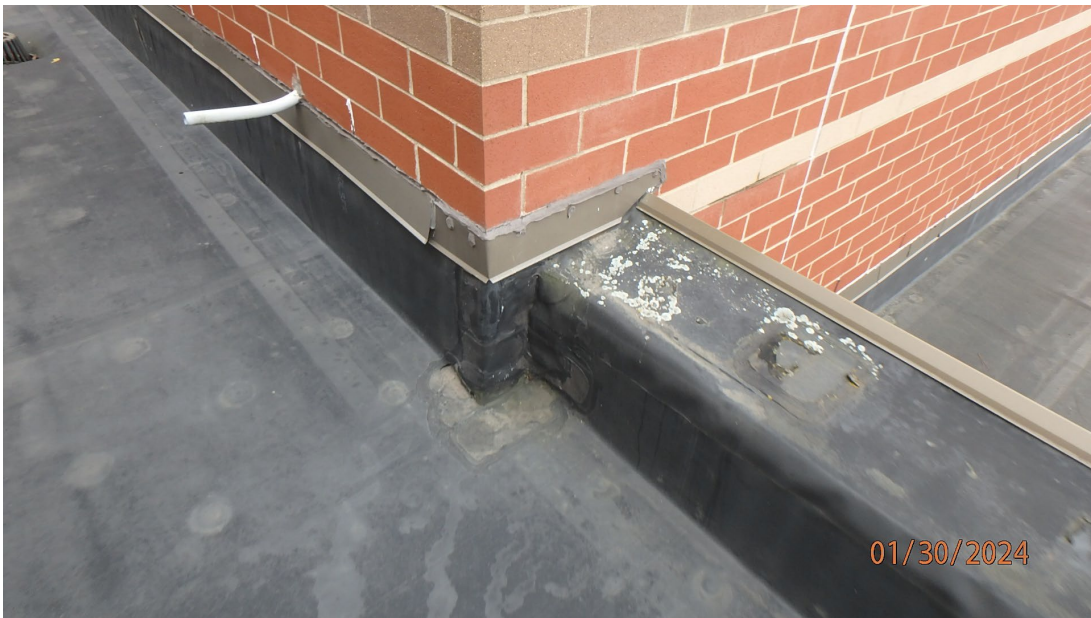
1.3.5 **Liberty Elementary** - View showing a sheet metal flashing has been installed at the masonry through wall flashing location, but it is not a 2-piece flashing that allows it to be removed to replace the roof base flashing.

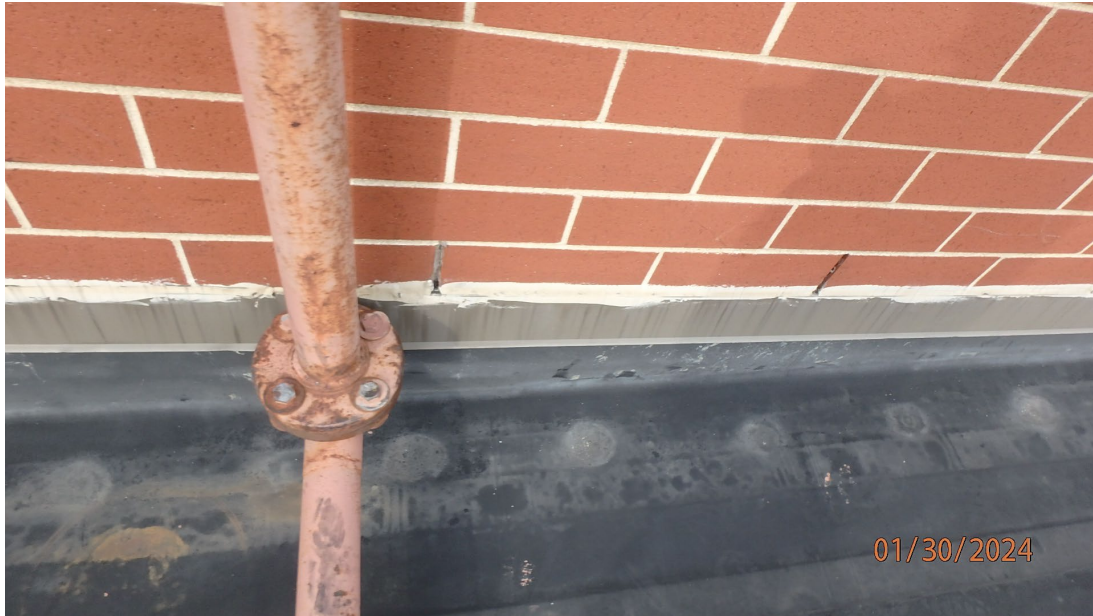
1.3.6 **Liberty Elementary** - View of an area where additional sealant has been installed between the sheet metal flashing and brick masonry.

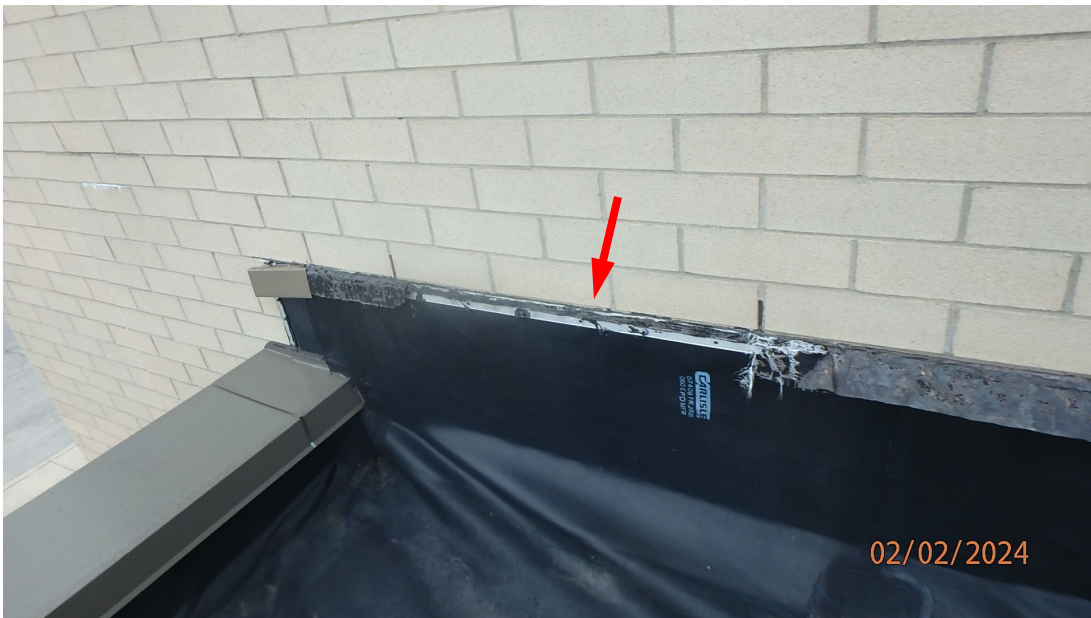
- 1.3.11 **River Valley Middle School** – View of a section where the outer portion of the masonry through wall flashing is missing.

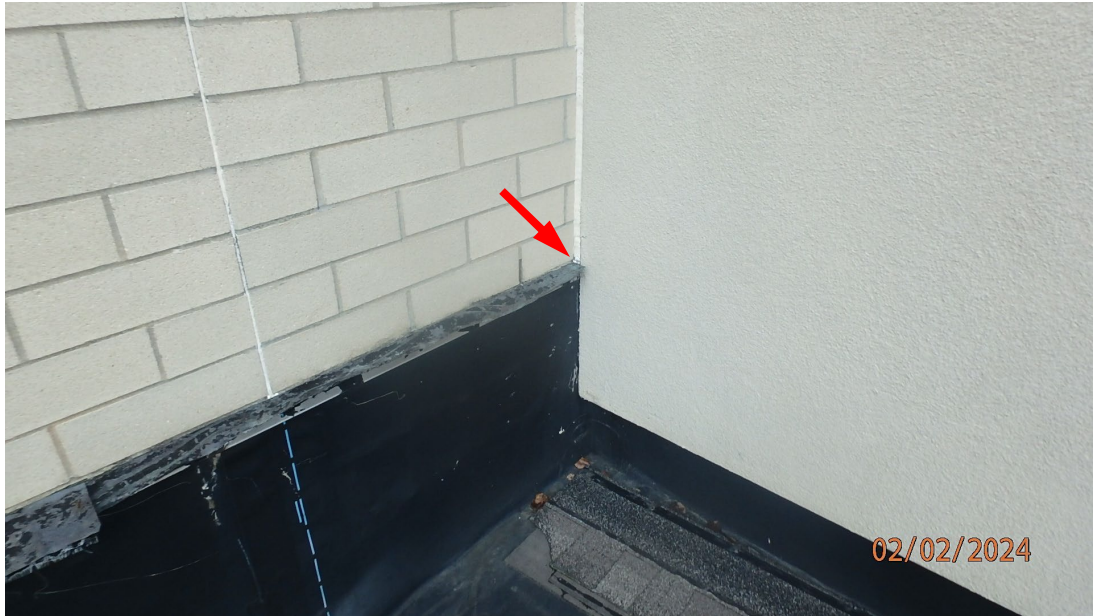
1.3.12 **River Valley Middle School** – View of a masonry through wall flashing that is terminated in the middle of a brick, so it cannot be properly end dammed.

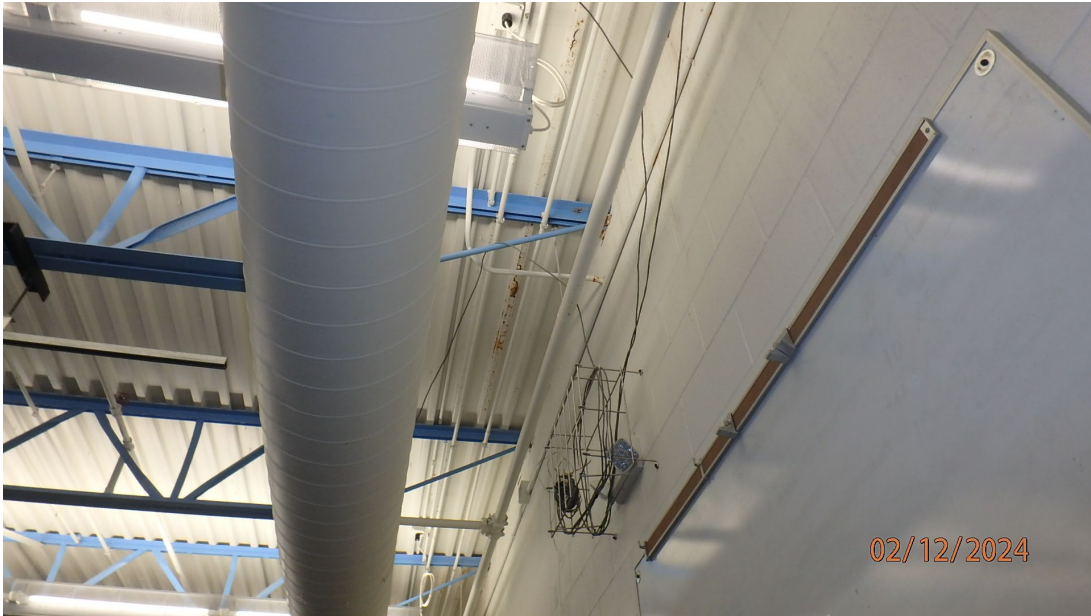
1.3.18 **River Valley High School** – View of severely deteriorated steel decking along the upper wall in the wrestling room. The wall extends above the roof and at this location, there is one (1) course of unflashed masonry between the roof counterflashing and the weeps.

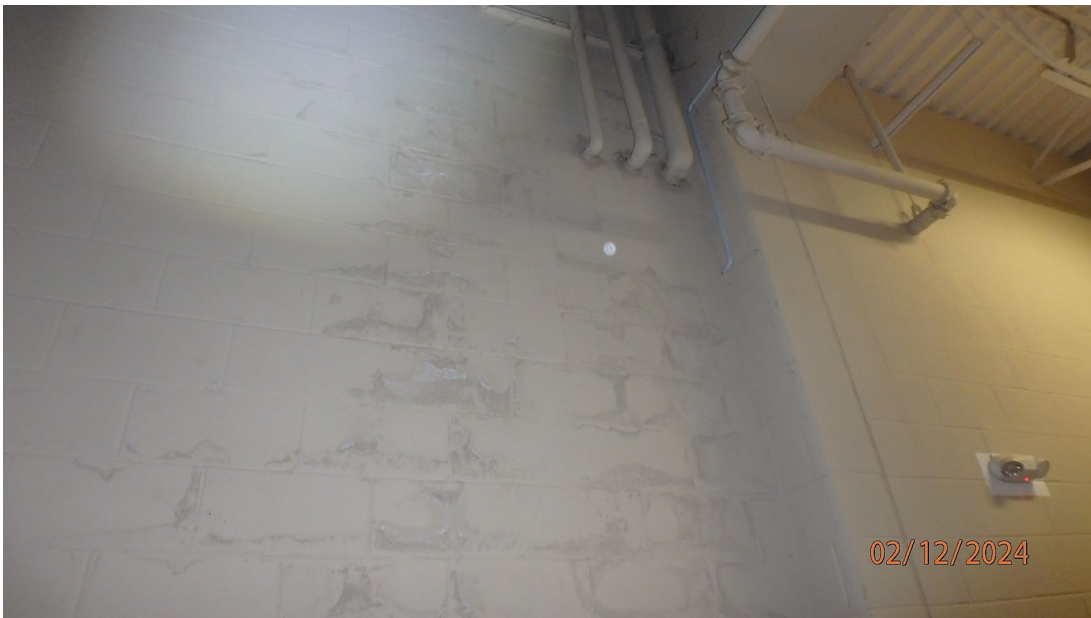
1.3.19 **River Valley High School** – View of an area at the rear of the stage where there is efflorescence in the masonry wall. Efflorescence is caused by moisture and this damage could be related to leakage at the masonry through wall flashing.

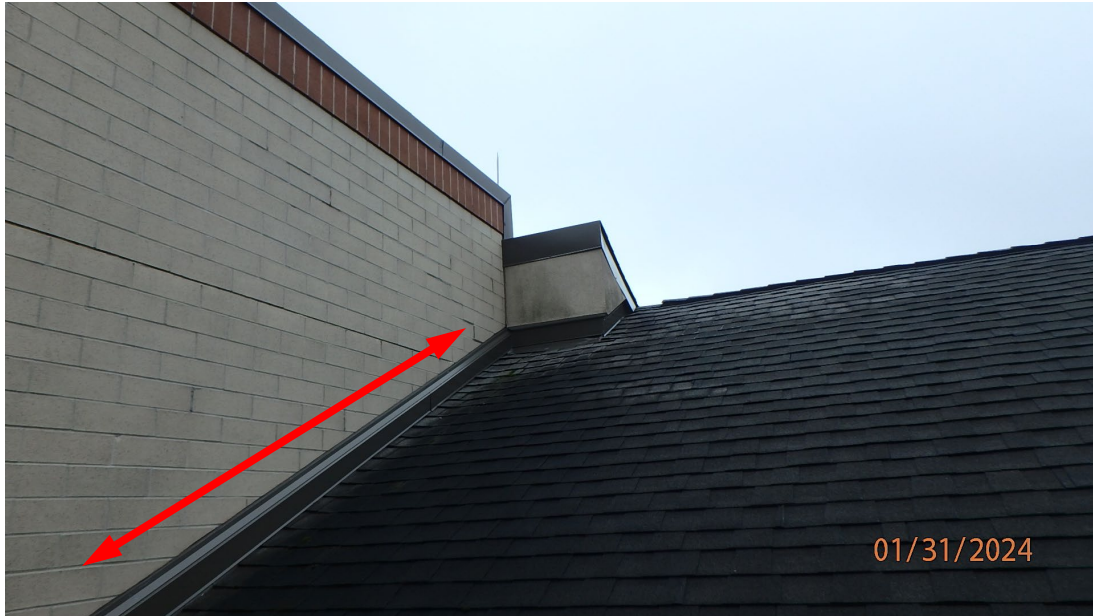
1.3.20 **River Valley High School** – View of an area where there is no apparent through wall flashing above the steep sloped roof area.

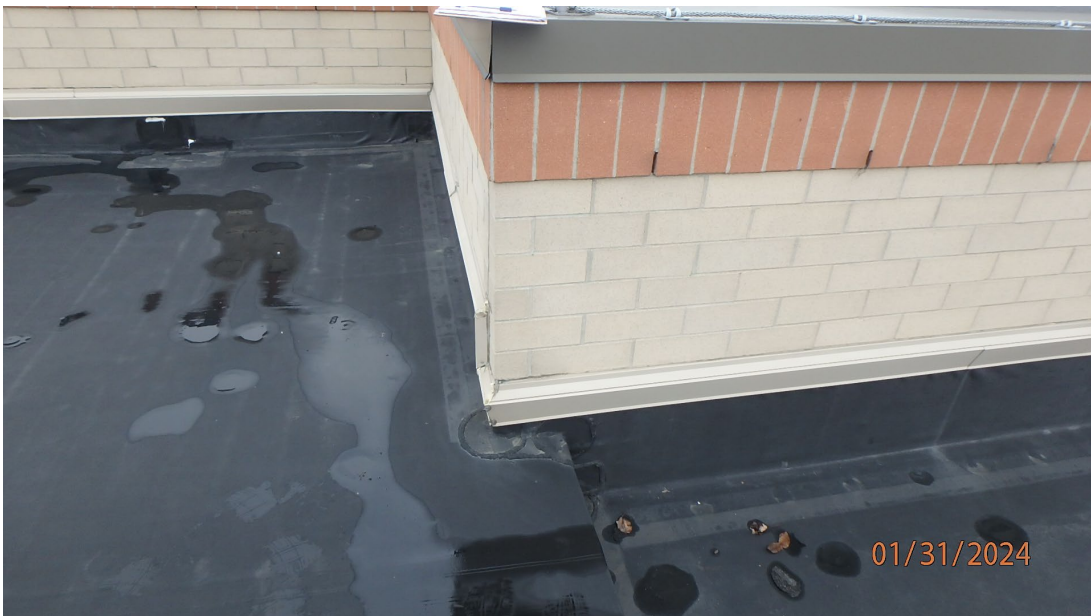
1.3.23 **River Valley High School** – View of an area where there are no weeps observed above the receiver.

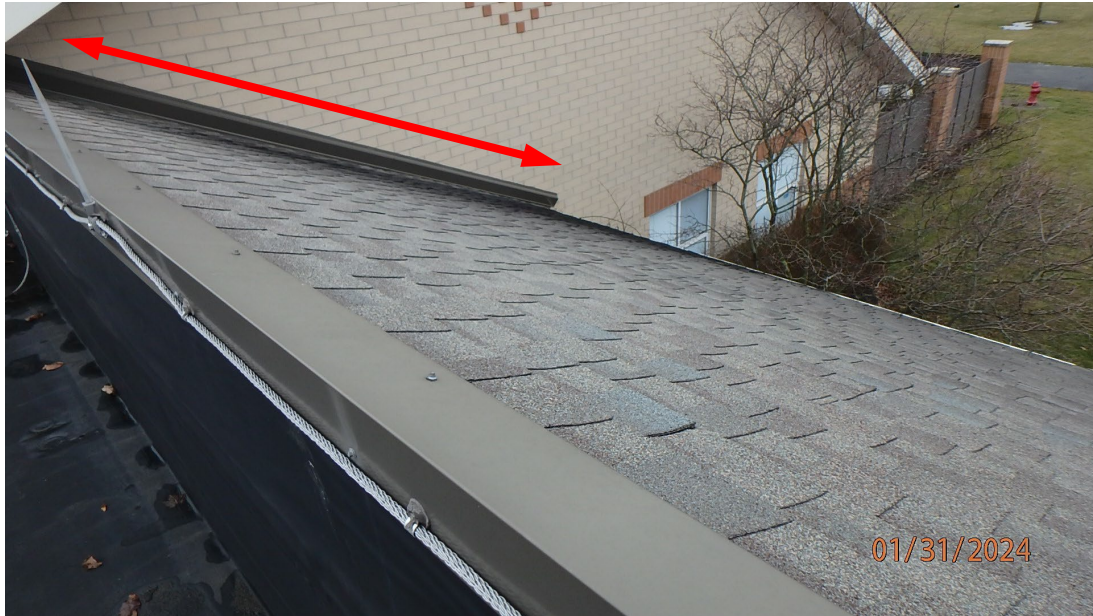
1.3.24 **River Valley High School** – View of another area where there is no apparent masonry through wall flashing above the steep sloped roof area.

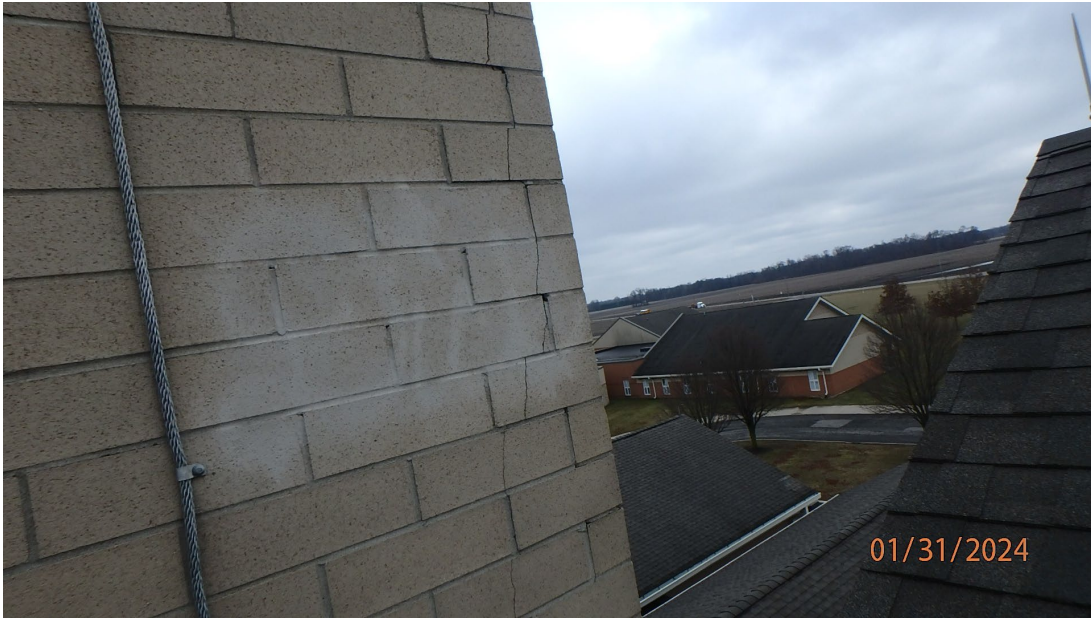
1.3.26 **River Valley High School** – View of crack observed in the masonry at an outside corner.

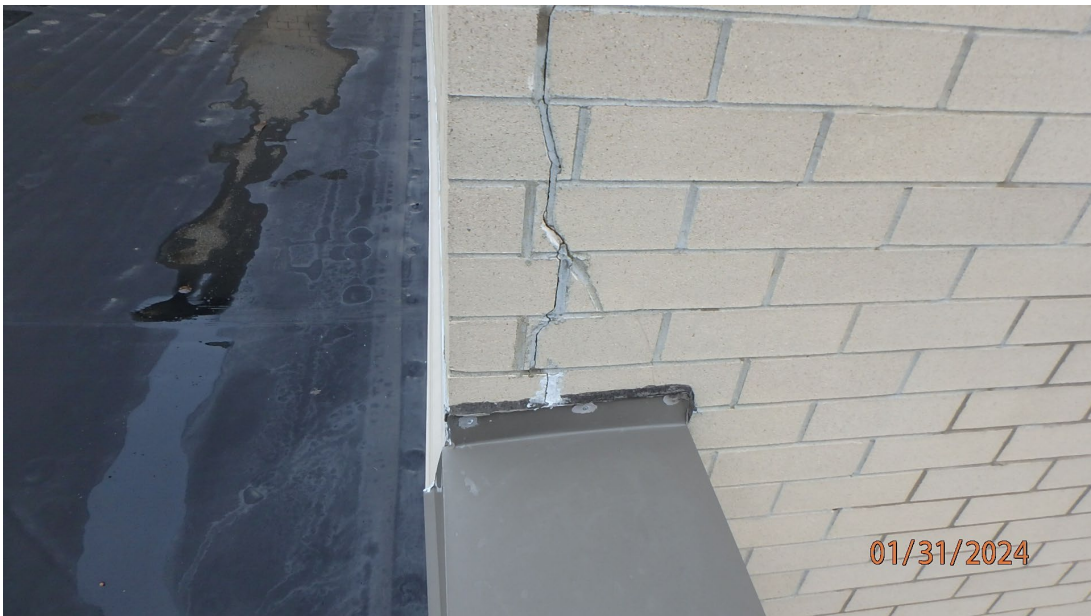
1.3.27 **River Valley High School** – View of crack in the masonry at another outside corner location.

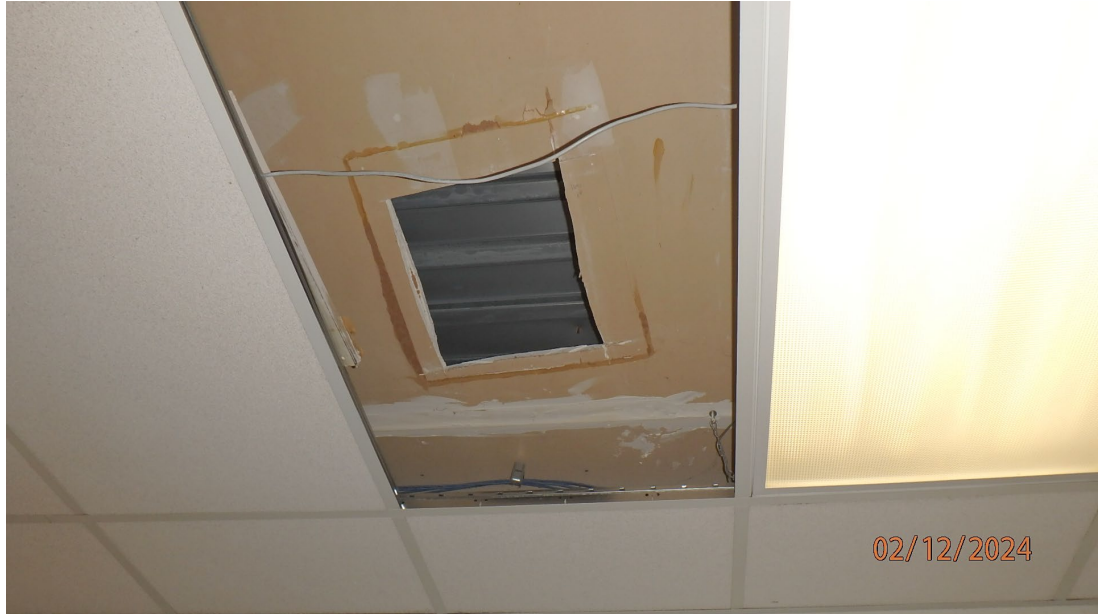
1.4.1.1 View of the construction above the drop ceiling at a classroom area. Drywall has been installed across the bottom of the cold-formed metal trusses. We removed a previously installed cover panel to see the eave detail.

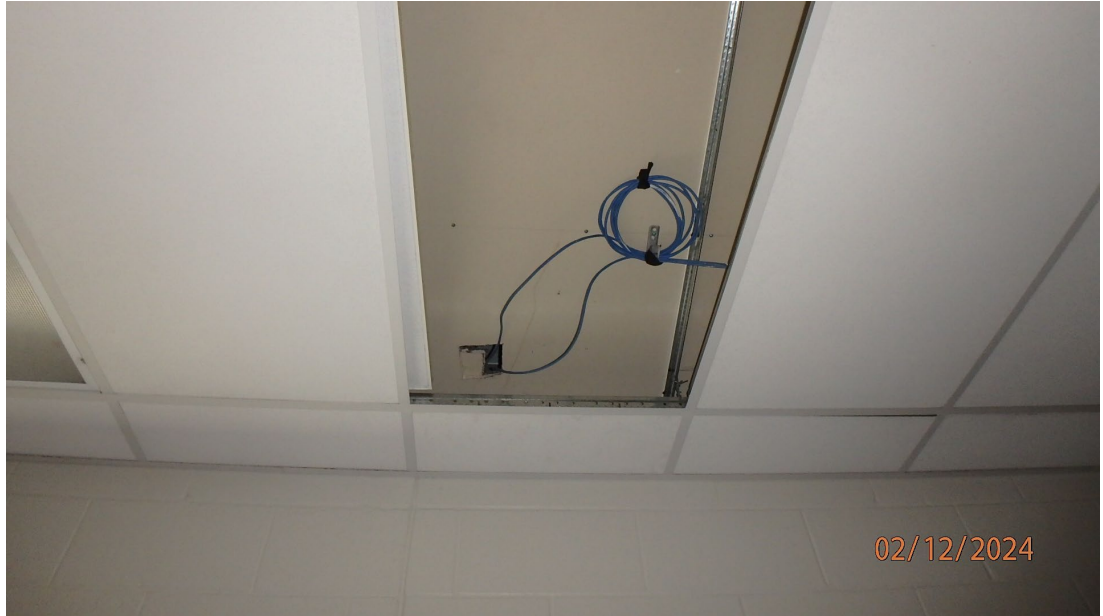
1.4.2.1 View of the construction above the drop ceiling at a classroom area. Drywall has been installed across the bottom of the cold-formed metal trusses.

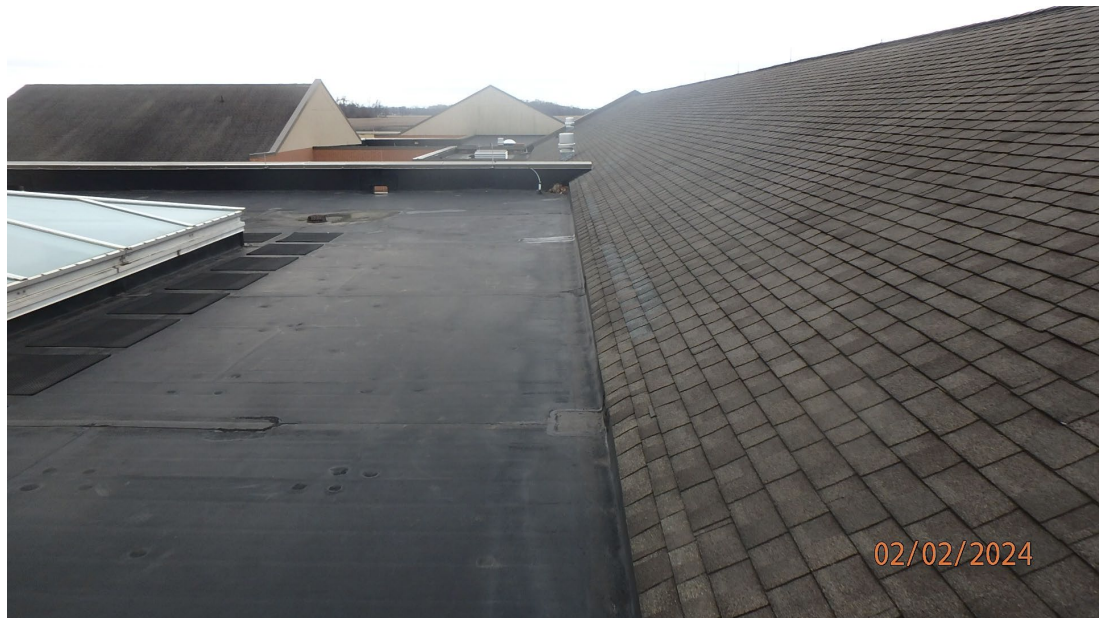
1.3.2.1 River Valley Middle School – View of an area where the steep slope roof directly ties into the low-sloped roof system.

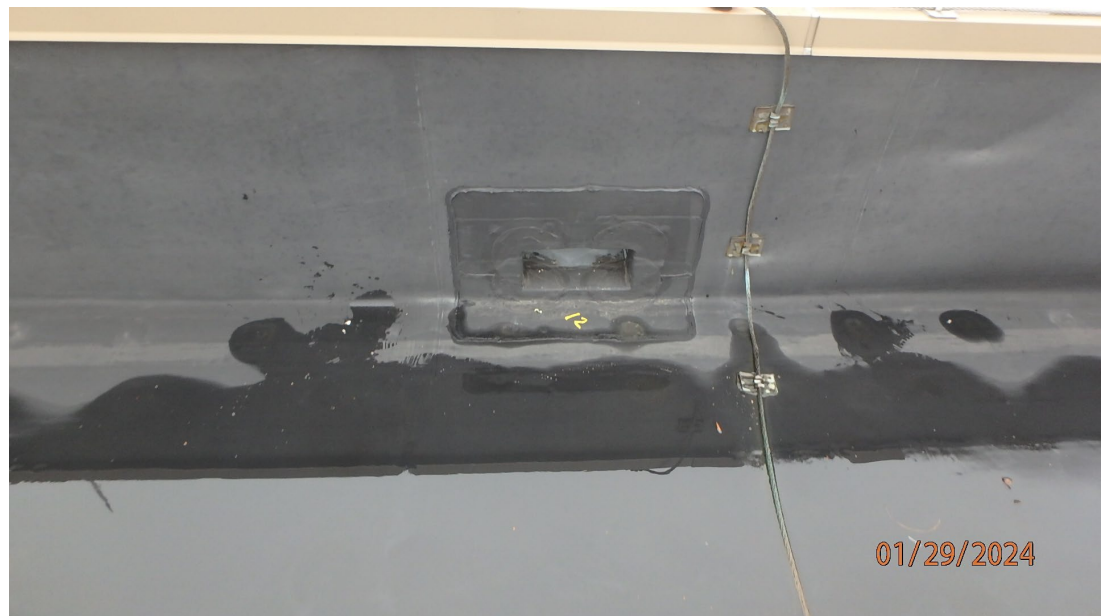
1.3.3.1 **Heritage Elementary** – View of roof overflow drainage scupper that may need to be modified slightly to accommodate the new roof system.

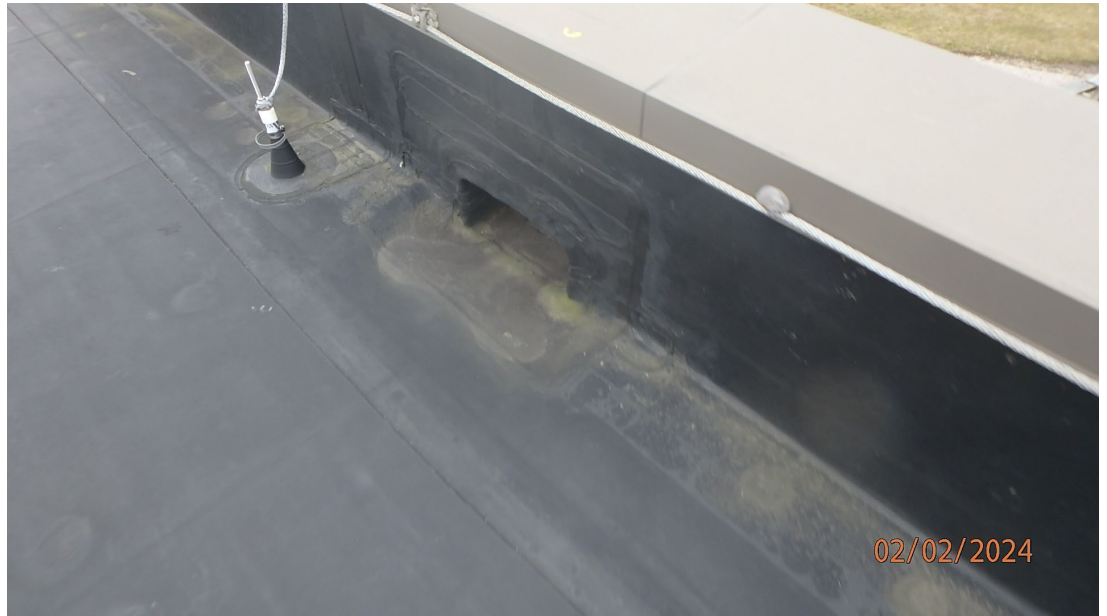
1.3.3.2 **River Valley Middle School** – View of a roof overflow drainage scupper that will need to be modified to accommodate the new roof system.

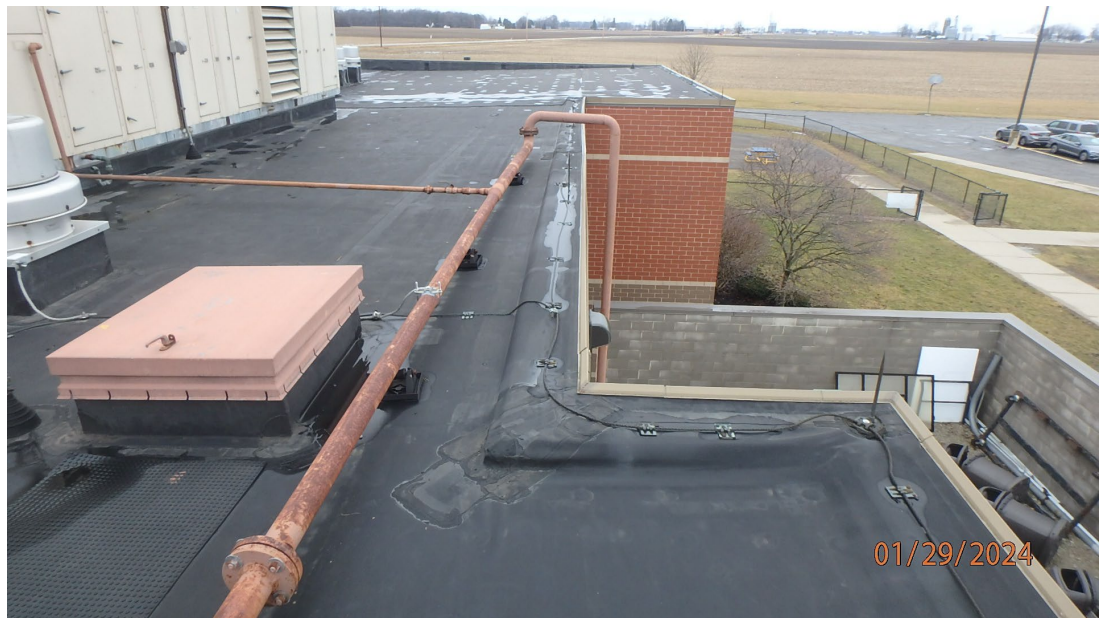
1.3.4.1 **Heritage Elementary** – View of a typical gas line where a hanger type support will need to be utilized so that the gas line does not need to be modified.

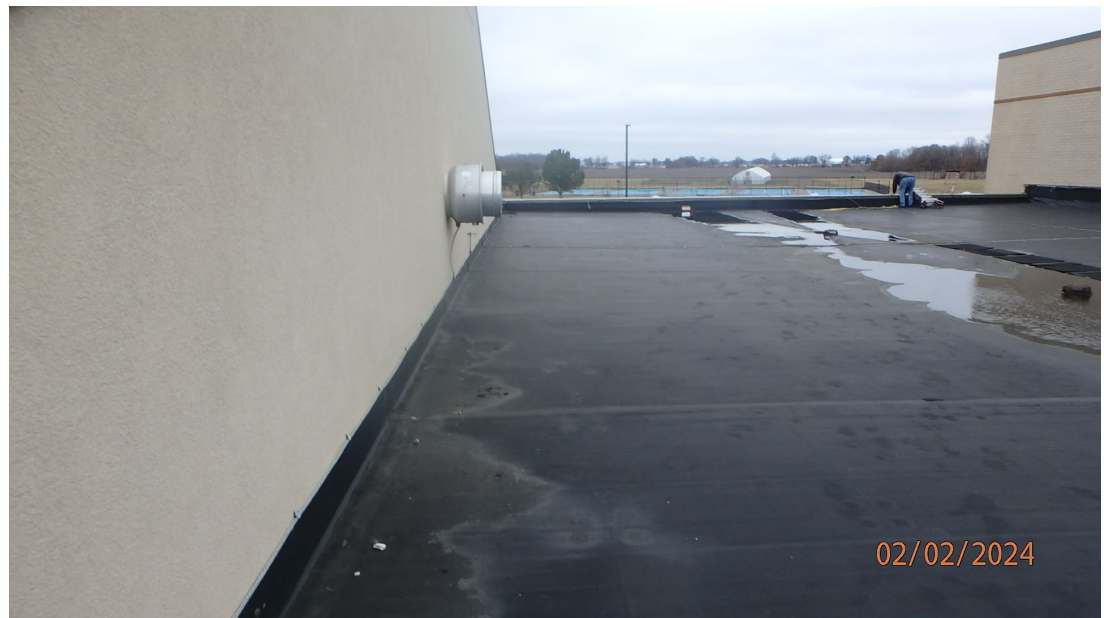
1.3.5.1 **River Valley Middle School** – View of an area where there is EIFS above the low-sloped roof system. The existing roof base flashing may be high enough that the EIFS does not need to be modified in this area.

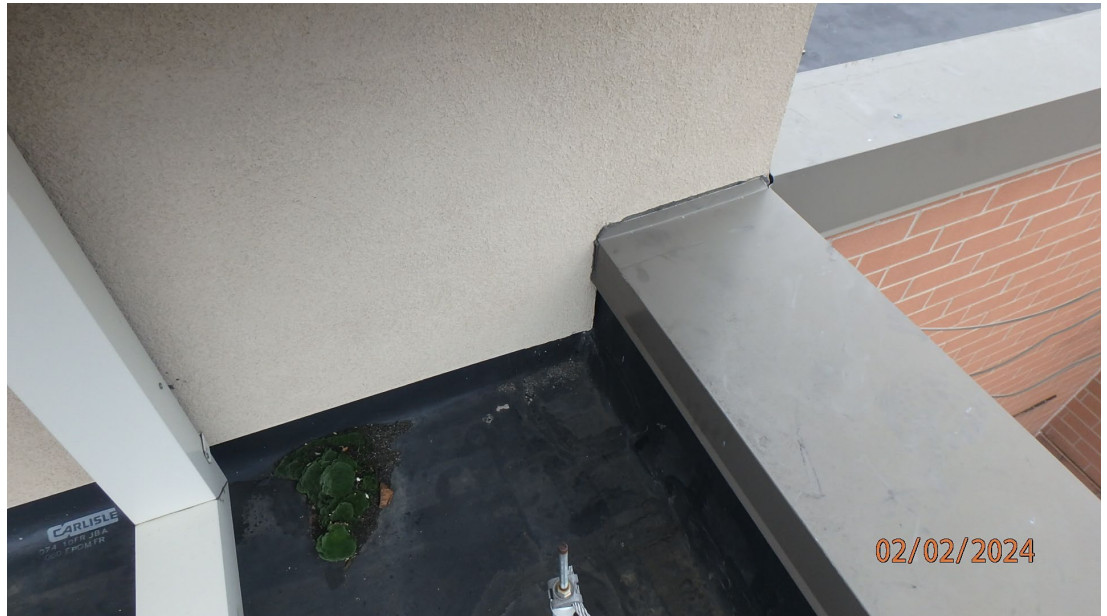
1.3.5.2 **River Valley Middle School** – View of an area where the EIFS will need to be modified so that a watertight transition can be provided at the coping cap. In addition, the base flashing height may need to be raised to accommodate the new roof system.

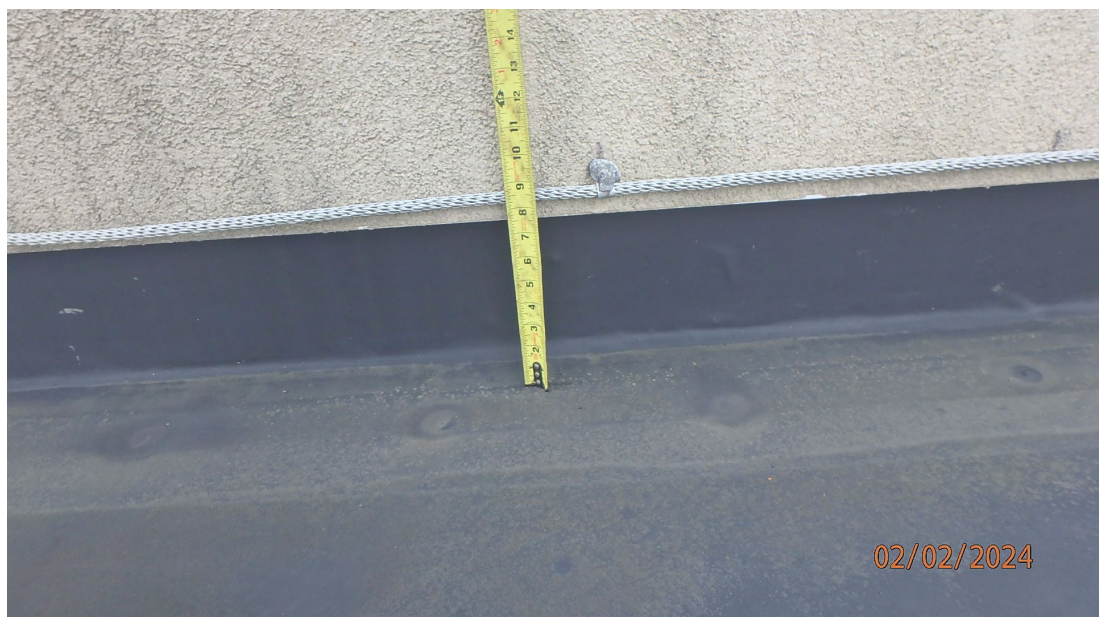
1.3.5.3 **River Valley Middle School** – View of an area where the EIFS will need to be modified in order to accommodate the height of the new roof system.

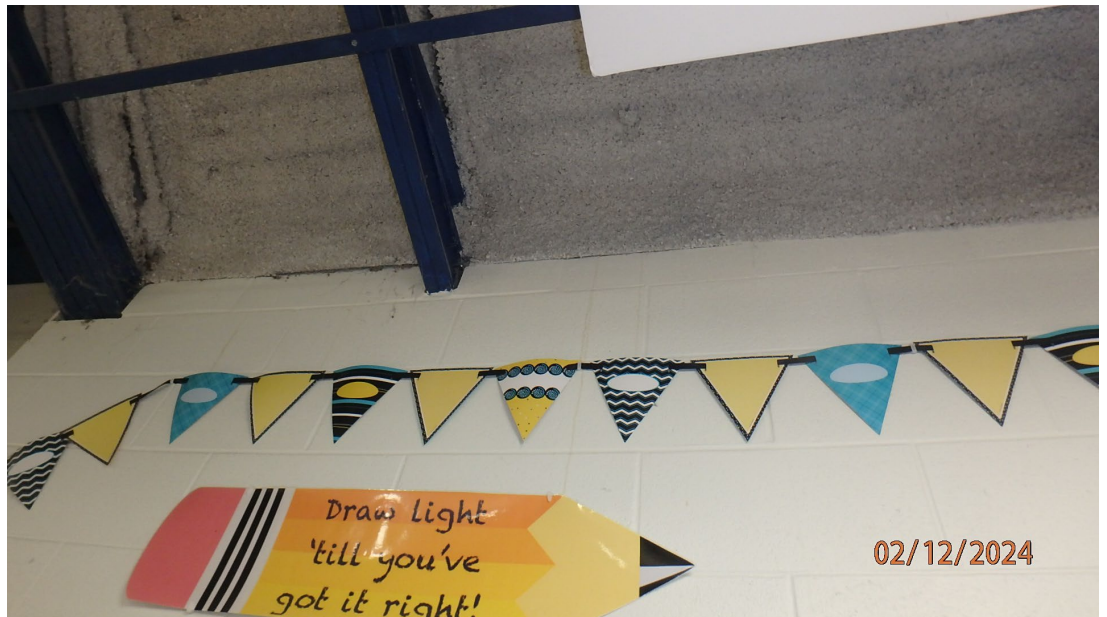
1.3.6.1 River Valley High School - View of the K-13 insulation installed on the bottom of the roof deck in Room 100.

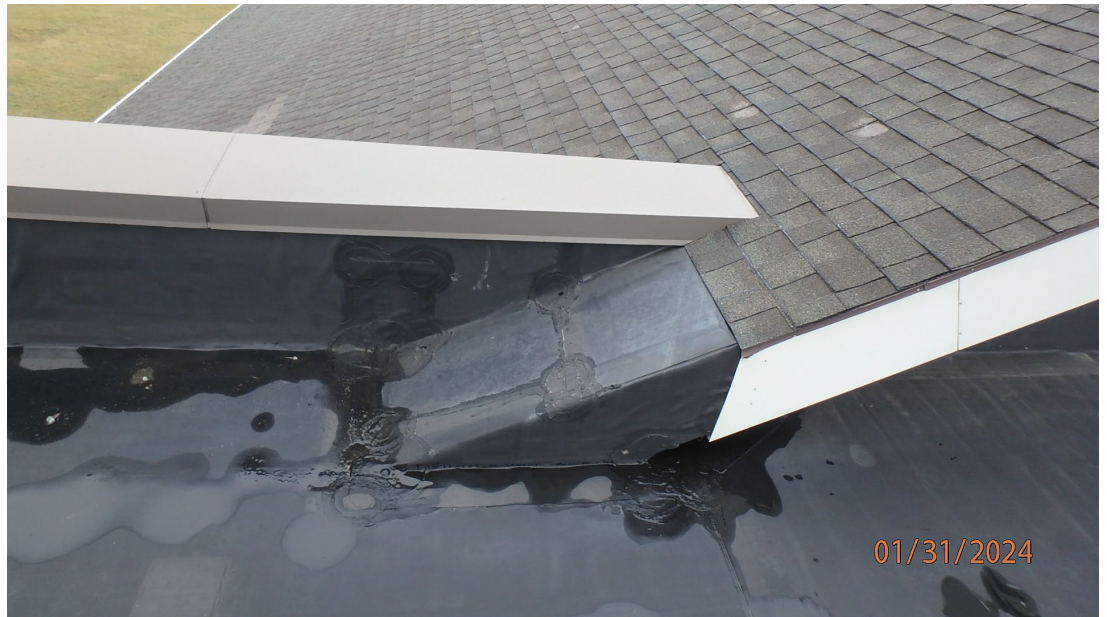
- 1.3.7.1 **River Valley High School** – There are some special detail conditions where the steep slope and low-sloped roof system intersect.

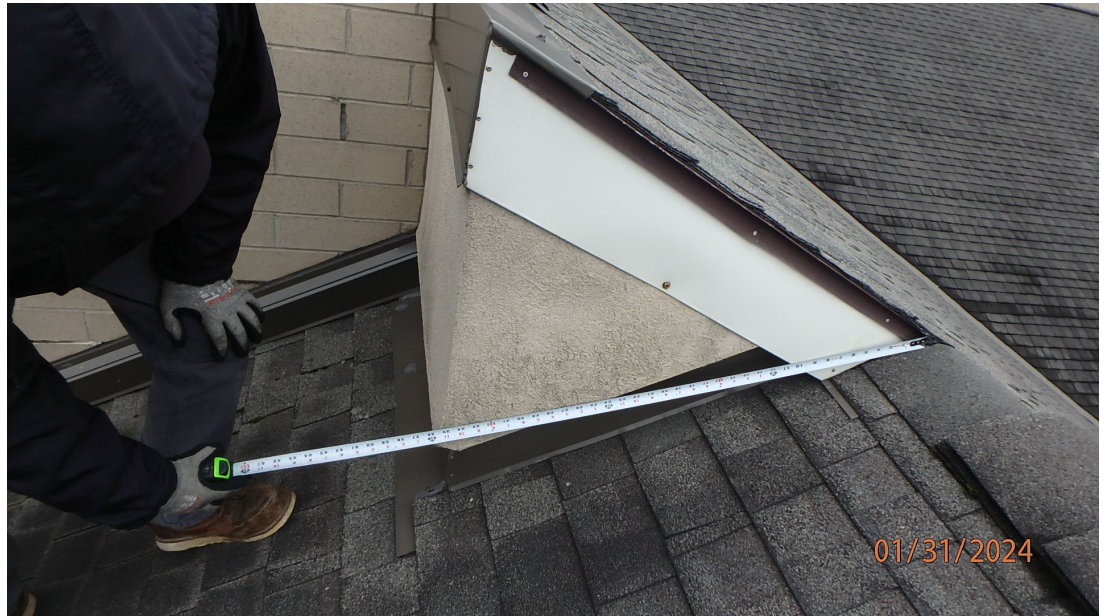
1.3.7.2 **River Valley High School** – View of a non-typical detail within the steep sloped roof system.

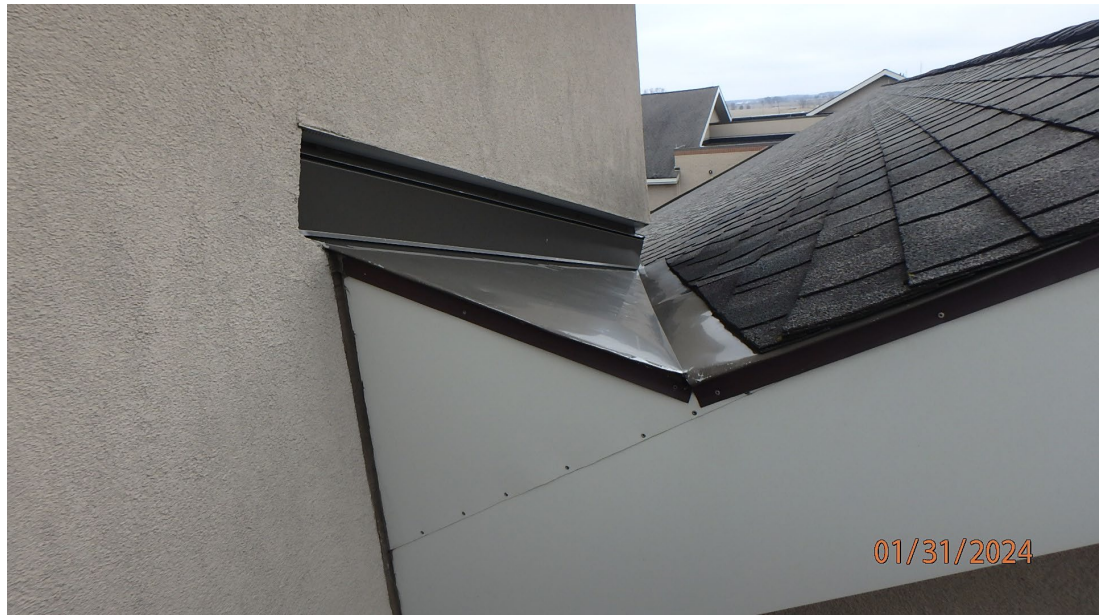
1.3.7.3 **River Valley High School** – View of a non-typical detail within the steep sloped roof system.
