## 6 | Easterly Parkway Elementary School

<b>Address:</b>	234 Easterly Parkway State College, PA 16801
<b>Construction Timeline:</b>	Originally constructed in 1955; renovation/addition in 2002.
<b>Building Square Footage:</b>	55,895 sf
<b>Site Acreage:</b>	11.4 acres

Easterly Parkway Elementary School is a 2-story building located in State College Boro, State College, PA. The school currently houses grades K-5. The property is served by public water, sewer and natural gas.

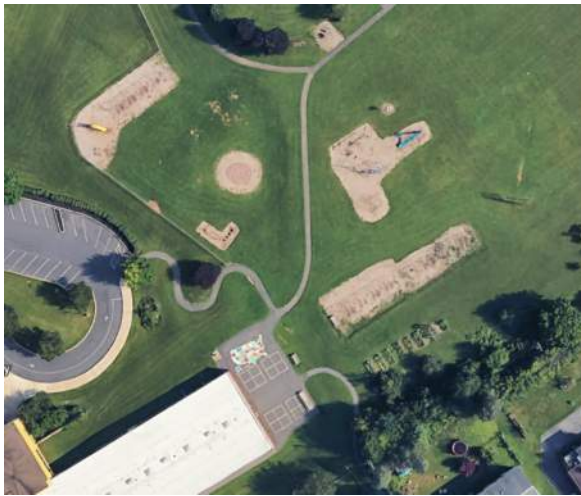
The site has two hard-surface play areas, including one with a basketball court. All are in good condition. The site also has multiple soft-surface play areas with play equipment. These are surfaced in loose wood chips. There are also large expanses of grassy areas. All play areas are well separated from vehicular traffic.

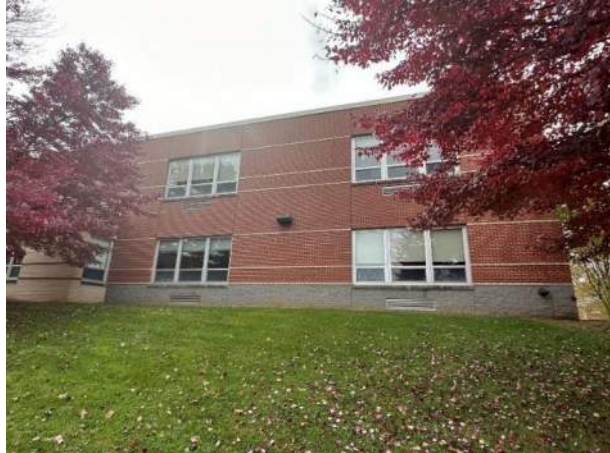
The building exterior consists of insulated masonry cavity walls with various brick and CMU veneers and CMU backup. Masonry walls are in very good condition with plenty of control joints located throughout the building envelope. There is some staining on the face brick below overflow scuppers where downspouts were not provided to collect the water. Windowsills are cast stone and in good condition, however some of the sills are becoming stained. Portions of the building are clad in various colors of corrugated metal wall panels as well as precast wall panels.

- General cleaning of brick veneer, cast stone sills, and precast and metal wall panel systems. May want to consider painting of metal wall panels where colors are beginning to fade or eventual replacement.. At precast wall panels, tuck point joints between panels and caulk.
- Metal column covers are beginning to deteriorate at the base where water tends to settle and wear through the paint finish. Consider patching column bases and re-painting.
- Monitor caulking at control joints and replace with any new building project.

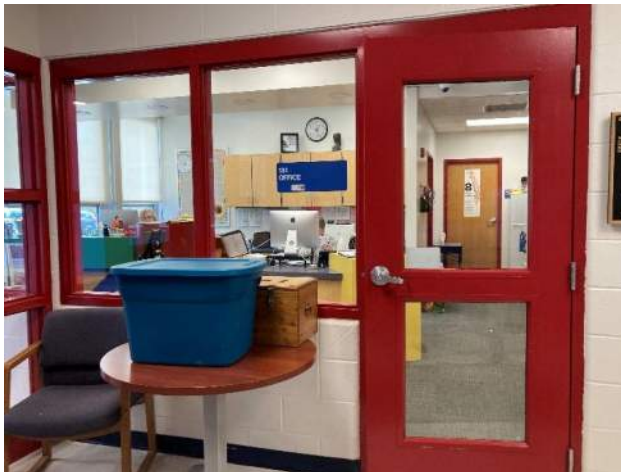
Interior doors are solid core wood and painted hollow metal in painted hollow metal frames and are in good condition. Interior aluminum doors and side lights are also in good condition.

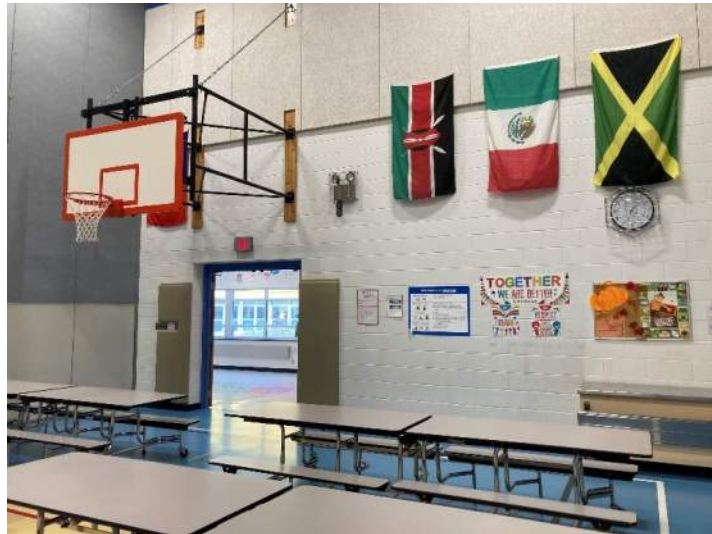
Gymnasium equipment in the multi-purpose room consists of retractable, ceiling-hung and wall-hung basketball backstops. There is also a folding partition that separates the room into 2 teaching stations. Acoustical wall panels are mounted high on the walls of the multi-purpose room to help with the acoustical performance of the room. All are in good condition. The stage curtain and lighting are original to the building and are assumed to have been replaced in 2002, they are also in good condition.

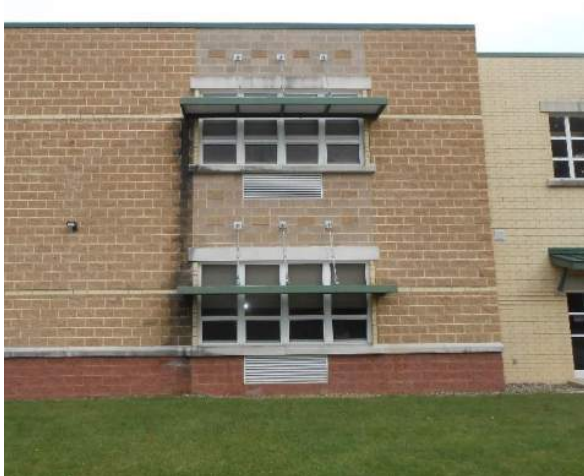
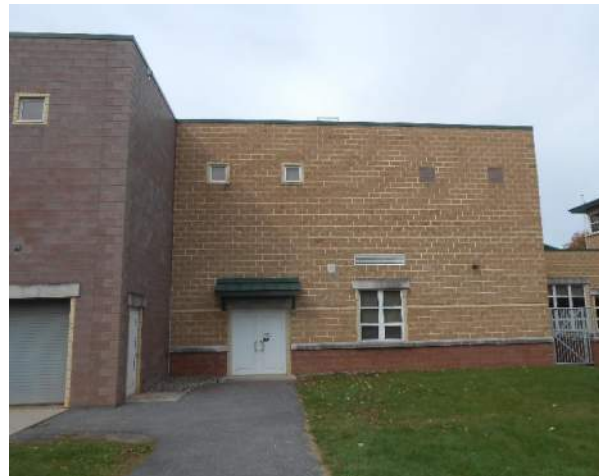
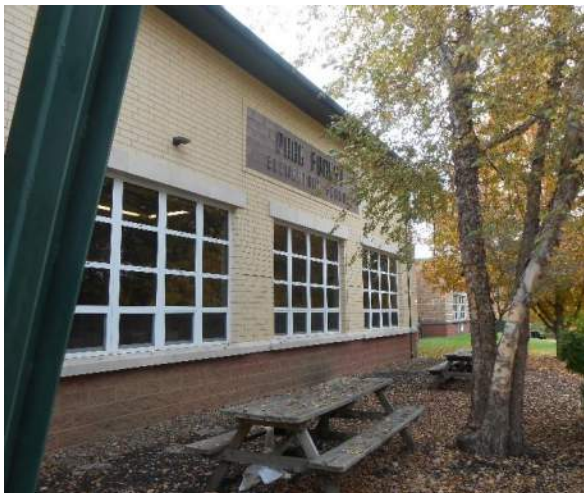
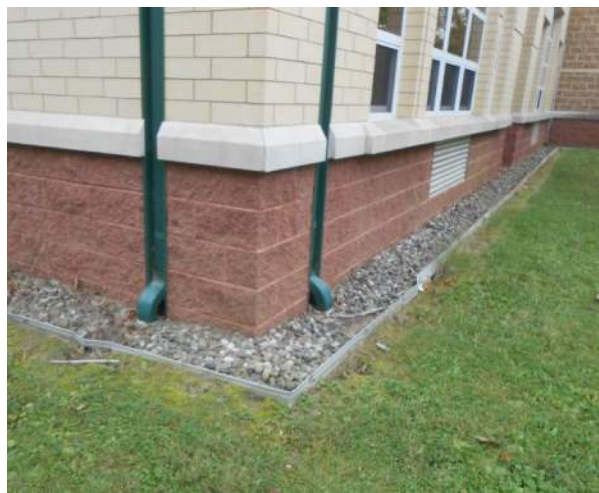
The building exterior consists of insulated masonry cavity walls with brick veneer or split face CMU at select locations and CMU backup. Window stools and headers are cast stone and in good condition. In some areas the stools and headers are darkened and stained. There is significant staining and efflorescence along some of the split face CMU along the 2-story wing, which appears to be caused by the exterior window shade devices.

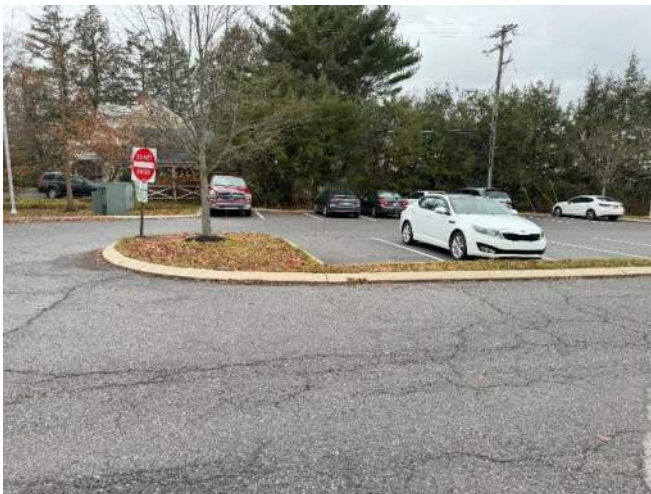
Some of the concrete walks are aging and starting to show signs of wear and tear, in that the aggregate (in the concrete) is beginning to show through to the outside surface. The concrete is also stained in many places. Cracking is occurring on some of the paved surfaces.

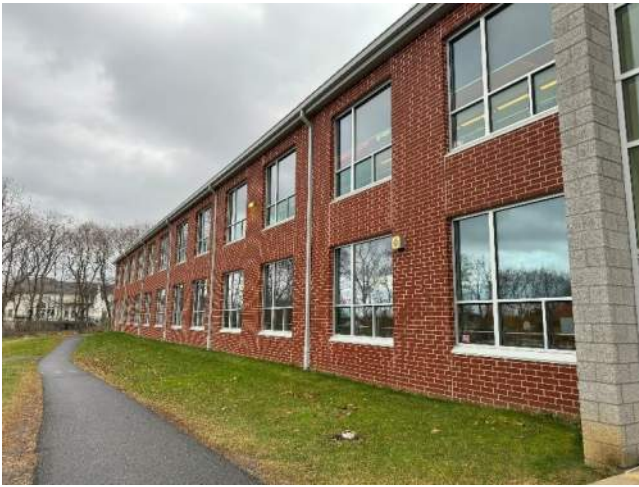
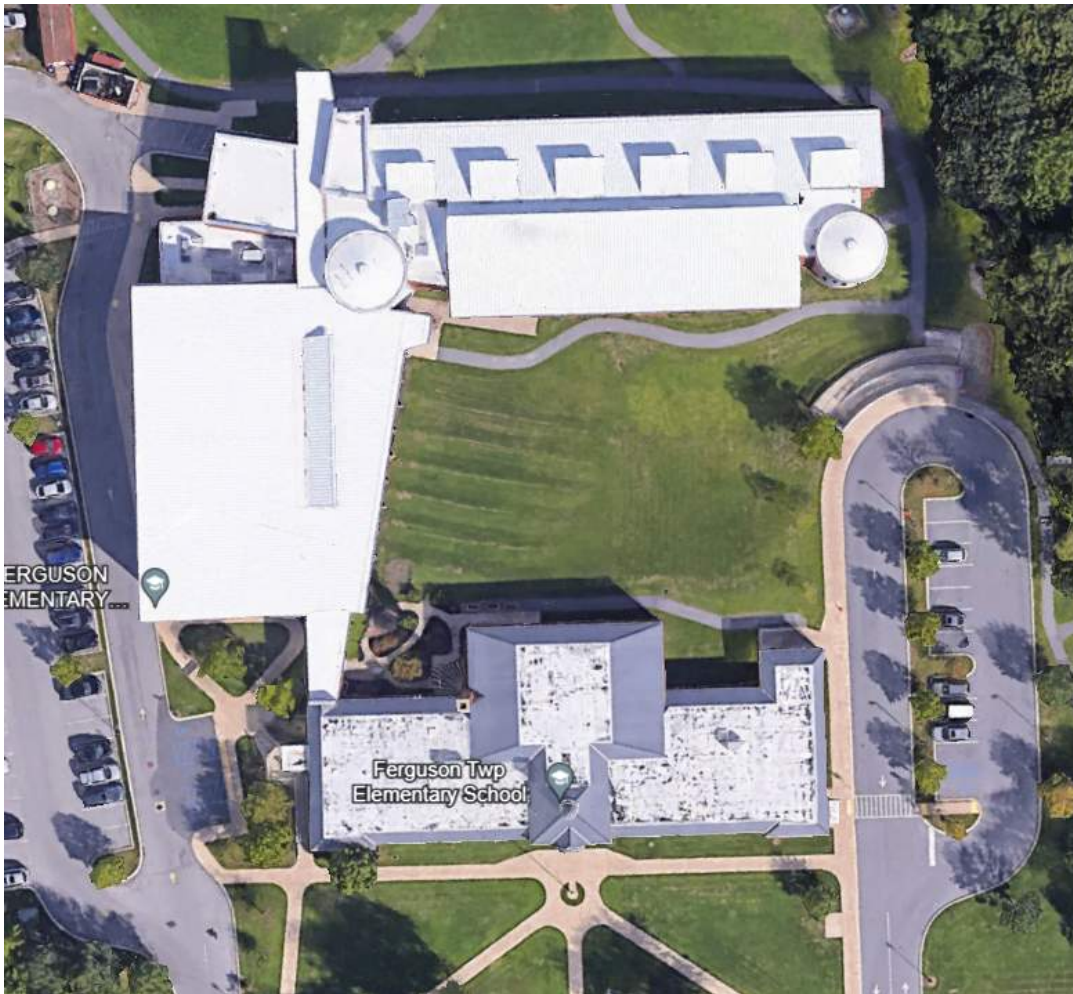
Rainwater for the most part is collected in metal gutters and taken down metal downspouts that tie into an underground storm system. Roofing and rainwater conveyance appear to be in good condition except for the one downspout/underground stormwater piping (shown below) that may be clogged and is staining the face brick.

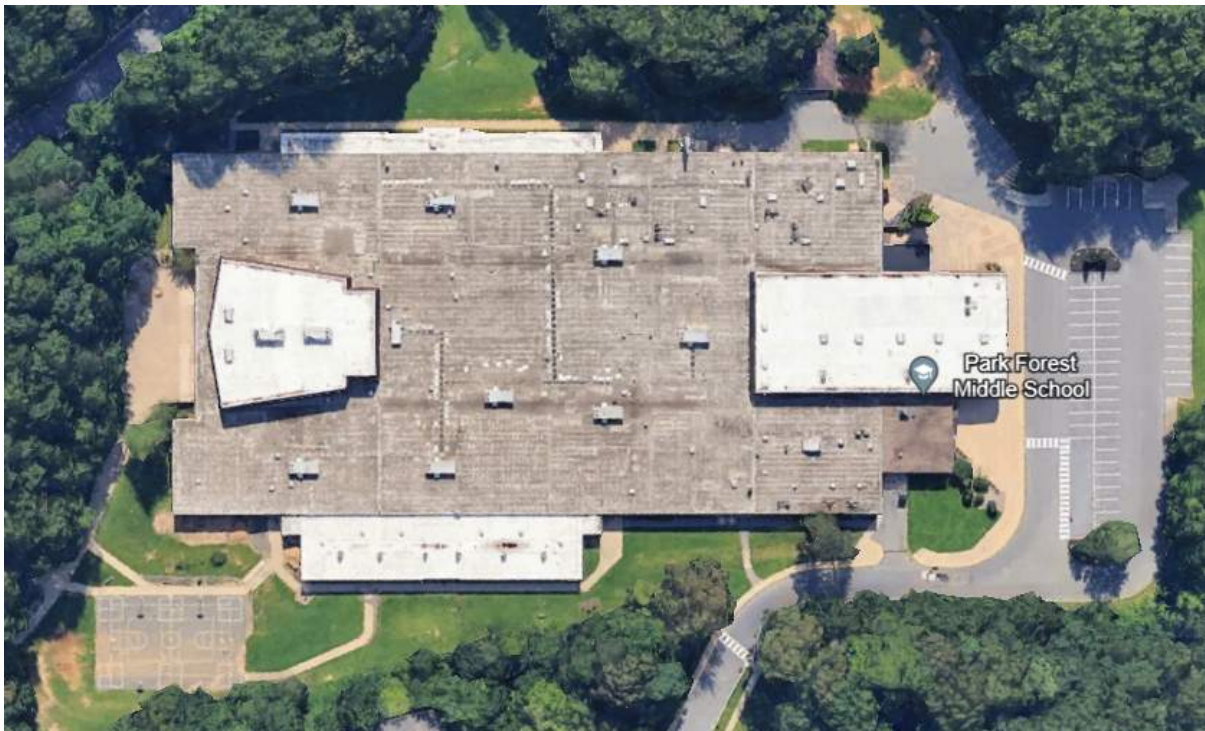
The roofs that are lighter in color on the plan below were roofs replaced in 2015 with a white TPO/EPDM membrane roofing system. The remainder of the flat roofs are built-up roofs that were replaced in 2009. One of the higher roofs has a mansard style roof with wood shingles and a flat roof in the middle that was one of the roofs replaced in 2015. The wood shingles appear to be in fair to poor condition. Rainwater is collected via roof drains and the internal roof water conductors run vertically to a point underground. From there they run horizontally and tie into exterior underground storm water piping.

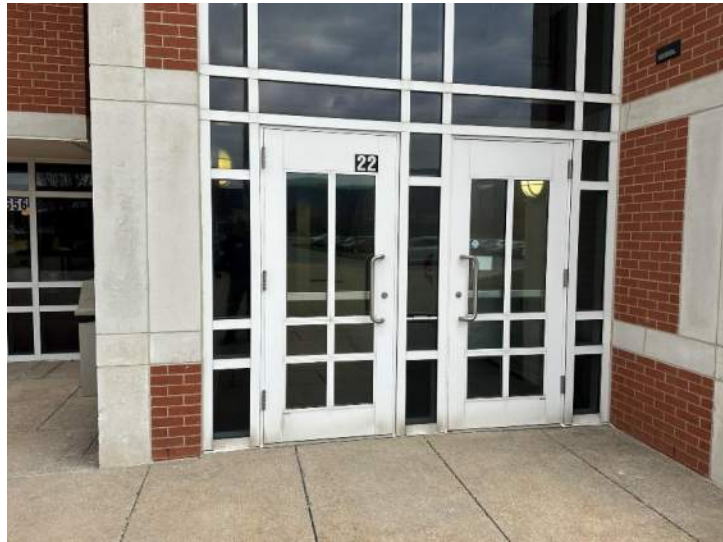
Entrances are clear anodized aluminum storefront with custom wide stile insulated aluminum doors. Aluminum doors and entrances are original to when the building was built and showing some signs of age.

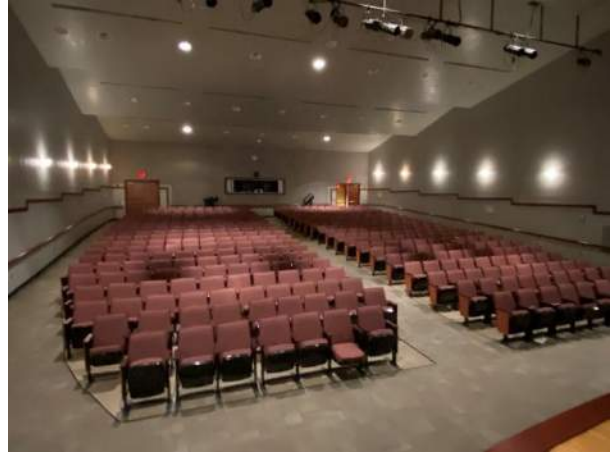
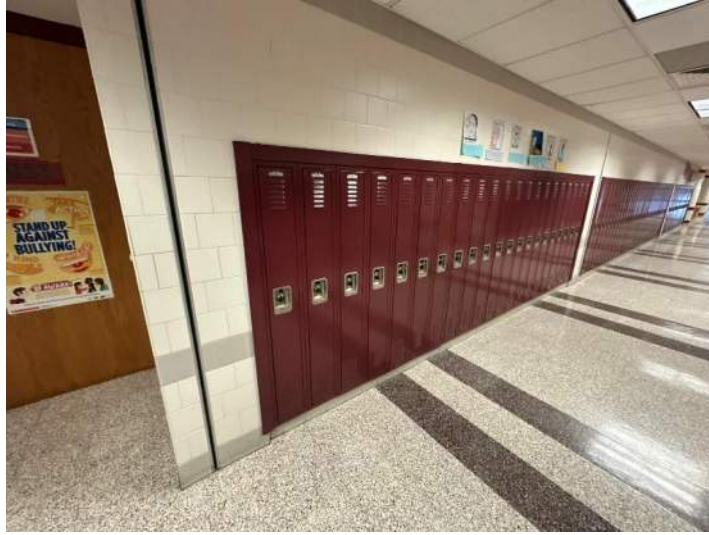
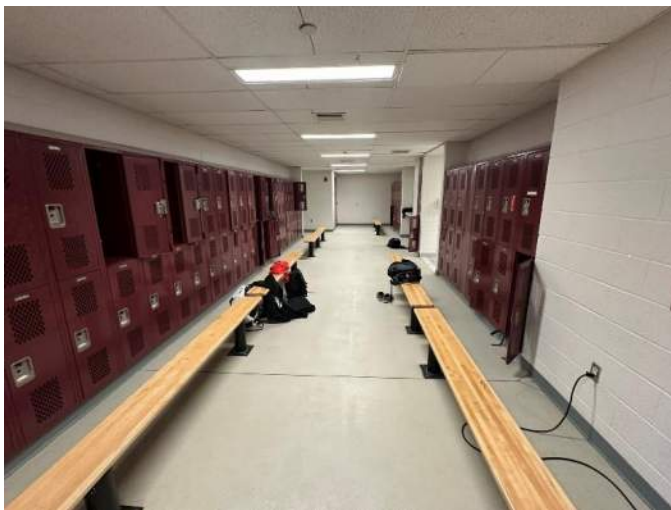
The auditorium seating appears to be original to when the building was constructed and is in fair condition. Some of the seats do not fold up when they are not being used.  
The rigging and lighting on the stage are original to when the building was constructed.
