## Canutillo ISD - Facility Condition Assessment

### Facility Condition by Campus

# **Facility Condition Assessment** Canutillo H. School Condition Assessment

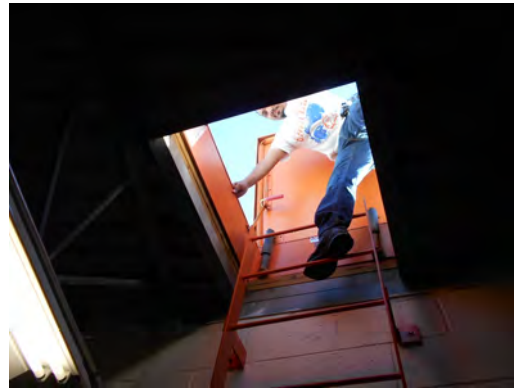
| Deficiency | Category | Qty | UoM | Priority | Repair Cost | ID |
|---|---|---|---|---|---|---|
| <b>Note:</b> Roof hatch / ladder system is installed incorretly. The hatch is oriented 180 degrees from what it should be. Safety hazard for maintenance personnel, as it is difficult to impossible to safely exit and enter the hatch from the roof<br><b>Location:</b> Auditorium and band wing roof | | | | | | |

Canutillo\_HS Roof ladder deficiencies

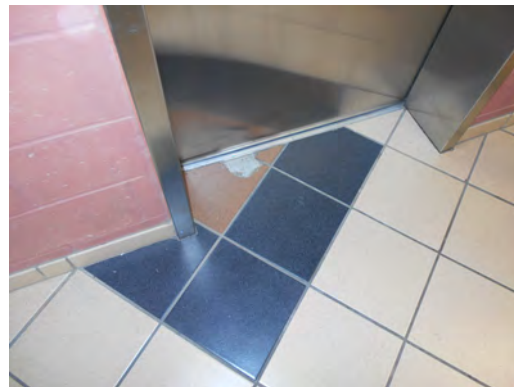
| Deficiency | Category | Qty | UoM | Priority | Repair Cost | ID |
|---|---|---|---|---|---|---|
| <b>Note:</b> Repair damaged and broken ceramic tiles<br><b>Location:</b> Throughout building | | | | | | |

Canutillo\_HS Ceramic floor tile deficiencies throughout building

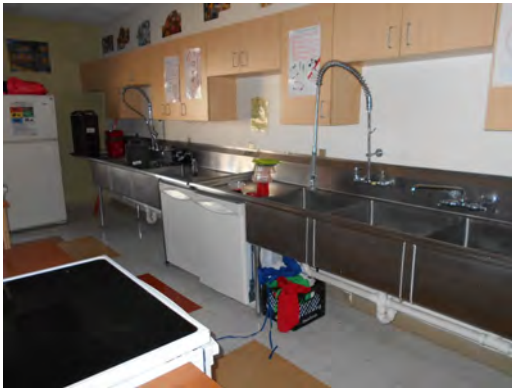
| Deficiency | Category | Qty | UoM | Priority | Repair Cost | ID |
|---|---|---|---|---|---|---|
| <b>Note:</b> The Culinary Arts classroom / kitchen is not functional. Inadequate electrical service, exhaust systems are not adequate, and the plumbing / drains are not adequate to meet code. Re-engineer and re-configure the Culinary Arts kitchen to meet code and functional adequacy requirements<br><b>Location:</b> Culinary Arts room | | | | | | |

Canutillo\_HS Cullinary Arts room deficiencies

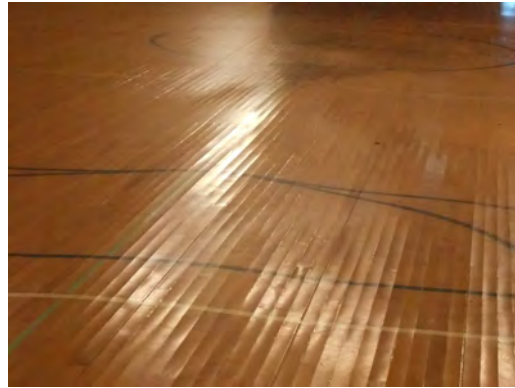
| Deficiency | Category | Qty | UoM | Priority | Repair Cost | ID |
|---|---|---|---|---|---|---|
| <b>Note:</b> Gym floor damaged from flooding, currently not usable<br><b>Location:</b> Gym | | | | | | |

Canutillo\_HS Gym floor water damage

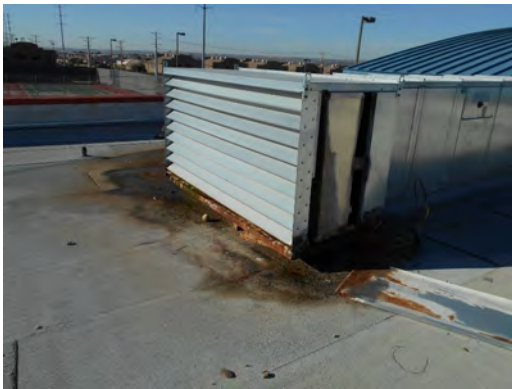
Canutillo\_HS Ag 1 Building, evaporative cooler failure

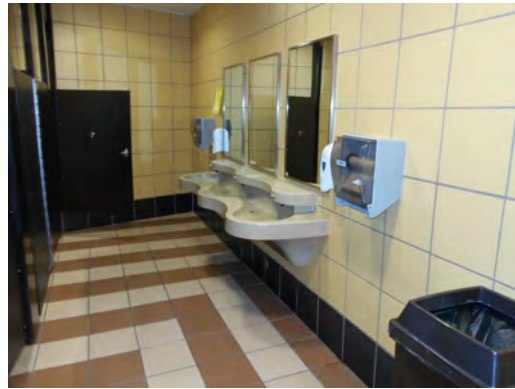
| Deficiency | Category | Qty | UoM | Priority | Repair Cost | ID |
|---|---|---|---|---|---|---|
| <b>Note:</b> Remove paper towel holders and install electric hand dryers. CISD identified deficiency.<br><b>Location:</b> All student restrooms | | | | | | |

Canutillo\_HS Replace paper towels with hand dryers

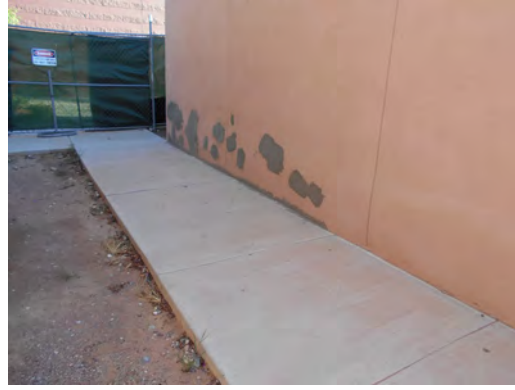
NW\_Early\_College\_Campus Exterior paint deficiency

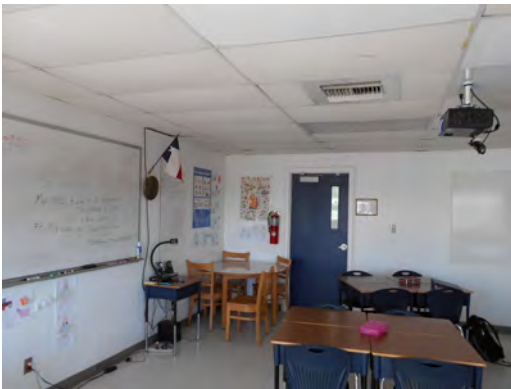
NW\_Early\_College\_Campus Classrooms need to be painted

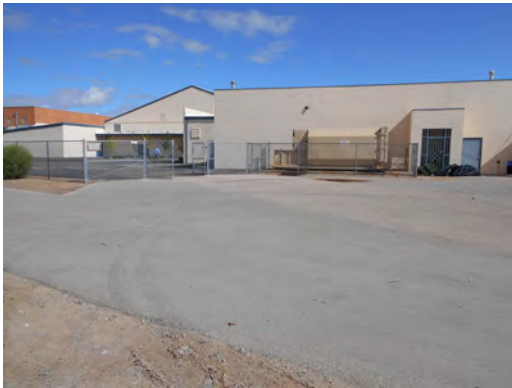
Canutillo\_MS Parking Lots, repave and restripe

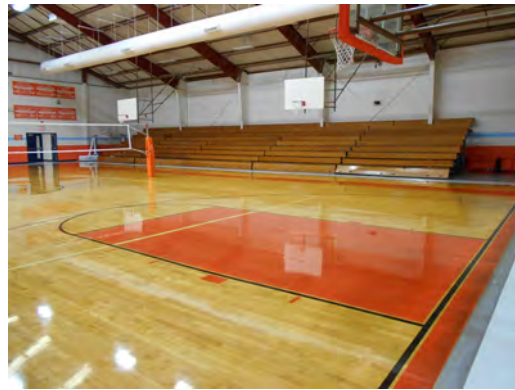
Canutillo\_MS Retractable Bleacher system, original, replace

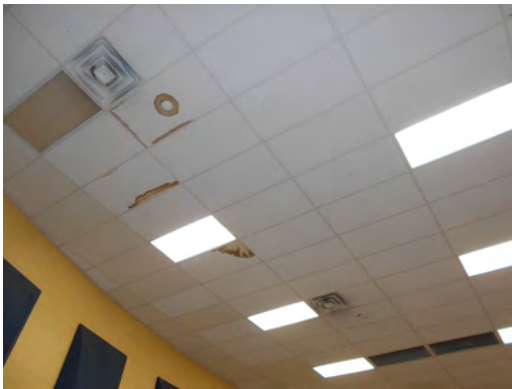
Canutillo\_MS Replace ceiling grid and tile systems

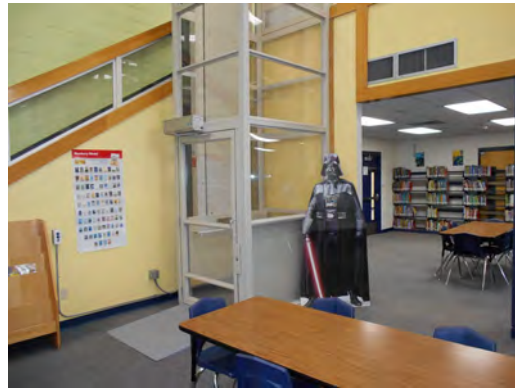
Canutillo\_MS Library lift station is not ADA compliant

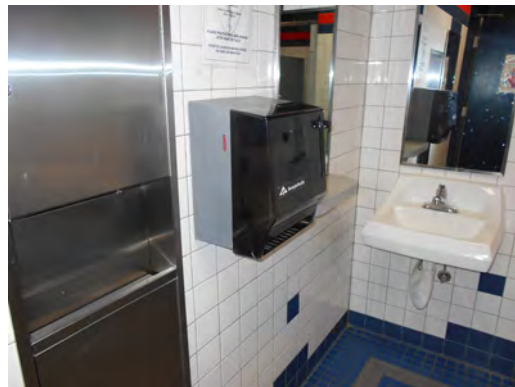
Canutillo\_MS Replace paper towels with hand dryers

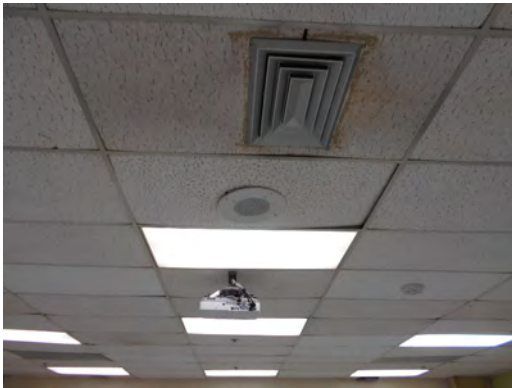
Canutilo\_MS Replace old ductwork and registers

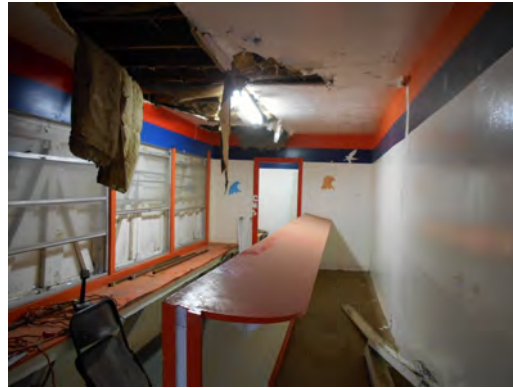
Canutilo\_MS Press Box, abandoned interior

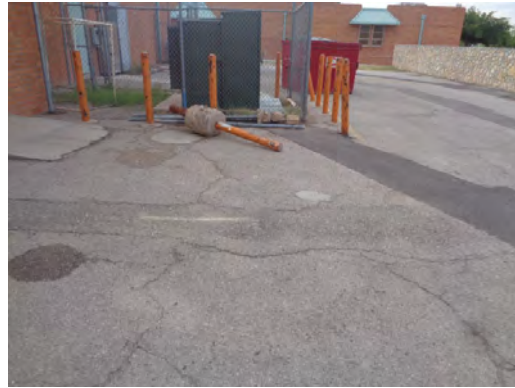
Alderete\_MS Bollard damaged

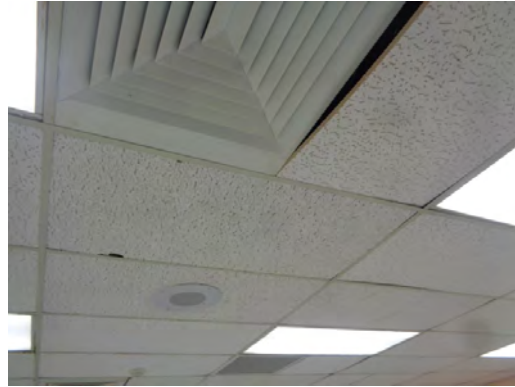
Alderete\_MS Ceiling grid and time system

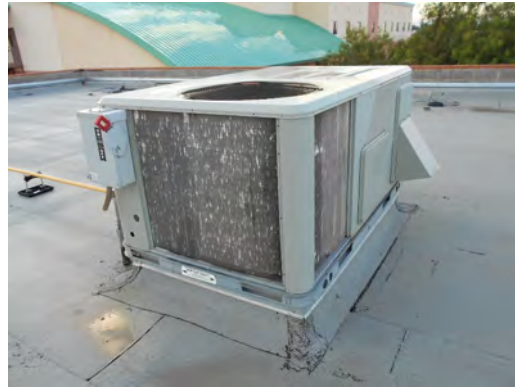
Alderete\_MS Main building, replace old RTU's

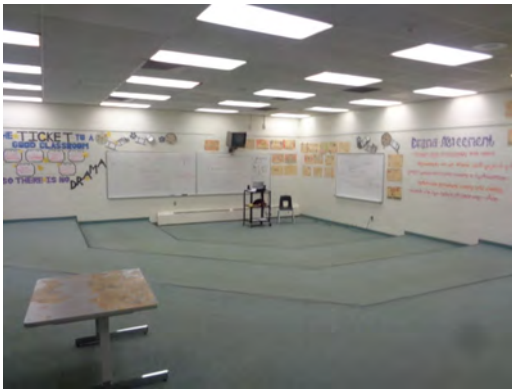
Alderete\_MS Main building, replace old worn carpet

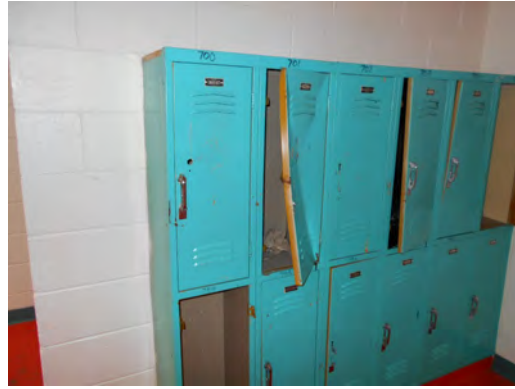
Alderete\_MS Main building, replace old damaged locker system

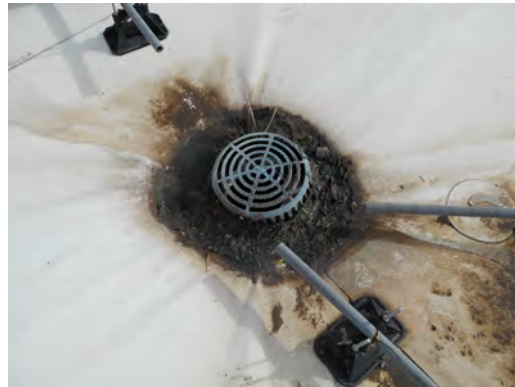
Alderete\_MS Main Building, clean and clear debris from roof

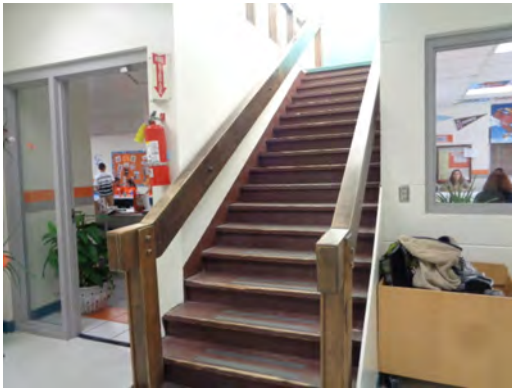
Alderete\_MS Main building, handrails not ADA compliant

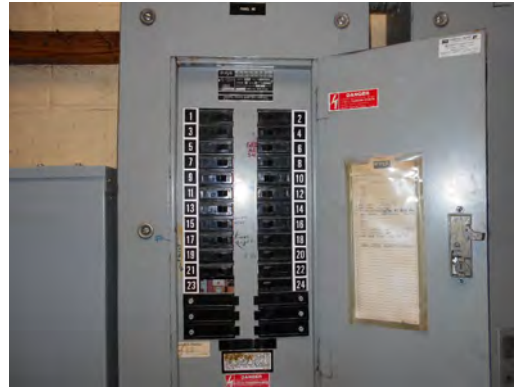
Alderete\_MS Main building, replace all old Federal Pacific electrical panels

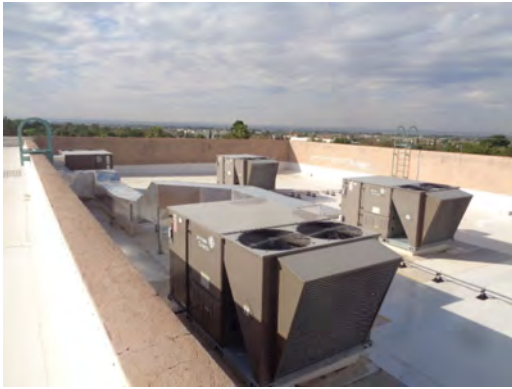
Alderete\_MS Main building, seal parapet walls and recaulk flashing joints

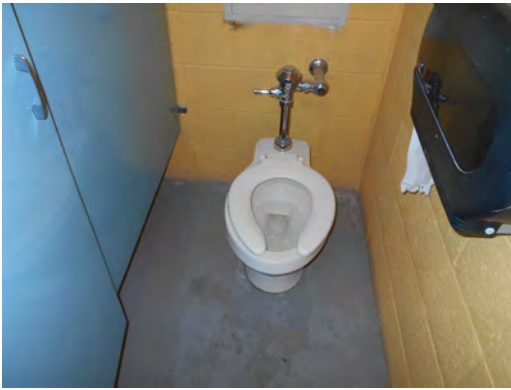
Canutillo ES\_Interior CMU needs repainting

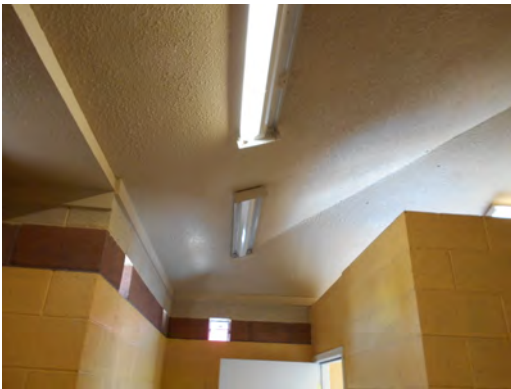
Canutillo ES\_Light fixtures failing

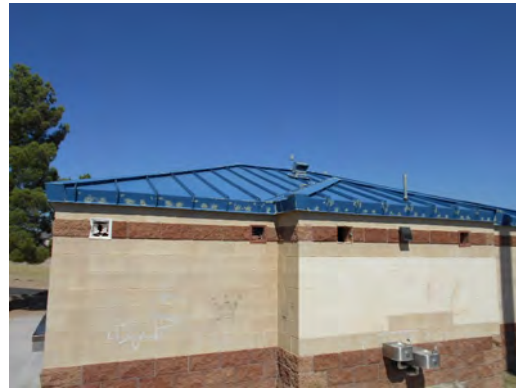
Canutillo ES\_Metal roof should be replaced

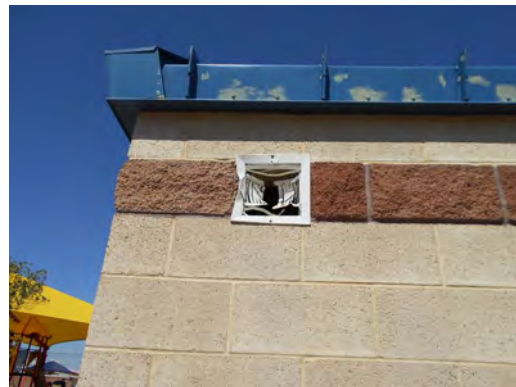
Canutillo ES\_Replace damaged metal cover

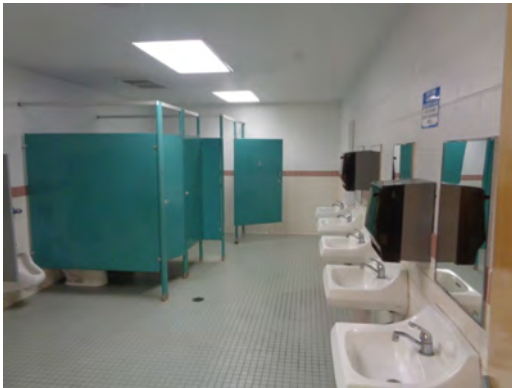
Canutillo ES\_Replace Paper Towel Holders

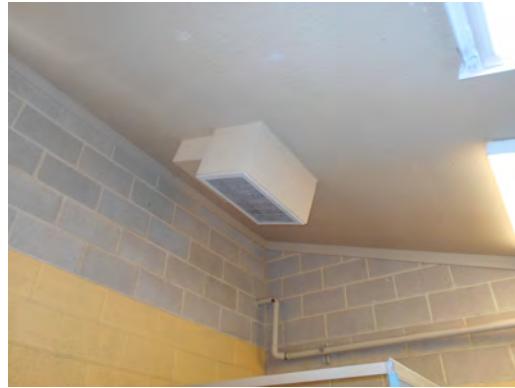
Canutillo ES\_Restroom exhaust deficient

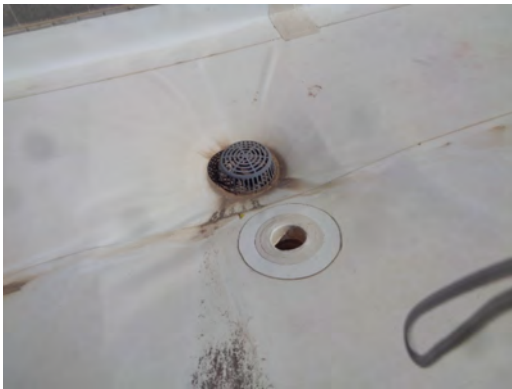
Canutillo ES\_Roof debris covers, stainers are missing

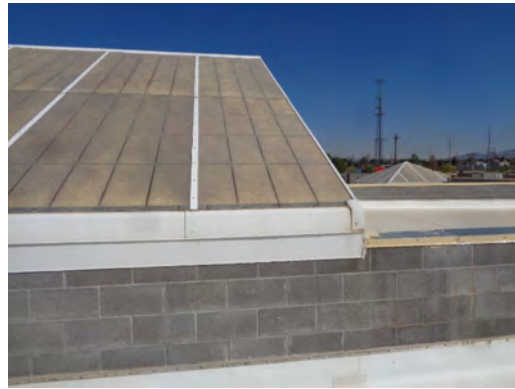
Canutillo ES\_Seal CMU wall and recaulk parapet wall joints

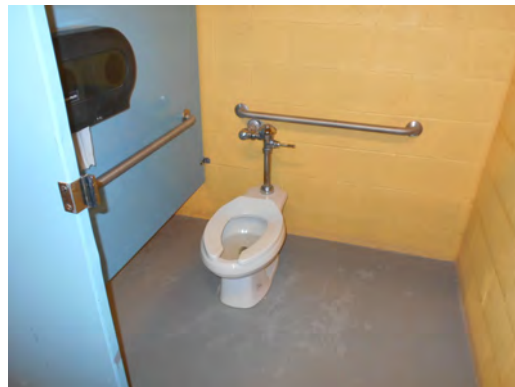
Canutillo ES\_Toilet partitions need to be painted

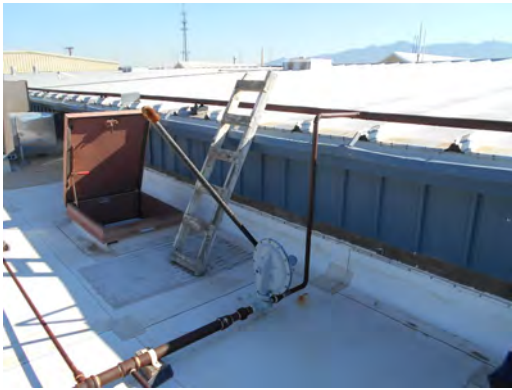
Canutilo ES\_Unsafe roof access 1

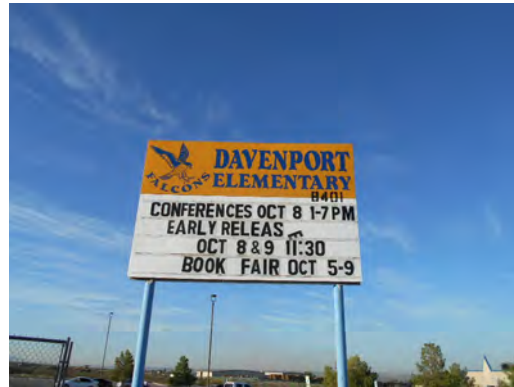
Davenport\_ES Replace old Marquee

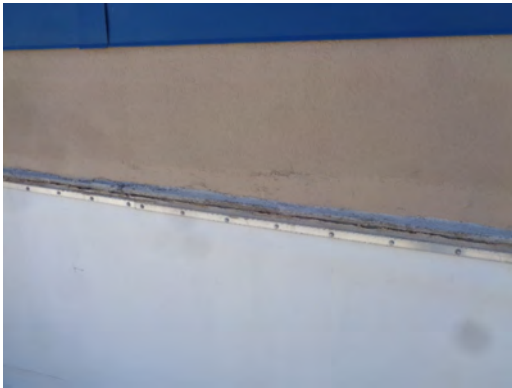
Davenport\_ES Parapet wall seal and caulk joints

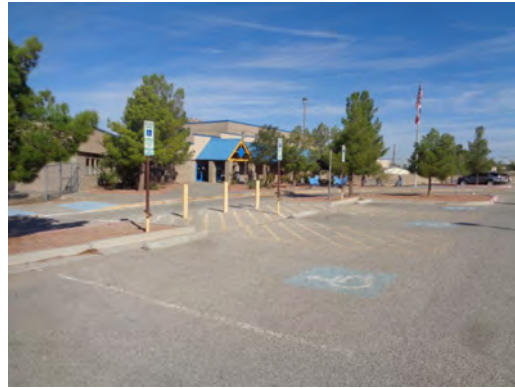
Davenport\_ES Parking lot repairs and restripe

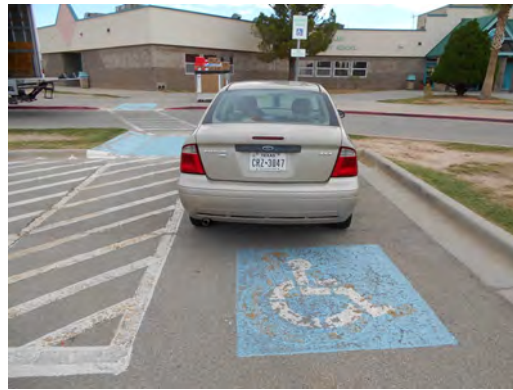
Damian\_ES Parking lot deficiency, restripe

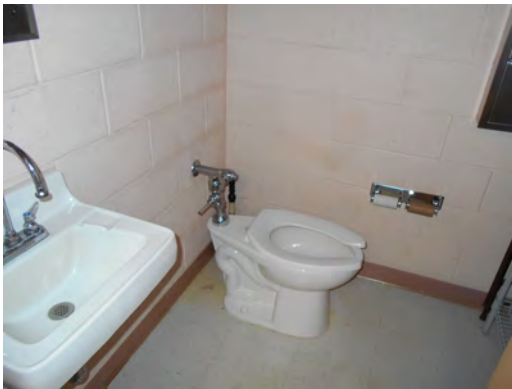
Damian\_ES Restroom is not ADA Compliant

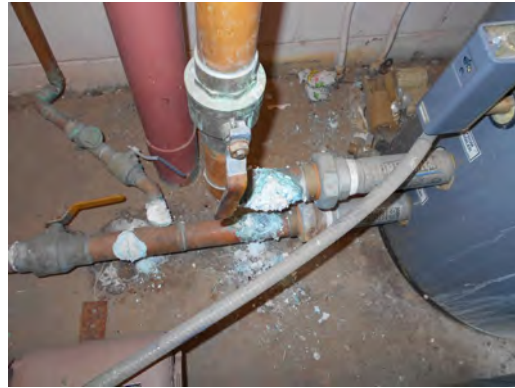
Damian\_ES Mechanical room, needed water pipe repairs

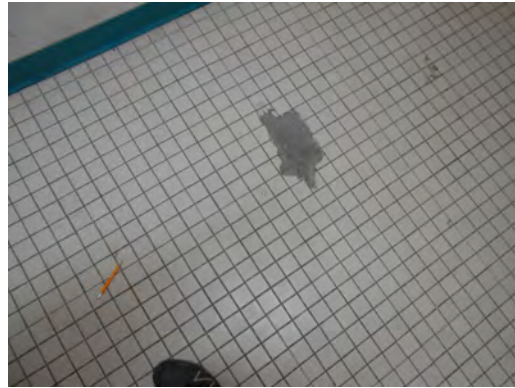
Childress ES\_Damaged ceramic tile

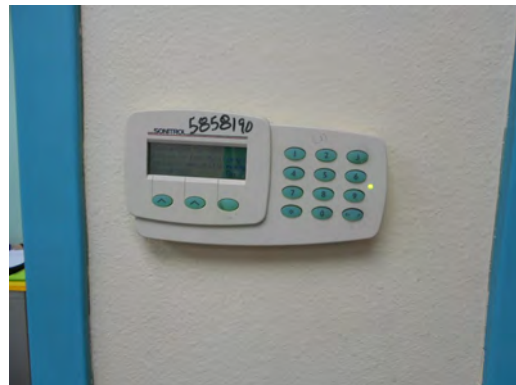
Childress ES\_Thermostat control

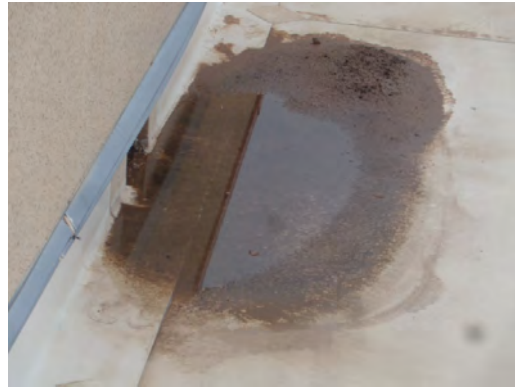
Garcia\_ES Clean debris from roof

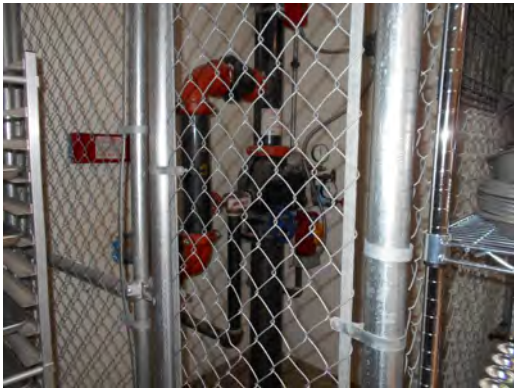
Canutillo\_Central\_Office Warehouse Sprinkler system

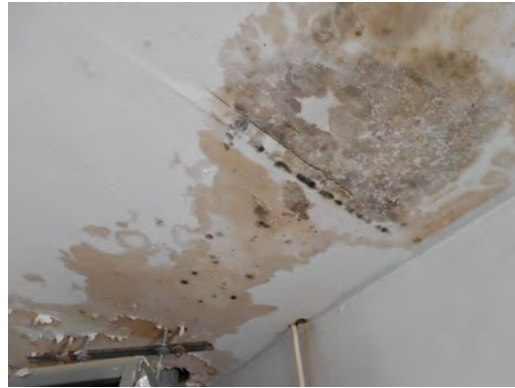
Lone\_Star\_Buildings Cottage 1, Interior Damage

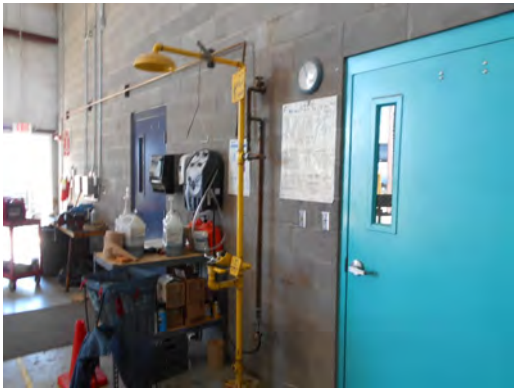
Canutillo\_Facilities\_Transportation Safety Shower

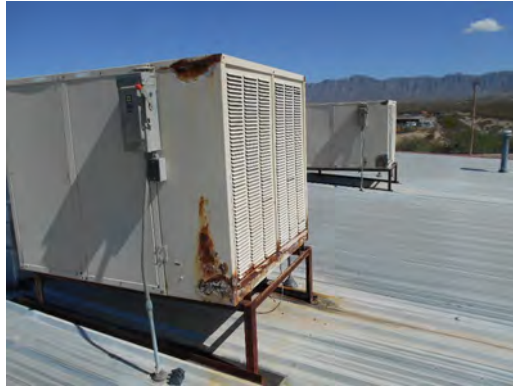
Canutillo\_Facilities\_Transportation Evaporative Cooler Deficiency
