July 17, 2023

Roanoke County Public Schools
5937 Cove Road
Roanoke, Virginia 24109

Subject: Asbestos Survey Services
Glen Cove Elementary School
5901 Cove Road
Roanoke, Virginia 24019
H&P Project: 20230842

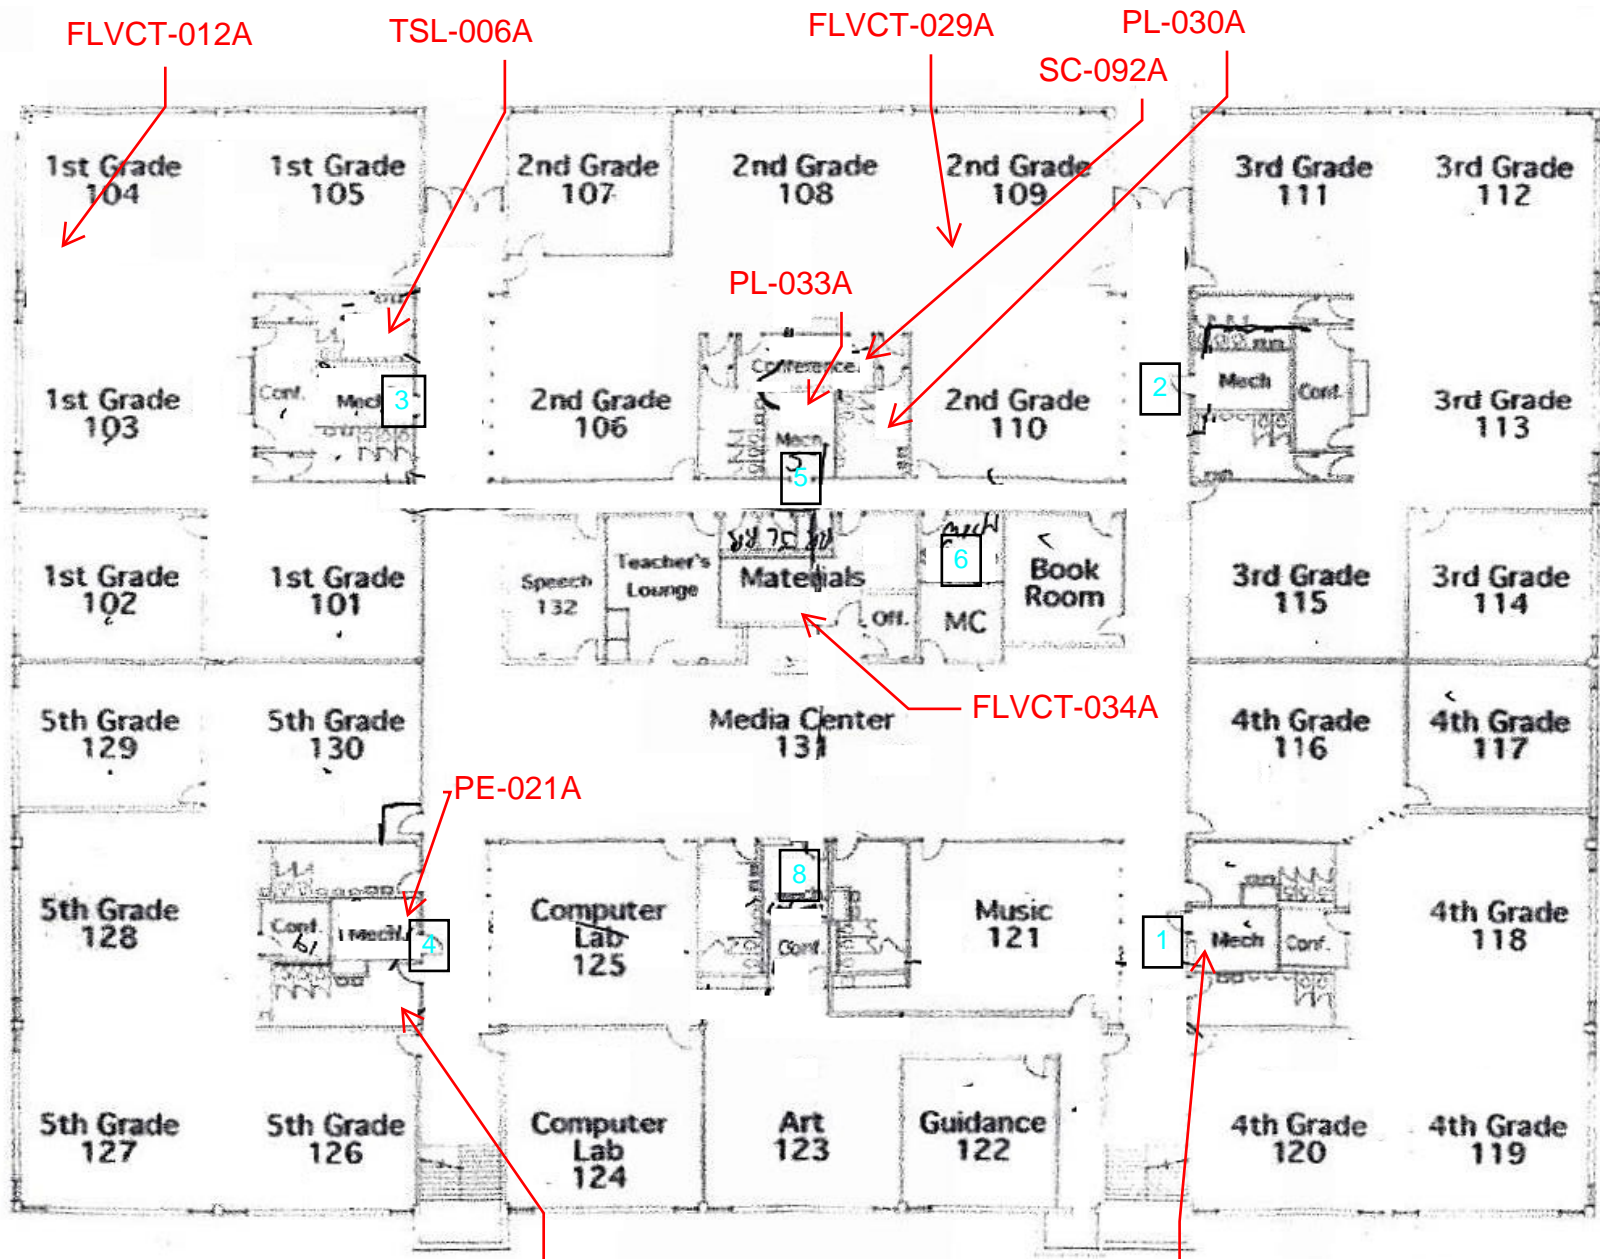
RED INDICATES APORXIMATE POSITIVE ASBESTOS SAMPLE LOCATION

PE-026A, PE-027A

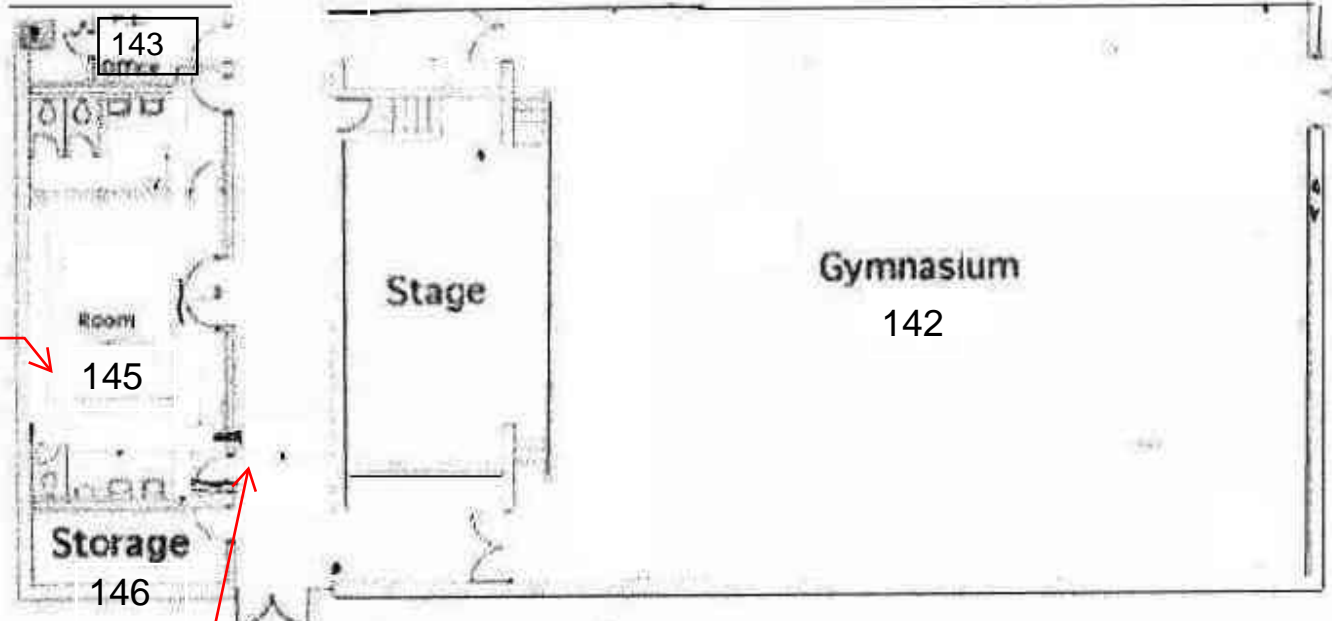
FIRST FLOOR

FLVCT-064A

PM-063A

RED INDICATES APORXIMATE
POSITIVE ASBESTOS SAMPLE
LOCATION

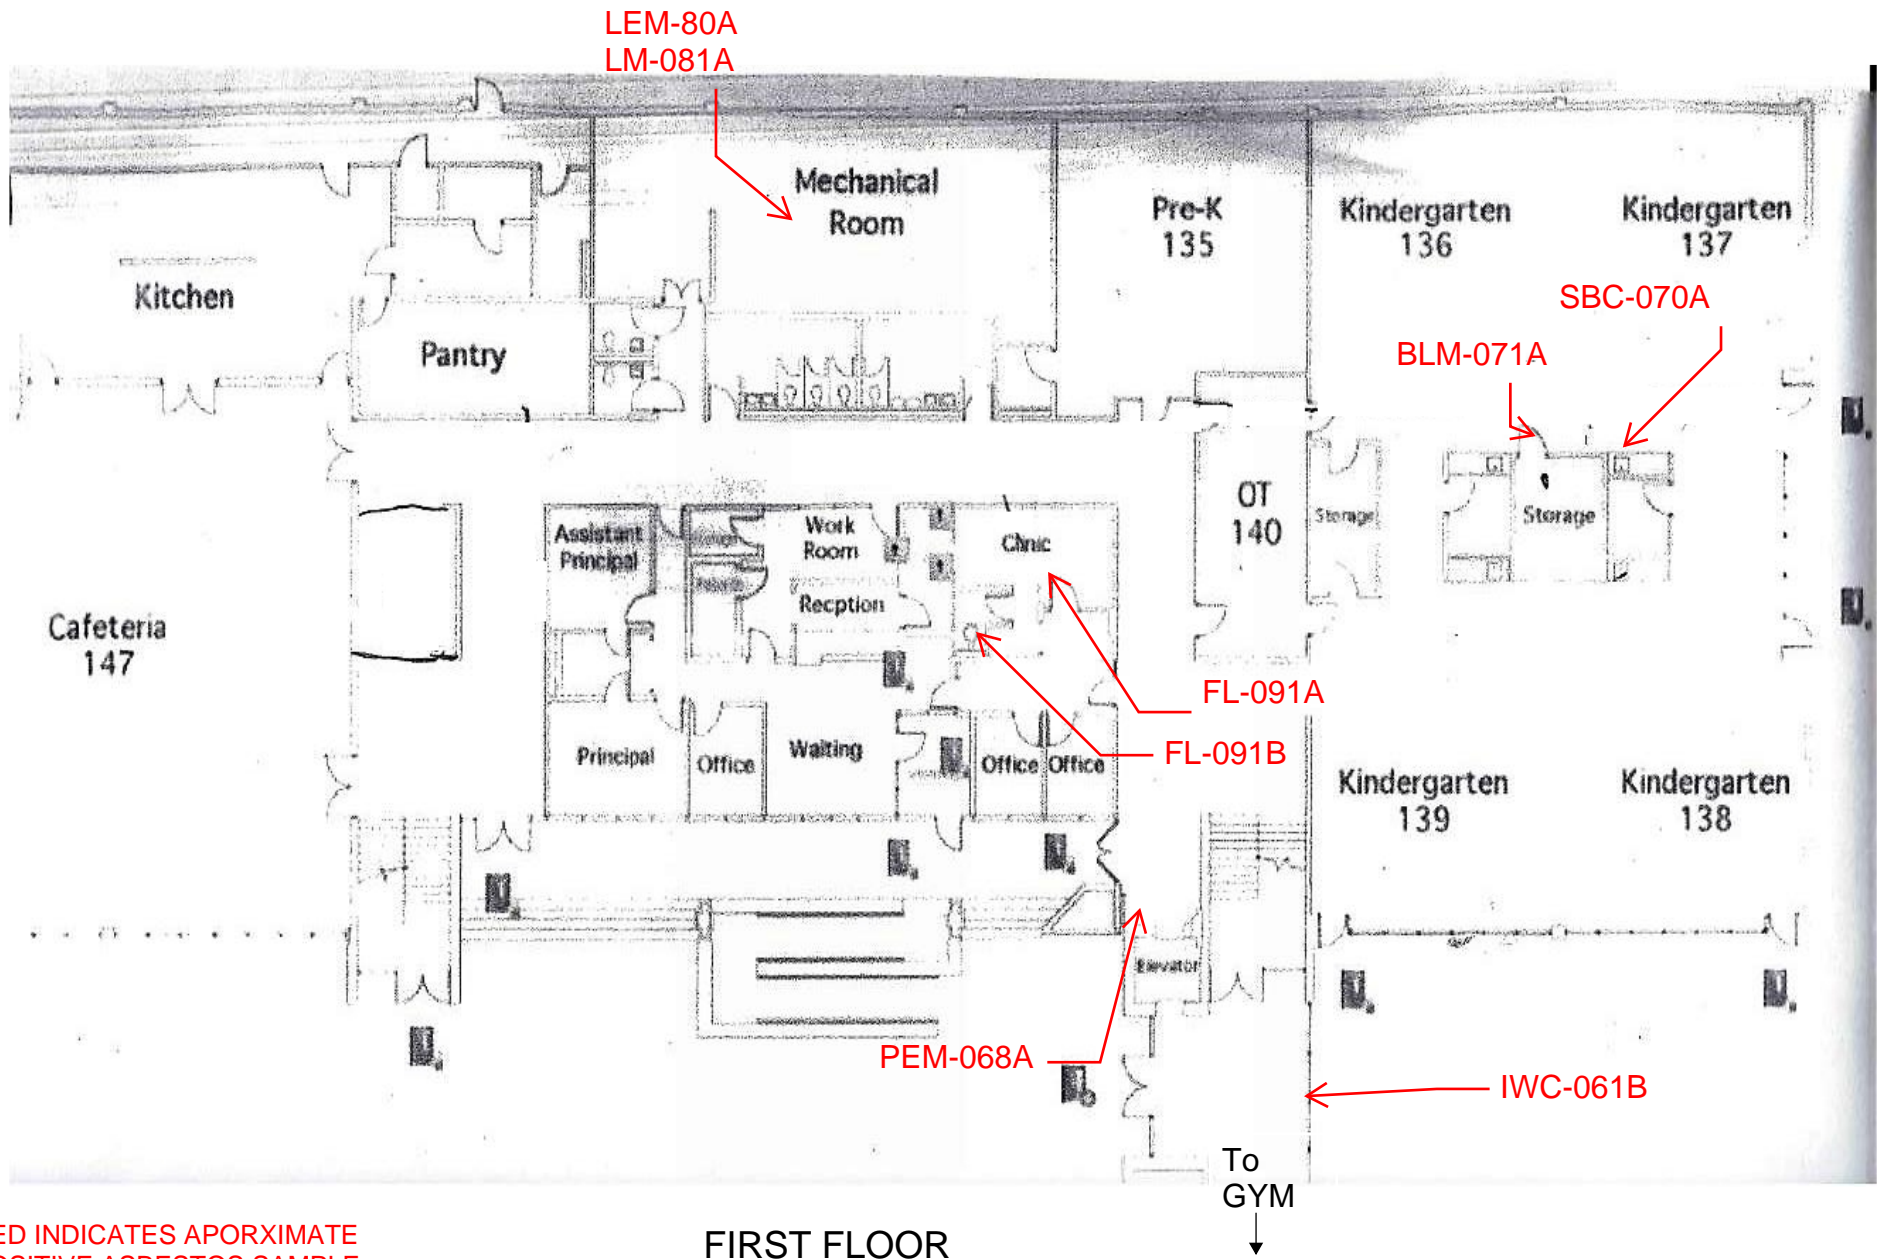
FIRST FLOOR

RED INDICATES APOXIMATE
 POSITIVE ASBESTOS SAMPLE
 LOCATION
