Subject: Asbestos Survey Services
W.E. Cundiff Elementary School
1200 Hardy Road
Vinton, Virginia 24179
H&P Project: 20230841

Hurt & Proffitt, Inc. (H&P) was requested to conduct a survey, sampling and analysis for suspect asbestos containing materials in W. E. Cundiff Elementary School located at 1200 Hardy Road in Vinton, Virginia. This letter and attachments represent H&P's report for the above-referenced project.

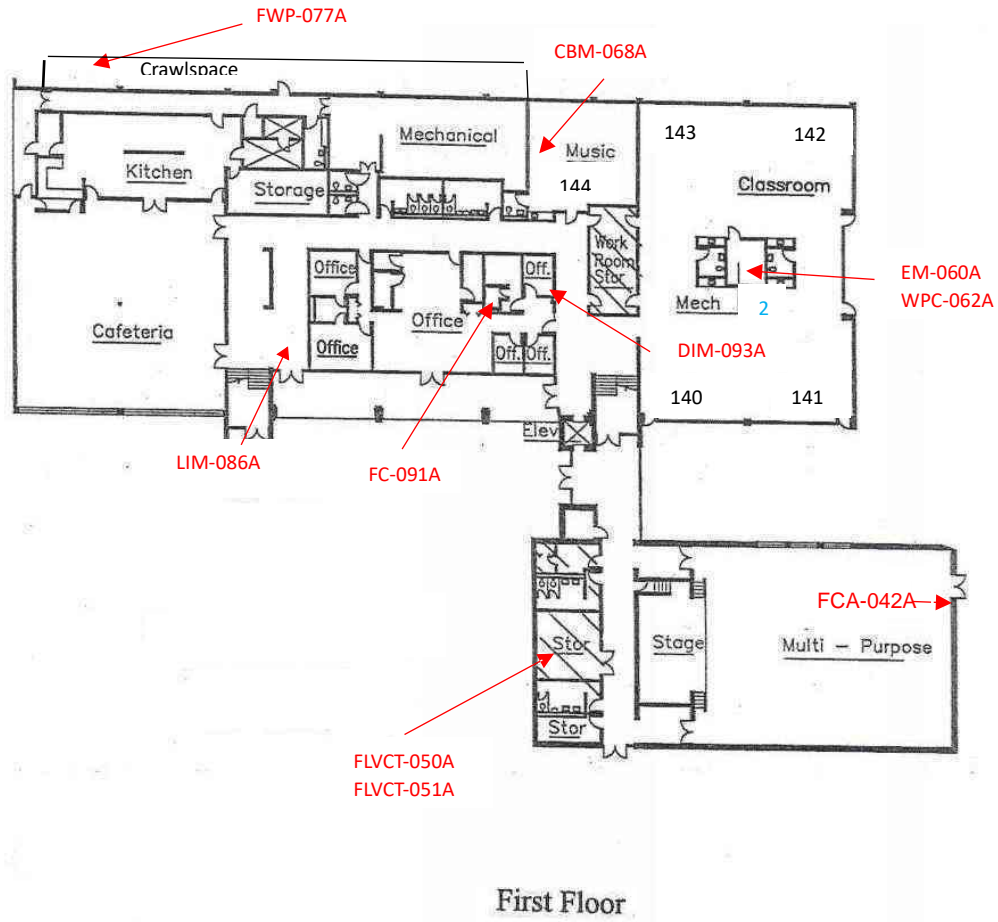
W.E. Cundiff Asbestos Inspection Site Map

Red Indicates Approximate Positive Asbestos Sample Location

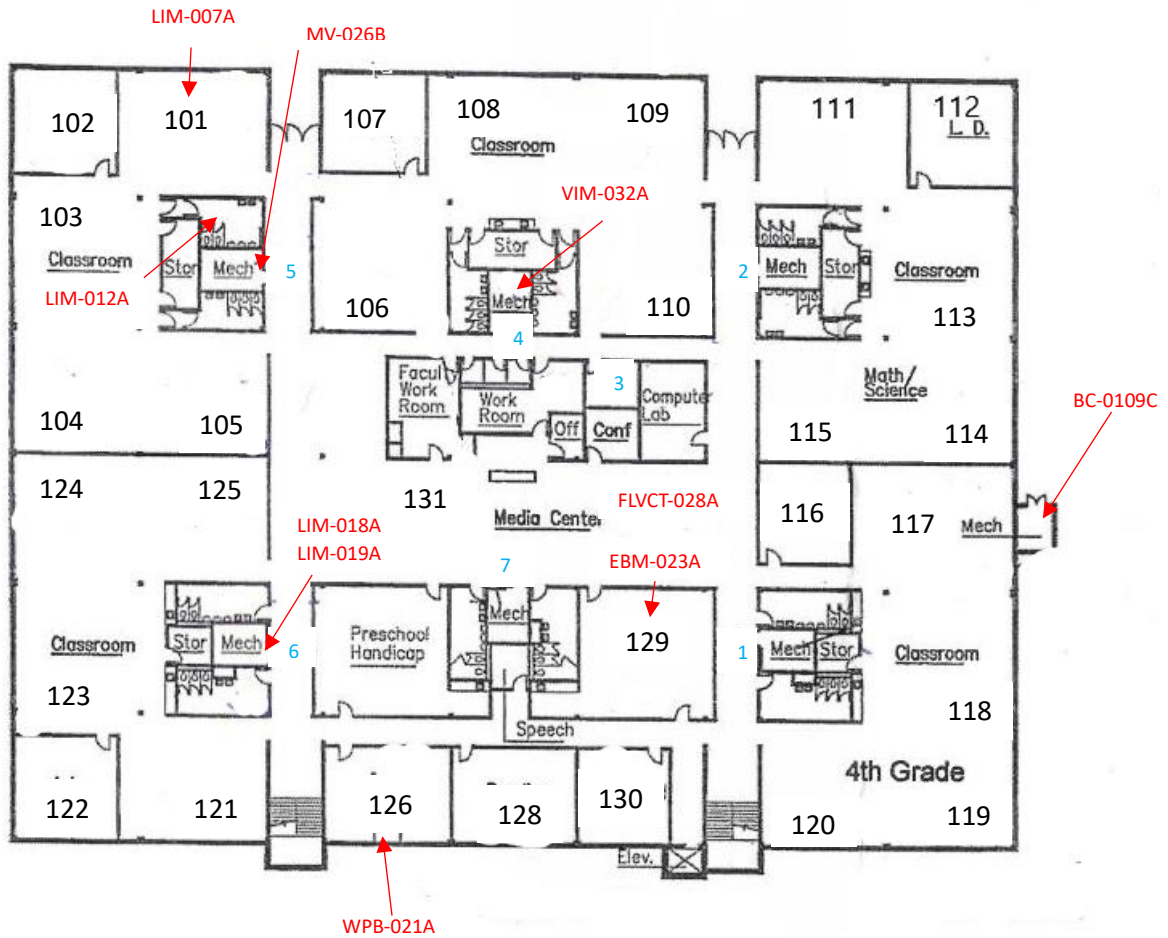
Second Floor

RED INDICATES APPROXIMATE POSITIVE ASBESTOS SAMPLE LOCATION
Blue Numbers Indicate Mech Room
